**Development of a Biodiesel Plant at  
Tseung Kwan O Industrial Estate**

**Monthly Environmental Monitoring and  
Audit Report for  
March 2021**

**Development of a Biodiesel Plant at Tseung Kwan O Industrial Estate - Operation Phase**

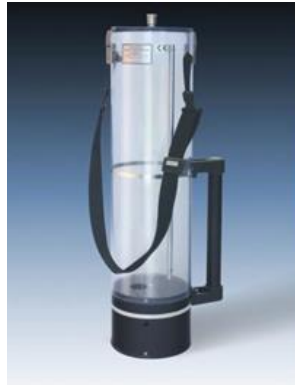
Odour Sampling System

Odour gas sample is collected by a Sampling Device Standard consists of a vacuum container, which is evacuated by a vacuum pump. The sampling point and the standard sampler are connected by a probe. Due to the evacuation in the sampling device, the sample bag, inside the device, sucks in sample air via the probe. During this process, none of its components come into contact with the sample air due to the construction of the sampling device.
