# ASB Biodiesel (Hong Kong) Limited

**Development of a Biodiesel Plant at  
Tseung Kwan O Industrial Estate**

**Monthly Environmental Monitoring and  
Audit Report for  
January 2022**

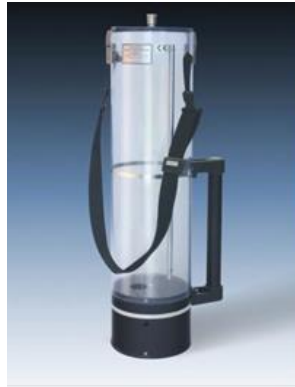
Odour Sampling System

Odour gas sample is collected by a Sampling Device Standard consists of a vacuum container, which is evacuated by a vacuum pump. The sampling point and the standard sampler are connected by a probe. Due to the evacuation in the sampling device, the sample bag, inside the device, sucks in sample air via the probe. During this process, none of its components come into contact with the sample air due to the construction of the sampling device.

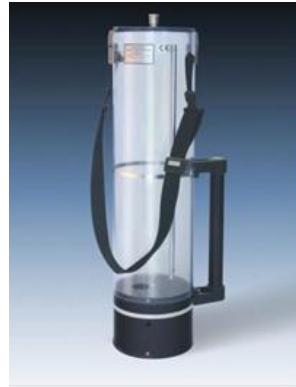
Odour Sampling System

Odour gas sample is collected by a Sampling Device Standard consists of a vacuum container, which is evacuated by a vacuum pump. The sampling point and the standard sampler are connected by a probe. Due to the evacuation in the sampling device, the sample bag, inside the device, sucks in sample air via the probe. During this process, none of its components come into contact with the sample air due to the construction of the sampling device.
