ASB Biodiesel (Hong Kong) Limited

**Development of a Biodiesel Plant at
Tseung Kwan O Industrial Estate**

**Monthly Environmental Monitoring and
Audit Report for
February 2022**

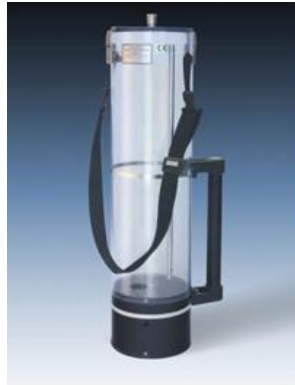
Odour Sampling System

Odour gas sample is collected by a Sampling Device Standard consists of a vacuum container, which is evacuated by a vacuum pump. The sampling point and the standard sampler are connected by a probe. Due to the evacuation in the sampling device, the sample bag, inside the device, sucks in sample air via the probe. During this process, none of its components come into contact with the sample air due to the construction of the sampling device.
