ASB Biodiesel (Hong Kong) Limited

**Development of a Biodiesel Plant at
Tseung Kwan O Industrial Estate**

**Monthly Environmental Monitoring and
Audit Report for
April 2022**

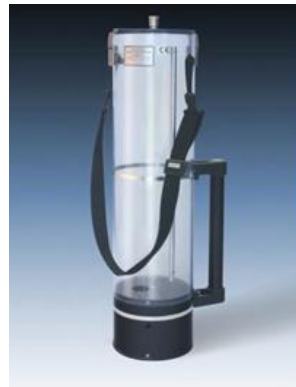
Odour Sampling System

Odour gas sample is collected by a Sampling Device Standard consists of a vacuum container, which is evacuated by a vacuum pump. The sampling point and the standard sampler are connected by a probe. Due to the evacuation in the sampling device, the sample bag, inside the device, sucks in sample air via the probe. During this process, none of its components come into contact with the sample air due to the construction of the sampling device.

Odour gas sample is collected by a Sampling Device Standard consists of a vacuum container, which is evacuated by a vacuum pump. The sampling point and the standard sampler are connected by a probe. Due to the evacuation in the sampling device, the sample bag, inside the device, sucks in sample air via the probe. During this process, none of its components come into contact with the sample air due to the construction of the sampling device.
