ASB Biodiesel (Hong Kong) Limited

Development of a Biodiesel Plant at Tseung Kwan O Industrial Estate

Monthly Environmental Monitoring and Audit Report for May 2022

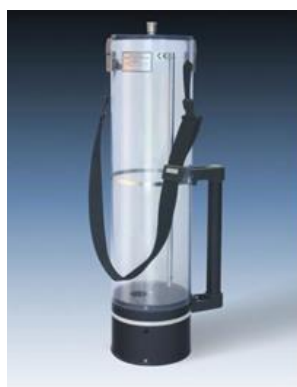
Odour Sampling System

Odour gas sample is collected by a Sampling Device Standard consists of a vacuum container, which is evacuated by a vacuum pump. The sampling point and the standard sampler are connected by a probe. Due to the evacuation in the sampling device, the sample bag, inside the device, sucks in sample air via the probe. During this process, none of its components come into contact with the sample air due to the construction of the sampling device.
