# ASB Biodiesel (Hong Kong) Limited

**Development of a Biodiesel Plant at  
Tseung Kwan O Industrial Estate**

**Monthly Environmental Monitoring and  
Audit Report for  
June 2022**

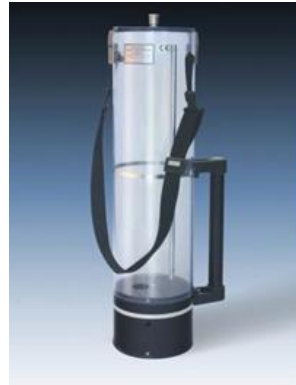
Odour Sampling System

Odour gas sample is collected by a Sampling Device Standard consists of a vacuum container, which is evacuated by a vacuum pump. The sampling point and the standard sampler are connected by a probe. Due to the evacuation in the sampling device, the sample bag, inside the device, sucks in sample air via the probe. During this process, none of its components come into contact with the sample air due to the construction of the sampling device.
