ASB Biodiesel (Hong Kong) Limited

Development of a Biodiesel Plant at Tseung Kwan O Industrial Estate

Monthly Environmental Monitoring and Audit Report for August 2022 (version 1.0)

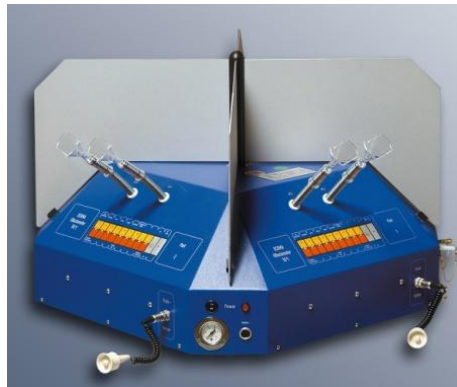
Odour concentration is determined by a Dynamic Olfactometer (TO9) in accordance with the European Standard Method (EN13725). This European Standard specifies a method for the objective determination of the odour concentration of a gaseous sample using dynamic olfactometry with human assessors and the emission rate of odours emanating from point sources, area sources with outward flow and area sources without outward flow. This European Standard is applicable to the measurement of odour concentration of pure substances, defined mixtures and undefined mixtures of gaseous odorants in air or nitrogen, using dynamic olfactometry with a panel of human assessors being the sensor. The unit of measurement is the odour unit per cubic metre: OU_E/m^3 . The odour concentration is measured by determining the dilution factor required to reach the detection threshold. The odour concentration at the detection threshold is defined as $1 OU_E/m^3$. The odour concentration is then expressed in terms of multiples of the detection threshold. The range of measurement is typically from $2^2 OU_E/m^3$ to $2^{17} OU_E/m^3$ (excluding pre-dilution).

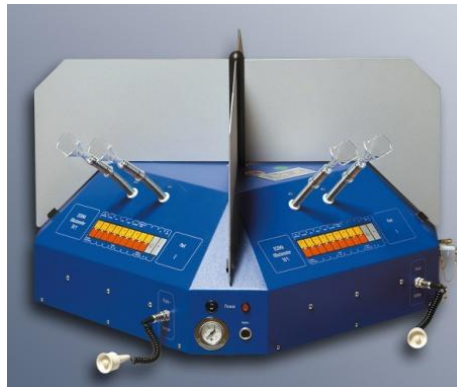
Odour concentration is determined by a Dynamic Olfactometer (TO9) in accordance with the European Standard Method (EN13725). This European Standard specifies a method for the objective determination of the odour concentration of a gaseous sample using dynamic olfactometry with human assessors and the emission rate of odours emanating from point sources, area sources with outward flow and area sources without outward flow. This European Standard is applicable to the measurement of odour concentration of pure substances, defined mixtures and undefined mixtures of gaseous odorants in air or nitrogen, using dynamic olfactometry with a panel of human assessors being the sensor. The unit of measurement is the odour unit per cubic metre: OU_E/m^3 . The odour concentration is measured by determining the dilution factor required to reach the detection threshold. The odour concentration at the detection threshold is defined as $1 OU_E/m^3$. The odour concentration is then expressed in terms of multiples of the detection threshold. The range of measurement is typically from $2^2 OU_E/m^3$ to $2^{17} OU_E/m^3$ (excluding pre-dilution).
