# ASB Biodiesel (Hong Kong) Limited

## Development of a Biodiesel Plant at Tseung Kwan O Industrial Estate

### Monthly Environmental Monitoring and Audit Report for December 2022

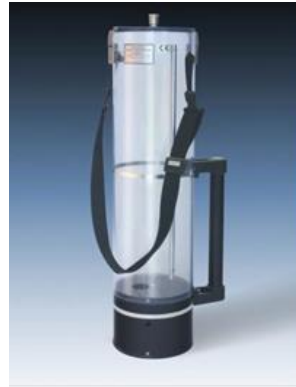
Odour Sampling System

Odour gas sample is collected by a Sampling Device Standard consists of a vacuum container, which is evacuated by a vacuum pump. The sampling point and the standard sampler are connected by a probe. Due to the evacuation in the sampling device, the sample bag, inside the device, sucks in sample air via the probe. During this process, none of its components come into contact with the sample air due to the construction of the sampling device.
