ASB Biodiesel (Hong Kong) Limited

**Development of a Biodiesel Plant at
Tseung Kwan O Industrial Estate**

**Monthly Environmental Monitoring and
Audit Report for
February 2023**

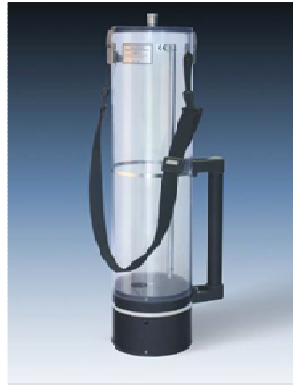
Odour Sampling System

Odour gas sample is collected by a Sampling Device Standard consists of a vacuum container, which is evacuated by a vacuum pump. The sampling point and the standard sampler are connected by a probe. Due to the evacuation in the sampling device, the sample bag, inside the device, sucks in sample air via the probe. During this process, none of its components come into contact with the sample air due to the construction of the sampling device.

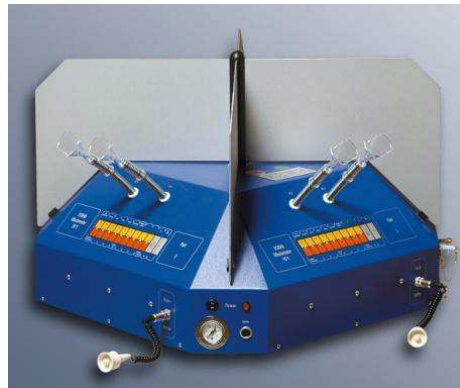
Odour concentration is determined by a Dynamic Olfactometer (TO9) in accordance with the European Standard Method (EN13725). This European Standard specifies a method for the objective determination of the odour concentration of a gaseous sample using dynamic olfactometry with human assessors and the emission rate of odours emanating from point sources, area sources with outward flow and area sources without outward flow. This European Standard is applicable to the measurement of odour concentration of pure substances, defined mixtures and undefined mixtures of gaseous odorants in air or nitrogen, using dynamic olfactometry with a panel of human assessors being the sensor. The unit of measurement is the odour unit per cubic metre: OU_E/m^3 . The odour concentration is measured by determining the dilution factor required to reach the detection threshold. The odour concentration at the detection threshold is defined as $1 \text{ OU}_E/\text{m}^3$. The odour concentration is then expressed in terms of multiples of the detection threshold. The range of measurement is typically from $2^2 \text{ OU}_E/\text{m}^3$ to $2^{17} \text{ OU}_E/\text{m}^3$ (excluding pre-dilution).

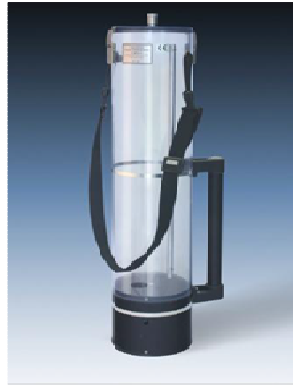
Odour Sampling System

Odour gas sample is collected by a Sampling Device Standard consists of a vacuum container, which is evacuated by a vacuum pump. The sampling point and the standard sampler are connected by a probe. Due to the evacuation in the sampling device, the sample bag, inside the device, sucks in sample air via the probe. During this process, none of its components come into contact with the sample air due to the construction of the sampling device.

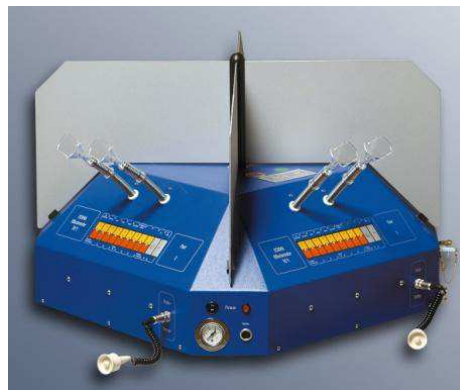
Odour concentration is determined by a Dynamic Olfactometer (TO9) in accordance with the European Standard Method (EN13725). This European Standard specifies a method for the objective determination of the odour concentration of a gaseous sample using dynamic olfactometry with human assessors and the emission rate of odours emanating from point sources, area sources with outward flow and area sources without outward flow. This European Standard is applicable to the measurement of odour concentration of pure substances, defined mixtures and undefined mixtures of gaseous odorants in air or nitrogen, using dynamic olfactometry with a panel of human assessors being the sensor. The unit of measurement is the odour unit per cubic metre: OU_E/m^3 . The odour concentration is measured by determining the dilution factor required to reach the detection threshold. The odour concentration at the detection threshold is defined as $1 \text{OU}_E/\text{m}^3$. The odour concentration is then expressed in terms of multiples of the detection threshold. The range of measurement is typically from $2^2 \text{OU}_E/\text{m}^3$ to $2^{17} \text{OU}_E/\text{m}^3$ (excluding pre-dilution).
