**Development of a Biodiesel Plant at
Tseung Kwan O Industrial Estate**

**Monthly Environmental Monitoring and
Audit Report for
April 2023**

(version 1.0)

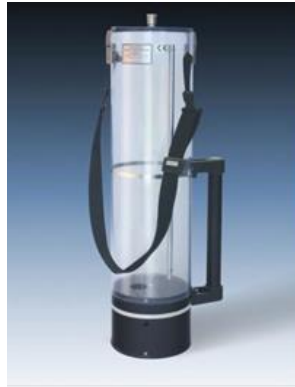
Odour Sampling System

Odour gas sample is collected by a Sampling Device Standard consists of a vacuum container, which is evacuated by a vacuum pump. The sampling point and the standard sampler are connected by a probe. Due to the evacuation in the sampling device, the sample bag, inside the device, sucks in sample air via the probe. During this process, none of its components come into contact with the sample air due to the construction of the sampling device.
