**Development of a Biodiesel Plant at
Tseung Kwan O Industrial Estate**

**Monthly Environmental Monitoring and
Audit Report for
December 2023**

Monthly Environmental Monitoring and Audit Report No. 93 (December 2023)

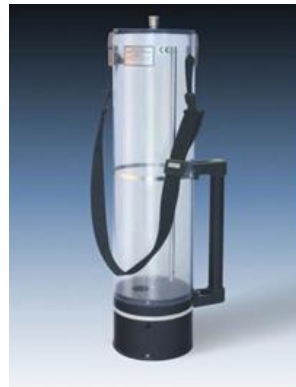
Odour Sampling System

Odour gas sample is collected by a Sampling Device Standard consists of a vacuum container, which is evacuated by a vacuum pump. The sampling point and the standard sampler are connected by a probe. Due to the evacuation in the sampling device, the sample bag, inside the device, sucks in sample air via the probe. During this process, none of its components come into contact with the sample air due to the construction of the sampling device.

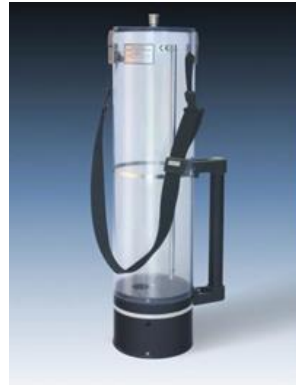
Odour Sampling System

Odour gas sample is collected by a Sampling Device Standard consists of a vacuum container, which is evacuated by a vacuum pump. The sampling point and the standard sampler are connected by a probe. Due to the evacuation in the sampling device, the sample bag, inside the device, sucks in sample air via the probe. During this process, none of its components come into contact with the sample air due to the construction of the sampling device.
