Contract No. HY/2010/02

Hong Kong – Zhuhai – Macao Bridge Hong Kong Boundary Crossing Facilities – Reclamation Works

Monthly EM&A Report for November 2014

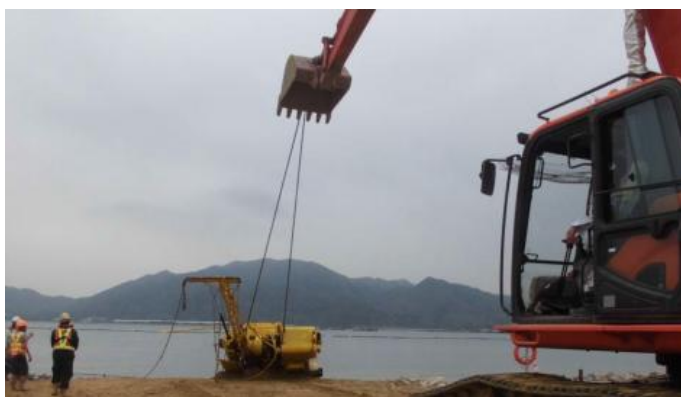
- 6.4.7.2 The oil spillage was caused by a drilling machine fell into the water near steel cell 51. The drilling machine which caused the oil spillage was lifted up and as informed by the Contractor, the machine was lifted and removed from the water on 12 November 2013 soon after the oil spillage incident was observed. (Also refer to photo record below).

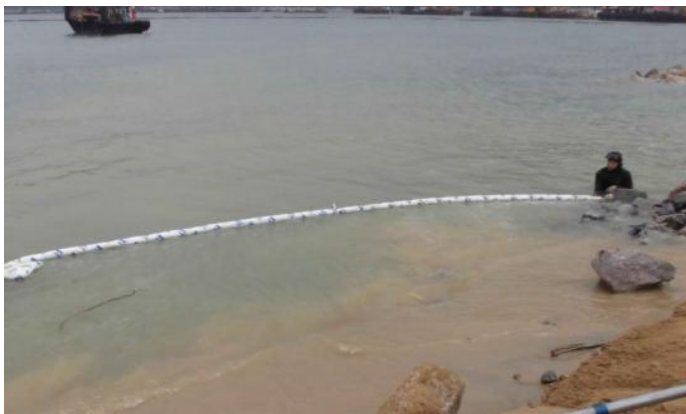
- 6.4.7.3 The Contractor used absorption booms to enclose and remove the floating oil from water and absorption booms used was collected using disposal bags as part of the spill kits item. The used absorption booms were disposed of as chemical waste (Also refer to photo record below).

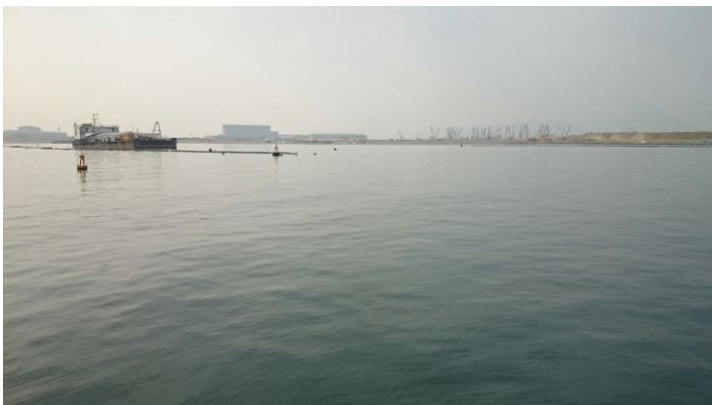
6.4.7.6 Ad hoc site inspection was conducted on 14 November 2014 and no oil spillage was observed on site. (Also refer to photo record below).

6.4.7.7 The contractor was reminded to continue to follow the spill response plan in the event of accidental oil spillage.

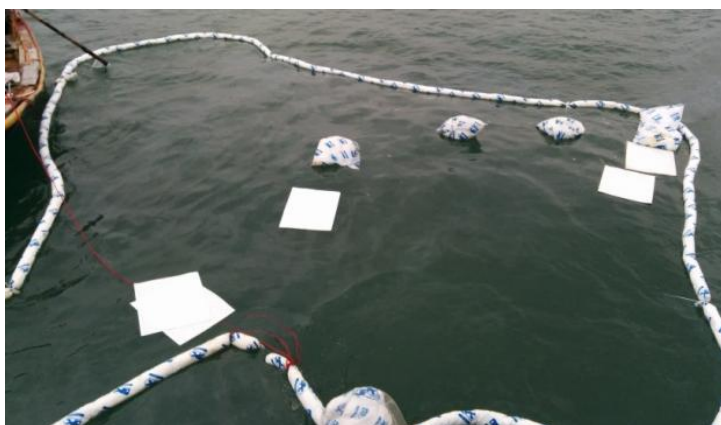
6.4.8.4 The Contractor used absorption booms as secondary oil container to contain and remove the floating oil from water and absorption booms used was collected using disposal bags as part of the spill kits item. The used absorption booms were disposed of as chemical waste. (Also refer to photo record below).

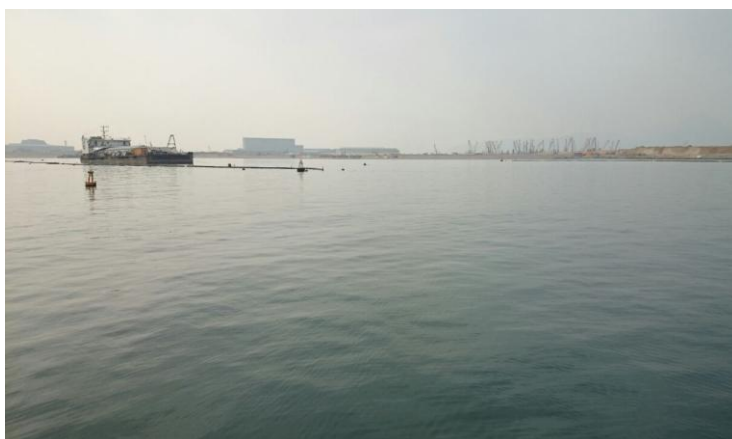
6.4.8.6 An independent site inspection was conducted on 14 November 2014 at sea area next to steel cell 51 and no oil spillage was observed on site. (Also refer to photo record below).
