Contract No. CV/2012/01
Sediment Removal at
Yim Tin Tsai (East) Fish Culture Zone

Monthly Environmental Monitoring &
Audit Report

March 2014

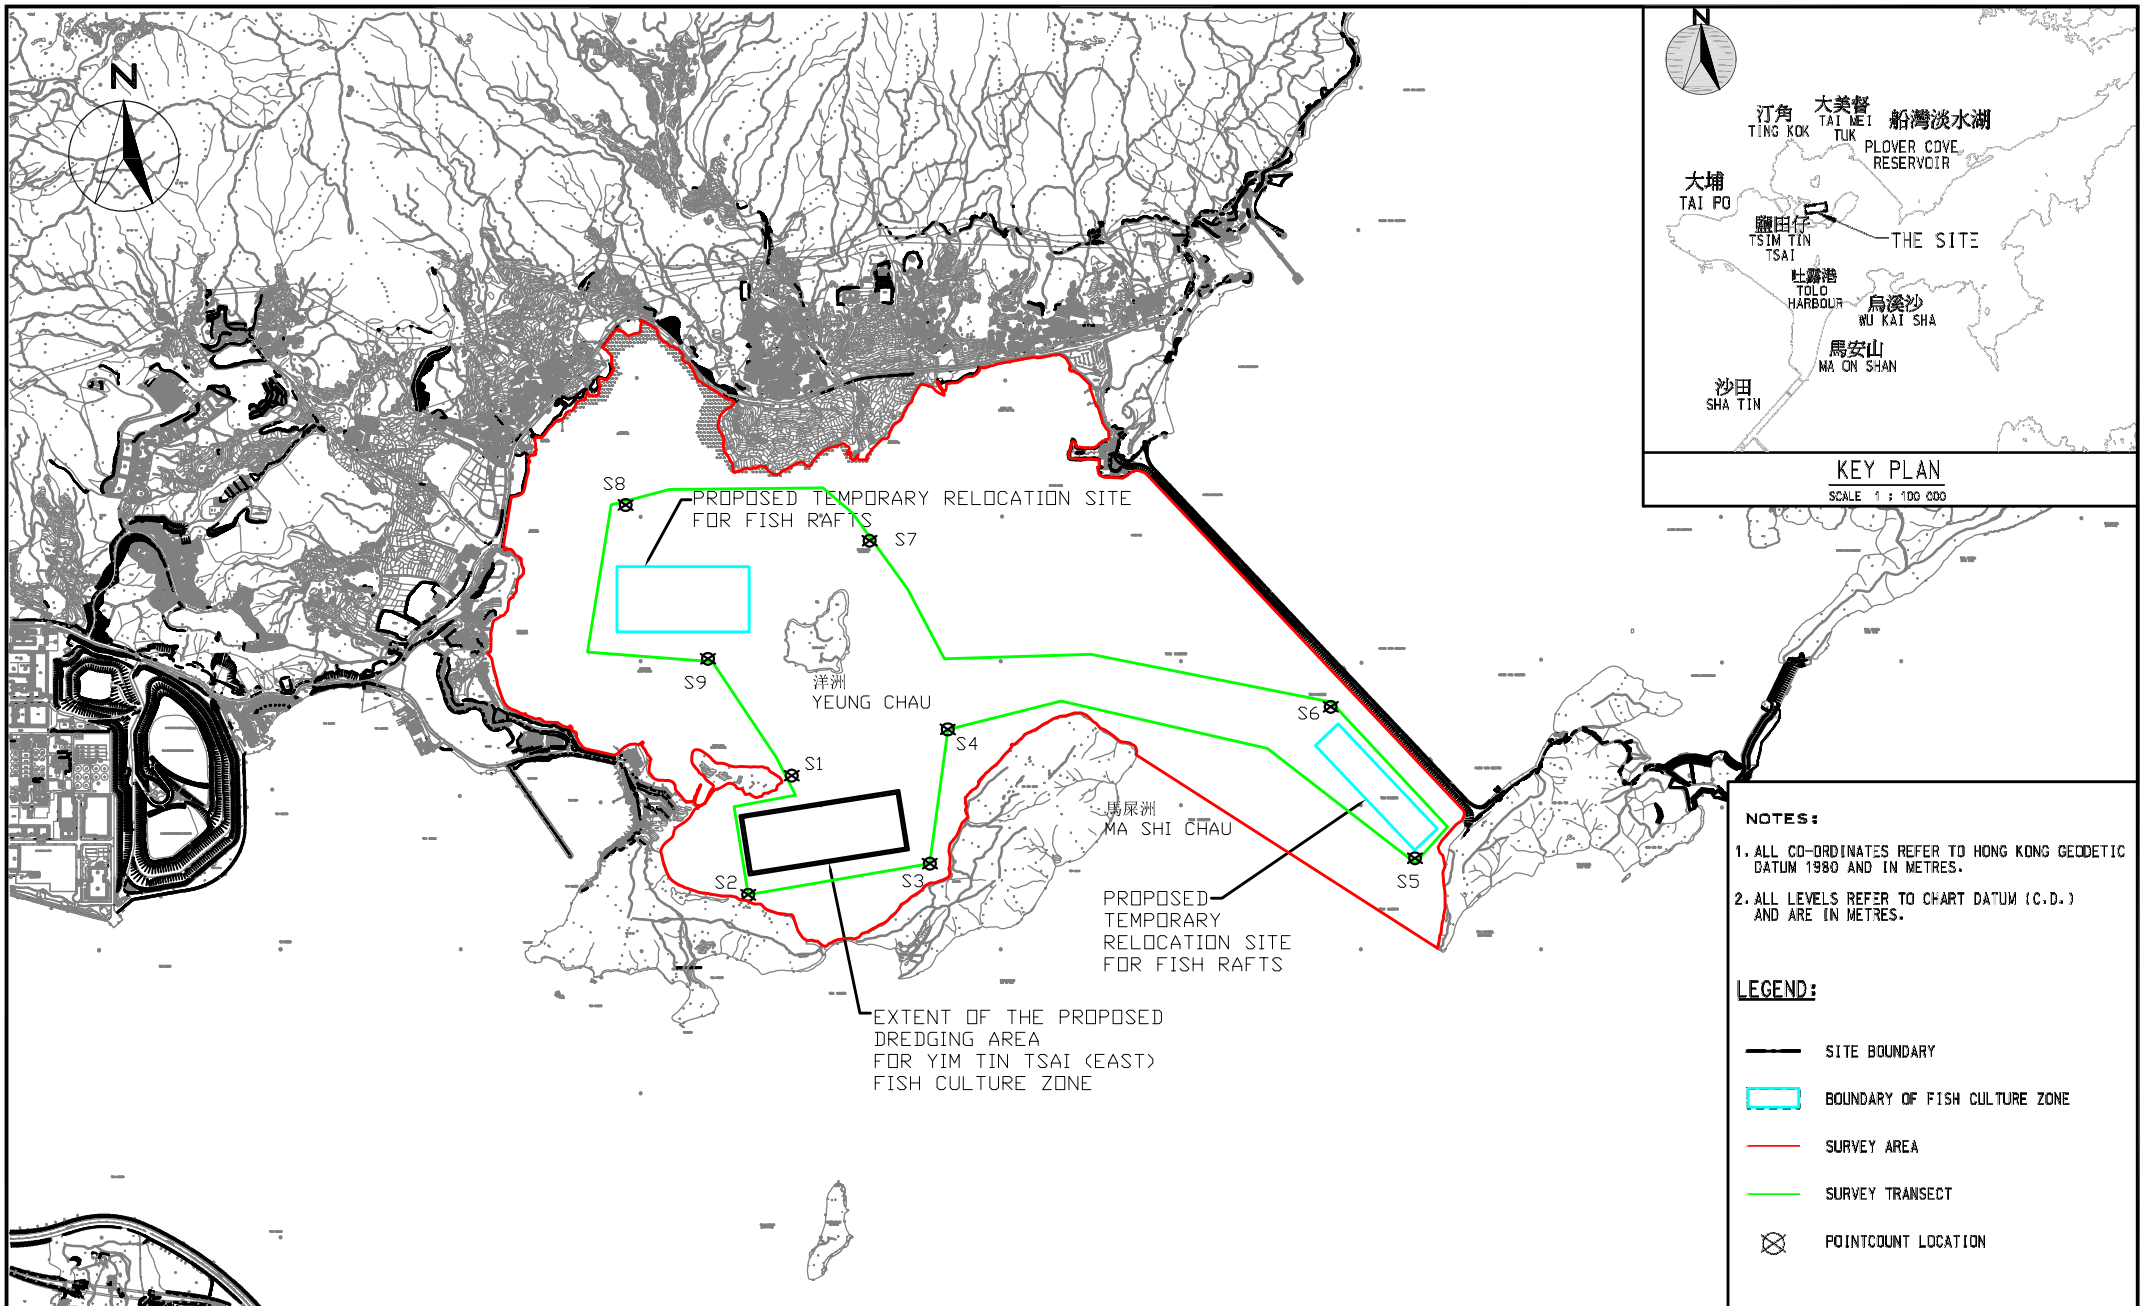
SCALE	1:800 @ A4	DATE	DEC 2013	
CHECK	IT	DRAWN	JW	
JOB No.	MA13027	FIGURE NO.	4	REV —

- 4.3 Transect route with some vantage points is shown in **Figure 4**. There are a total of 9 point count locations. The counting vantage points are selected with at least 500m distance with each other to avoid double-counting. The main focus areas of survey are the location of existing fish rafts before and after dredging works and Yeung Chau, where ardeids were observed in the past records.
