**AUES JOB NO.: TCS01230/21**

TUEN MUN - CHEK LAP KOK LINK **CONTRACT NO. HY/2021/13-**PROVISION OF REMAINING COMPENSATION TREE PLANTING FOR THE TUEN MUN - CHEK LAP KOK LINK PROJECT

16<sup>th</sup> Monthly Environmental Monitoring and AUDIT (EM&A) REPORT-SEPTEMBER 2023

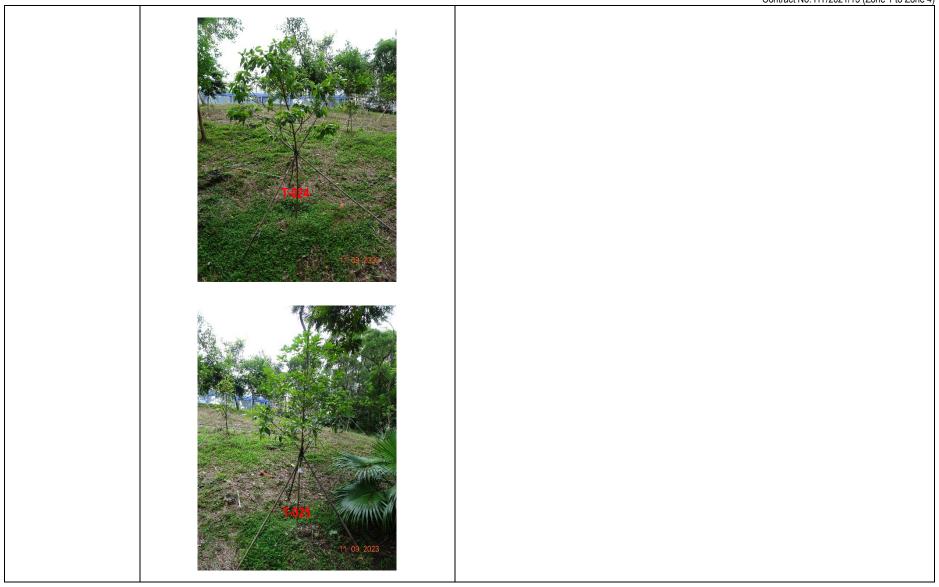
- 7. The wilted tree (T-027: Elaeocarpus sylvestris) in Zone 2 Slope 6SW-C/F233 was replaced.
- The removed trees (T-023, T-024, T-025 & T-039: Machilus chekiangensis) in Zone 2 Slope 6SW-C/FR200 were replanted.

- 9. The removed tree (T-033: Ilex rotunda var. microcarpa) in Zone 2 Slope 6SW-C/FR200 were replanted.
- 10. The wilted tree (T-031: Tabebuia chrysantha) in Zone 3 Slope 9SE-B/F56 was replaced.

1	Contract No. HY/2021/13 (Zone 1 to Zone 4)
Zone 2	11 100 2023	Follow-up 7: The wilted tree (T-027: Elaeocarpus sylvestris) in Zone 2 Slope 6SW-C/F233 was replaced.
Zone 2	Tables 1	Follow-up 8: The removed trees (T-023, T-024, T-025 & T-039: Machilus chekiangensis) in Zone 2 Slope 6SW-C/FR200 were replanted.
