Contract No. HY/2012/08
Tuen Mun – Chek Lap Kok Link –
Northern Connection Sub-sea Tunnel
Section

Thirty-fourth Monthly Environmental Monitoring & Audit (EM&A) Report

12 September 2016

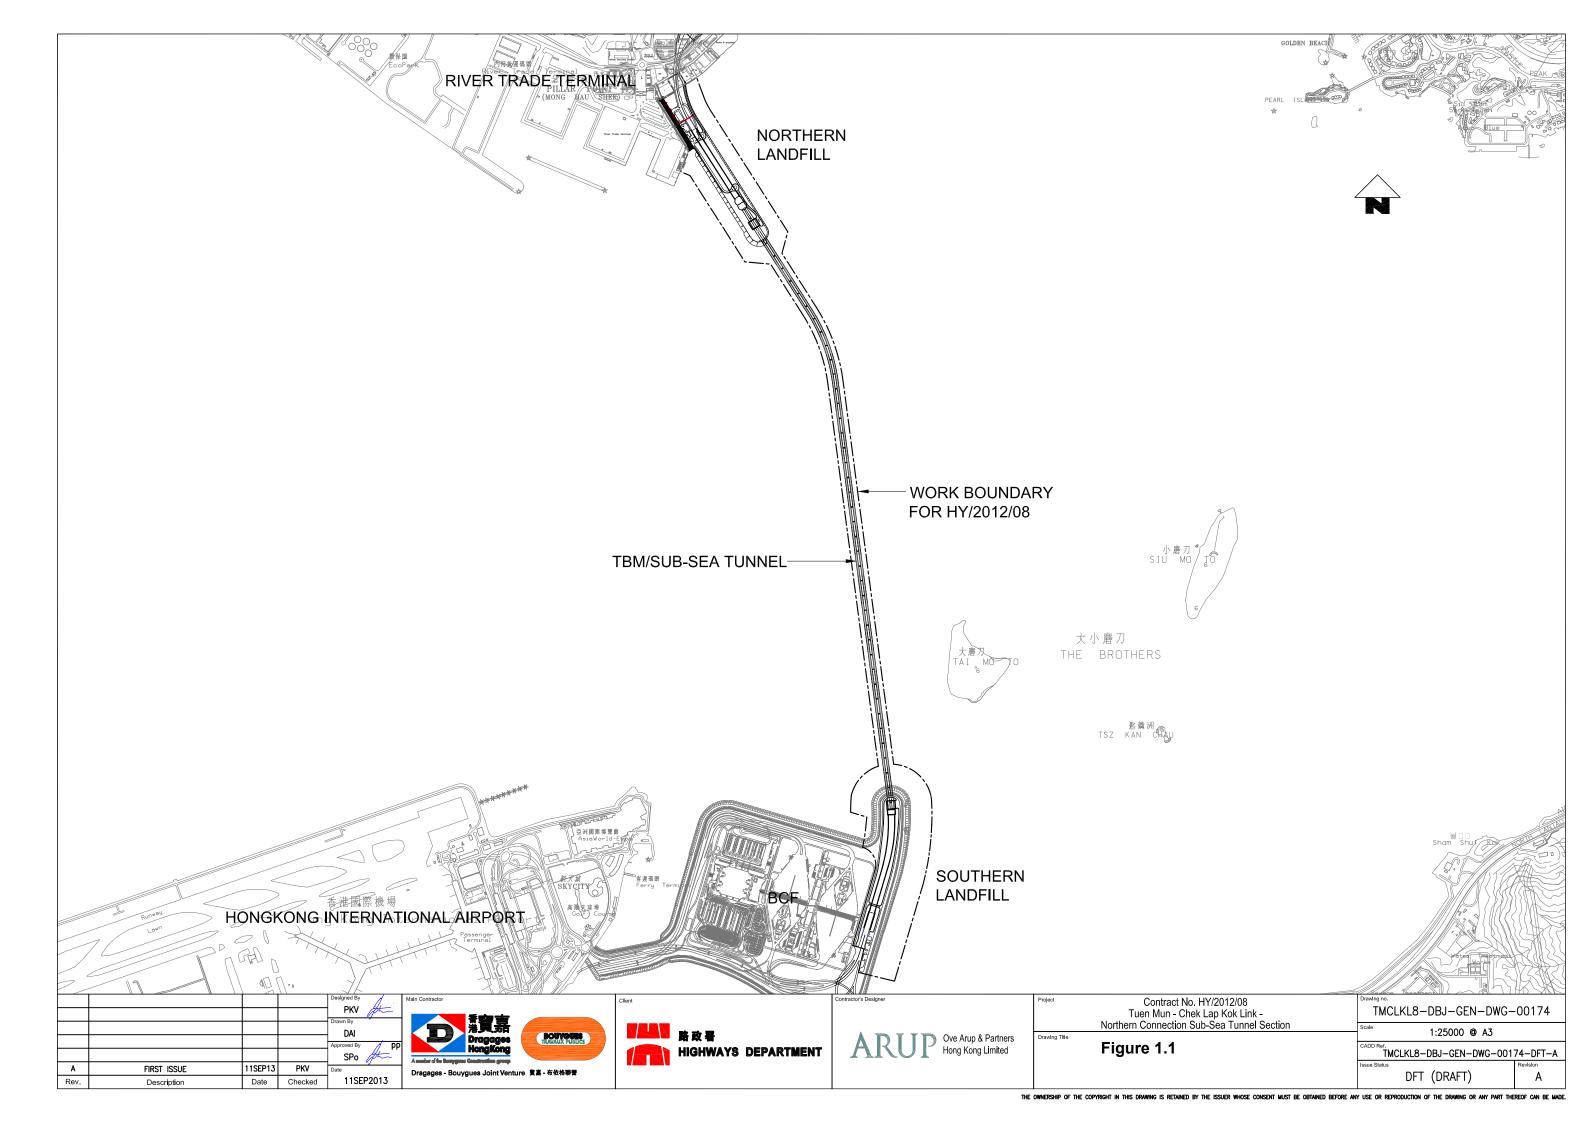
Layout of the Contract components is presented in *Figure 1.1*.

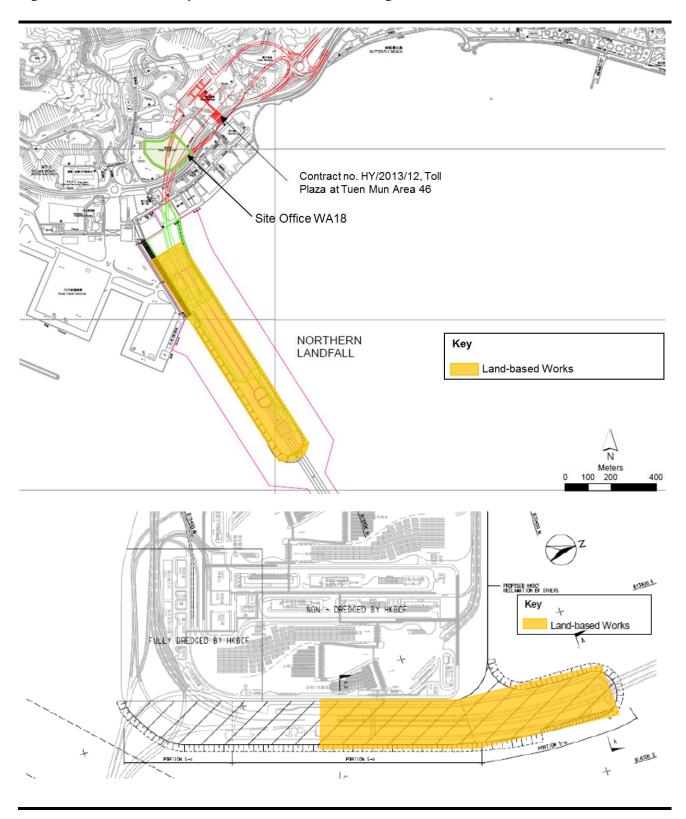
Figure 1.2 Locations of Construction Activities - August 2016

- Box Culvert Extension at Works Area Portion N-A;
- Shaft Structure and Backfilling Portion N-C;
- Construction of Cross Passage Tympanum TBM tunnel;
- Cross Passage Lining Installation TBM Tunnel;
- Corbel Construction TBM Tunnel;
- Excavation of Sub-sea Tunnel TBM tunnel;
- Sub-sea Tunnel Gallery Installation TBM tunnel;
- Deep Band Drain Installation Portion S-A;
- Dewatering Deep well Installation Portion S-A; and
- Jet Grouting, CSM Ground Treatment and Diaphragm Wall Construction Portion S-A.

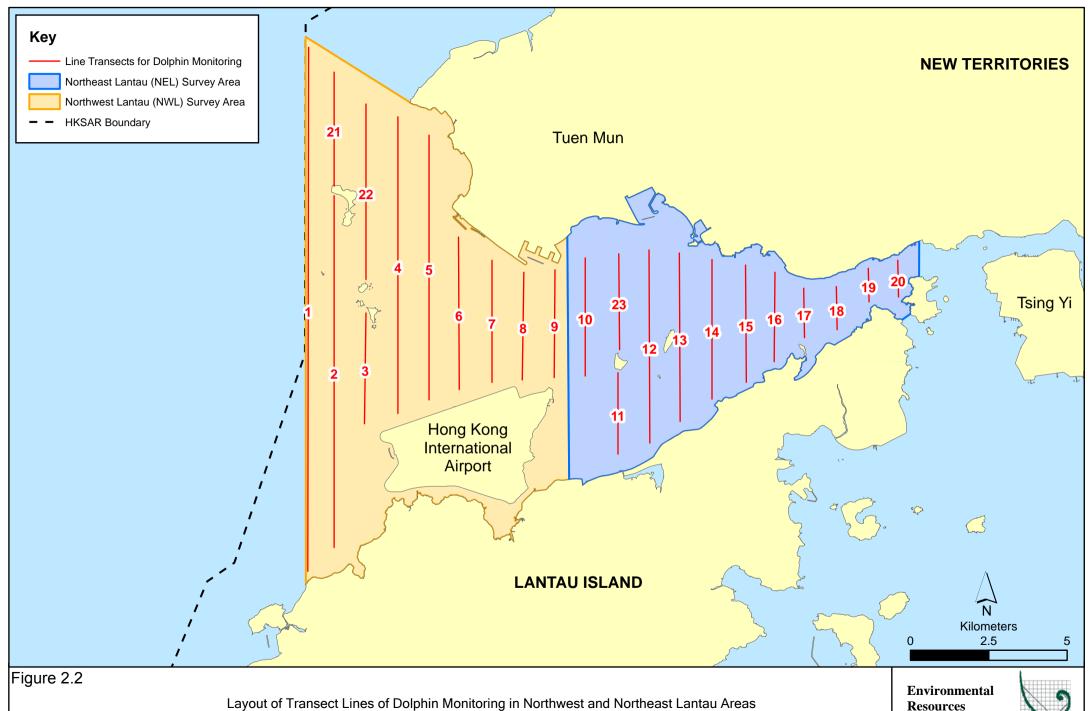
The impact dolphin monitoring was carried out in the NEL and NWL along the line transect as depicted in *Figure 2.2*. The co-ordinates of all transect lines are shown in *Table 2.6* below.

Layout of Transect Lines of Dolphin Monitoring in Northwest and Northeast Lantau Areas

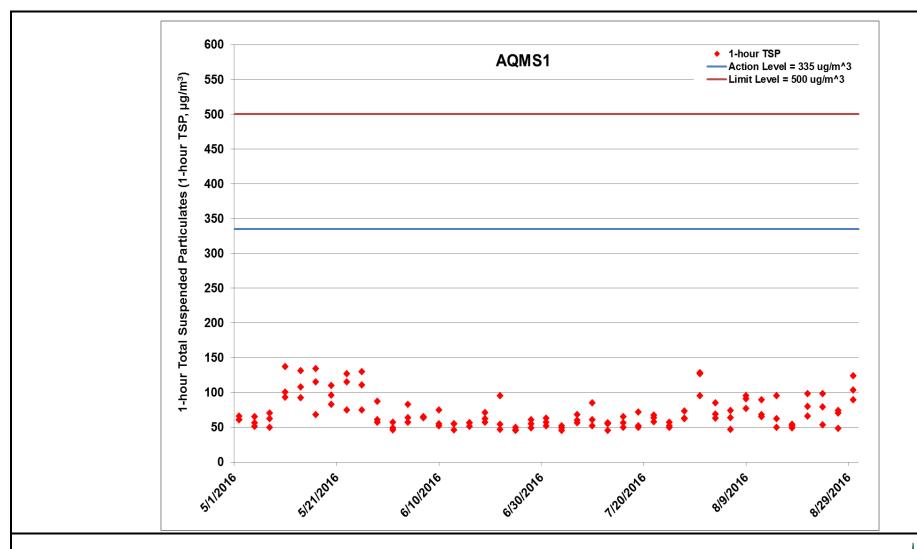
Figure G.1 Impact Monitoring – 1-hour Total Suspended Particulates (μg/m³) at AQMS1 between 1 May 2016 and 31 August 2016 during impact monitoring period. The weather conditions during the monitoring period varied from sunny to cloudy. Major land-based construction activities included: CSM Ground Treatment and Diaphragm Wall Construction (1/5/2016 – 31/8/2016) and Box Culvert Extension (1/5/2016 – 31/8/2016). *Ref:* 0212330_Impact AQM graphs_ August 2016_REV a.xlsx

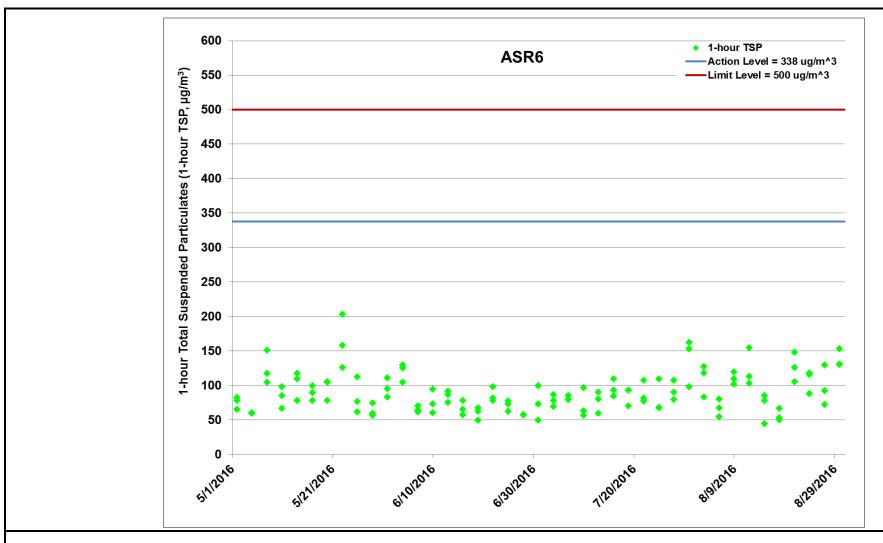
Figure G.2 Impact Monitoring – 1-hour Total Suspended Particulates (μg/m³) at ASR6 between 1 May 2016 and 31 August 2016 during impact monitoring period. The weather conditions during the monitoring period varied from sunny to cloudy. Major land-based construction activities included: CSM Ground Treatment and Diaphragm Wall Construction (1/5/2016 – 31/8/2016) and Box Culvert Extension (1/5/2016 – 31/8/2016). *Ref:* 0212330_Impact AQM graphs_ August 2016_REV a.xlsx

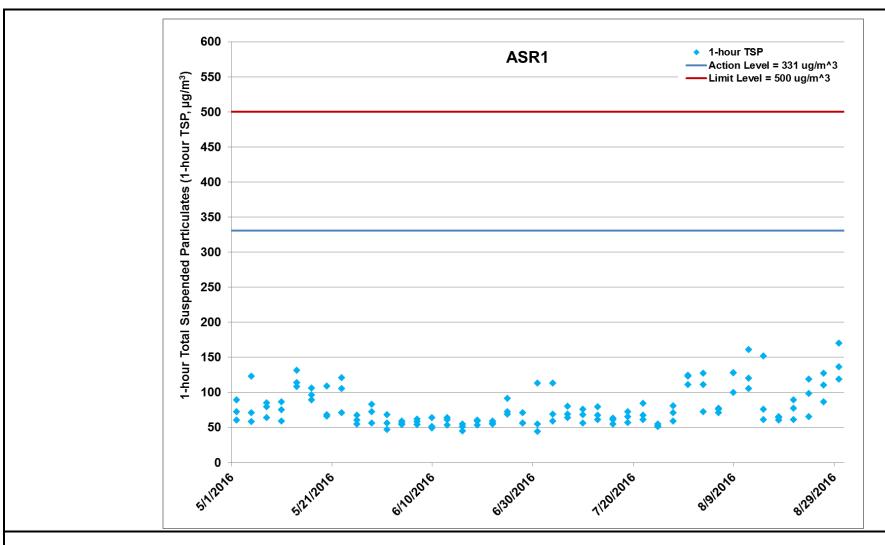
Figure G.3 Impact Monitoring – 1-hour Total Suspended Particulates (μg/m³) at ASR1 between 1 May 2016 and 31 August 2016 during impact monitoring period. The weather conditions during the monitoring period varied from sunny to cloudy. Major land-based construction activities included: CSM Ground Treatment and Diaphragm Wall Construction (1/5/2016 – 31/8/2016) and Box Culvert Extension (1/5/2016 – 31/8/2016). *Ref:* 0212330_Impact AQM graphs_ August 2016_REV a.xlsx

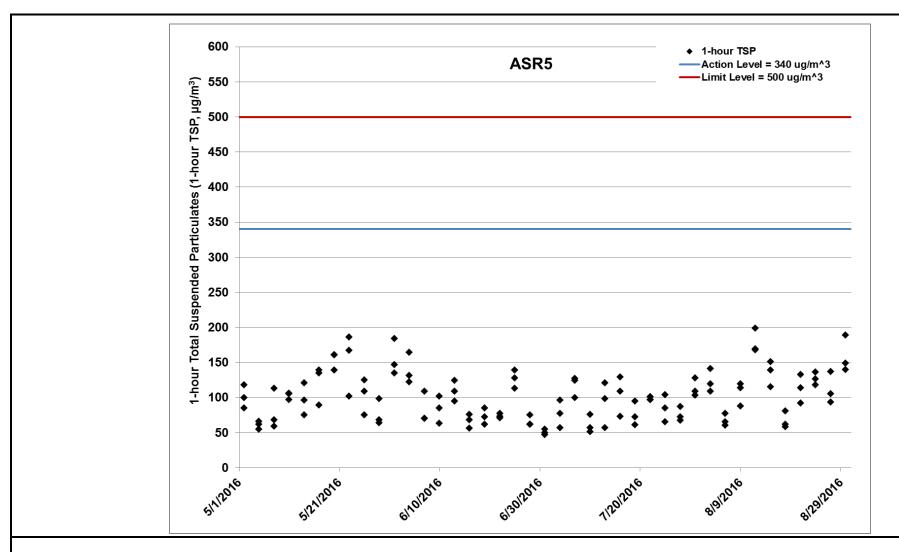
Figure G.4 Impact Monitoring – 1-hour Total Suspended Particulates (μg/m³) at ASR5 between 1 May 2016 and 31 August 2016 during impact monitoring period. The weather conditions during the monitoring period varied from sunny to cloudy. Major land-based construction activities included: CSM Ground Treatment and Diaphragm Wall Construction (1/5/2016 – 31/8/2016) and Box Culvert Extension (1/5/2016 – 31/8/2016). *Ref:* 0212330_Impact AQM graphs_ August 2016_REV a.xlsx

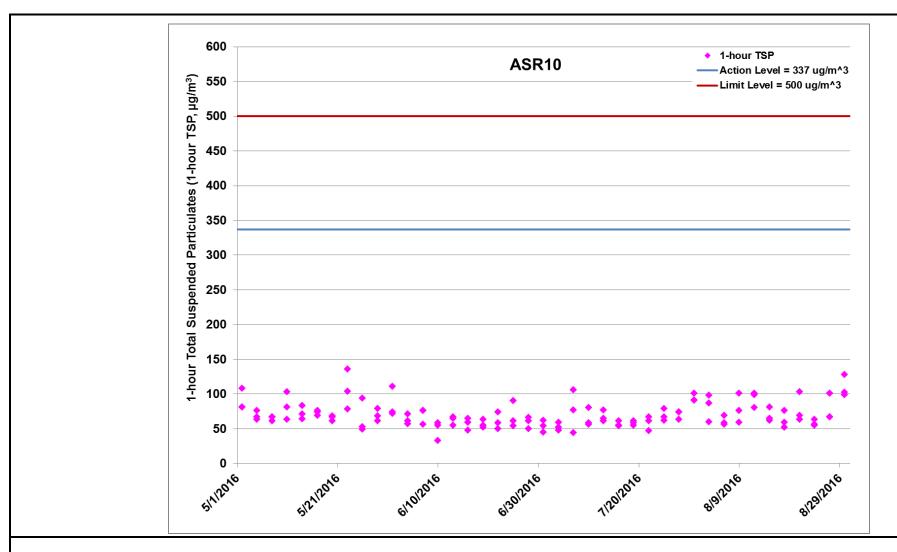
Figure G.5 Impact Monitoring – 1-hour Total Suspended Particulates (µg/m³) at ASR10 between 1 May 2016 and 31 August 2016 during impact monitoring period. The weather conditions during the monitoring period varied from sunny to cloudy. Major land-based construction activities included: CSM Ground Treatment and Diaphragm Wall Construction (1/5/2016 – 31/8/2016) and Box Culvert Extension (1/5/2016 – 31/8/2016). Ref: 0212330_Impact AQM graphs_ August 2016_REV a.xlsx

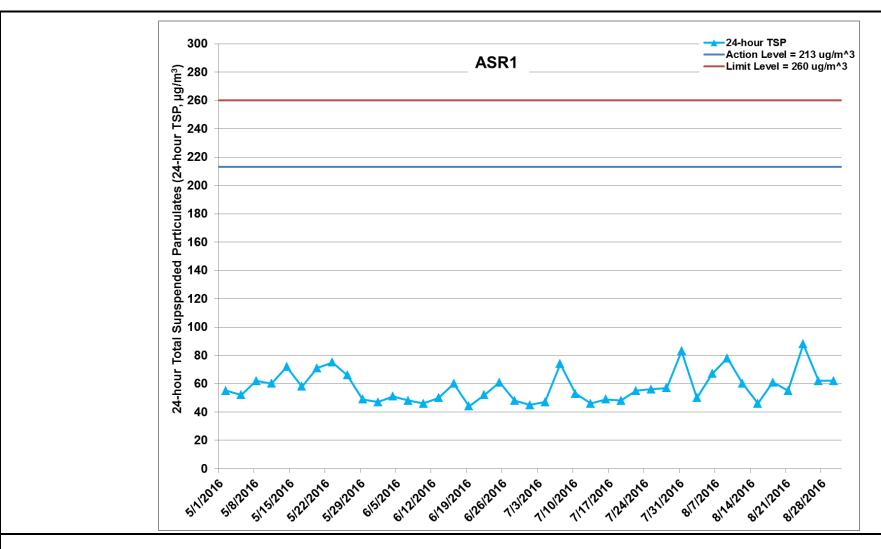
Figure G.6 Impact Monitoring – 24-hour Total Suspended Particulates (μg/m³) at ASR1 between 1 May 2016 and 31 August 2016 during impact monitoring period. The weather conditions during the monitoring period varied from sunny to cloudy. Major land-based construction activities included: CSM Ground Treatment and Diaphragm Wall Construction (1/5/2016 – 31/8/2016) and Box Culvert Extension (1/5/2016 – 31/8/2016). Ref: 0212330_Impact AQM graphs_ August 2016_REV a.xlsx

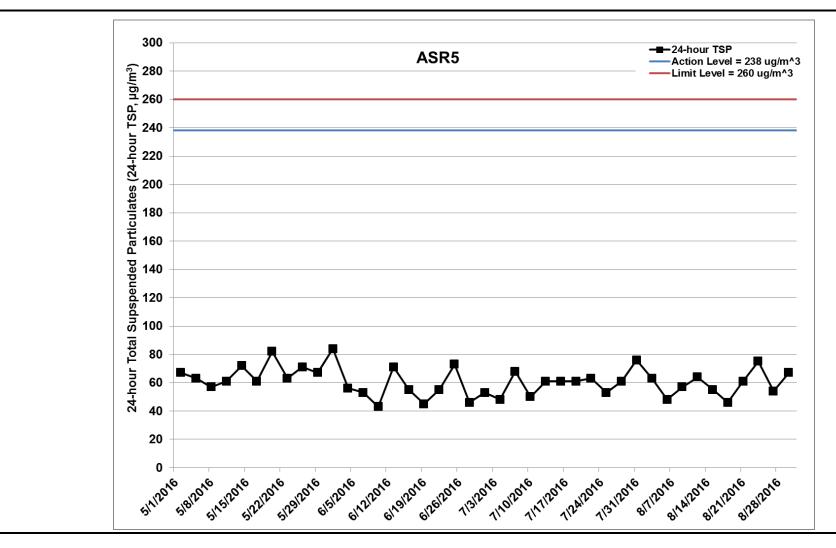
Figure G.7 Impact Monitoring – 24-hour Total Suspended Particulates (μg/m³) at ASR5 between 1 May 2016 and 31 August 2016 during impact monitoring period. The weather conditions during the monitoring period varied from sunny to cloudy. Major land-based construction activities included: CSM Ground Treatment and Diaphragm Wall Construction (1/5/2016 – 31/8/2016) and Box Culvert Extension (1/5/2016 – 31/8/2016). *Ref:* 0212330_Impact AQM graphs_ August 2016_REV a.xlsx

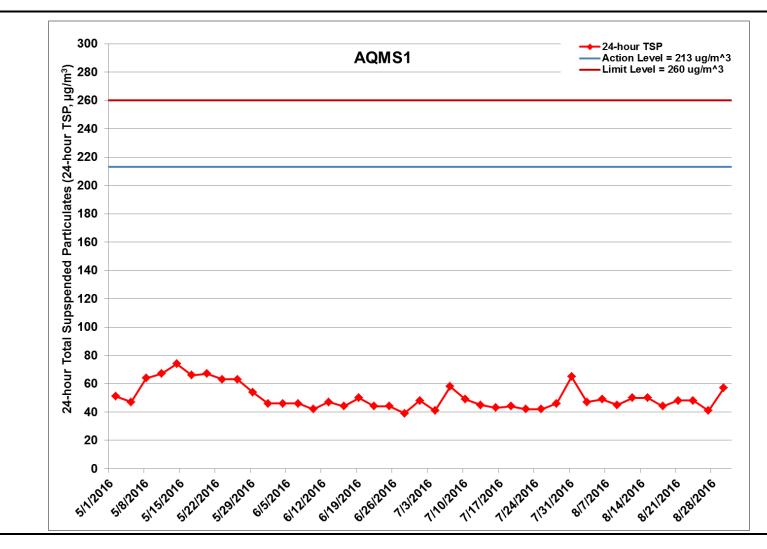
Figure G.8 Impact Monitoring – 24-hour Total Suspended Particulates (μg/m³) at AQMS1 between 1 May 2016 and 31 August 2016 during impact monitoring period. The weather conditions during the monitoring period varied from sunny to cloudy. Major land-based construction activities included: CSM Ground Treatment and Diaphragm Wall Construction (1/5/2016 – 31/8/2016) and Box Culvert Extension (1/5/2016 – 31/8/2016). Ref: 0212330_Impact AQM graphs_ August 2016_REV a.xlsx

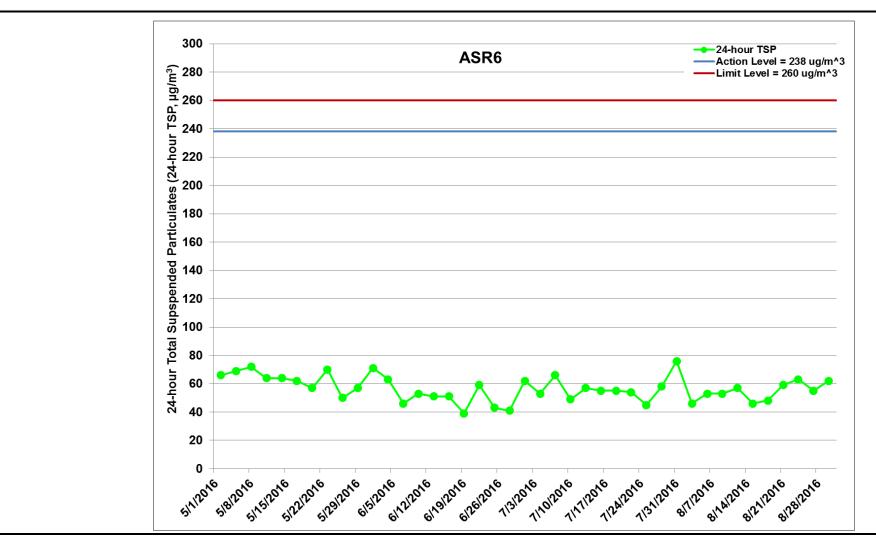
Figure G.9 Impact Monitoring – 24-hour Total Suspended Particulates (μg/m³) at ASR6 between 1 May 2016 and 31 August 2016 during impact monitoring period. The weather conditions during the monitoring period varied from sunny to cloudy. Major land-based construction activities included: CSM Ground Treatment and Diaphragm Wall Construction (1/5/2016 – 31/8/2016) and Box Culvert Extension (1/5/2016 – 31/8/2016). Ref: 0212330_Impact AQM graphs_ August 2016_REV a.xlsx

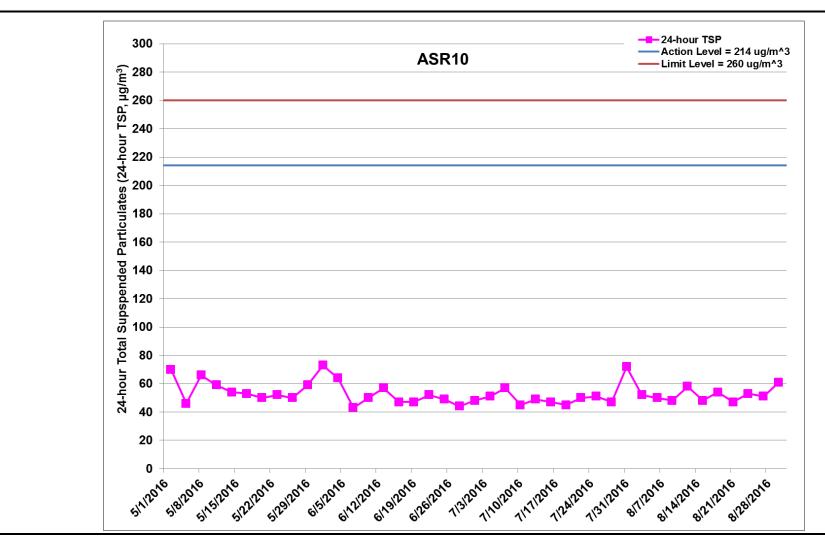
Figure G.10 Impact Monitoring – 24-hour Total Suspended Particulates (µg/m³) at ASR10 between 1 May 2016 and 31 August 2016 during impact monitoring period. The weather conditions during the monitoring period varied from sunny to cloudy. Major land-based construction activities included: CSM Ground Treatment and Diaphragm Wall Construction (1/5/2016 – 31/8/2016) and Box Culvert Extension (1/5/2016 – 31/8/2016). Ref: 0212330_Impact AQM graphs_ August 2016_REV a.xlsx

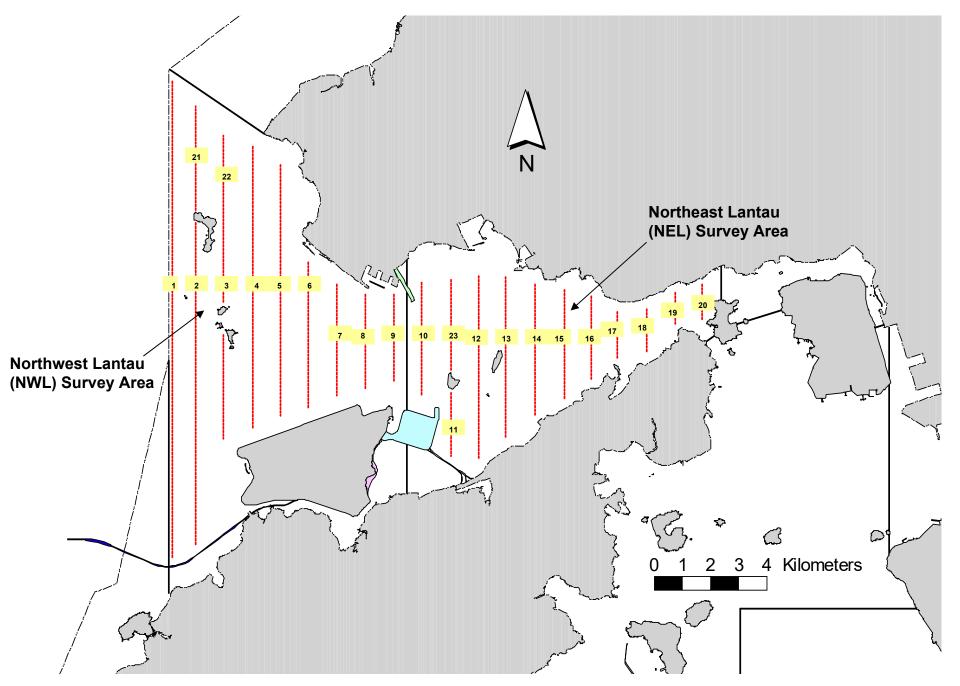
Figure 1. Transect Line Layout in Northwest and Northeast Lantau Survey Areas

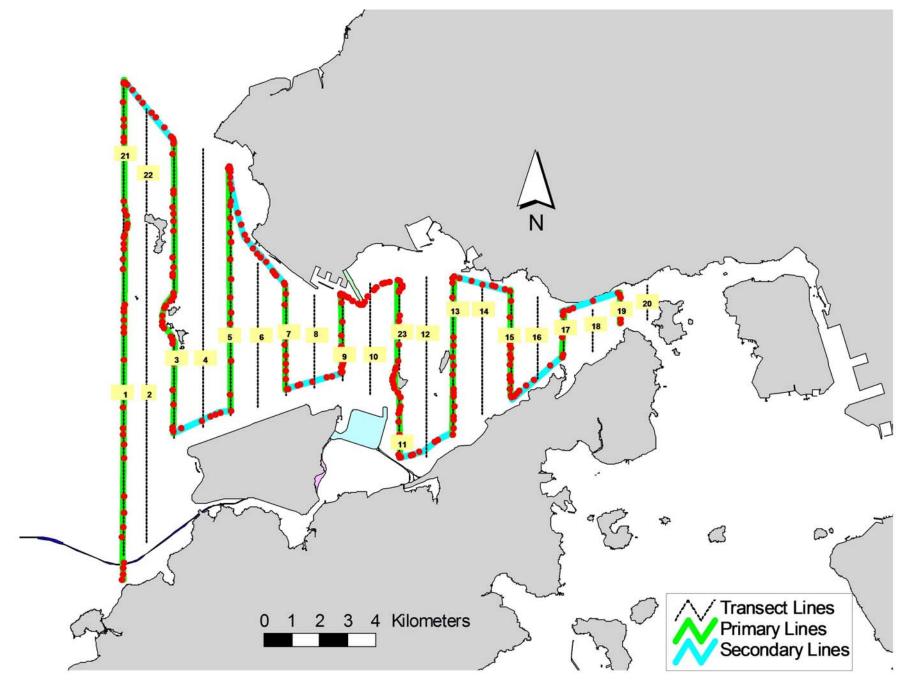
Figure 2. Survey Route on August 5th, 2016 (from HKLR03 project)

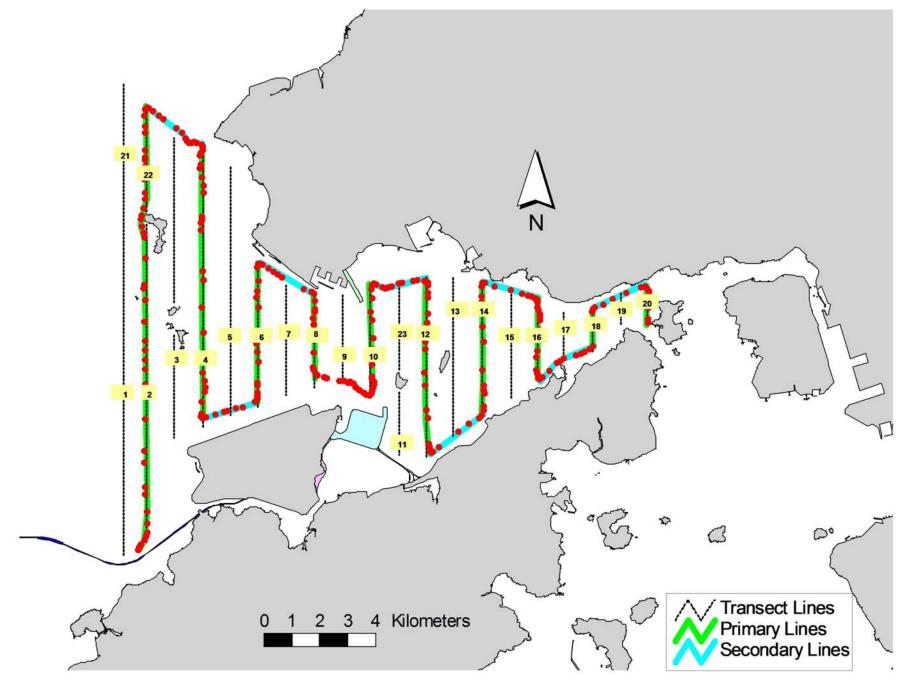
Figure 3. Survey Route on August 9th, 2016 (from HKLR03 project)

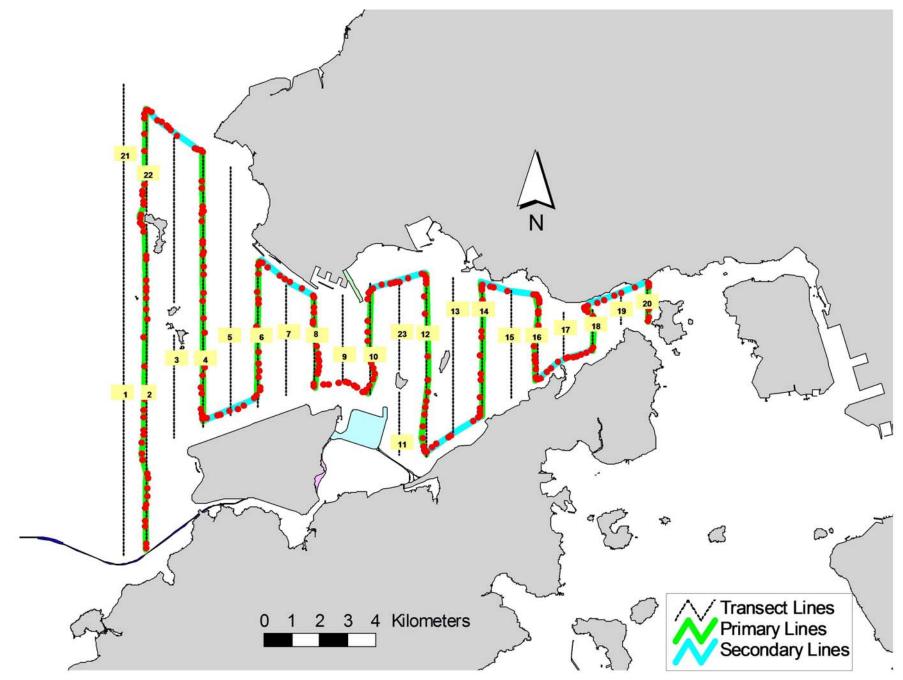
Figure 4. Survey Route on August 17th, 2016 (from HKLR03 project)

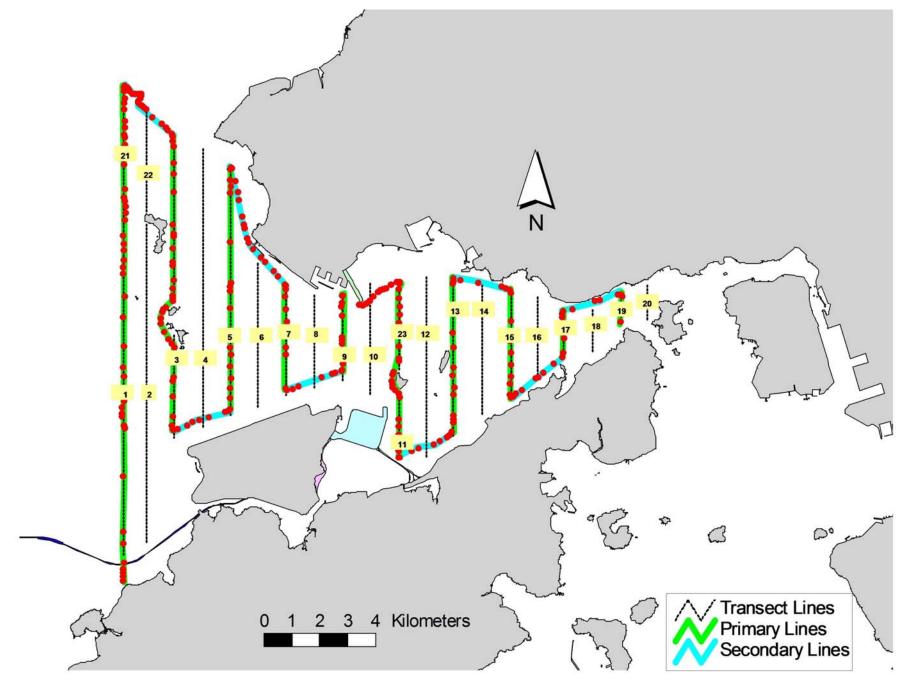
Figure 5. Survey Route on August 23rd, 2016 (from HKLR03 project)

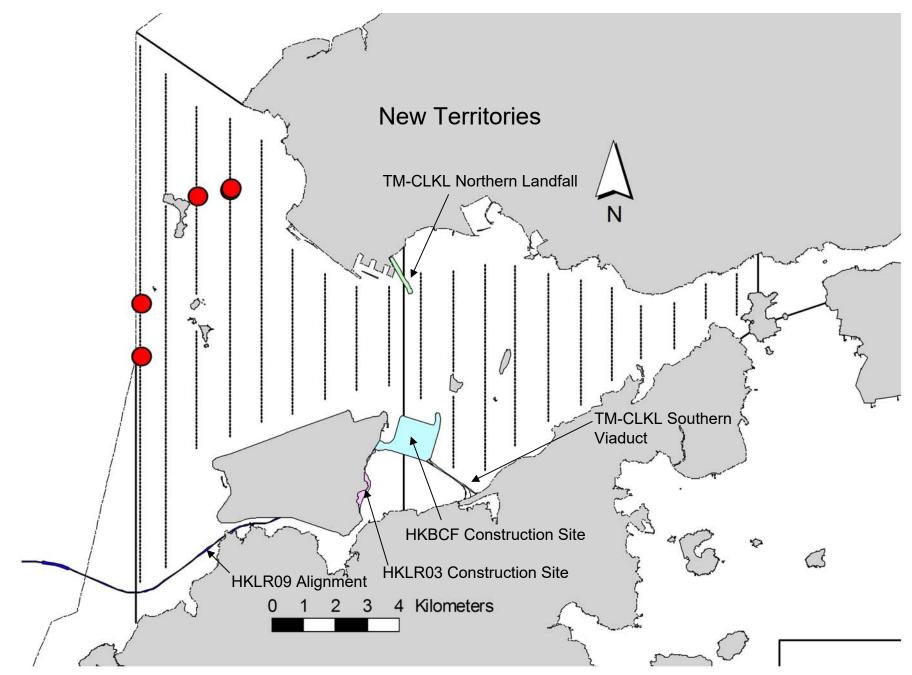
Figure 6. Distribution of Chinese White Dolphin Sightings during August 2016 HKLR03 Monitoring Surveys
