**Contract No. HY/2012/08  
Tuen Mun – Chek Lap Kok Link –  
Northern Connection Sub-sea Tunnel  
Section**

*Fifty-seventh Monthly Environmental Monitoring  
& Audit (EM&A) Report*

08 August 2018

**Contract No. HY/2012/08 TM-CLKL Northern Connection Sub-sea  
Tunnel Section  
57<sup>th</sup> Monthly EM&A Report for July 2018 (EP-354/2009/D)**

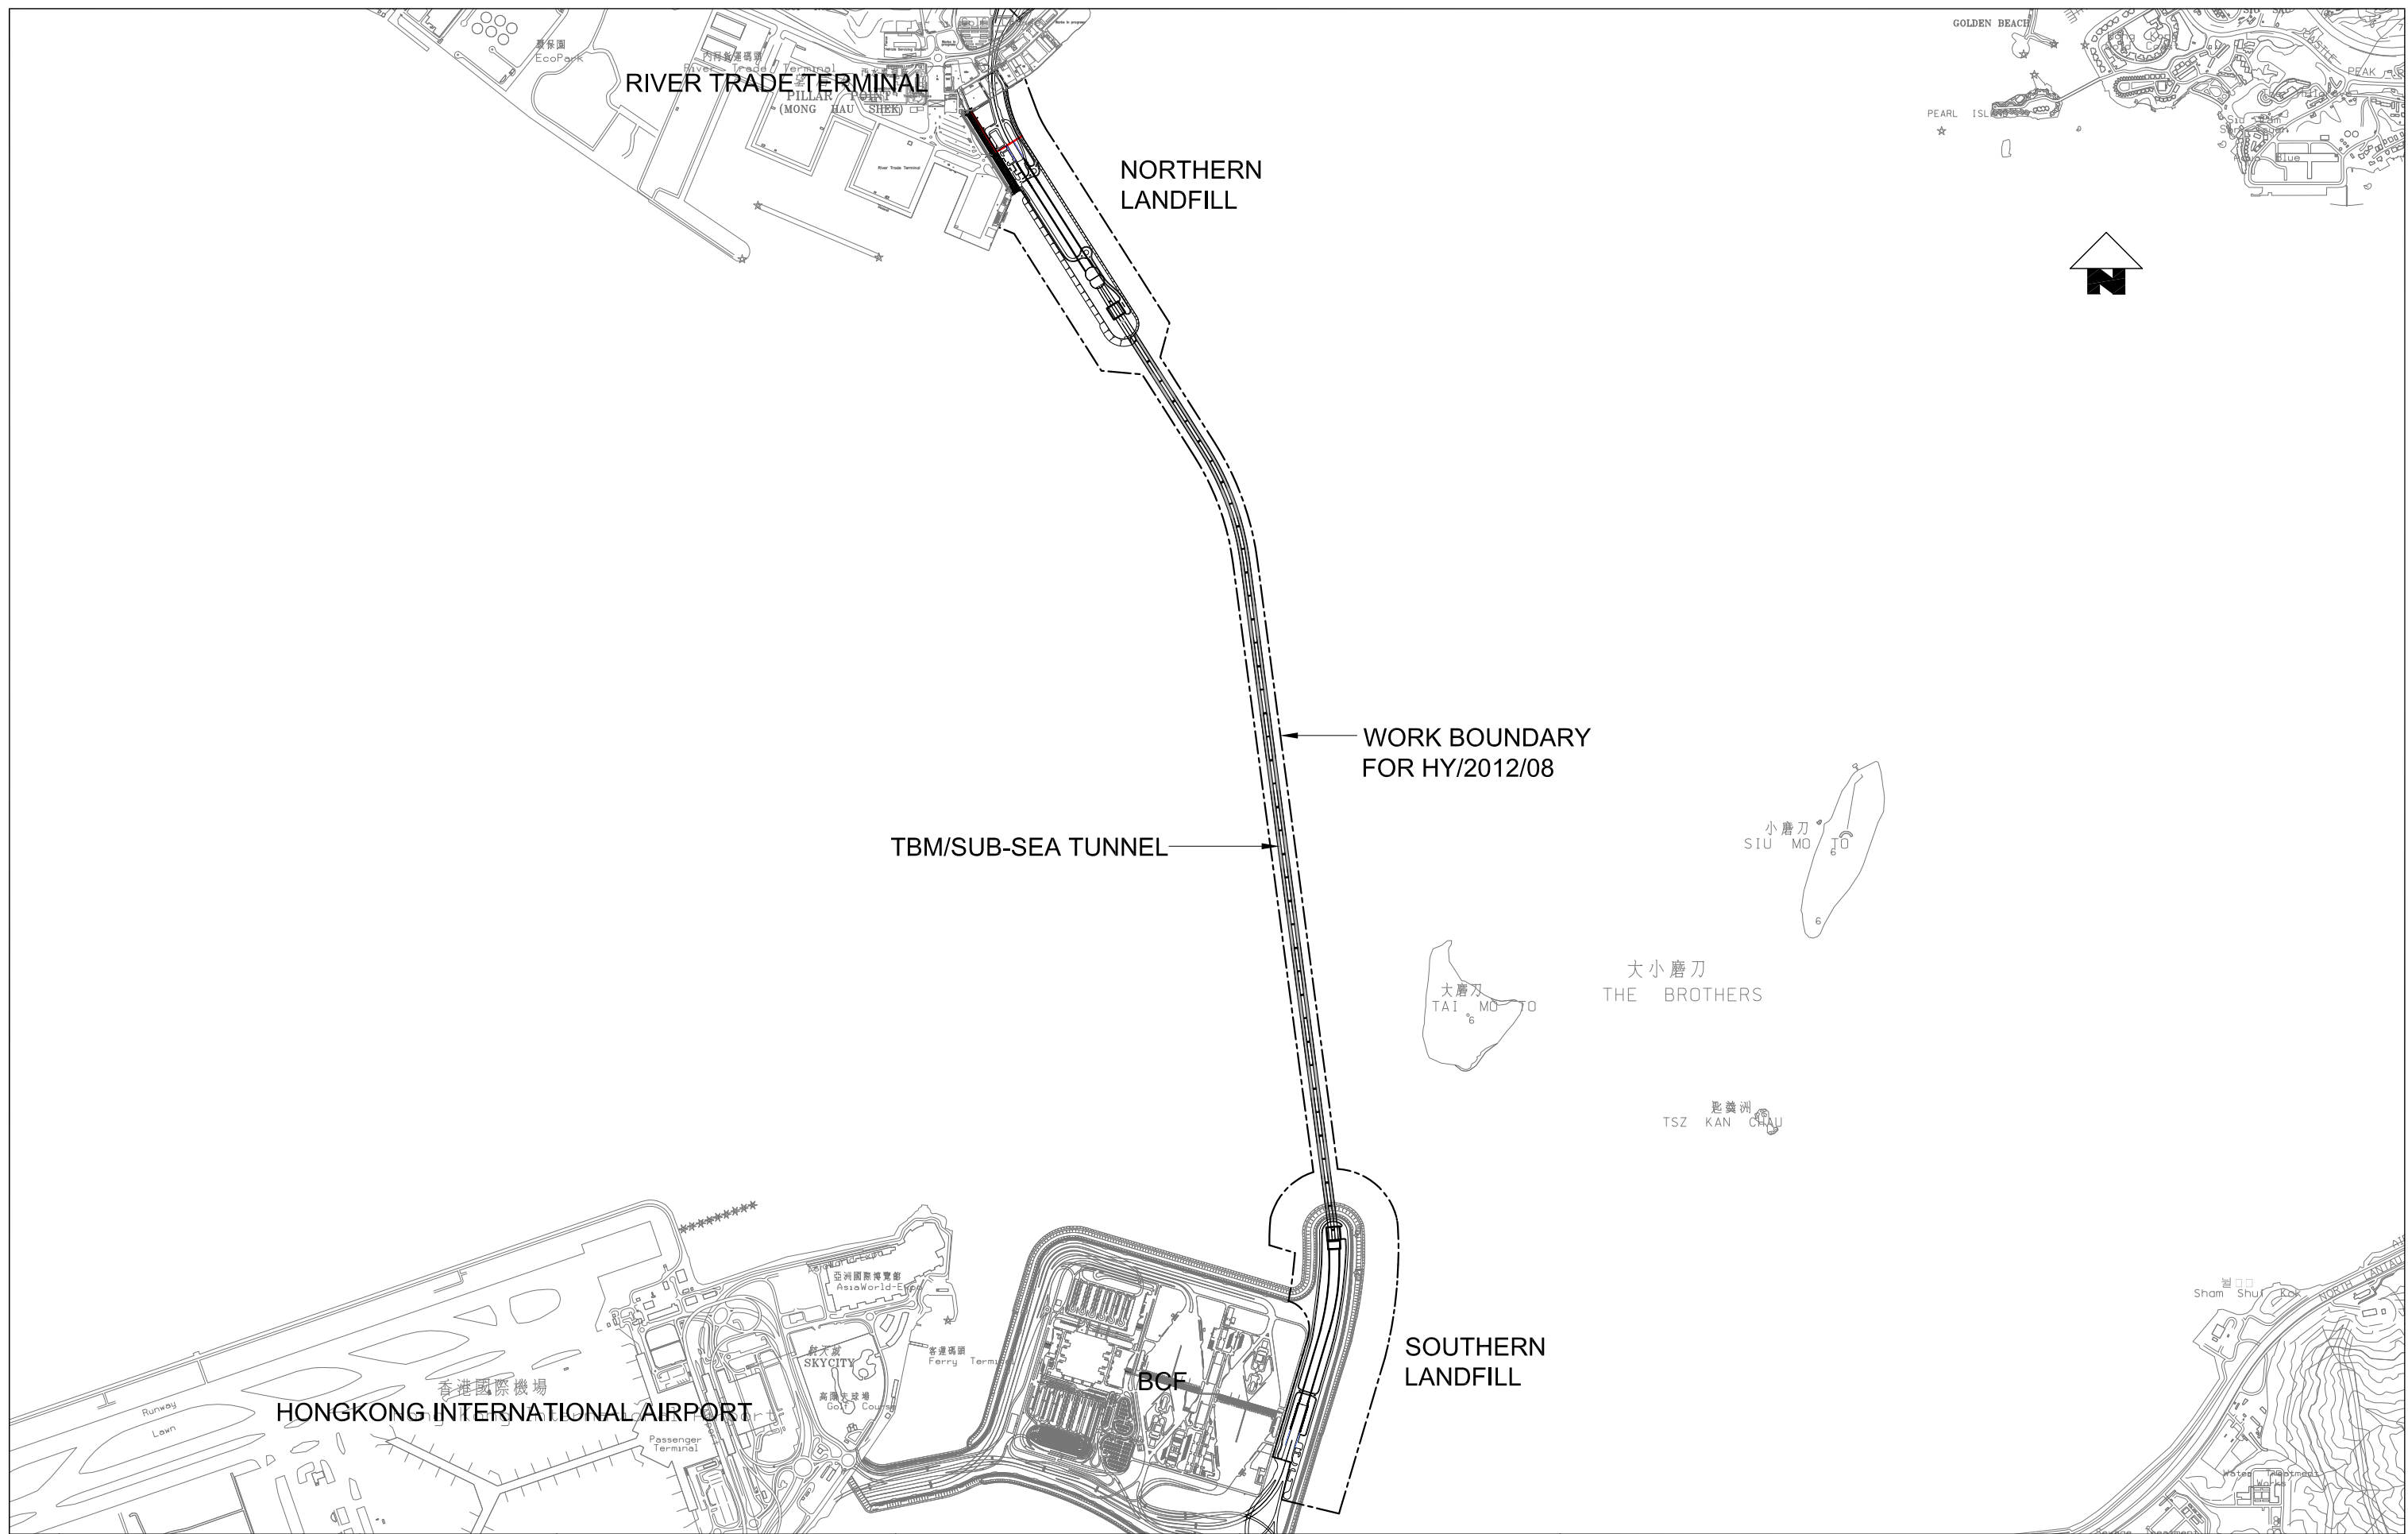
Layout of the Contract components is presented in *Figure 1.1*.

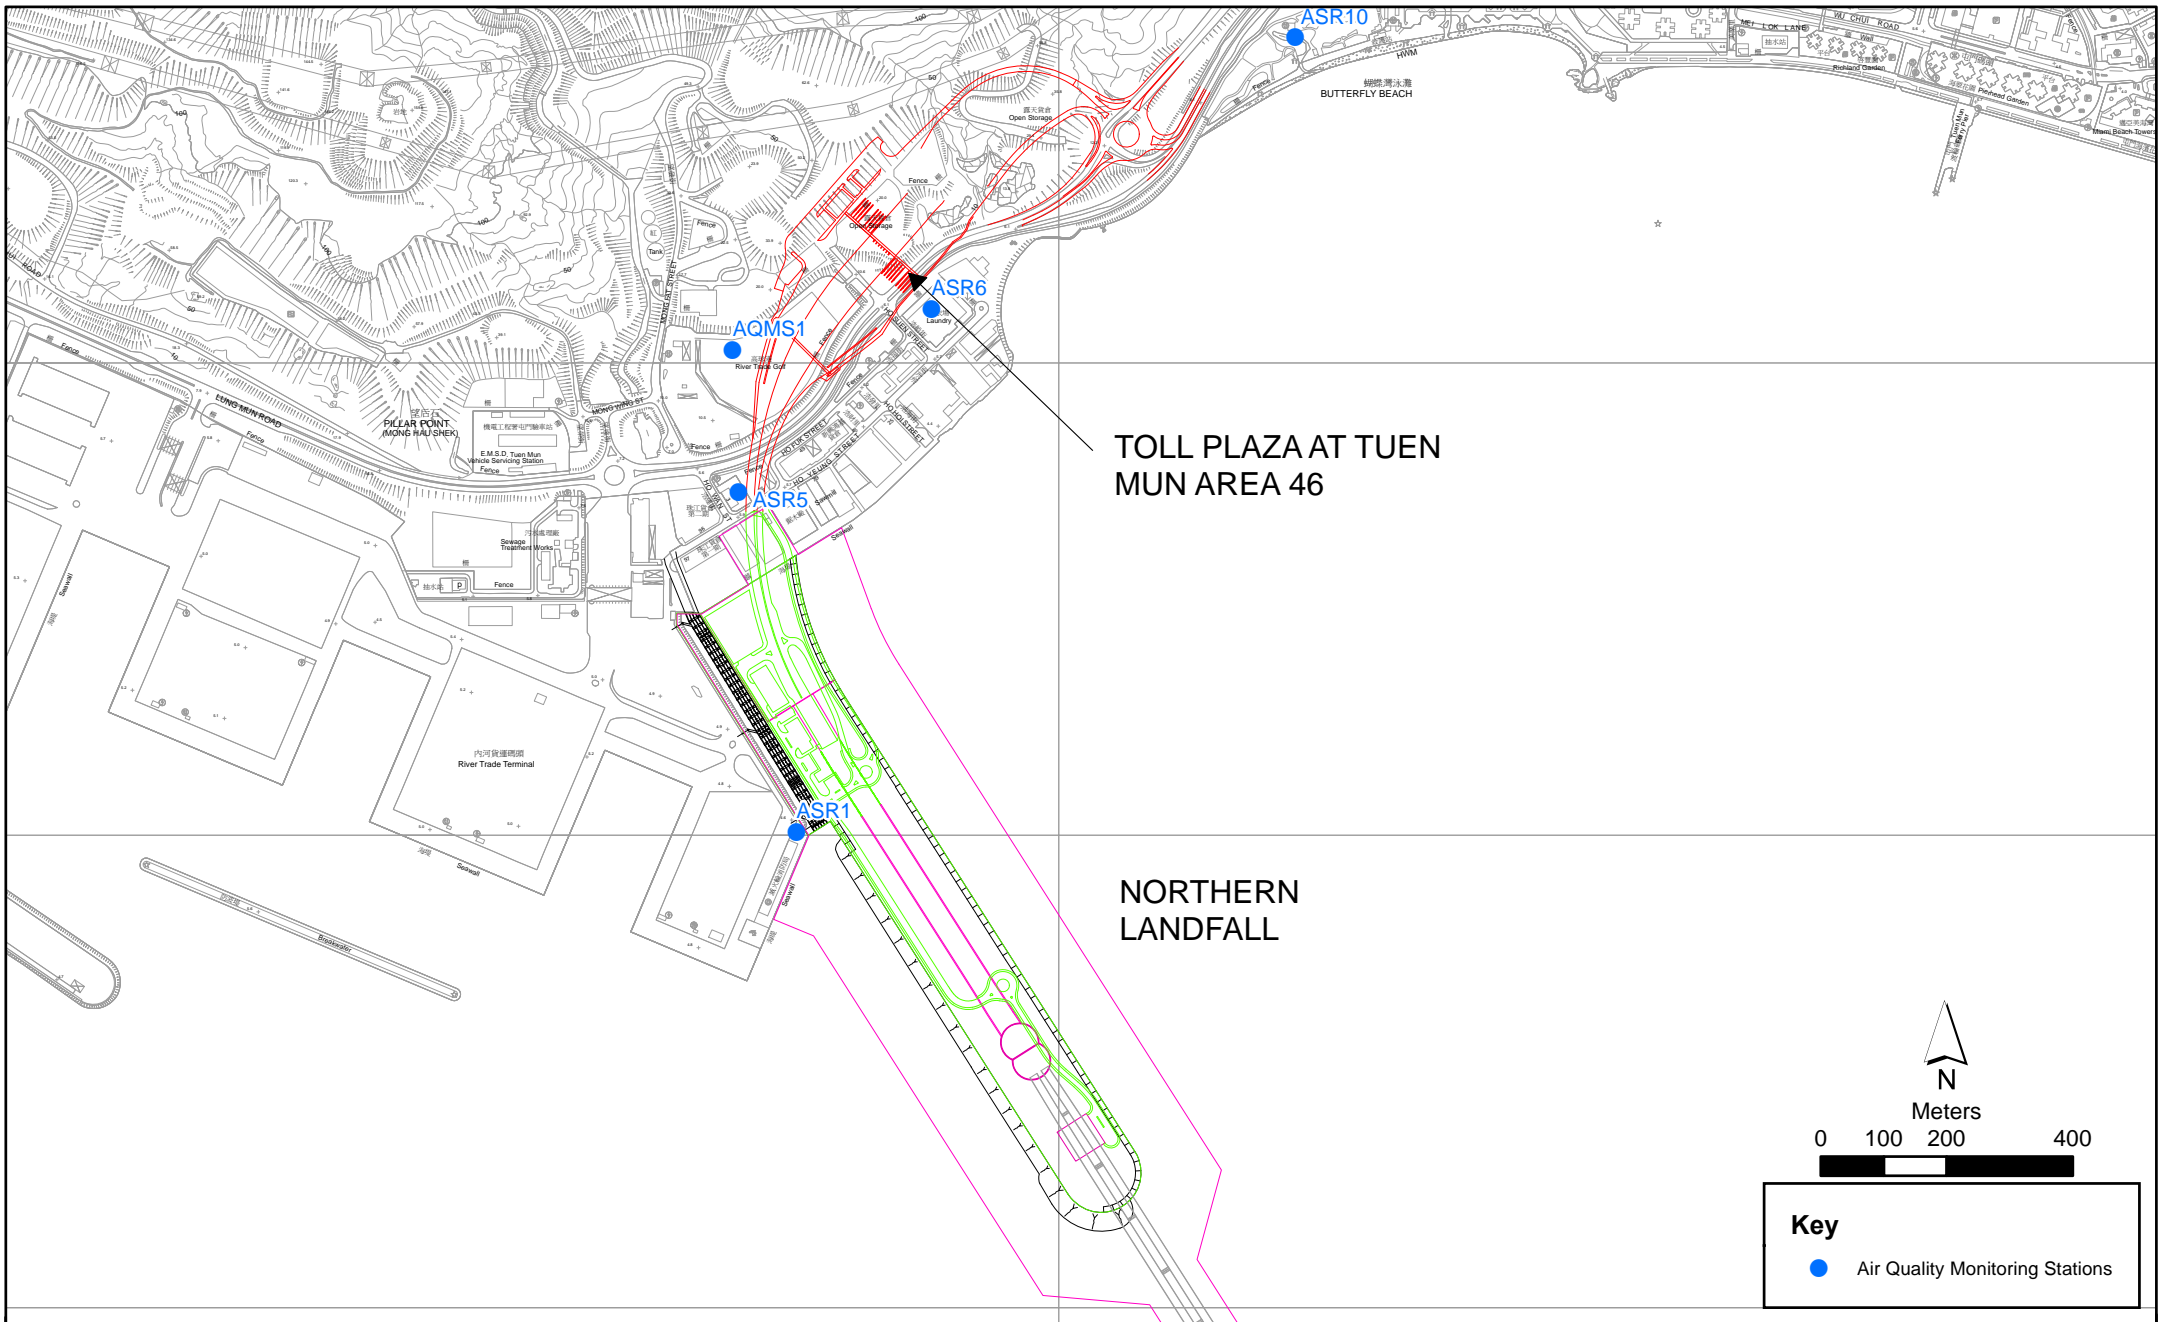
Figure 2.1

Air Quality Monitoring Stations for the Enhanced TSP Monitoring

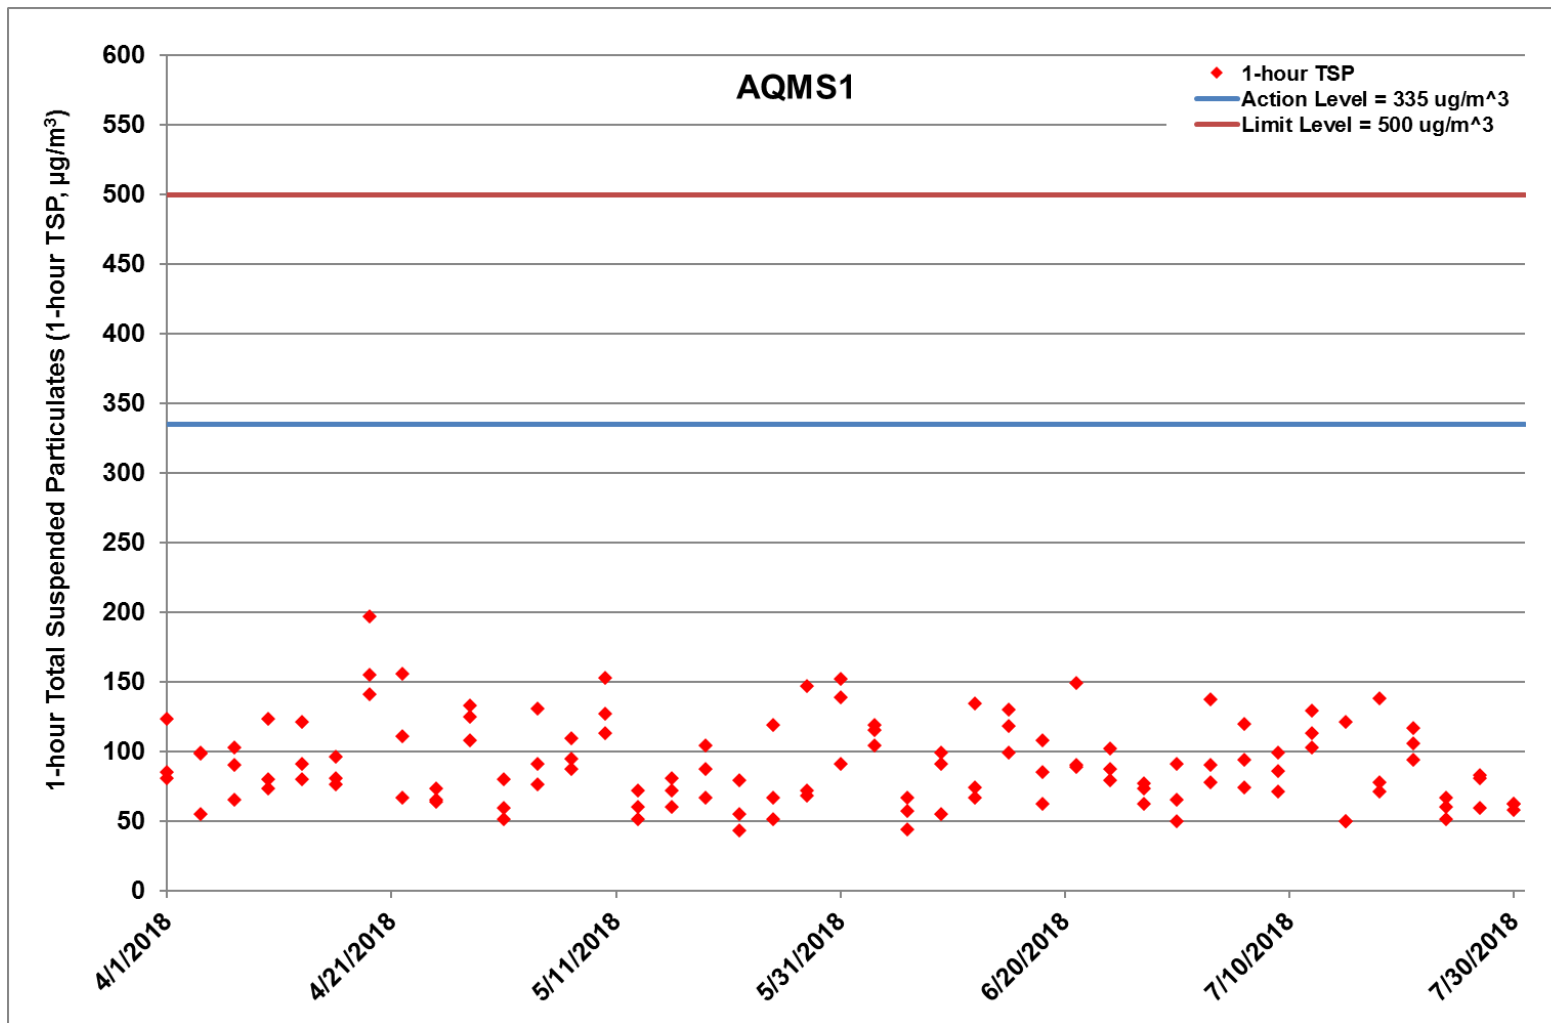
Figure G.1 Impact Monitoring – 1-hour Total Suspended Particulates (μg/m<sup>3</sup>) at AQMS1 between 1 April 2018 and 31 July 2018 during impact monitoring period. The weather conditions during the monitoring period varied from sunny to cloudy. Major land-based construction activities included: Box Culvert Extension, Tunnel Works (1/4/2018 – 31/7/2018)
