**Contract No. HY/2012/08
Tuen Mun - Chek Lap Kok Link -
Northern Connection Sub-sea Tunnel
Section**

***Eighty-Second Monthly Environmental
Monitoring & Audit (EM&A) Report***

09 September 2020

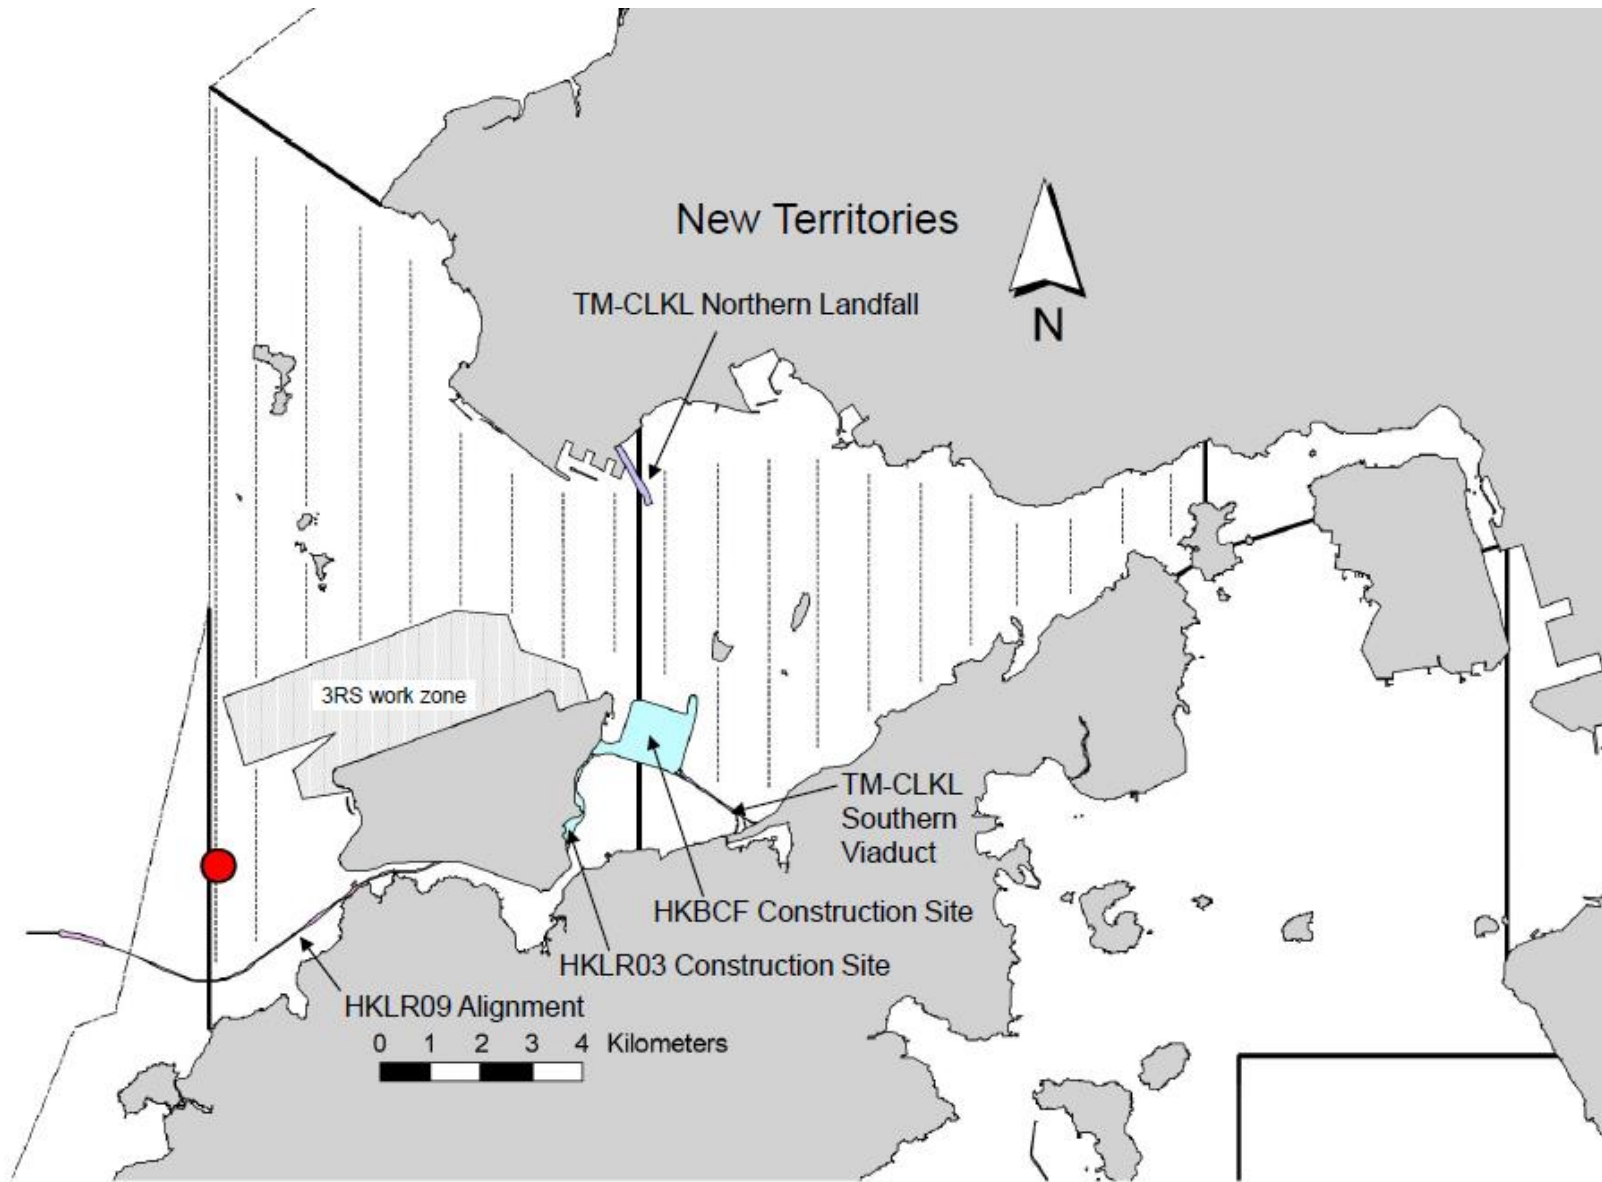
Figure 2.4

HY/2012/08 TM-CLKL Northern Connection Sub-sea Tunnel Section
 The distribution of dolphin sightings during the reporting period

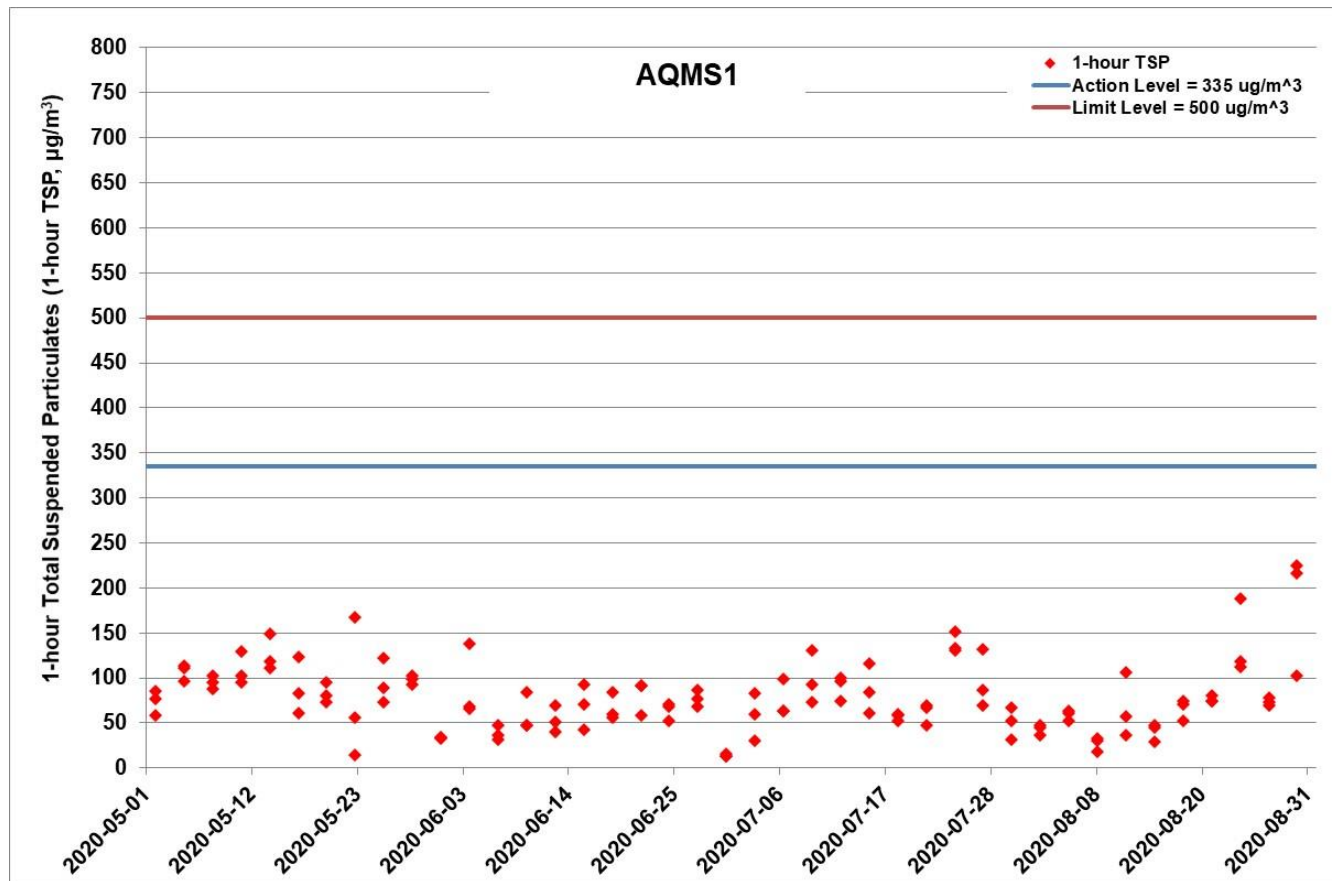
- Figure G.1 Impact Monitoring - 1-hour Total Suspended Particulates ($\mu\text{g}/\text{m}^3$) at AQMS1 between 1 May 2020 and 31 August 2020 during impact monitoring period. The weather conditions during the monitoring period varied from sunny to cloudy. Major land-based construction activities included Road & Drainage works - Portion S-A, S-B & S-C; UU installation - Portion S-A, S-B & S-C; and Carpark Formation - Portion S-A, S-B & S-C and Hard Paving and Footpath - Pump Sump Area at Northern Landfall (1/5/2020 - 31/8/2020)

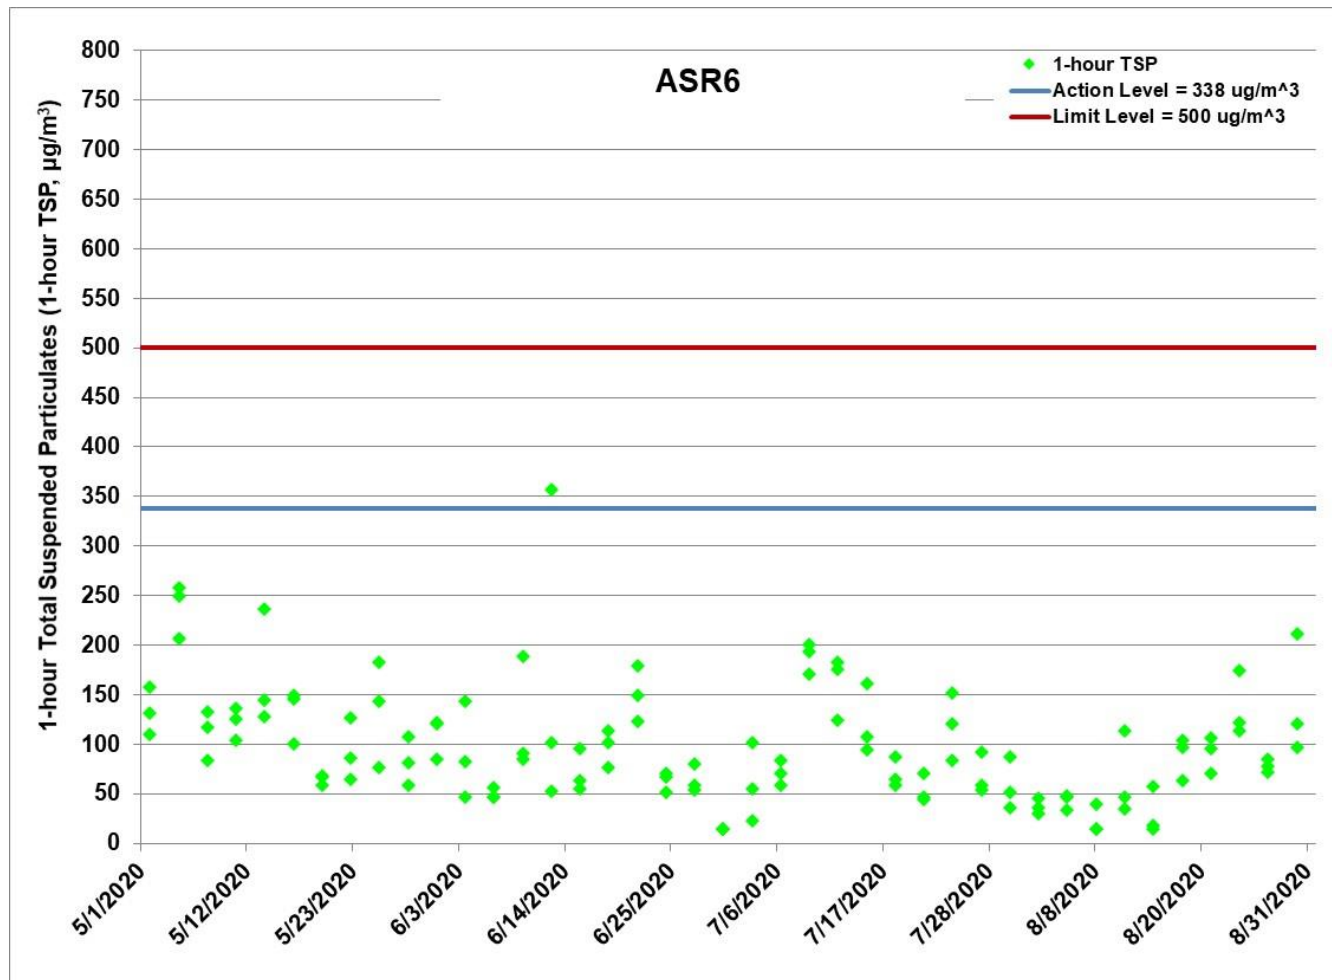
Figure G.2 Impact Monitoring - 1-hour Total Suspended Particulates ($\mu\text{g}/\text{m}^3$) at ASR6 between 1 May 2020 and 31 August 2020 during impact monitoring period. The weather conditions during the monitoring period varied from sunny to cloudy. Major land-based construction activities included Road & Drainage works - Portion S-A, S-B & S-C; UU installation - Portion S-A, S-B & S-C; and Carpark Formation - Portion S-A, S-B & S-C and Hard Paving and Footpath - Pump Sump Area at Northern Landfall (1/5/2020 - 31/8/2020)

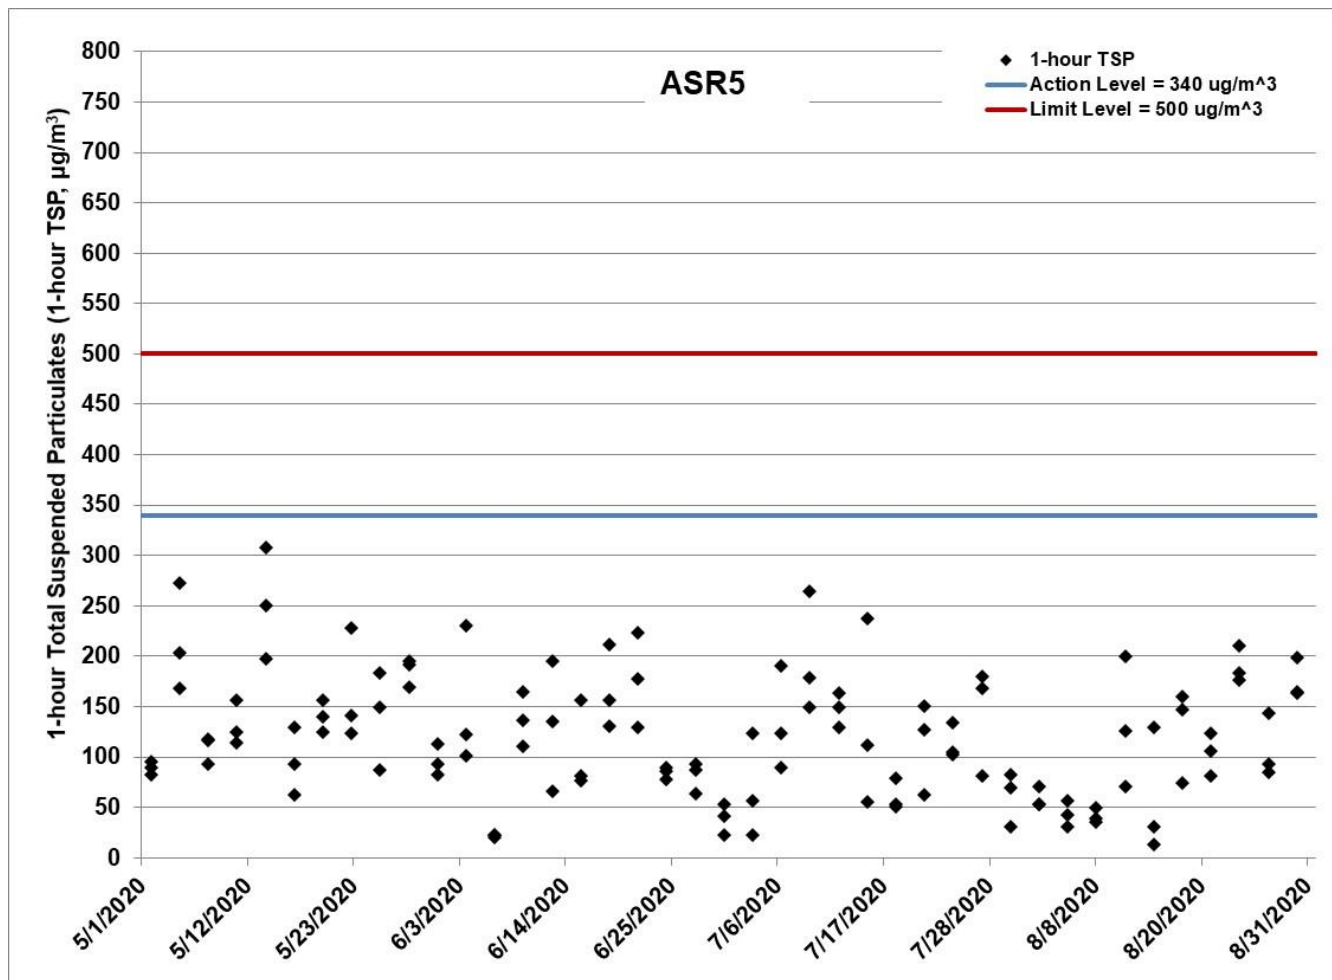
Figure G.4 Impact Monitoring - 1-hour Total Suspended Particulates ($\mu\text{g}/\text{m}^3$) at ASR5 between 1 May 2020 and 31 August 2020 during impact monitoring period. The weather conditions during the monitoring period varied from sunny to cloudy. Major land-based construction activities included Road & Drainage works - Portion S-A, S-B & S-C; UU installation - Portion S-A, S-B & S-C; and Carpark Formation - Portion S-A, S-B & S-C and Hard Paving and Footpath - Pump Sump Area at Northern Landfall (1/5/2020 - 31/8/2020)

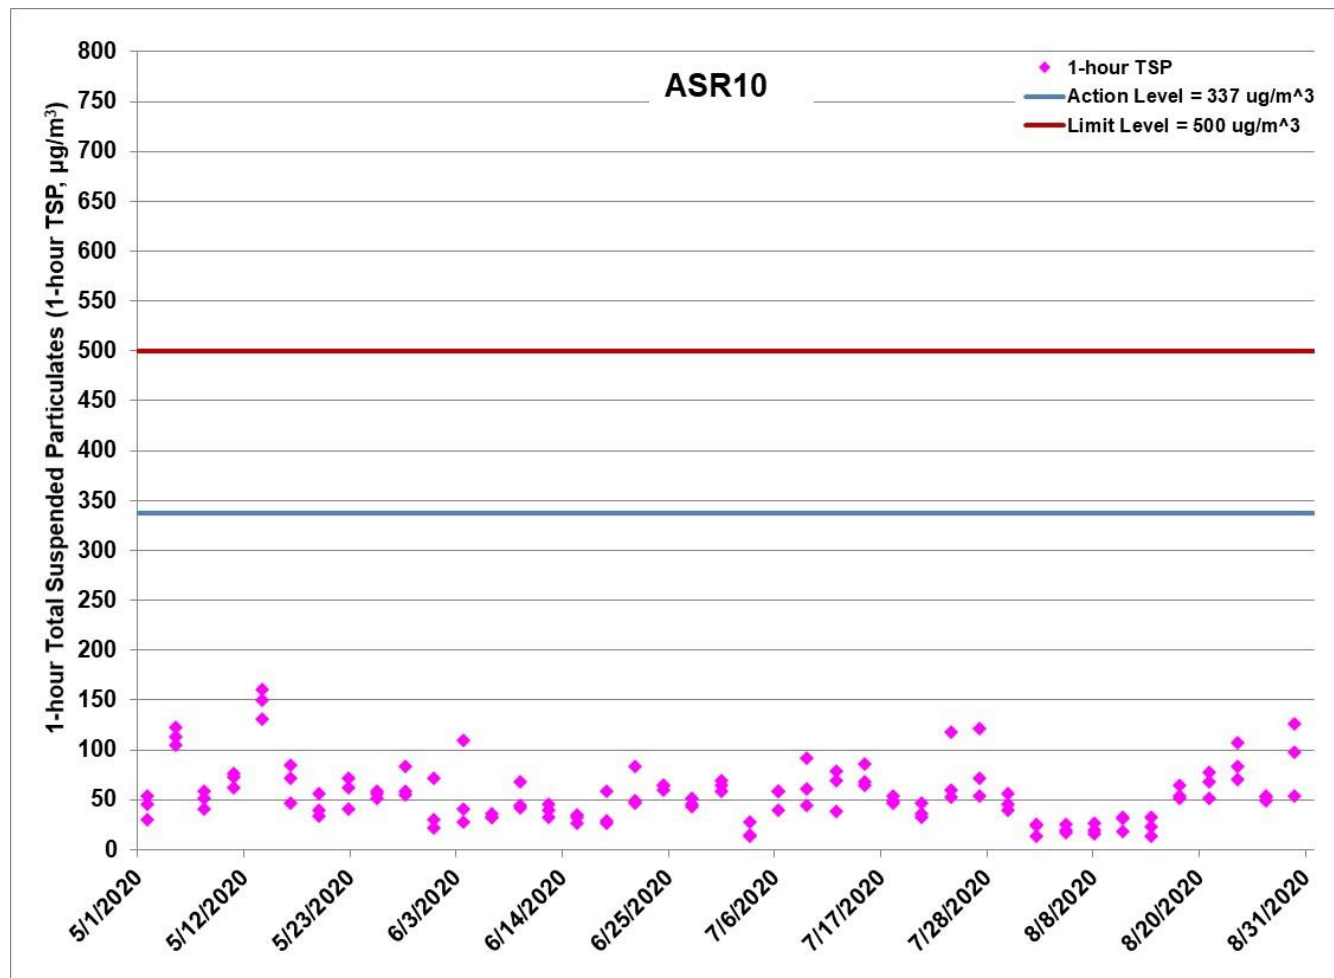
Figure G.5 Impact Monitoring - 1-hour Total Suspended Particulates ($\mu\text{g}/\text{m}^3$) at ASR10 between 1 May 2020 and 31 August 2020 during impact monitoring period. The weather conditions during the monitoring period varied from sunny to cloudy. Major land-based construction activities included Road & Drainage works - Portion S-A, S-B & S-C; UU installation - Portion S-A, S-B & S-C; and Carpark Formation - Portion S-A, S-B & S-C and Hard Paving and Footpath - Pump Sump Area at Northern Landfall (1/5/2020 - 31/8/2020)

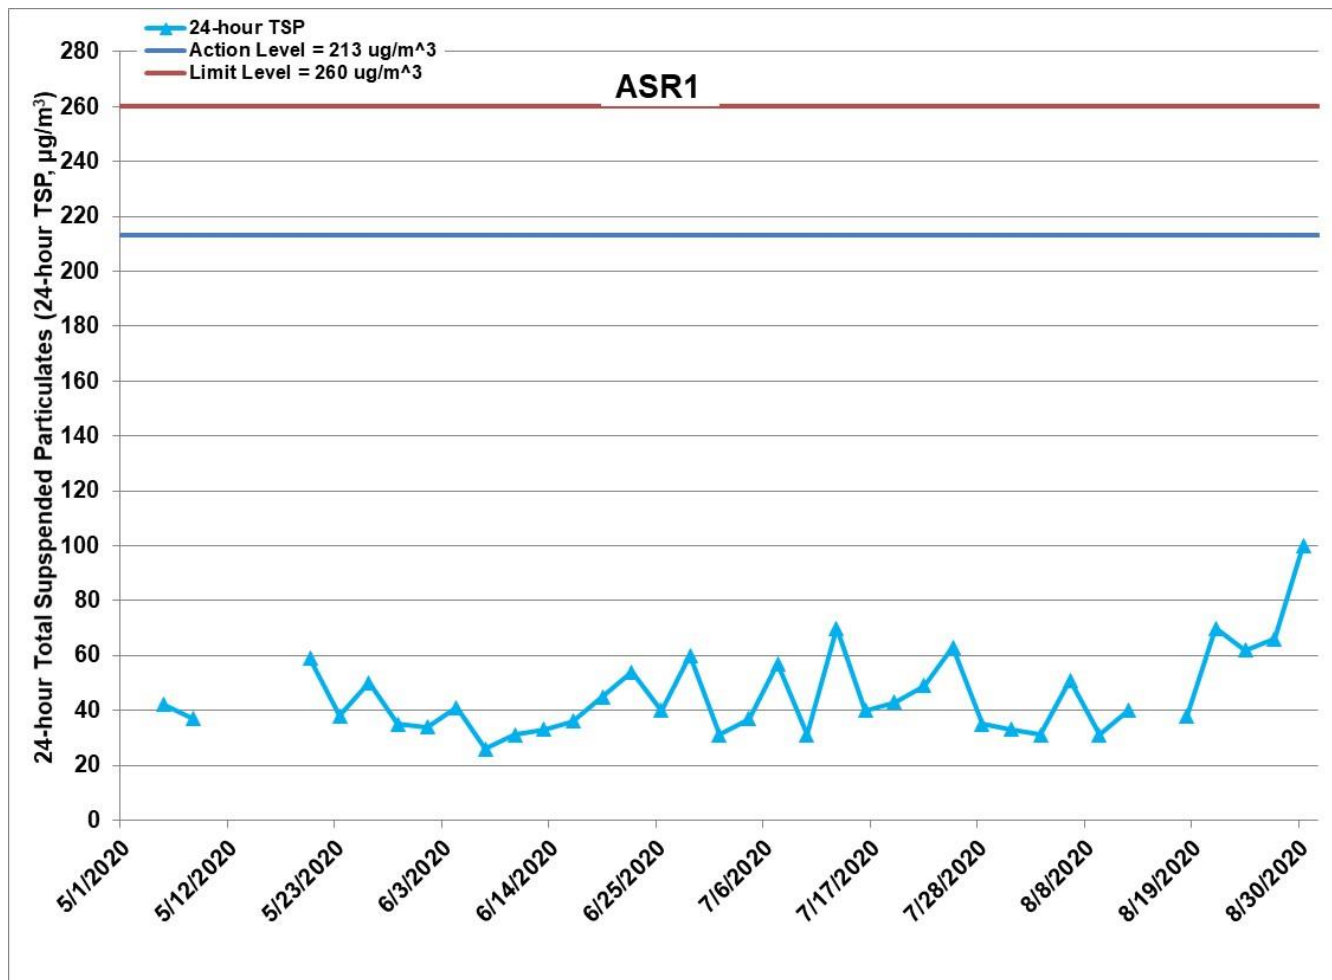
Figure G.6 Impact Monitoring - 24-hour Total Suspended Particulates ($\mu\text{g}/\text{m}^3$) at ASR1 between 1 May 2020 and 31 August 2020 during impact monitoring period. The weather conditions during the monitoring period varied from sunny to cloudy. Major land-based construction activities included Road & Drainage works - Portion S-A, S-B & S-C; UU installation - Portion S-A, S-B & S-C; and Carpark Formation - Portion S-A, S-B & S-C and Hard Paving and Footpath - Pump Sump Area at Northern Landfall (1/5/2020 - 31/8/2020)

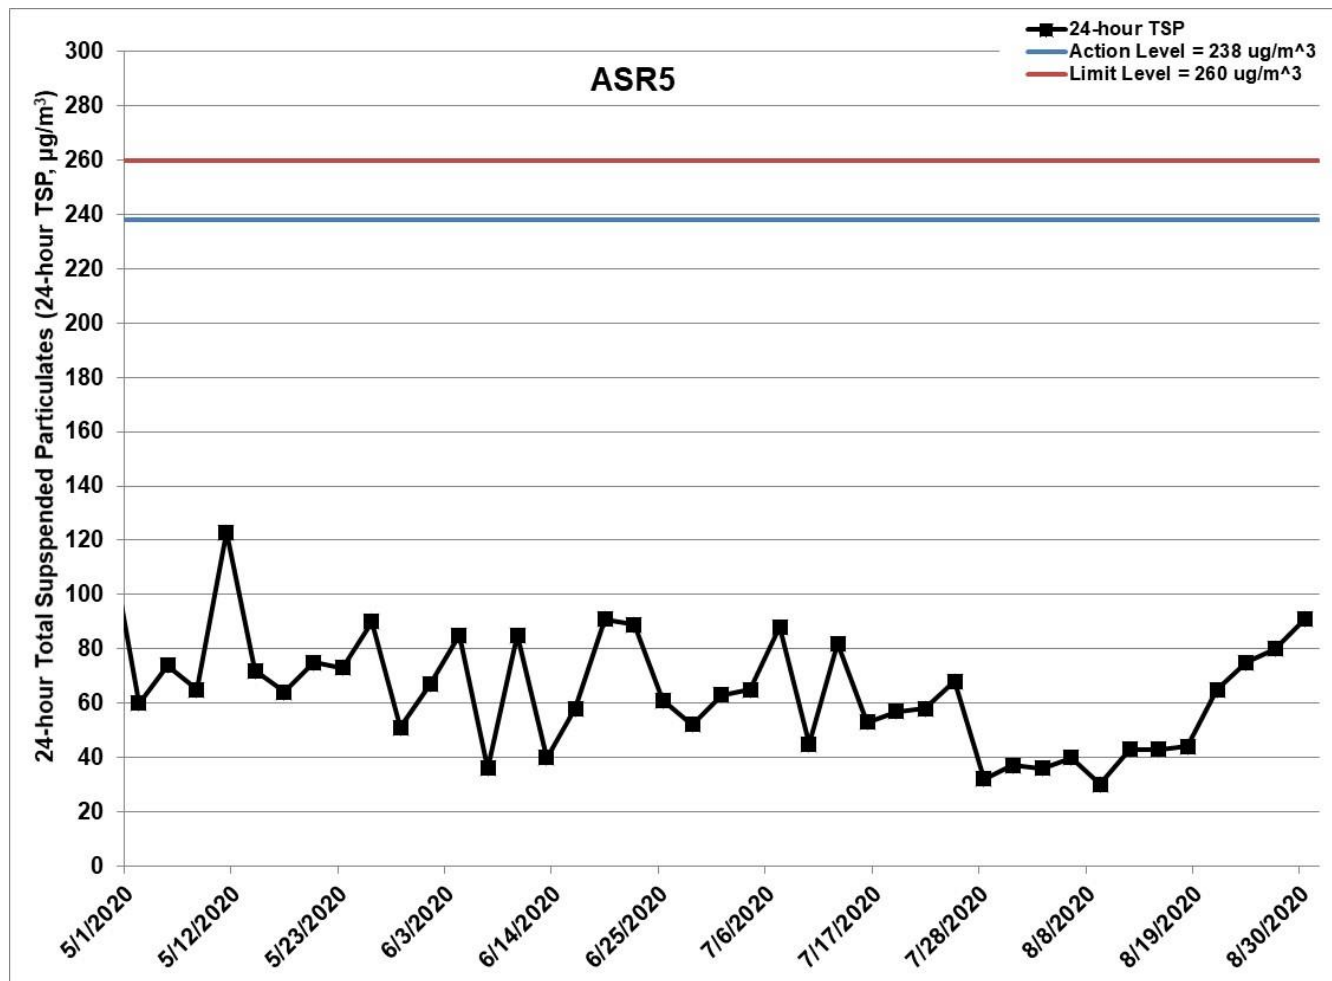
Figure G.7 Impact Monitoring – 24-hour Total Suspended Particulates ($\mu\text{g}/\text{m}^3$) at ASR5 between 1 May 2020 and 31 August 2020 during impact monitoring period. The weather conditions during the monitoring period varied from sunny to cloudy. Major land-based construction activities included Road & Drainage works – Portion S-A, S-B & S-C; UU installation – Portion S-A, S-B & S-C; and Carpark Formation – Portion S-A, S-B & S-C and Hard Paving and Footpath – Pump Sump Area at Northern Landfall (1/5/2020 – 31/8/2020)

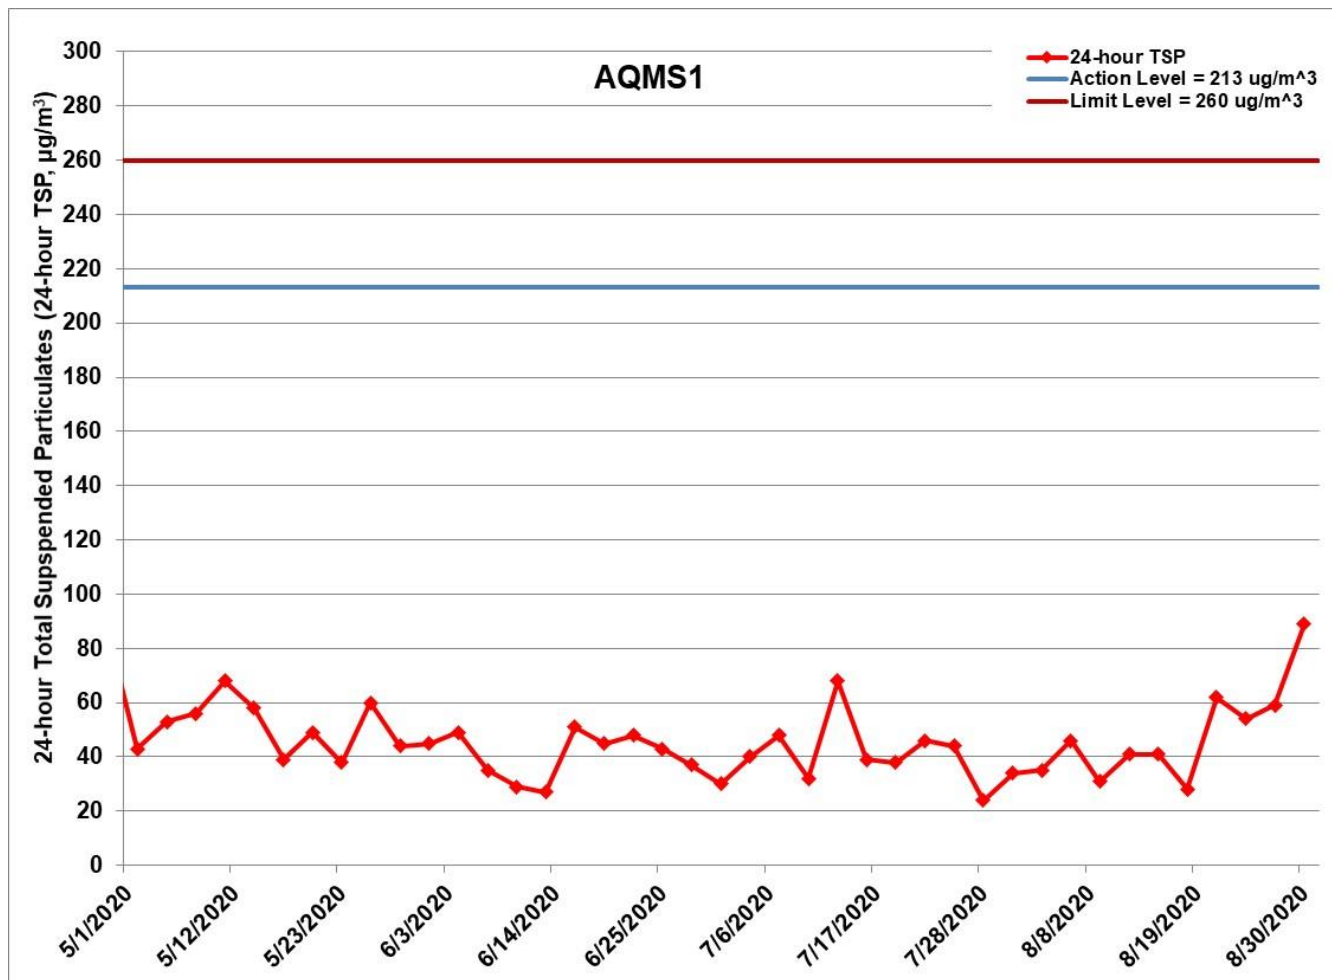
Figure G.8 Impact Monitoring - 24-hour Total Suspended Particulates ($\mu\text{g}/\text{m}^3$) at AQMS1 between 1 May 2020 and 31 August 2020 during impact monitoring period. The weather conditions during the monitoring period varied from sunny to cloudy. Major land-based construction activities included Road & Drainage works - Portion S-A, S-B & S-C; UU installation - Portion S-A, S-B & S-C; and Carpark Formation - Portion S-A, S-B & S-C and Hard Paving and Footpath - Pump Sump Area at Northern Landfall (1/5/2020 - 31/8/2020)

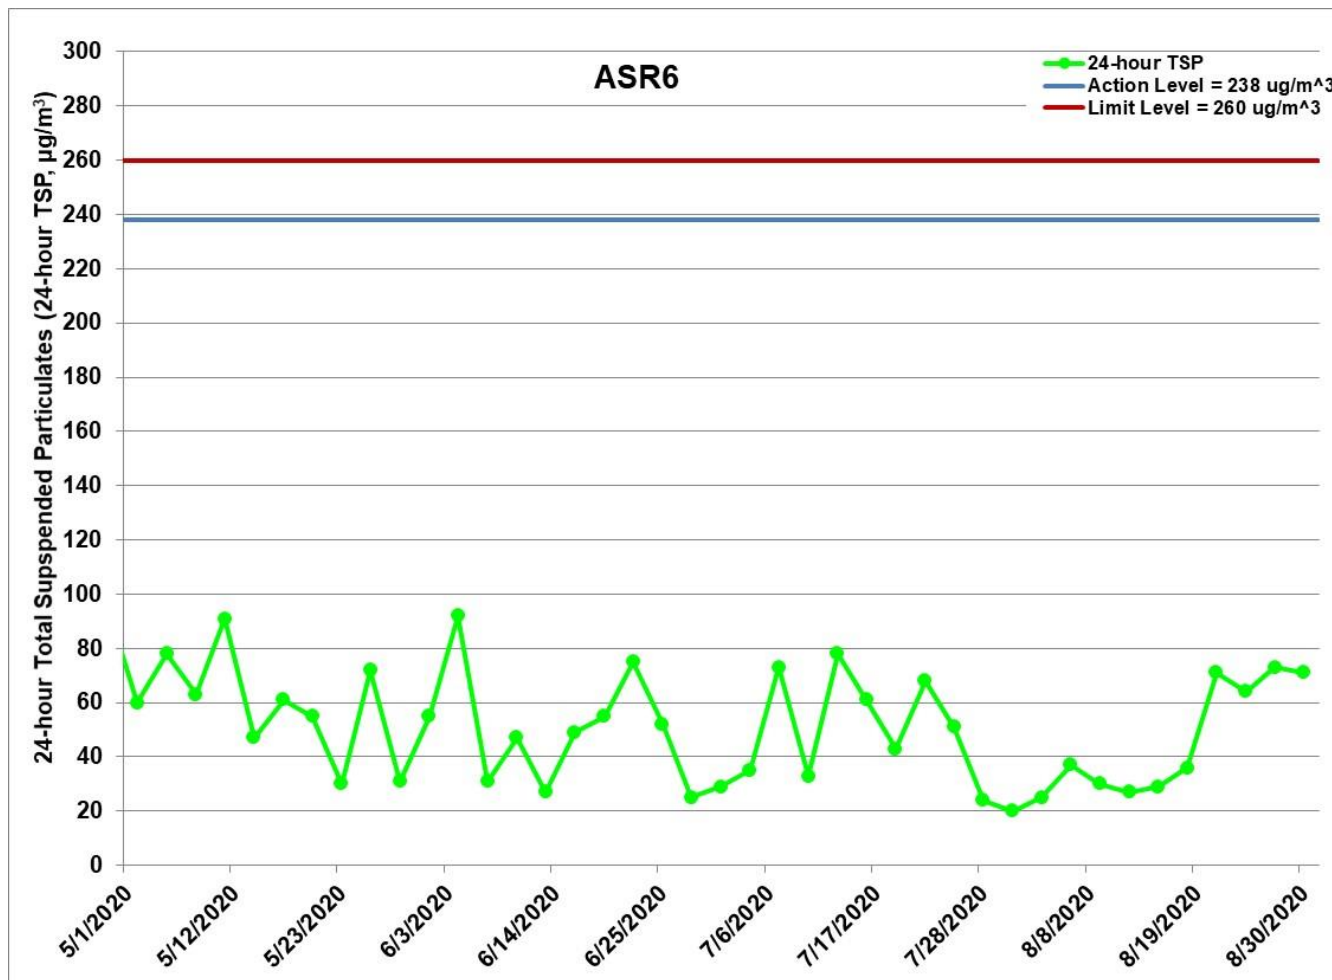
Figure G.9 Impact Monitoring - 24-hour Total Suspended Particulates ($\mu\text{g}/\text{m}^3$) at ASR6 between 1 May 2020 and 31 August 2020 during impact monitoring period. The weather conditions during the monitoring period varied from sunny to cloudy. Major land-based construction activities included Road & Drainage works - Portion S-A, S-B & S-C; UU installation - Portion S-A, S-B & S-C; and Carpark Formation - Portion S-A, S-B & S-C and Hard Paving and Footpath - Pump Sump Area at Northern Landfall (1/5/2020 - 31/8/2020)

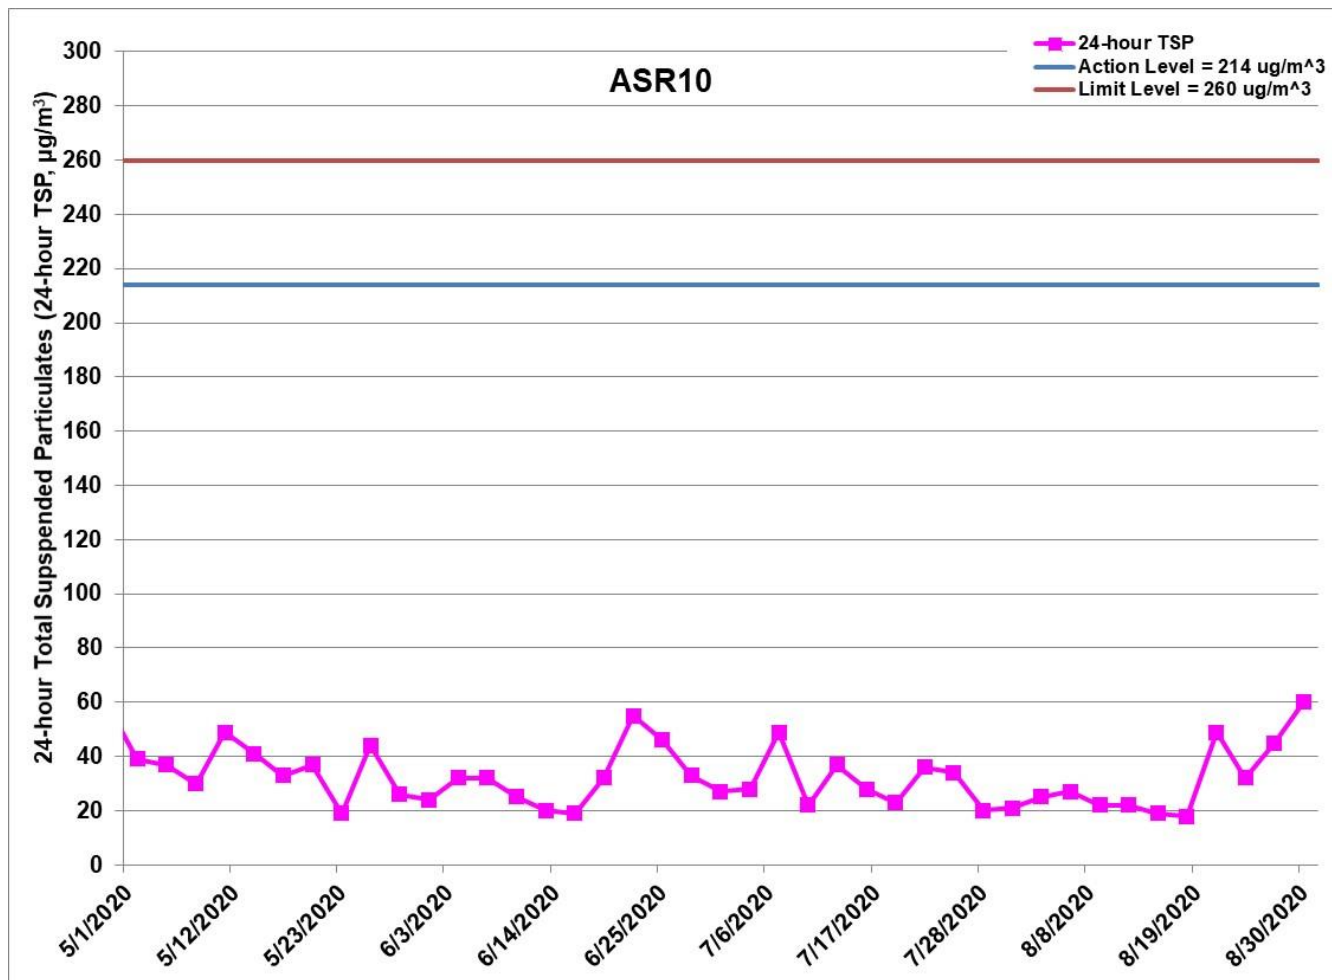
Figure G.10 Impact Monitoring - 24-hour Total Suspended Particulates ($\mu\text{g}/\text{m}^3$) at ASR10 between 1 May 2020 and 31 August 2020 during impact monitoring period. The weather conditions during the monitoring period varied from sunny to cloudy. Major land-based construction activities included Road & Drainage works - Portion S-A, S-B & S-C; UU installation - Portion S-A, S-B & S-C; and Carpark Formation - Portion S-A, S-B & S-C and Hard Paving and Footpath - Pump Sump Area at Northern Landfall (1/5/2020 - 31/8/2020)

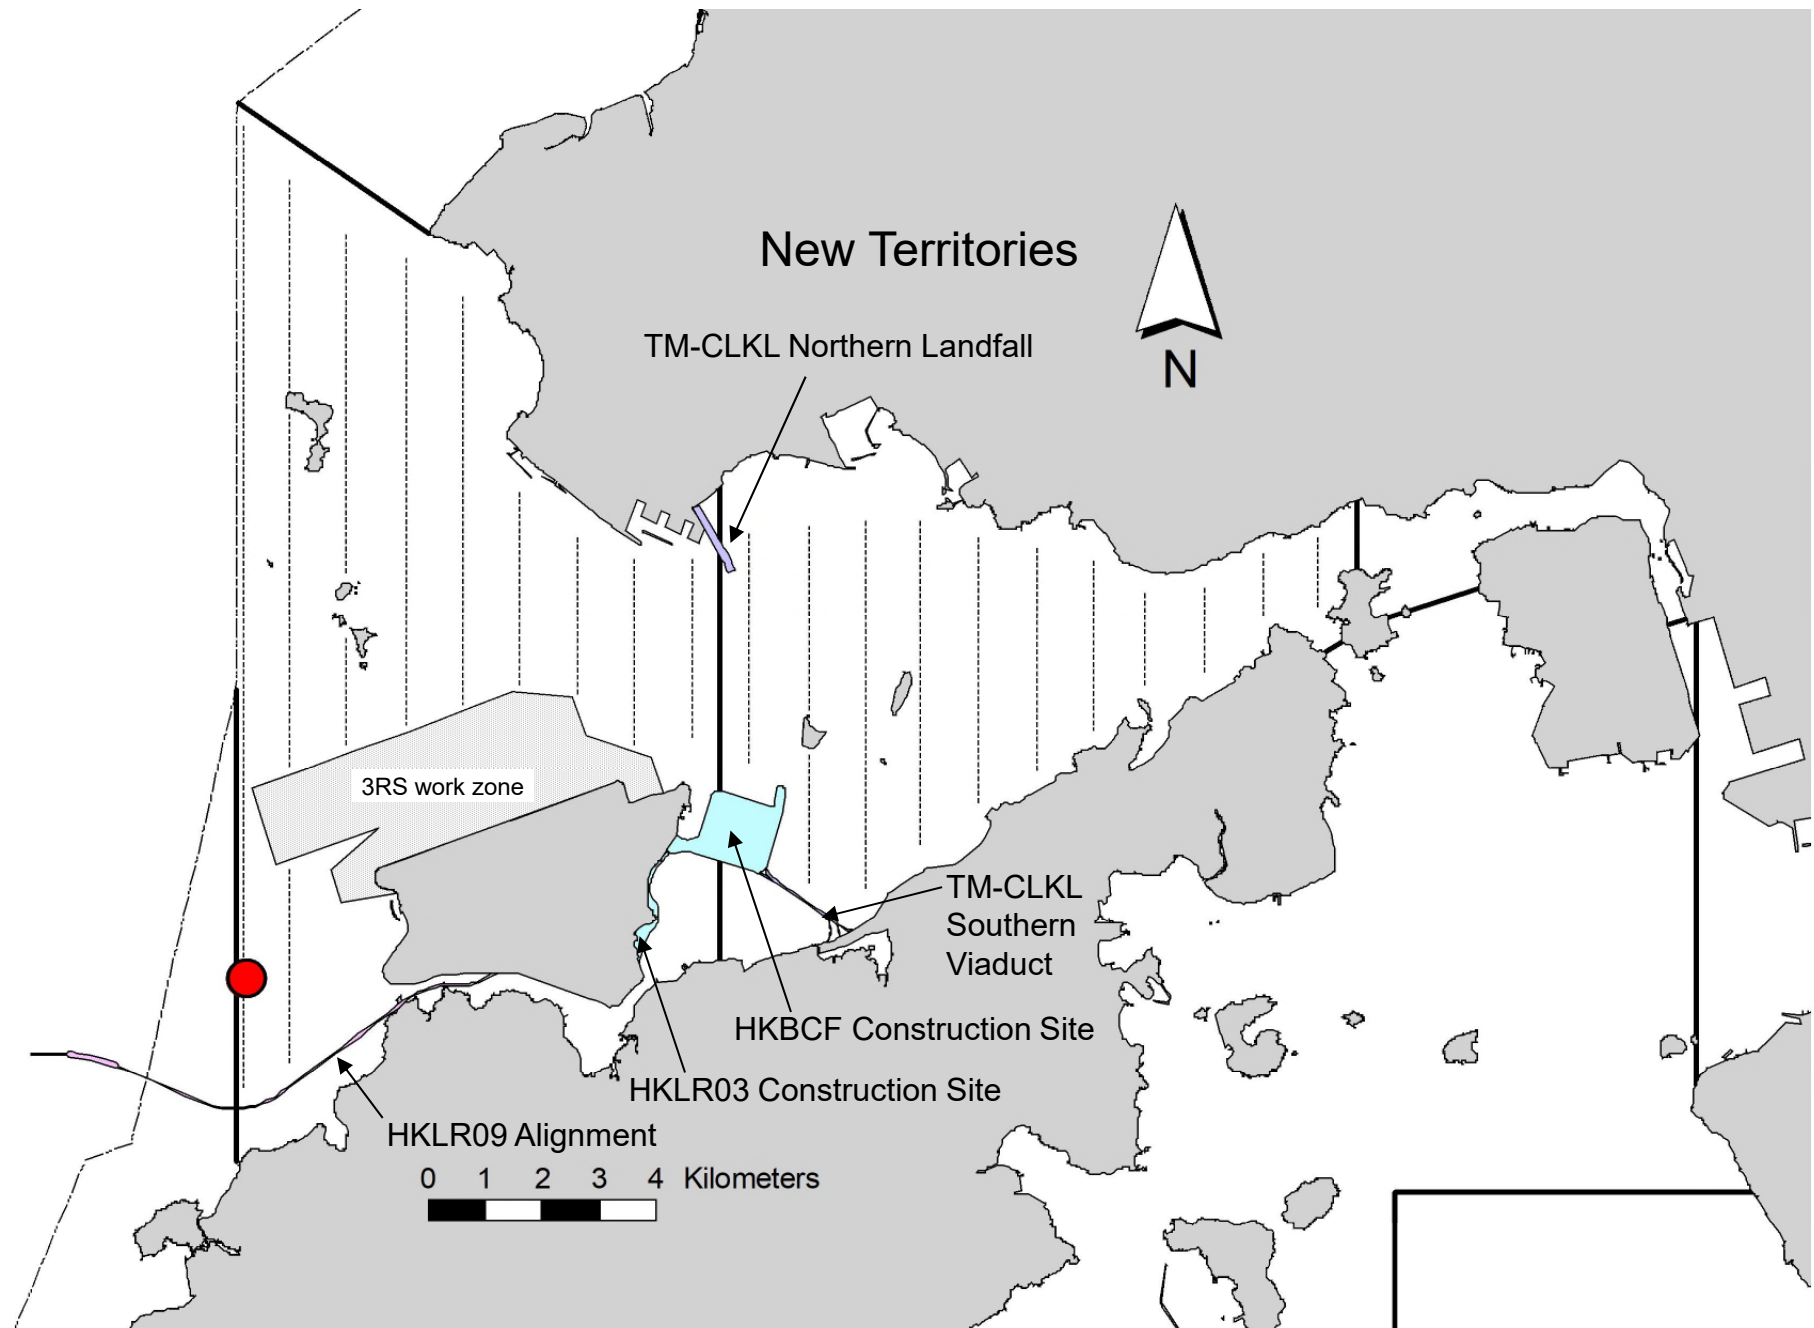
Figure 6. Distribution of Chinese White Dolphin Sightings during August 2020 Monitoring Surveys

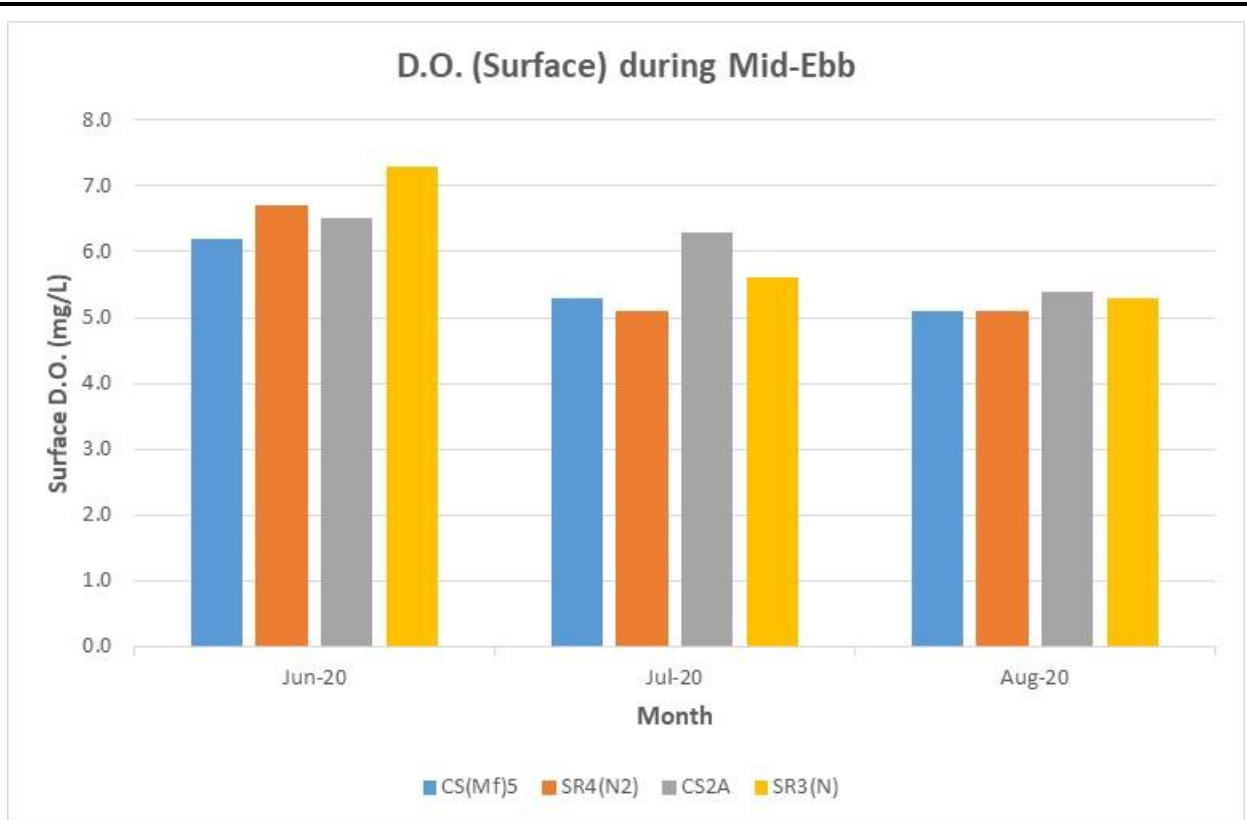
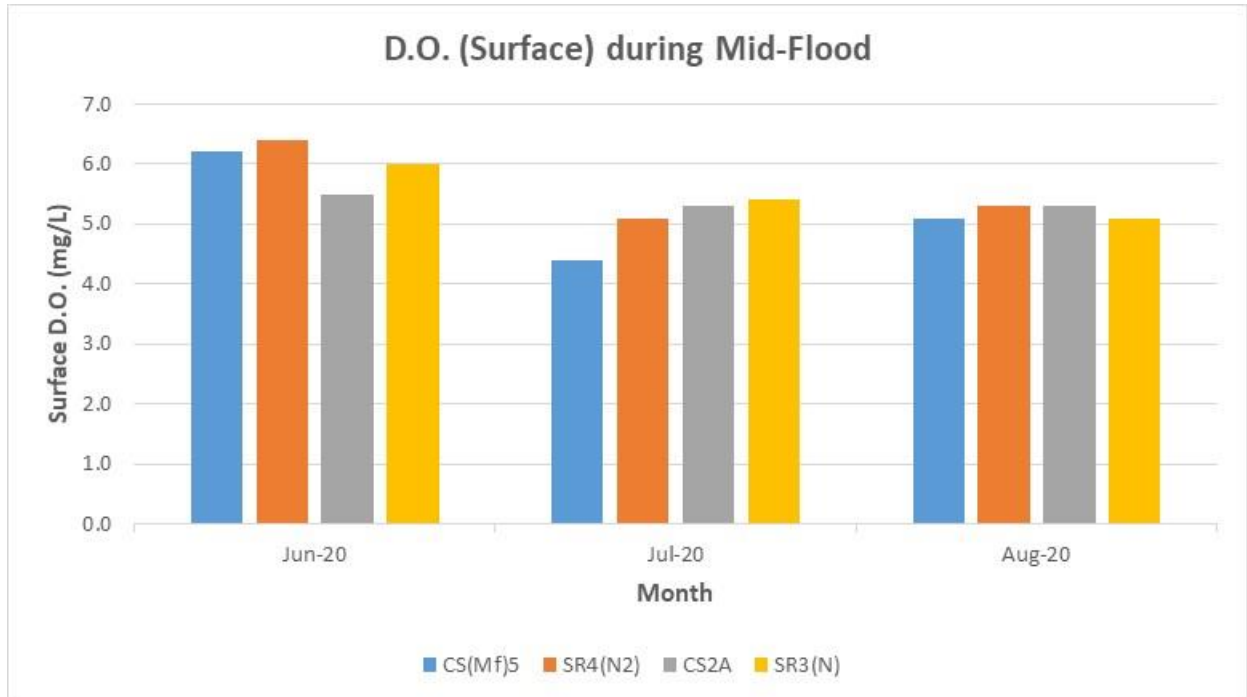
Figure J1 Operational Phase Monitoring - Mean Level of Dissolved Oxygen (mg/L) in surface waters between 1 June 2020 and 31 August 2020. The weather conditions during the monitoring period varied mostly from sunny to cloudy.

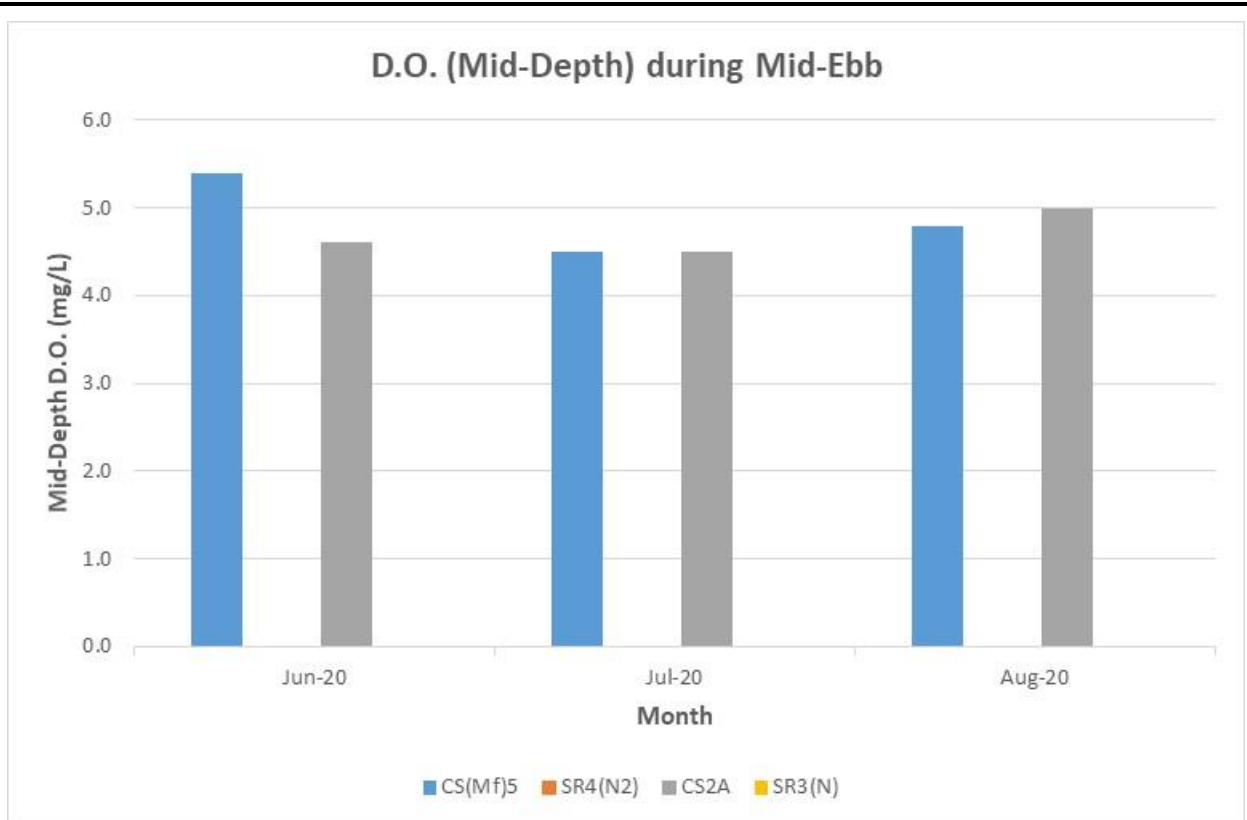
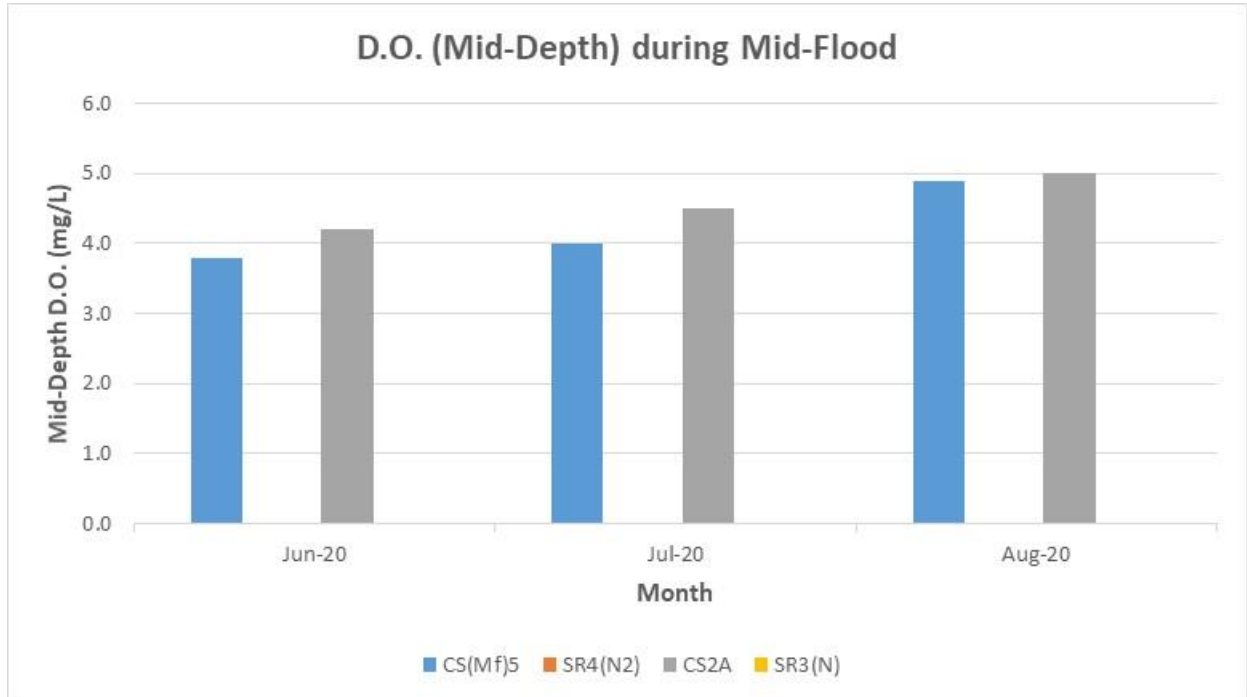
Figure J2 Operational Phase Monitoring - Mean Level of Dissolved Oxygen (mg/L) in mid-depth waters between 1 June 2020 and 31 August 2020. The weather conditions during the monitoring period varied mostly from sunny to cloudy.

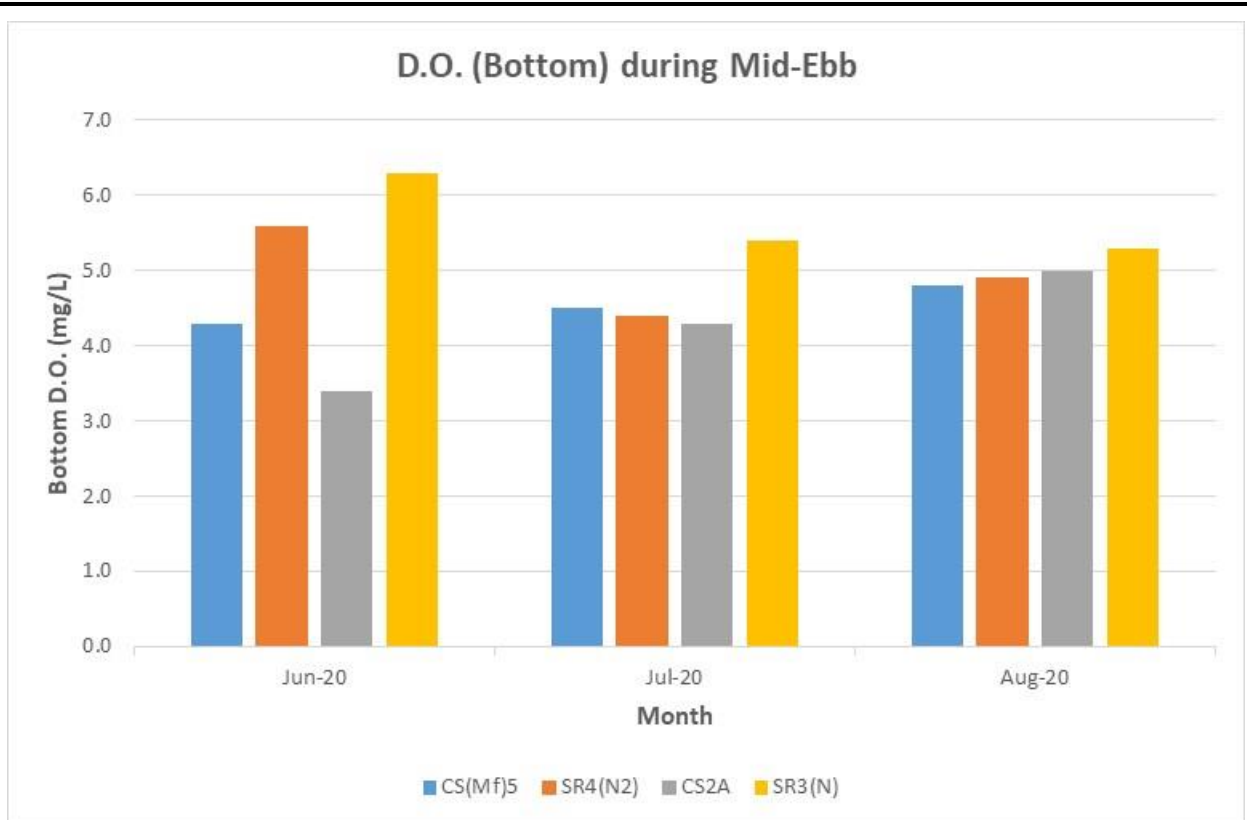
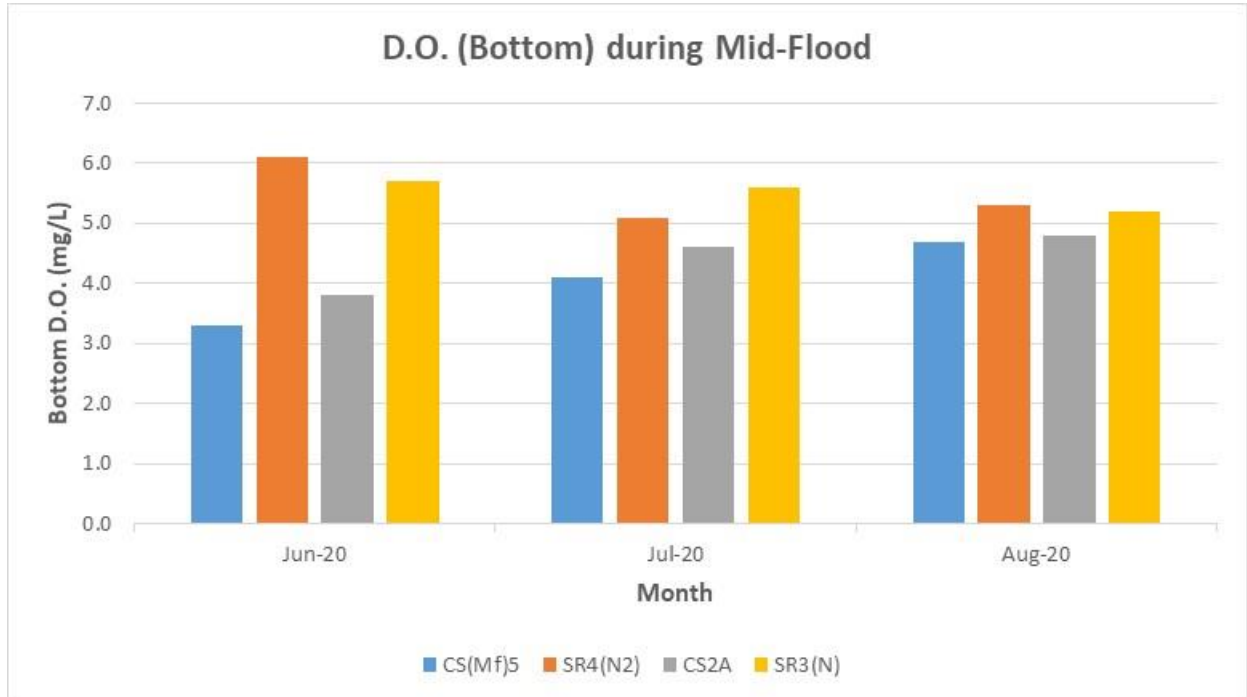
Figure J3 Operational Phase Monitoring - Mean Level of Dissolved Oxygen (mg/L) in bottom waters between 1 June 2020 and 31 August 2020. The weather conditions during the monitoring period varied mostly from sunny to cloudy.
