**Contract No. HY/2012/08
Tuen Mun - Chek Lap Kok Link -
Northern Connection Sub-sea Tunnel
Section**

***Eighty-Second Monthly Environmental
Monitoring & Audit (EM&A) Report***

09 September 2020

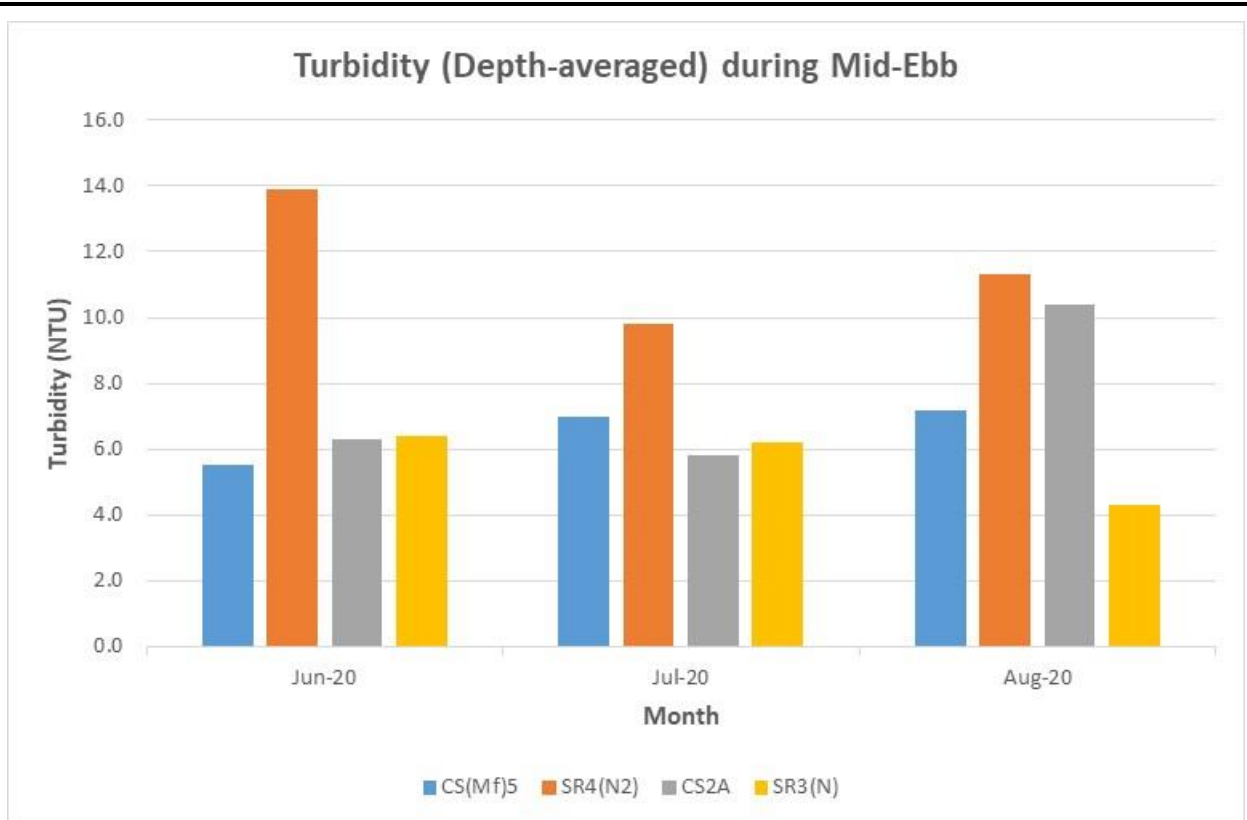
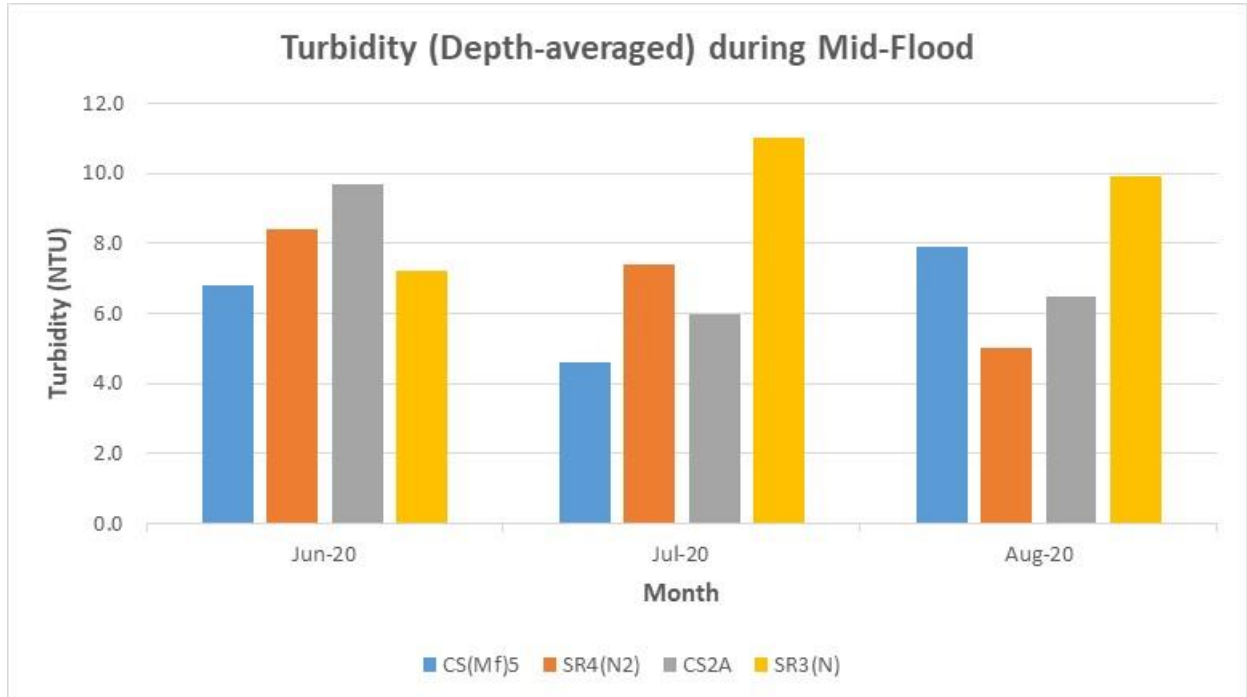
Figure J4 Operational Phase Monitoring - Mean Depth-averaged Level of Turbidity (NTU) between 1 June 2020 and 31 August 2020. The weather conditions during the monitoring period varied mostly from sunny to cloudy.

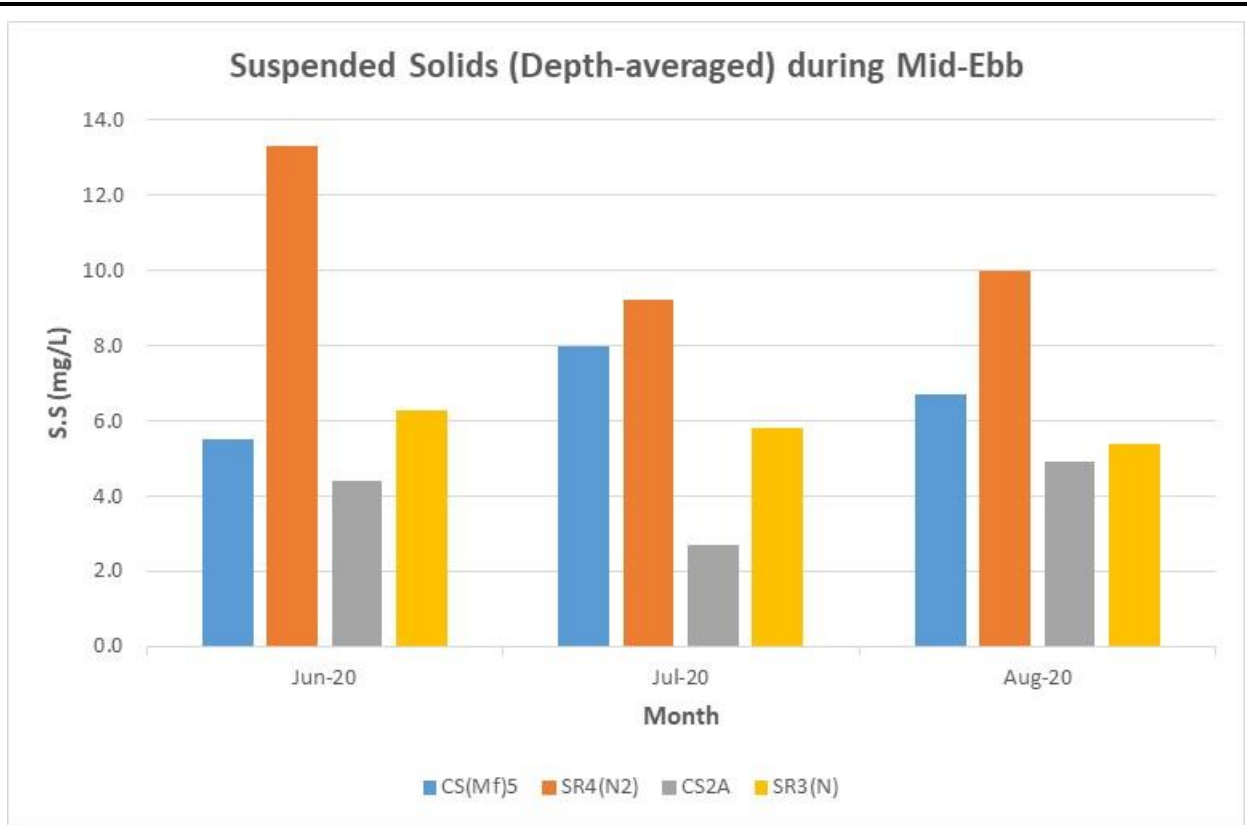
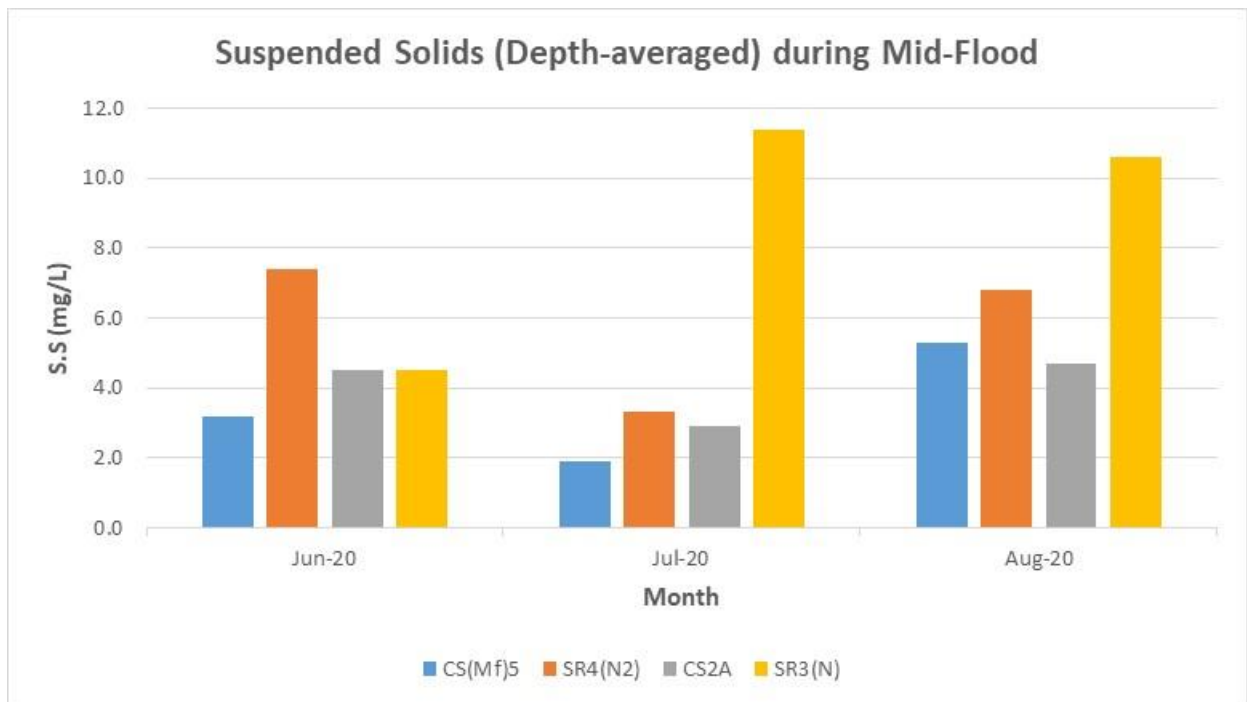
Figure J5 Operational Phase Monitoring – Mean Depth-averaged Level of Suspended Solids (mg/L) between 1 June 2020 and 31 August 2020. The weather conditions during the monitoring period varied mostly from sunny to cloudy.

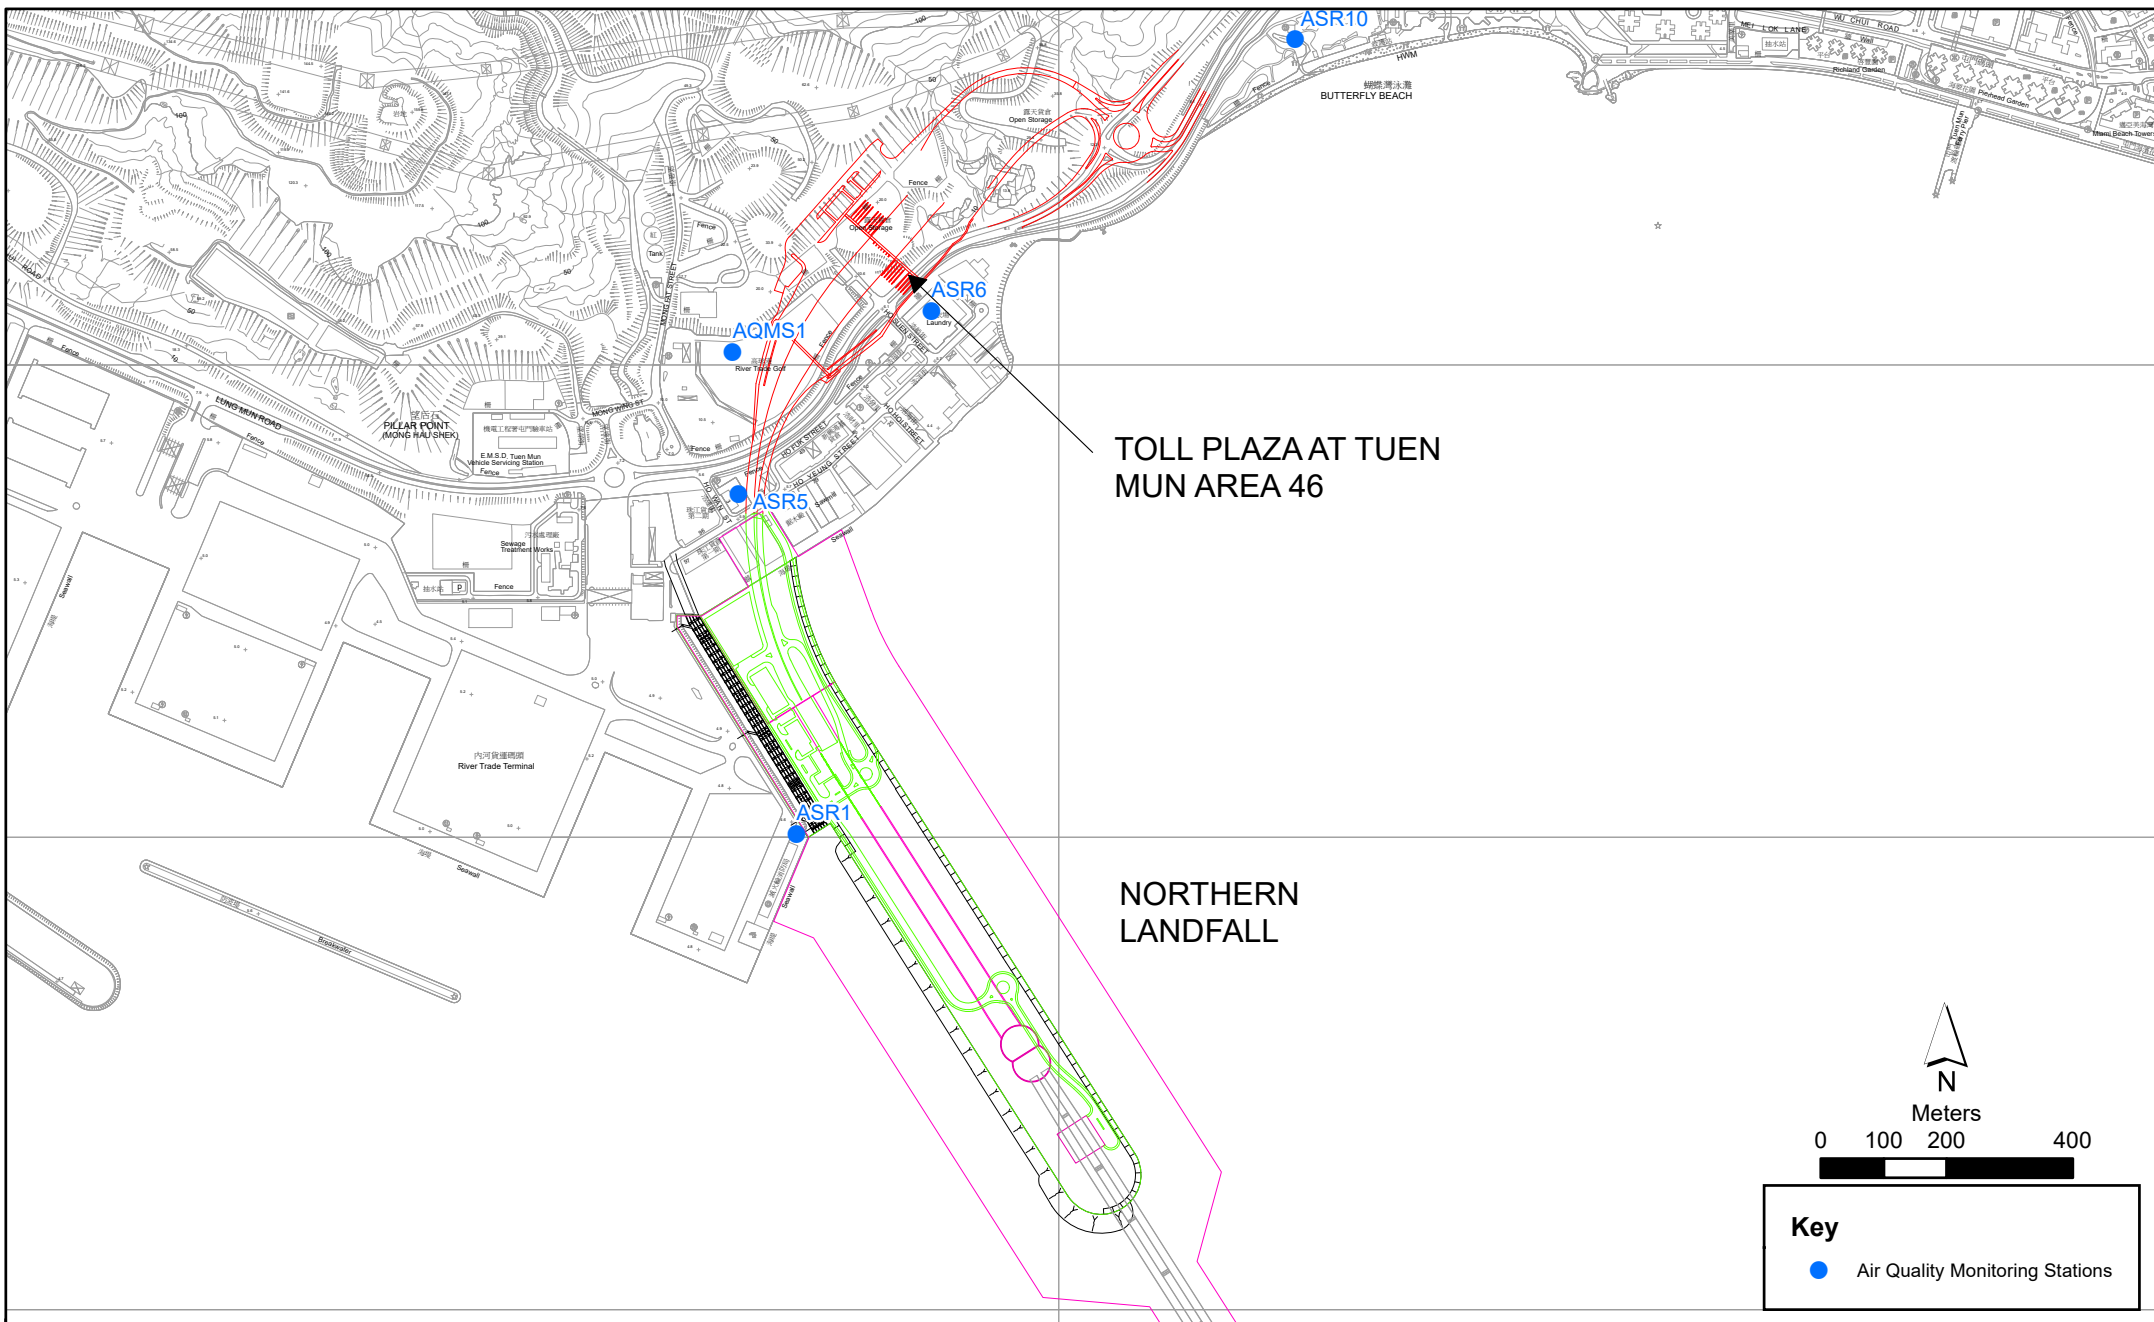
Figure 2.1

Air Quality Monitoring Stations for the Enhanced TSP Monitoring
