**Contract No. HY/2012/08  
Tuen Mun - Chek Lap Kok Link -  
Northern Connection Sub-sea Tunnel  
Section**

***Eighty-Fifth Monthly Environmental Monitoring  
& Audit (EM&A) Report***

11 December 2020

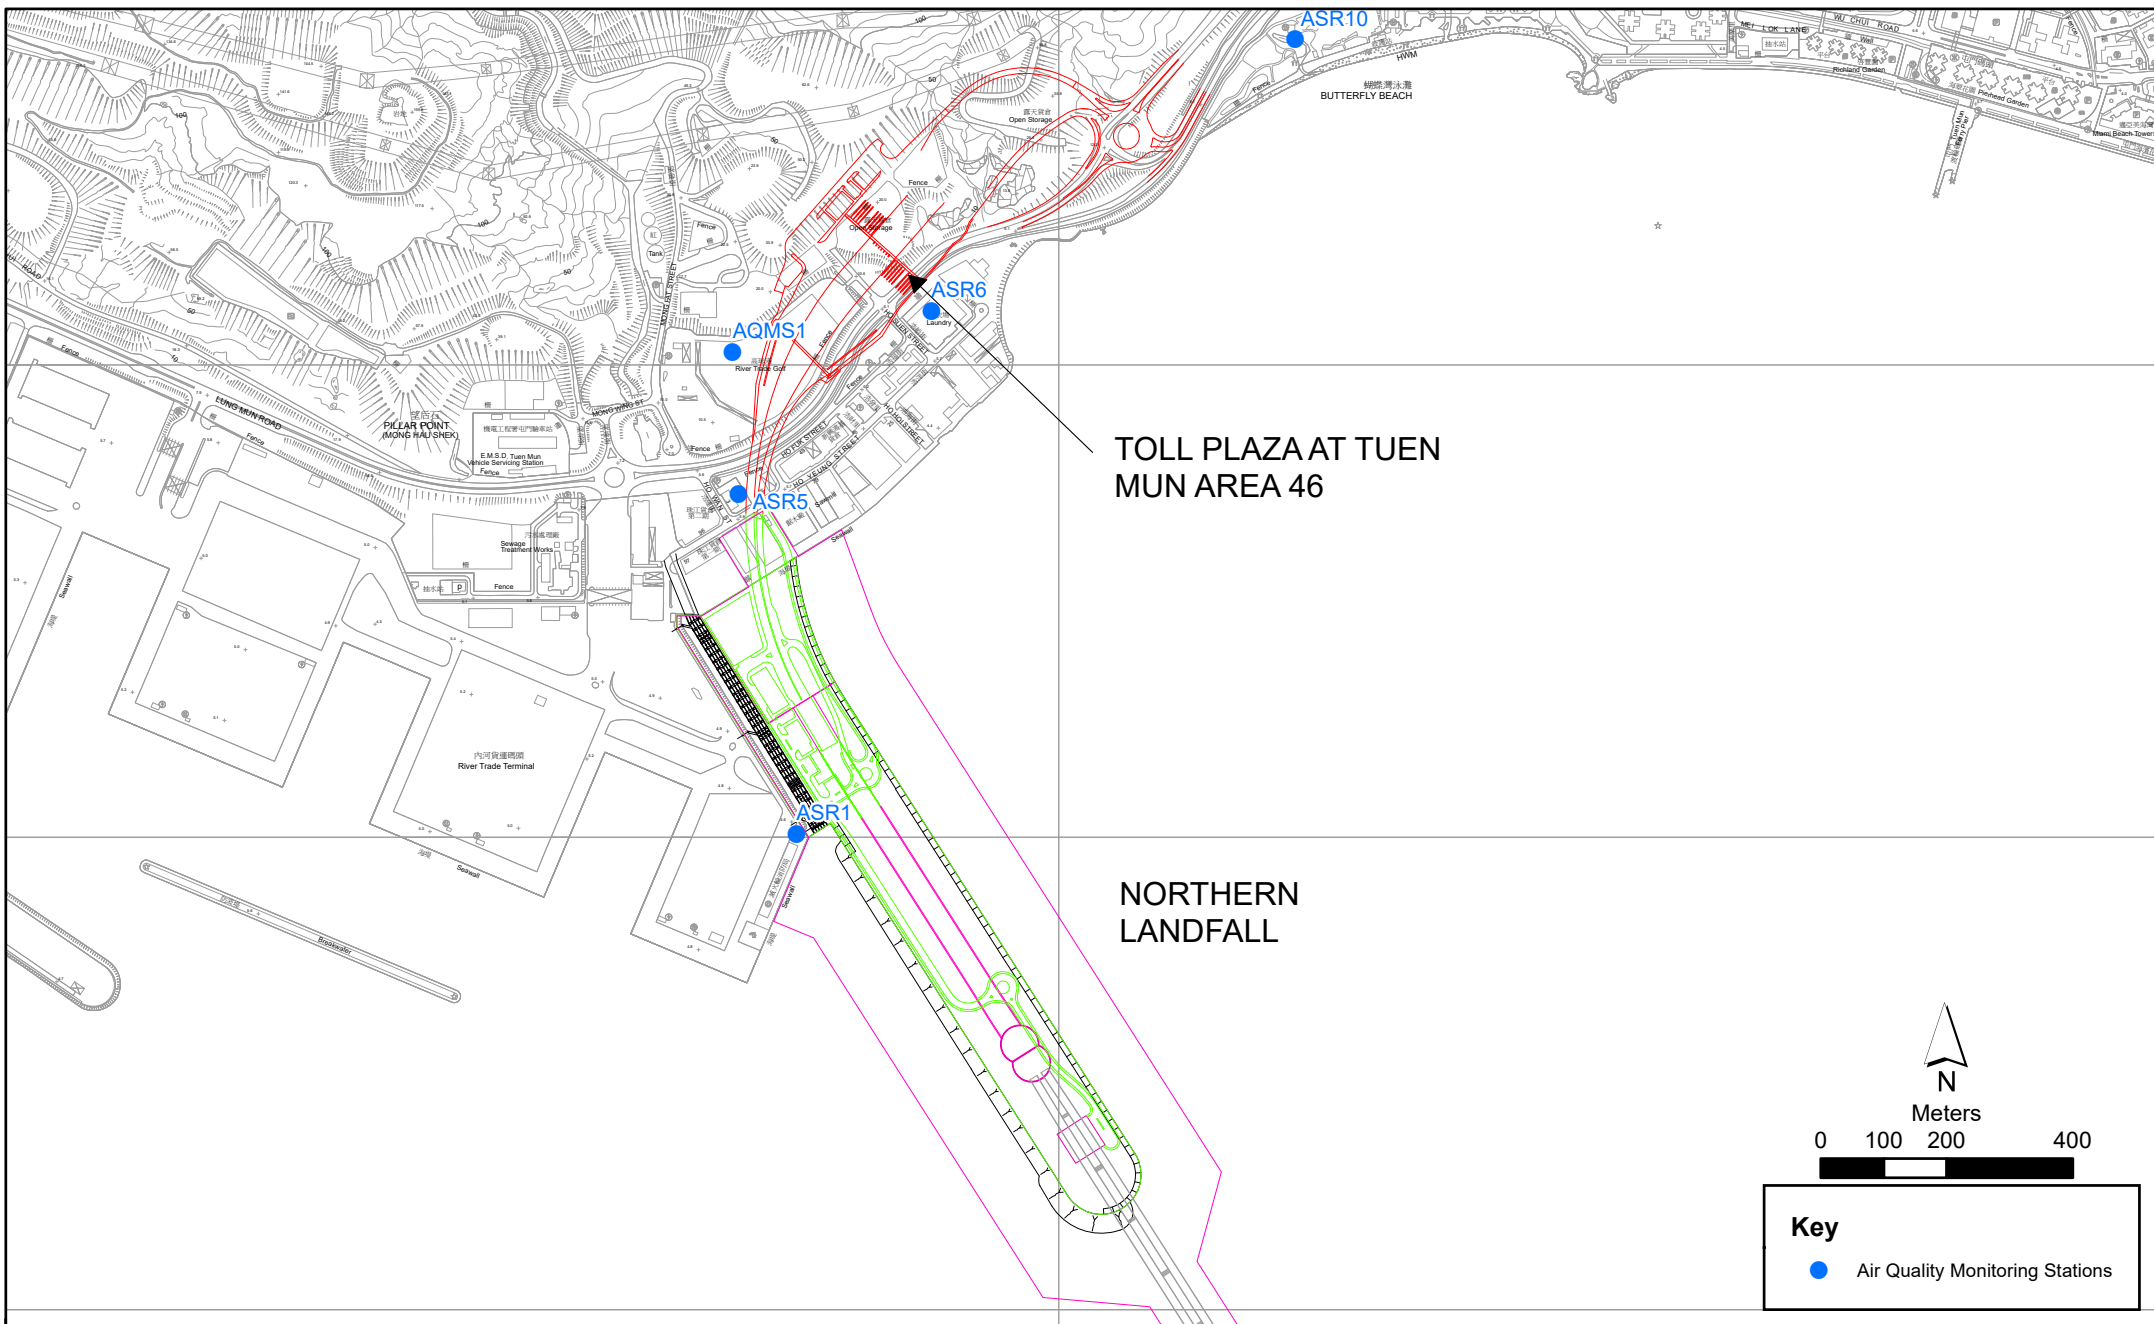
Figure 2.1

Air Quality Monitoring Stations for the Enhanced TSP Monitoring

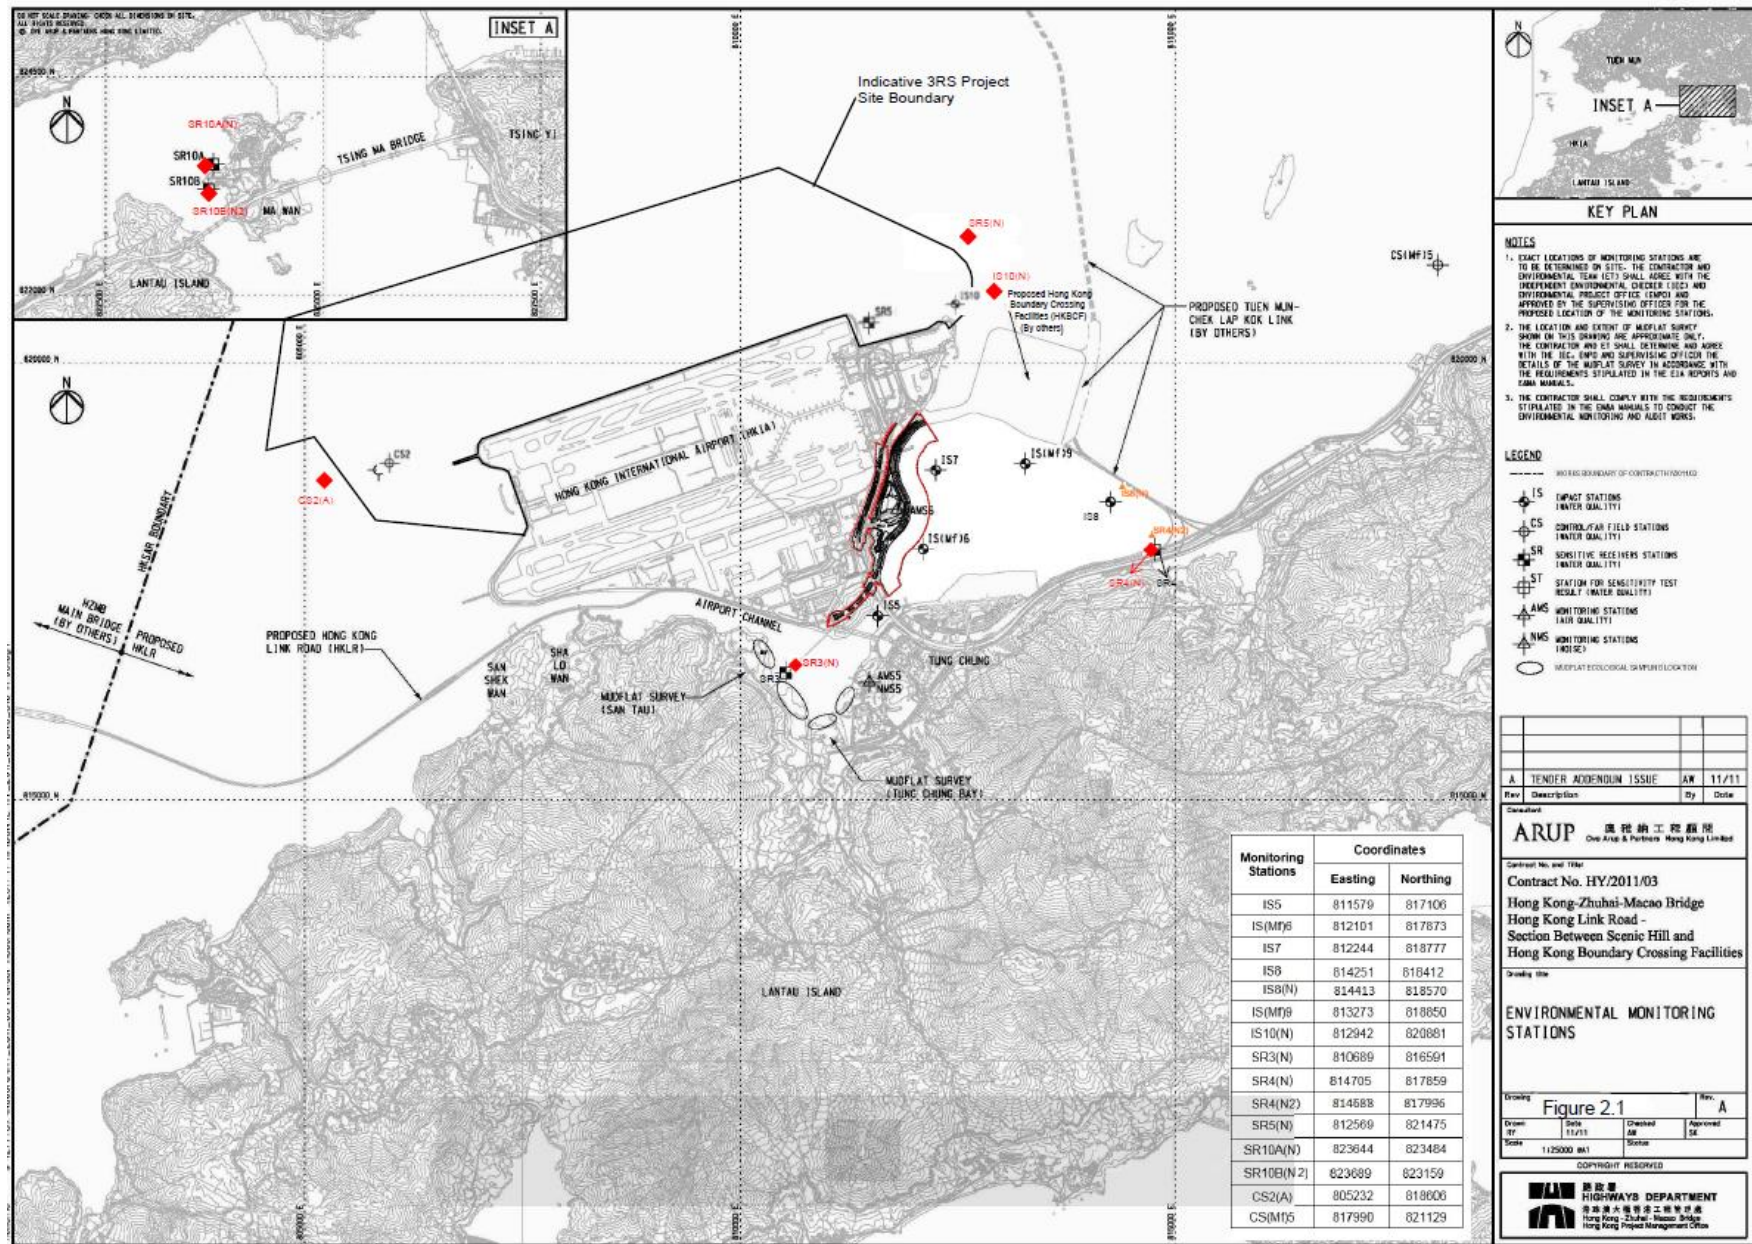
Figure 2.2

Operational Phase Water Quality Monitoring Stations SR3(N), CS2(A), SR4(N2) & CS(Mf)5

One monitoring event for operational phase water quality monitoring was conducted at all designated monitoring stations in the reporting month. Operational phase water quality monitoring results are provided in Appendix J.

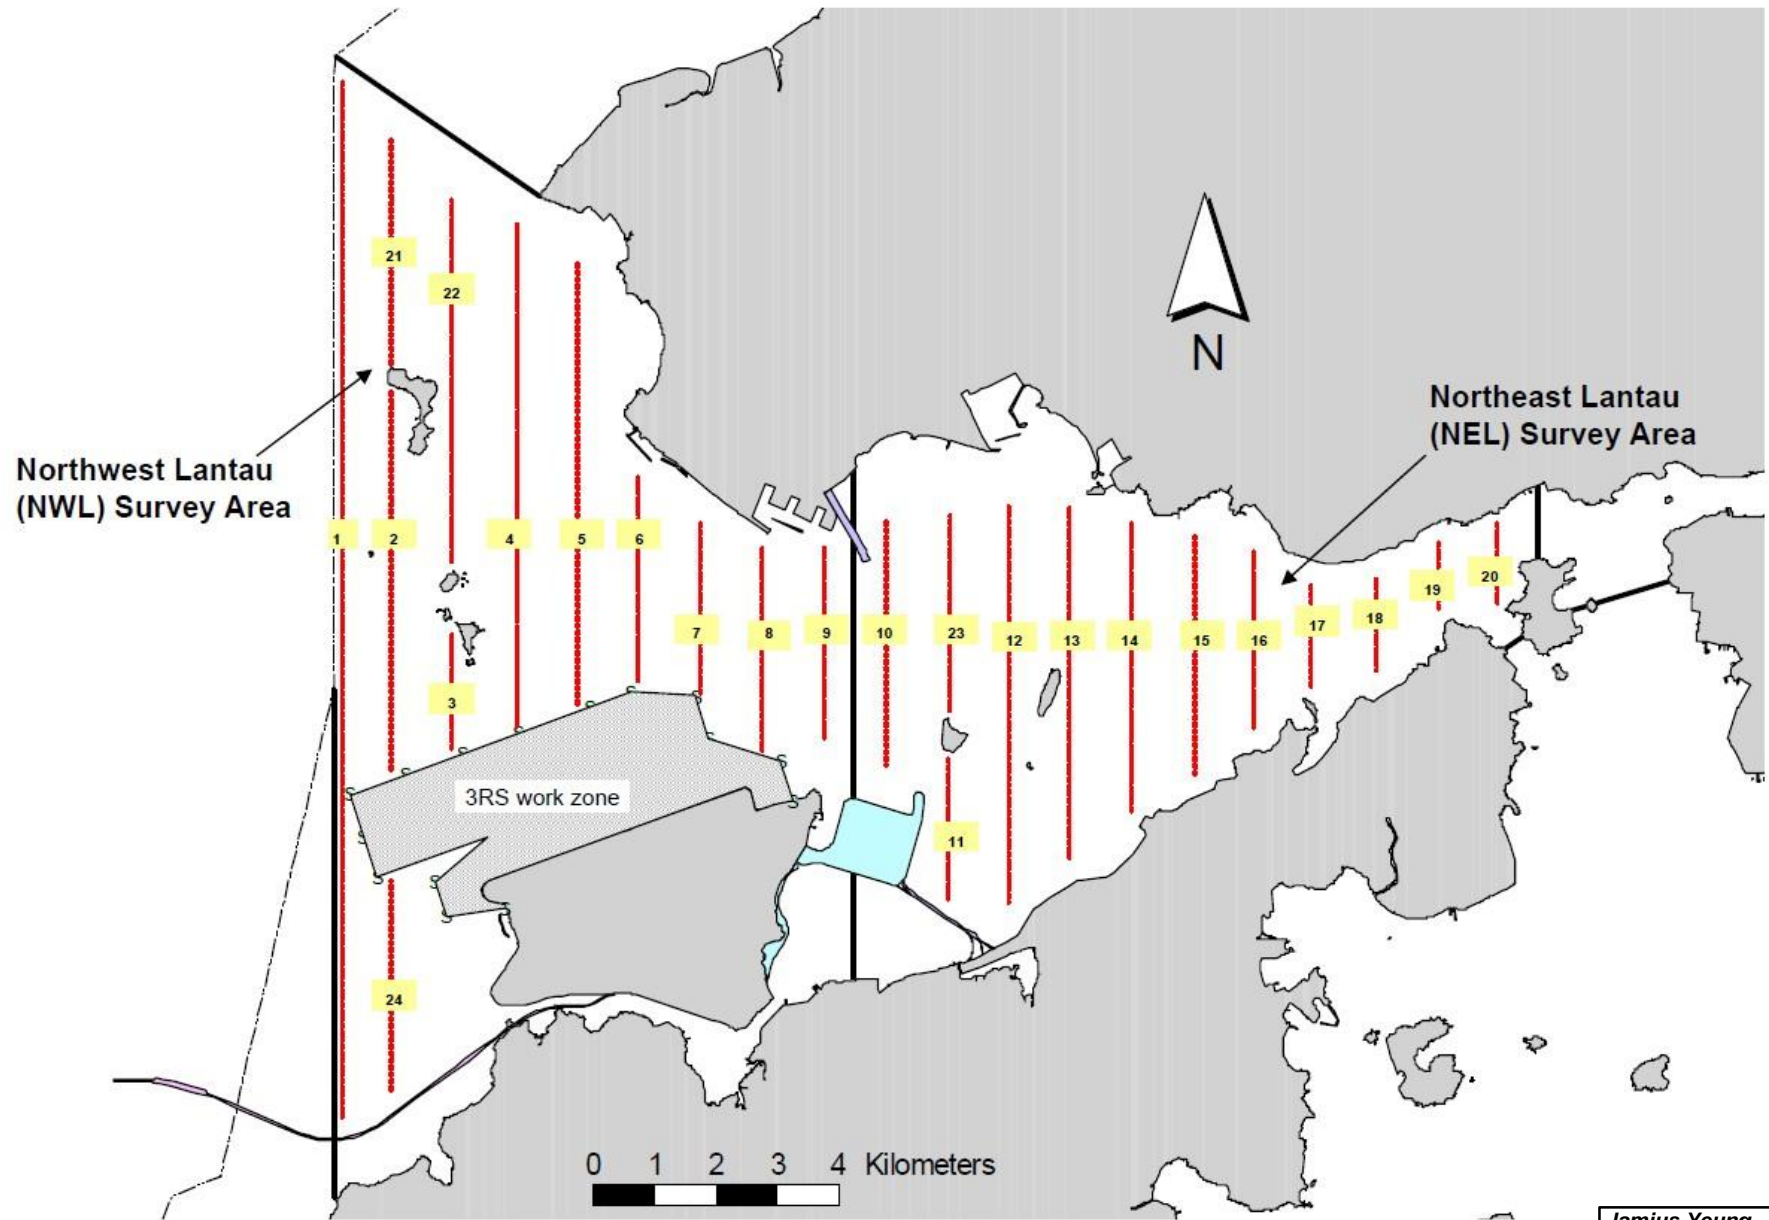
Figure 2.3

The operational phase dolphin monitoring was carried out in the NEL and NWL along the line transect as depicted in *Figure 2.3*. The co-ordinates of all transect lines are shown in *Table 2.8* below.

Layout of Transect Lines of Dolphin Monitoring in Northwest and Northeast Lantau Areas

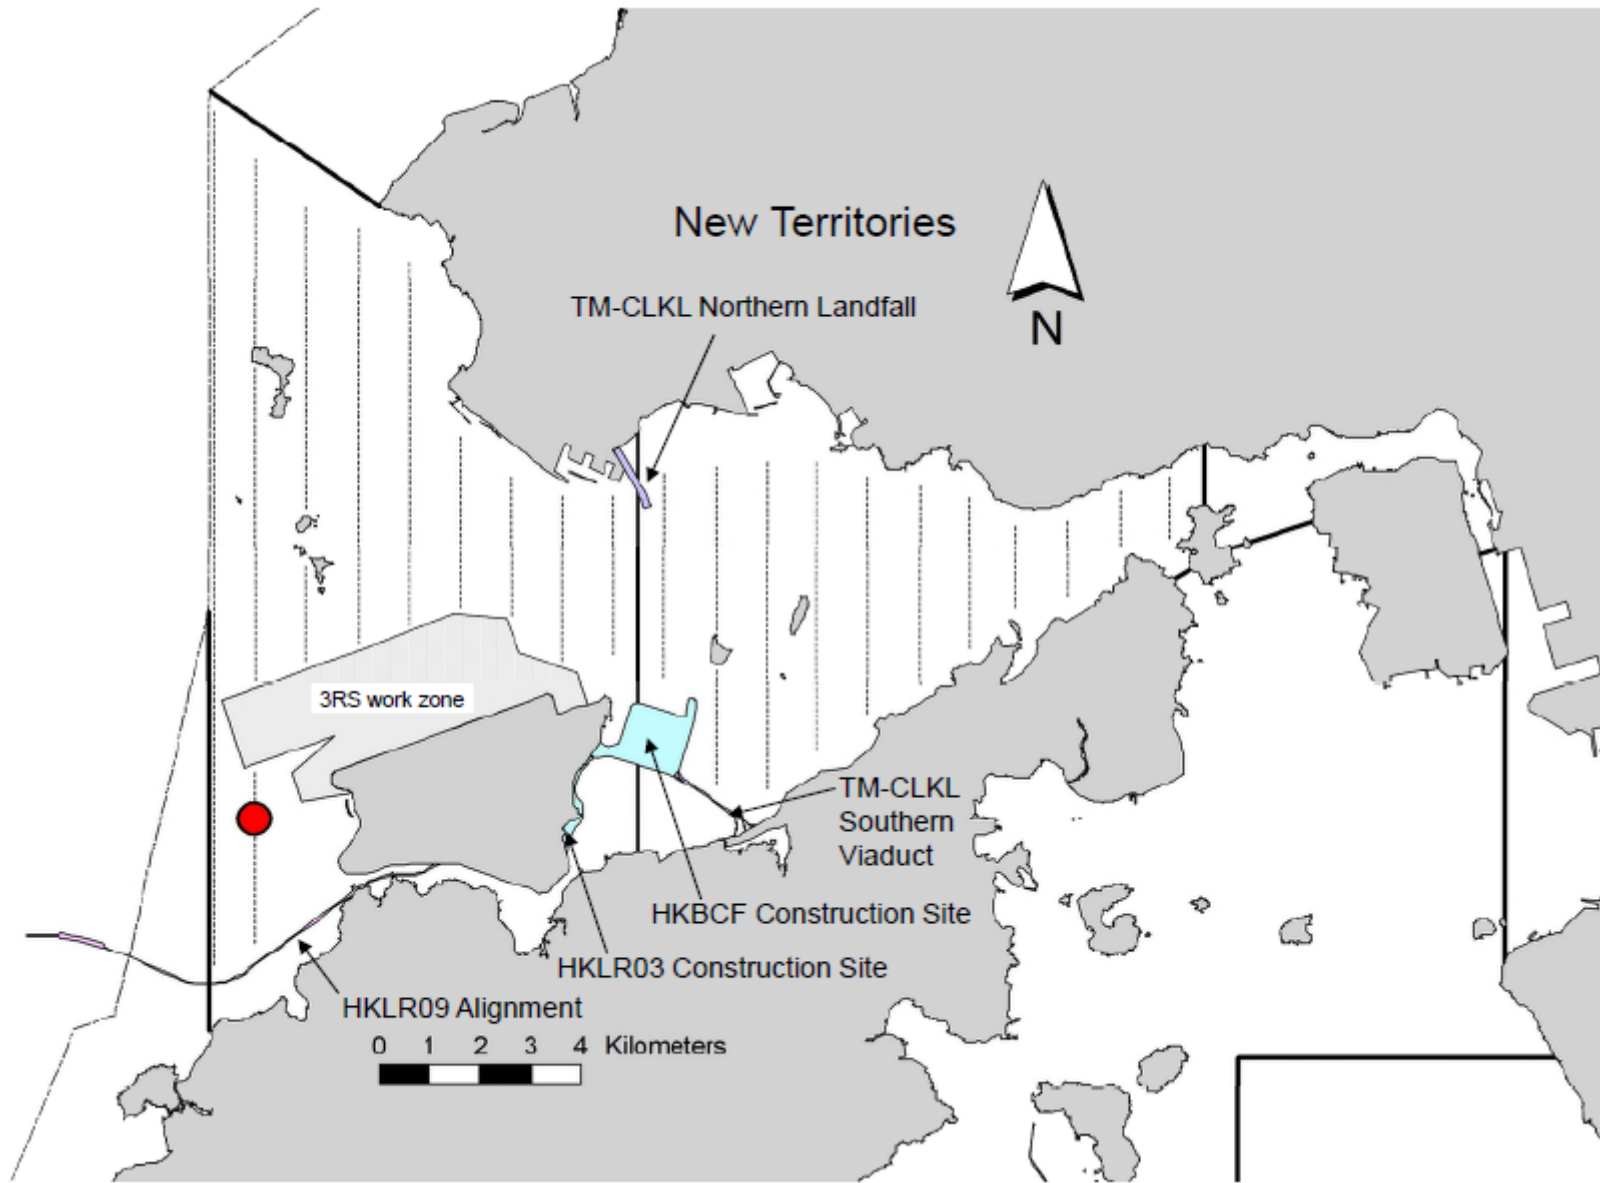
Figure 2.4

HY/2012/08 TM-CLKL Northern Connection Sub-sea Tunnel Section  
 The distribution of dolphin sightings during the reporting period

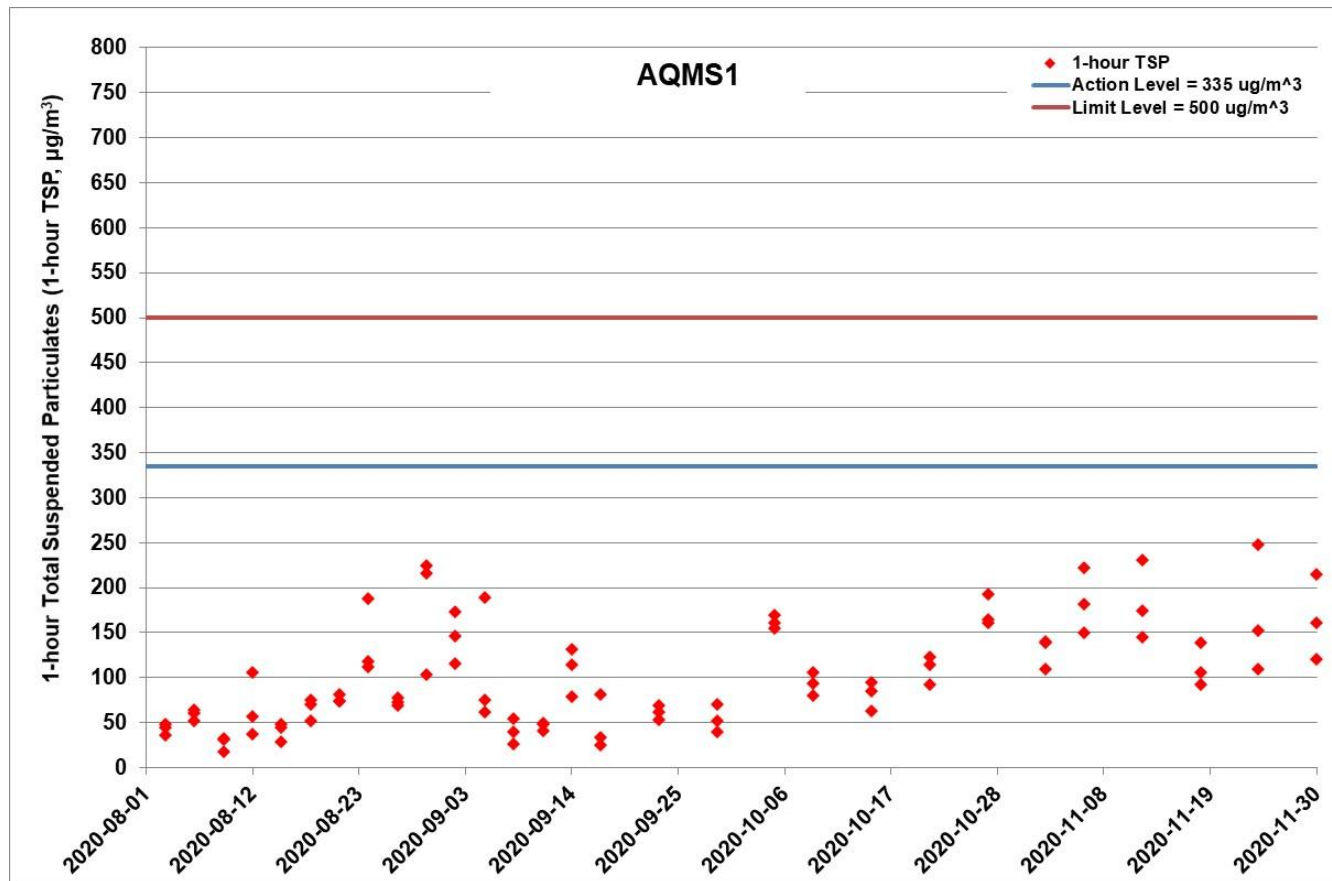
- Figure G.1 Impact Monitoring - 1-hour Total Suspended Particulates ( $\mu\text{g}/\text{m}^3$ ) at AQMS1 between 1 August 2020 and 30 November 2020 during impact monitoring period. The weather conditions during the monitoring period were sunny and hazy. Major land-based construction activities included SVB green roof system & chain fence - South Ventilation Building; Defect works for reinstatement at Box culvert - Northern Landfall (1/8/2020 - 30/11/2020)

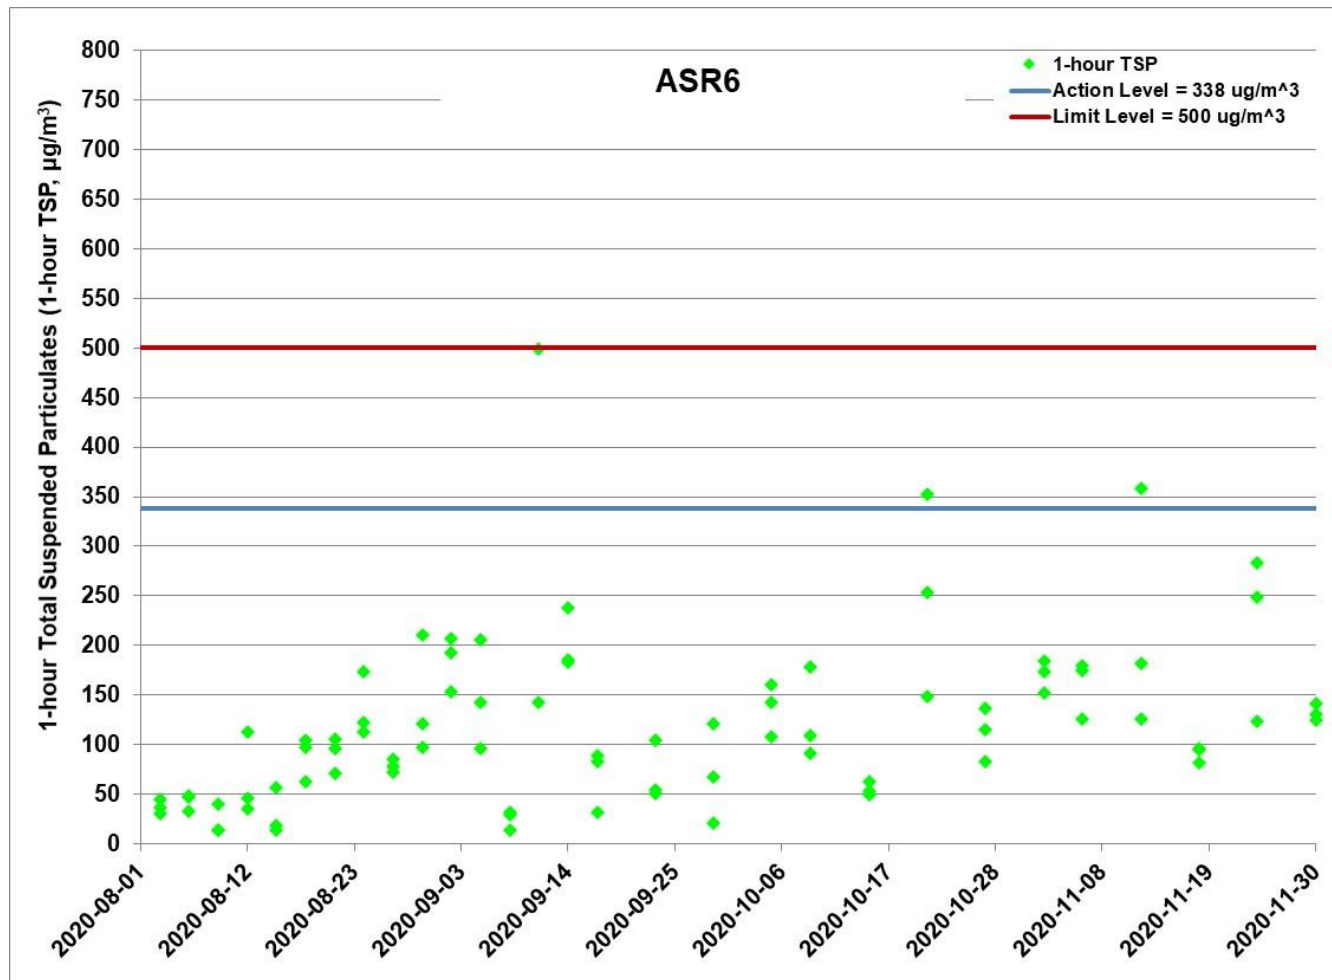
Figure G.2 Impact Monitoring - 1-hour Total Suspended Particulates ( $\mu\text{g}/\text{m}^3$ ) at ASR6 between 1 August 2020 and 30 November 2020 during impact monitoring period. The weather conditions during the monitoring period were sunny and hazy. Major land-based construction activities included SVB green roof system & chain fence - South Ventilation Building; Defect works for reinstatement at Box culvert - Northern Landfall (1/8/2020 - 30/11/2020)

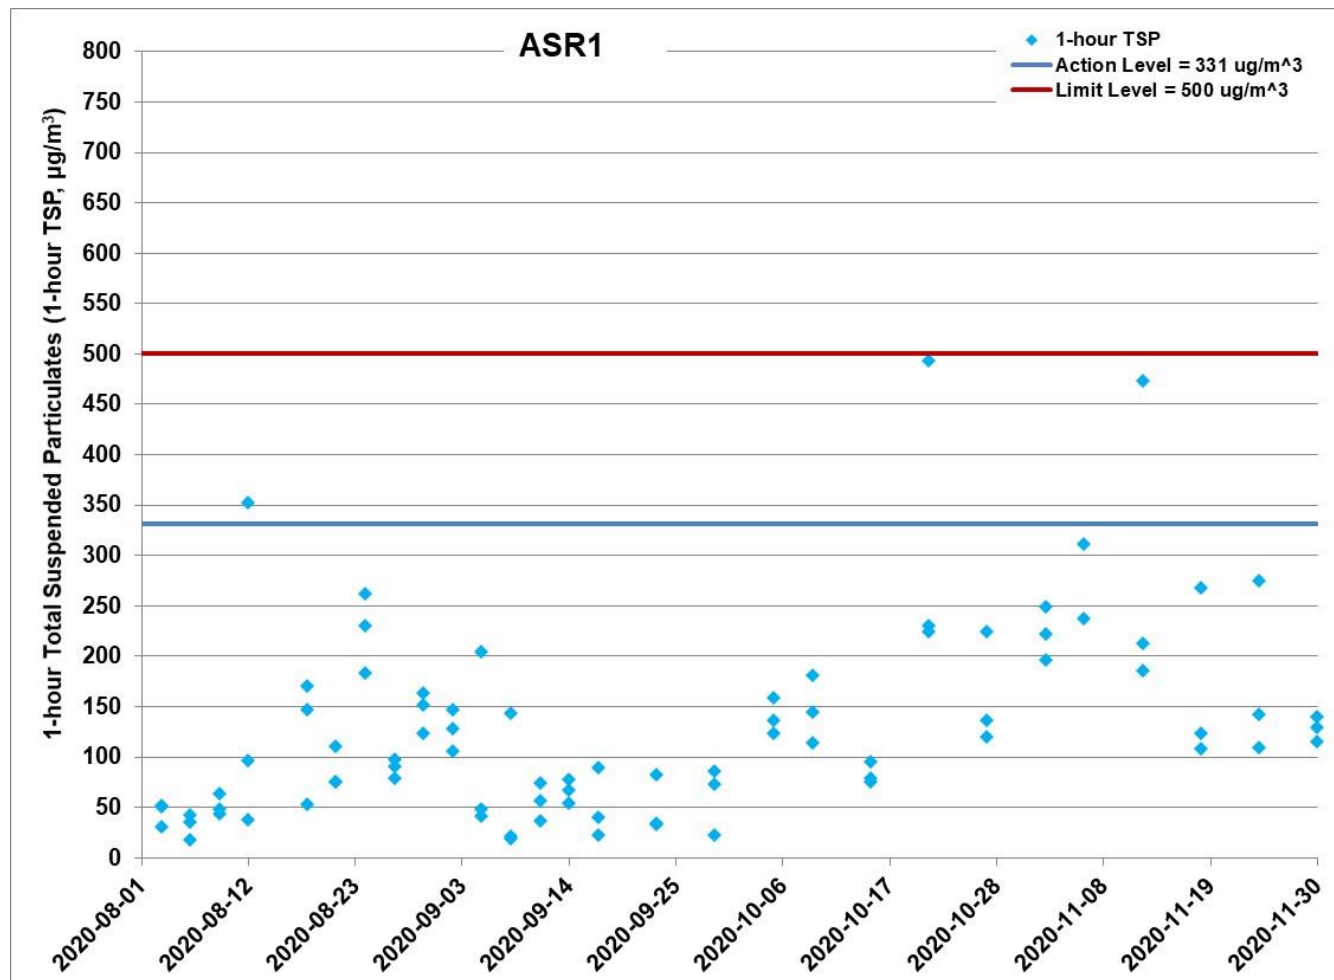
Figure G.3 Impact Monitoring – 1-hour Total Suspended Particulates ( $\mu\text{g}/\text{m}^3$ ) at ASR1 between 1 August 2020 and 30 November 2020 during impact monitoring period. The weather conditions during the monitoring period were sunny and hazy. Major land-based construction activities included SVB green roof system & chain fence – South Ventilation Building; Defect works for reinstatement at Box culvert - Northern Landfall (1/8/2020 – 30/11/2020)

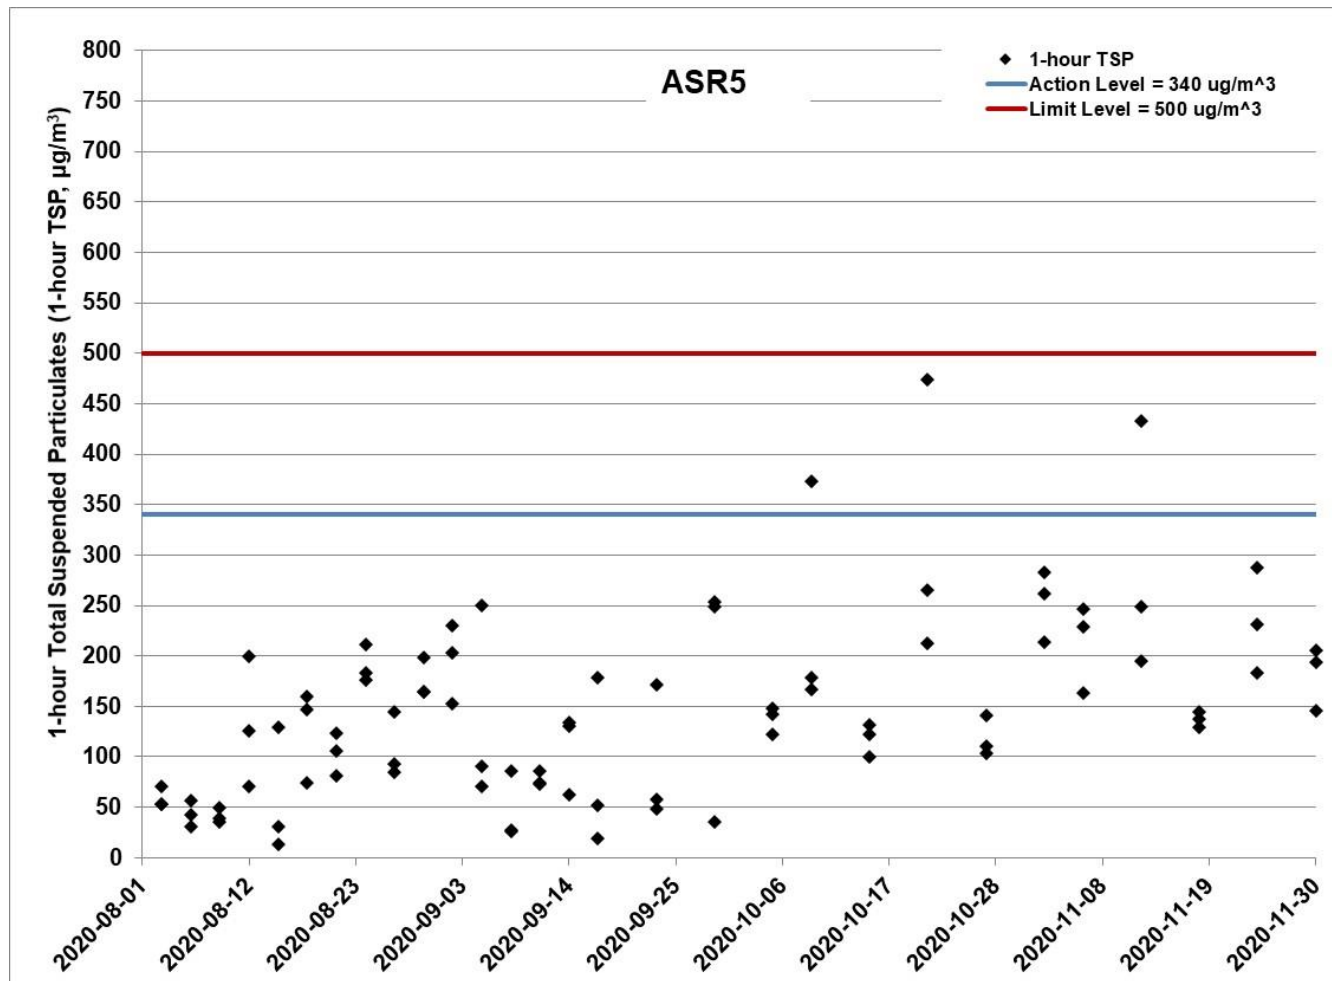
Figure G.4 Impact Monitoring - 1-hour Total Suspended Particulates ( $\mu\text{g}/\text{m}^3$ ) at ASR5 between 1 August 2020 and 30 November 2020 during impact monitoring period. The weather conditions during the monitoring period were sunny and hazy. Major land-based construction activities included SVB green roof system & chain fence - South Ventilation Building; Defect works for reinstatement at Box culvert - Northern Landfall (1/8/2020 - 30/11/2020)

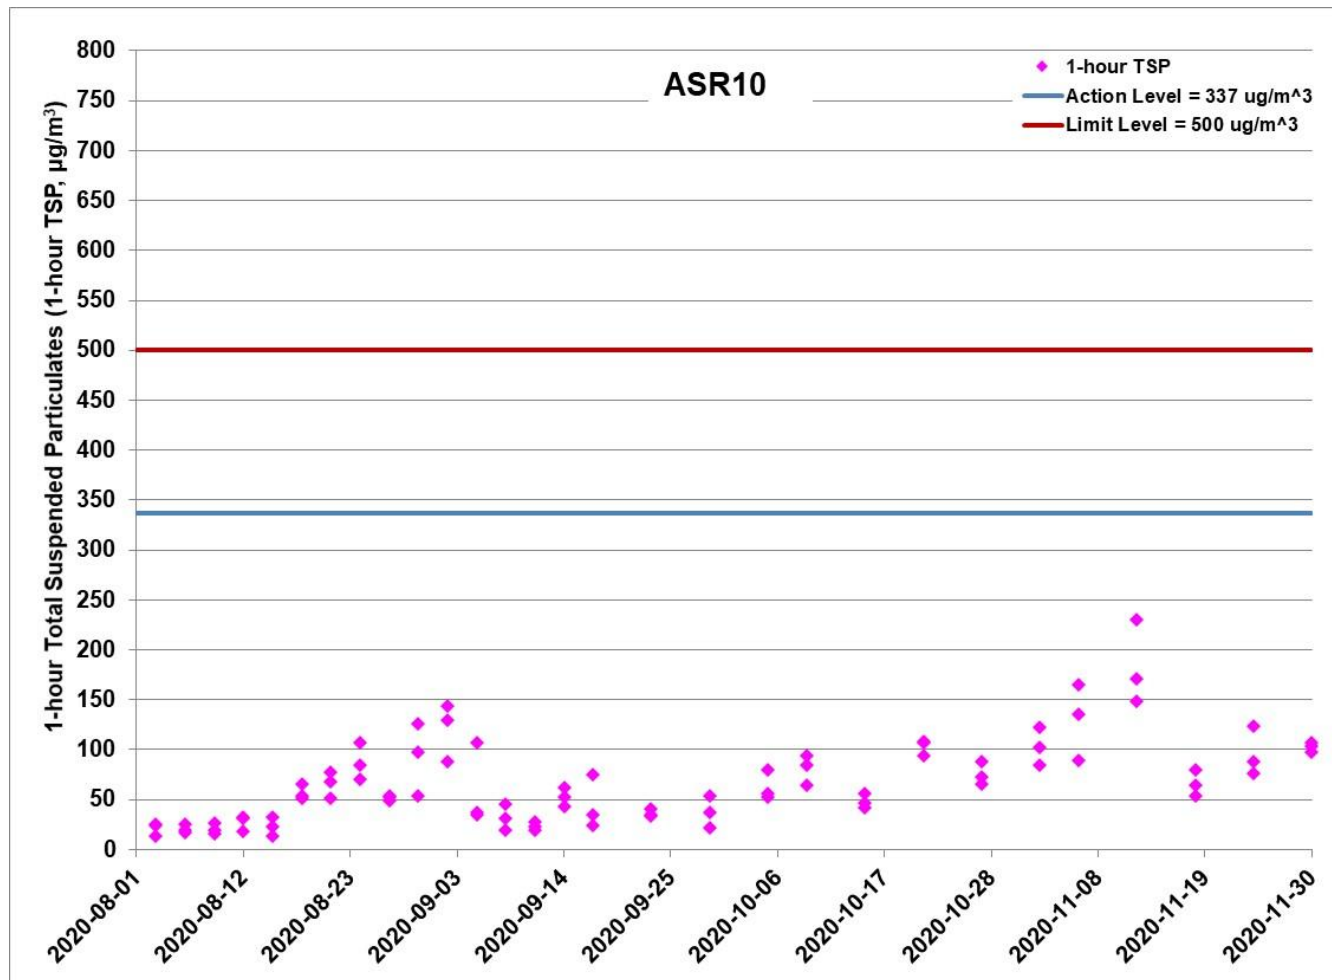
Figure G.5 Impact Monitoring - 1-hour Total Suspended Particulates ( $\mu\text{g}/\text{m}^3$ ) at ASR10 between 1 August 2020 and 30 November 2020 during impact monitoring period. The weather conditions during the monitoring period were sunny and hazy. Major land-based construction activities included SVB green roof system & chain fence - South Ventilation Building; Defect works for reinstatement at Box culvert - Northern Landfall (1/8/2020 - 30/11/2020)

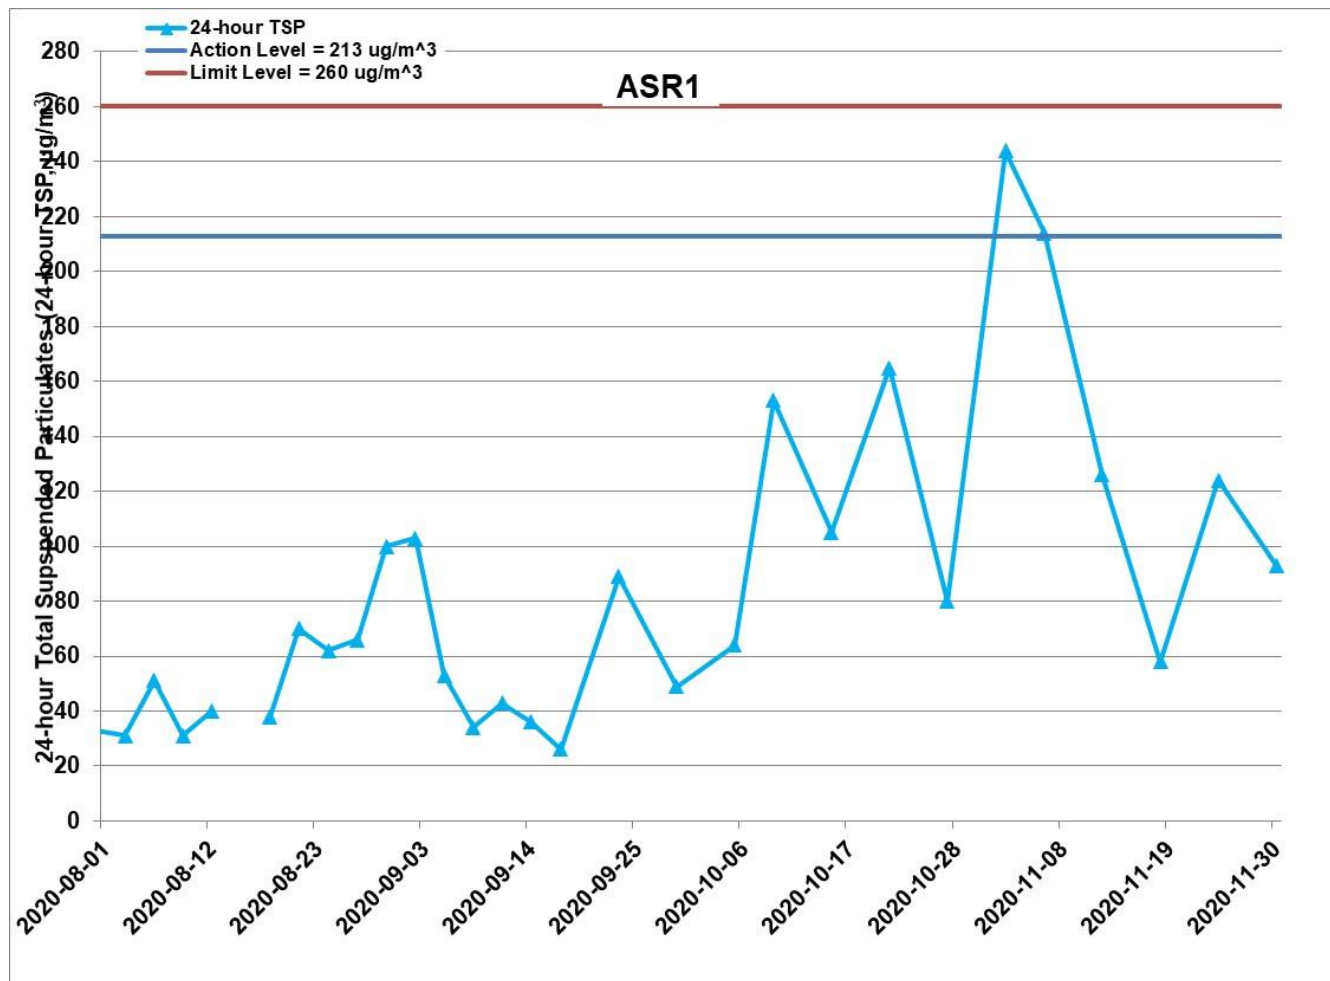
Figure G.6 Impact Monitoring – 24-hour Total Suspended Particulates ( $\mu\text{g}/\text{m}^3$ ) at ASR1 between 1 August 2020 and 30 November 2020 during impact monitoring period. The weather conditions during the monitoring period were sunny and hazy. Major land-based construction activities included SVB green roof system & chain fence – South Ventilation Building; Defect works for reinstatement at Box culvert - Northern Landfall (1/8/2020 – 30/11/2020)

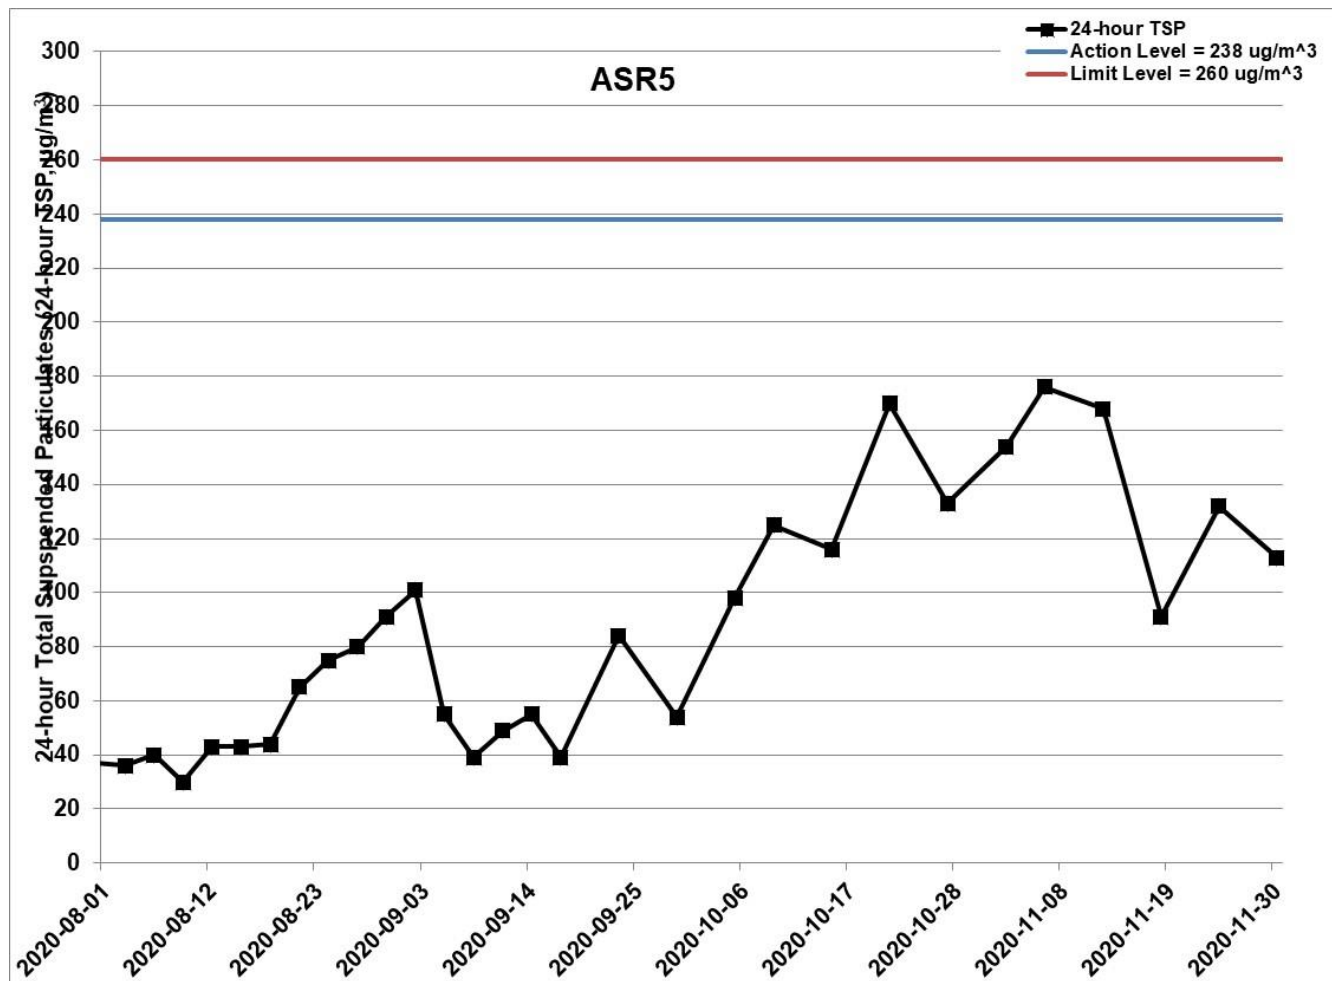
Figure G.7 Impact Monitoring - 24-hour Total Suspended Particulates ( $\mu\text{g}/\text{m}^3$ ) at ASR5 between 1 August 2020 and 30 November 2020 during impact monitoring period. The weather conditions during the monitoring period were sunny and hazy. Major land-based construction activities included SVB green roof system & chain fence - South Ventilation Buiding; Defect works for reinstatement at Box culvert - Northern Landfall (1/8/2020 - 30/11/2020)

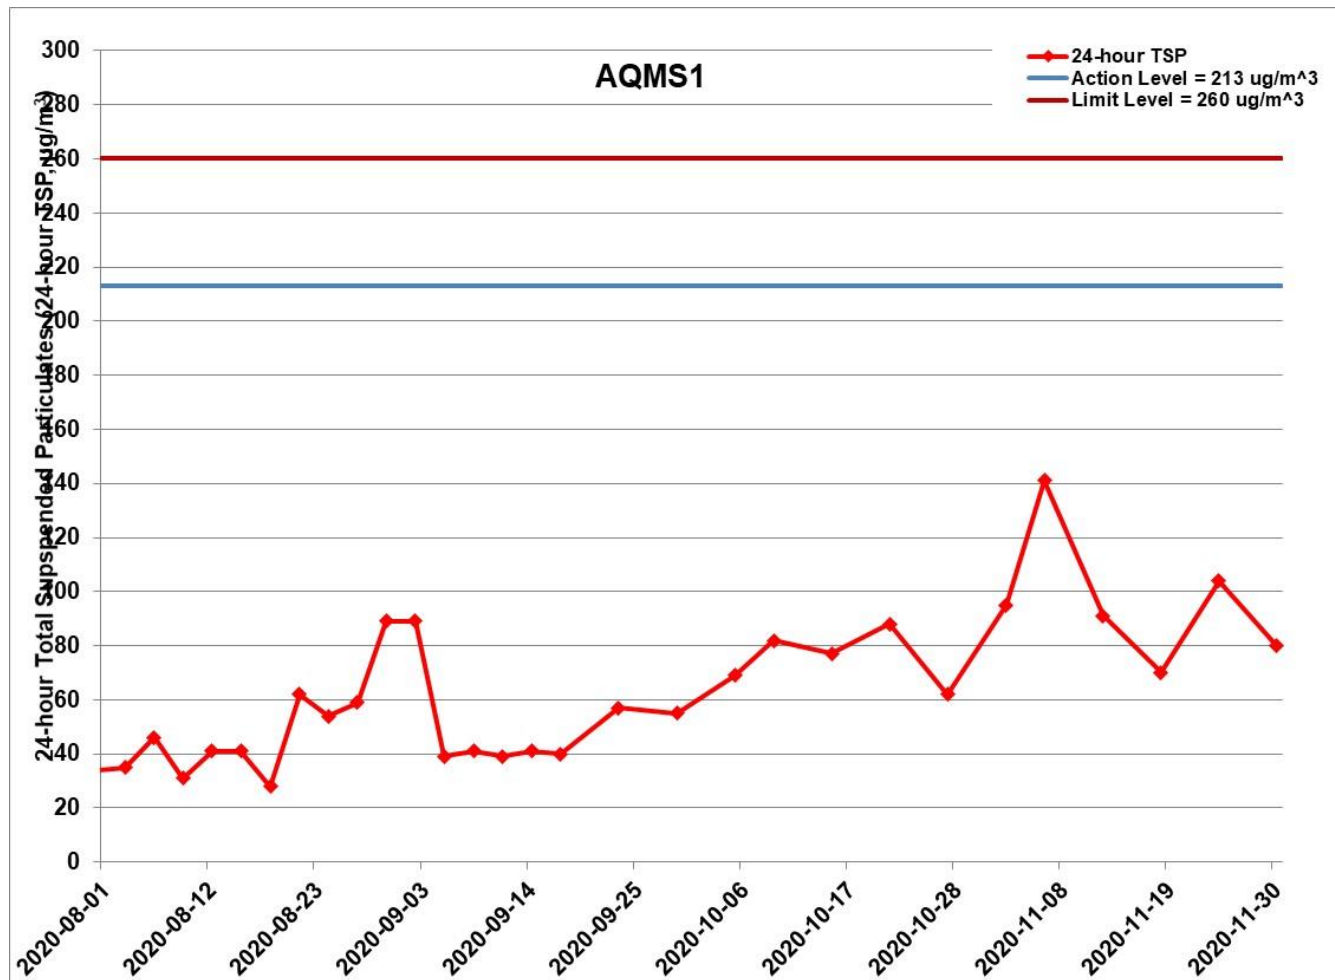
Figure G.8 Impact Monitoring - 24-hour Total Suspended Particulates ( $\mu\text{g}/\text{m}^3$ ) at AQMS1 between 1 August 2020 and 30 November 2020 during impact monitoring period. The weather conditions during the monitoring period were sunny and hazy. Major land-based construction activities included SVB green roof system & chain fence - South Ventilation Building; Defect works for reinstatement at Box culvert - Northern Landfall (1/8/2020 - 30/11/2020)

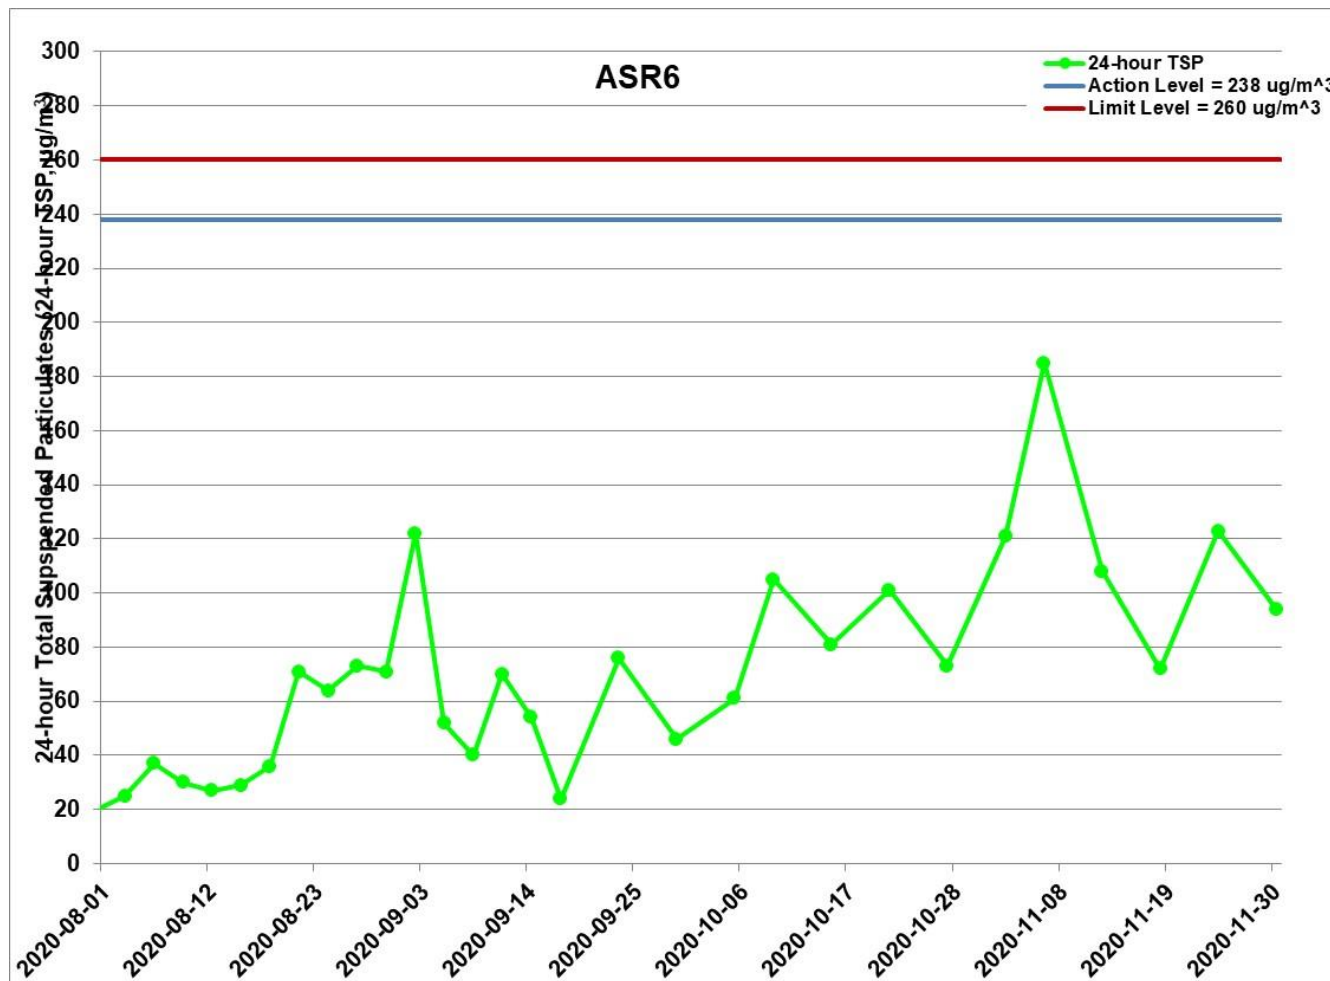
Figure G.9 Impact Monitoring - 24-hour Total Suspended Particulates ( $\mu\text{g}/\text{m}^3$ ) at ASR6 between 1 August 2020 and 30 November 2020 during impact monitoring period. The weather conditions during the monitoring period were sunny and hazy. Major land-based construction activities included SVB green roof system & chain fence - South Ventilation Buiding; Defect works for reinstatement at Box culvert - Northern Landfall (1/8/2020 - 30/11/2020)
