**Contract No. HY/2012/08  
Tuen Mun - Chek Lap Kok Link -  
Northern Connection Sub-sea Tunnel  
Section**

***Eighty-Fifth Monthly Environmental Monitoring  
& Audit (EM&A) Report***

11 December 2020

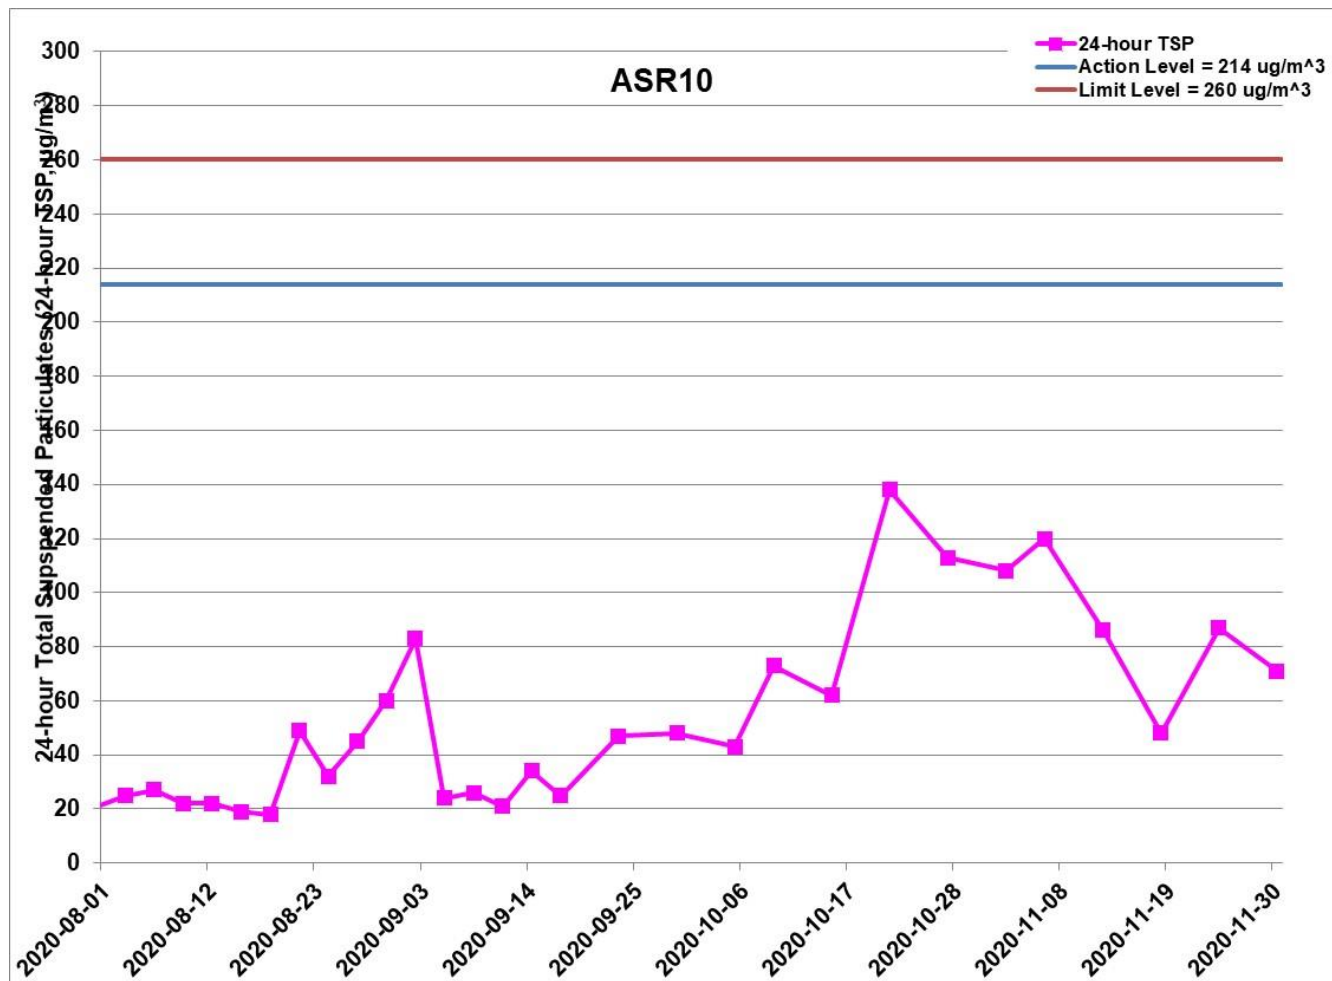
Figure G.10 Impact Monitoring - 24-hour Total Suspended Particulates ( $\mu\text{g}/\text{m}^3$ ) at ASR10 between 1 August 2020 and 30 November 2020 during impact monitoring period. The weather conditions during the monitoring period were sunny and hazy. Major land-based construction activities included SVB green roof system & chain fence - South Ventilation Building; Defect works for reinstatement at Box culvert - Northern Landfall (1/8/2020 - 30/11/2020)

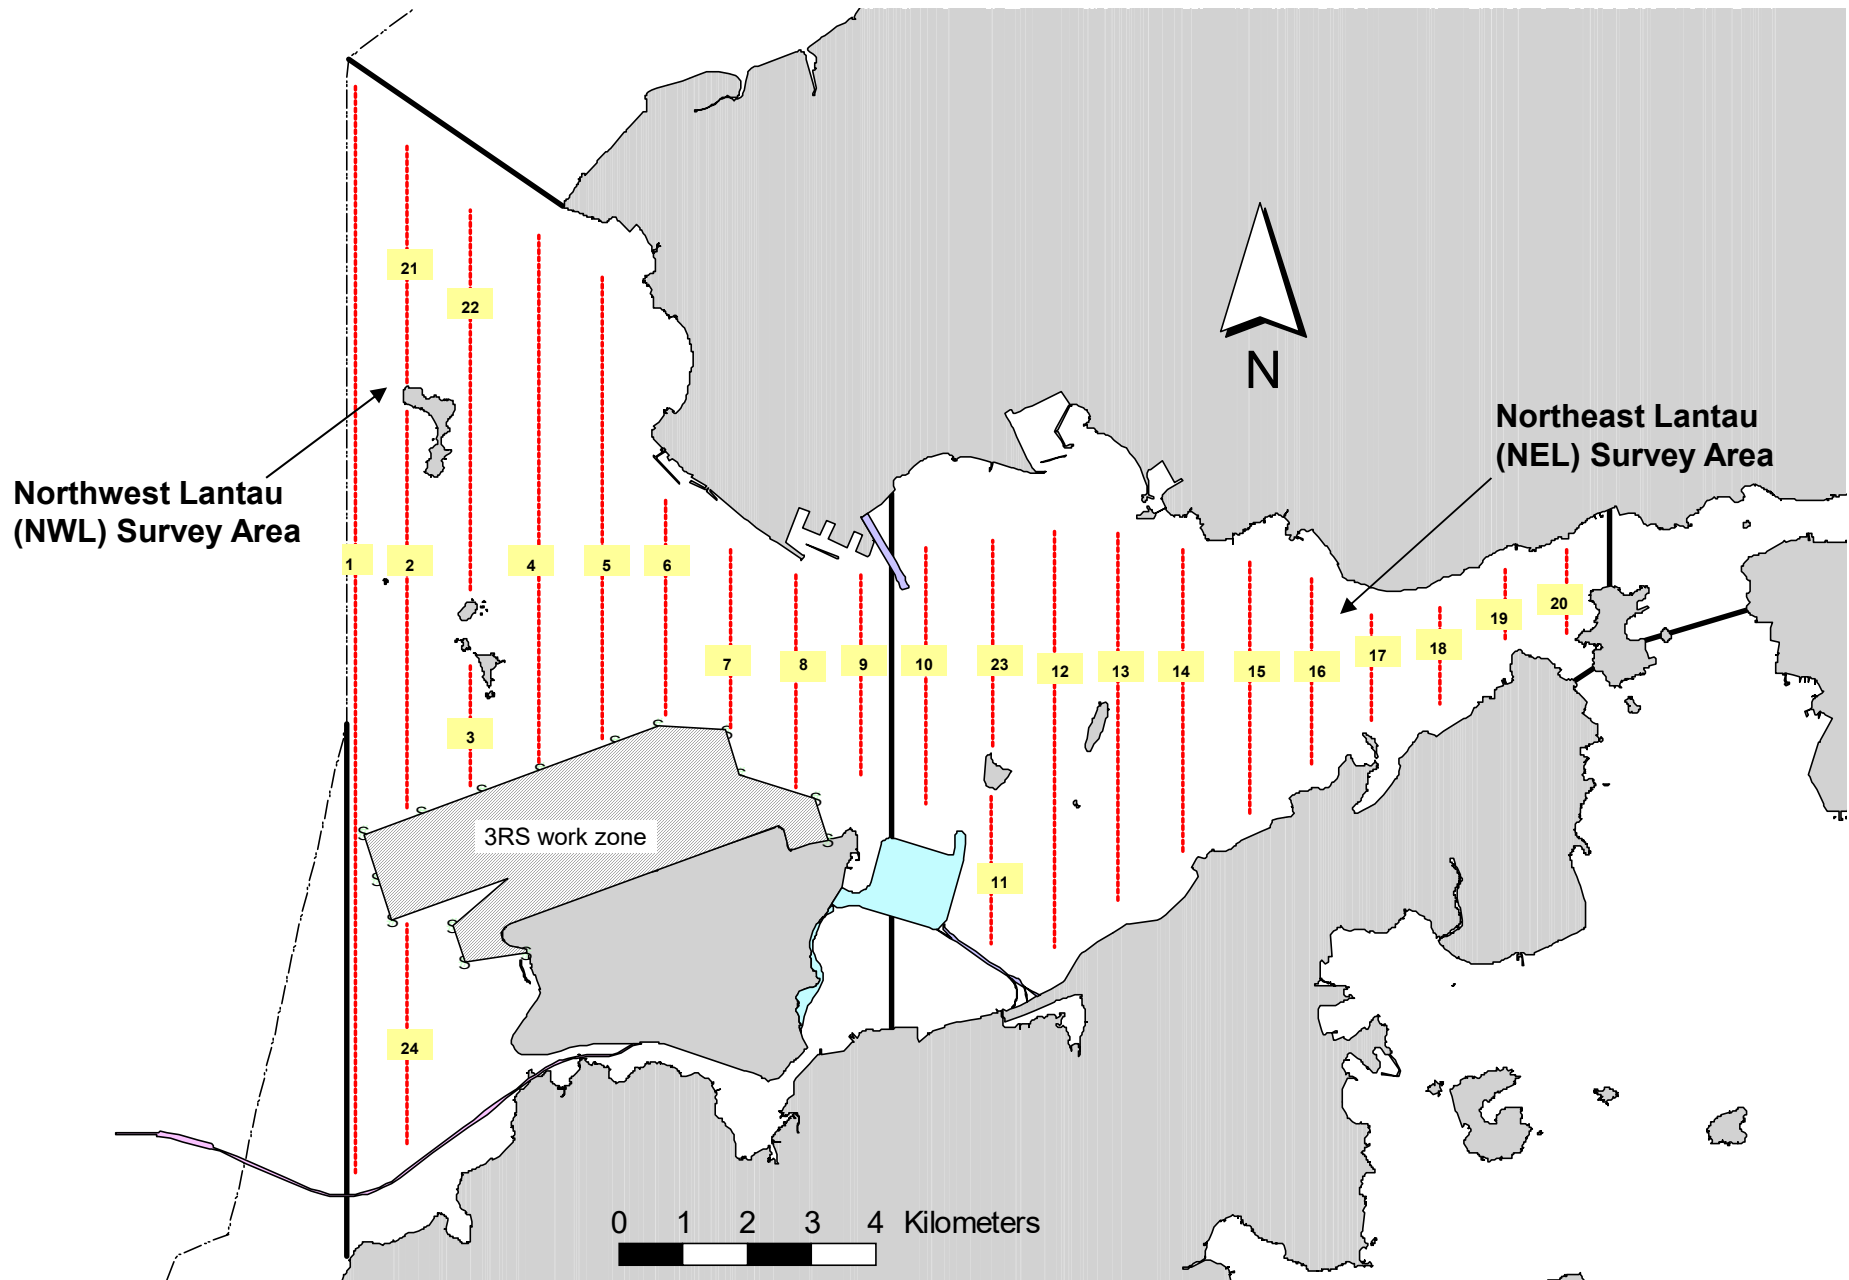
Figure 1. Transect Line Layout in Northwest and Northeast Lantau Survey Areas

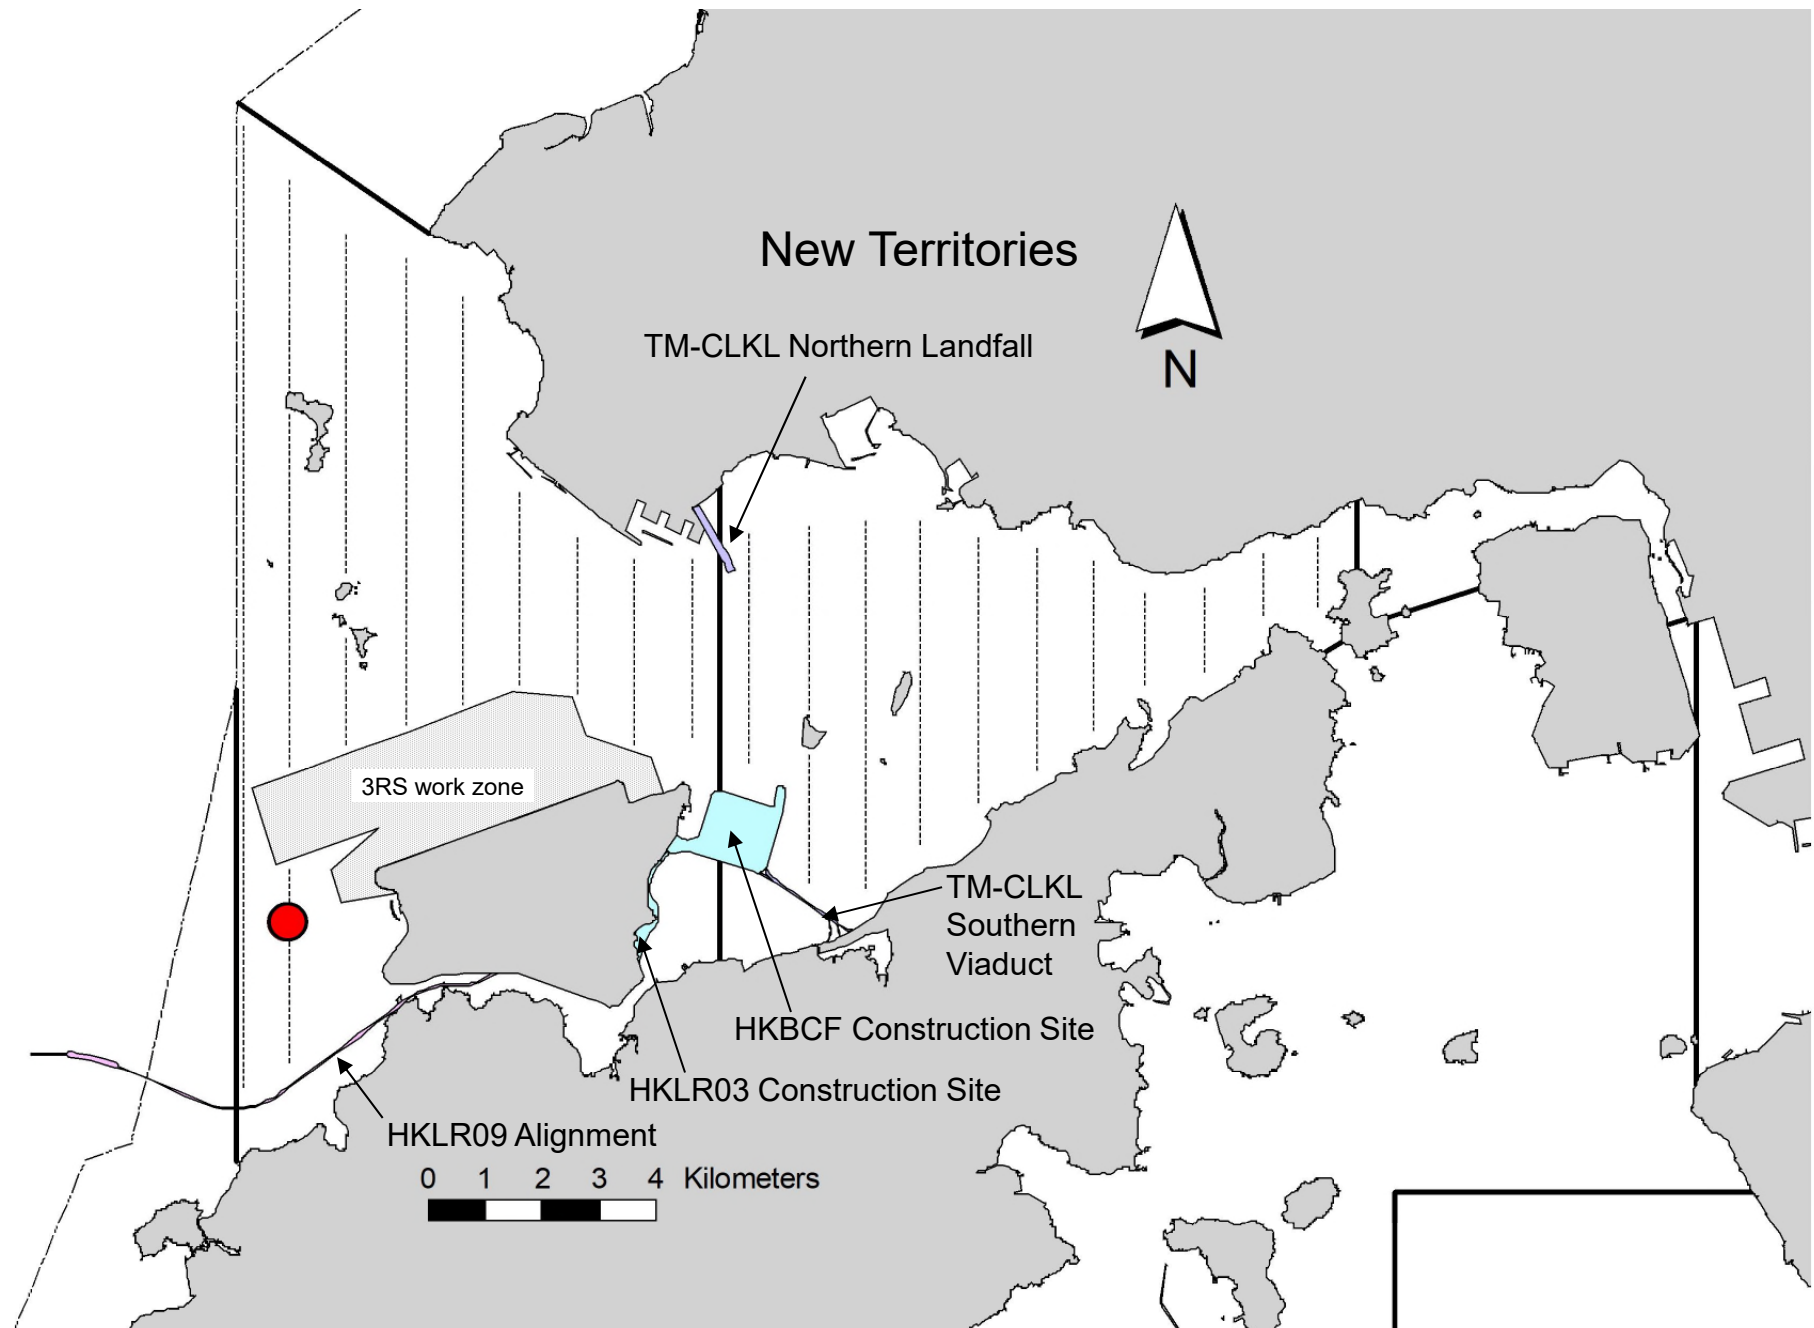
Figure 6. Distribution of Chinese White Dolphin Sightings during November 2020 Monitoring Surveys

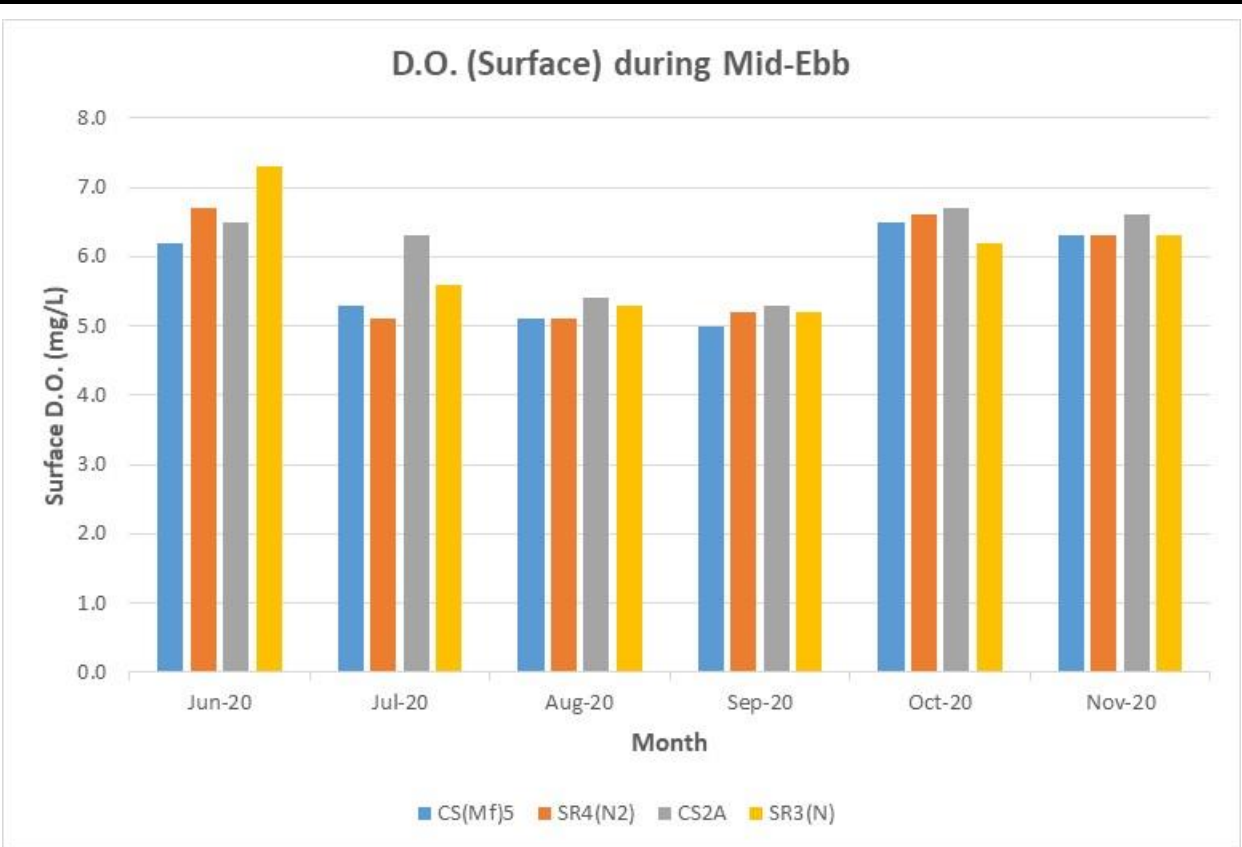
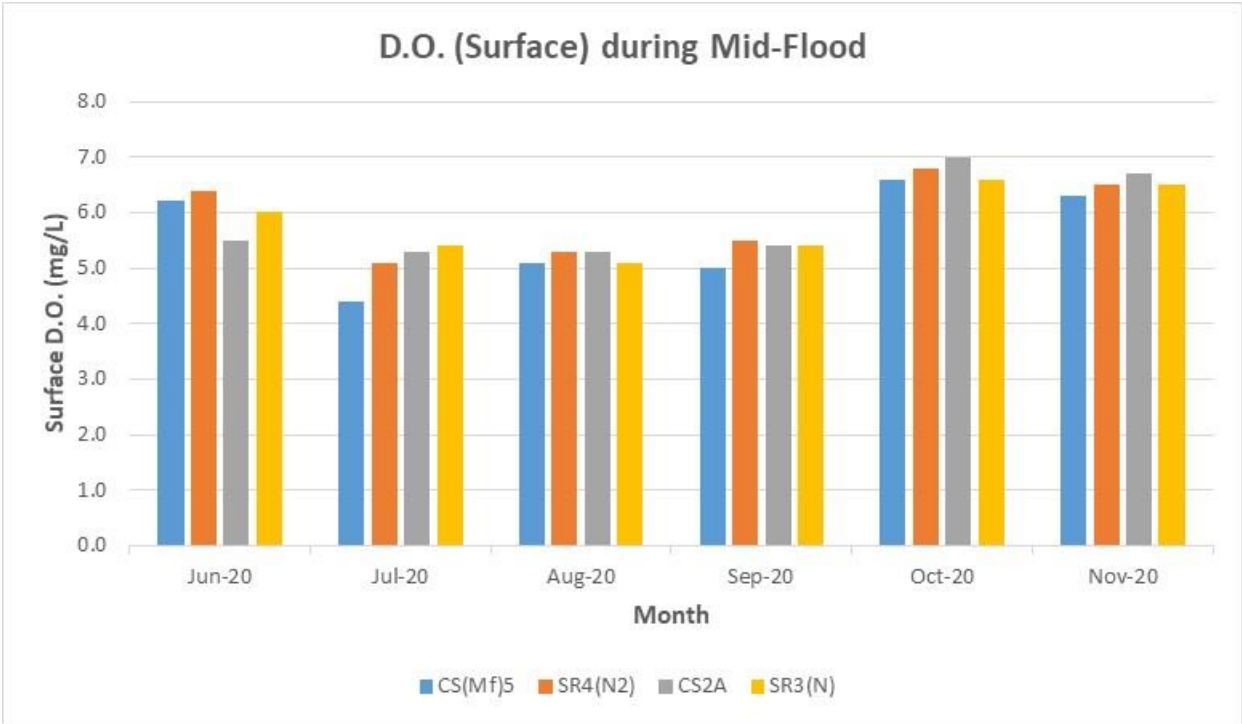
**Figure J1 Operational Phase Monitoring - Mean Level of Dissolved Oxygen (mg/L) in surface waters between 1 June 2020 and 30 November 2020. The weather conditions during the monitoring period varied mostly from sunny to cloudy.**

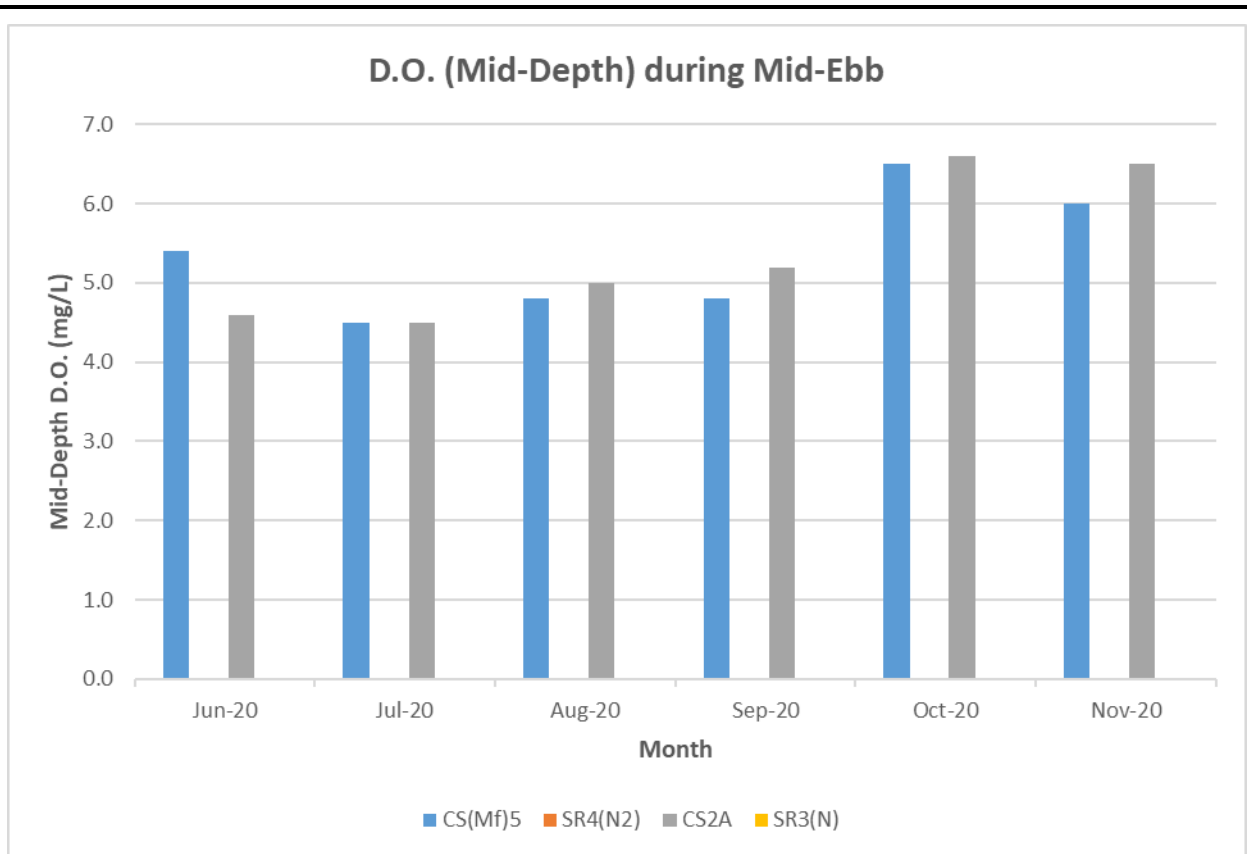
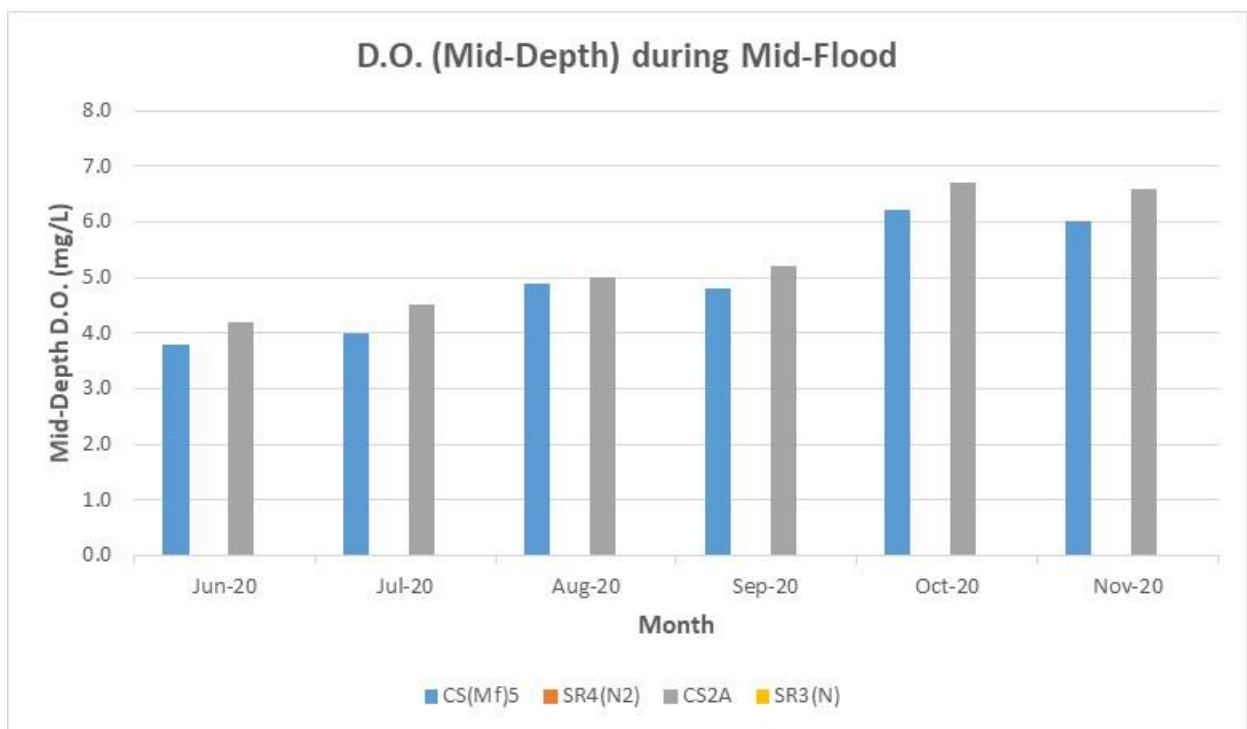
**Figure J2 Operational Phase Monitoring - Mean Level of Dissolved Oxygen (mg/L) in mid-depth waters between 1 June 2020 and 30 November 2020. The weather conditions during the monitoring period varied mostly from sunny to cloudy.**

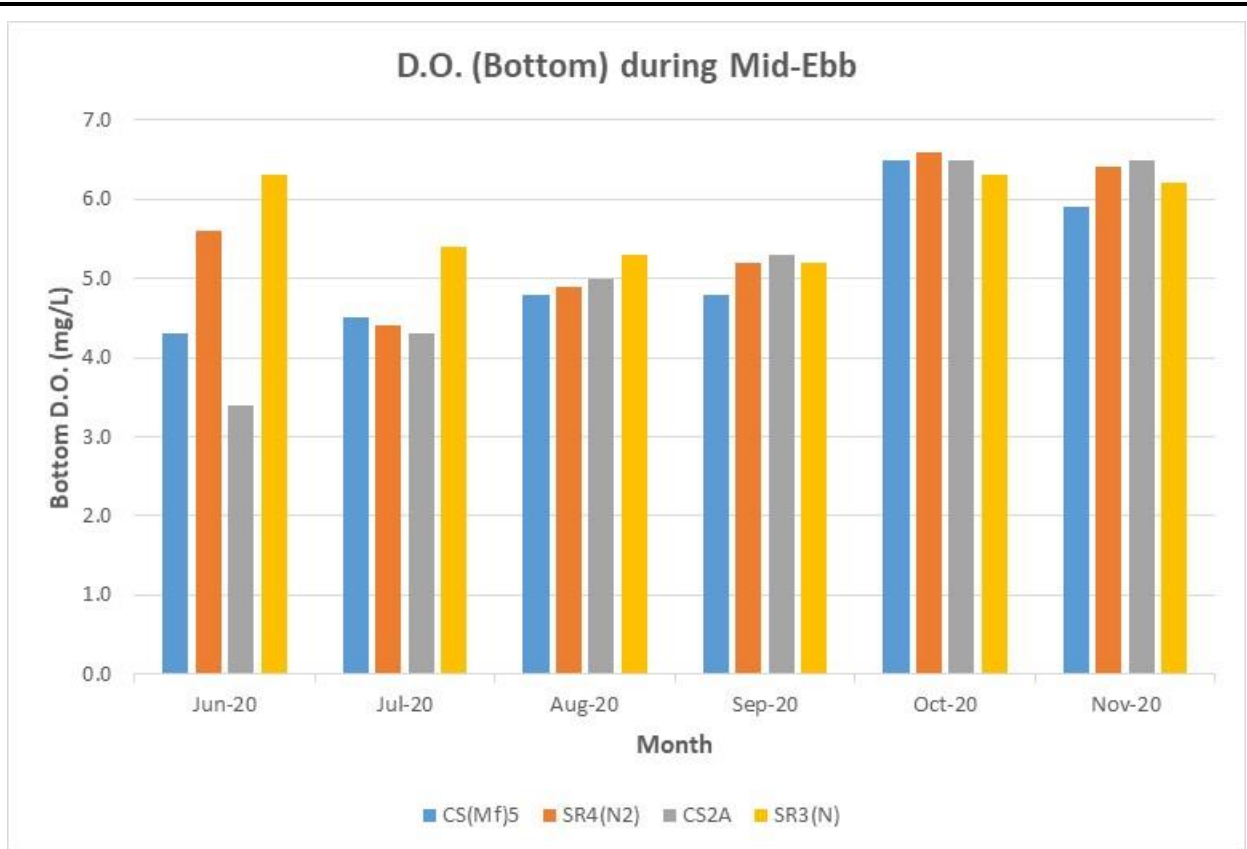
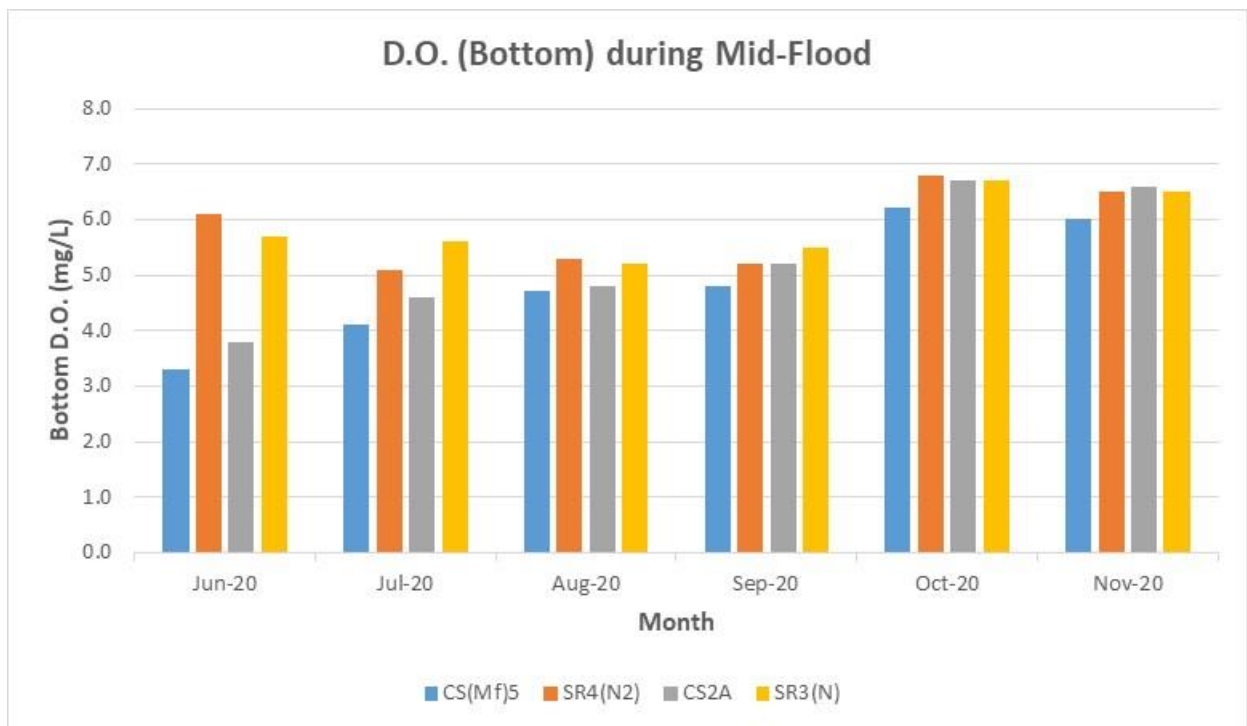
**Figure J3 Operational Phase Monitoring - Mean Level of Dissolved Oxygen (mg/L) in bottom waters between 1 June 2020 and 30 November 2020. The weather conditions during the monitoring period varied mostly from sunny to cloudy.**

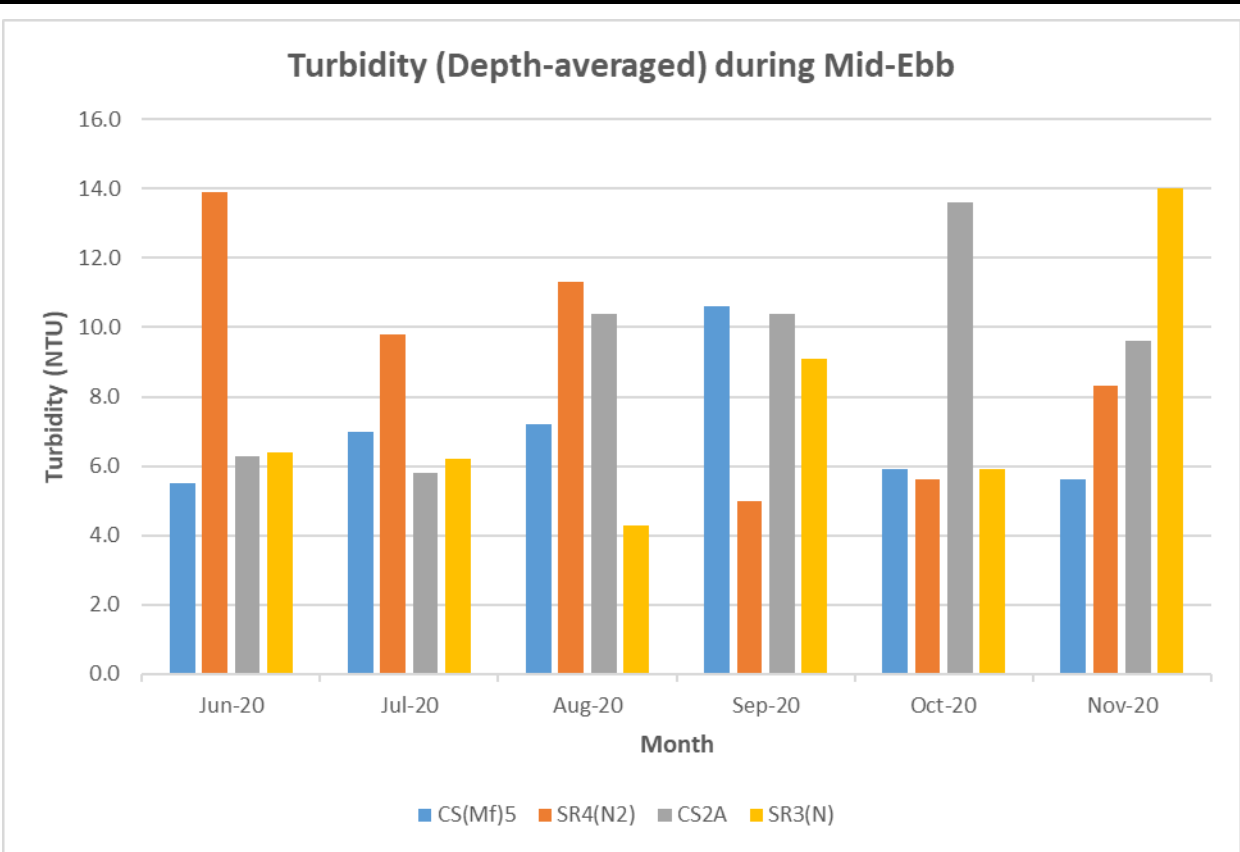
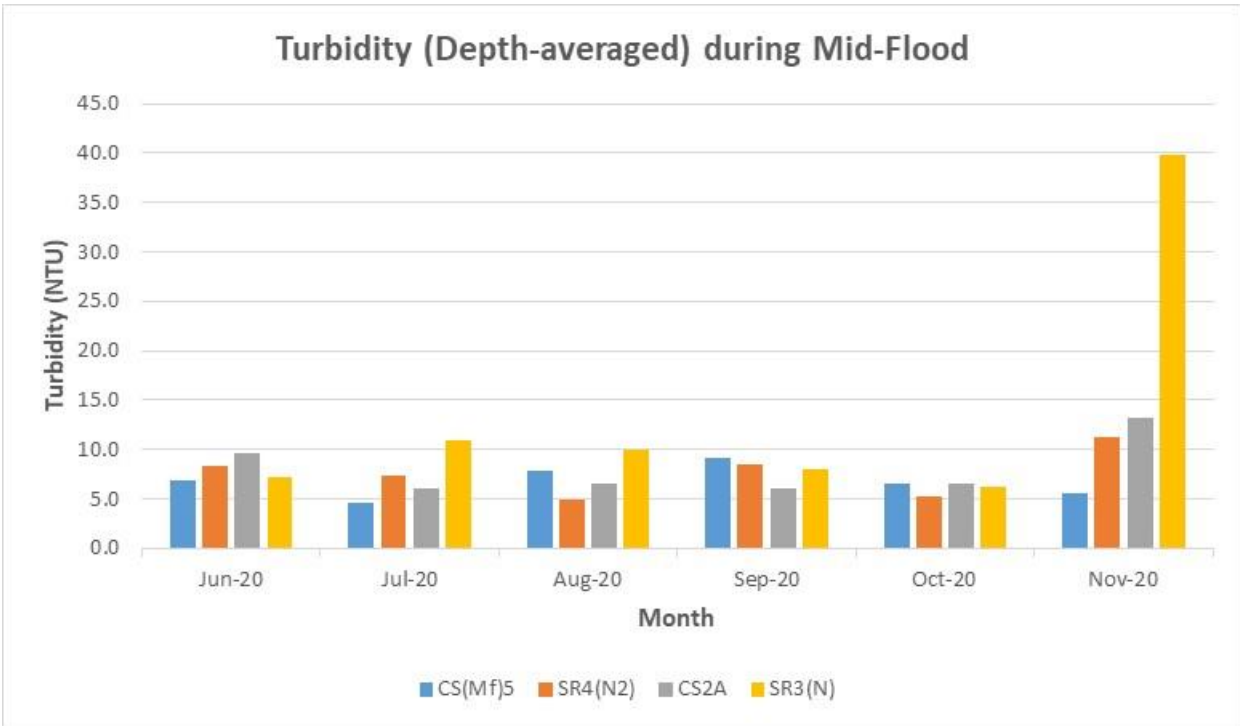
**Figure J4 Operational Phase Monitoring - Mean Depth-averaged Level of Turbidity (NTU) between 1 June 2020 and 30 November 2020. The weather conditions during the monitoring period varied mostly from sunny to cloudy.**

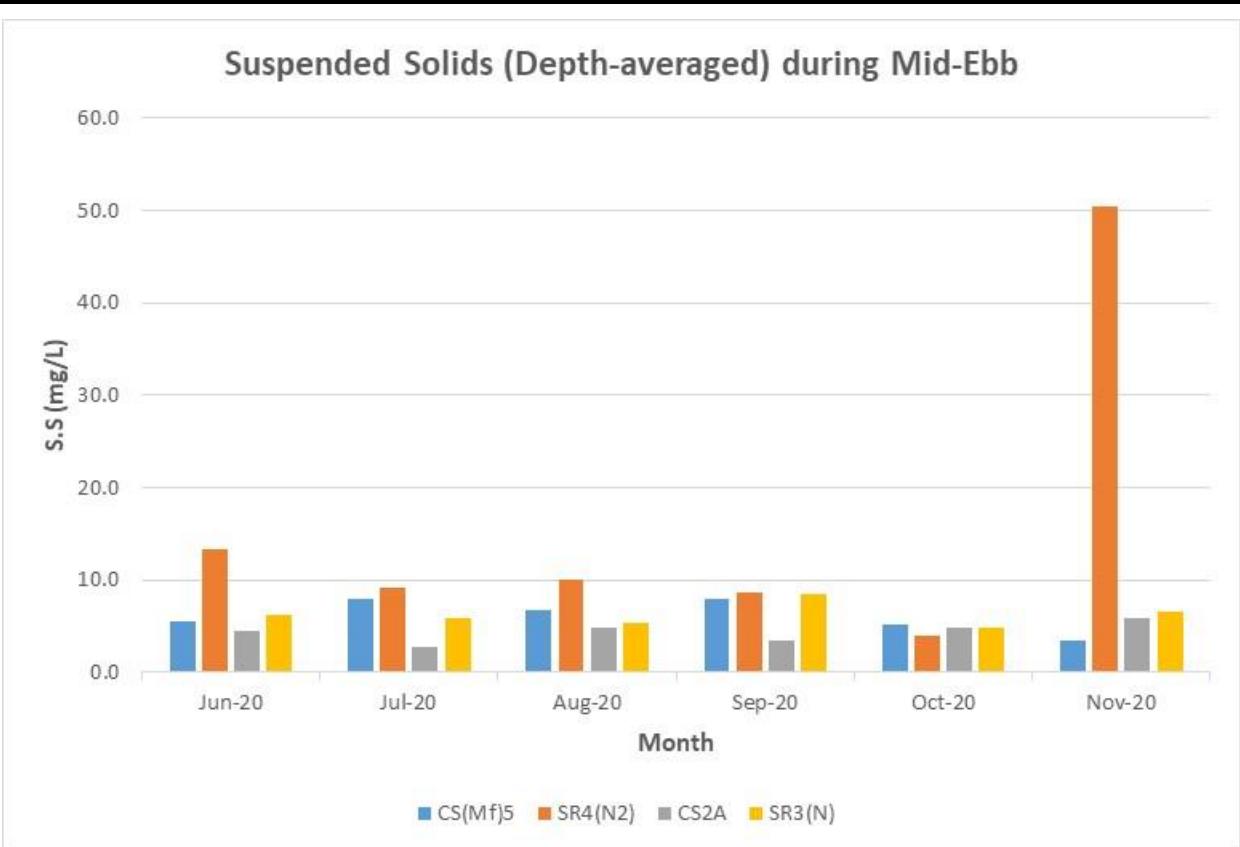
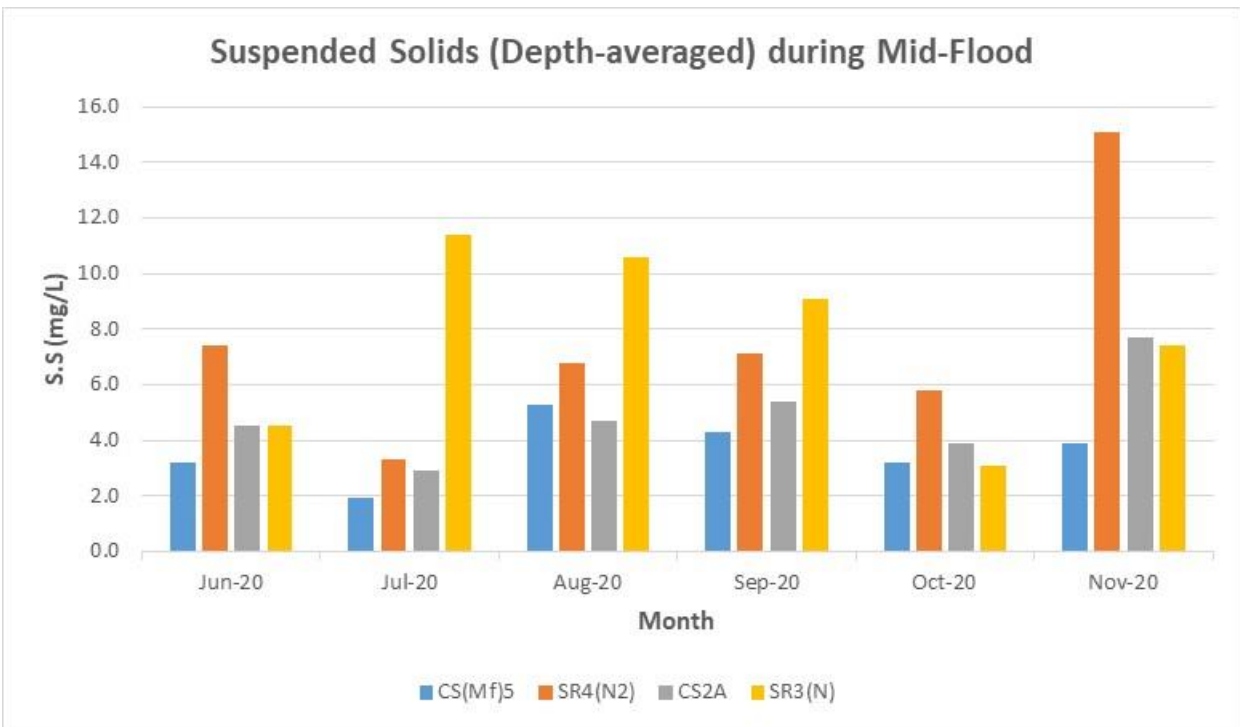
**Figure J5 Operational Phase Monitoring - Mean Depth-averaged Level of Suspended Solids (mg/L) between 1 June 2020 and 30 November 2020. The weather conditions during the monitoring period varied mostly from sunny to cloudy.**
