**Contract No. HY/2012/08  
Tuen Mun - Chek Lap Kok Link -  
Northern Connection Sub-sea Tunnel  
Section**

***Eighty-Ninth Monthly Environmental Monitoring  
& Audit (EM&A) Report***

14 April 2021

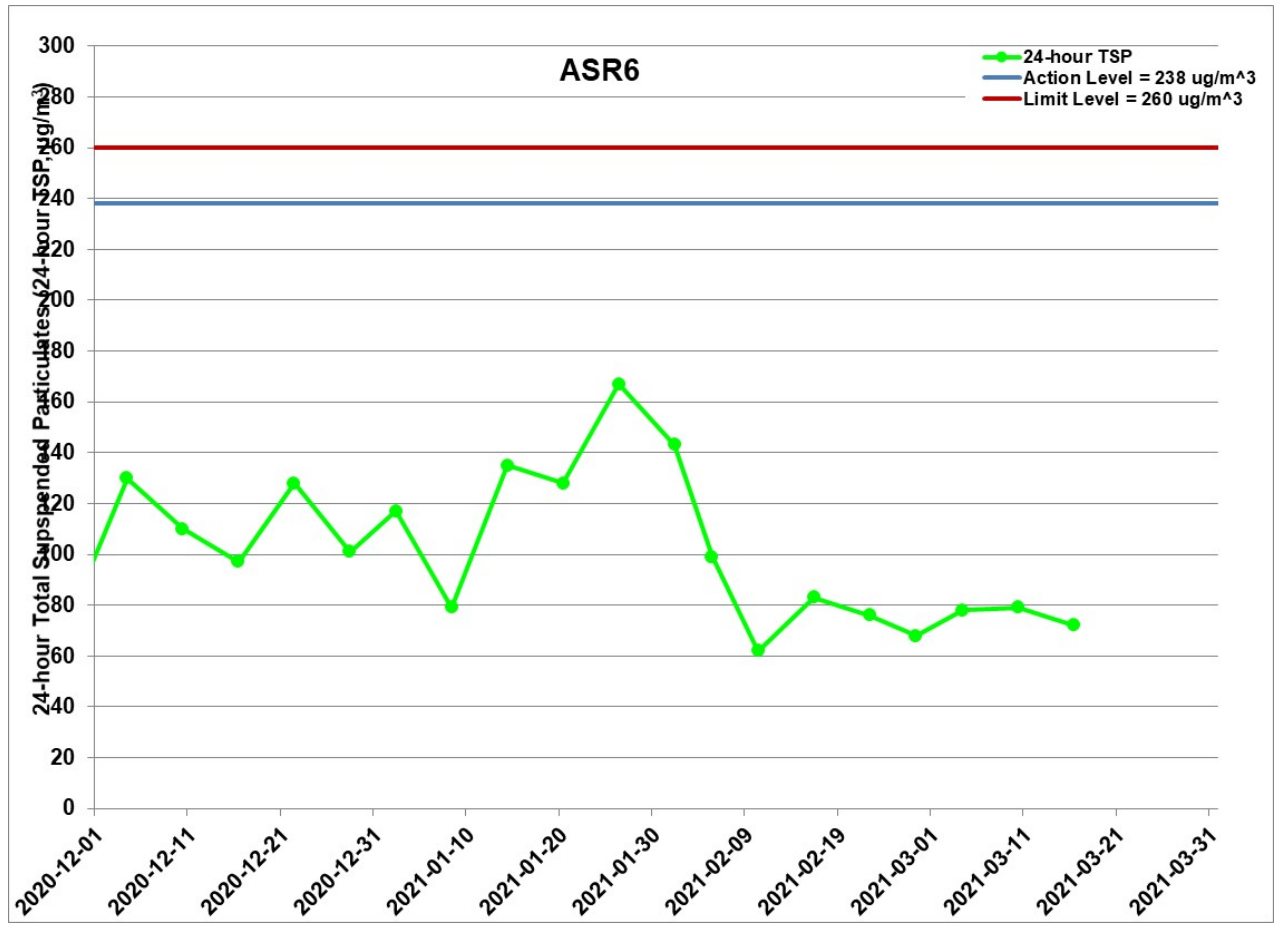
Figure G.9 Impact Monitoring – 24-hour Total Suspended Particulates ( $\mu\text{g}/\text{m}^3$ ) at ASR6 between 1 December 2020 and 19 March 2021 during impact monitoring period. The weather conditions during the monitoring period were sunny and hazy. No major land-based construction activities was conducted in the reporting period (1/12/2020 – 19/3/2021)
