**Contract No. HY/2012/07
Tuen Mun – Chek Lap Kok Link –
Southern Connection Viaduct Section**

Fifty-first Monthly EM&A Report

13 February 2018

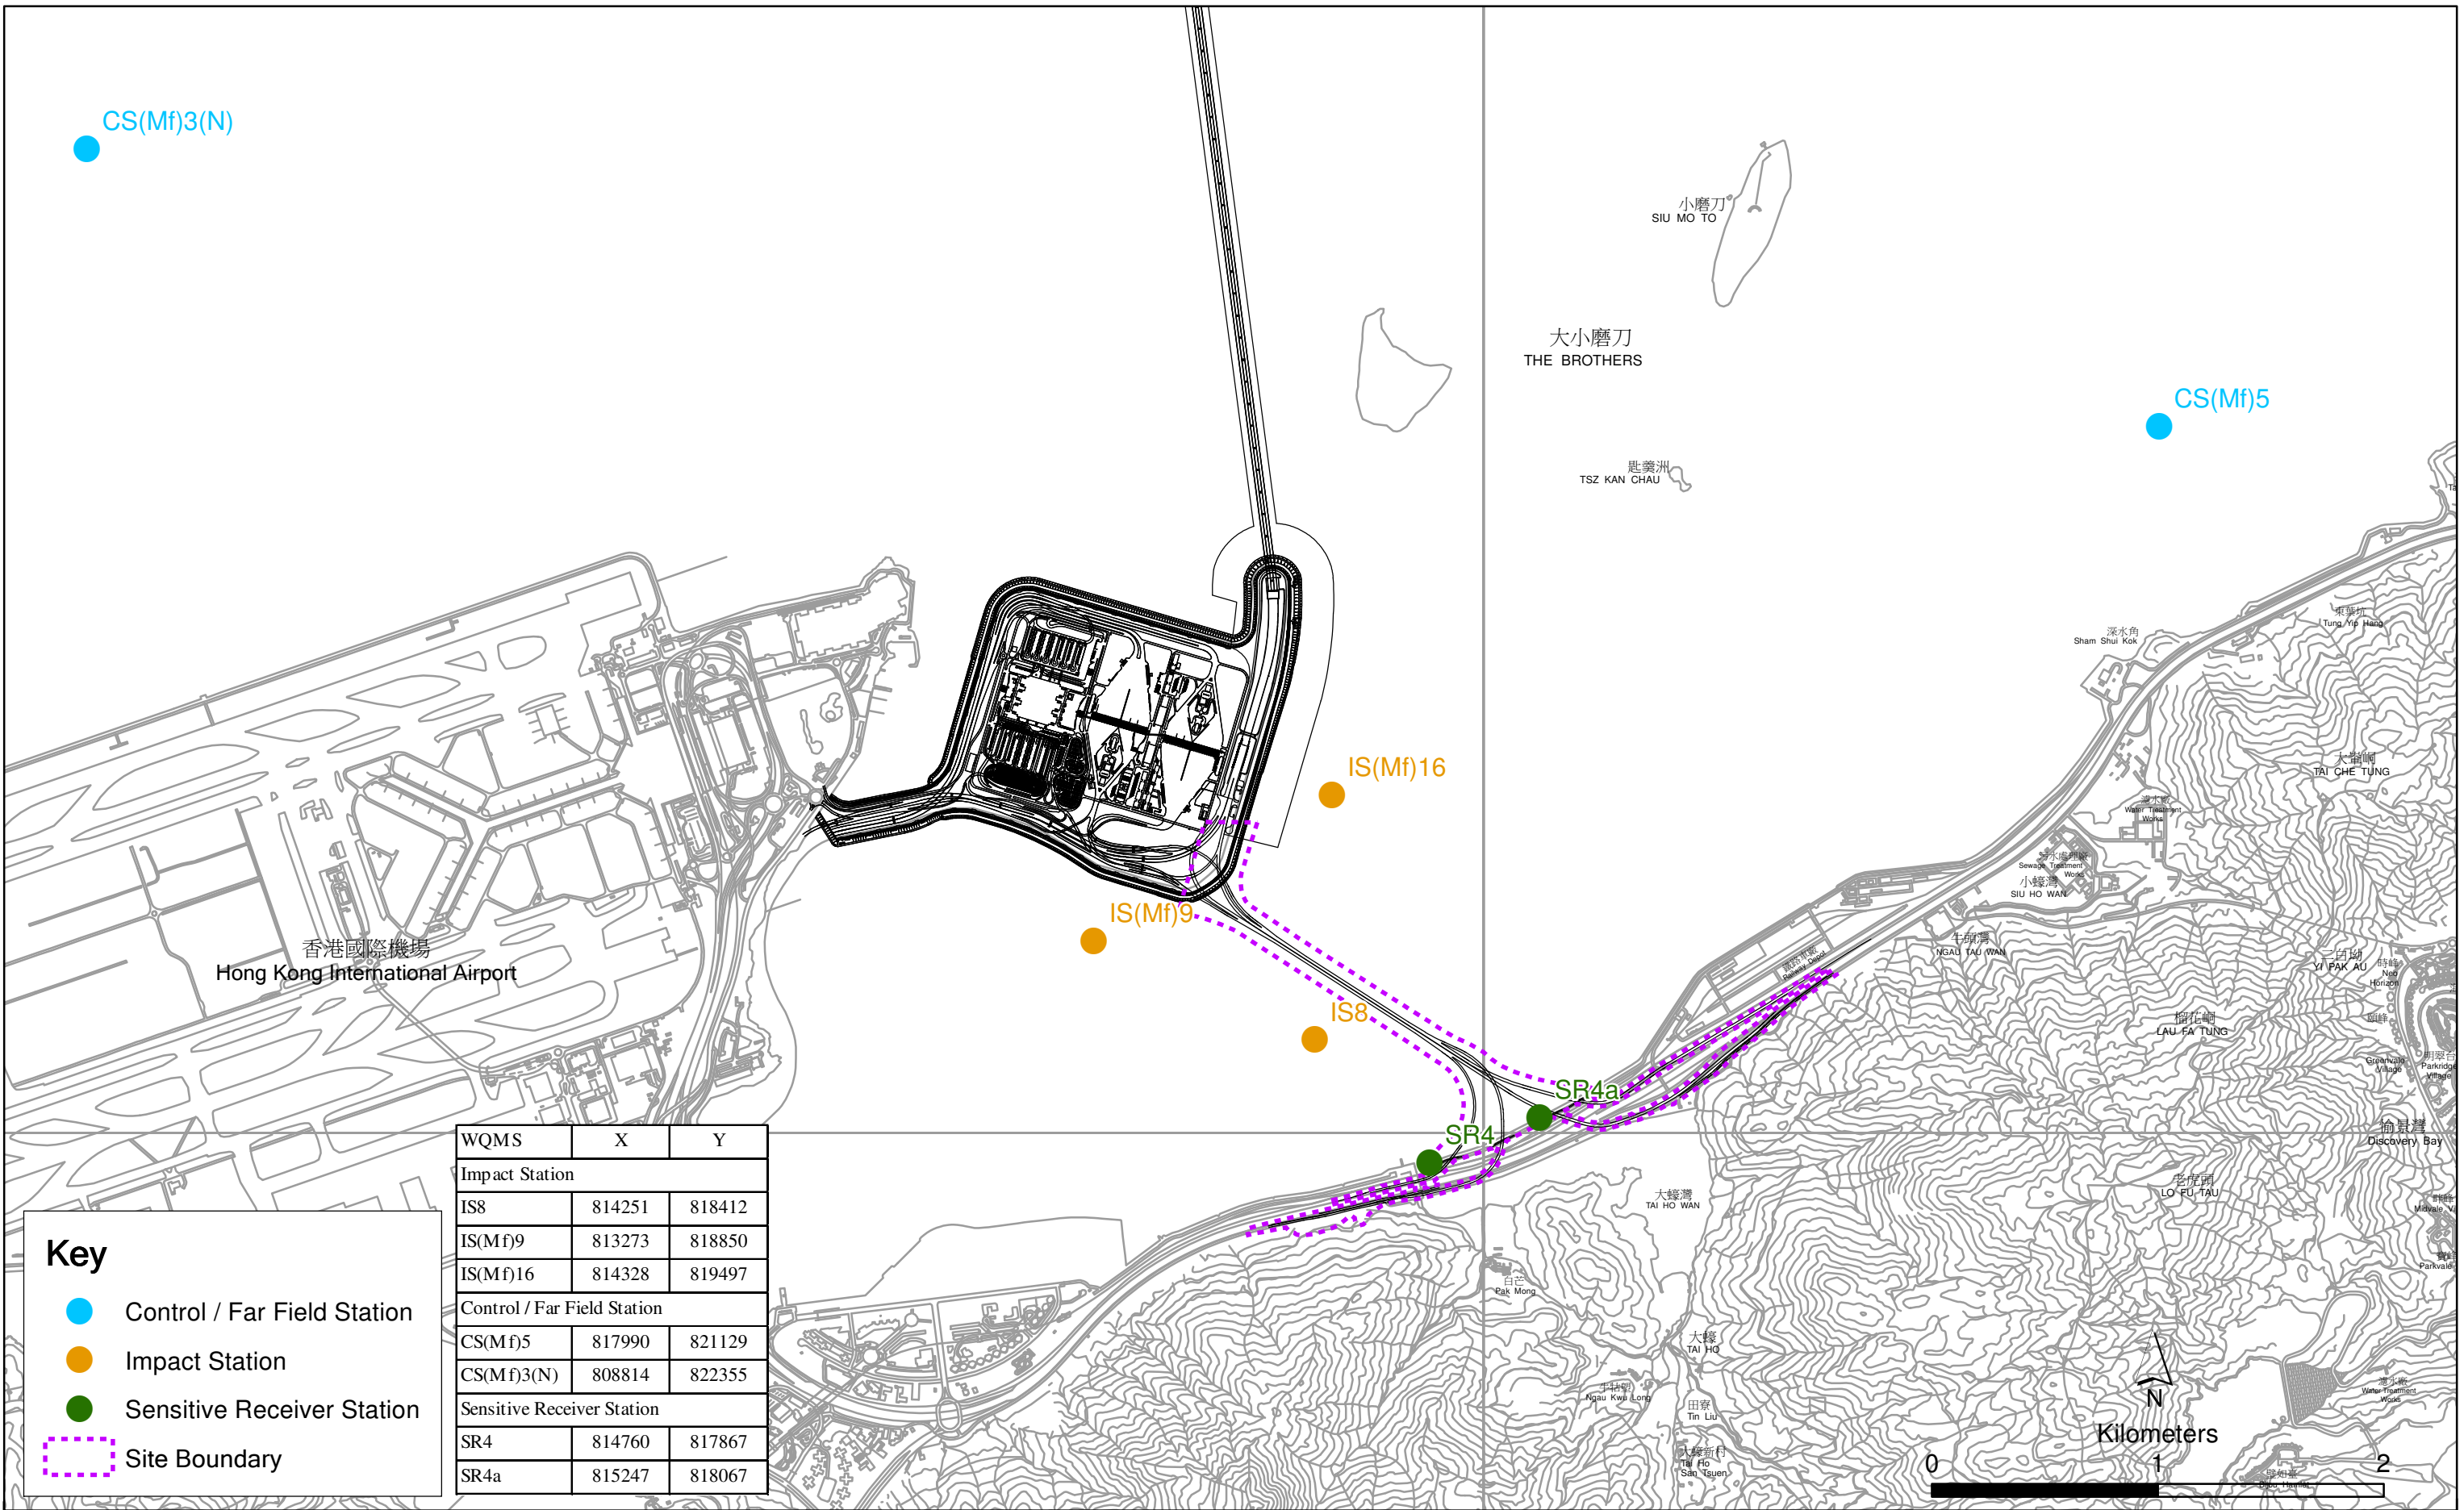
Figure 2.3

Locations of Water Quality Monitoring Stations

The locations of the monitoring stations under the Contract are shown in *Figure 2.3* and *Table 2.8*.

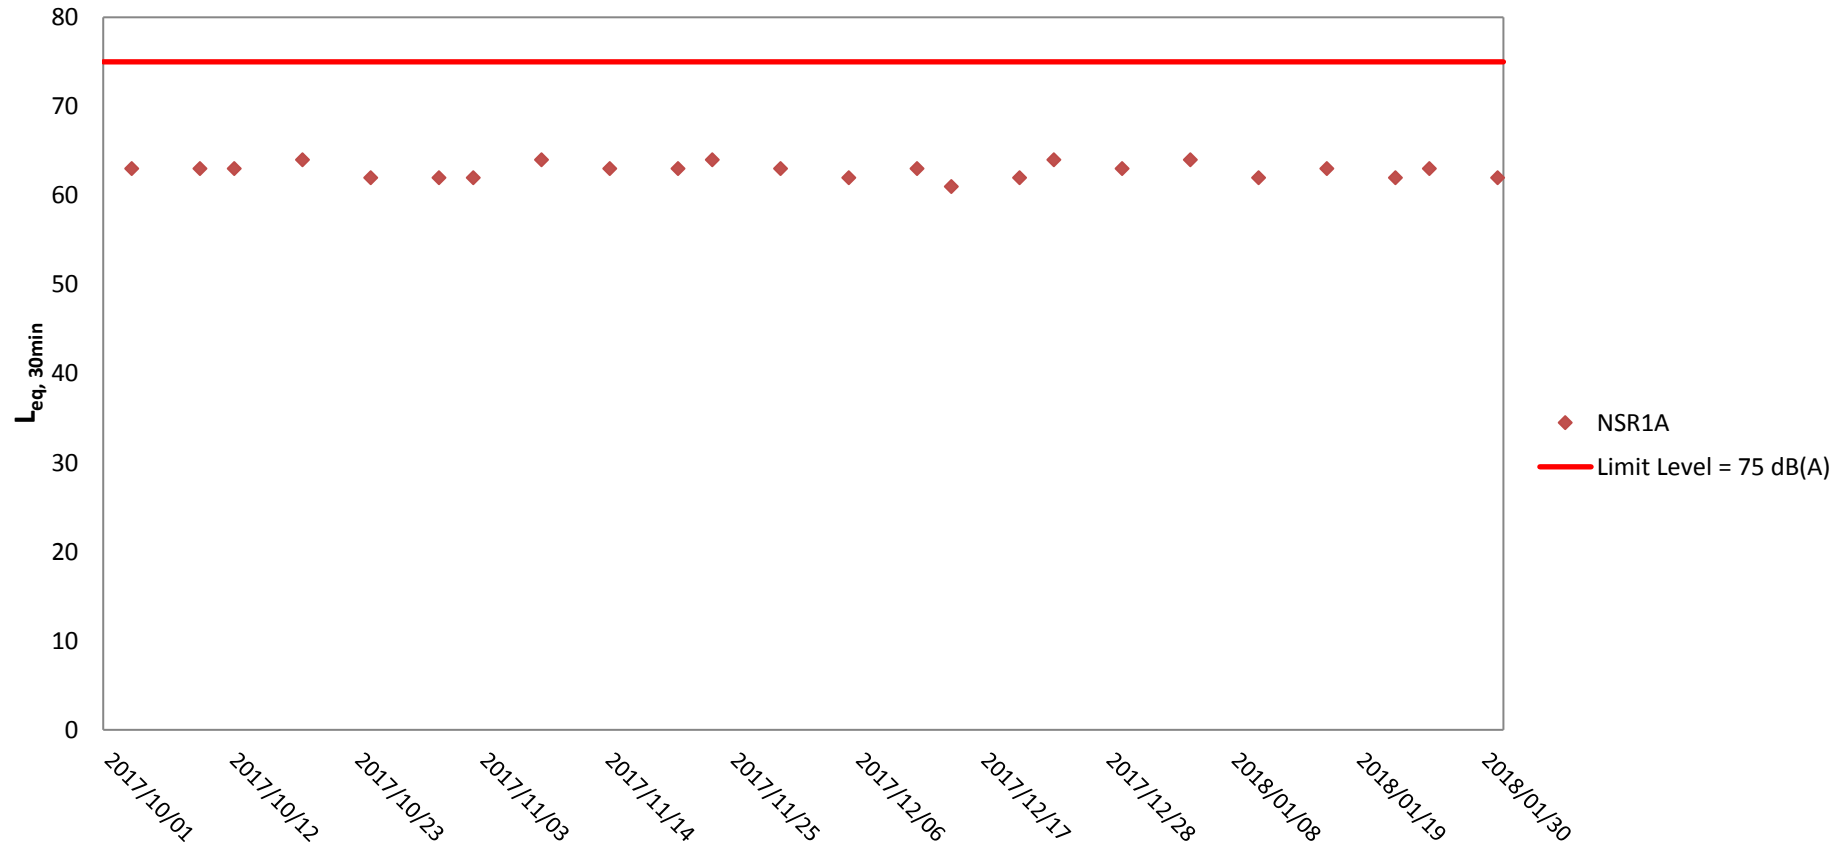
Noise Monitoring Results at NSR 1A ($L_{eq, 30min}$)

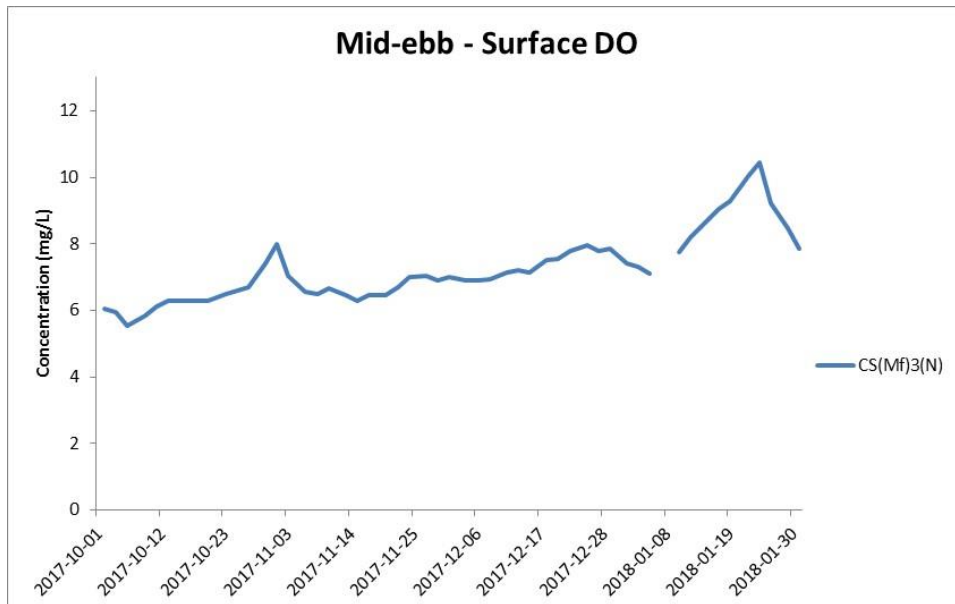
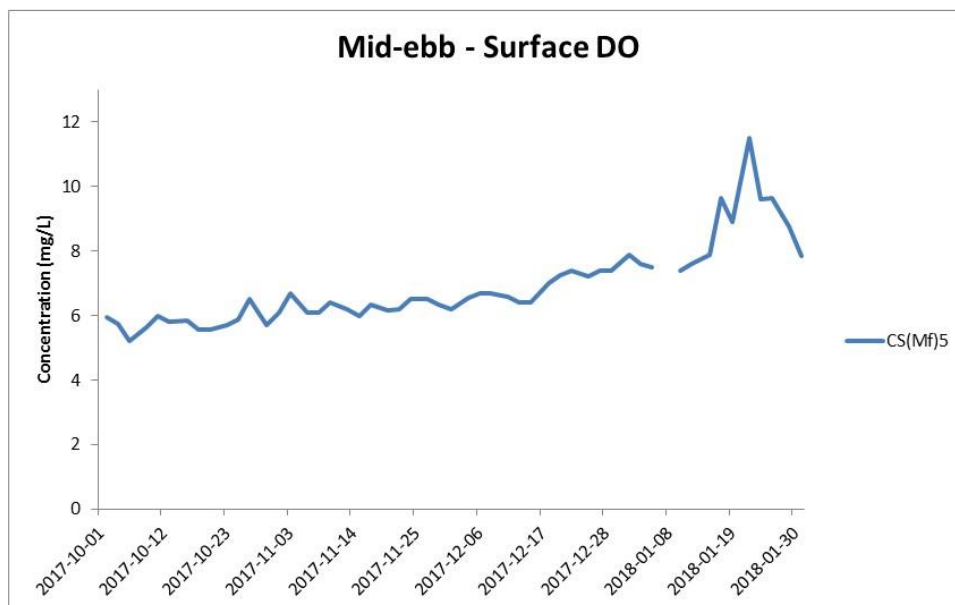
Figure J1 Impact Monitoring - Mean Level of Dissolved Oxygen (mg/L) in surface waters during mid-ebb tide between 1 October 2017 and 31 January 2018 at CS(Mf)3(N) and CS(Mf)5.

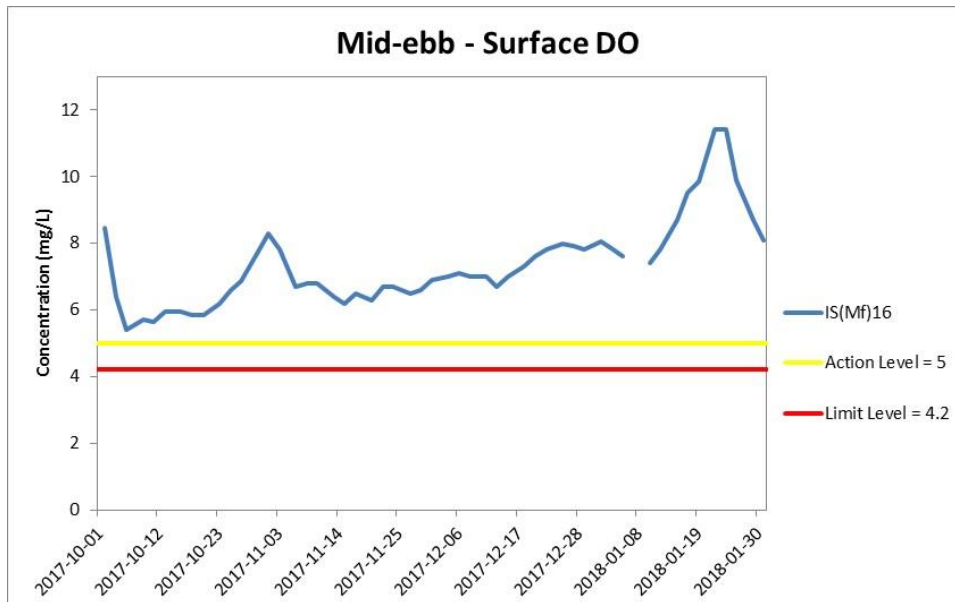
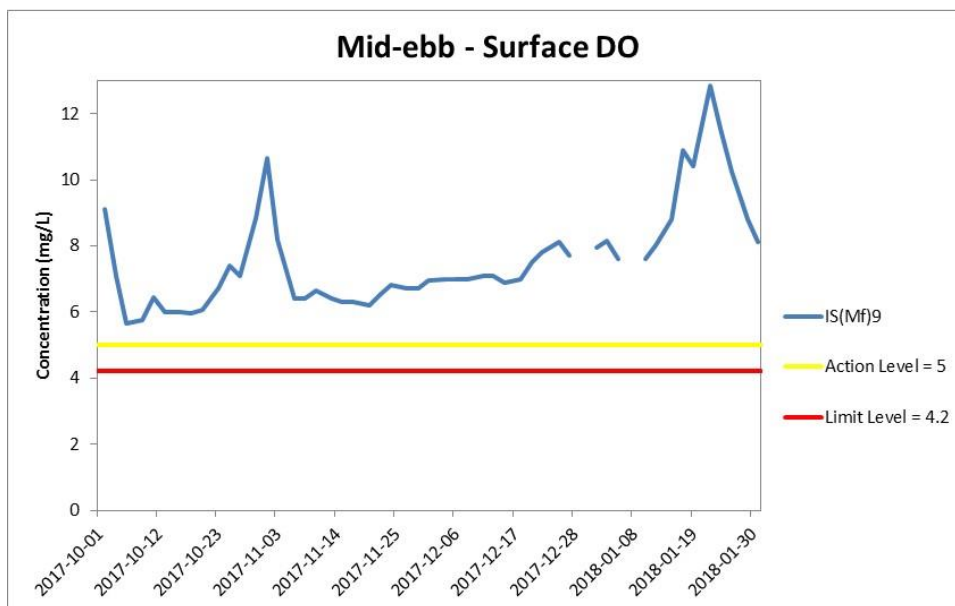
Figure J2 Impact Monitoring - Mean Level of Dissolved Oxygen (mg/L) in surface waters during mid-ebb tide between 1 October 2017 and 31 January 2018 at IS(Mf)16 and IS(Mf)9.

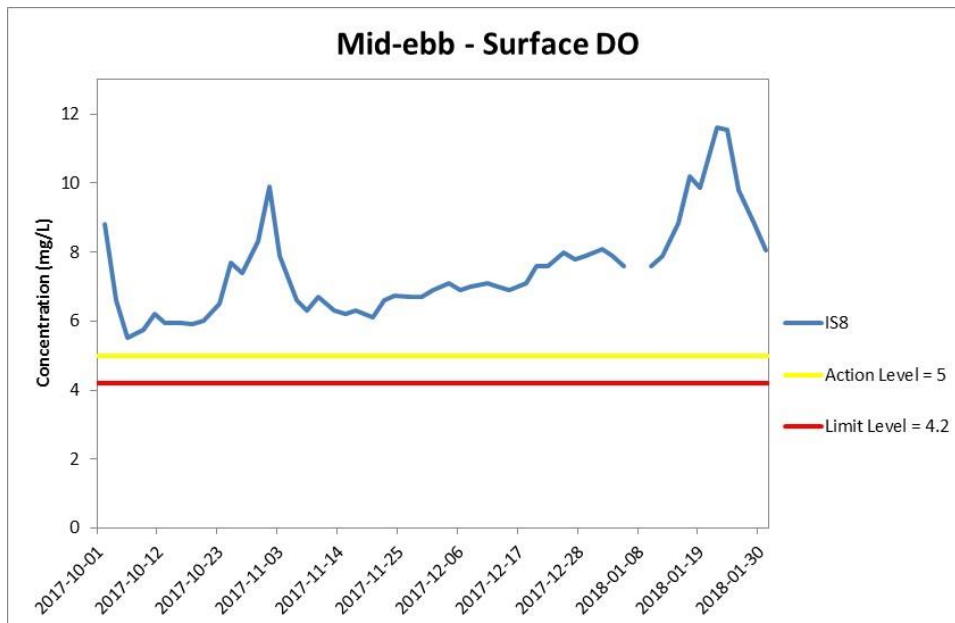
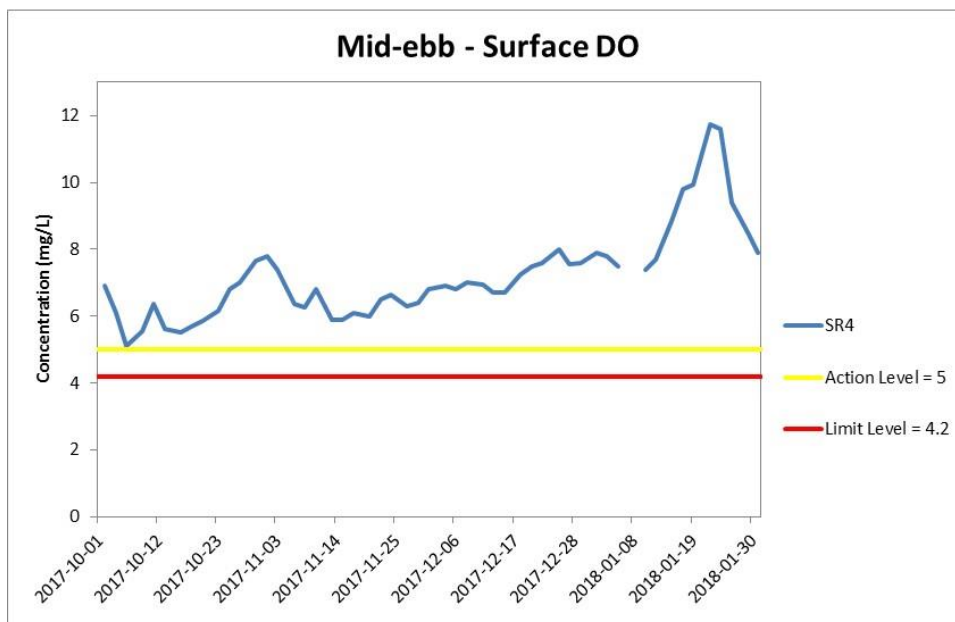
Figure J3 Impact Monitoring - Mean Level of Dissolved Oxygen (mg/L) in surface waters during mid-ebb tide between 1 October 2017 and 31 January 2018 at IS8 and SR4.

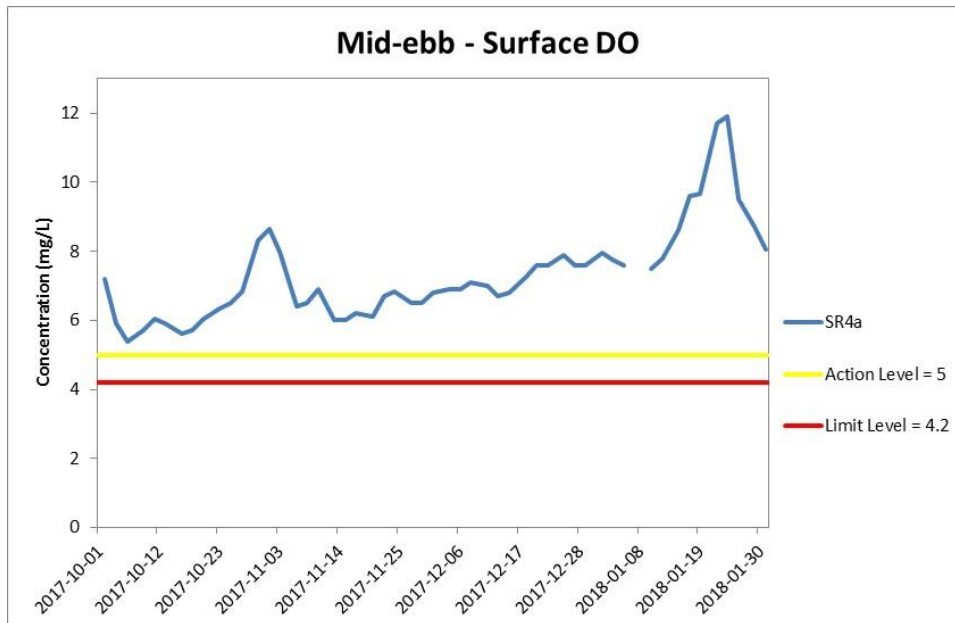
Figure J4 Impact Monitoring - Mean Level of Dissolved Oxygen (mg/L) in surface waters during mid-ebb tide between 1 October 2017 and 31 January 2018 at SR4a.

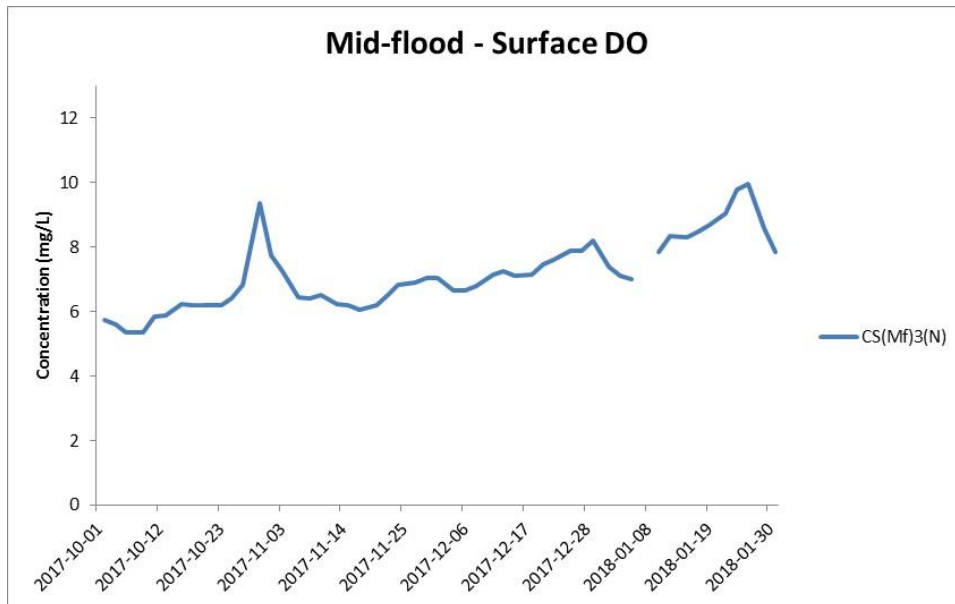
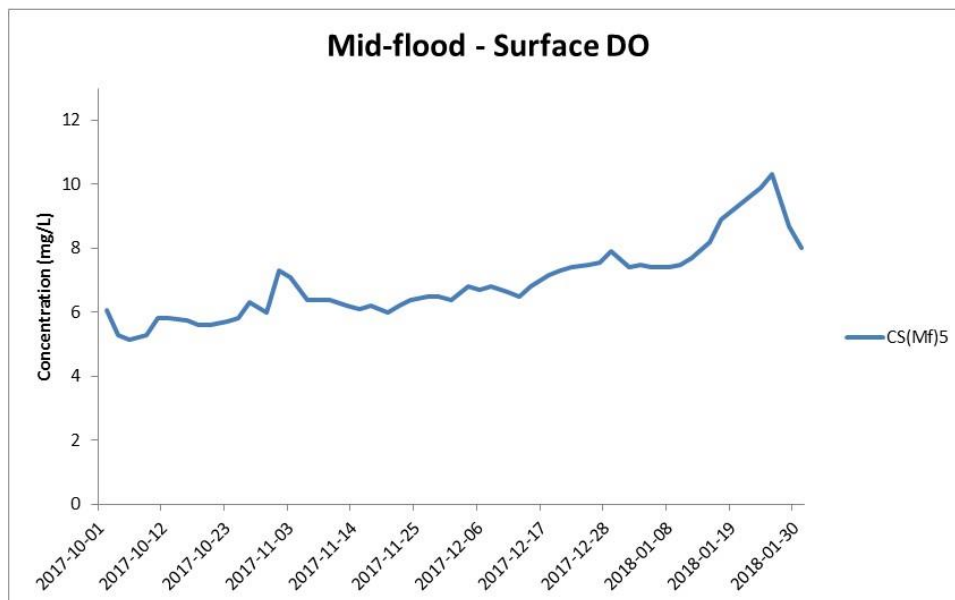
Figure J5 Impact Monitoring - Mean Level of Dissolved Oxygen (mg/L) in surface waters during mid-flood tide between 1 October 2017 and 31 January 2018 at CS(Mf)3(N) and CS(Mf)5.

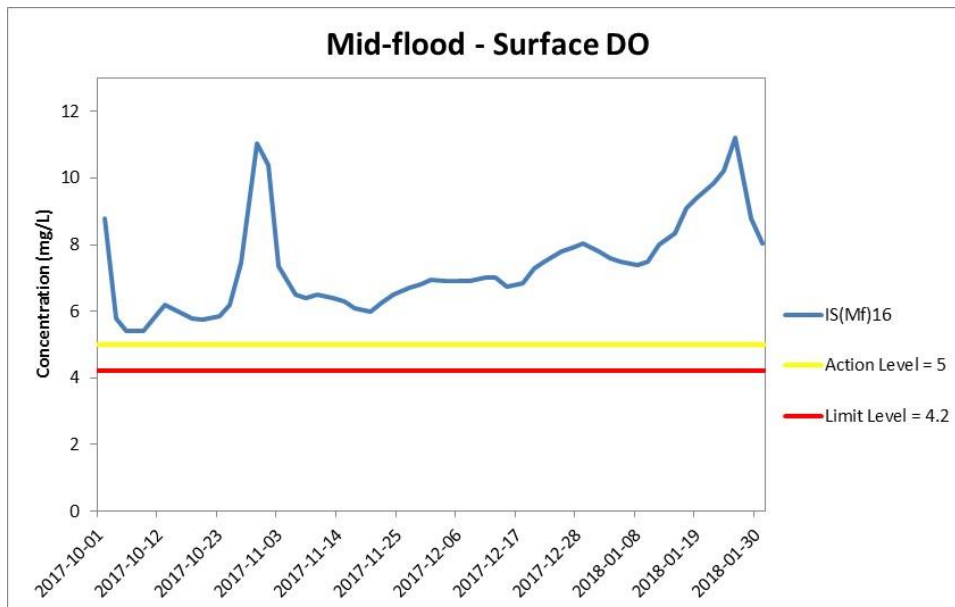
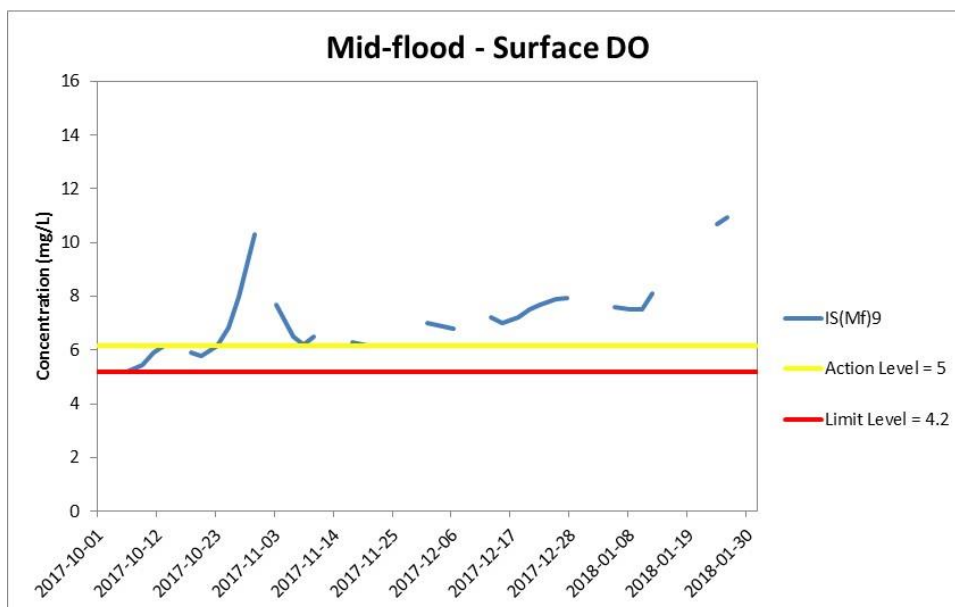
Figure J6 Impact Monitoring – Mean Level of Dissolved Oxygen (mg/L) in surface waters during mid-flood tide between 1 October 2017 and 31 January 2018 at IS(Mf)16 and IS(Mf)9.

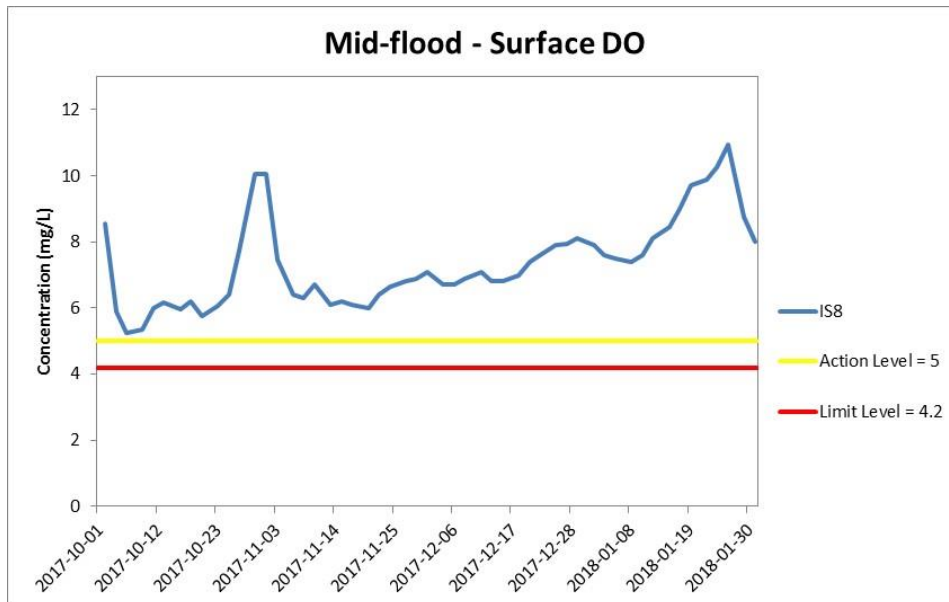
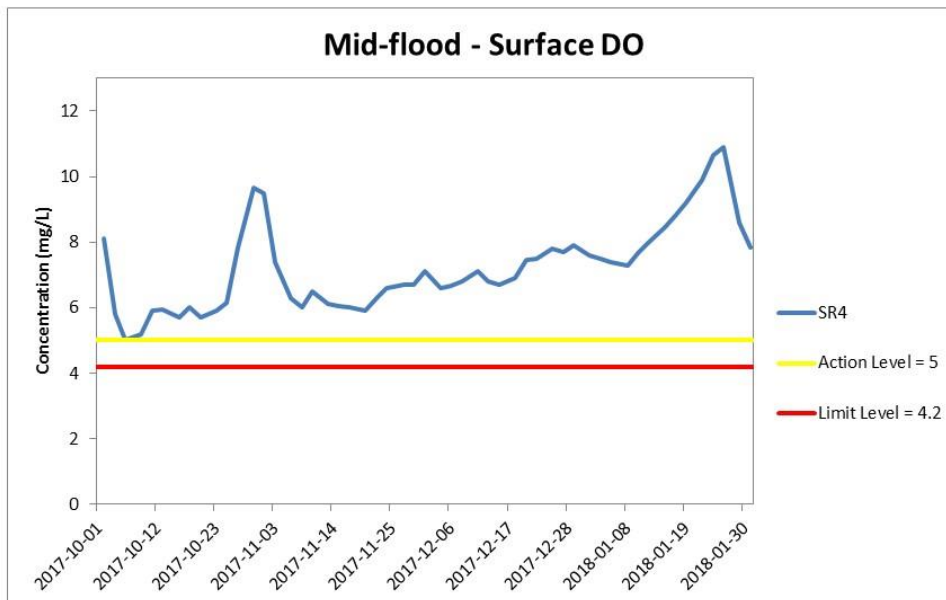
Figure J7 Impact Monitoring – Mean Level of Dissolved Oxygen (mg/L) in surface waters during mid-flood tide between 1 October 2017 and 31 January 2018 at IS8 and SR4.

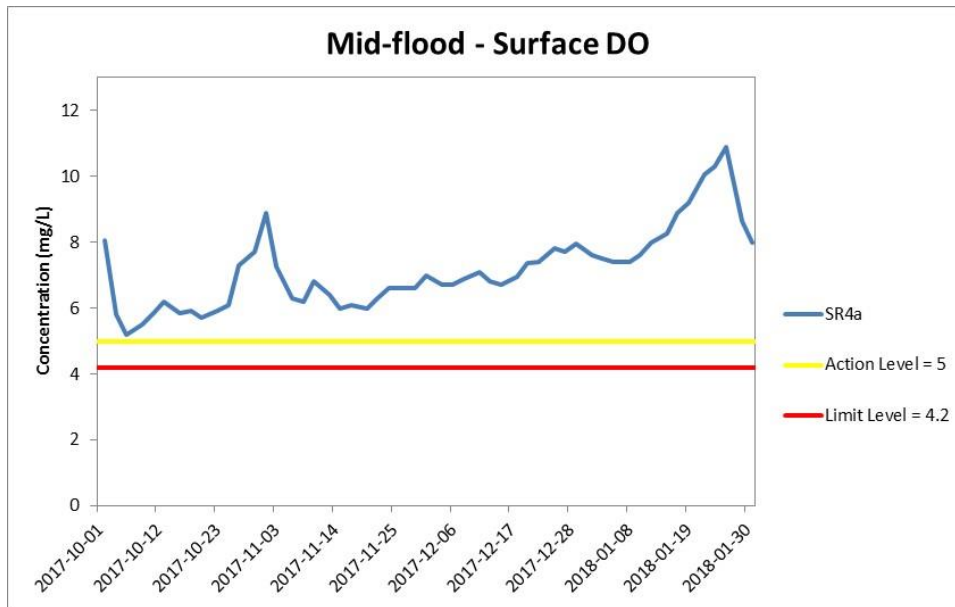
Figure J8 Impact Monitoring - Mean Level of Dissolved Oxygen (mg/L) in surface waters during mid-flood tide between 1 October 2017 and 31 January 2018 at SR4a.

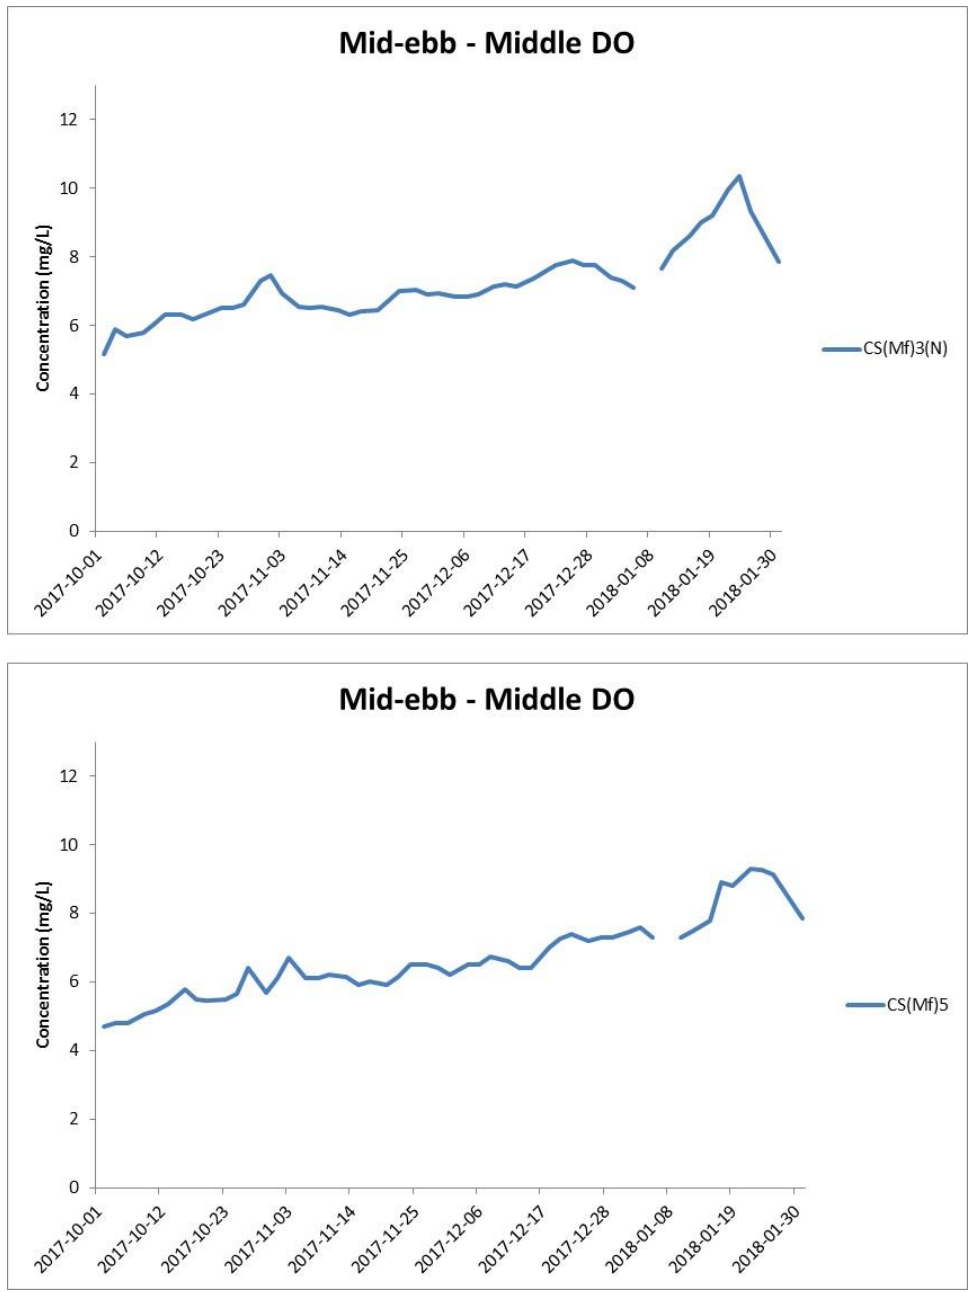
Figure J9 Impact Monitoring – Mean Level of Dissolved Oxygen (mg/L) in mid-depth waters during mid-ebb tide between 1 October 2017 and 31 January 2018 at CS(Mf)3(N) and CS(Mf)5.

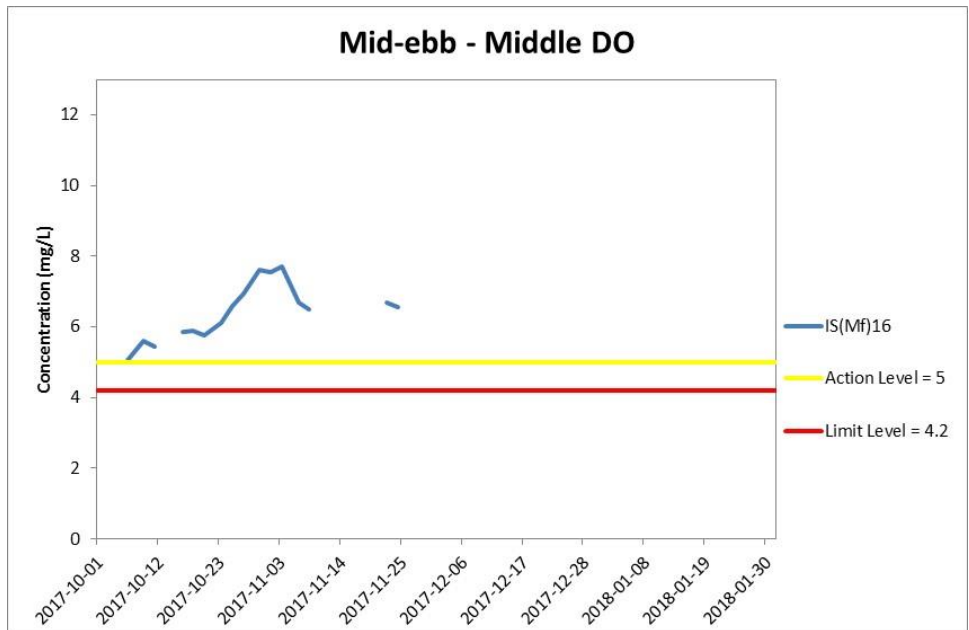
Figure J10 Impact Monitoring - Mean Level of Dissolved Oxygen (mg/L) in mid-depth waters during mid-ebb tide between 1 October 2017 and 31 January 2018 at IS(Mf)16.

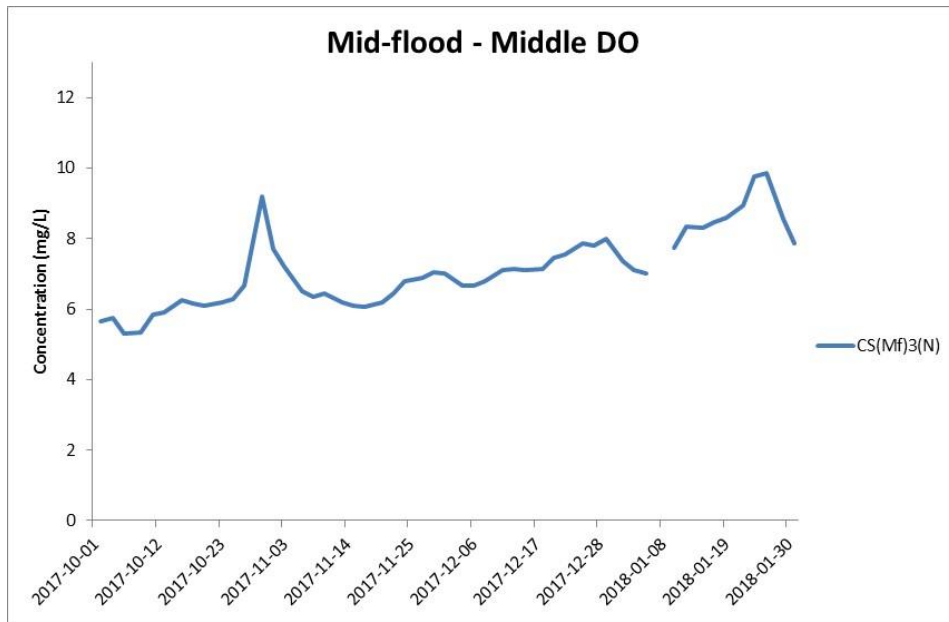
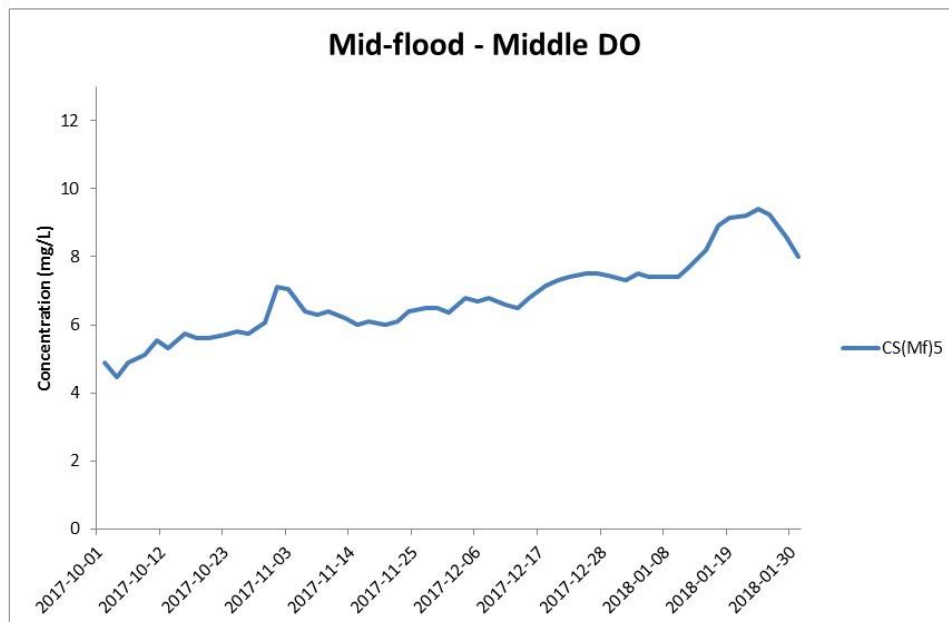
Figure J11 Impact Monitoring – Mean Level of Dissolved Oxygen (mg/L) in mid-depth waters during mid-flood tide between 1 October 2017 and 31 January 2018 at CS(Mf)3(N) and CS(Mf)5.

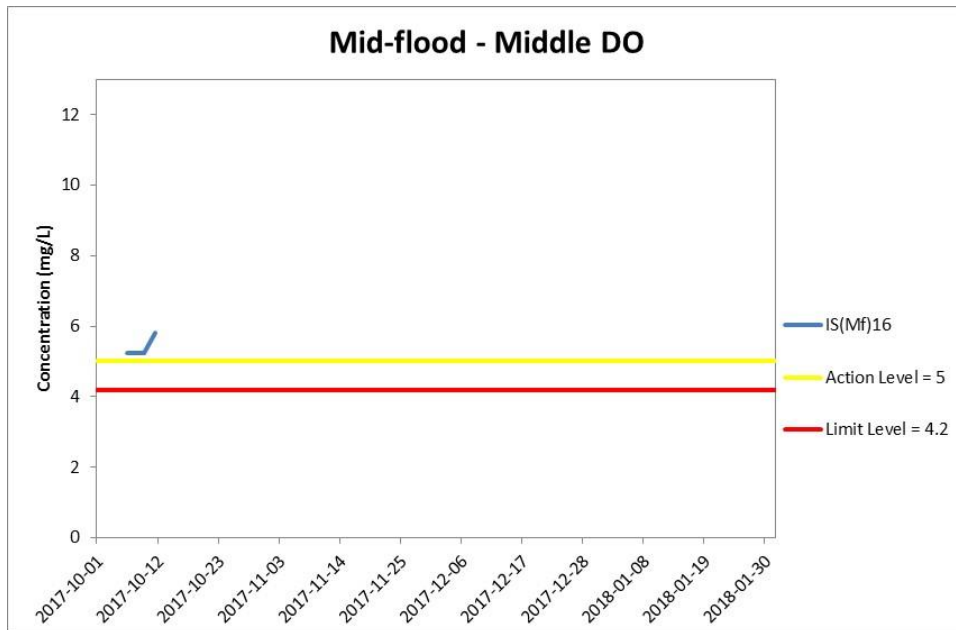
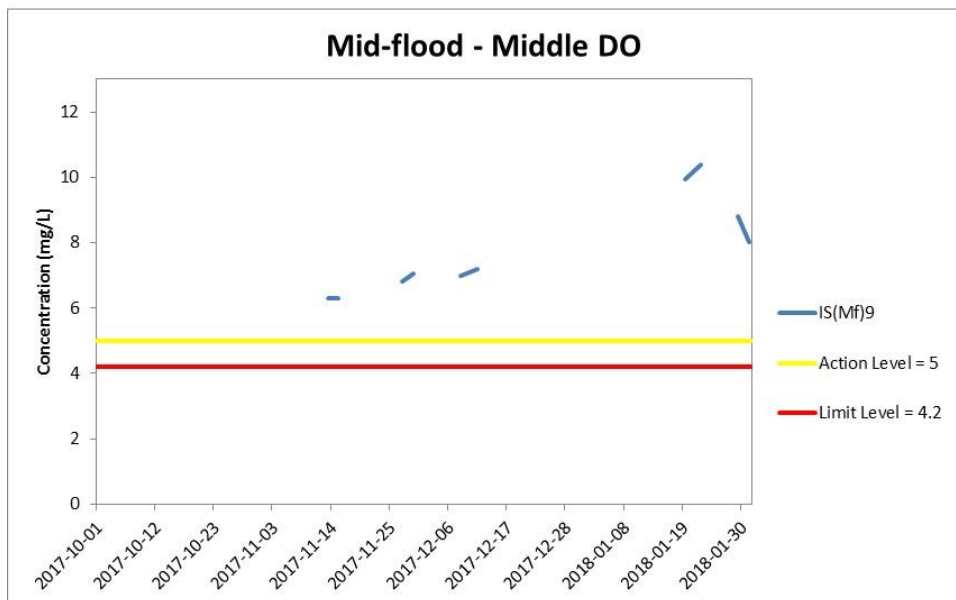
Figure J12 Impact Monitoring - Mean Level of Dissolved Oxygen (mg/L) in mid-depth waters during mid-flood tide between 1 October 2017 and 31 January 2018 at IS(Mf)16 and IS(Mf)9.

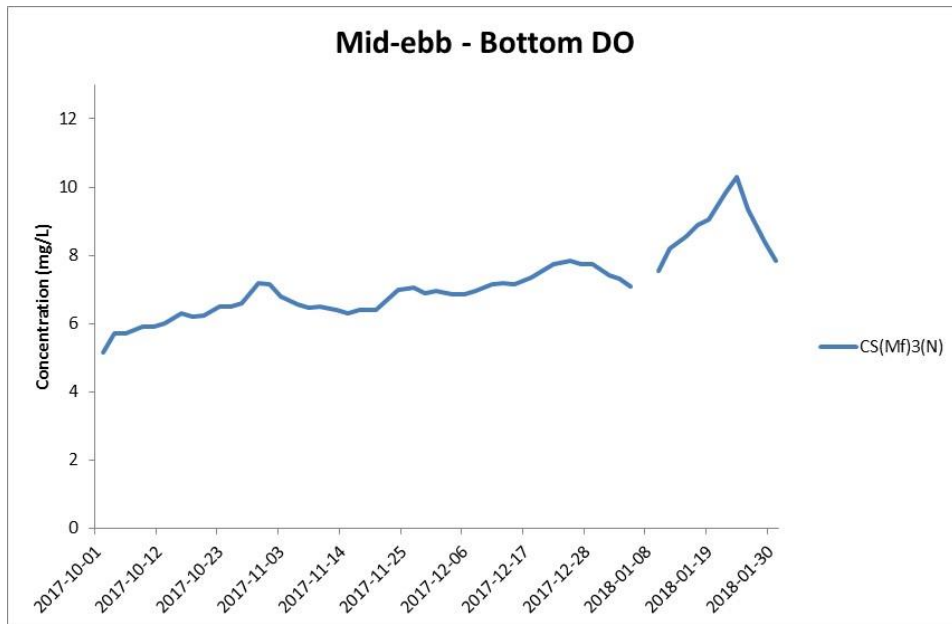
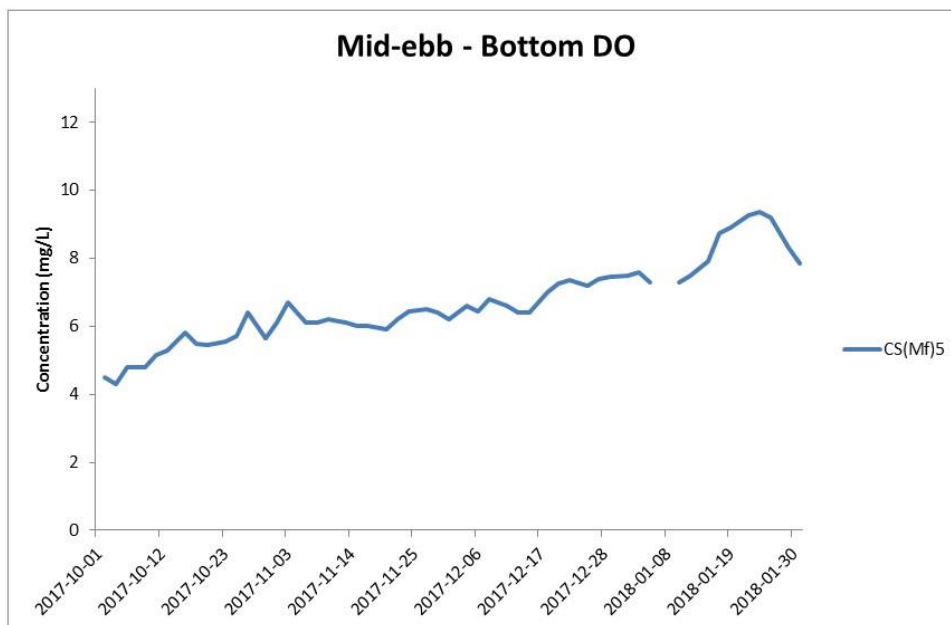
Figure J13 Impact Monitoring - Mean Level of Dissolved Oxygen (mg/L) in bottom waters during mid-ebb tide between 1 October 2017 and 31 January 2018 at CS(Mf)3(N) and CS(Mf)5.

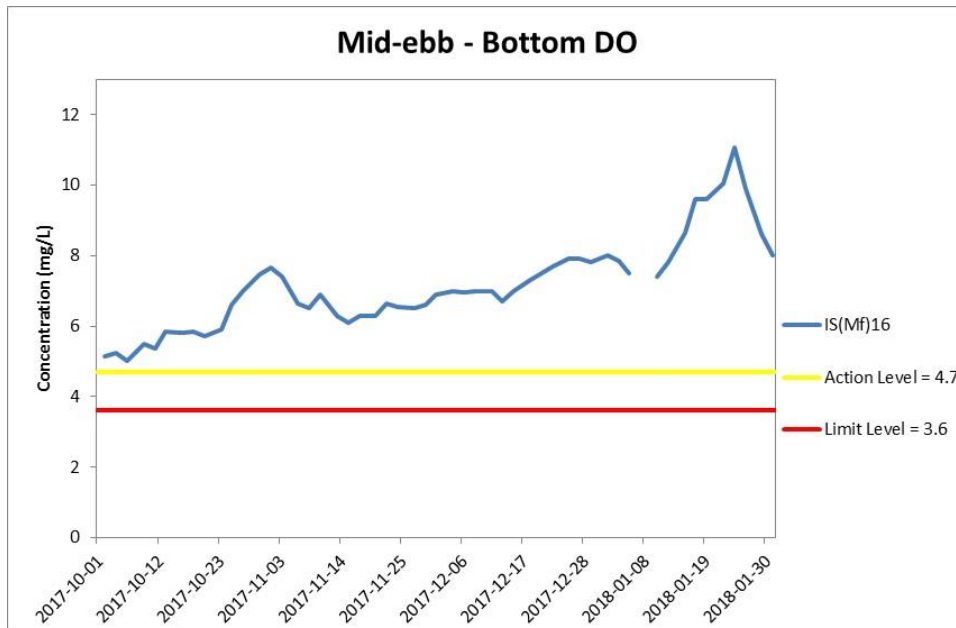
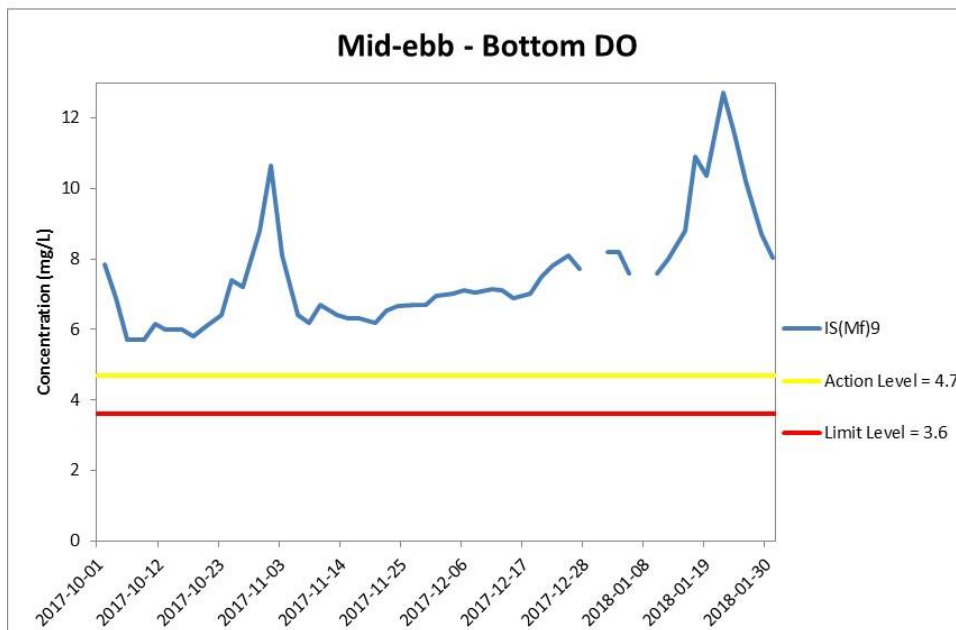
Figure J14 Impact Monitoring - Mean Level of Dissolved Oxygen (mg/L) in bottom waters during mid-ebb tide between 1 October 2017 and 31 January 2018 at IS(Mf)16 and IS(Mf)9.

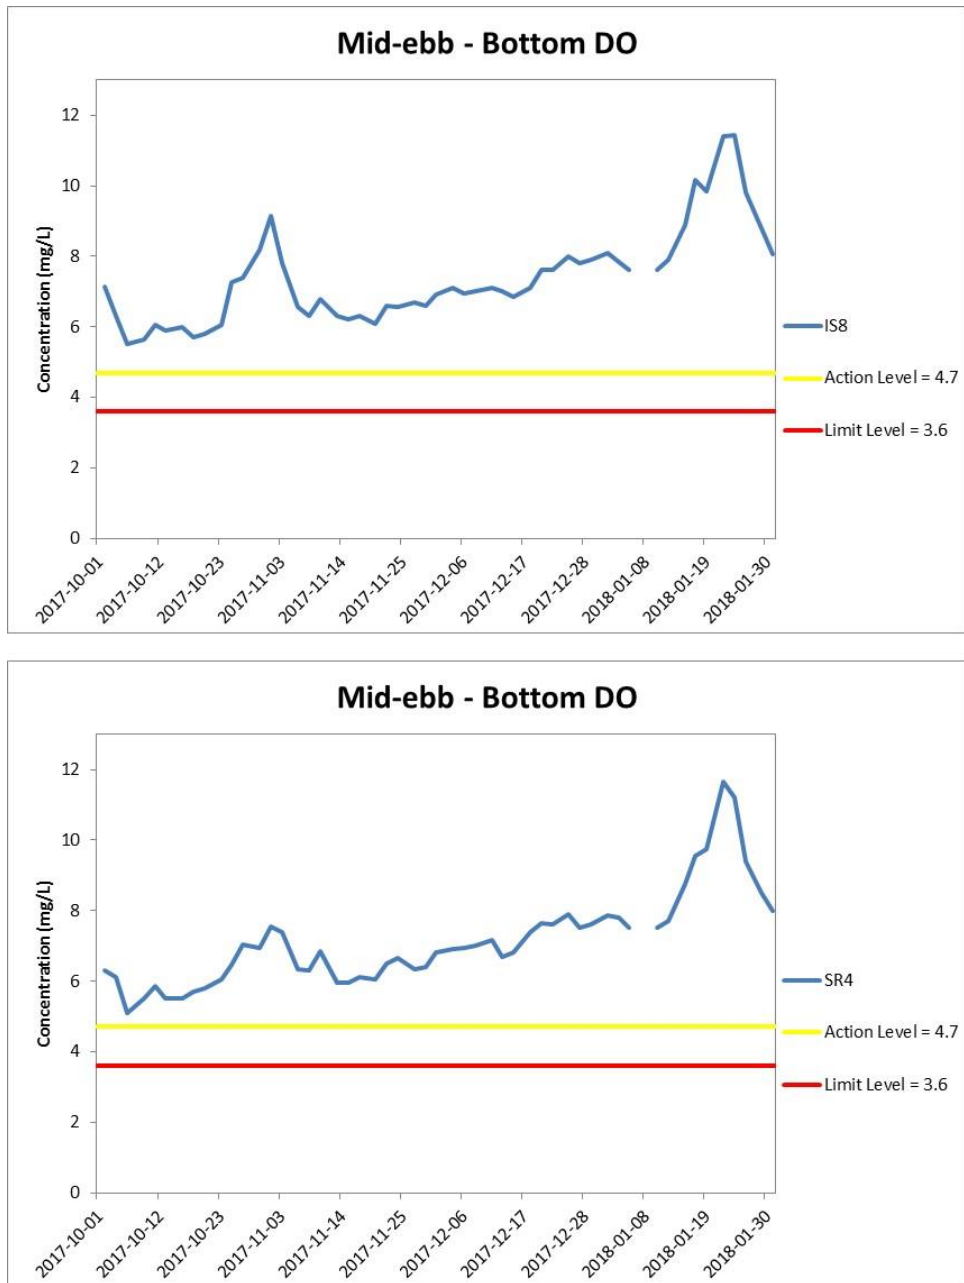
Figure J15 Impact Monitoring – Mean Level of Dissolved Oxygen (mg/L) in bottom waters during mid-ebb tide between 1 October 2017 and 31 January 2018 at IS8 and SR4.

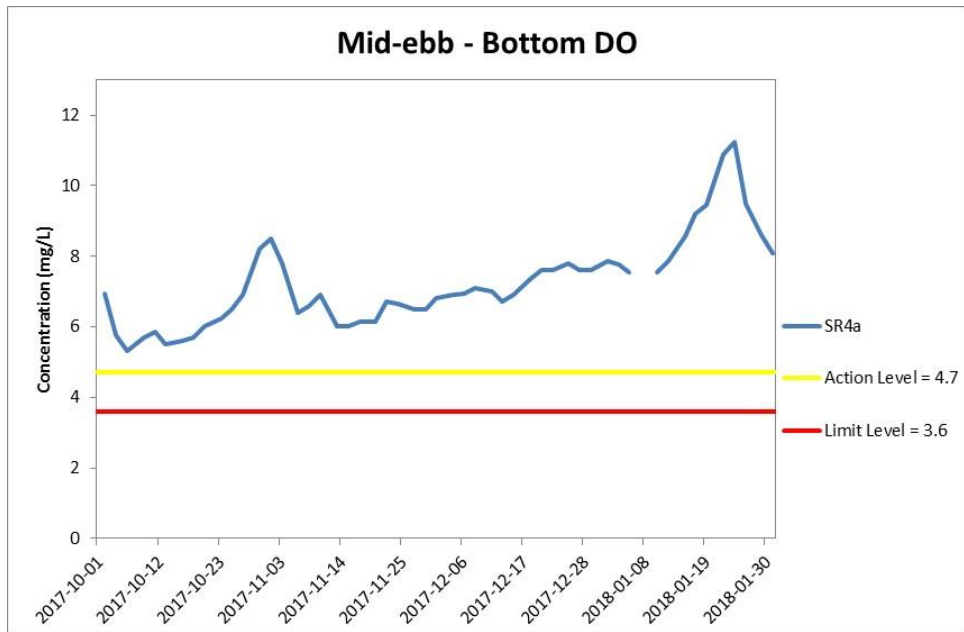
Figure J16 Impact Monitoring - Mean Level of Dissolved Oxygen (mg/L) in bottom waters during mid-ebb tide between 1 October 2017 and 31 January 2018 at SR4a.
