**Contract No. HY/2012/07
Tuen Mun – Chek Lap Kok Link –
Southern Connection Viaduct Section**

Fifty-first Monthly EM&A Report

13 February 2018

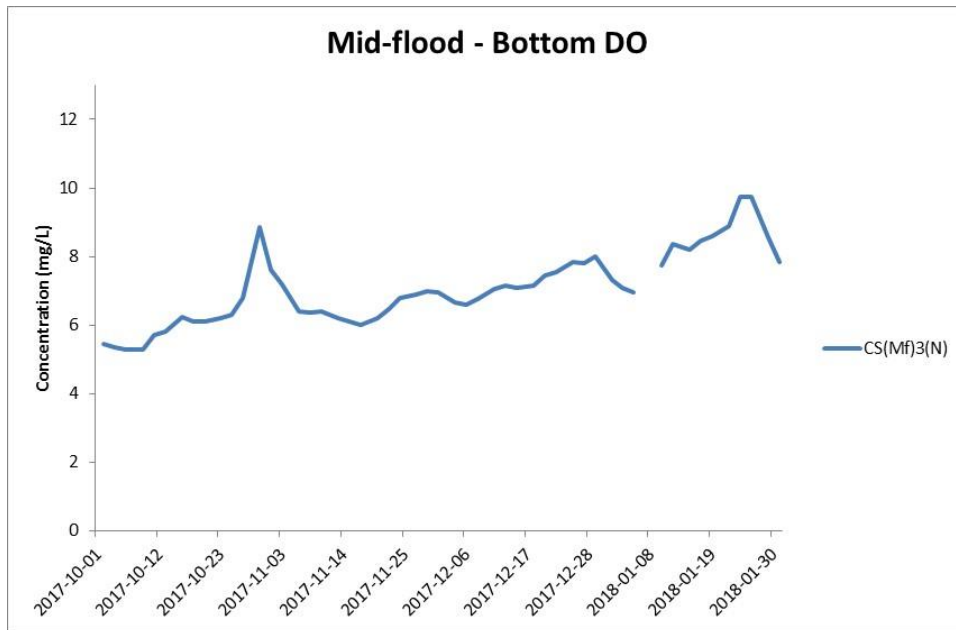
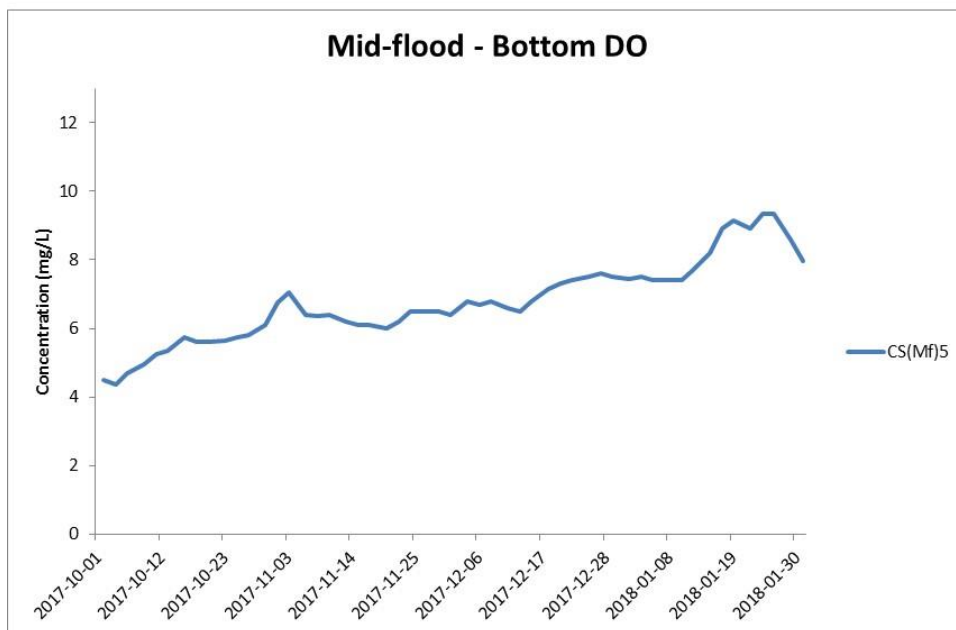
Figure J17 Impact Monitoring – Mean Level of Dissolved Oxygen (mg/L) in bottom waters during mid-flood tide between 1 October 2017 and 31 January 2018 at CS(Mf)3(N) and CS(Mf)5.

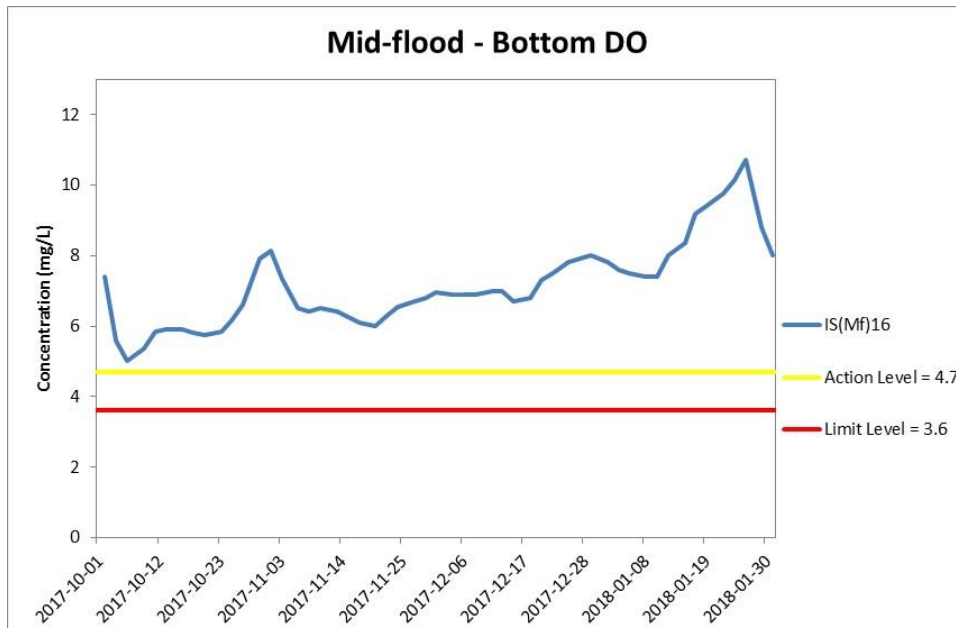
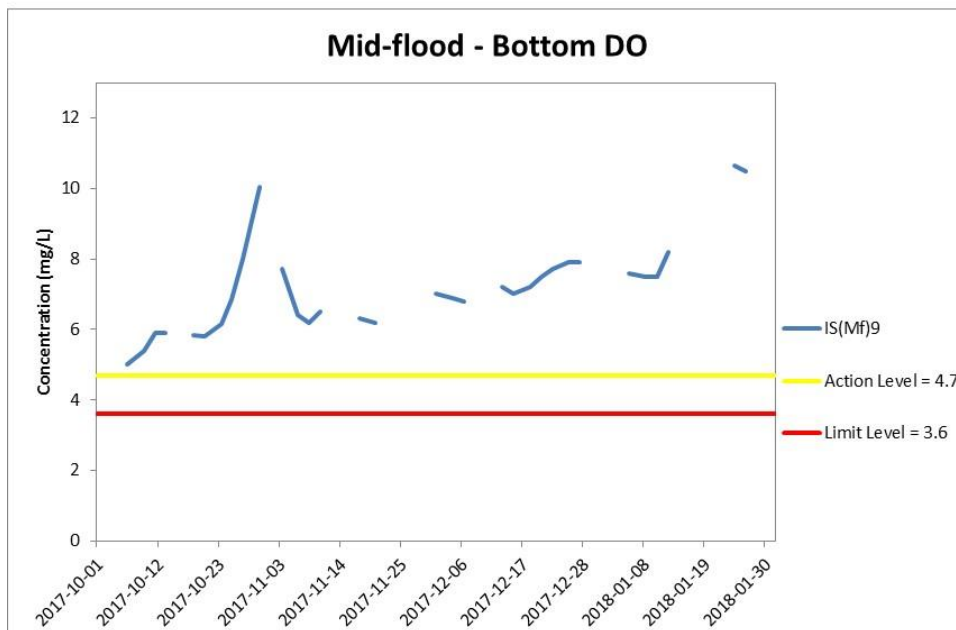
Figure J18 Impact Monitoring – Mean Level of Dissolved Oxygen (mg/L) in bottom waters during mid-flood tide between 1 October 2017 and 31 January 2018 at IS(Mf)16 and IS(Mf)9.

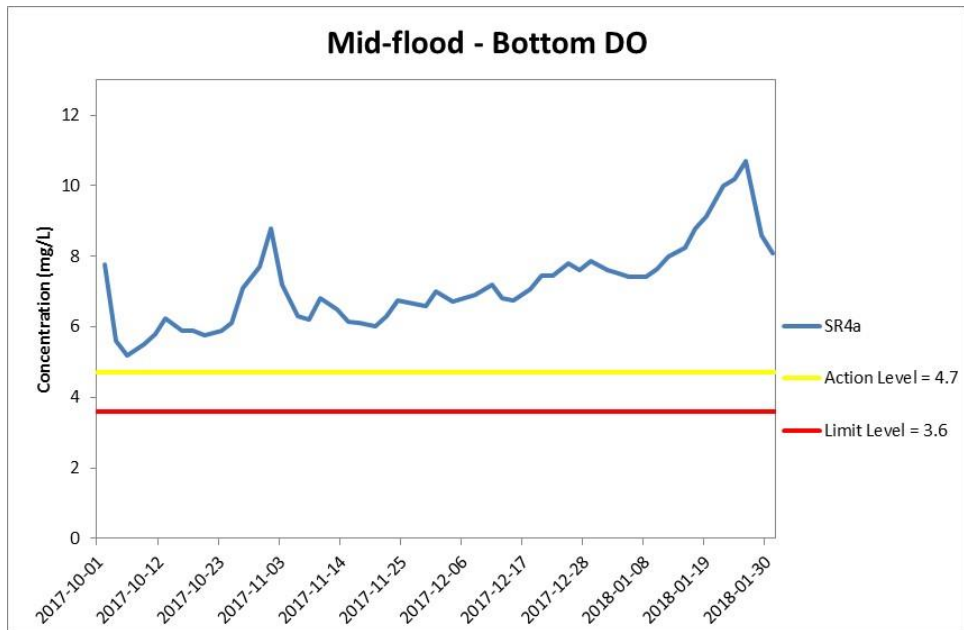
Figure J20 Impact Monitoring - Mean Level of Dissolved Oxygen (mg/L) in bottom waters during mid-flood tide between 1 October 2017 and 31 January 2018 at SR4a.

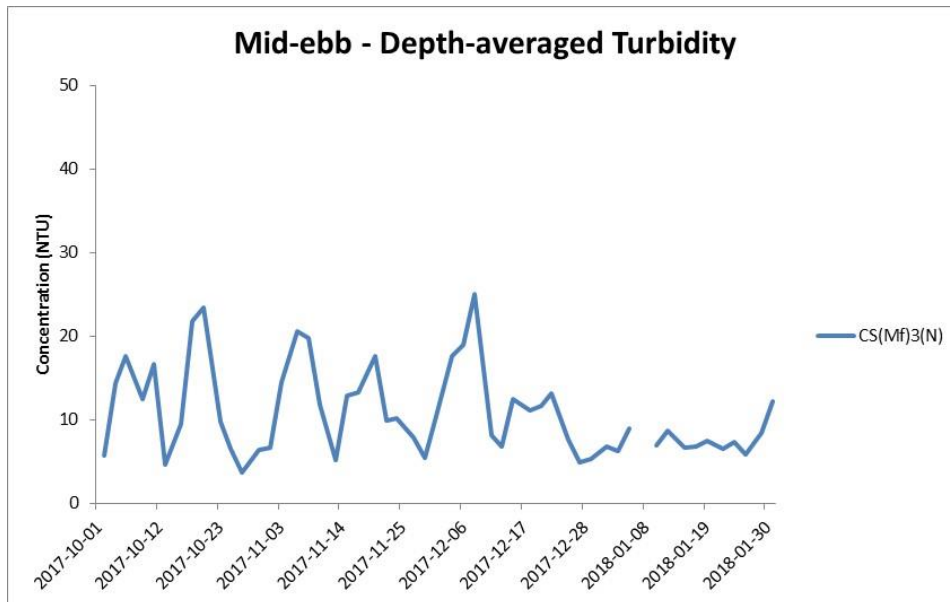
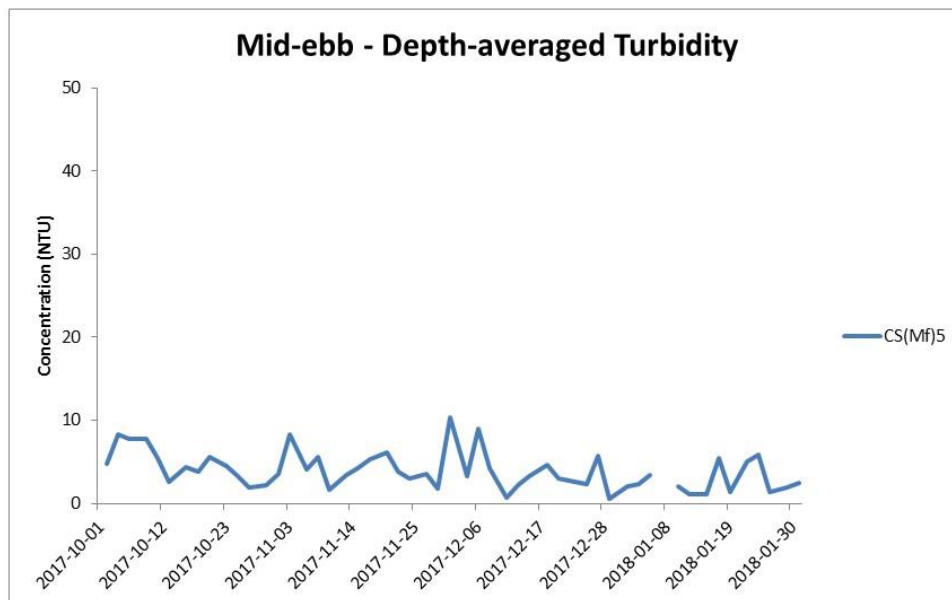
Figure J21 Impact Monitoring – Mean Level of depth-averaged Turbidity (NTU) during mid-ebb tide between 1 October 2017 and 31 January 2018 at CS(Mf)3(N) and CS(Mf)5.

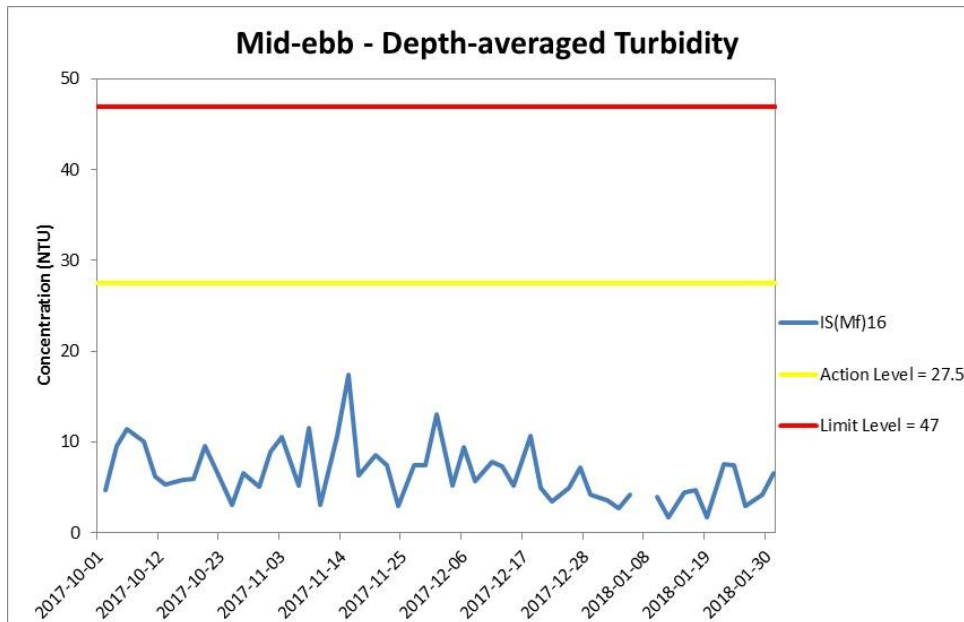
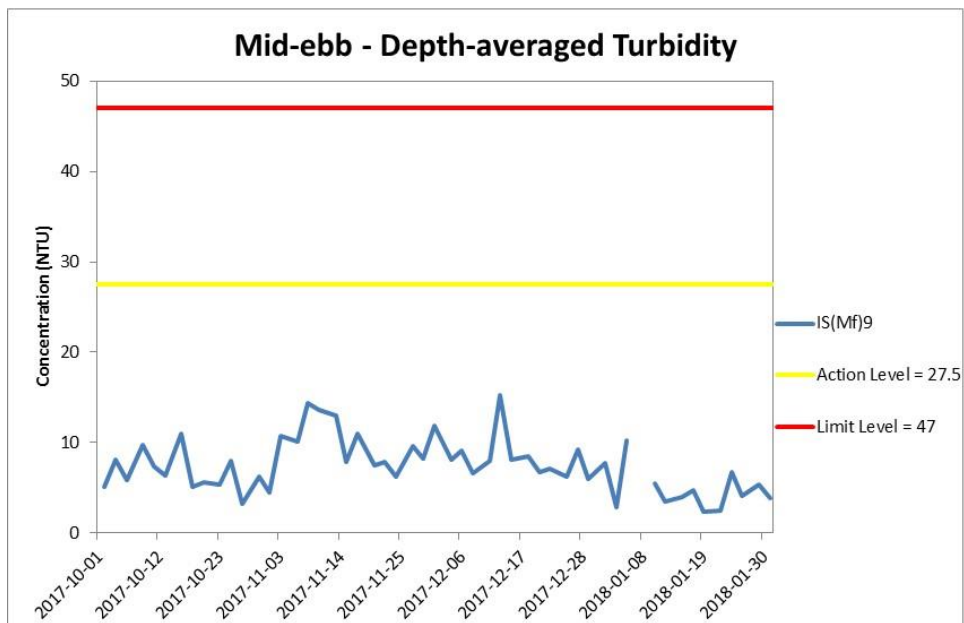
Figure J22 Impact Monitoring – Mean Level of depth-averaged Turbidity (NTU) during mid-ebb tide between 1 October 2017 and 31 January 2018 at IS(Mf)16 and IS(Mf)9.

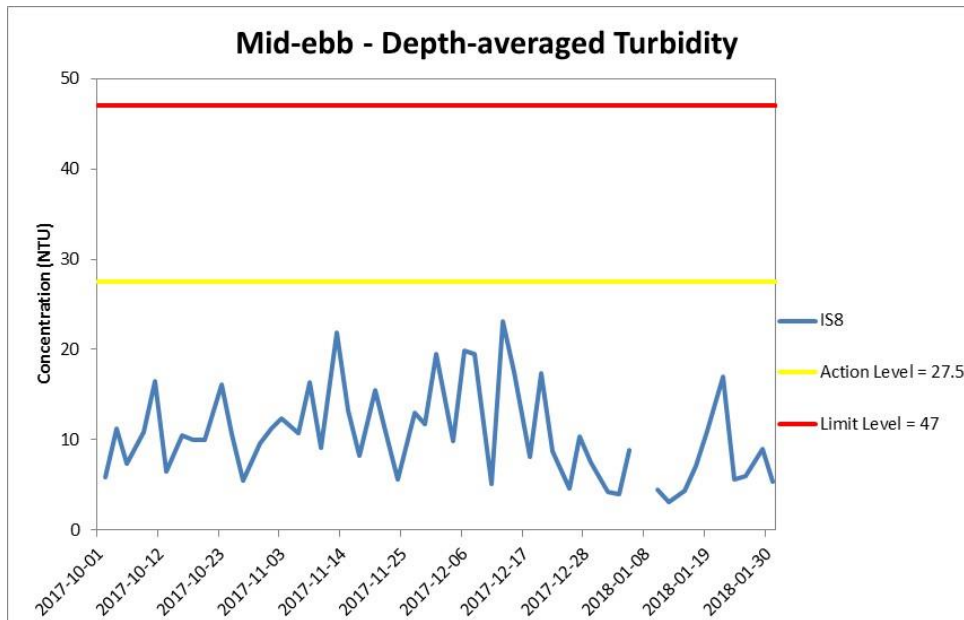
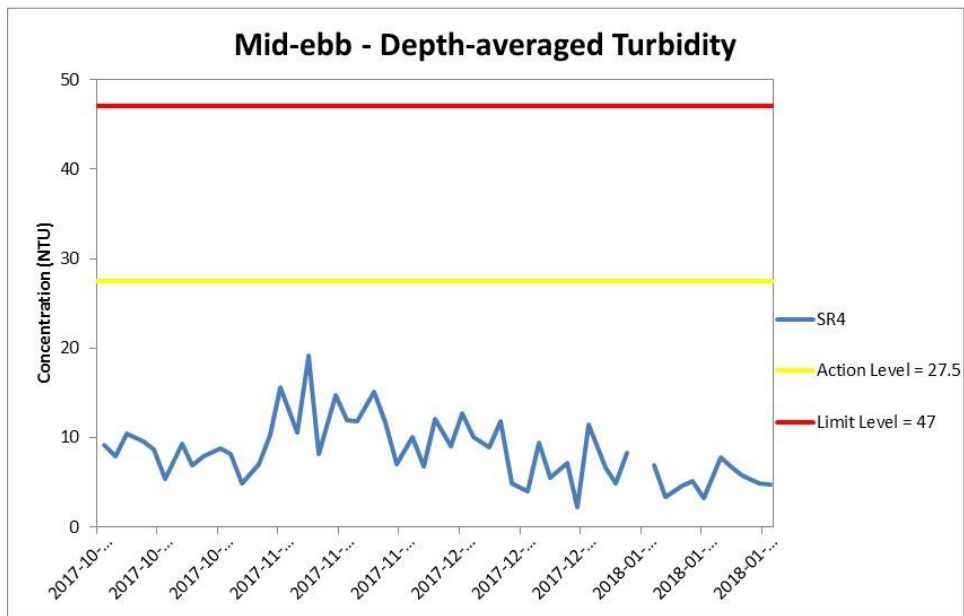
Figure J23 Impact Monitoring - Mean Level of depth-averaged Turbidity (NTU) during mid-ebb tide between 1 October 2017 and 31 January 2018 at IS8 and SR4.

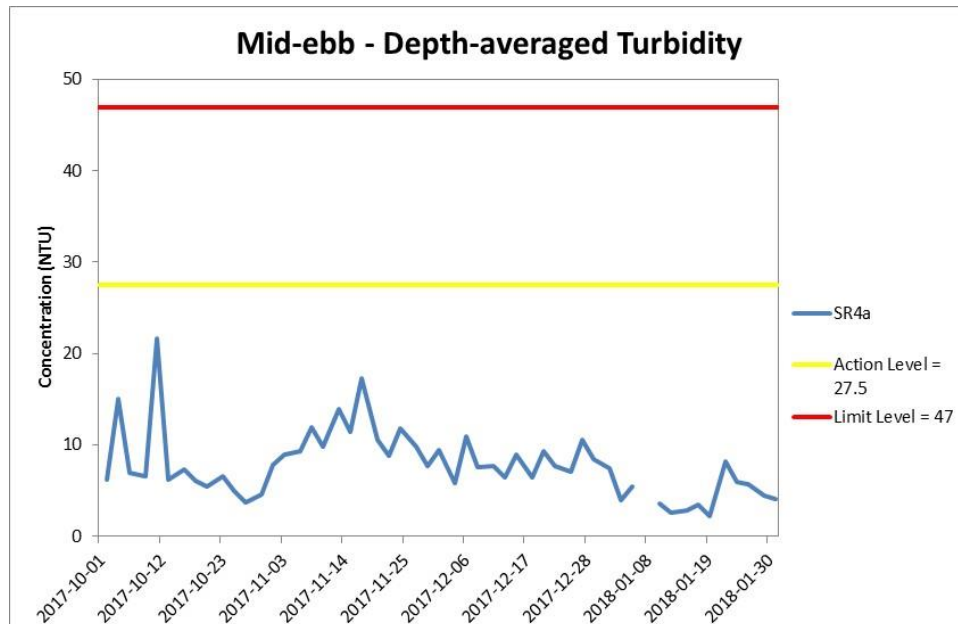
Figure J24 Impact Monitoring - Mean Level of depth-averaged Turbidity (NTU) during mid-ebb tide between 1 October 2017 and 31 January 2018 at SR4a.

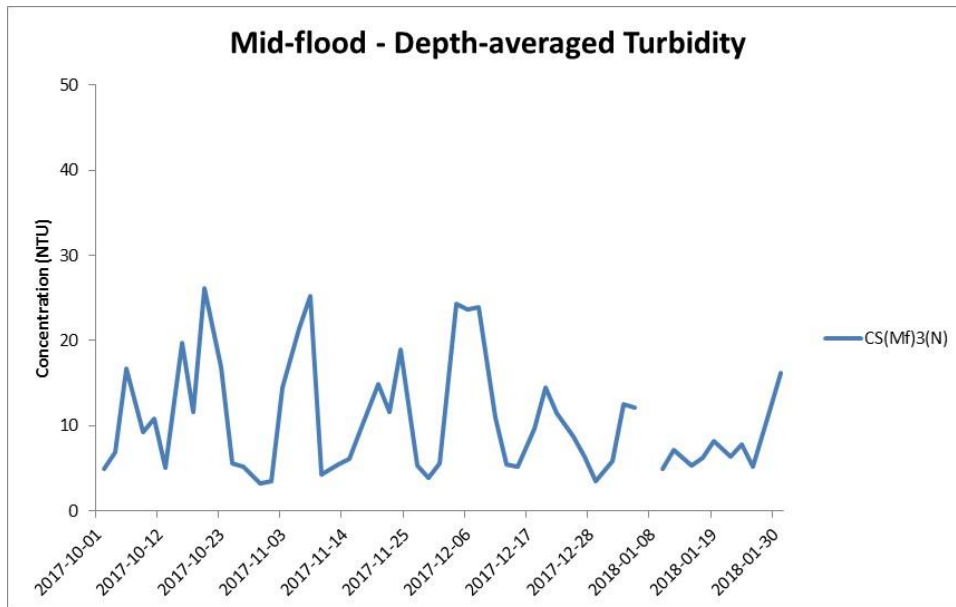
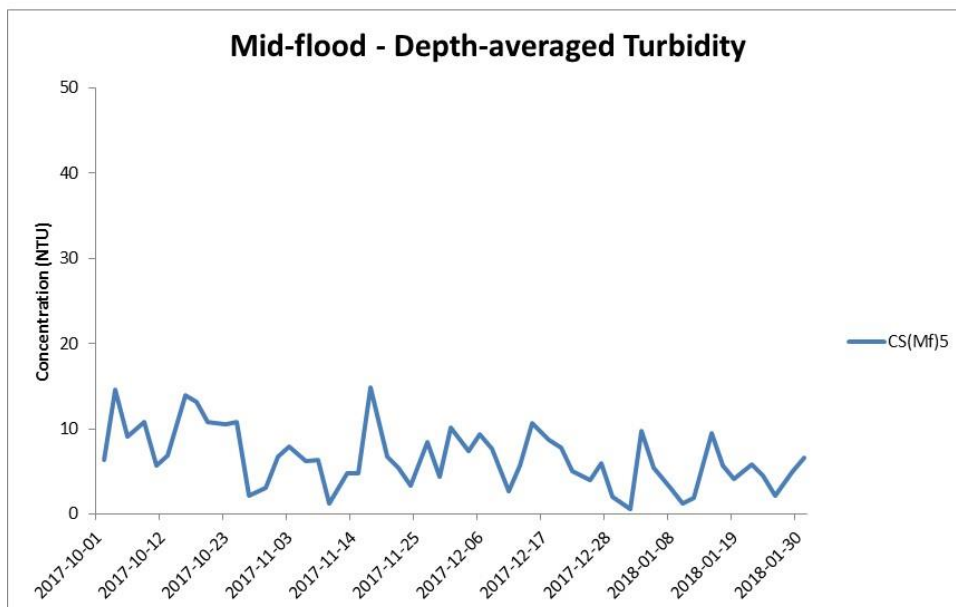
Figure J25 Impact Monitoring – Mean Level of depth-averaged Turbidity (NTU) during mid-flood tide between 1 October 2017 and 31 January 2018 at CS(Mf)3(N) and CS(MF)5.

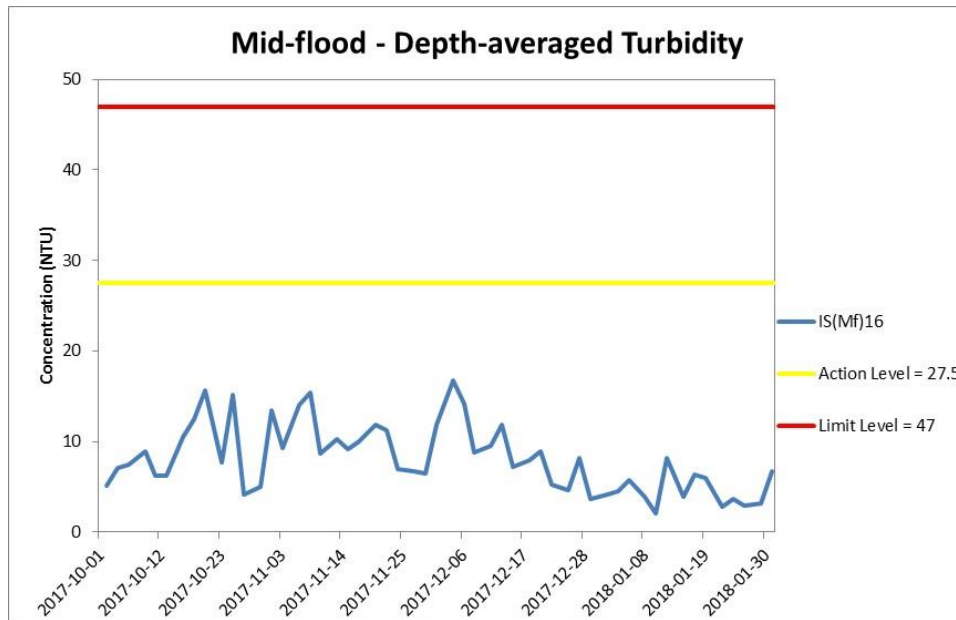
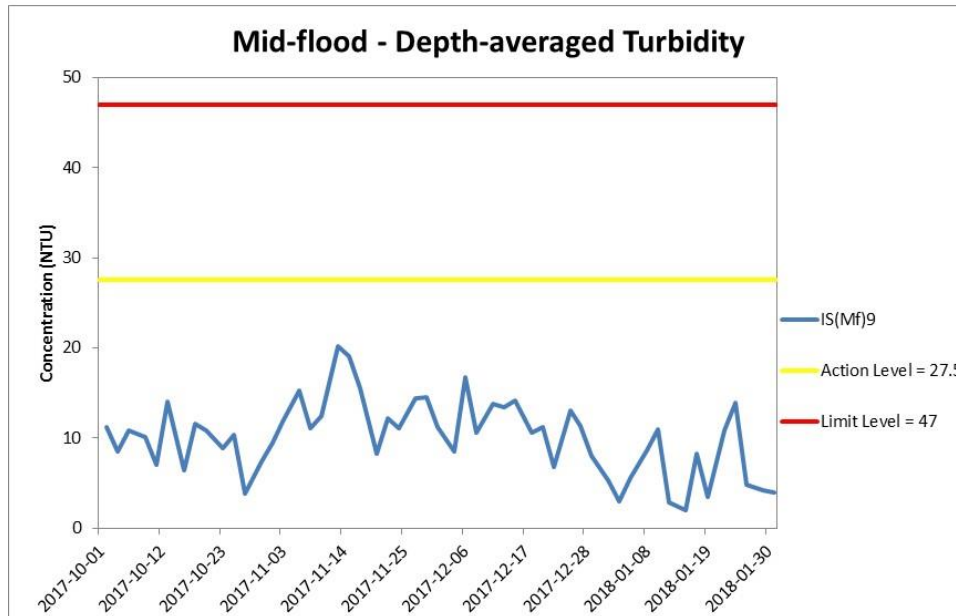
Figure J26 Impact Monitoring - Mean Level of depth-averaged Turbidity (NTU) during mid-flood tide between 1 October 2017 and 31 January 2018 at IS(Mf)16 and IS(Mf)9.

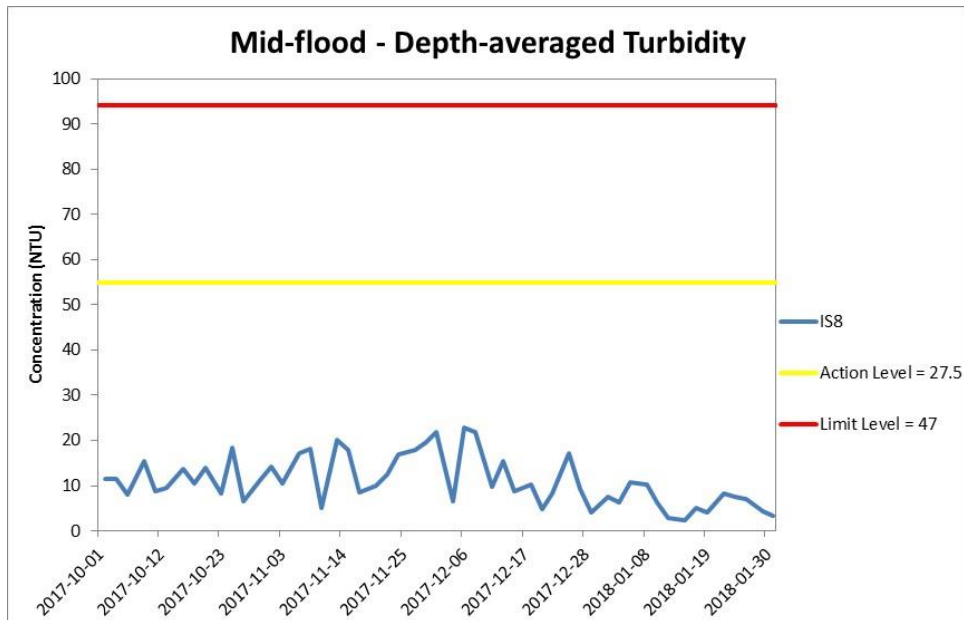
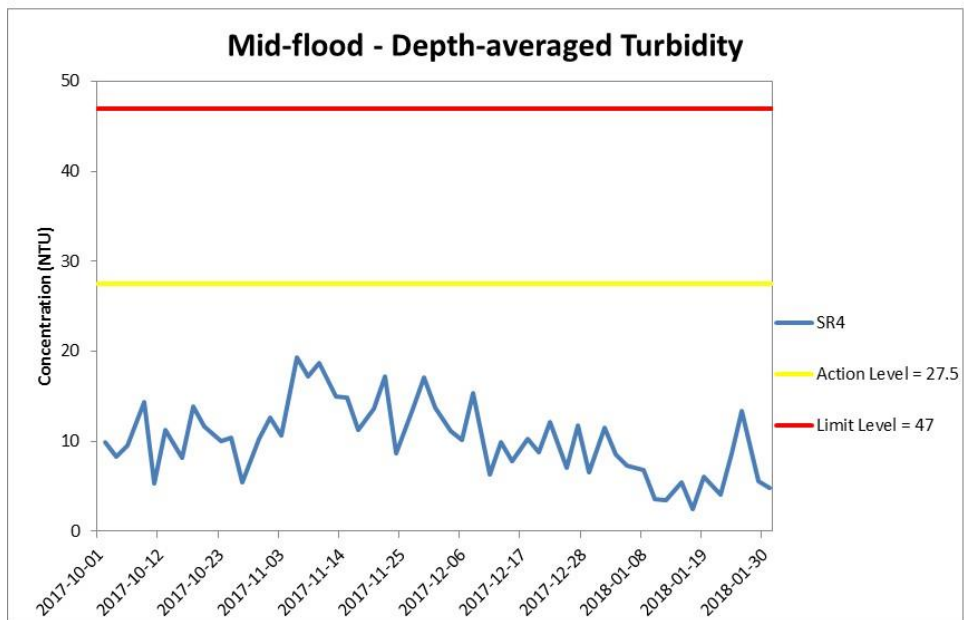
Figure J27 Impact Monitoring – Mean Level of depth-averaged Turbidity (NTU) during mid-flood tide between 1 October 2017 and 31 January 2018 at IS8 and SR4.

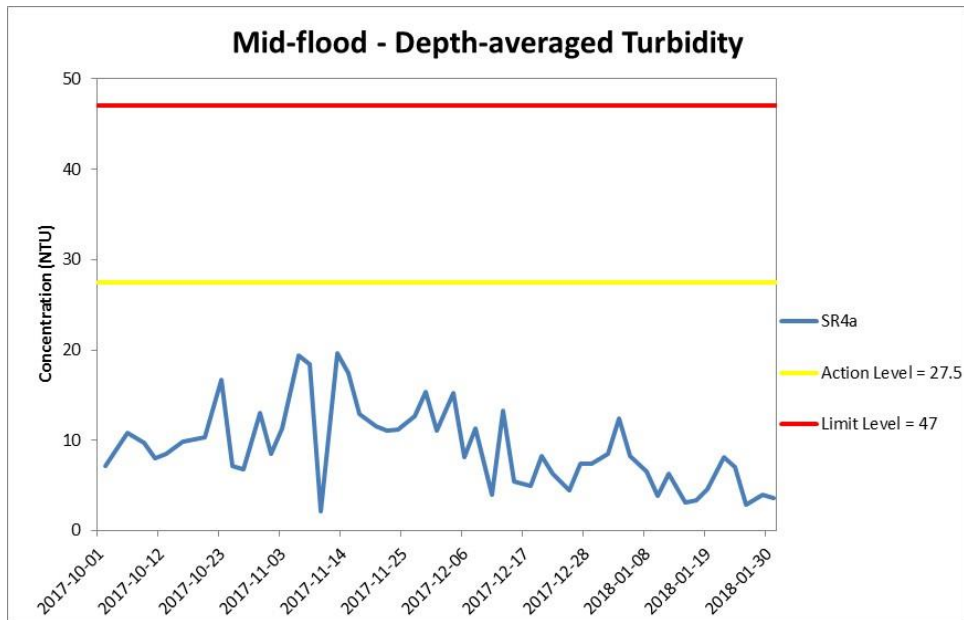
Figure J28 Impact Monitoring – Mean Level of depth-averaged Turbidity (NTU) during mid-flood tide between 1 October 2017 and 31 January 2018 at SR4a.

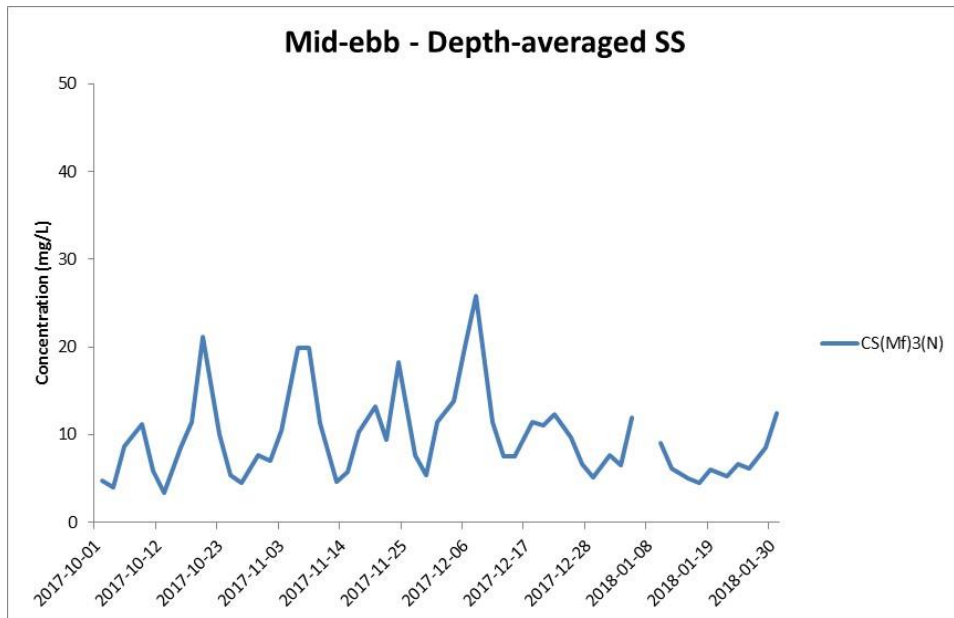
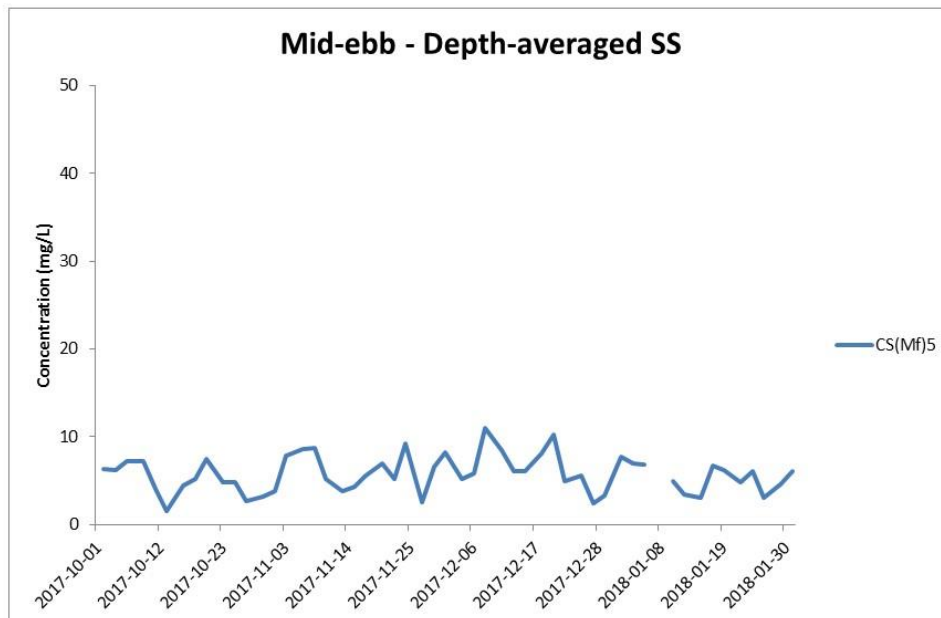
Figure J29 Impact Monitoring - Mean depth-averaged level of Suspended Solids (mg/L) during mid-ebb tide between 1 October 2017 and 31 January 2018 at CS(Mf)3(N) and CS(Mf)5.

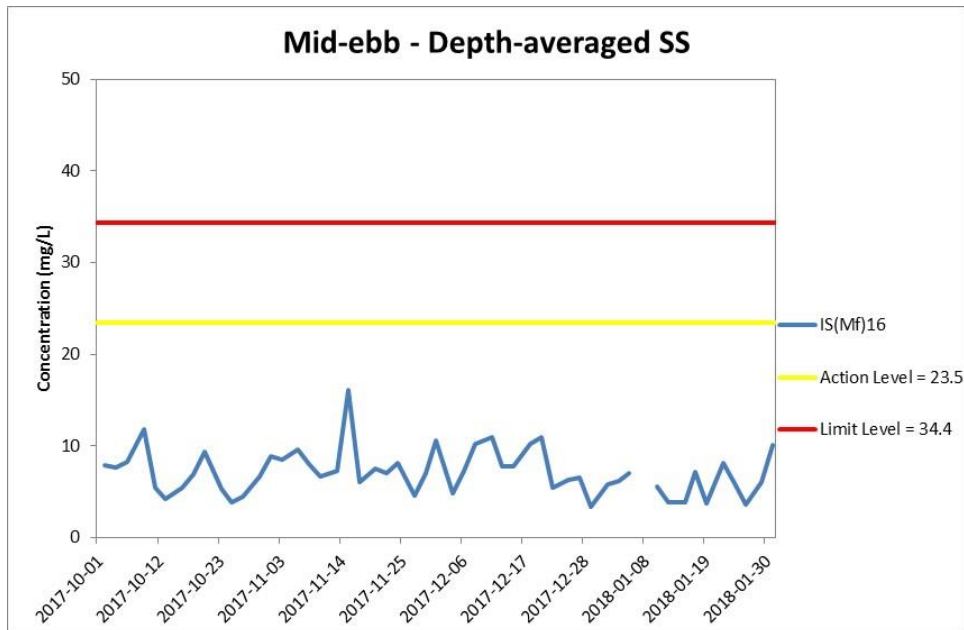
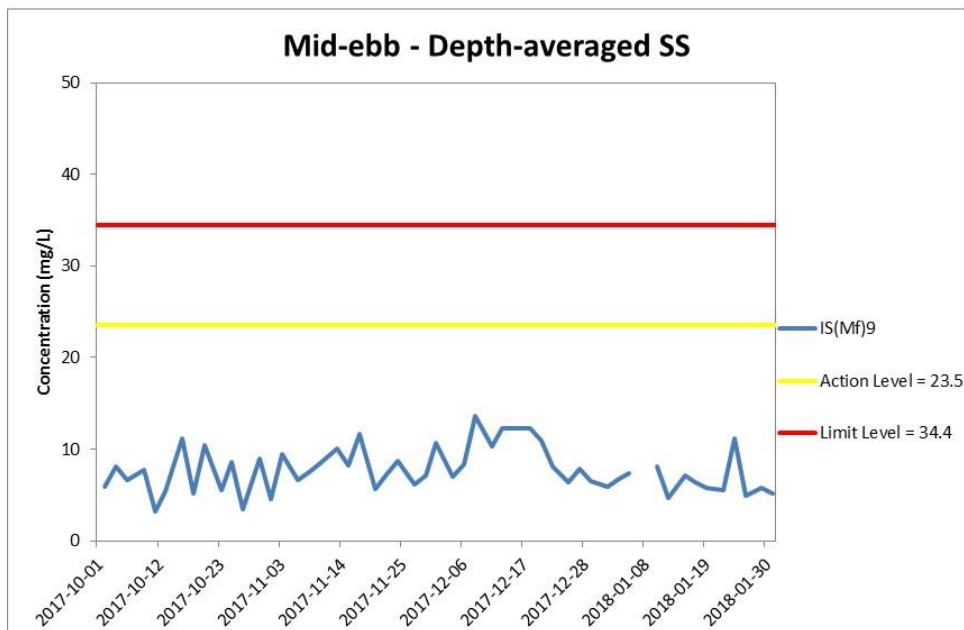
Figure J30 Impact Monitoring – Mean depth-averaged level of Suspended Solids (mg/L) during mid-ebb tide between 1 October 2017 and 31 January 2018 at IS(Mf)16 and IS(Mf)9.

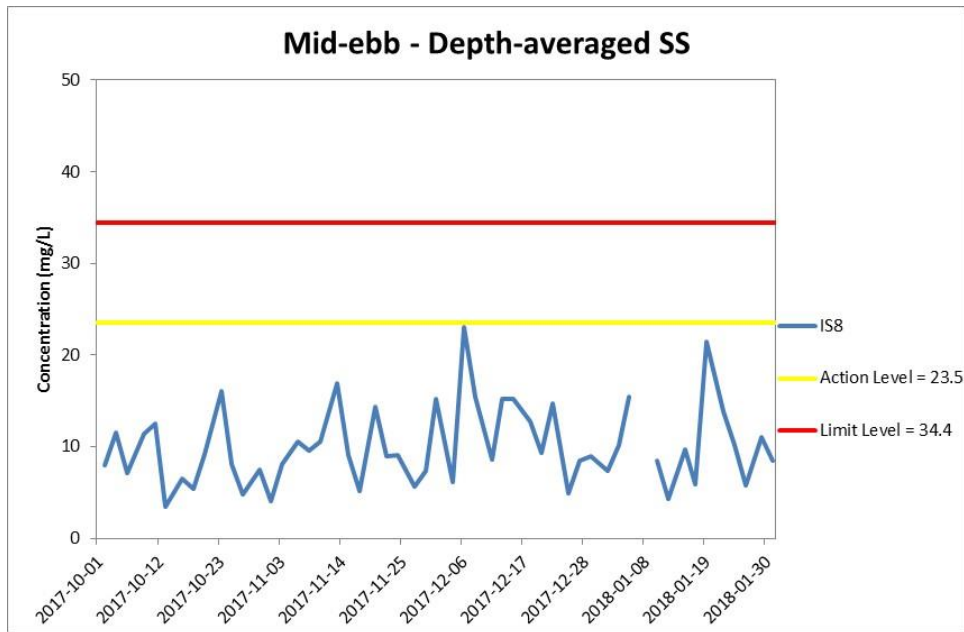
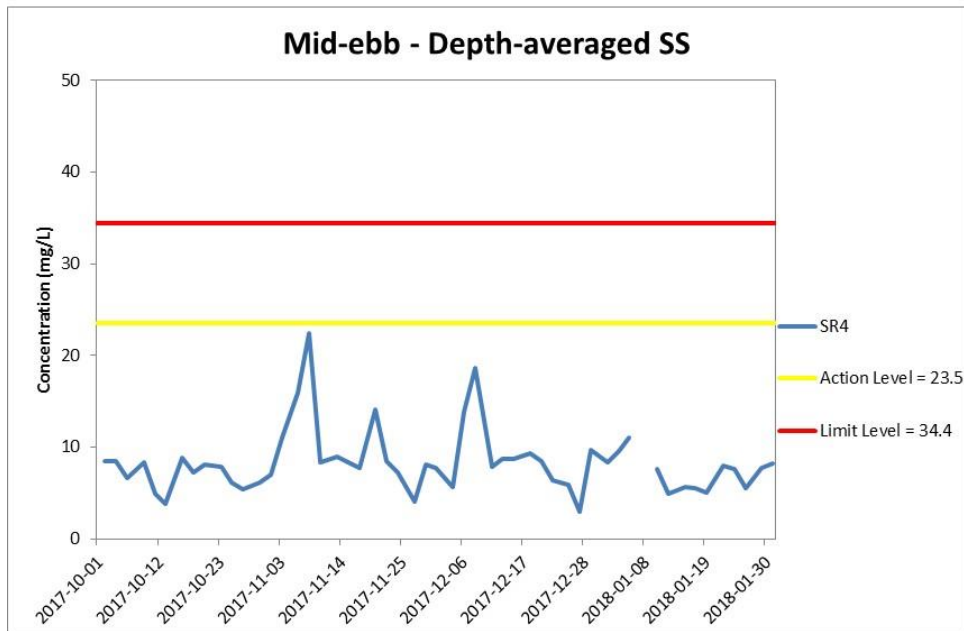
Figure J31 Impact Monitoring – Mean depth-averaged level of Suspended Solids (mg/L) during mid-ebb tide between 1 October 2017 and 31 January 2018 at IS8 and SR4.

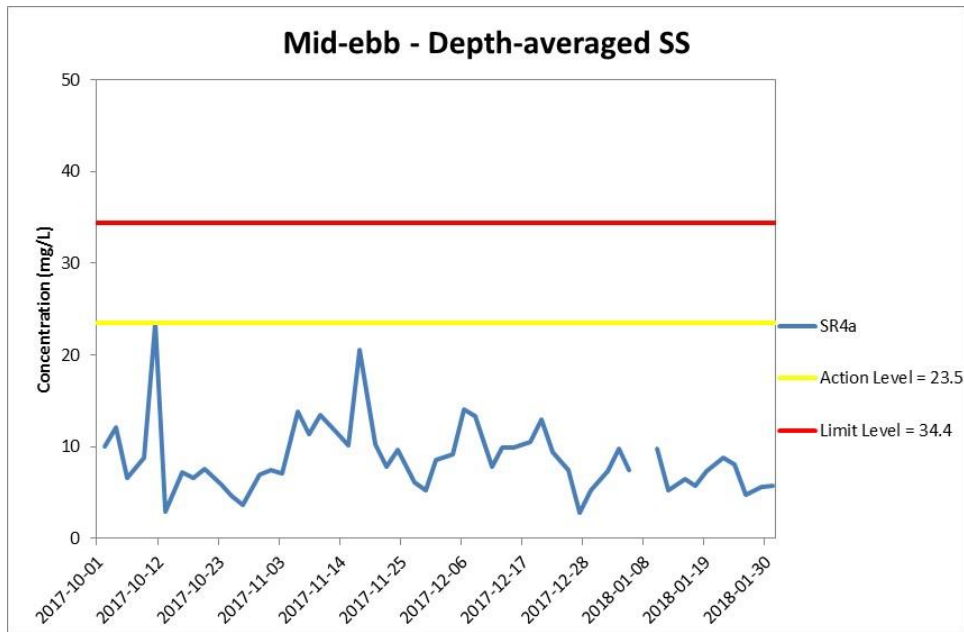
Figure J32 Impact Monitoring - Mean depth-averaged level of Suspended Solids (mg/L) during mid-ebb tide between 1 October 2017 and 31 January 2018 at SR4a.

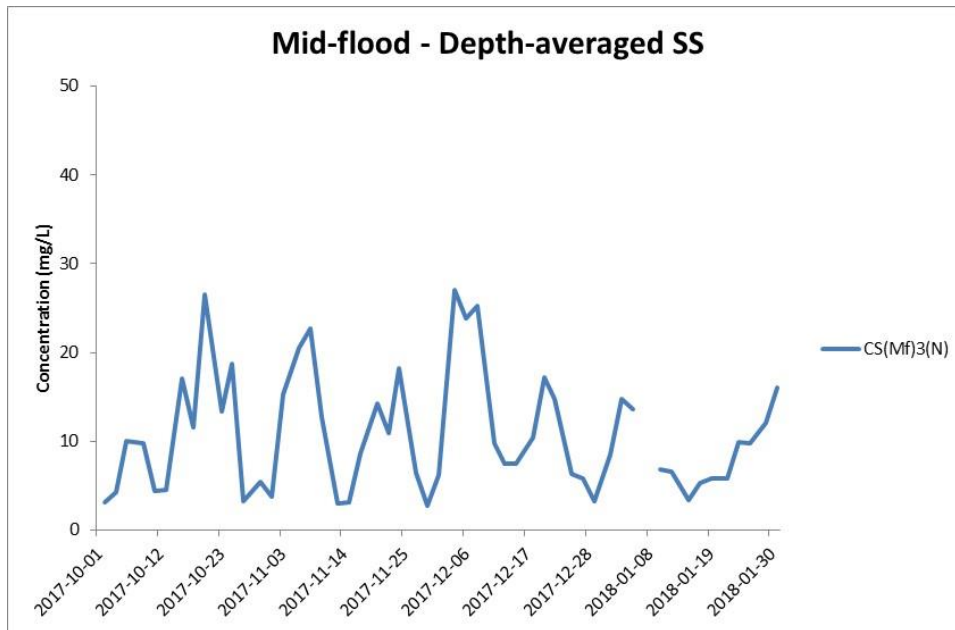
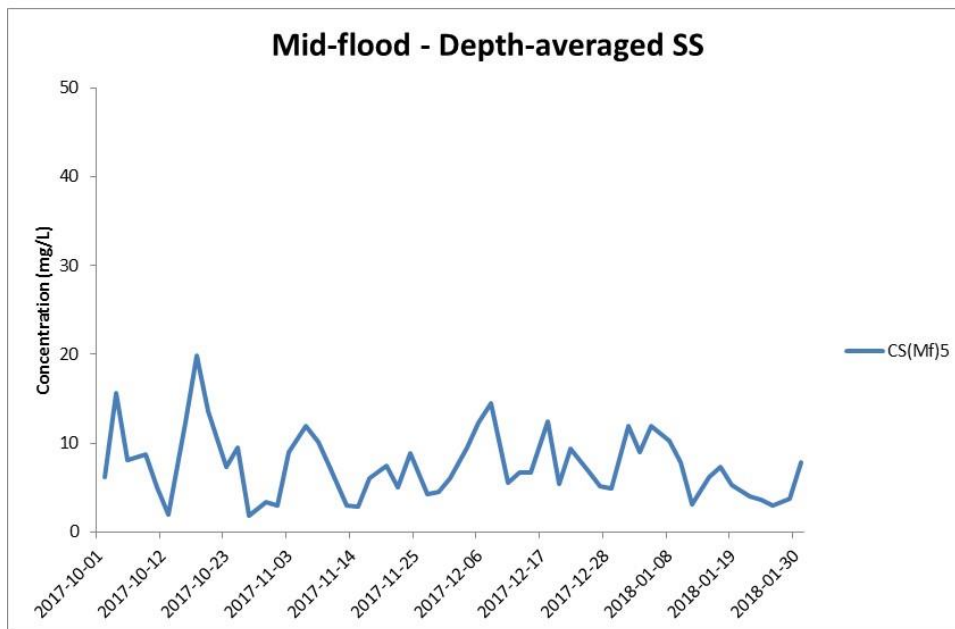
Figure J33 Impact Monitoring - Mean depth-averaged level of Suspended Solids (mg/L) during mid-flood tide between 1 October 2017 and 31 January 2018 at CS(Mf)3(N) and CS(Mf)5.

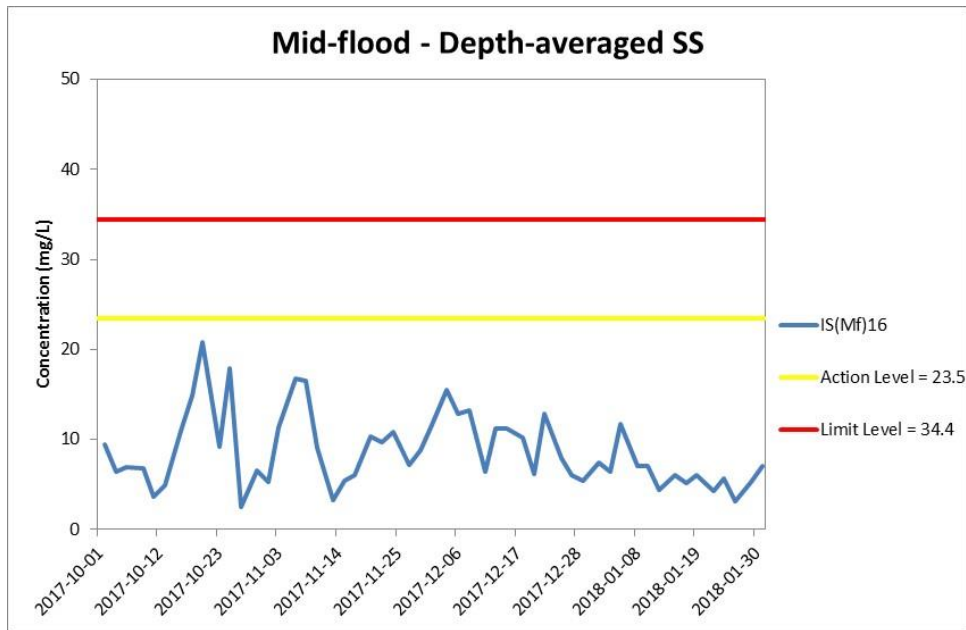
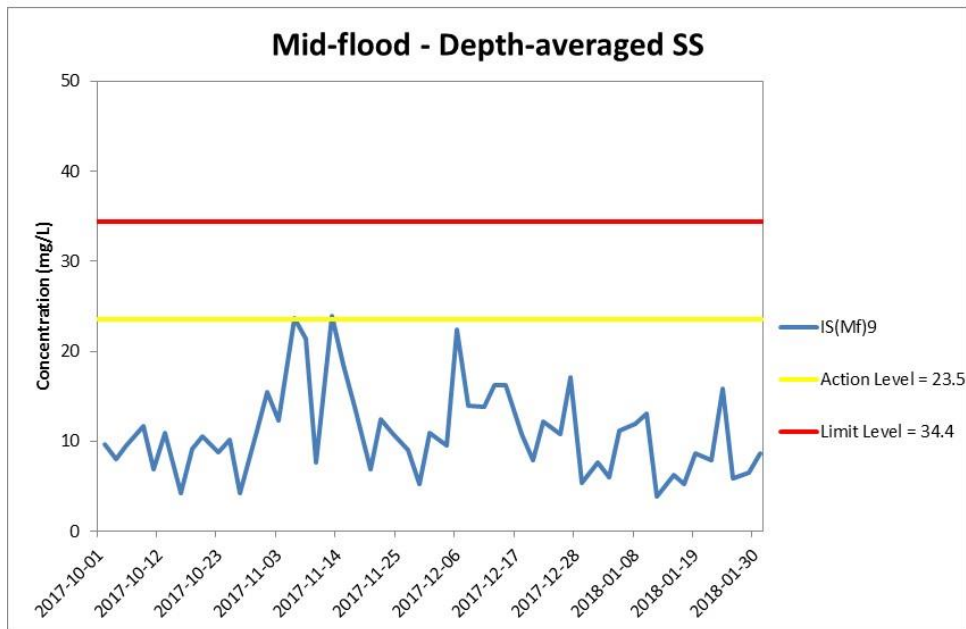
Figure J34 Impact Monitoring - Mean depth-averaged level of Suspended Solids (mg/L) during mid-flood tide between 1 October 2017 and 31 January 2018 at IS(Mf)16 and IS(Mf)9.

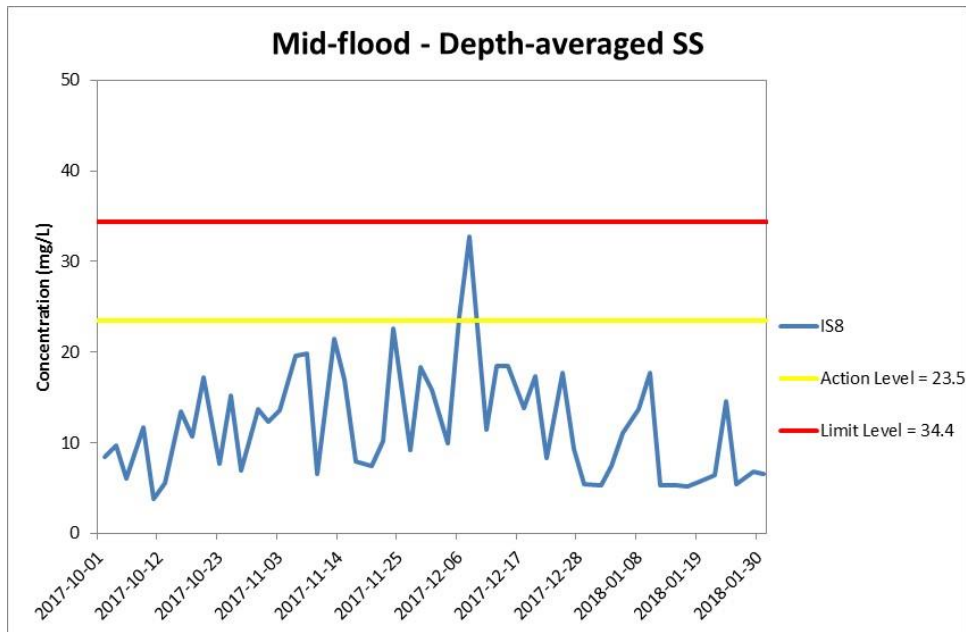
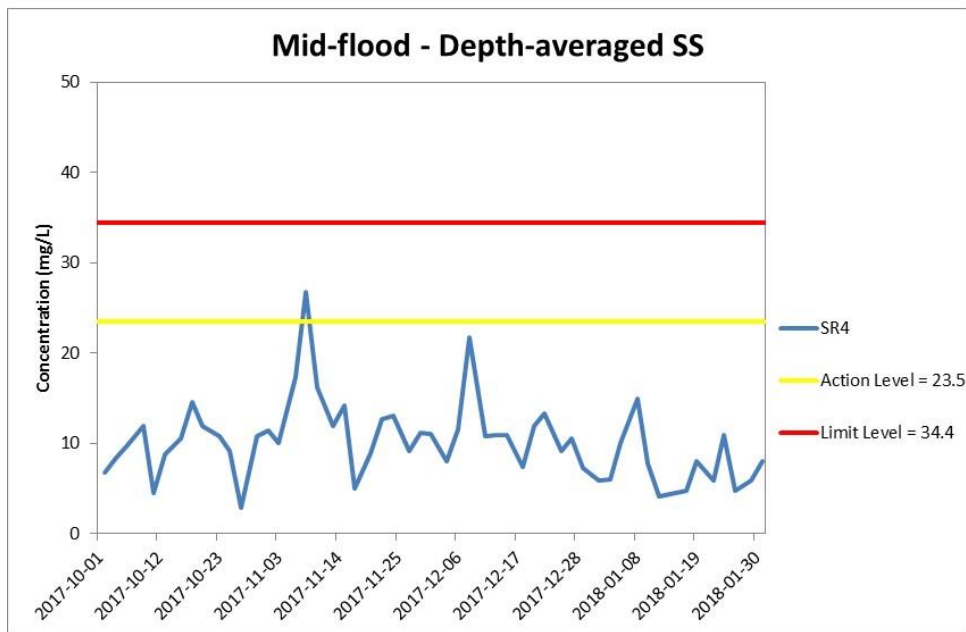
Figure J35 Impact Monitoring - Mean depth-averaged level of Suspended Solids (mg/L) during mid-flood tide between 1 October 2017 and 31 January 2018 at IS8 and SR4.

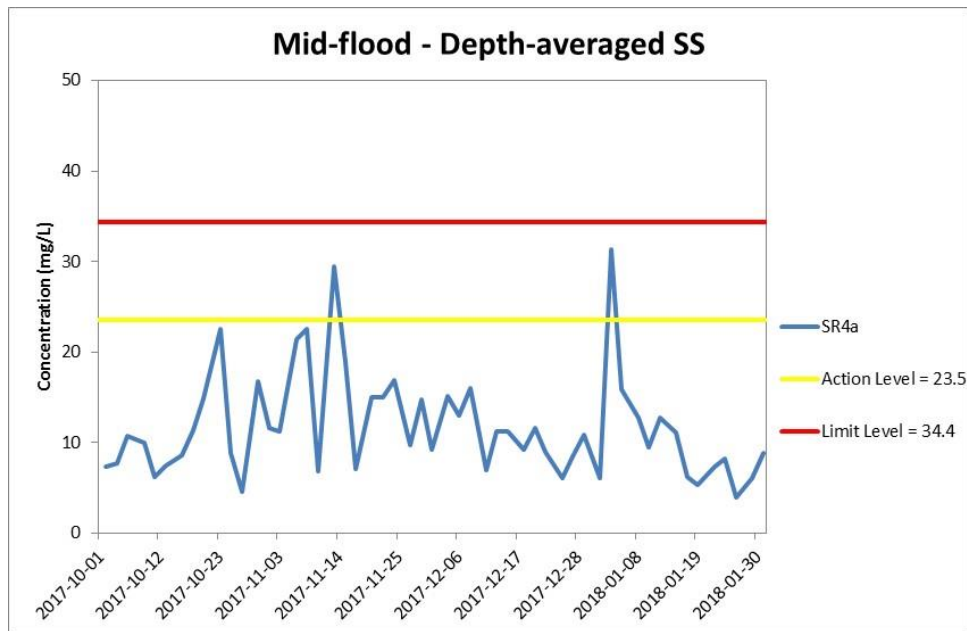
Figure J36 Impact Monitoring - Mean depth-averaged level of Suspended Solids (mg/L) during mid-flood tide between 1 October 2017 and 31 January 2018 at SR4a.
