**Contract No. HY/2012/07  
Tuen Mun – Chek Lap Kok Link –  
Southern Connection Viaduct Section**

*Fifty-seventh Monthly EM&A Report*

09 August 2018

**Contract No. HY/2012/07 TM-CLKL Southern Connection Viaduct  
Section  
57<sup>th</sup> Monthly EM&A Report for July 2018 (EP-354/2009/D)**

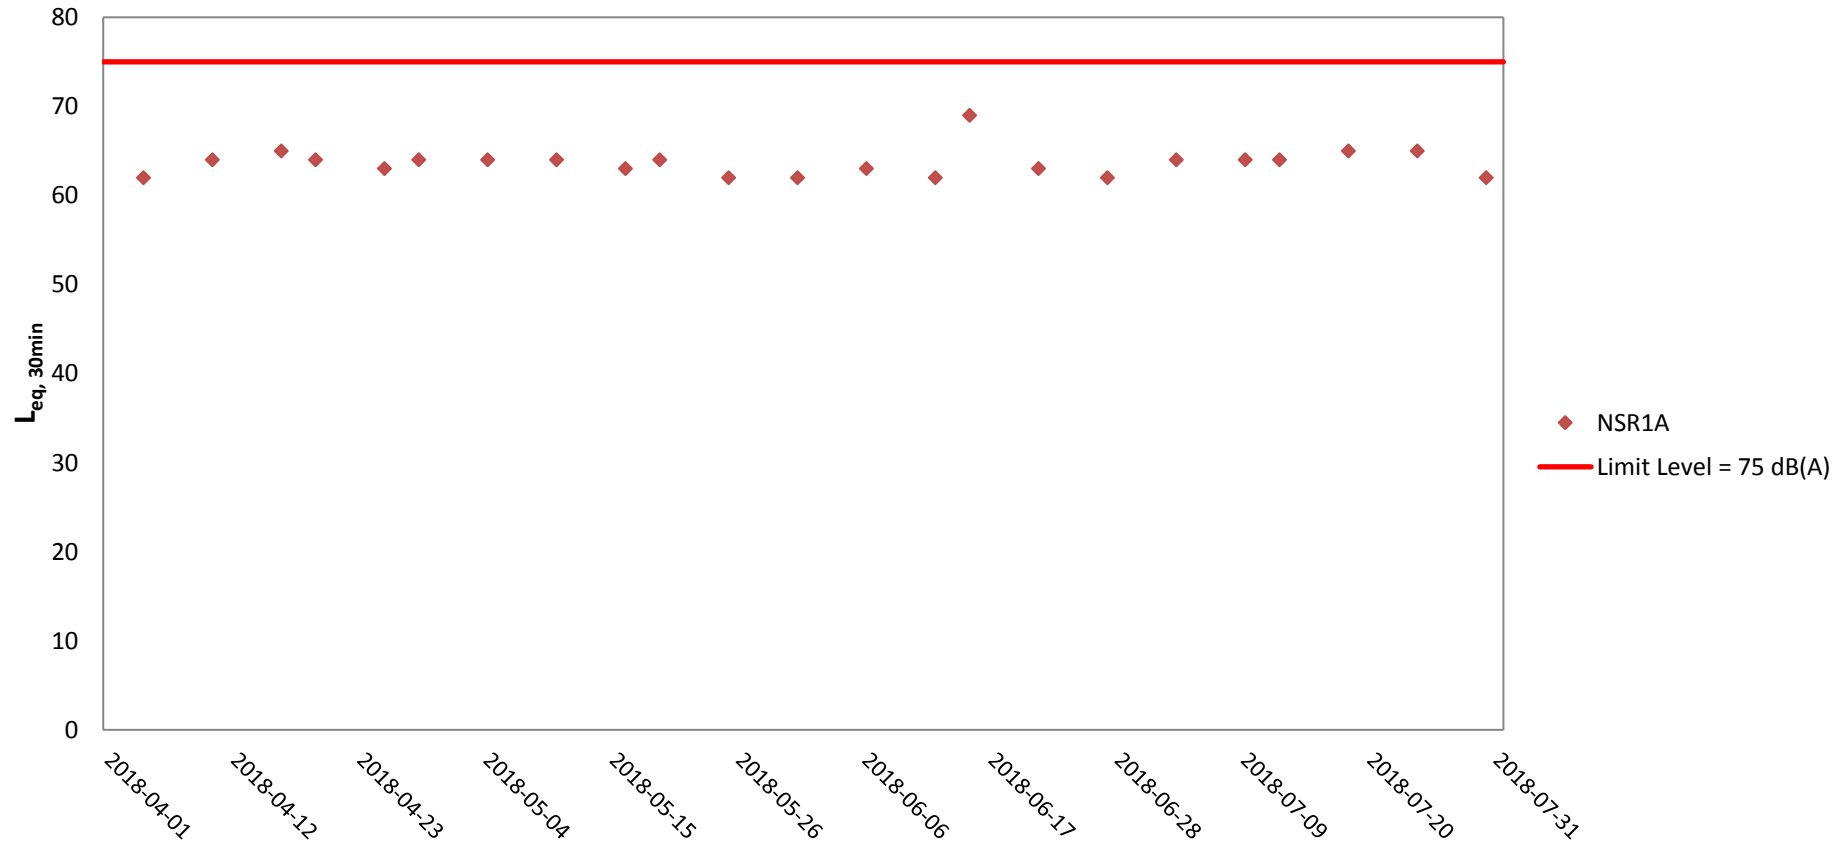
### Noise Monitoring Results at NSR 1A ( $L_{eq, 30min}$ )

Weather condition within the reporting period varied between sunny to rainy.

Major construction works undertaken within the reporting period include Pier construction; Re-alignment of Cheung Tung Road; Road works along North Lantau Highway; Installation of pier head and deck segments; Asphalt paving; Sign gantries construction; Parapet installation; and Slope work of Viaducts A, B, C & D.

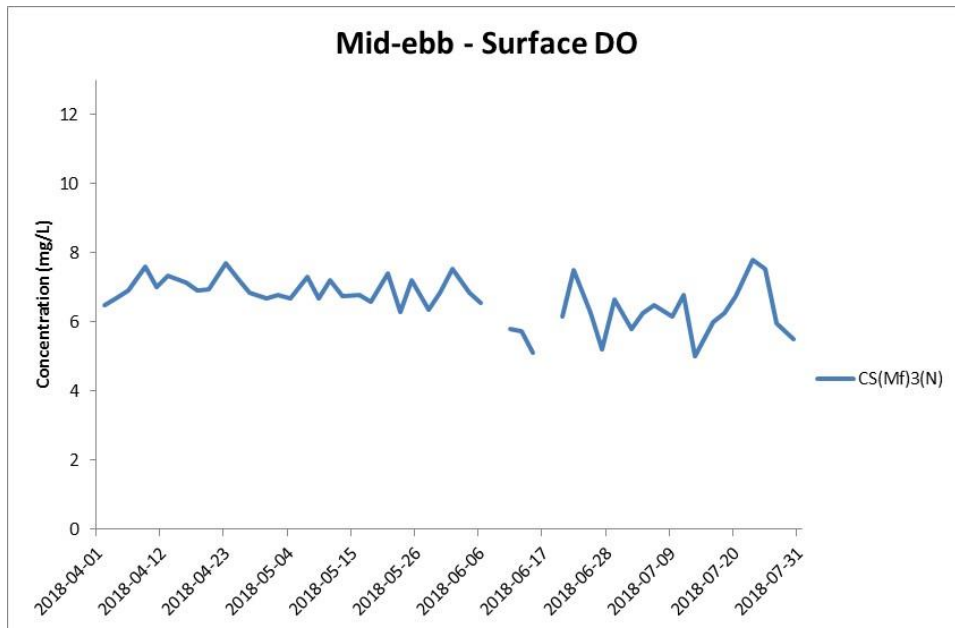
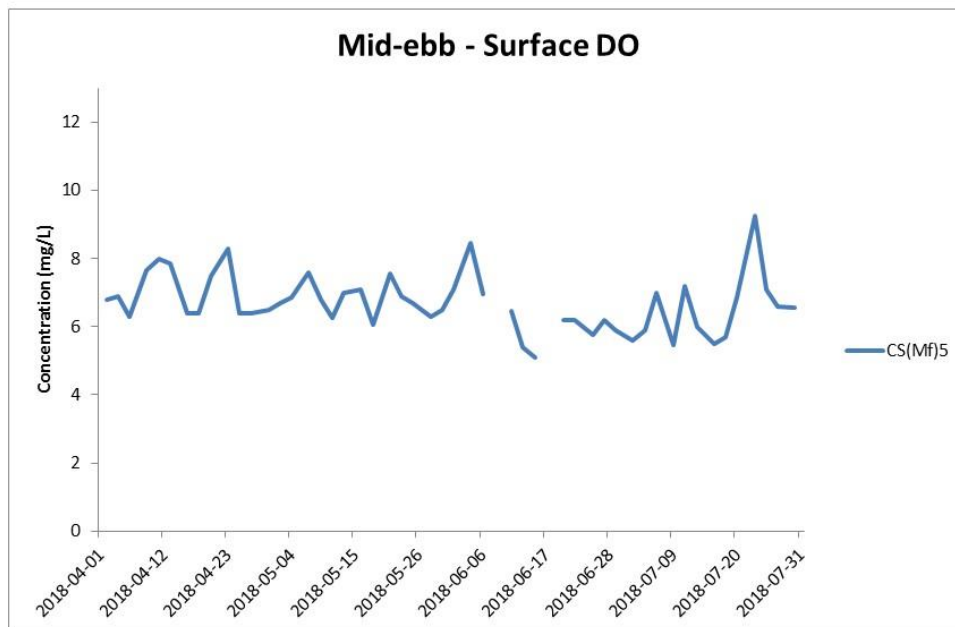
**Figure J1 Impact Monitoring - Mean Level of Dissolved Oxygen (mg/L) in surface waters during mid-ebb tide between 1 April and 31 July 2018 at CS(Mf)3(N) and CS(Mf)5.**

*(Weather condition varied between sunny to rainy within the reporting period.)*  
 WQM during mid-flood at all water quality monitoring stations on 18 July 2018 was canceled due to adverse weather. In-situ monitoring is taken according to the requirement specified in the EM&A Manual, i.e. 3 water depth namely 1m below sea surface, mid-depth and 1m above sea bed. If the water depth is less than 3m, mid-depth sampling only. If water depth less than 6m, mid-depth may be omitted.

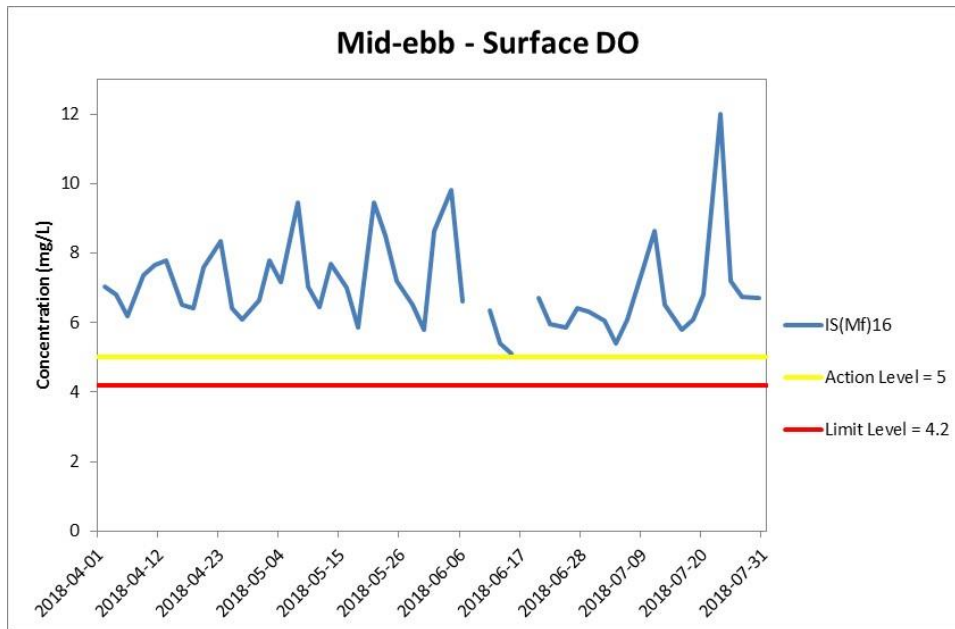
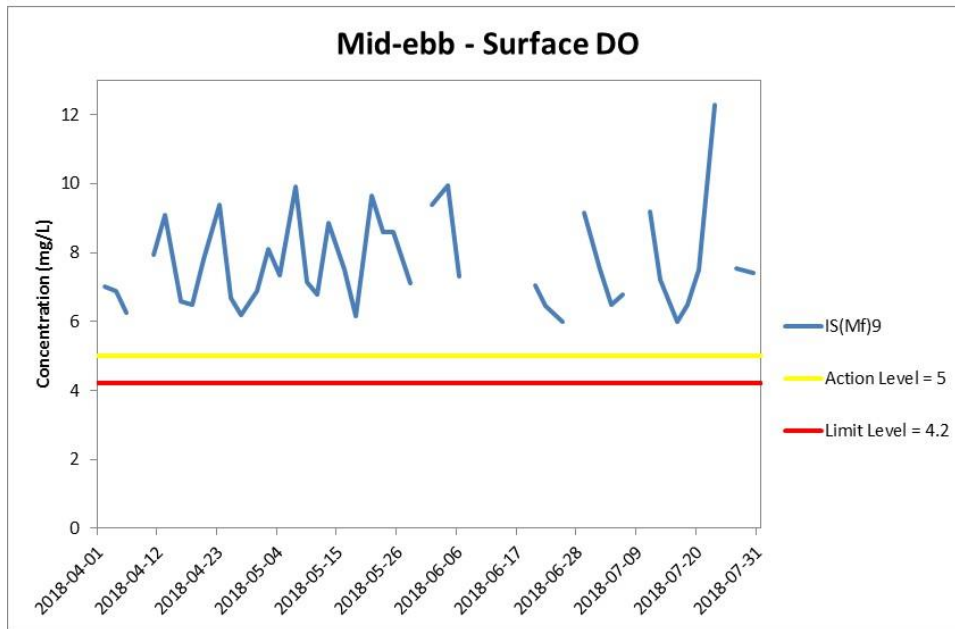
**Figure J2 Impact Monitoring - Mean Level of Dissolved Oxygen (mg/L) in surface waters during mid-ebb tide between 1 April and 31 July 2018 at IS(Mf)16 and IS(Mf)9.**

*(Weather condition varied between sunny to rainy within the reporting period.) WQM during mid-flood at all water quality monitoring stations on 18 July 2018 was canceled due to adverse weather. In-situ monitoring is taken according to the requirement specified in the EM&A Manual, i.e. 3 water depth namely 1m below sea surface, mid-depth and 1m above sea bed. If the water depth is less than 3m, mid-depth sampling only. If water depth less than 6m, mid-depth may be omitted.*

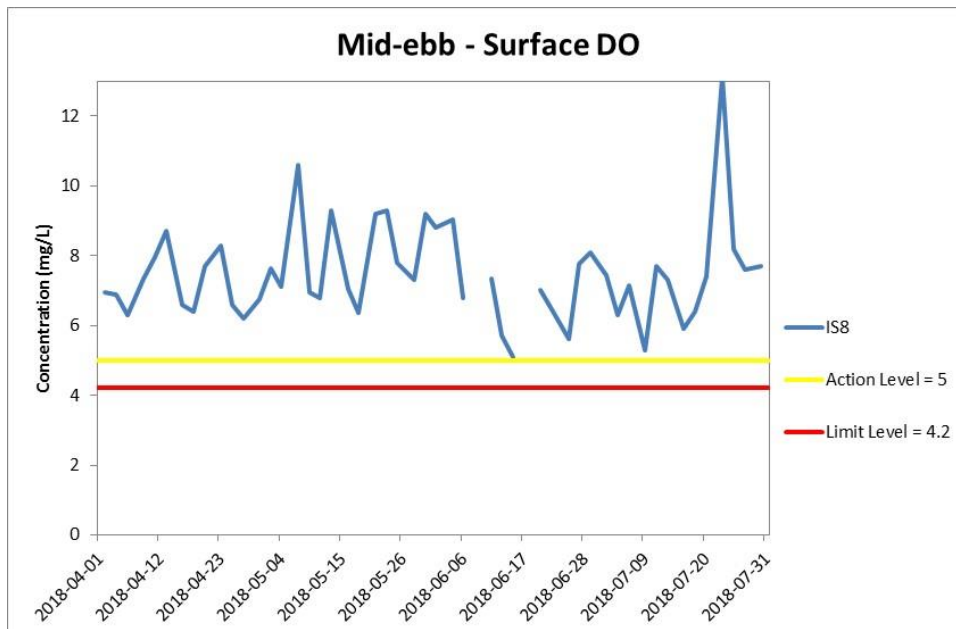
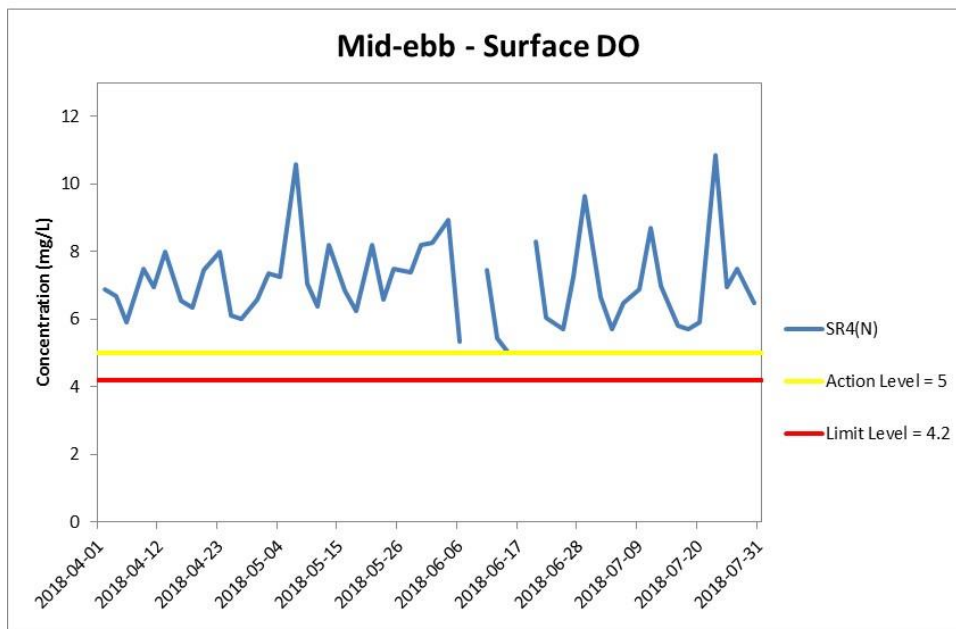
**Figure J3 Impact Monitoring - Mean Level of Dissolved Oxygen (mg/L) in surface waters during mid-ebb tide between 1 April and 31 July 2018 at IS8 and SR4(N).**

*(Weather condition varied between sunny to rainy within the reporting period.)*  
 WQM during mid-flood at all water quality monitoring stations on 18 July 2018 was canceled due to adverse weather. In-situ monitoring is taken according to the requirement specified in the EM&A Manual, i.e. 3 water depth namely 1m below sea surface, mid-depth and 1m above sea bed. If the water depth is less than 3m, mid-depth sampling only. If water depth less than 6m, mid-depth may be omitted.

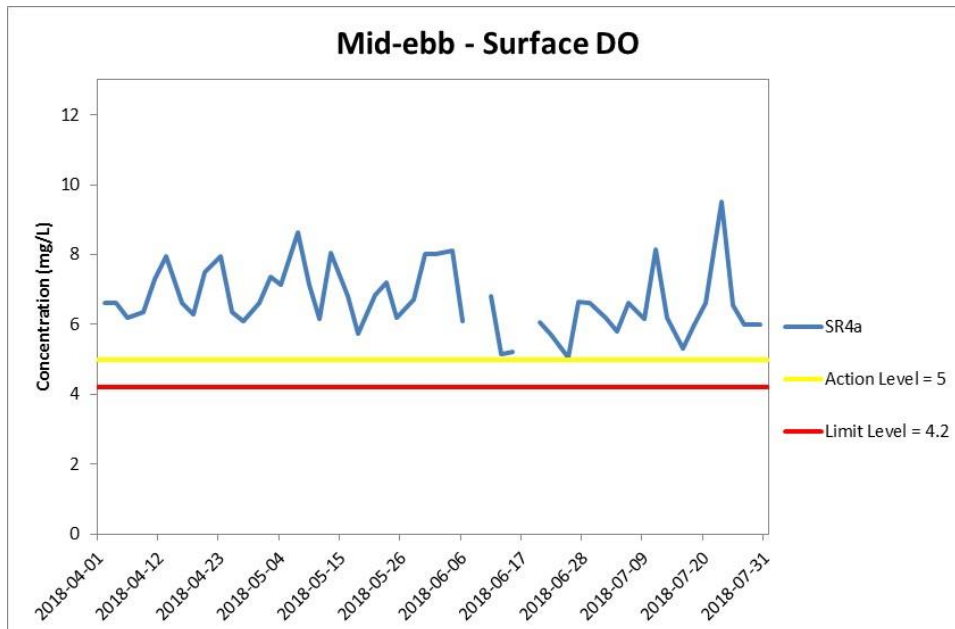
**Figure J4 Impact Monitoring – Mean Level of Dissolved Oxygen (mg/L) in surface waters during mid-ebb tide between 1 April and 31 July 2018 at SR4a.**

*(Weather condition varied between sunny to rainy within the reporting period.)*  
 WQM during mid-flood at all water quality monitoring stations on 18 July 2018 was canceled due to adverse weather. In-situ monitoring is taken according to the requirement specified in the EM&A Manual, i.e. 3 water depth namely 1m below sea surface, mid-depth and 1m above sea bed. If the water depth is less than 3m, mid-depth sampling only. If water depth less than 6m, mid-depth may be omitted.

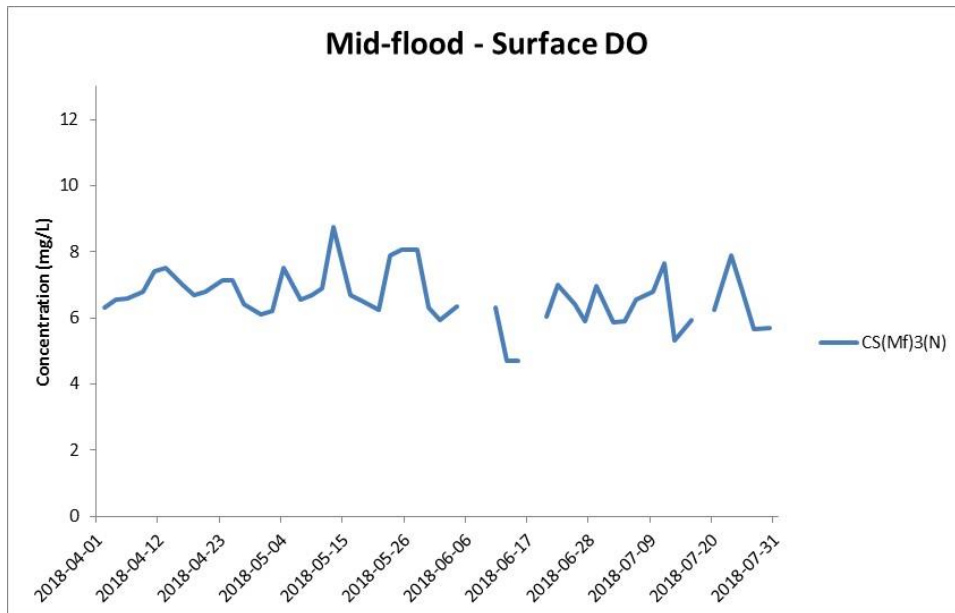
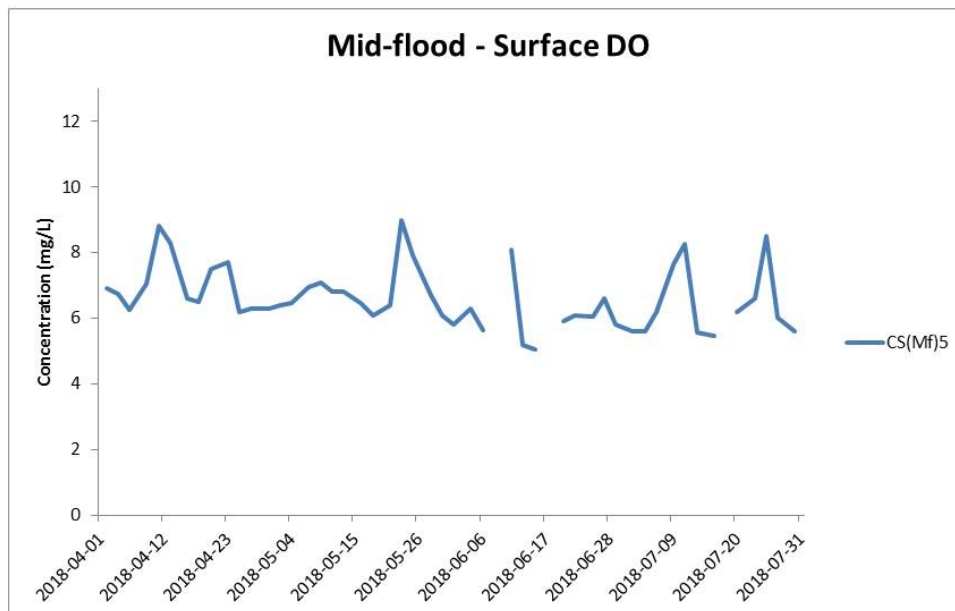
**Figure J5 Impact Monitoring - Mean Level of Dissolved Oxygen (mg/L) in surface waters during mid-flood tide between 1 April and 31 July 2018 at CS(Mf)3(N) and CS(Mf)5.**

*(Weather condition varied between sunny to rainy within the reporting period.)*  
 WQM during mid-flood at all water quality monitoring stations on 18 July 2018 was canceled due to adverse weather. In-situ monitoring is taken according to the requirement specified in the EM&A Manual, i.e. 3 water depth namely 1m below sea surface, mid-depth and 1m above sea bed. If the water depth is less than 3m, mid-depth sampling only. If water depth less than 6m, mid-depth may be omitted.

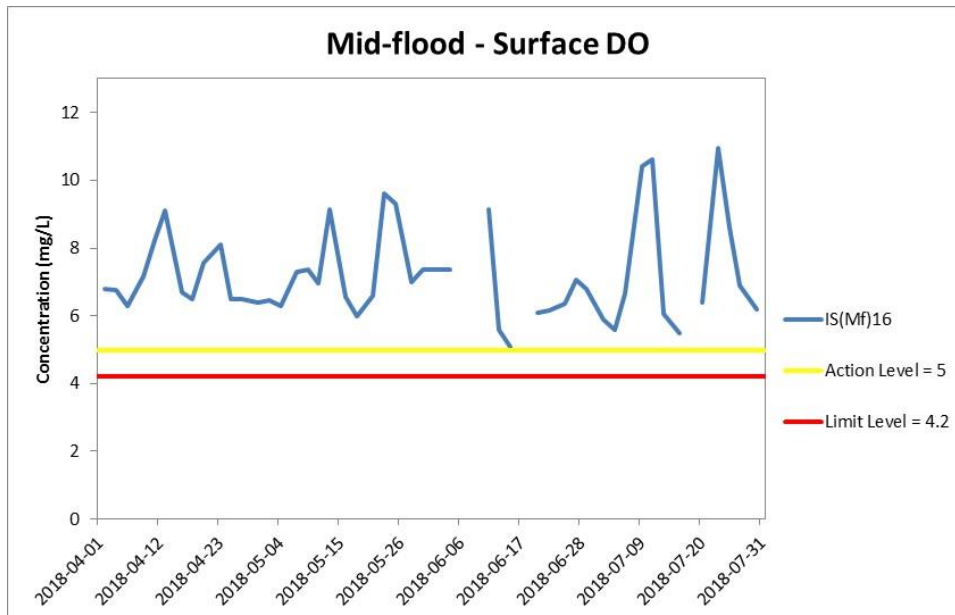
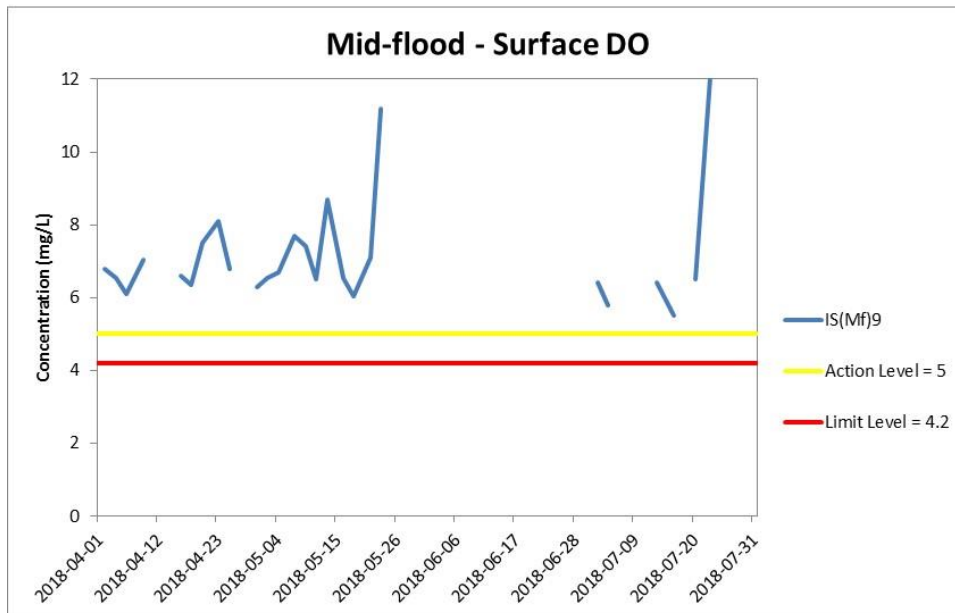
**Figure J6 Impact Monitoring – Mean Level of Dissolved Oxygen (mg/L) in surface waters during mid-flood tide between 1 April and 31 July 2018 at IS(Mf)16 and IS(Mf)9.**

*(Weather condition varied between sunny to rainy within the reporting period.)*

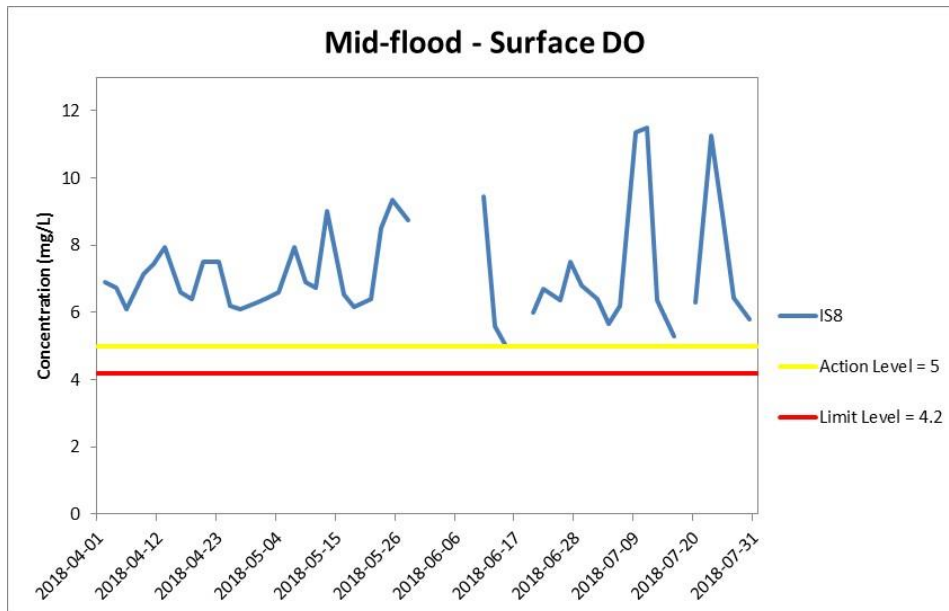
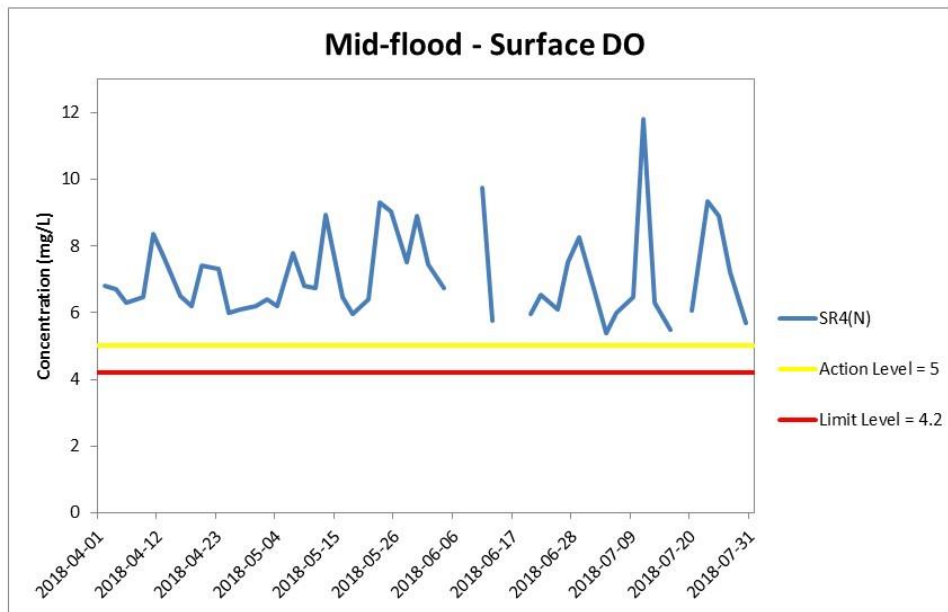
**Figure J7 Impact Monitoring – Mean Level of Dissolved Oxygen (mg/L) in surface waters during mid-flood tide between 1 April and 31 July 2018 at IS8 and SR4(N).**

*(Weather condition varied between sunny to rainy within the reporting period.)* WQM during mid-flood at all water quality monitoring stations on 18 July 2018 was canceled due to adverse weather. In-situ monitoring is taken according to the requirement specified in the EM&A Manual, i.e. 3 water depth namely 1m below sea surface, mid-depth and 1m above sea bed. If the water depth is less than 3m, mid-depth sampling only. If water depth less than 6m, mid-depth may be omitted.

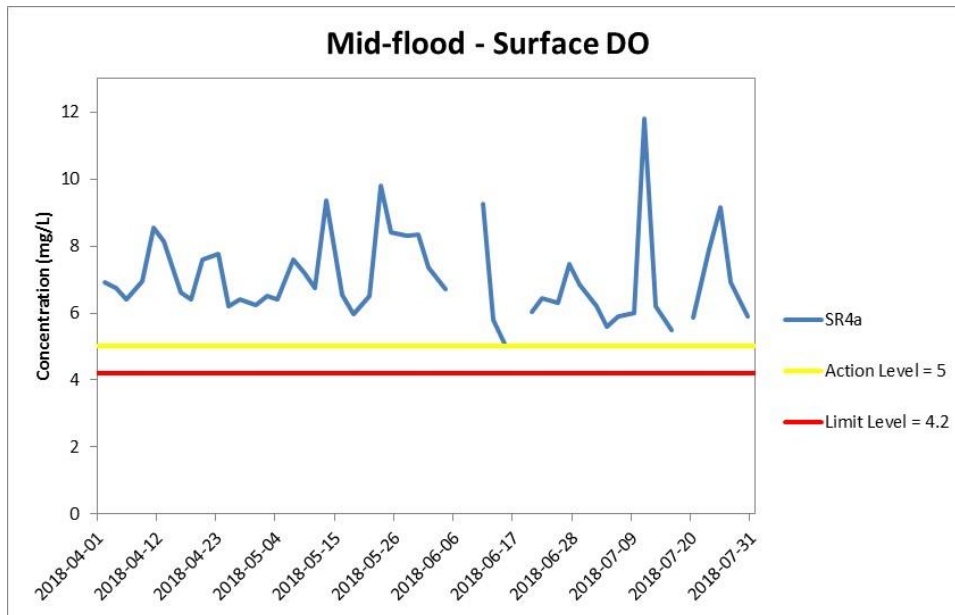
**Figure J8 Impact Monitoring - Mean Level of Dissolved Oxygen (mg/L) in surface waters during mid-flood tide between 1 April and 31 July 2018 at SR4a.**

*(Weather condition varied between sunny to rainy within the reporting period.)*  
 WQM during mid-flood at all water quality monitoring stations on 18 July 2018 was canceled due to adverse weather. In-situ monitoring is taken according to the requirement specified in the EM&A Manual, i.e. 3 water depth namely 1m below sea surface, mid-depth and 1m above sea bed. If the water depth is less than 3m, mid-depth sampling only. If water depth less than 6m, mid-depth may be omitted.

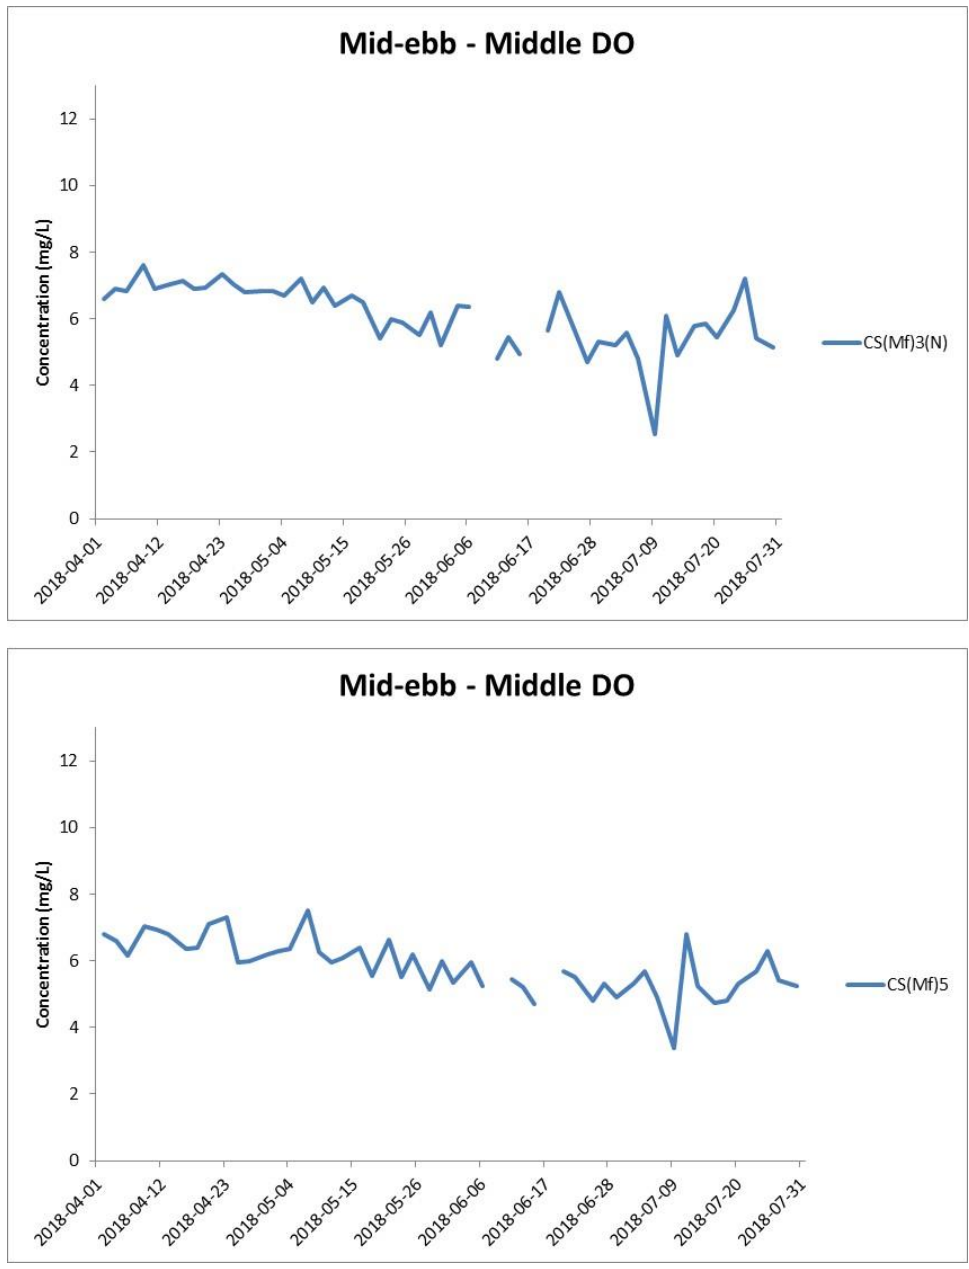
**Figure J9 Impact Monitoring - Mean Level of Dissolved Oxygen (mg/L) in mid-depth waters during mid-ebb tide between 1 April and 31 July 2018 at CS(Mf)3(N) and CS(Mf)5.**

*(Weather condition varied between sunny to rainy within the reporting period.)*  
 WQM during mid-flood at all water quality monitoring stations on 18 July 2018 was canceled due to adverse weather. In-situ monitoring is taken according to the requirement specified in the EM&A Manual, i.e. 3 water depth namely 1m below sea surface, mid-depth and 1m above sea bed. If the water depth is less than 3m, mid-depth sampling only. If water depth less than 6m, mid-depth may be omitted.

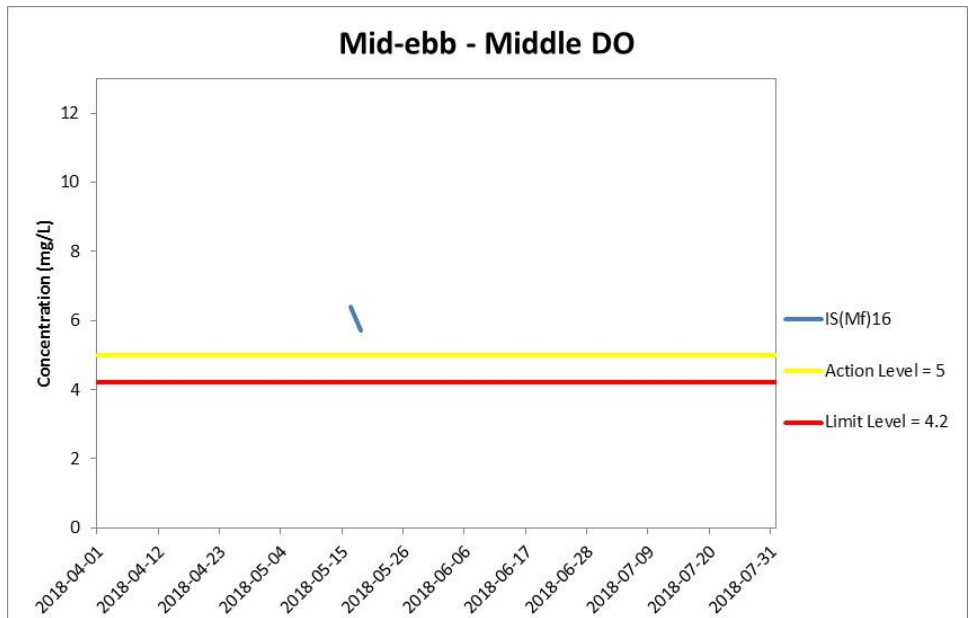
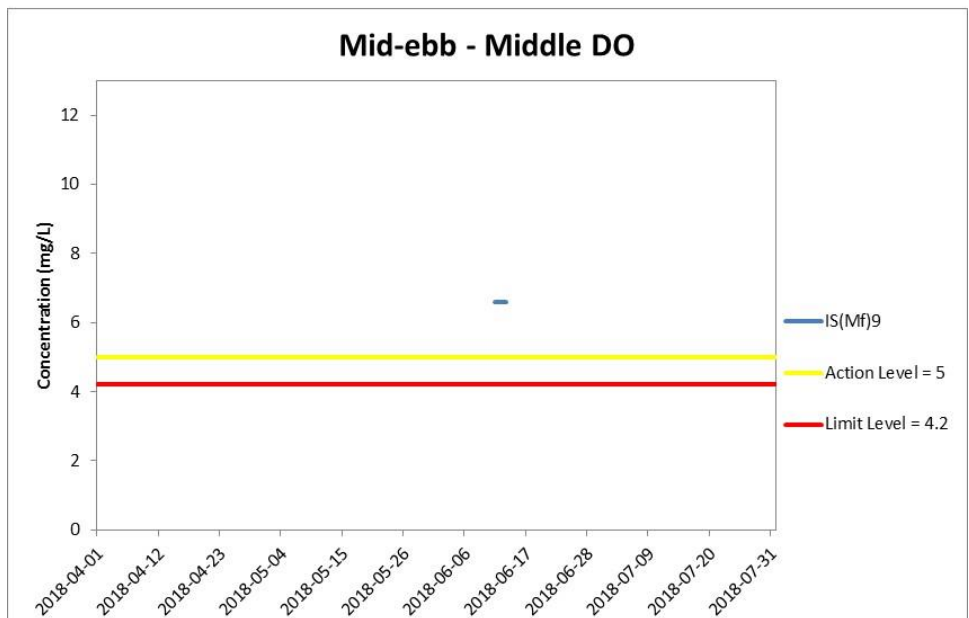
**Figure J10 Impact Monitoring – Mean Level of Dissolved Oxygen (mg/L) in mid-depth waters during mid-ebb tide between 1 April and 31 July 2018 at IS(Mf)16 and IS(Mf)9.**

*(Weather condition varied between sunny to rainy within the reporting period.)*  
 WQM during mid-flood at all water quality monitoring stations on 18 July 2018 was canceled due to adverse weather. In-situ monitoring is taken according to the requirement specified in the EM&A Manual, i.e. 3 water depth namely 1m below sea surface, mid-depth and 1m above sea bed. If the water depth is less than 3m, mid-depth sampling only. If water depth less than 6m, mid-depth may be omitted.

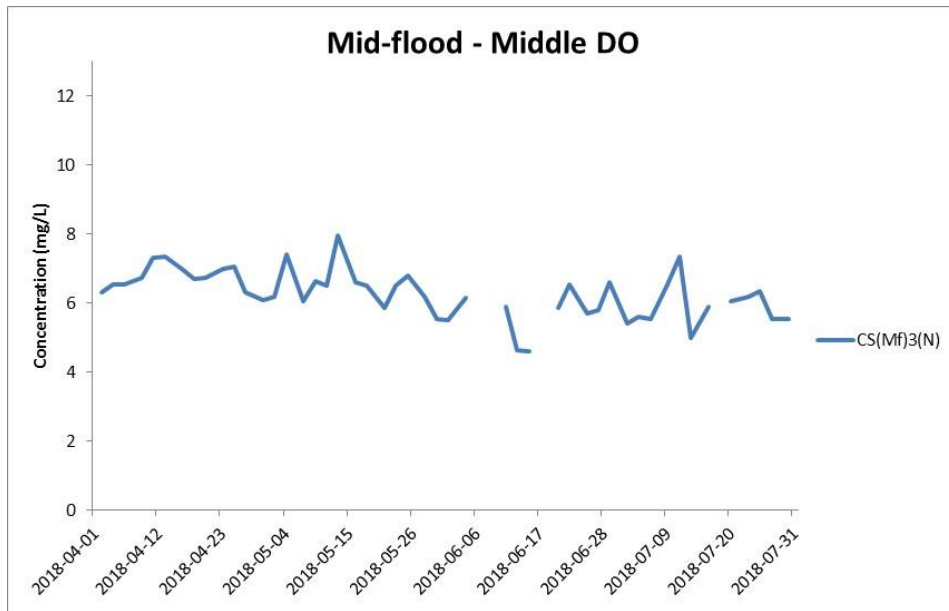
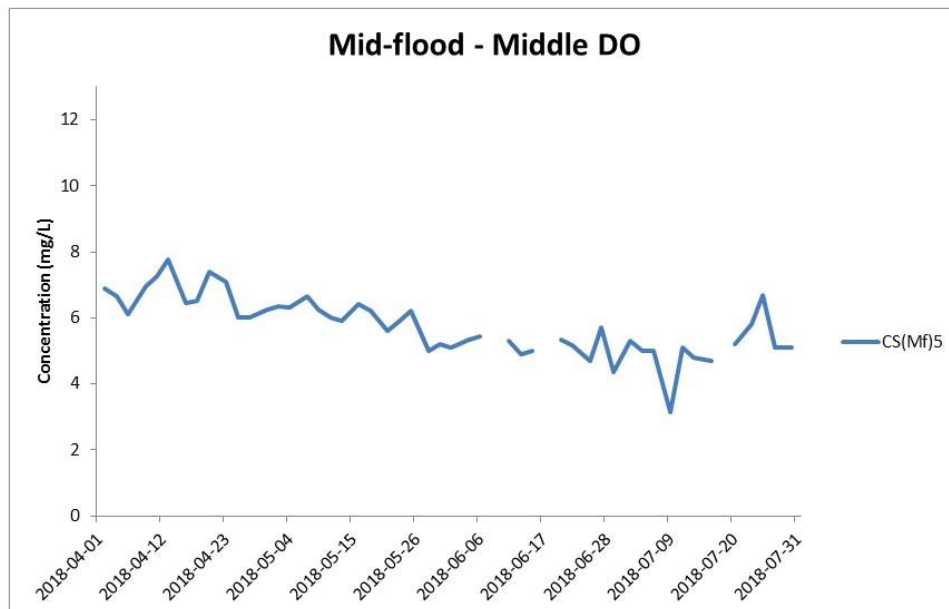
**Figure J11 Impact Monitoring – Mean Level of Dissolved Oxygen (mg/L) in mid-depth waters during mid-flood tide between 1 April and 31 July 2018 at CS(Mf)3(N) and CS(Mf)5.**

*(Weather condition varied between sunny to rainy within the reporting period.)*  
 WQM during mid-flood at all water quality monitoring stations on 18 July 2018 was canceled due to adverse weather. In-situ monitoring is taken according to the requirement specified in the EM&A Manual, i.e. 3 water depth namely 1m below sea surface, mid-depth and 1m above sea bed. If the water depth is less than 3m, mid-depth sampling only. If water depth less than 6m, mid-depth may be omitted.

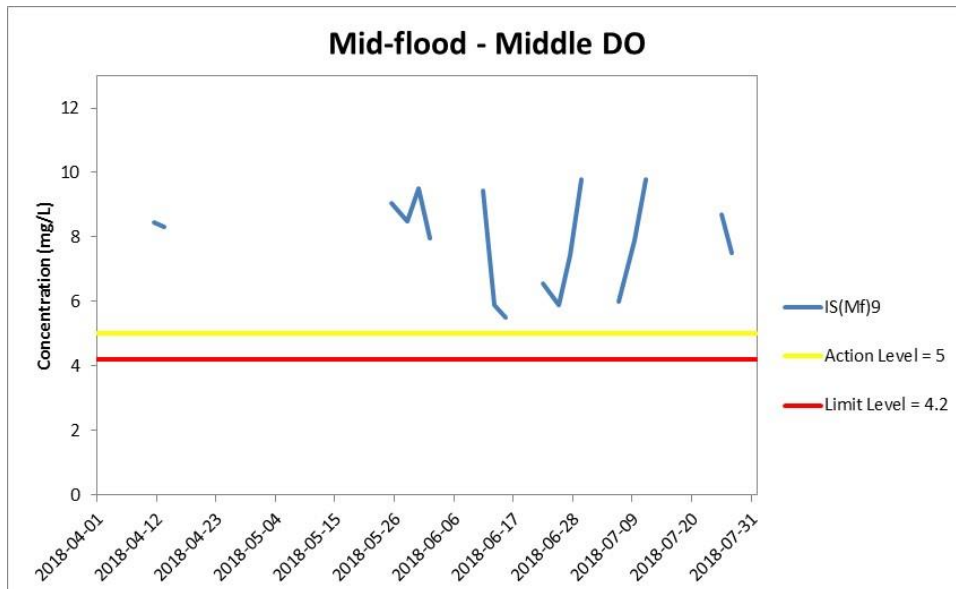
**Figure J12 Impact Monitoring – Mean Level of Dissolved Oxygen (mg/L) in mid-depth waters during mid-flood tide between 1 April and 31 July 2018 at IS(Mf)9.**

*(Weather condition varied between sunny to rainy within the reporting period.)*  
 WQM during mid-flood at all water quality monitoring stations on 18 July 2018 was canceled due to adverse weather. In-situ monitoring is taken according to the requirement specified in the EM&A Manual, i.e. 3 water depth namely 1m below sea surface, mid-depth and 1m above sea bed. If the water depth is less than 3m, mid-depth sampling only. If water depth less than 6m, mid-depth may be omitted.

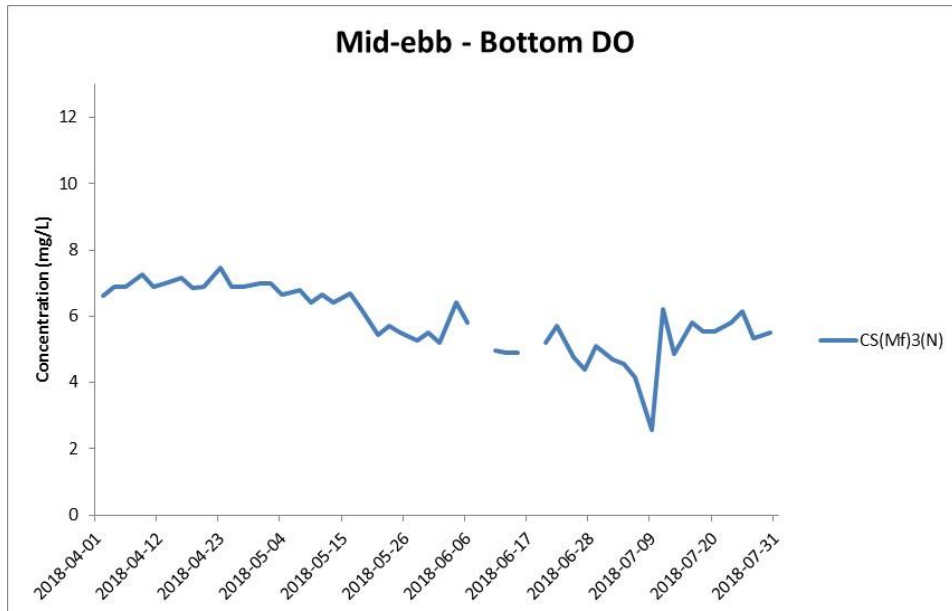
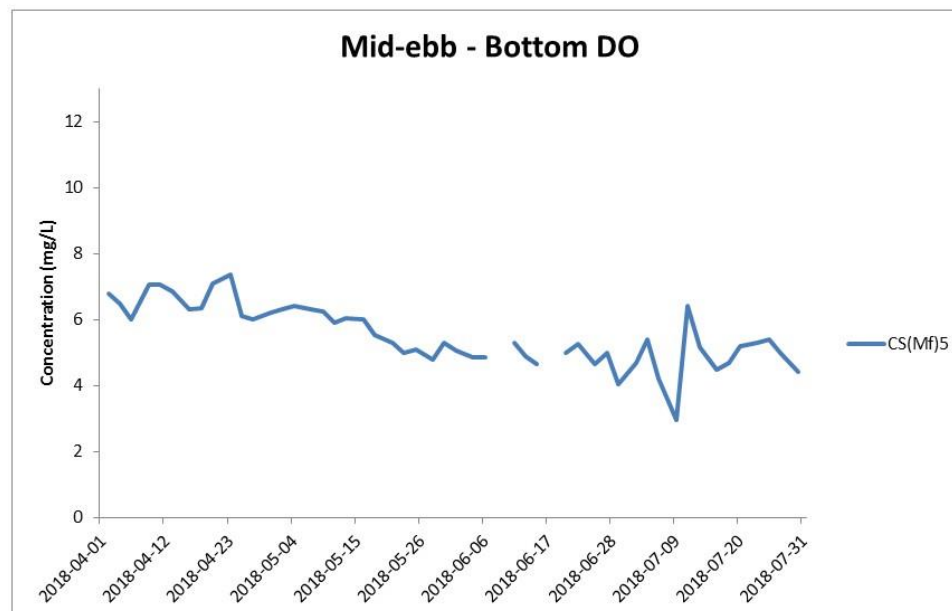
**Figure J13 Impact Monitoring - Mean Level of Dissolved Oxygen (mg/L) in bottom waters during mid-ebb tide between 1 April and 31 July 2018 at CS(Mf)3(N) and CS(Mf)5.**

*(Weather condition varied between sunny to rainy within the reporting period.)*  
 WQM during mid-flood at all water quality monitoring stations on 18 July 2018 was canceled due to adverse weather. In-situ monitoring is taken according to the requirement specified in the EM&A Manual, i.e. 3 water depth namely 1m below sea surface, mid-depth and 1m above sea bed. If the water depth is less than 3m, mid-depth sampling only. If water depth less than 6m, mid-depth may be omitted.

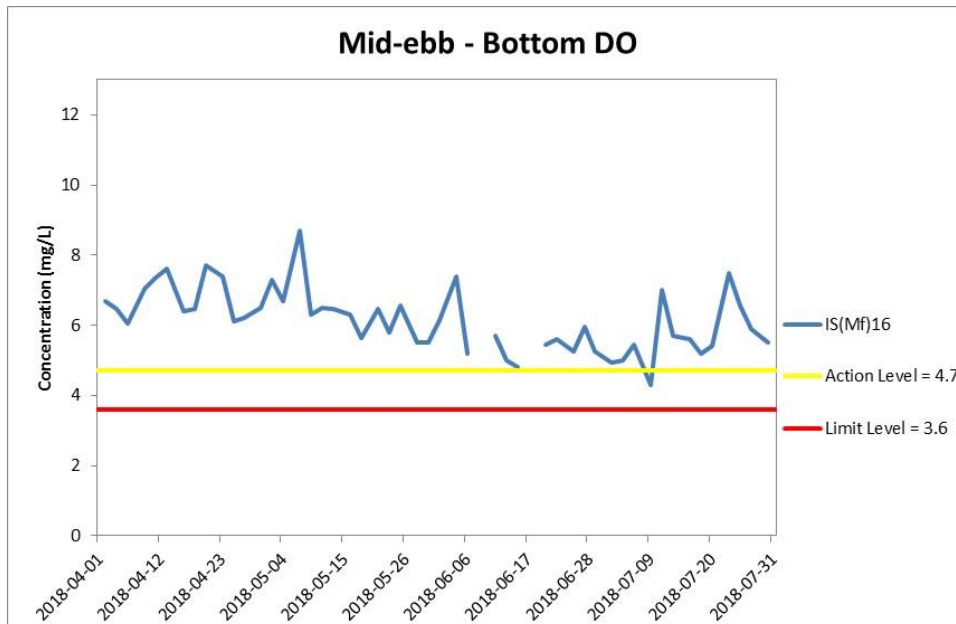
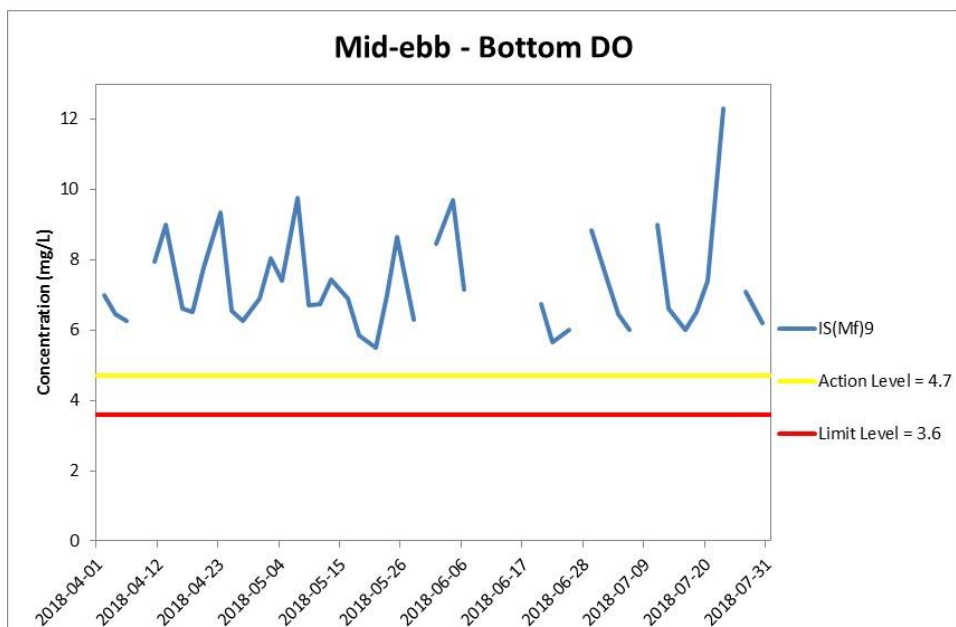
**Figure J14 Impact Monitoring - Mean Level of Dissolved Oxygen (mg/L) in bottom waters during mid-ebb tide between 1 April and 31 July 2018 at IS(Mf)16 and IS(Mf)9.**

*(Weather condition varied between sunny to rainy within the reporting period.)*  
 WQM during mid-flood at all water quality monitoring stations on 18 July 2018 was canceled due to adverse weather. In-situ monitoring is taken according to the requirement specified in the EM&A Manual, i.e. 3 water depth namely 1m below sea surface, mid-depth and 1m above sea bed. If the water depth is less than 3m, mid-depth sampling only. If water depth less than 6m, mid-depth may be omitted.

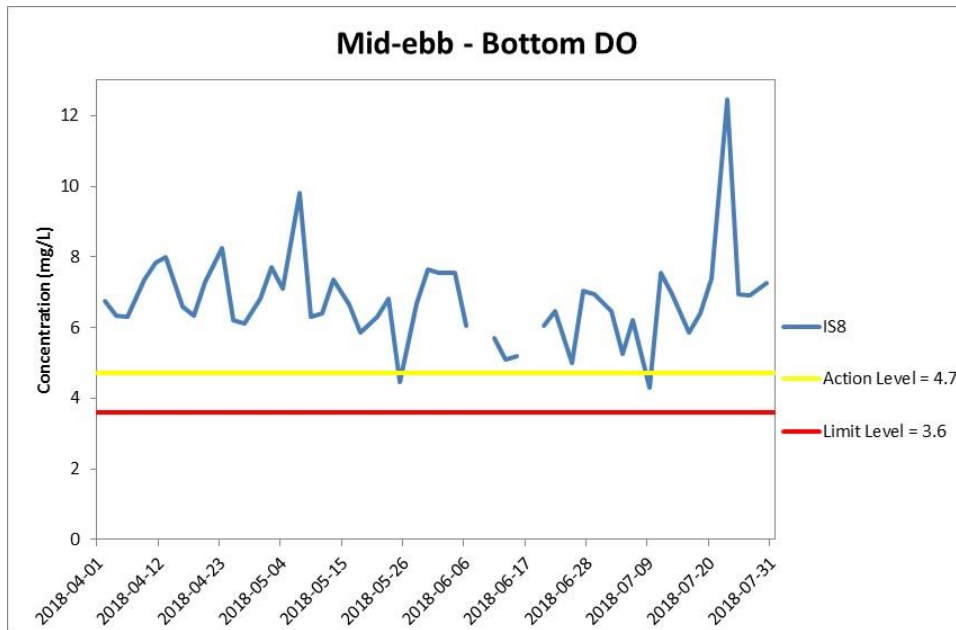
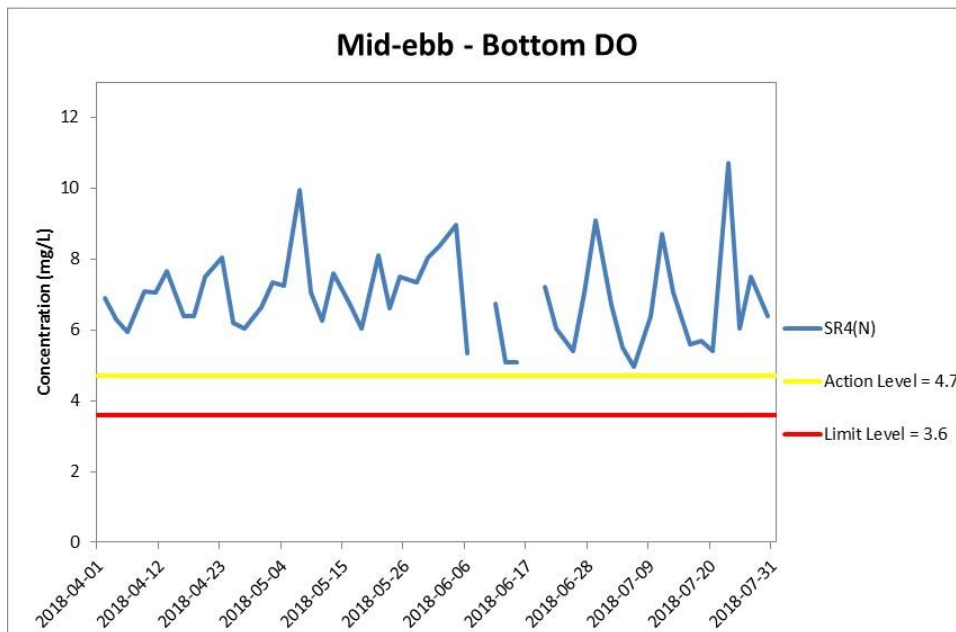
**Figure J15 Impact Monitoring - Mean Level of Dissolved Oxygen (mg/L) in bottom waters during mid-ebb tide between 1 April and 31 July 2018 at IS8 and SR4(N).**

*(Weather condition varied between sunny to rainy within the reporting period.)*  
 WQM during mid-flood at all water quality monitoring stations on 18 July 2018 was canceled due to adverse weather. In-situ monitoring is taken according to the requirement specified in the EM&A Manual, i.e. 3 water depth namely 1m below sea surface, mid-depth and 1m above sea bed. If the water depth is less than 3m, mid-depth sampling only. If water depth less than 6m, mid-depth may be omitted.

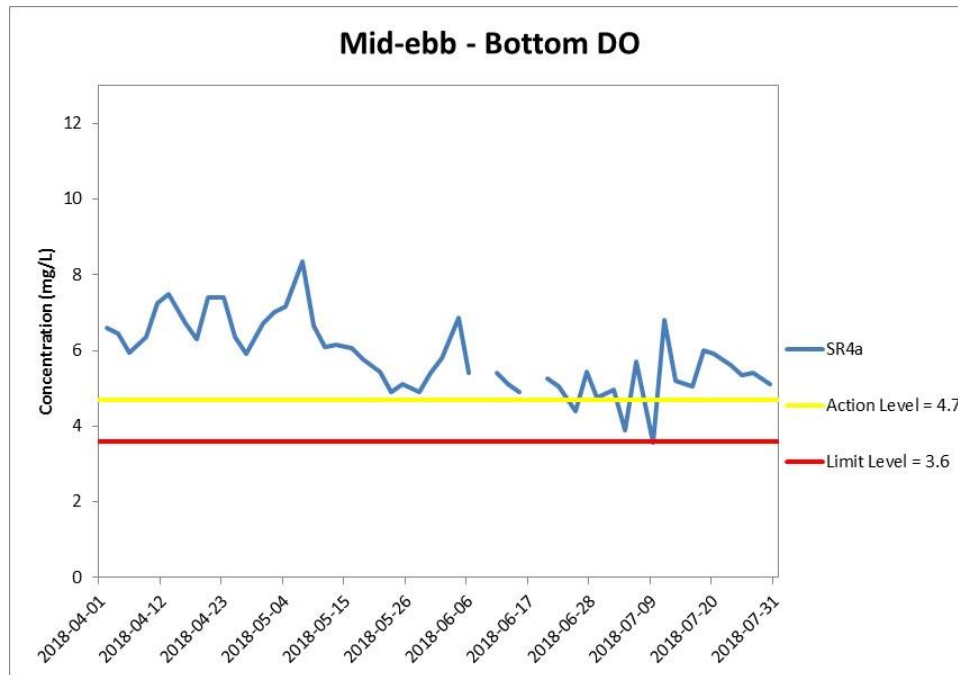
**Figure J16 Impact Monitoring - Mean Level of Dissolved Oxygen (mg/L) in bottom waters during mid-ebb tide between 1 April and 31 July 2018 at SR4a.**

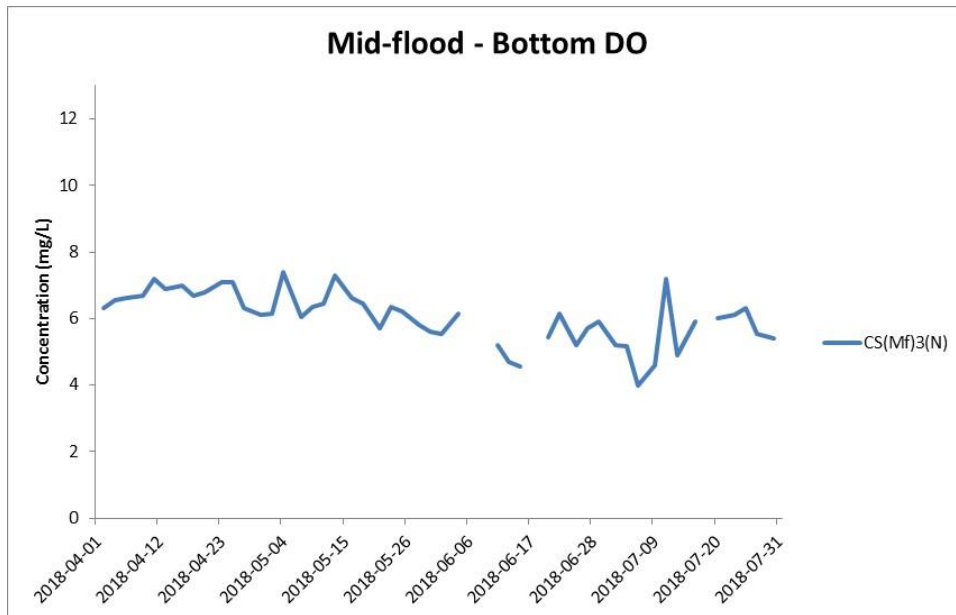
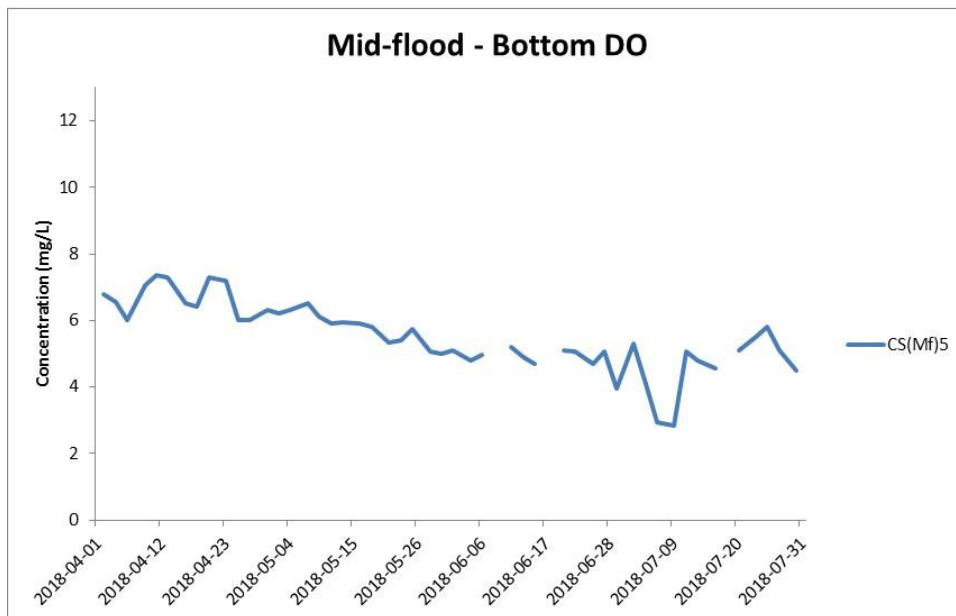
**Figure J17 Impact Monitoring - Mean Level of Dissolved Oxygen (mg/L) in bottom waters during mid-flood tide between 1 April and 31 July 2018 at CS(Mf)3(N) and CS(Mf)5.**
