**Contract No. HY/2012/07  
Tuen Mun – Chek Lap Kok Link –  
Southern Connection Viaduct Section**

*Fifty-seventh Monthly EM&A Report*

09 August 2018

**Contract No. HY/2012/07 TM-CLKL Southern Connection Viaduct  
Section  
57<sup>th</sup> Monthly EM&A Report for July 2018 (EP-354/2009/D)**

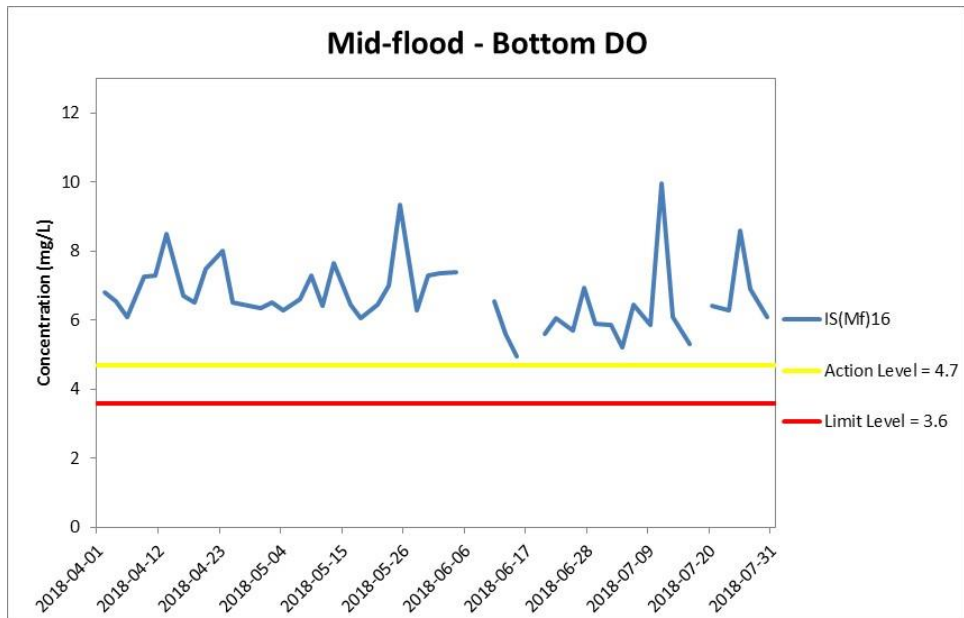
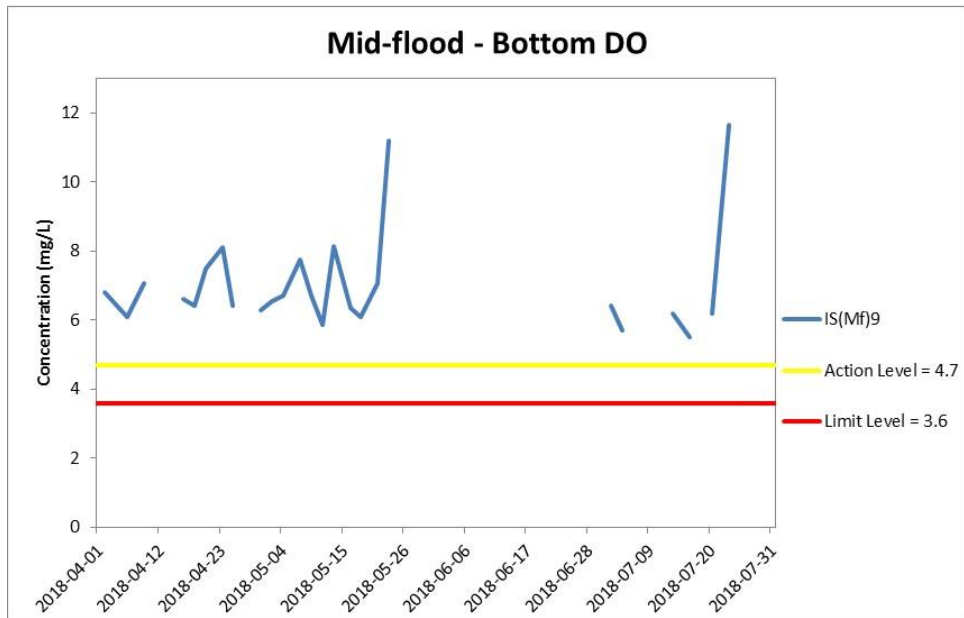
**Figure J18 Impact Monitoring - Mean Level of Dissolved Oxygen (mg/L) in bottom waters during mid-flood tide between 1 April and 31 July 2018 at IS(Mf)16 and IS(Mf)9.**

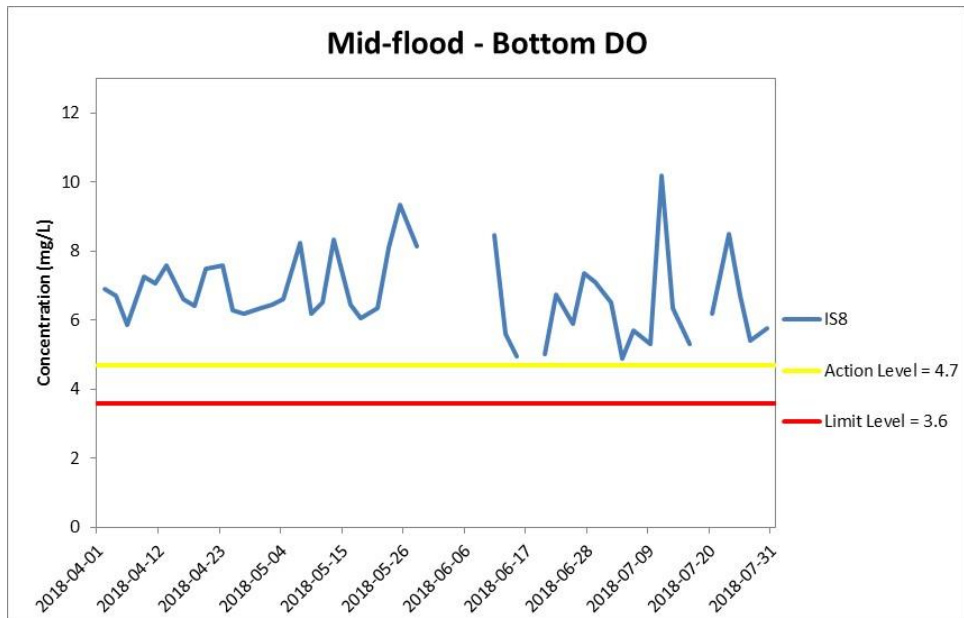
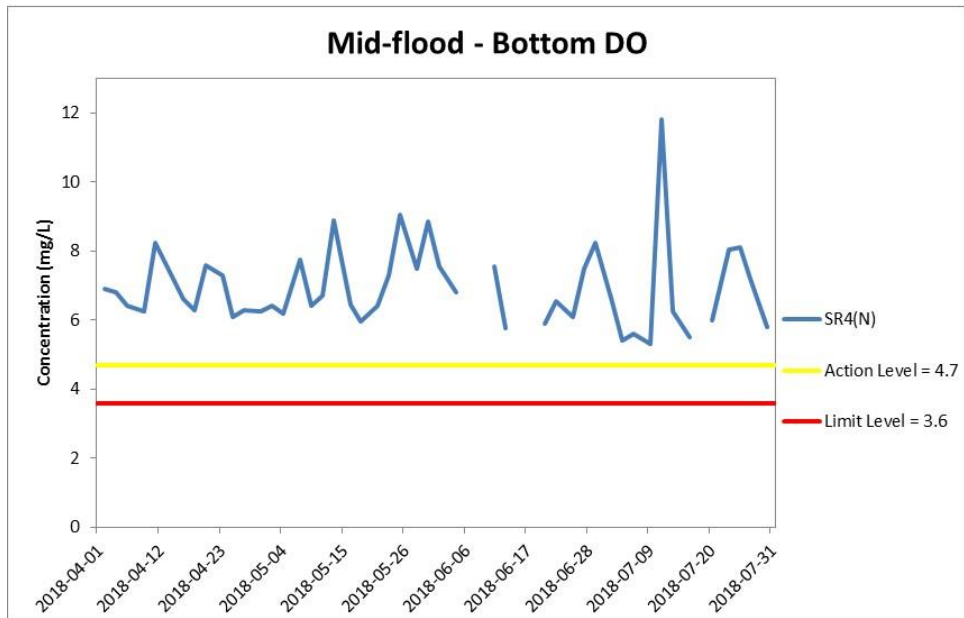
**Figure J19 Impact Monitoring - Mean Level of Dissolved Oxygen (mg/L) in bottom waters during mid-flood tide between 1 April and 31 July 2018 at IS8 and SR4(N).**

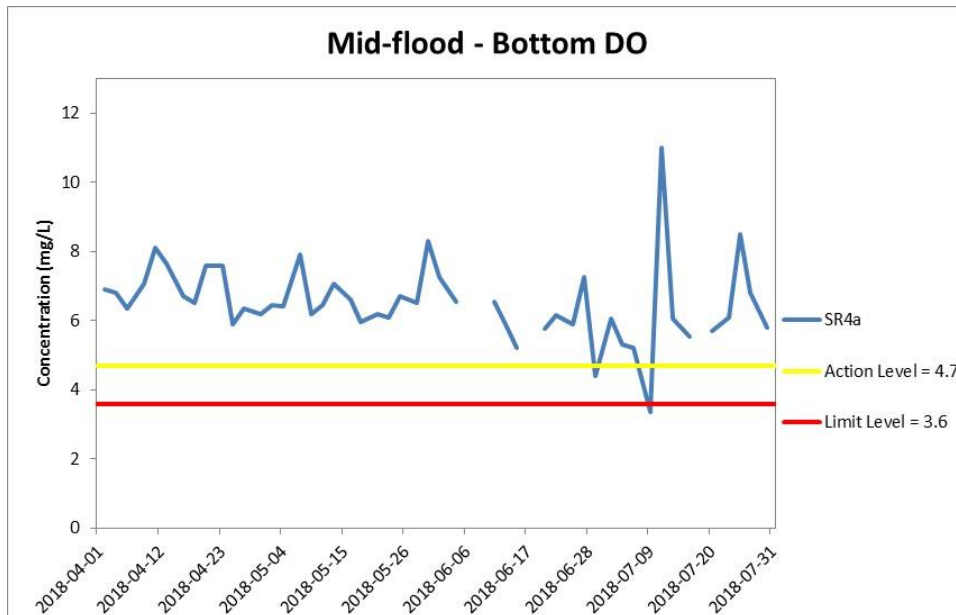
**Figure J20 Impact Monitoring - Mean Level of Dissolved Oxygen (mg/L) in bottom waters during mid-flood tide between 1 April and 31 July 2018 at SR4a.**

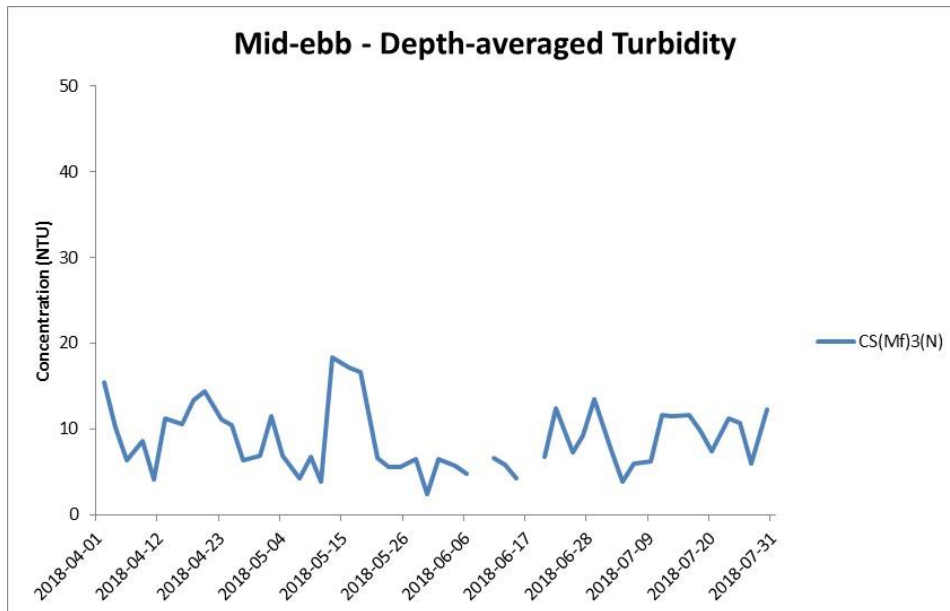
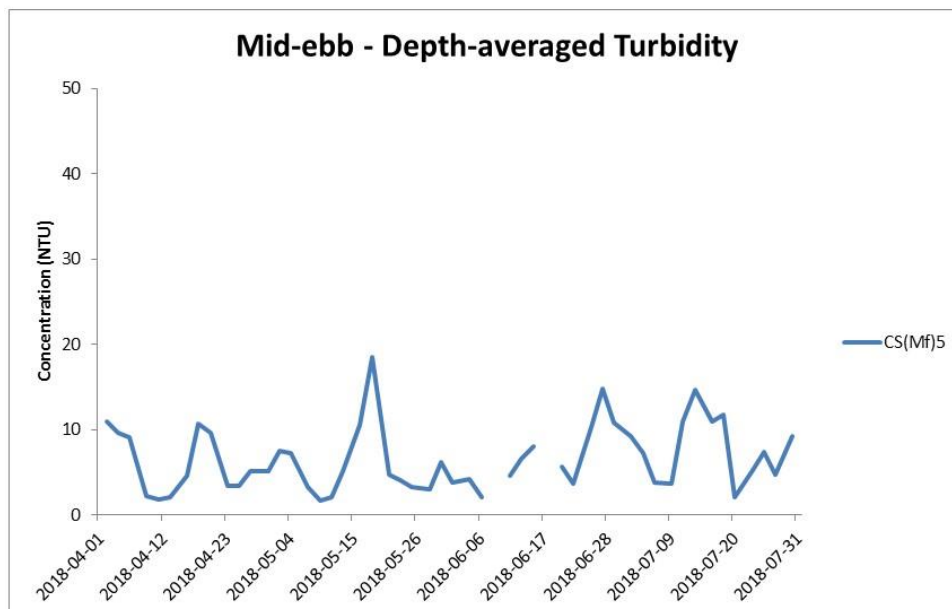
**Figure J21 Impact Monitoring - Mean Level of depth-averaged Turbidity (NTU) during mid-ebb tide between 1 April and 31 July 2018 at CS(Mf)3(N) and CS(Mf)5.**

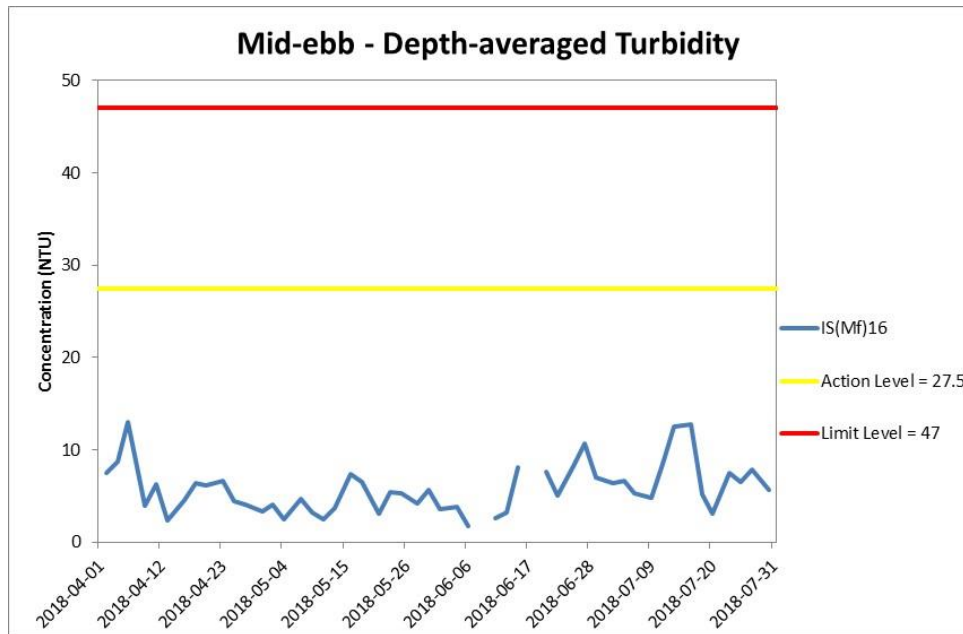
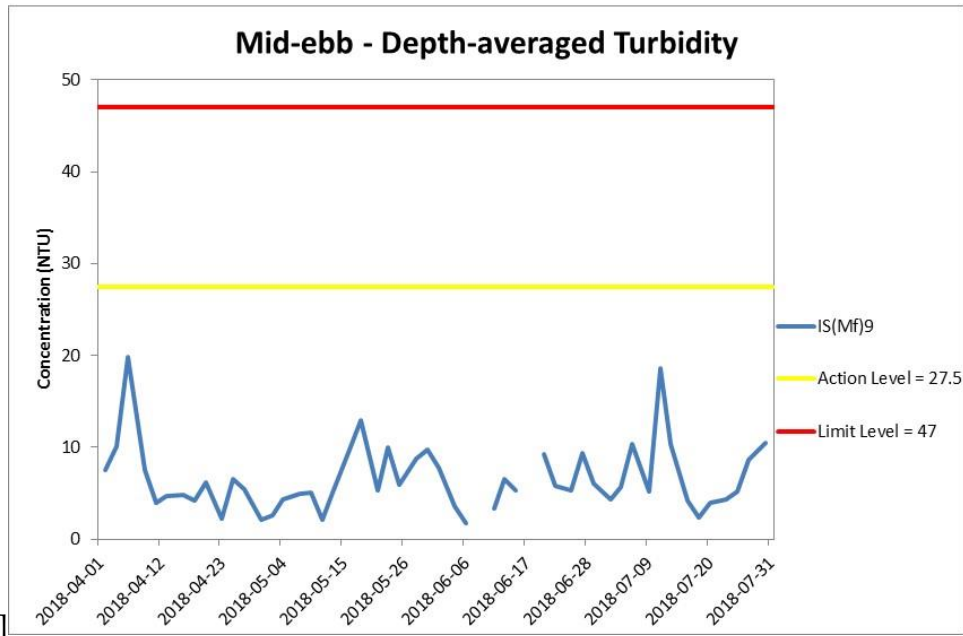
**Figure J22 Impact Monitoring - Mean Level of depth-averaged Turbidity (NTU) during mid-ebb tide between 1 April and 31 July 2018 at IS(Mf)16 and IS(Mf)9.**

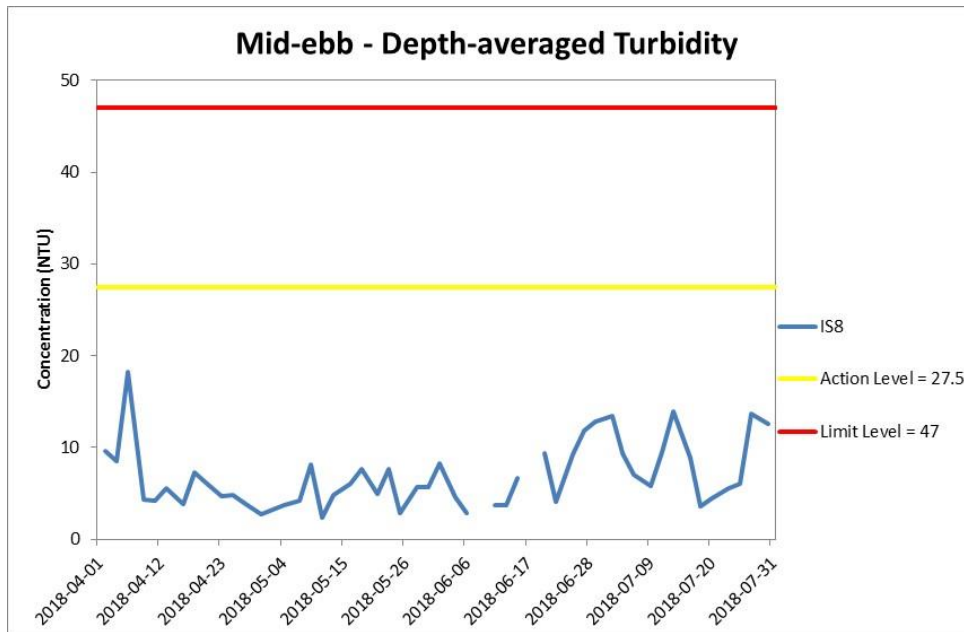
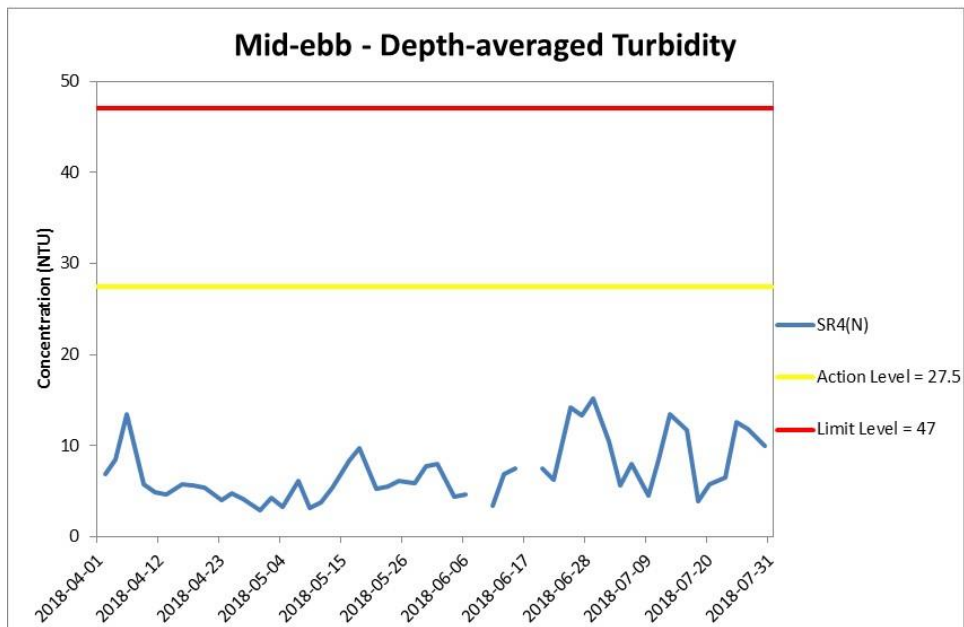
**Figure J23 Impact Monitoring - Mean Level of depth-averaged Turbidity (NTU) during mid-ebb tide between 1 April and 31 July 2018 at IS8 and SR4(N).**

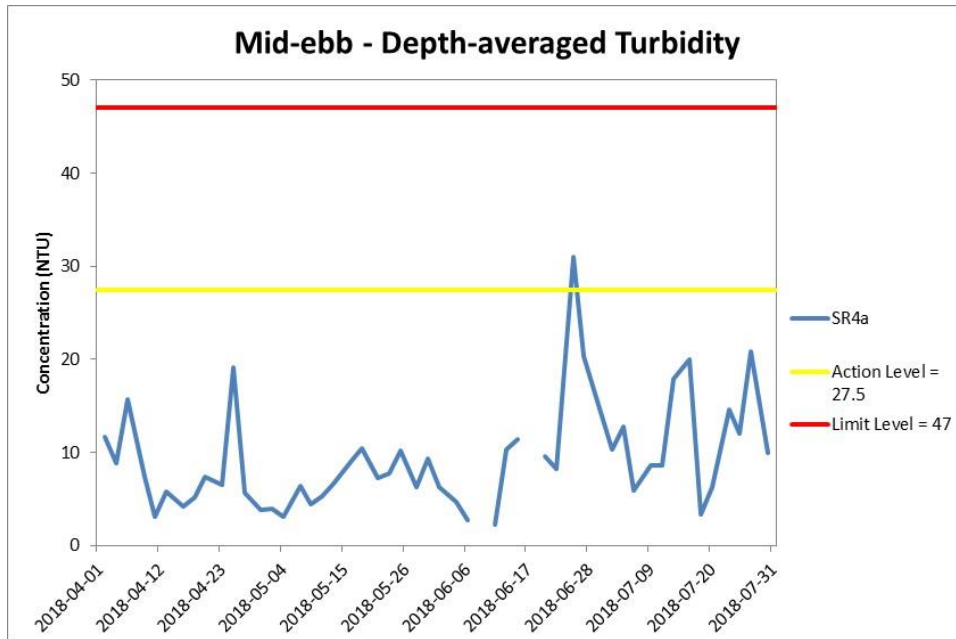
**Figure J24 Impact Monitoring - Mean Level of depth-averaged Turbidity (NTU) during mid-ebb tide between 1 April and 31 July 2018 at SR4a.**

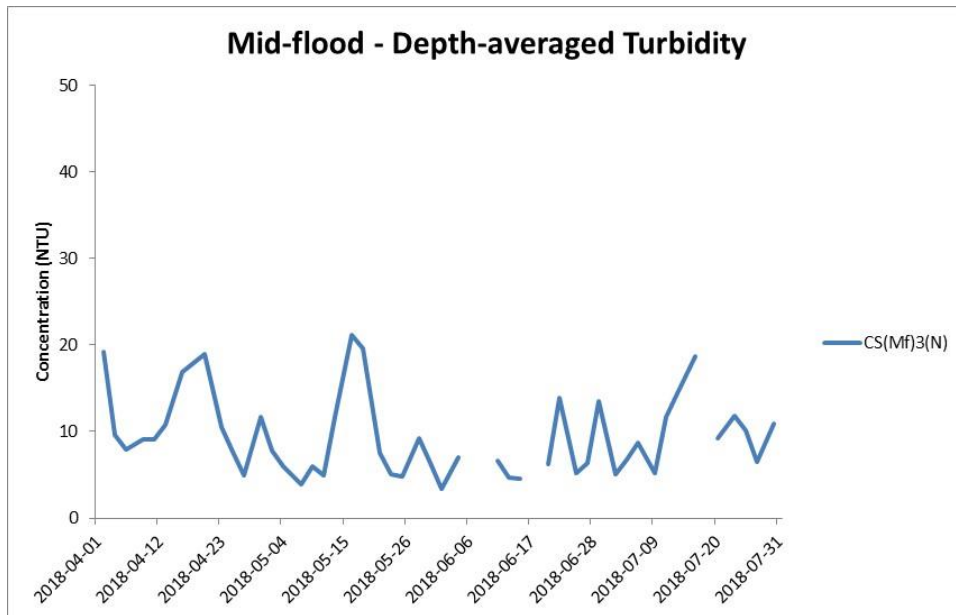
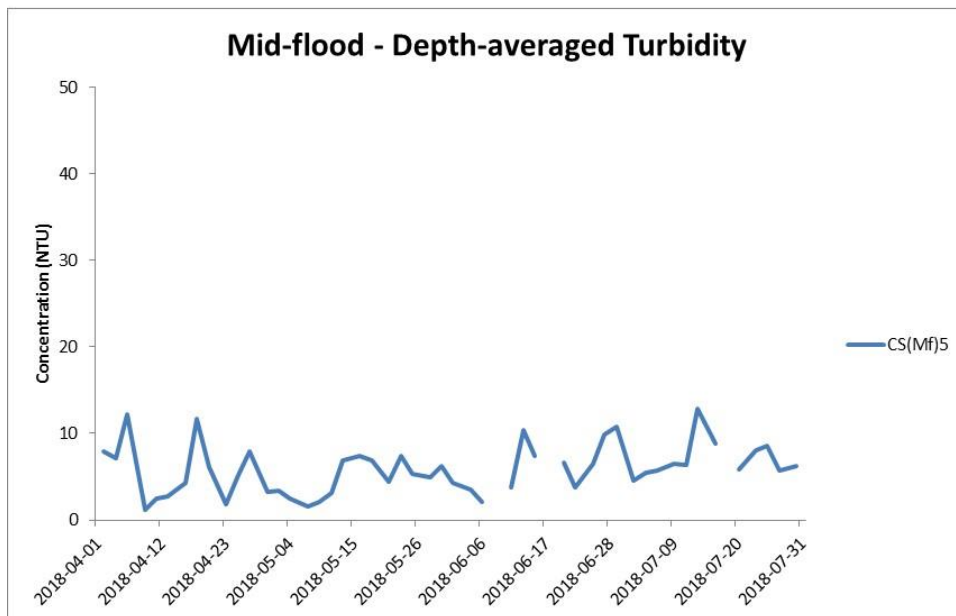
**Figure J25 Impact Monitoring - Mean Level of depth-averaged Turbidity (NTU) during mid-flood tide between 1 April and 31 July 2018 at CS(Mf)3(N) and CS(Mf)5.**

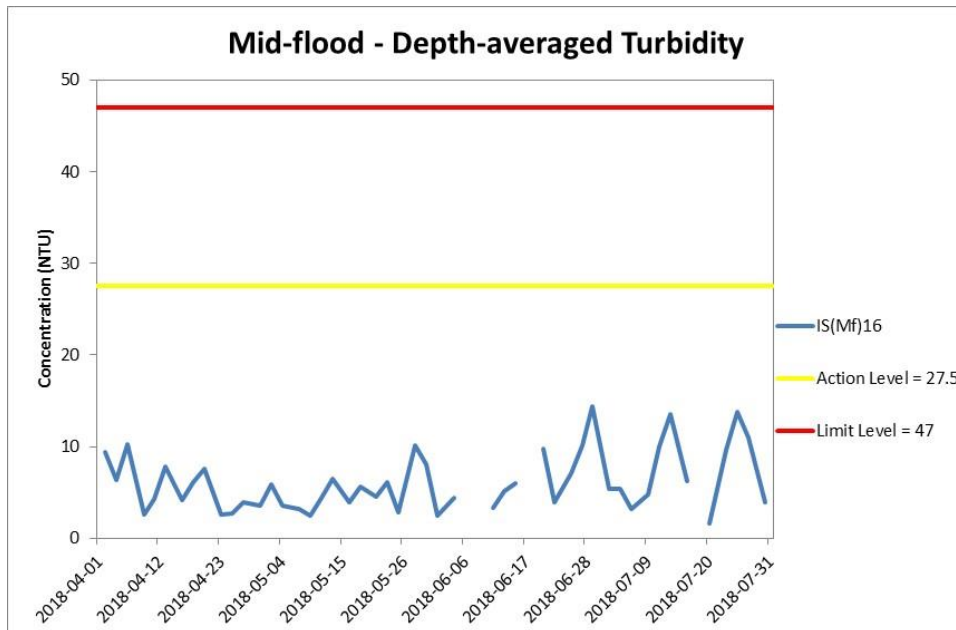
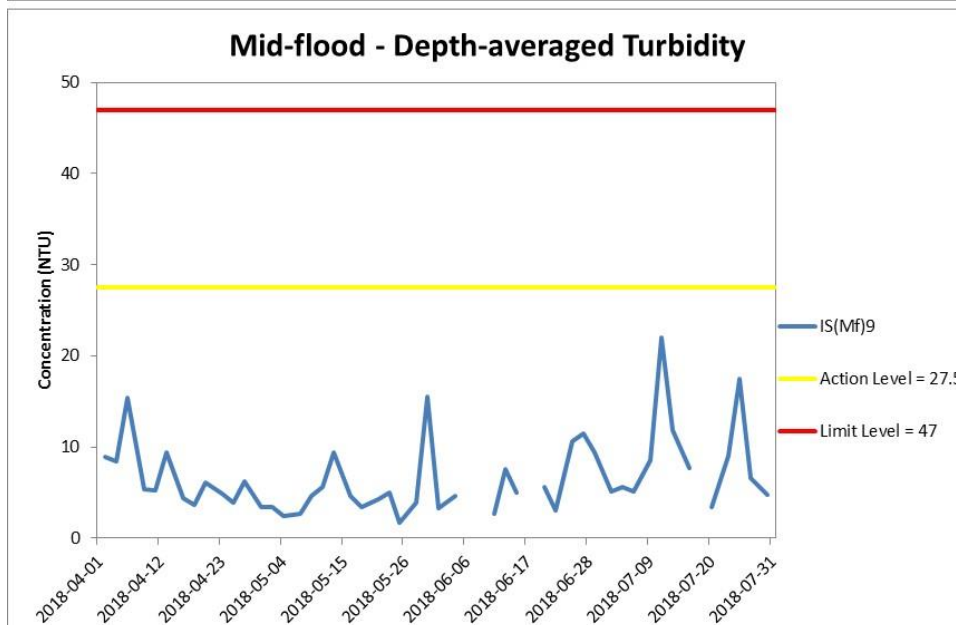
**Figure J26 Impact Monitoring - Mean Level of depth-averaged Turbidity (NTU) during mid-flood tide between 1 April and 31 July 2018 at IS(Mf)16 and IS(Mf)9.**

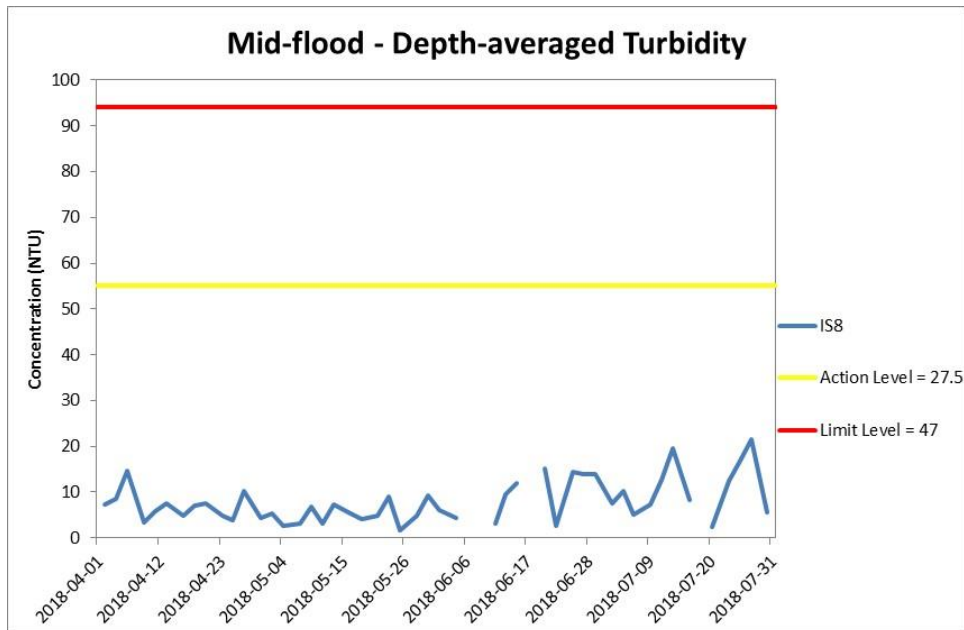
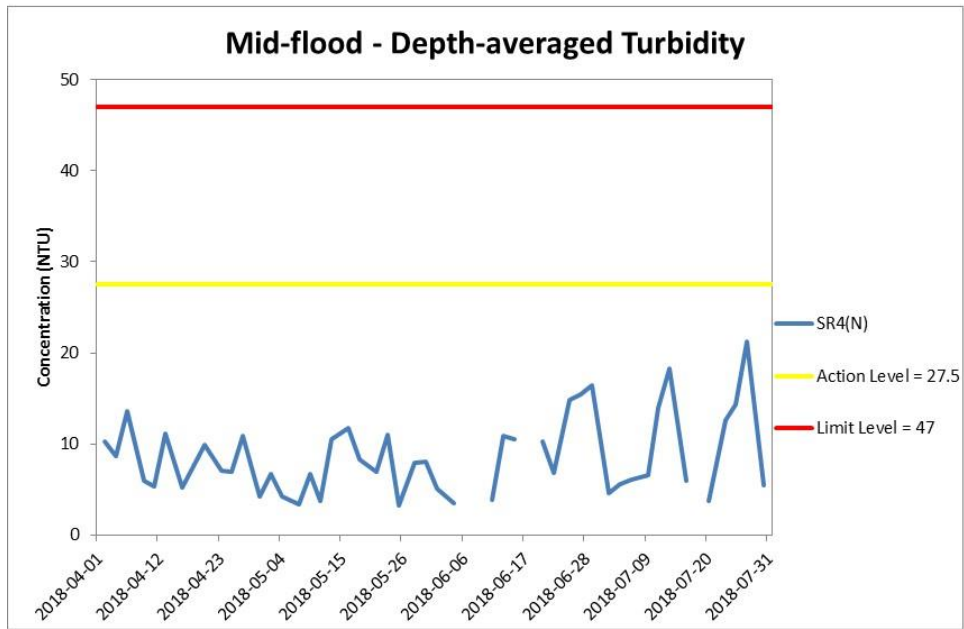
**Figure J27 Impact Monitoring – Mean Level of depth-averaged Turbidity (NTU) during mid-flood tide between 1 April and 31 July 2018 at IS8 and SR4(N).**

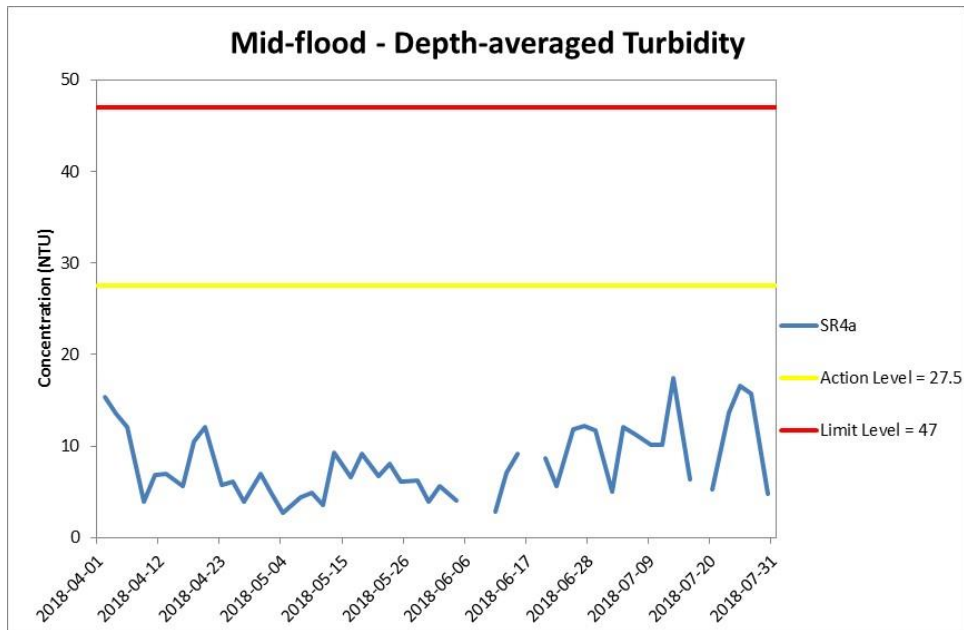
**Figure J28 Impact Monitoring - Mean Level of depth-averaged Turbidity (NTU) during mid-flood tide between 1 April and 31 July 2018 at SR4a.**

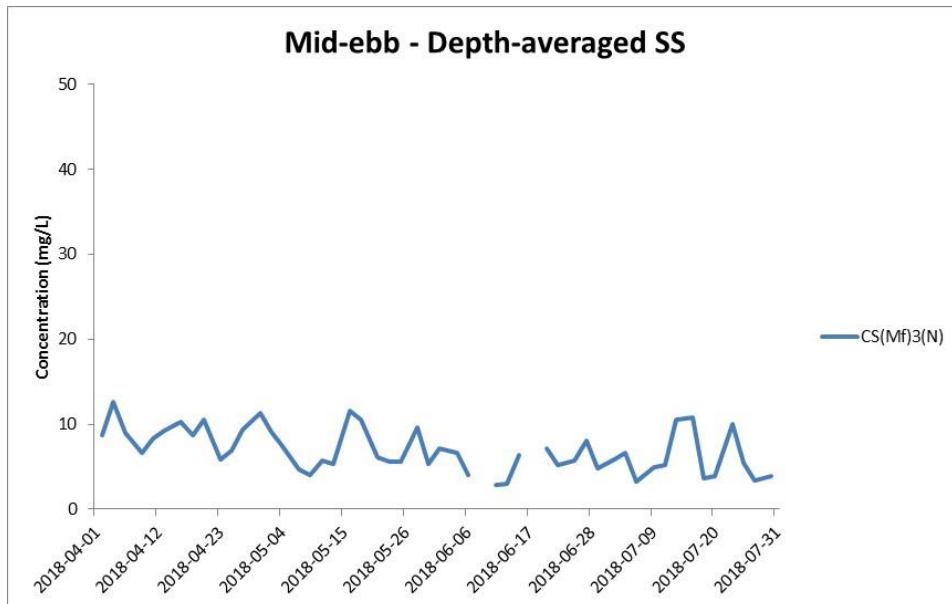
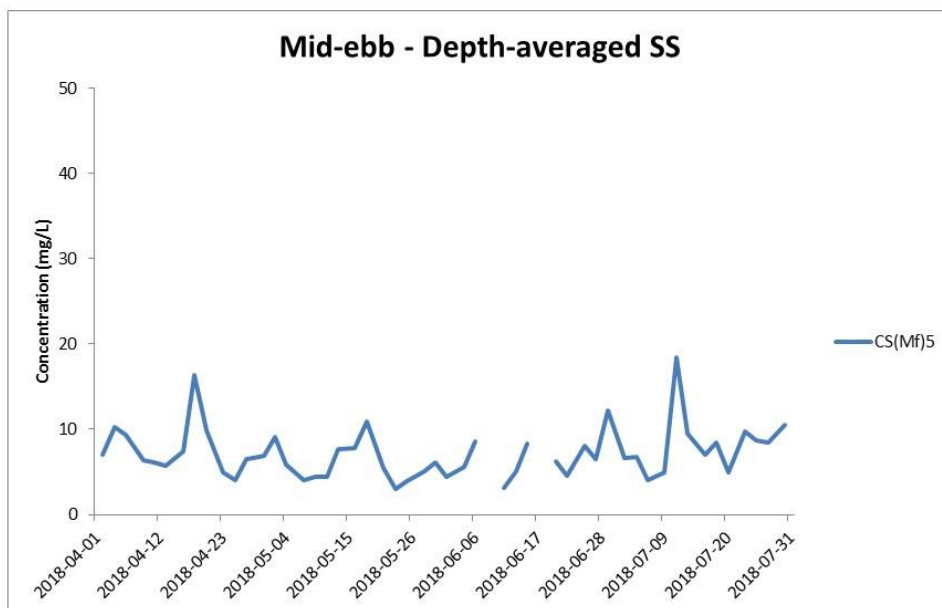
**Figure J29 Impact Monitoring - Mean depth-averaged level of Suspended Solids (mg/L) during mid-ebb tide between 1 April and 31 July 2018 at CS(Mf)3(N) and CS(Mf)5.**

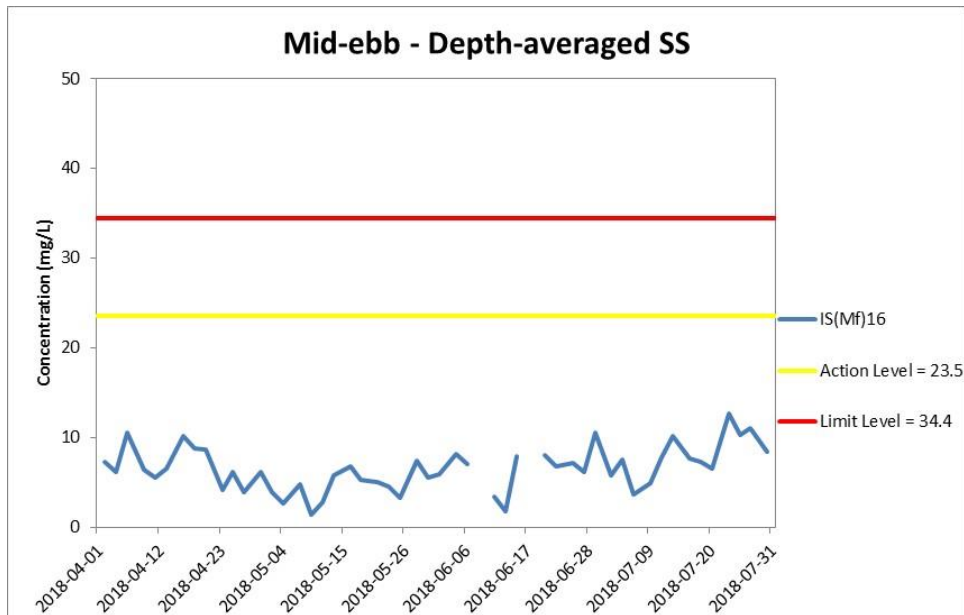
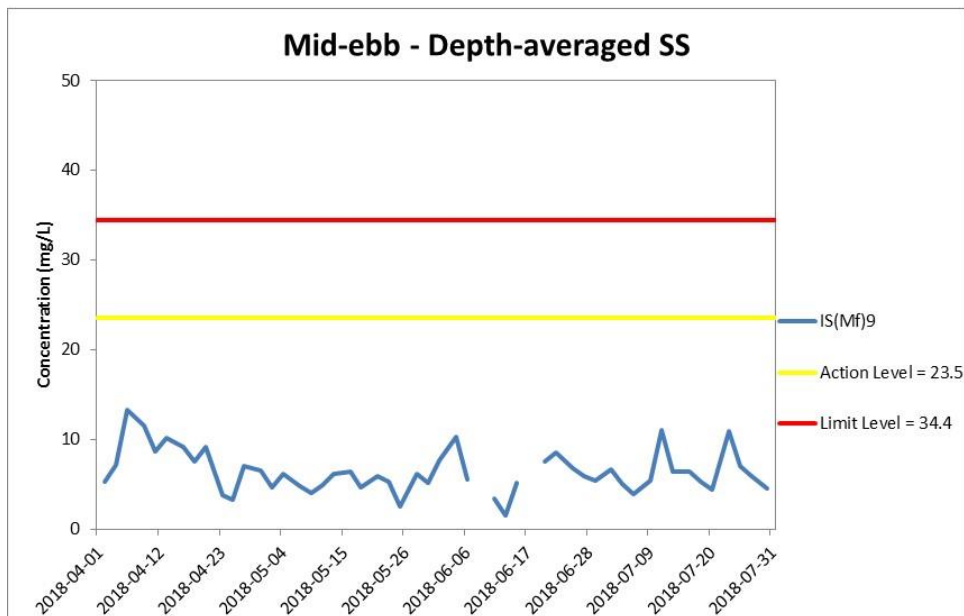
**Figure J30 Impact Monitoring - Mean depth-averaged level of Suspended Solids (mg/L) during mid-ebb tide between 1 April and 31 July 2018 at IS(Mf)16 and IS(Mf)9.**

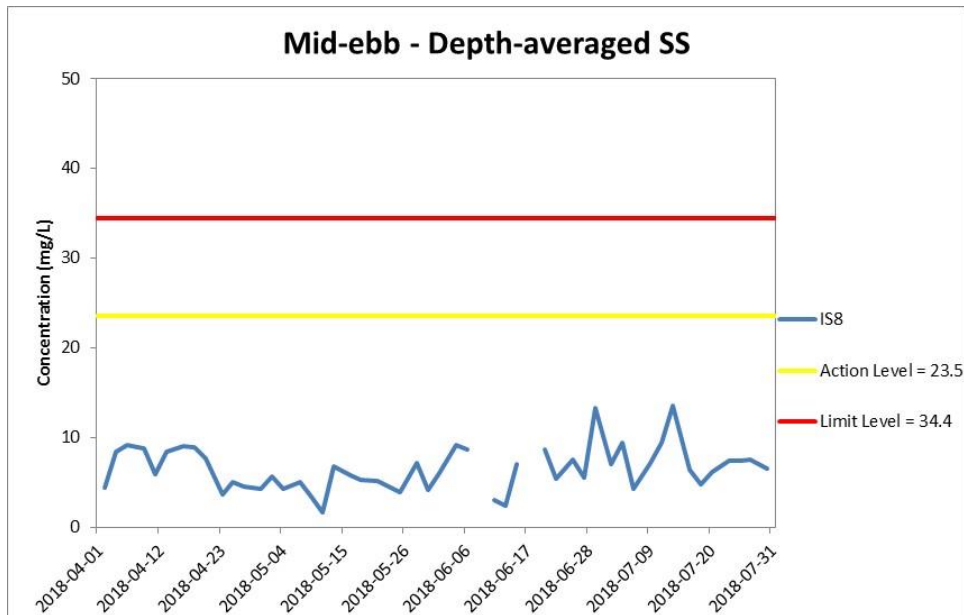
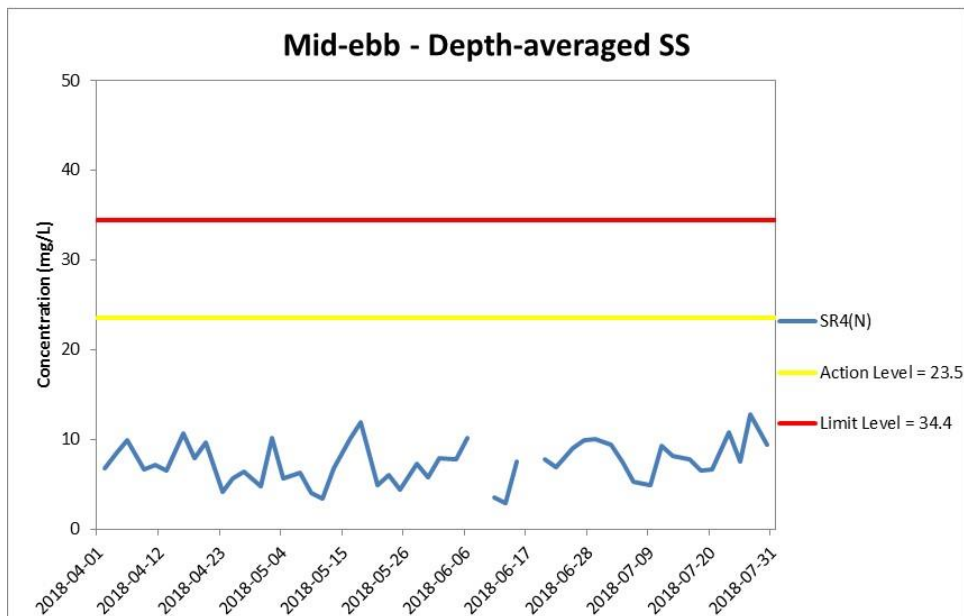
**Figure J31 Impact Monitoring - Mean depth-averaged level of Suspended Solids (mg/L) during mid-ebb tide between 1 April and 31 July 2018 at IS8 and SR4(N).**

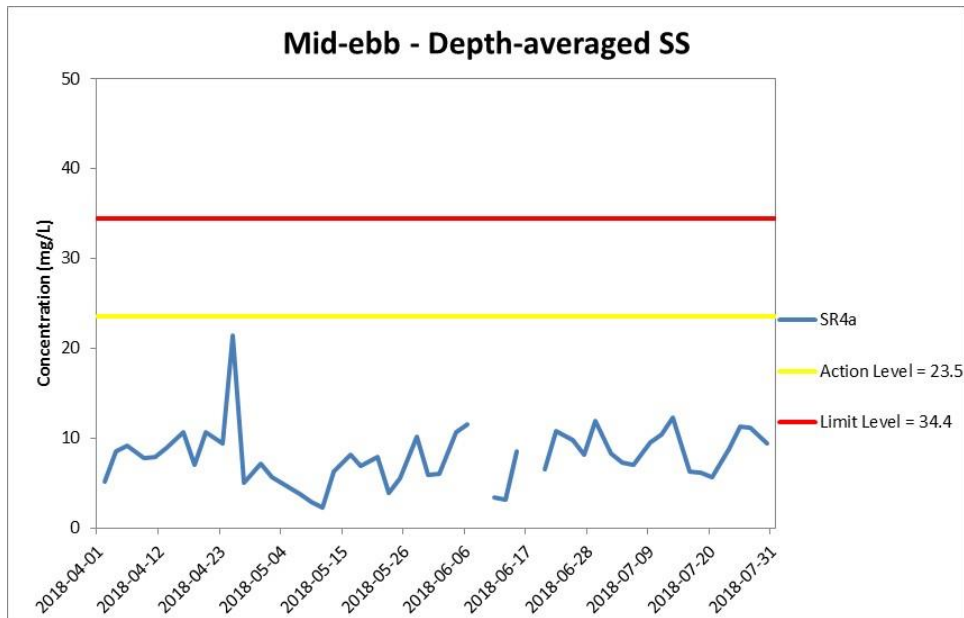
**Figure J32 Impact Monitoring – Mean depth-averaged level of Suspended Solids (mg/L) during mid-ebb tide between 1 April and 31 July 2018 at SR4a.**

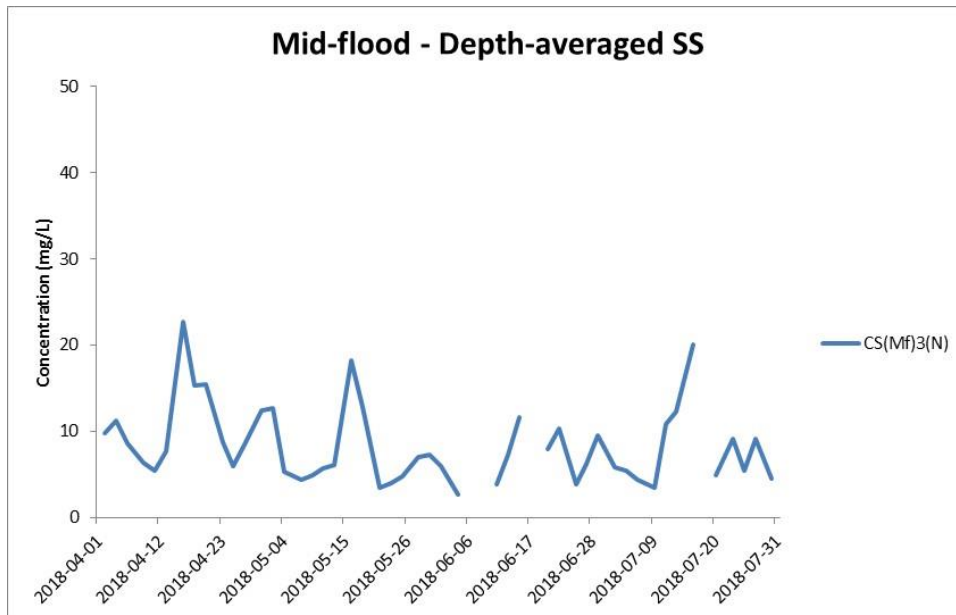
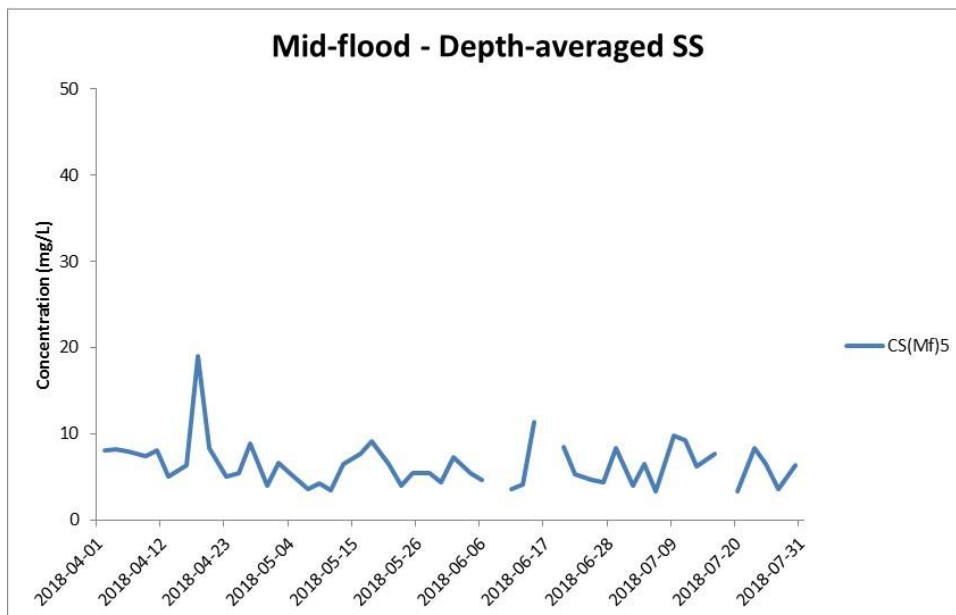
**Figure J33 Impact Monitoring - Mean depth-averaged level of Suspended Solids (mg/L) during mid-flood tide between 1 April and 31 July 2018 at CS(Mf)3(N) and CS(Mf)5.**

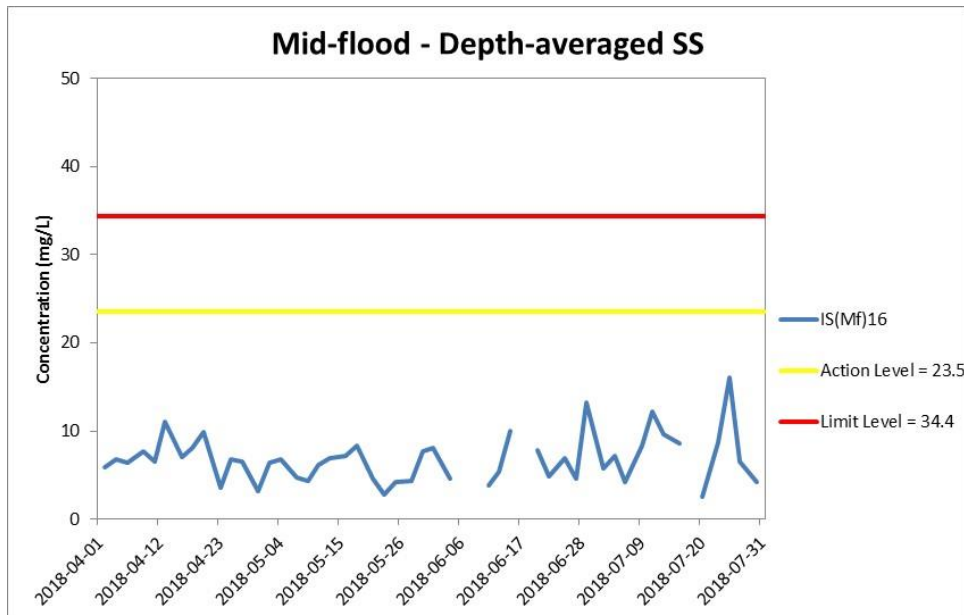
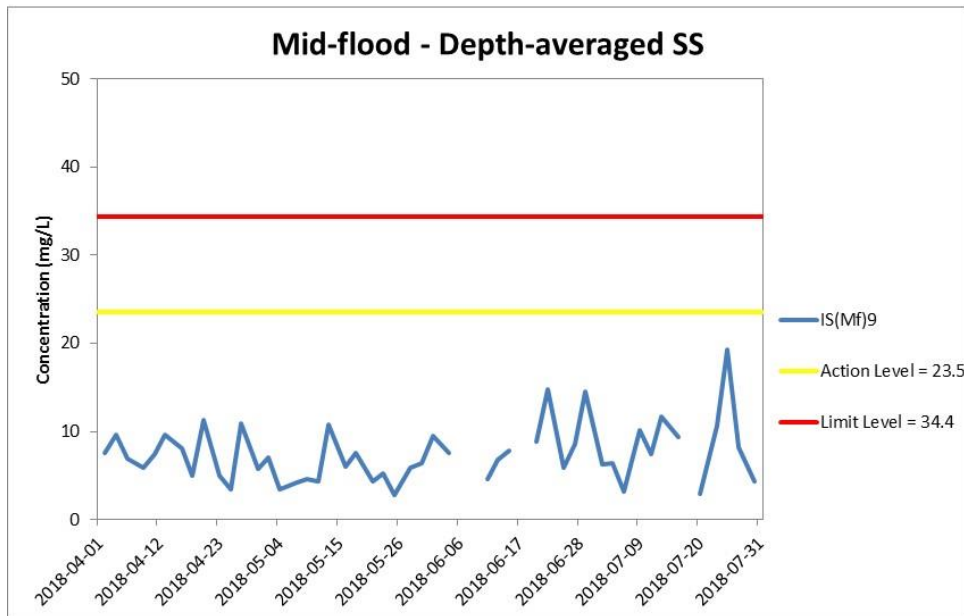
**Figure J34 Impact Monitoring - Mean depth-averaged level of Suspended Solids (mg/L) during mid-flood tide between 1 April and 31 July 2018 at IS(Mf)16 and IS(Mf)9.**

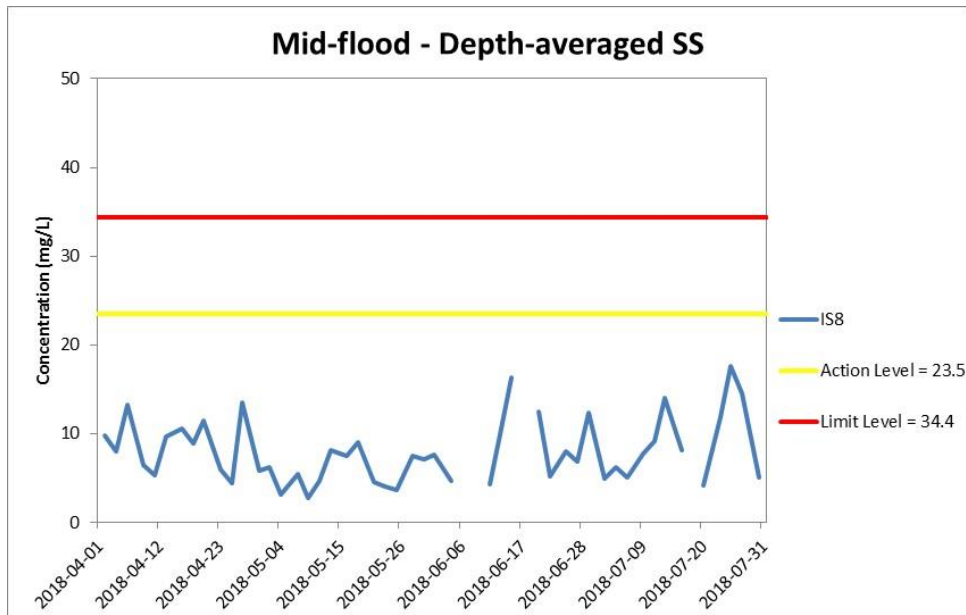
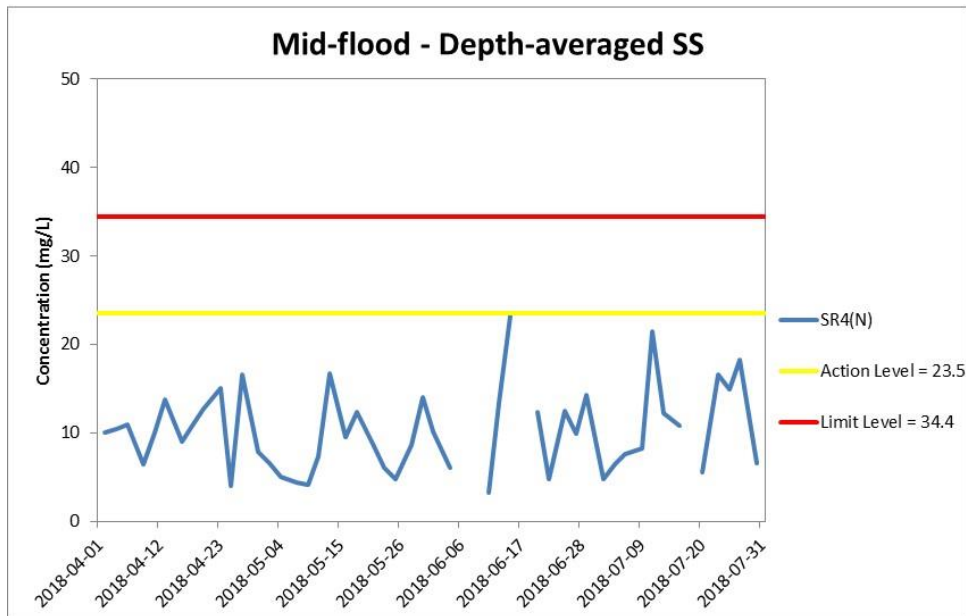
**Figure J35 Impact Monitoring - Mean depth-averaged level of Suspended Solids (mg/L) during mid-flood tide between 1 April and 31 July 2018 at IS8 and SR4(N).**

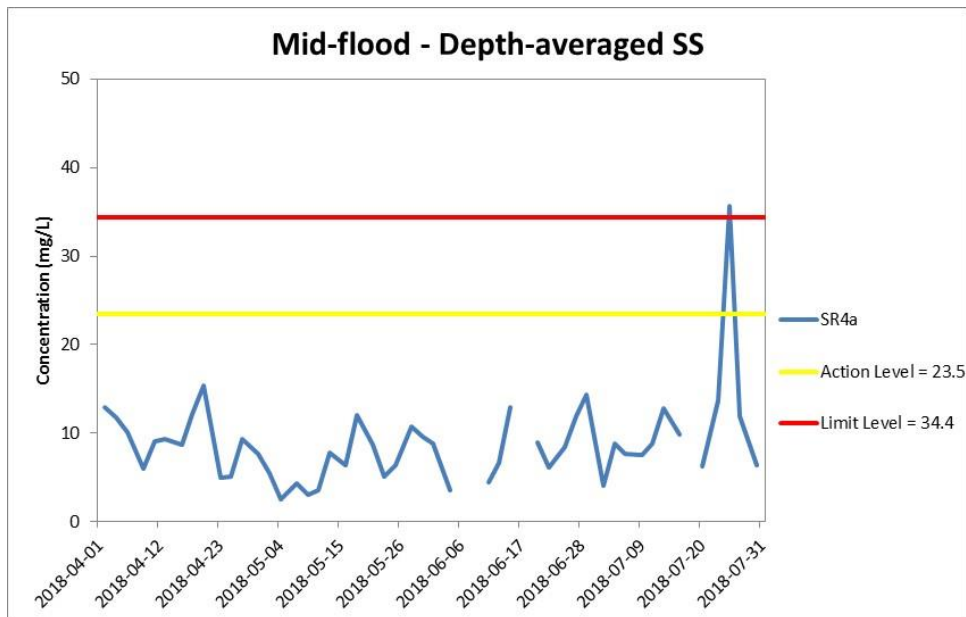
**Figure J36 Impact Monitoring – Mean depth-averaged level of Suspended Solids (mg/L) during mid-flood tide between 1 April and 31 July 2018 at SR4a.**
