**Contract No. HY/2012/07
Tuen Mun – Chek Lap Kok Link –
Southern Connection Viaduct Section**

Fifty-eighth Monthly EM&A Report

12 September 2018

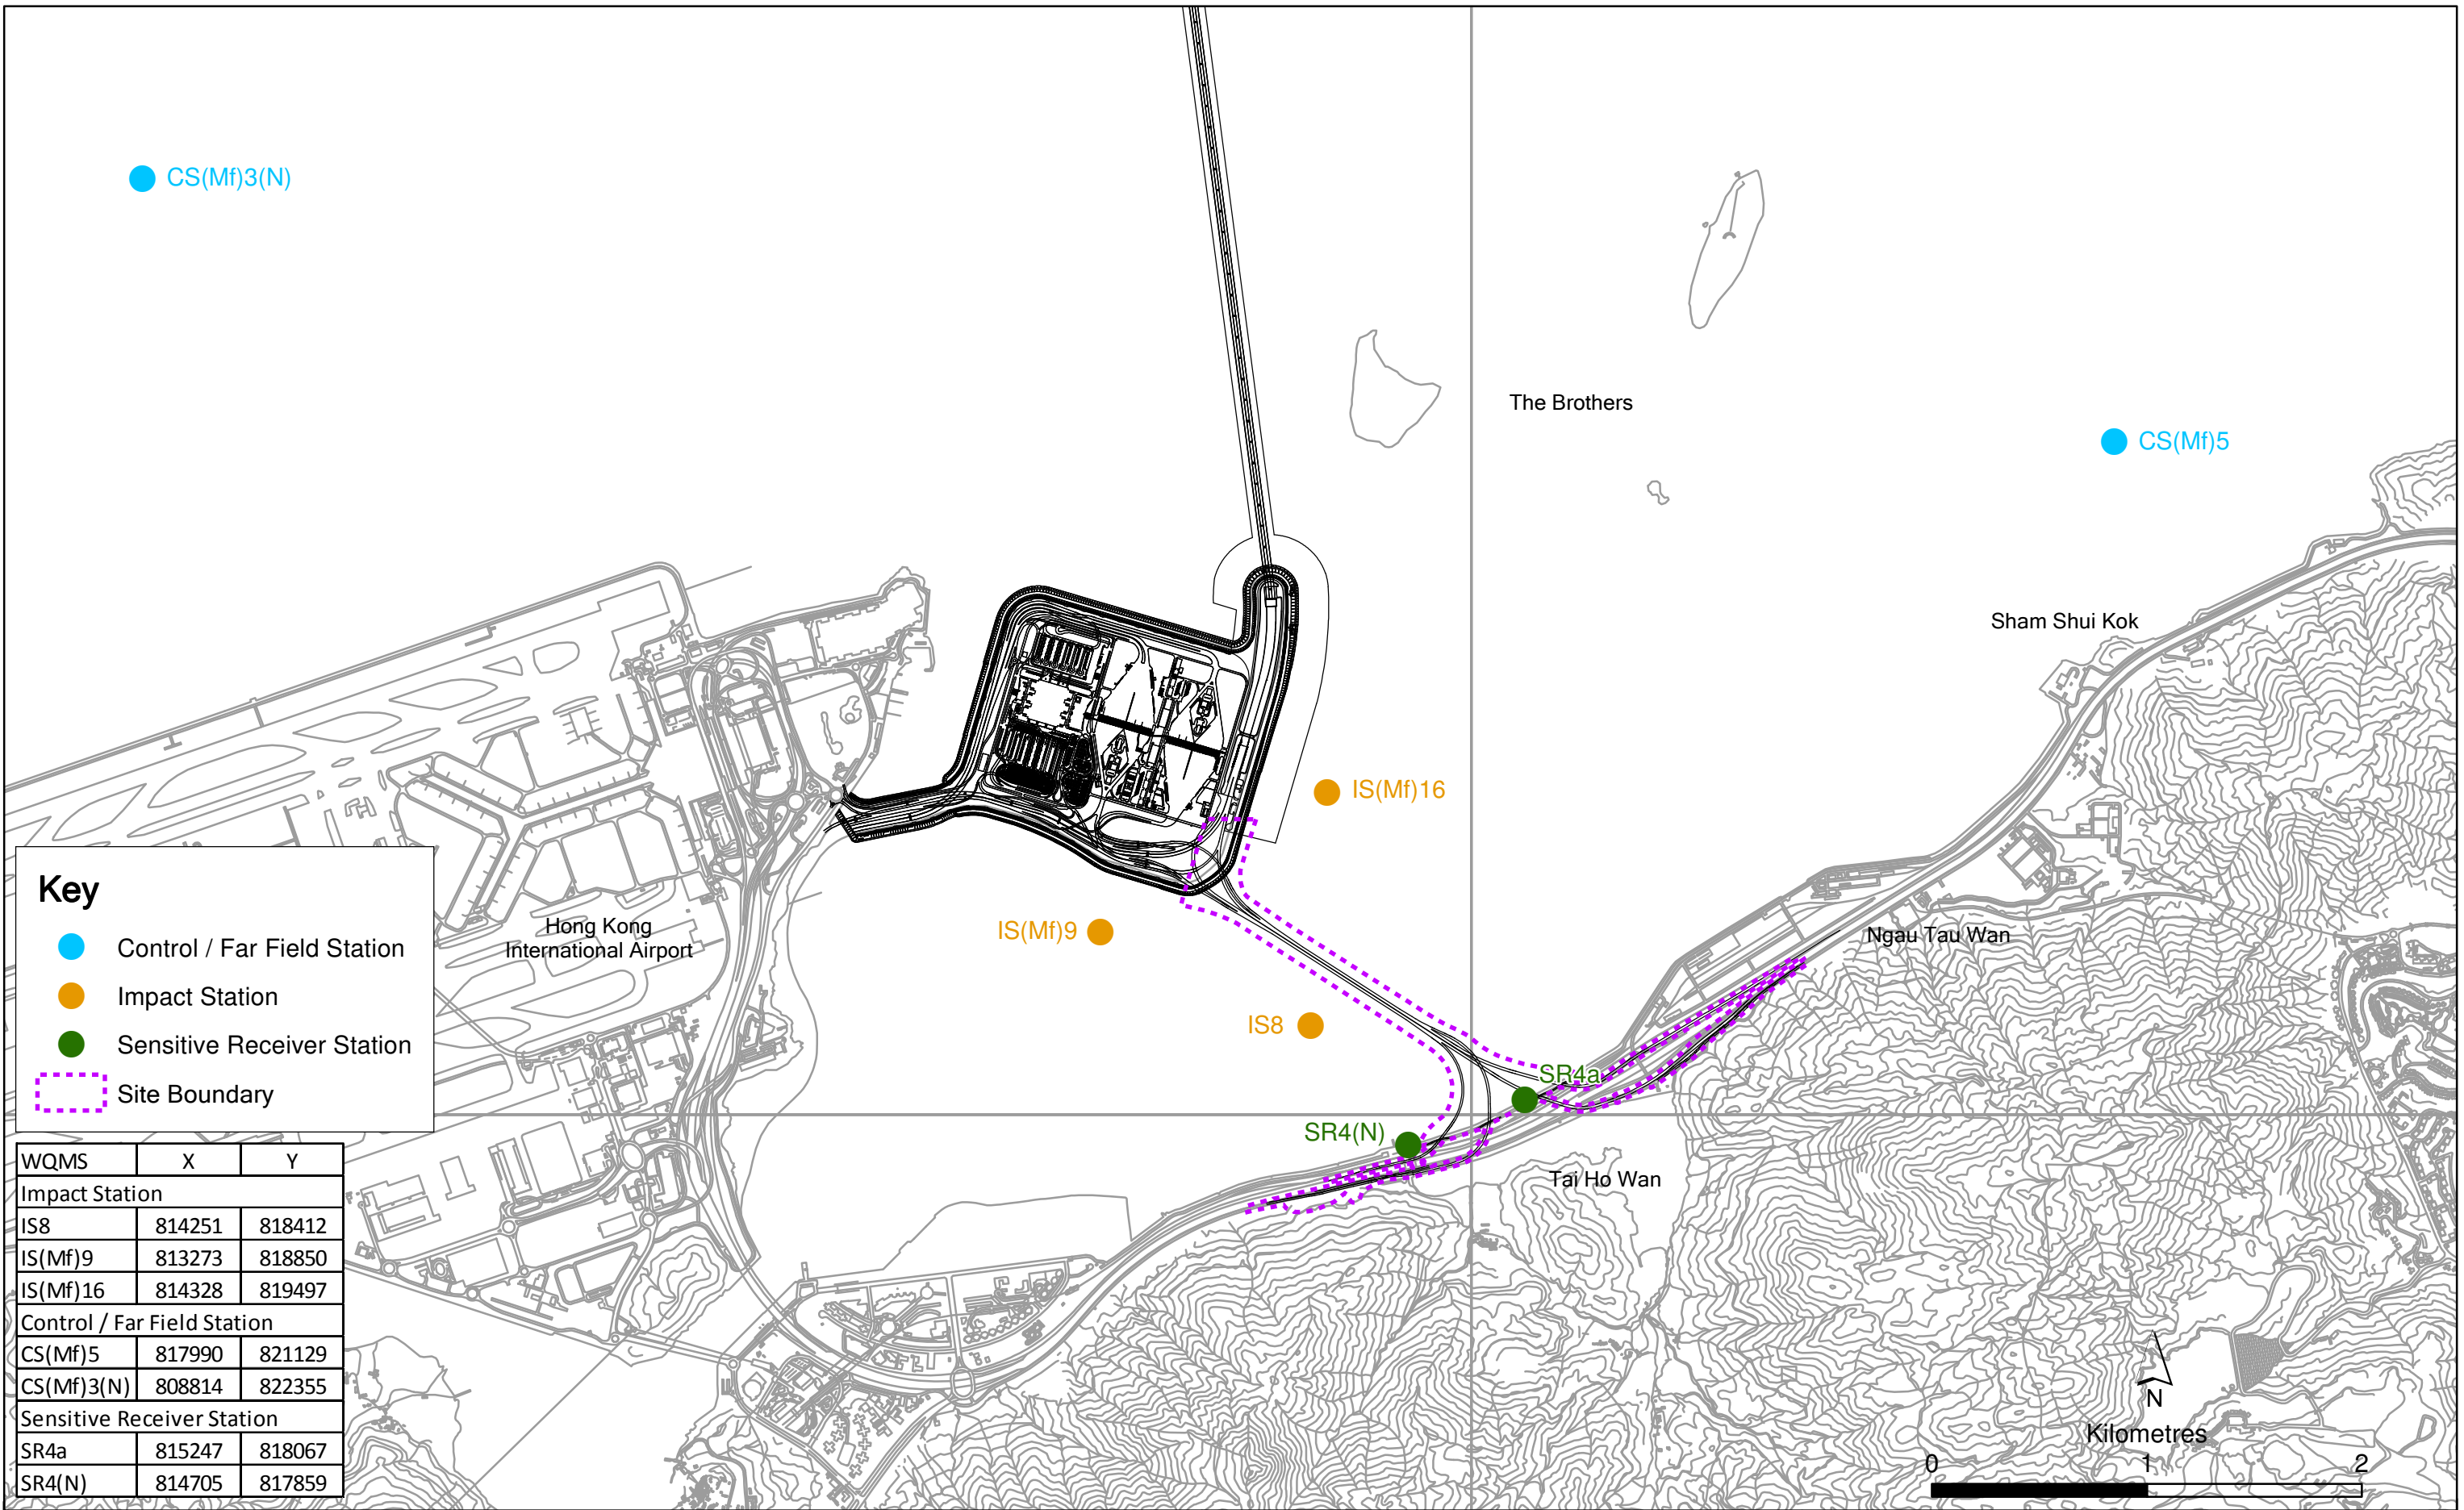
Figure 2.3

Locations of Water Quality Monitoring Stations

The locations of the monitoring stations under the Contract are shown in *Figure 2.3* and *Table 2.8*.

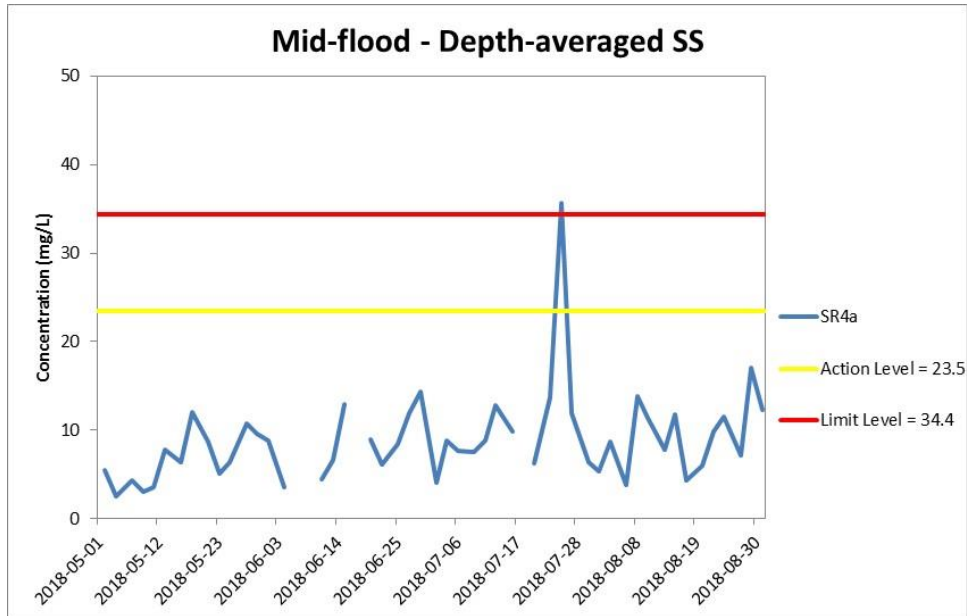
Figure J36 Impact Monitoring – Mean depth-averaged level of Suspended Solids (mg/L) during mid-flood tide between 1 May and 31 August 2018 at SR4a.
