**Contract No. HY/2012/07
Tuen Mun – Chek Lap Kok Link –
Southern Connection Viaduct Section**

Fifty-ninth Monthly EM&A Report

12 October 2018

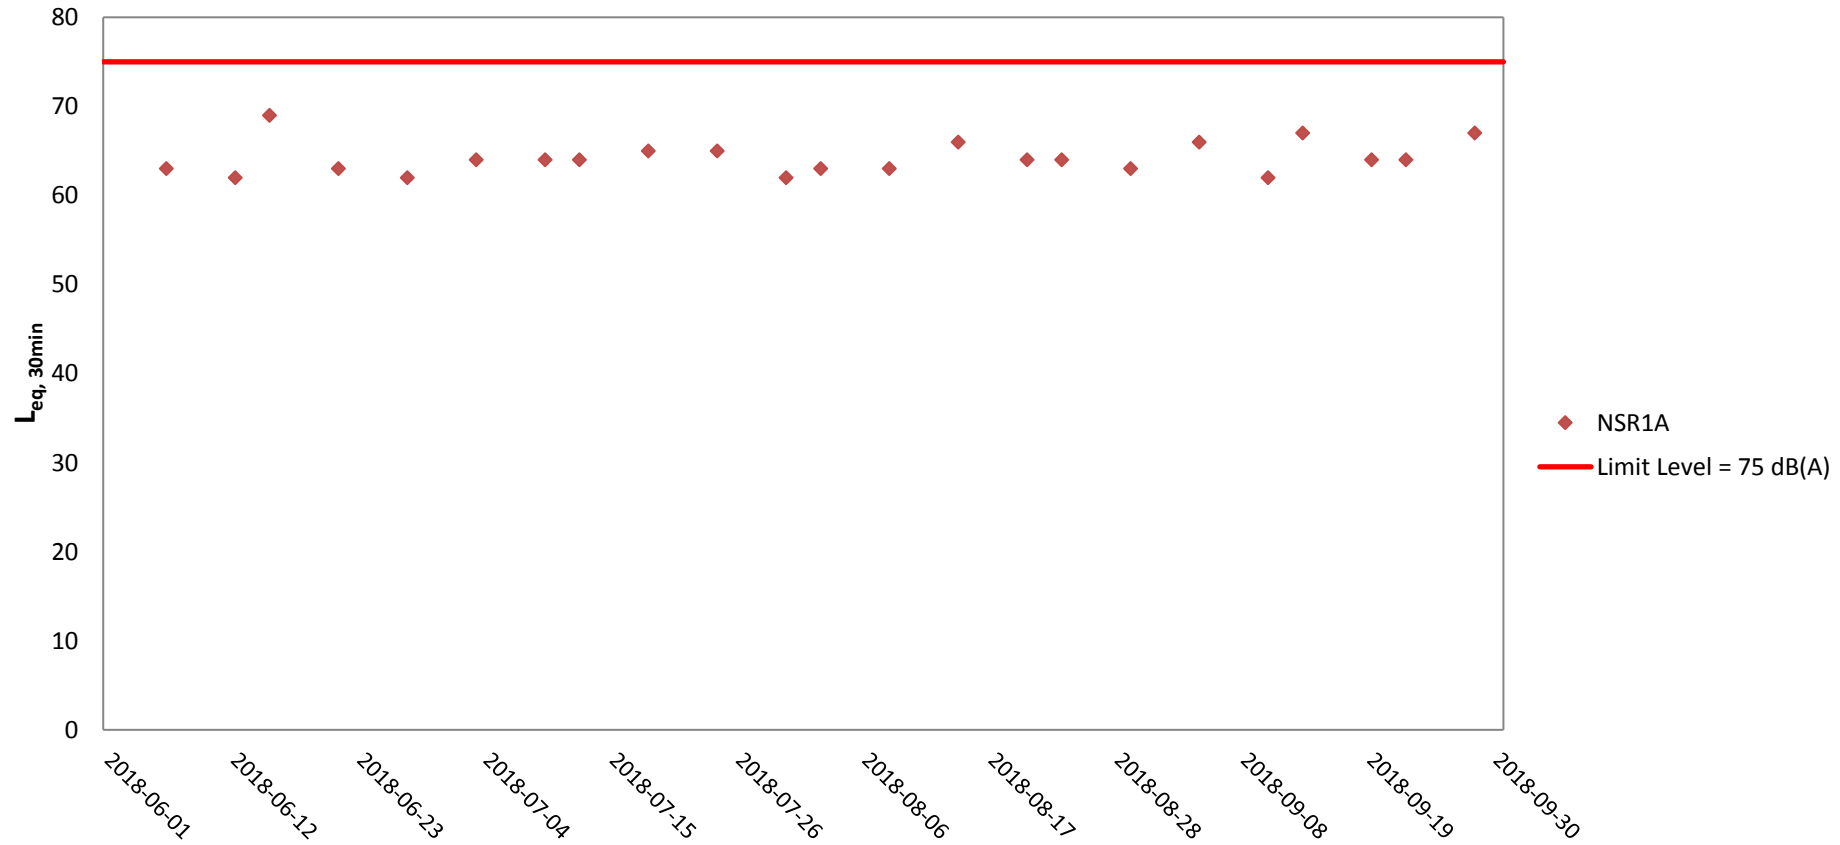
Noise Monitoring Results at NSR 1A ($L_{eq, 30min}$)

Weather condition within the reporting period varied between sunny to rainy.

Major construction works undertaken within the reporting period include Pier construction; Re-alignment of Cheung Tung Road; Road works along North Lantau Highway; Asphalt paving; Sign gantries construction; Parapet installation; and Slope work of Viaducts A, B,C & D.

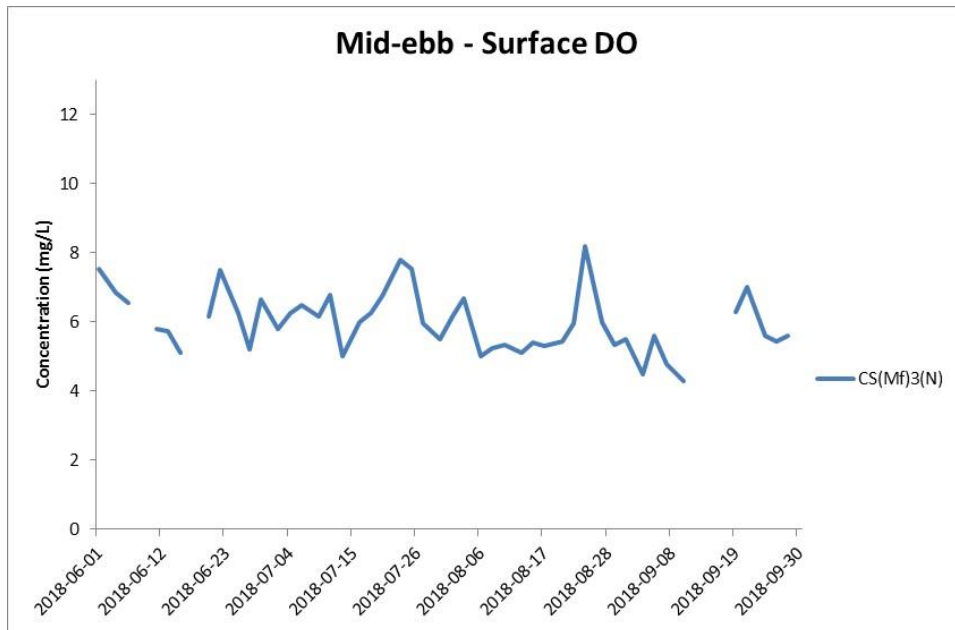
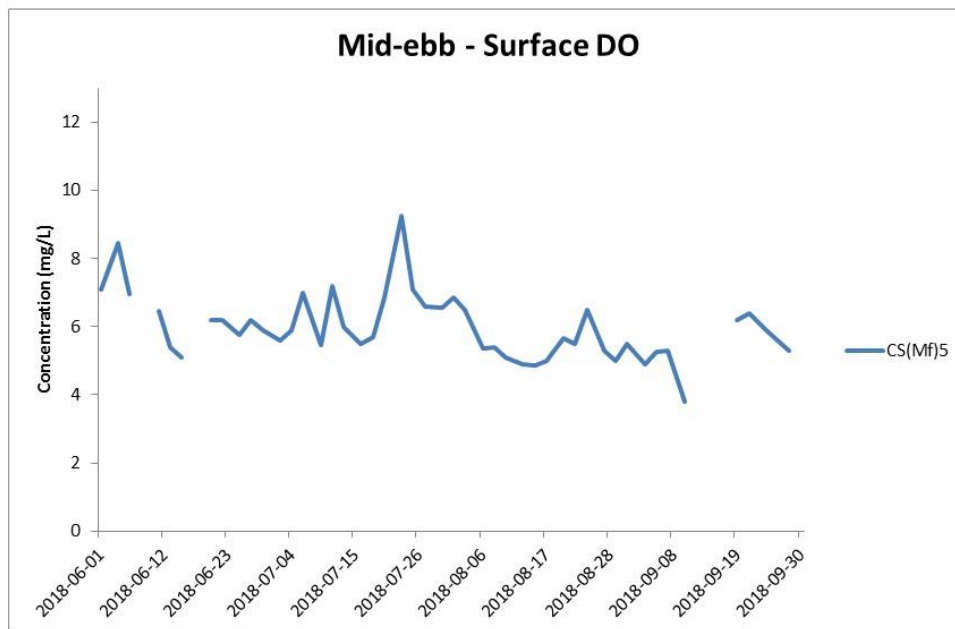
Figure J1 Impact Monitoring - Mean Level of Dissolved Oxygen (mg/L) in surface waters during mid-ebb tide between 1 June and 30 September 2018 at CS(Mf)3(N) and CS(Mf)5.

*(Weather condition varied between sunny to rainy within the reporting period.)
WQM during mid-ebb tide on 12 September 2018 and WQM on 17 September were canceled due to adverse weather.*

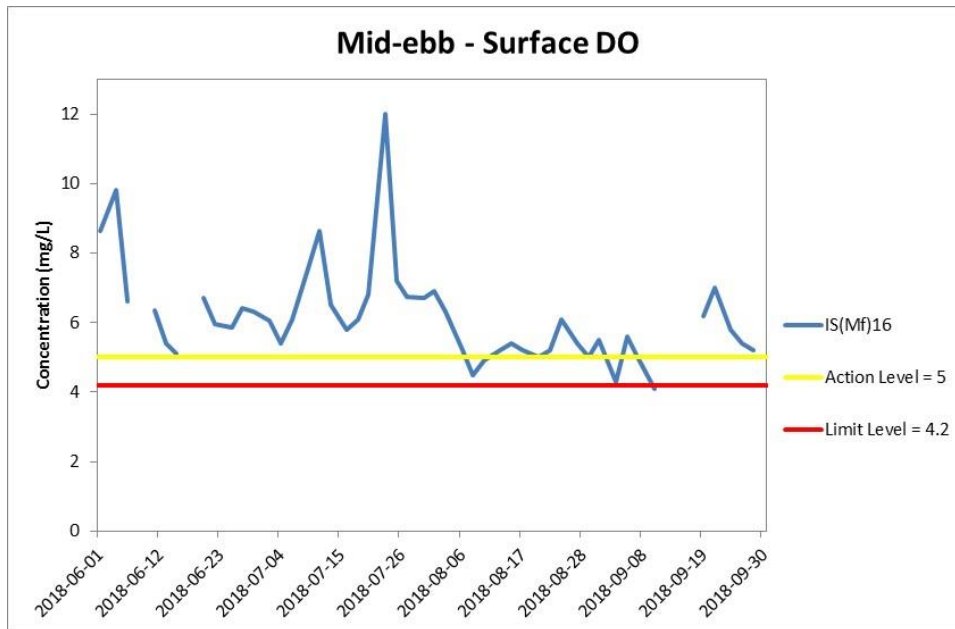
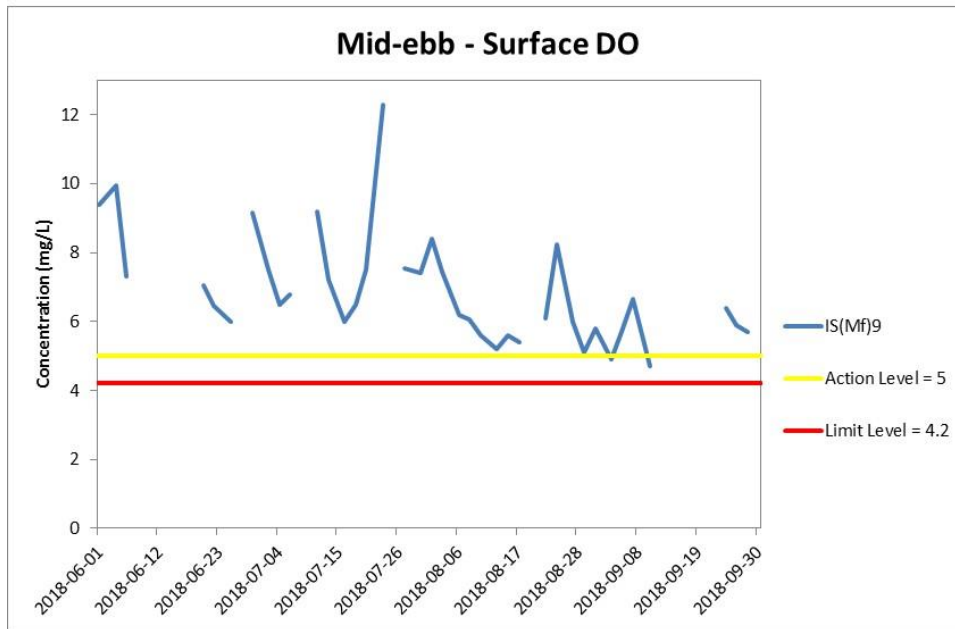
Figure J2 Impact Monitoring - Mean Level of Dissolved Oxygen (mg/L) in surface waters during mid-ebb tide between 1 June and 30 September 2018 at IS(Mf)16 and IS(Mf)9.

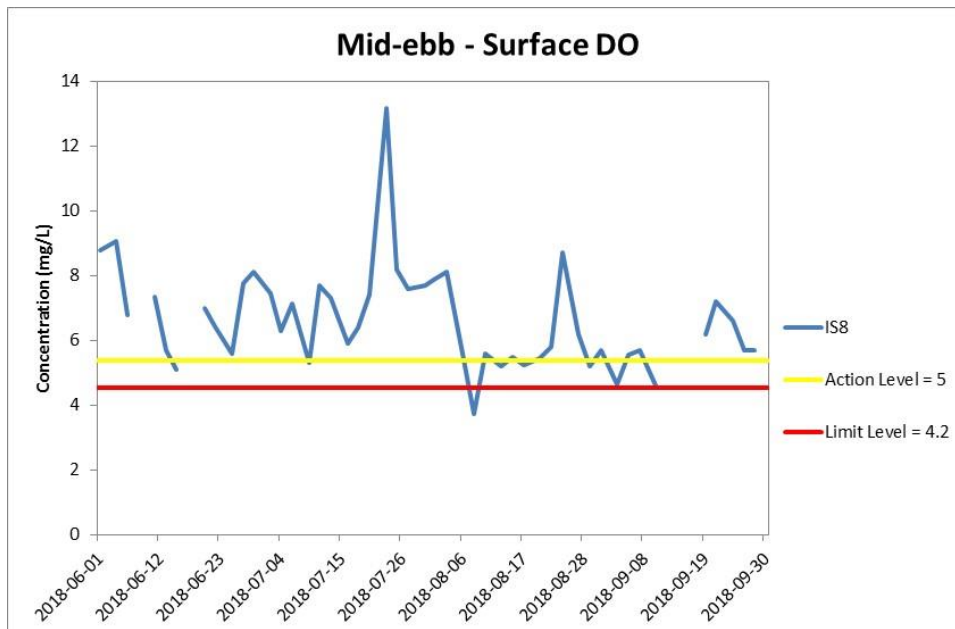
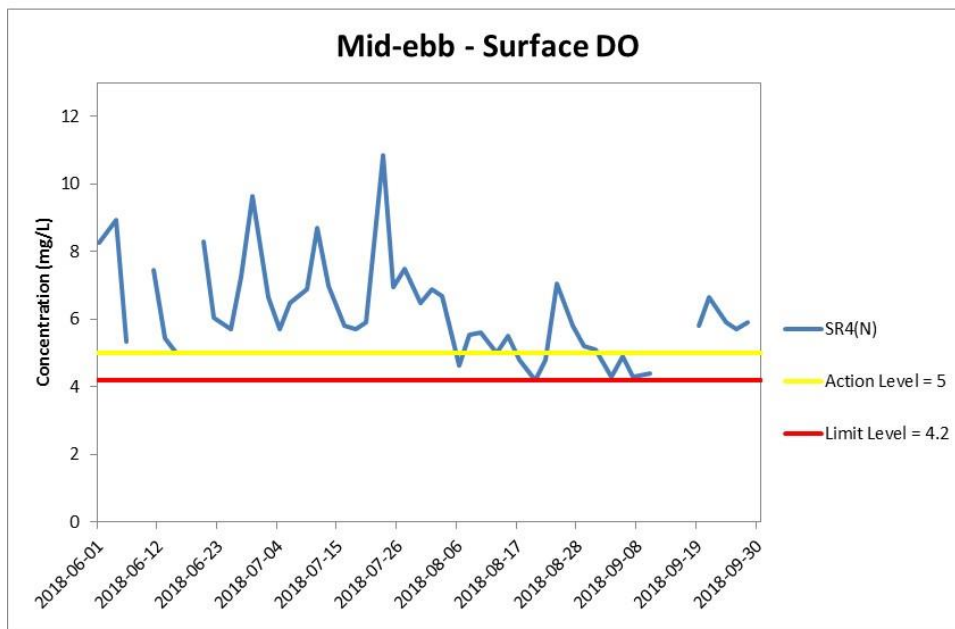
Figure J3 Impact Monitoring - Mean Level of Dissolved Oxygen (mg/L) in surface waters during mid-ebb tide between 1 June and 30 September 2018 at IS8 and SR4(N).

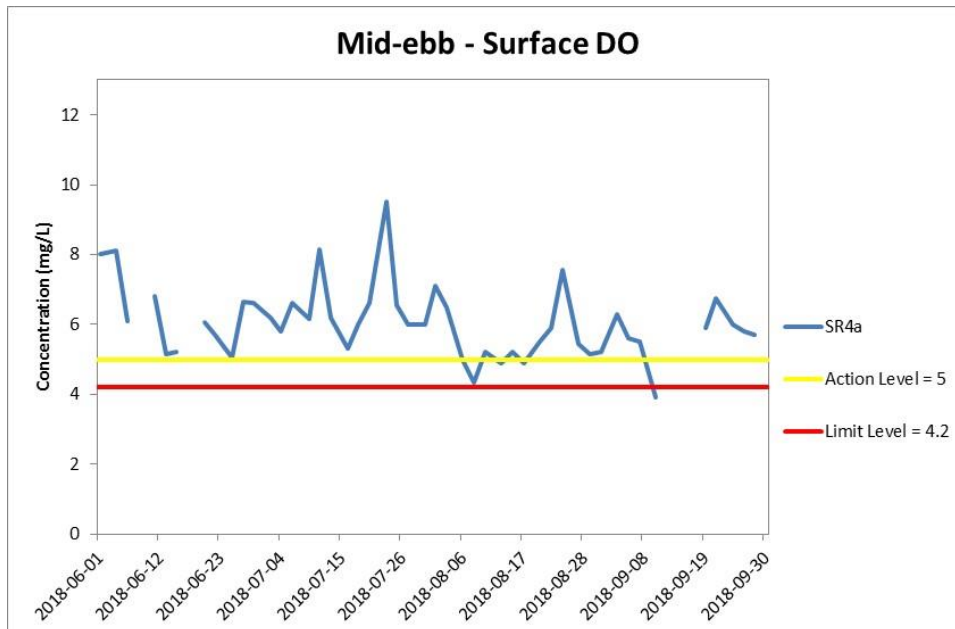
Figure J4 Impact Monitoring – Mean Level of Dissolved Oxygen (mg/L) in surface waters during mid-ebb tide between 1 June and 30 September 2018 at SR4a.

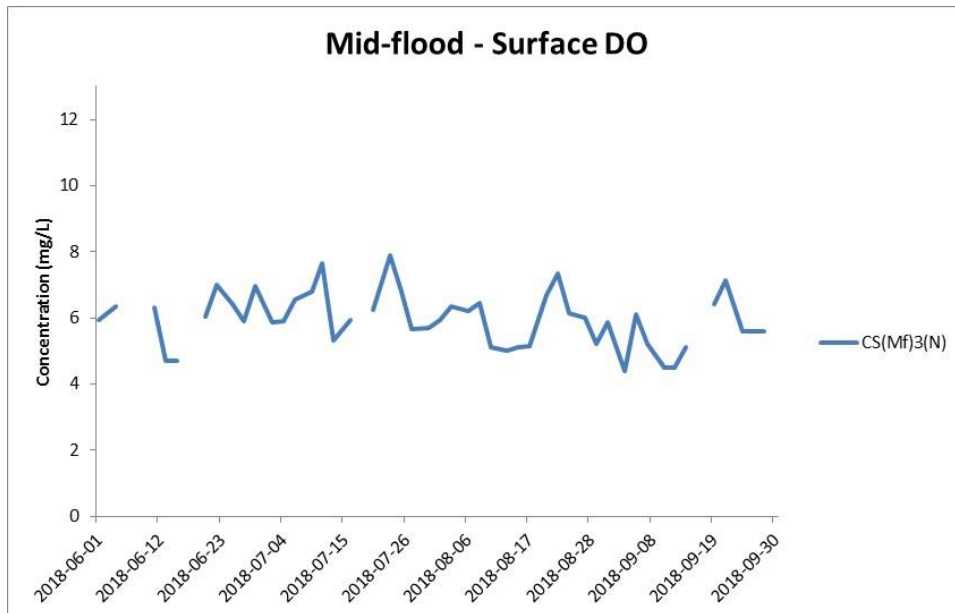
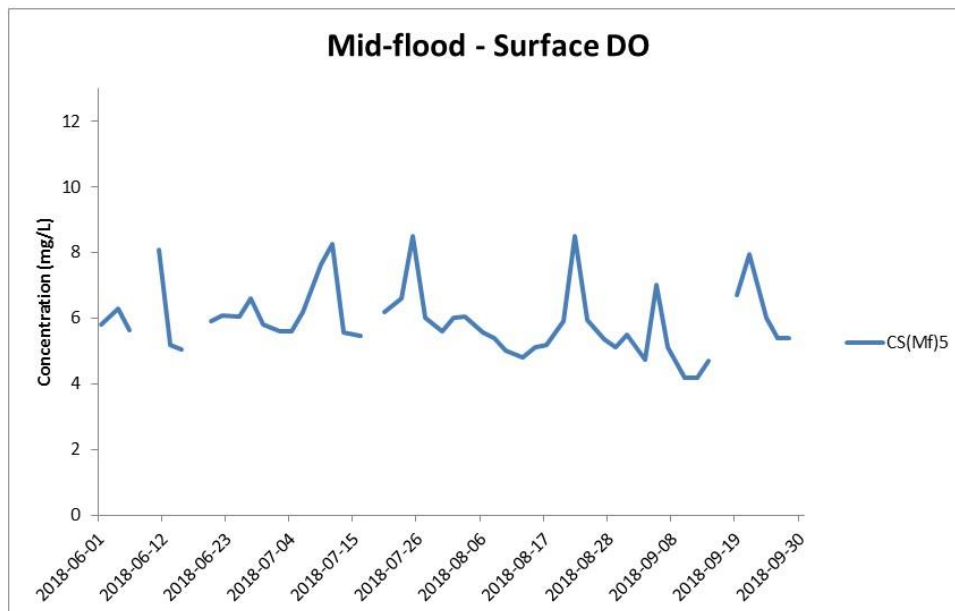
Figure J5 Impact Monitoring - Mean Level of Dissolved Oxygen (mg/L) in surface waters during mid-flood tide between 1 June and 30 September 2018 at CS(Mf)3(N) and CS(Mf)5.

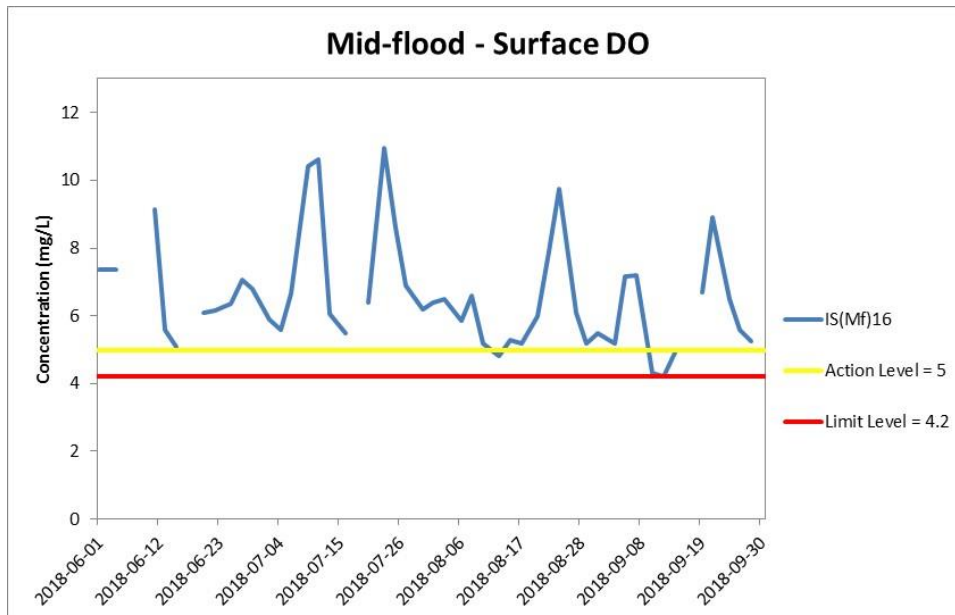
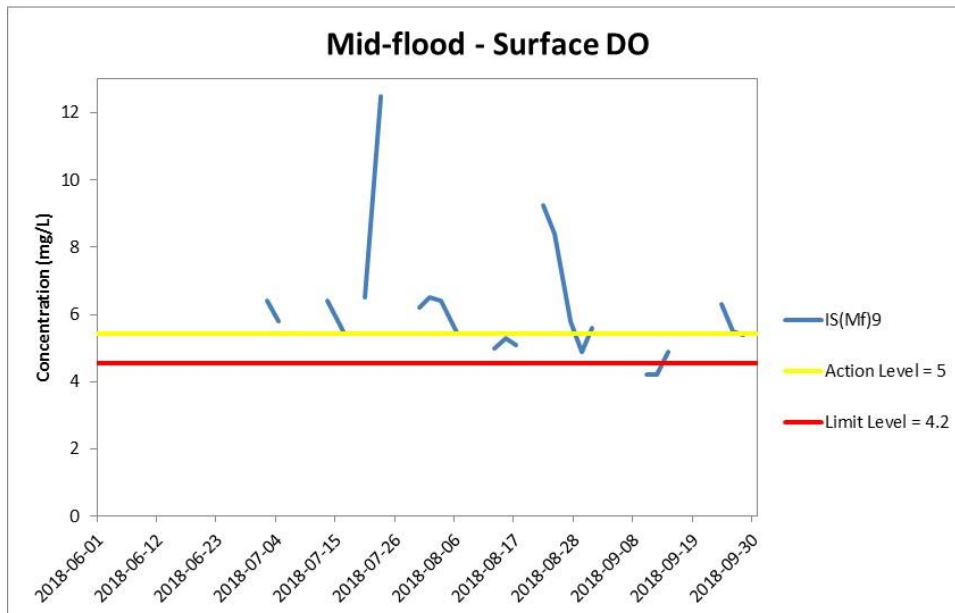
Figure J6 Impact Monitoring – Mean Level of Dissolved Oxygen (mg/L) in surface waters during mid-flood tide between 1 June and 30 September 2018 at IS(Mf)16 and IS(Mf)9.

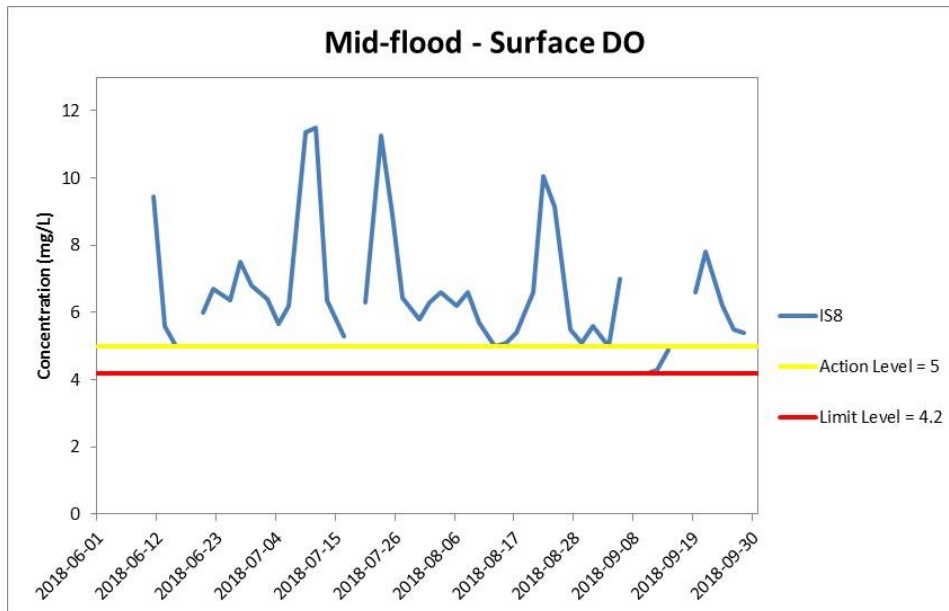
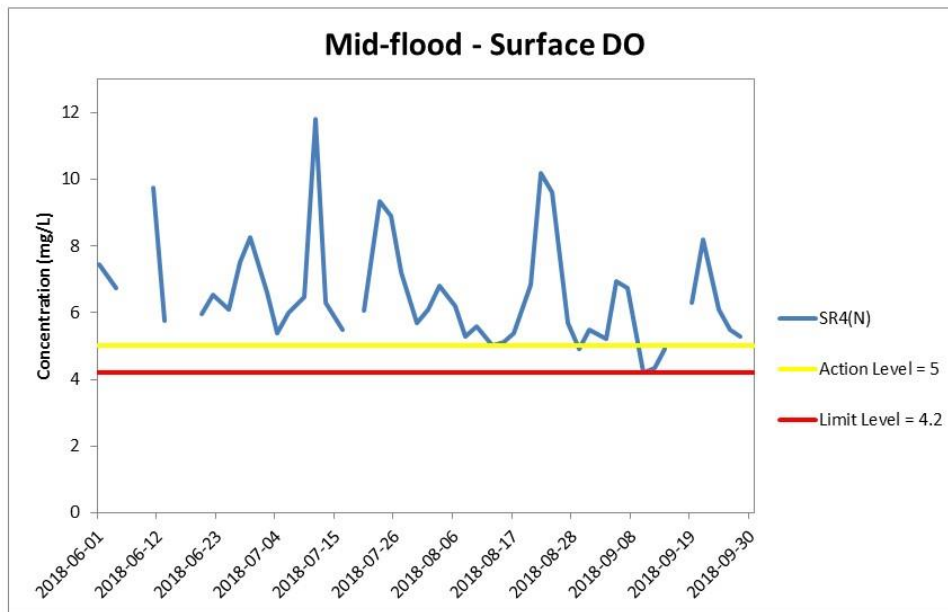
Figure J7 Impact Monitoring – Mean Level of Dissolved Oxygen (mg/L) in surface waters during mid-flood tide between 1 June and 30 September 2018 at IS8 and SR4(N).

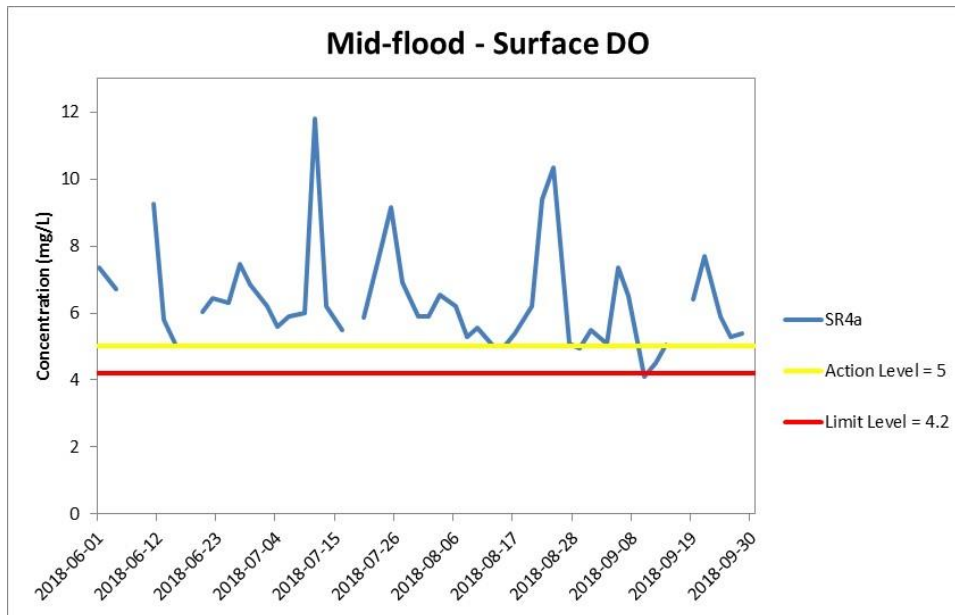
Figure J8 Impact Monitoring - Mean Level of Dissolved Oxygen (mg/L) in surface waters during mid-flood tide between 1 June and 30 September 2018 at SR4a.

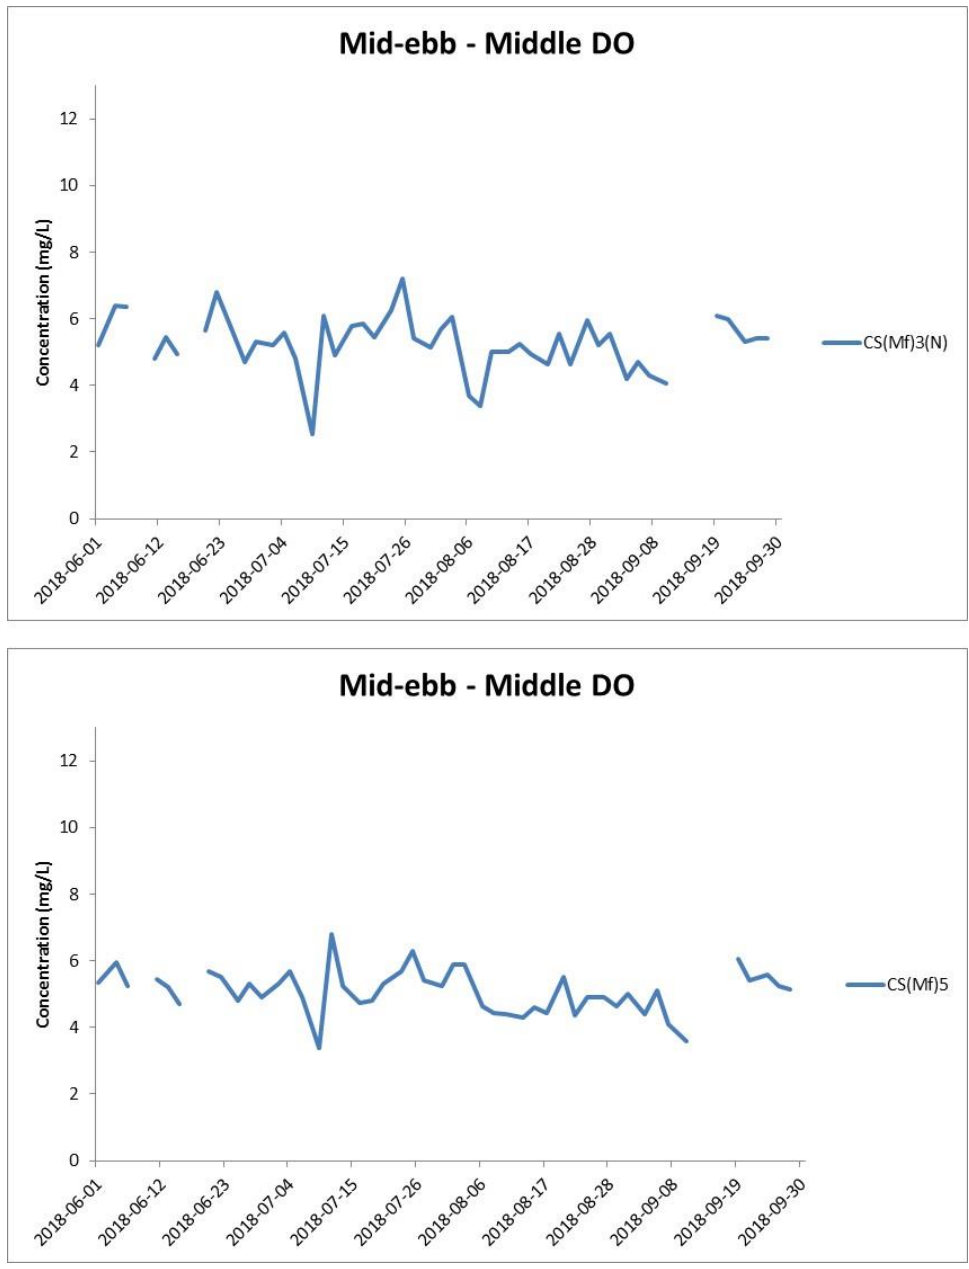
Figure J9 Impact Monitoring - Mean Level of Dissolved Oxygen (mg/L) in mid-depth waters during mid-ebb tide between 1 June and 30 September 2018 at CS(Mf)3(N) and CS(Mf)5.

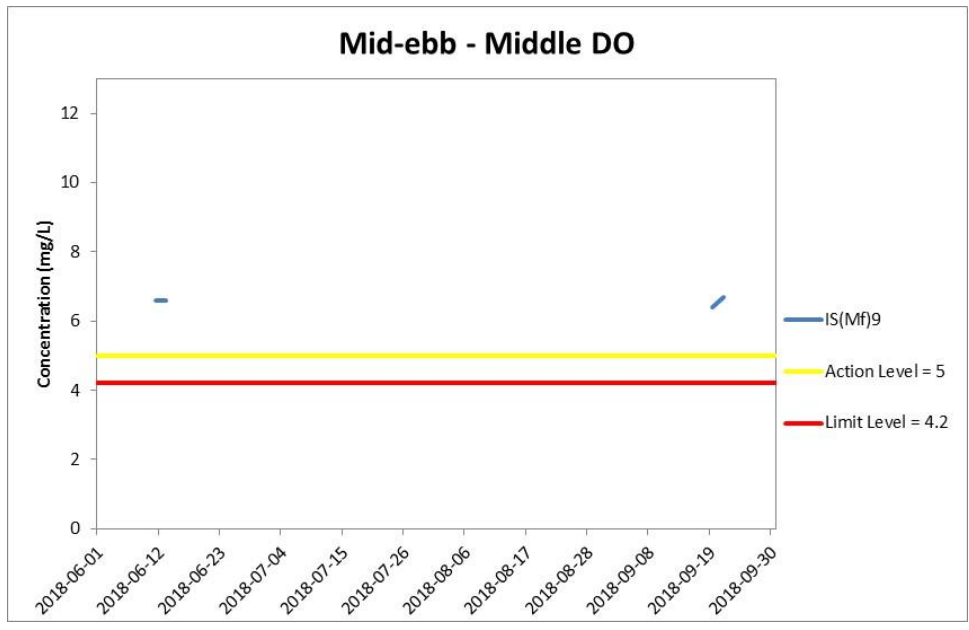
Figure J10 Impact Monitoring – Mean Level of Dissolved Oxygen (mg/L) in mid-depth waters during mid-ebb tide between 1 June and 30 September 2018 at IS(Mf)9.

(Weather condition varied between sunny to rainy within the reporting period.)
WQM during mid-ebb tide on 12 September 2018 and WQM on 17 September were canceled due to adverse weather.
In-situ monitoring is taken according to the requirement specified in the EM&A Manual, i.e. 3 water depth namely 1m below sea surface, mid-depth and 1m above sea bed. If the water depth is less than 3m, mid-depth sampling only. If water depth less than 6m, mid-depth may be omitted.

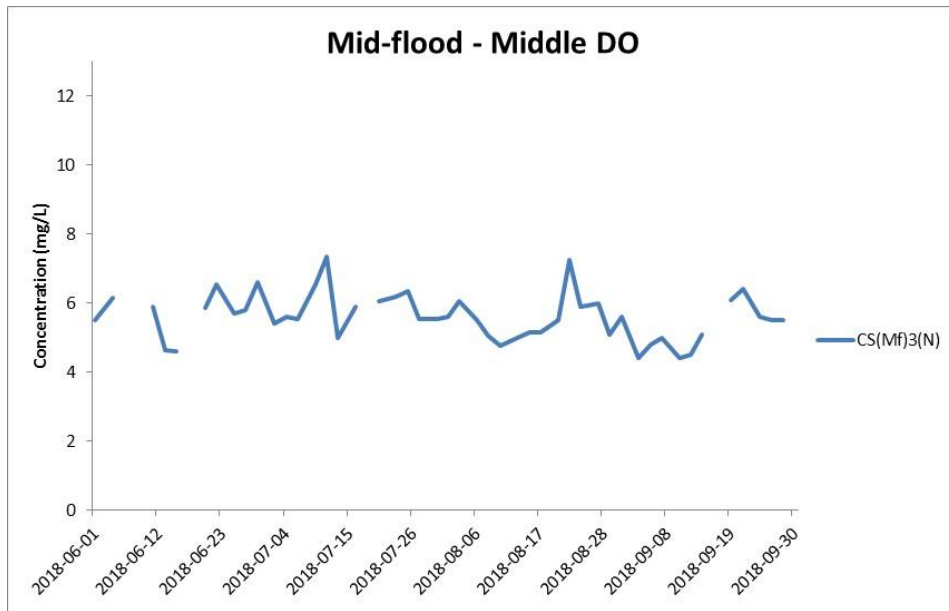
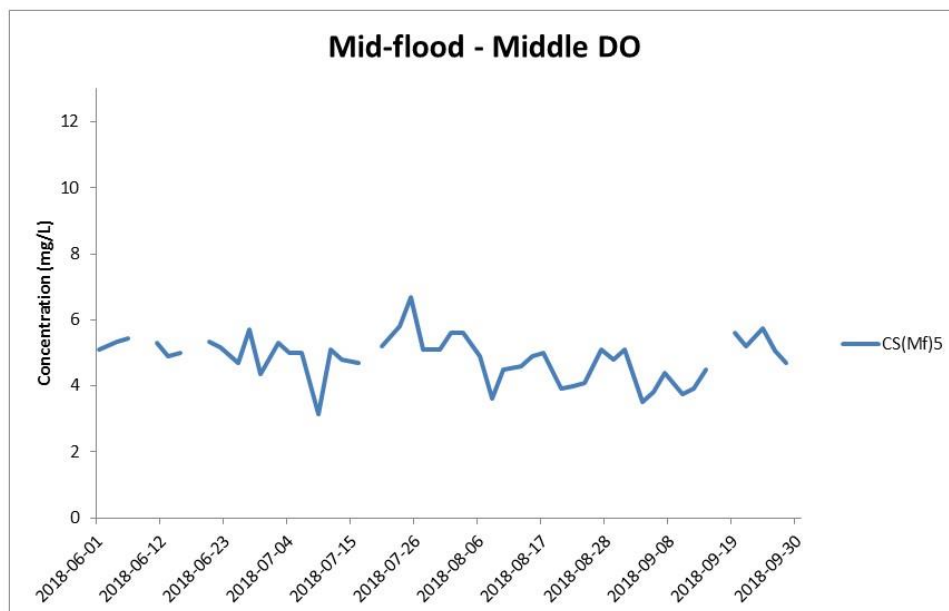
Figure J11 Impact Monitoring – Mean Level of Dissolved Oxygen (mg/L) in mid-depth waters during mid-flood tide between 1 June and 30 September 2018 at CS(Mf)3(N) and CS(Mf)5.

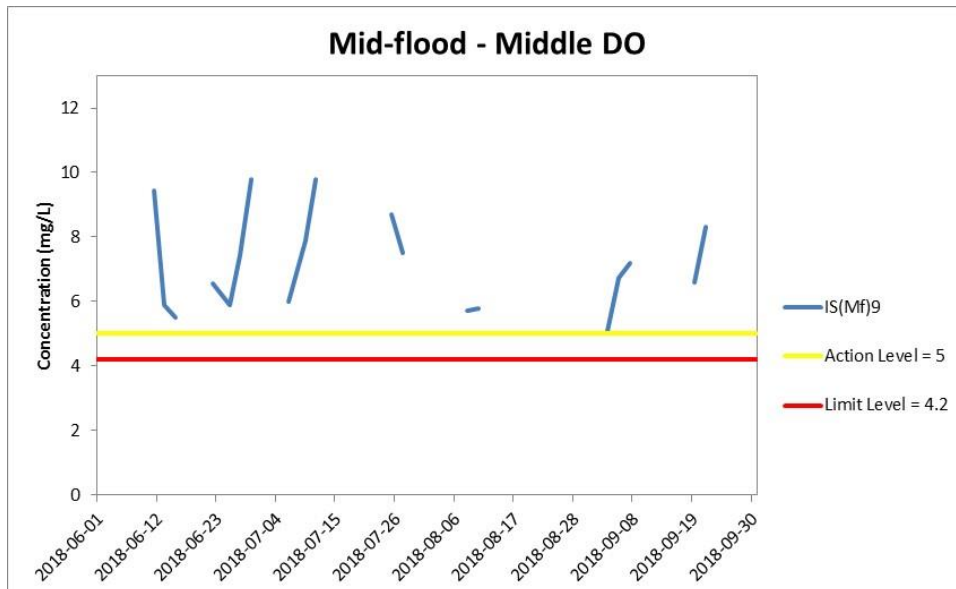
Figure J12 Impact Monitoring - Mean Level of Dissolved Oxygen (mg/L) in mid-depth waters during mid-flood tide between 1 June and 30 September 2018 at IS(Mf)9.

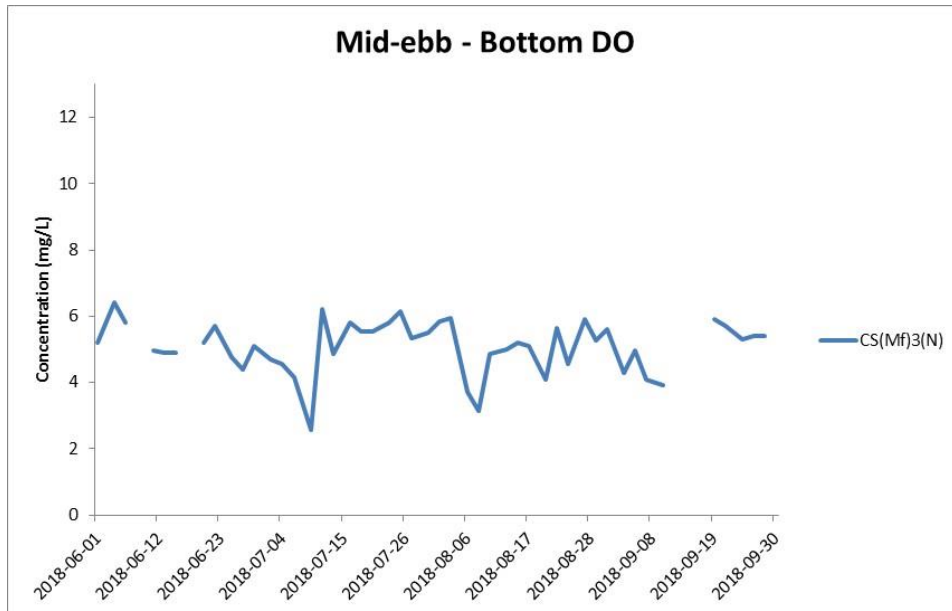
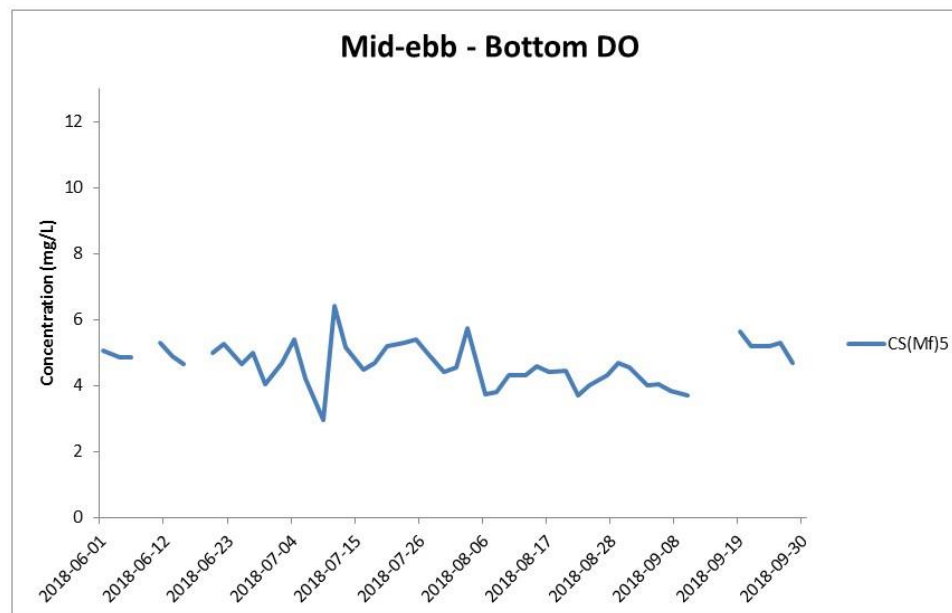
Figure J13 Impact Monitoring - Mean Level of Dissolved Oxygen (mg/L) in bottom waters during mid-ebb tide between 1 June and 30 September 2018 at CS(Mf)3(N) and CS(Mf)5.

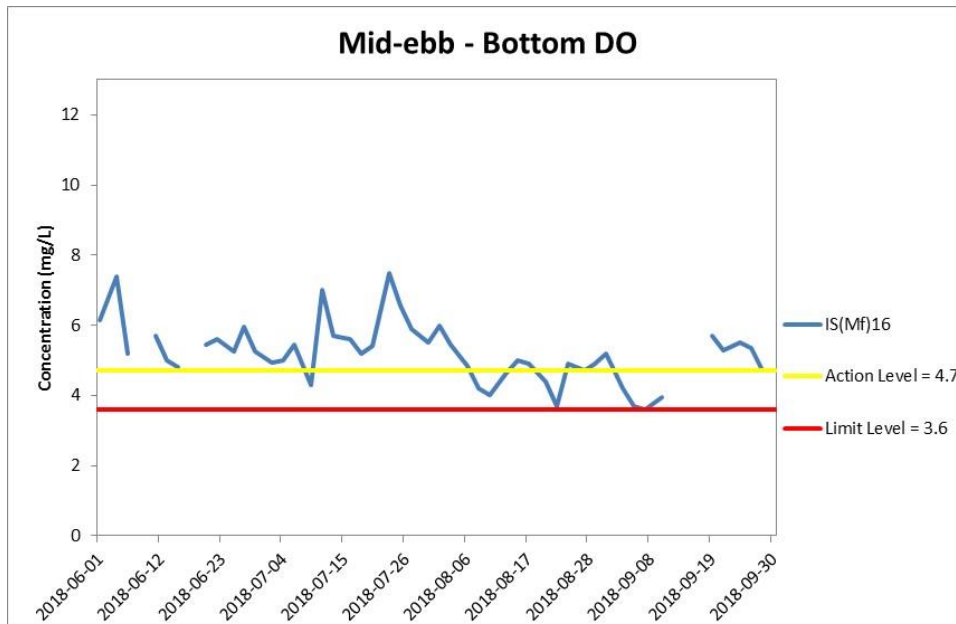
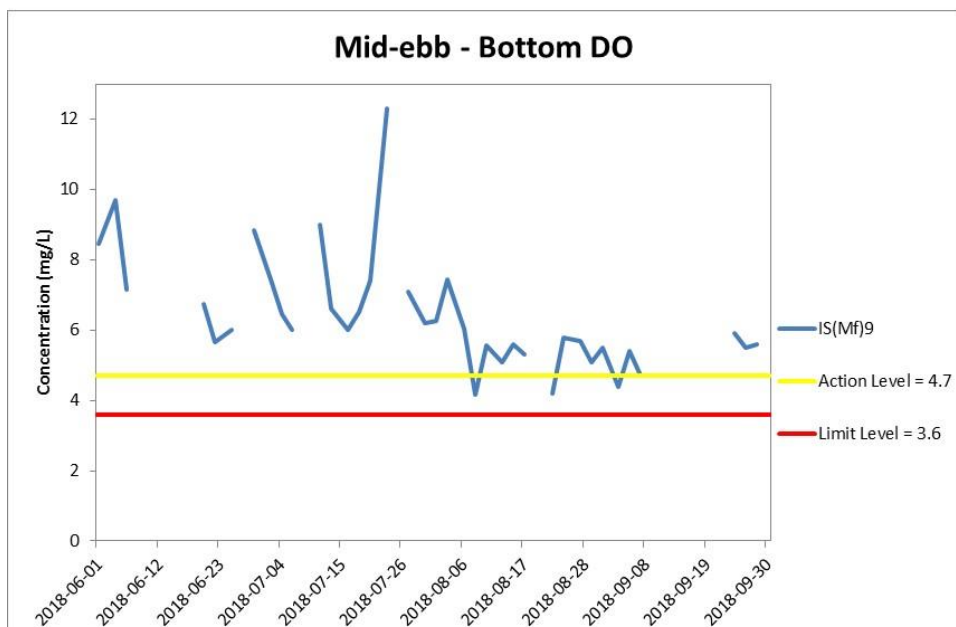
Figure J14 Impact Monitoring – Mean Level of Dissolved Oxygen (mg/L) in bottom waters during mid-ebb tide between 1 June and 30 September 2018 at IS(Mf)16 and IS(Mf)9.

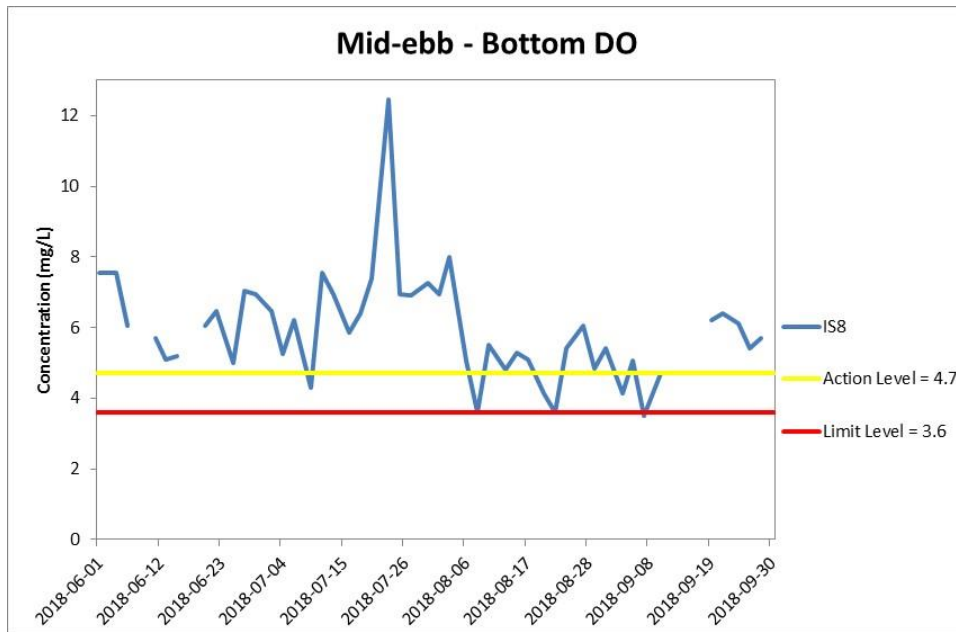
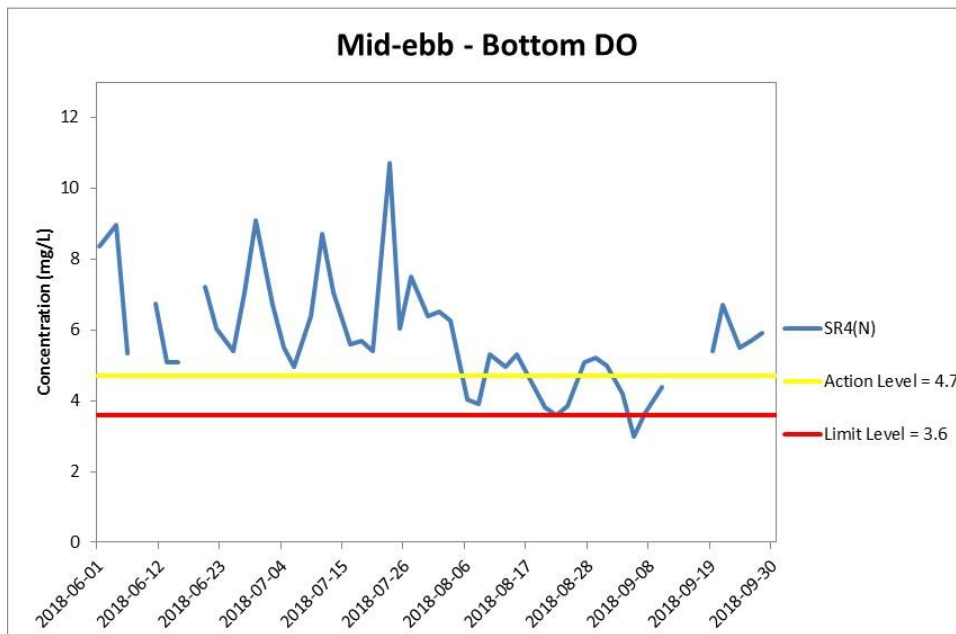
Figure J15 Impact Monitoring - Mean Level of Dissolved Oxygen (mg/L) in bottom waters during mid-ebb tide between 1 June and 30 September 2018 at IS8 and SR4(N).

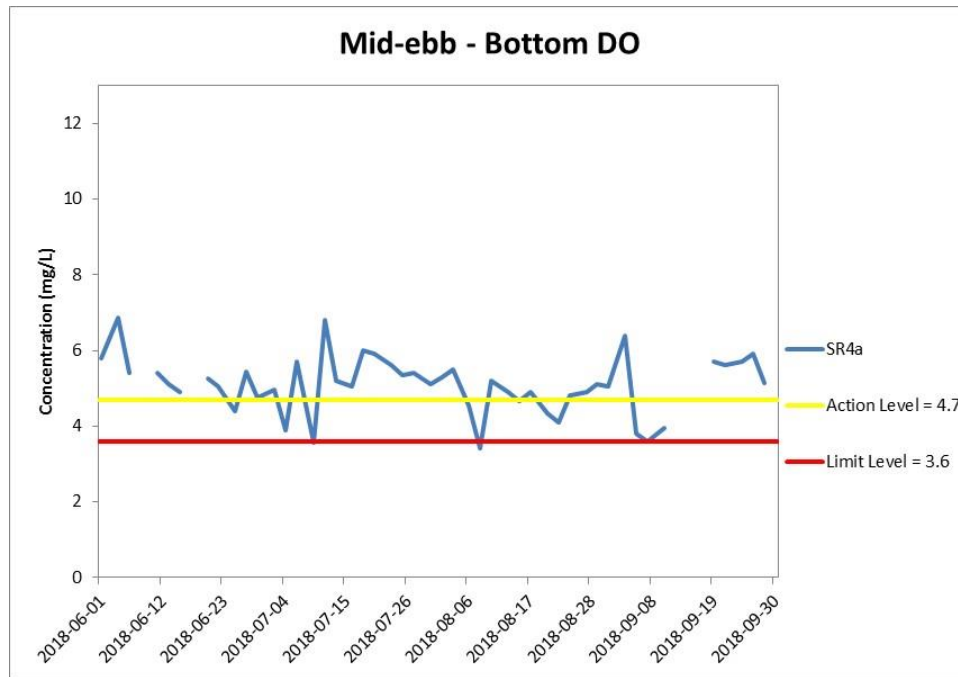
Figure J16 Impact Monitoring – Mean Level of Dissolved Oxygen (mg/L) in bottom waters during mid-ebb tide between 1 June and 30 September 2018 at SR4a.

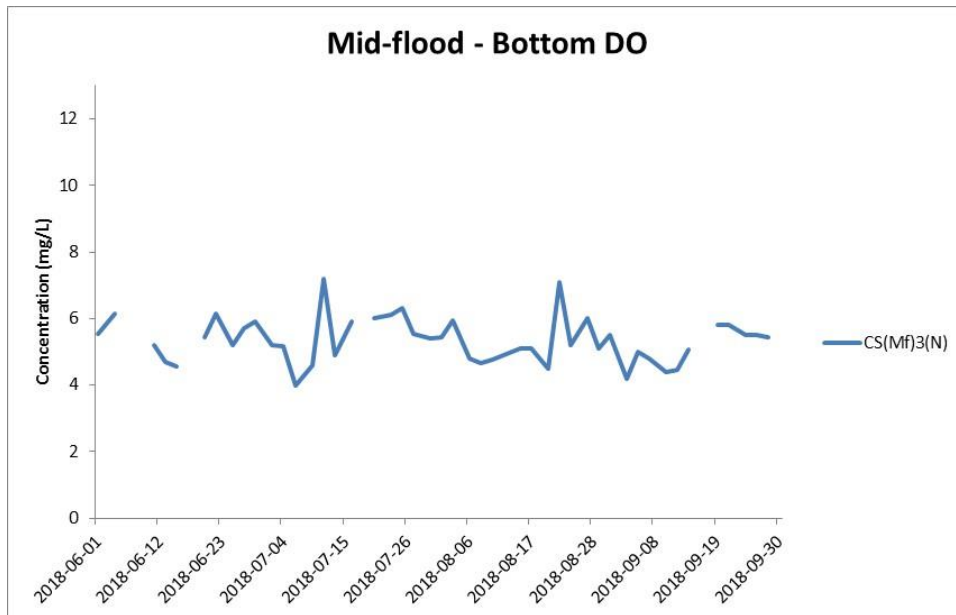
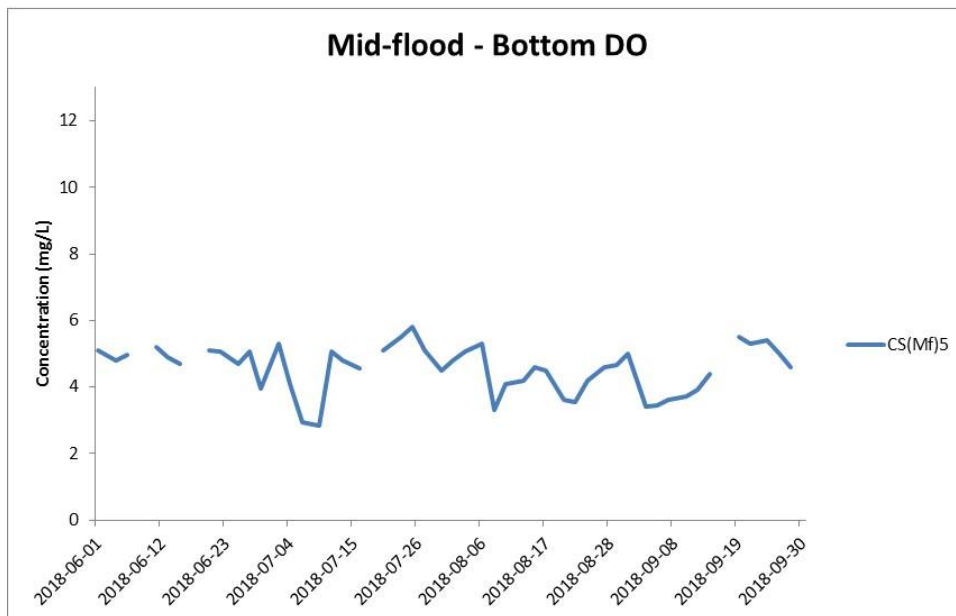
Figure J17 Impact Monitoring - Mean Level of Dissolved Oxygen (mg/L) in bottom waters during mid-flood tide between 1 June and 30 September 2018 at CS(Mf)3(N) and CS(Mf)5.

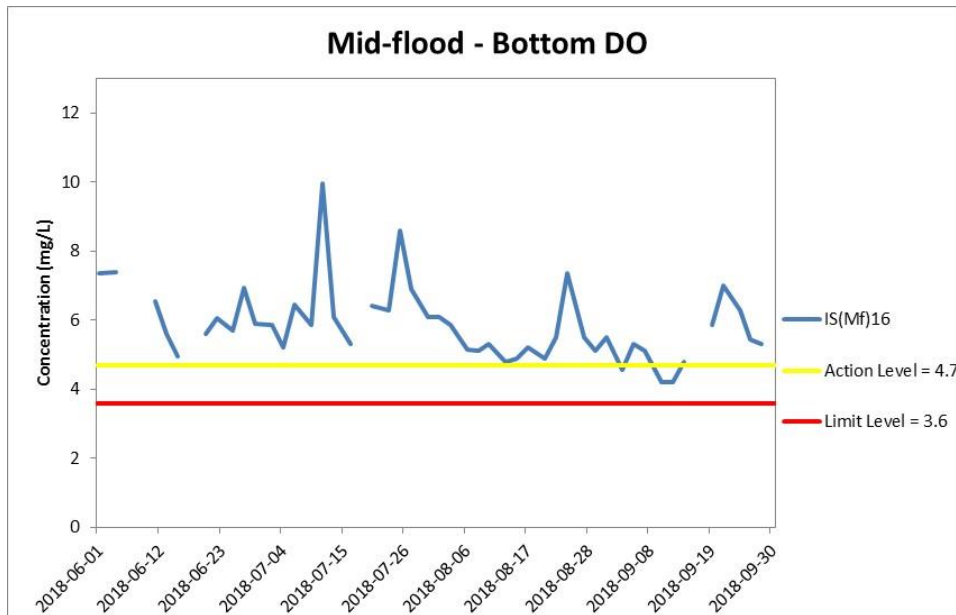
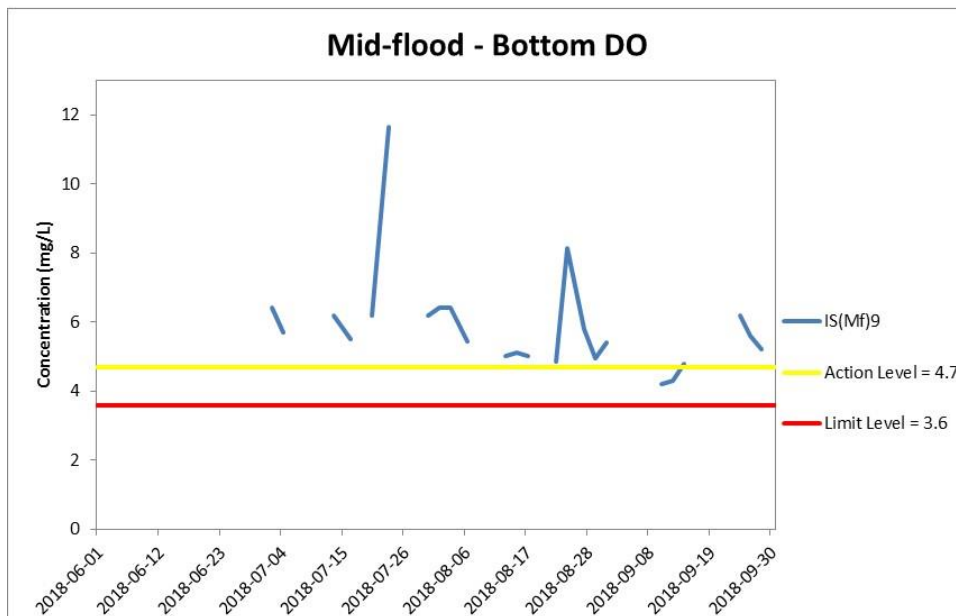
Figure J18 Impact Monitoring - Mean Level of Dissolved Oxygen (mg/L) in bottom waters during mid-flood tide between 1 June and 30 September 2018 at IS(Mf)16 and IS(Mf)9.

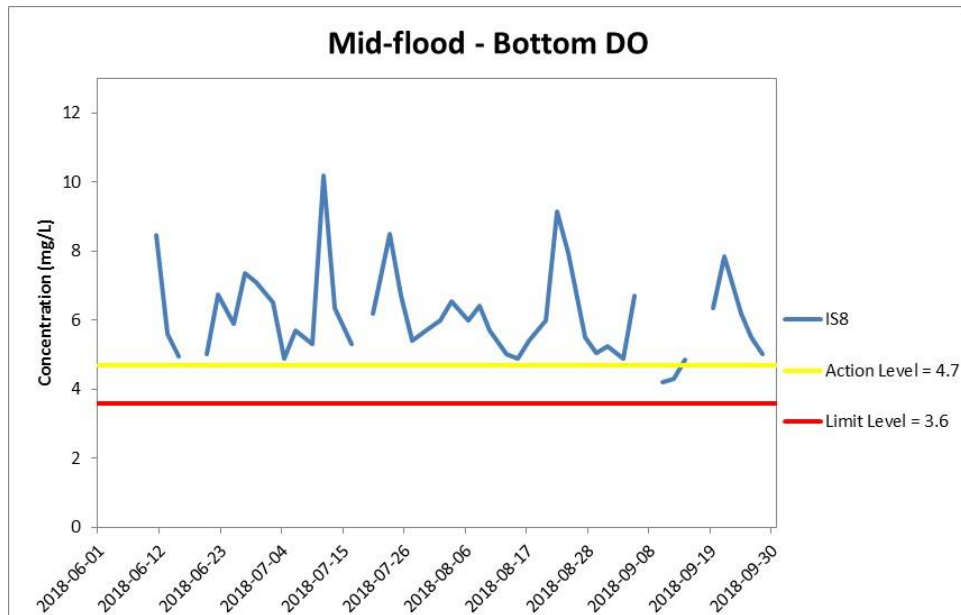
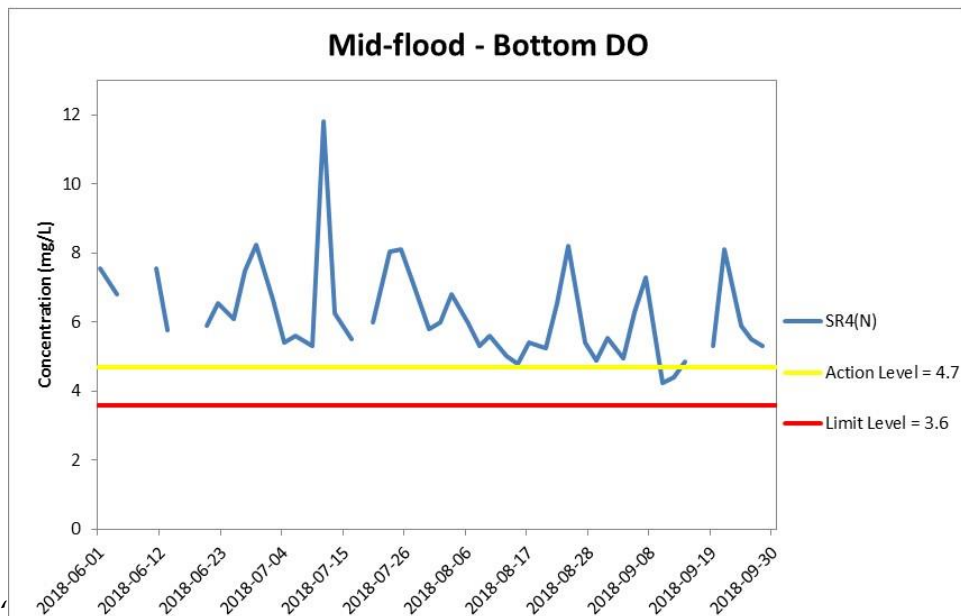
Figure J19 Impact Monitoring - Mean Level of Dissolved Oxygen (mg/L) in bottom waters during mid-flood tide between 1 June and 30 September 2018 at IS8 and SR4(N).

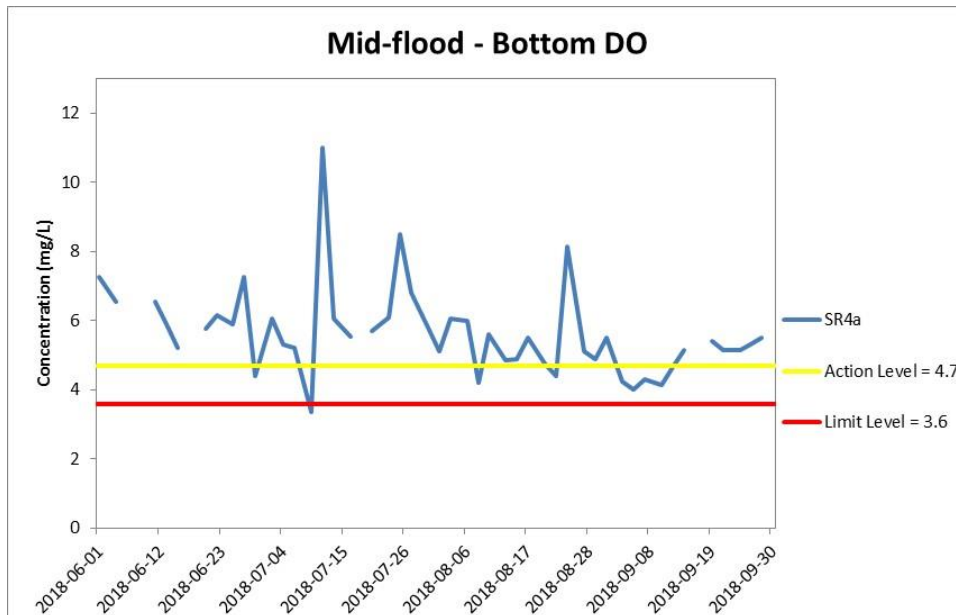
Figure J20 Impact Monitoring – Mean Level of Dissolved Oxygen (mg/L) in bottom waters during mid-flood tide between 1 June and 30 September 2018 at SR4a.
