**Contract No. HY/2012/07
Tuen Mun – Chek Lap Kok Link –
Southern Connection Viaduct Section**

Fifty-ninth Monthly EM&A Report

12 October 2018

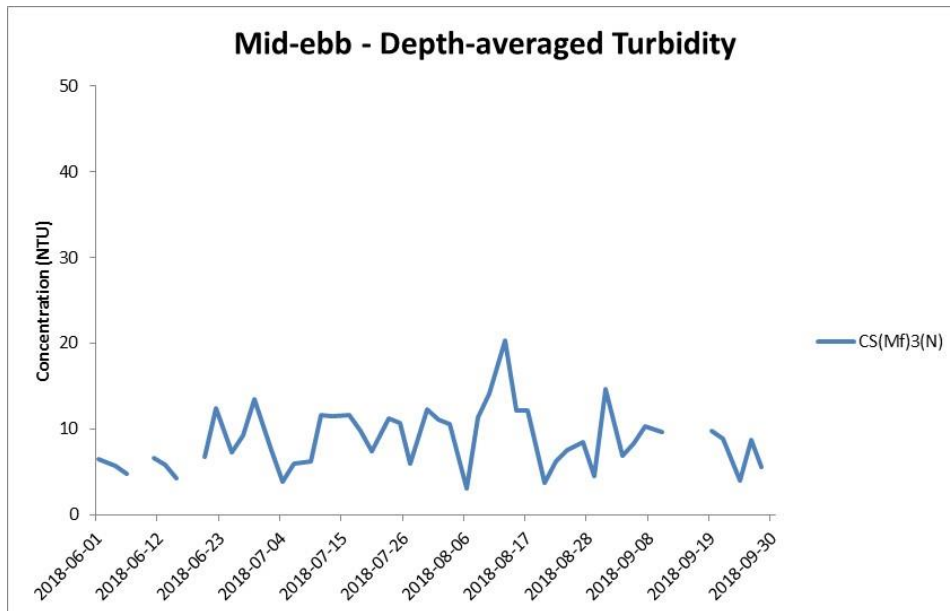
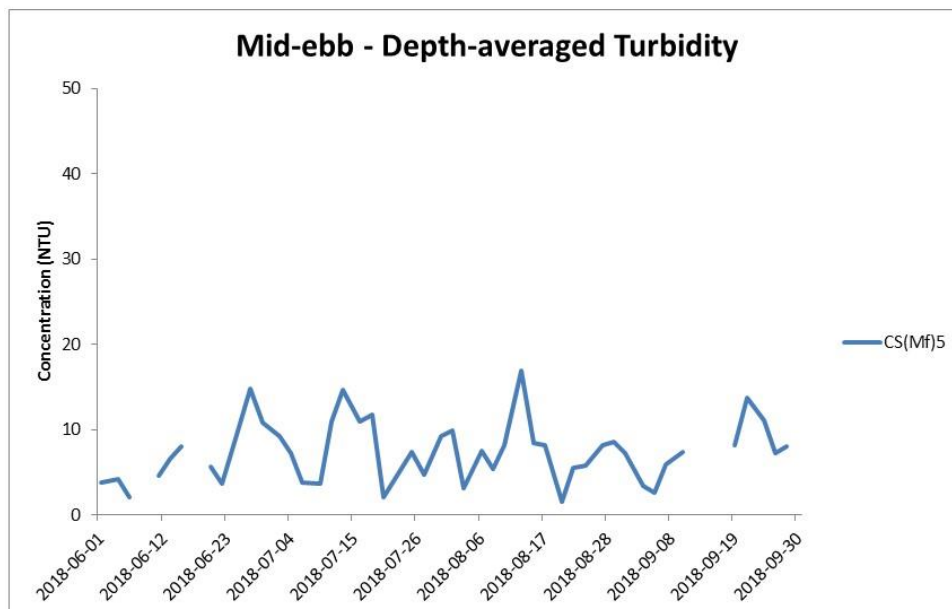
Figure J21 Impact Monitoring - Mean Level of depth-averaged Turbidity (NTU) during mid-ebb tide between 1 June and 30 September 2018 at CS(Mf)3(N) and CS(Mf)5.

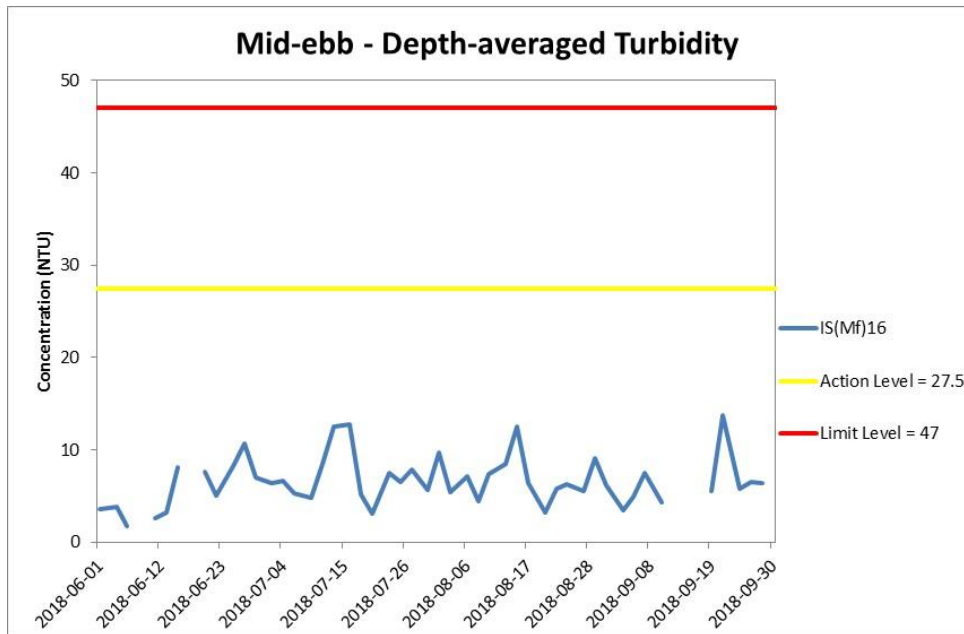
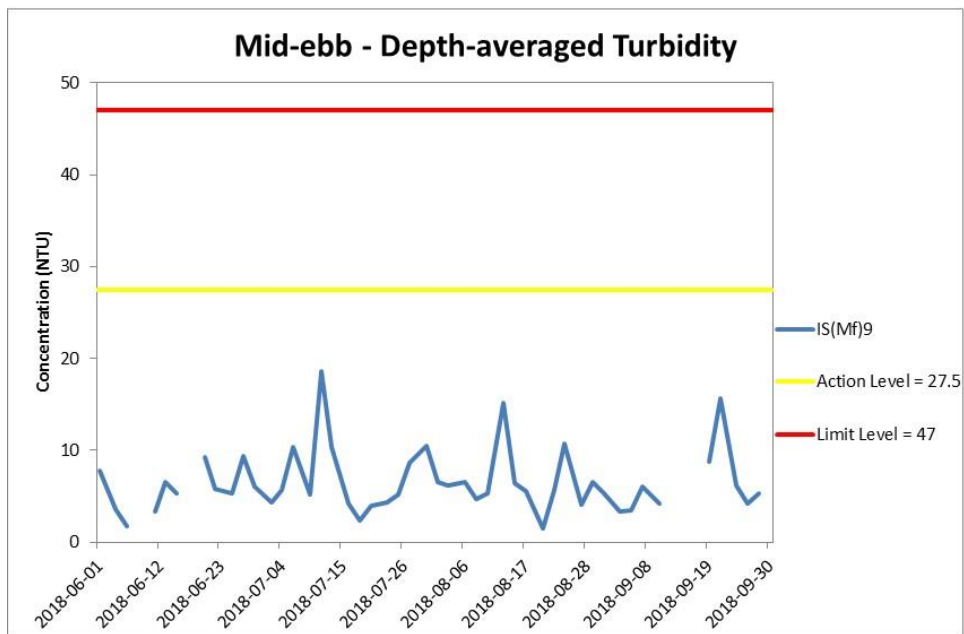
Figure J22 Impact Monitoring - Mean Level of depth-averaged Turbidity (NTU) during mid-ebb tide between 1 June and 30 September 2018 at IS(Mf)16 and IS(Mf)9.

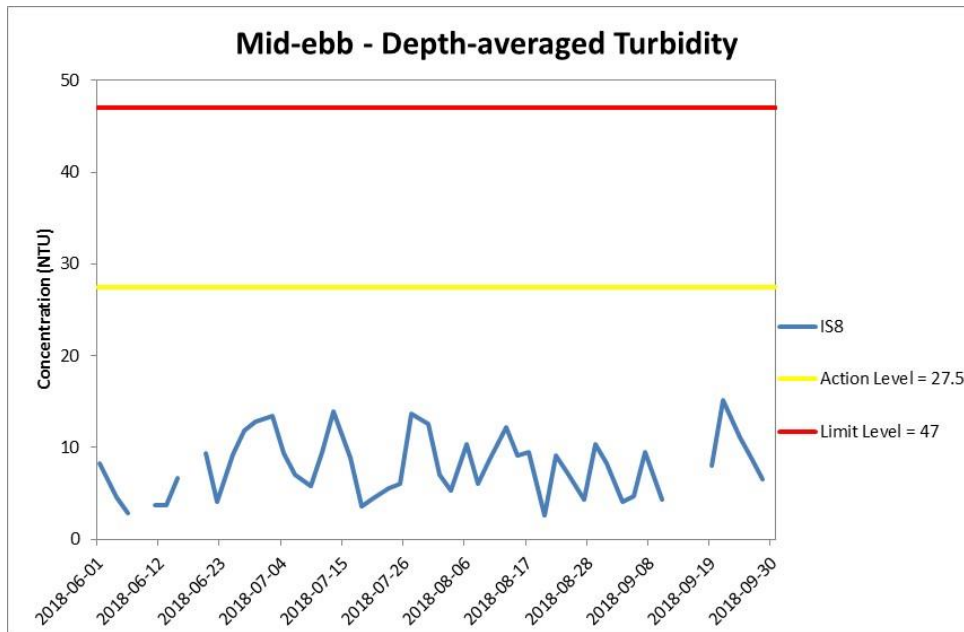
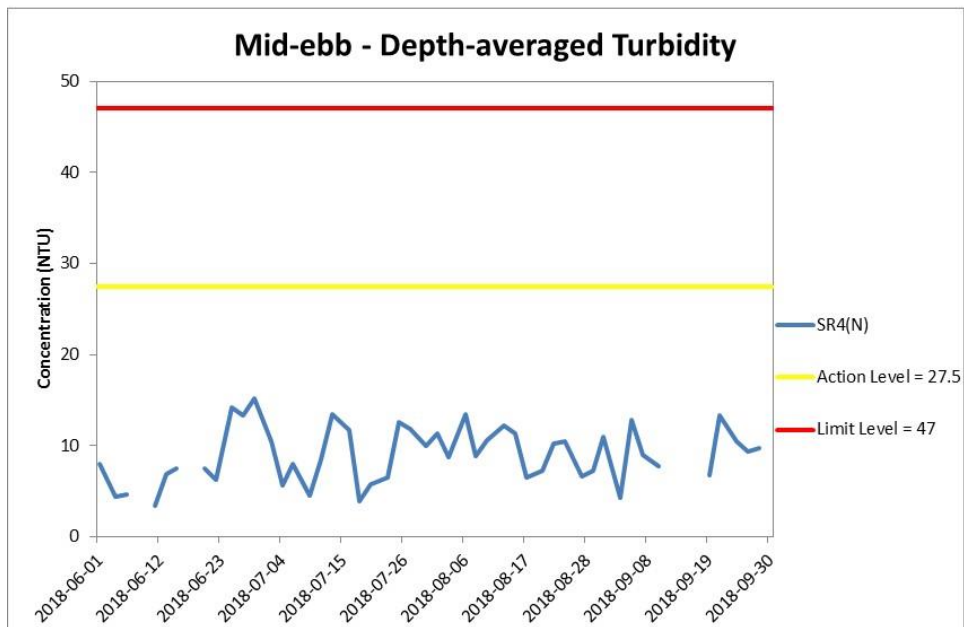
Figure J23 Impact Monitoring – Mean Level of depth-averaged Turbidity (NTU) during mid-ebb tide between 1 June and 30 September 2018 at IS8 and SR4(N).

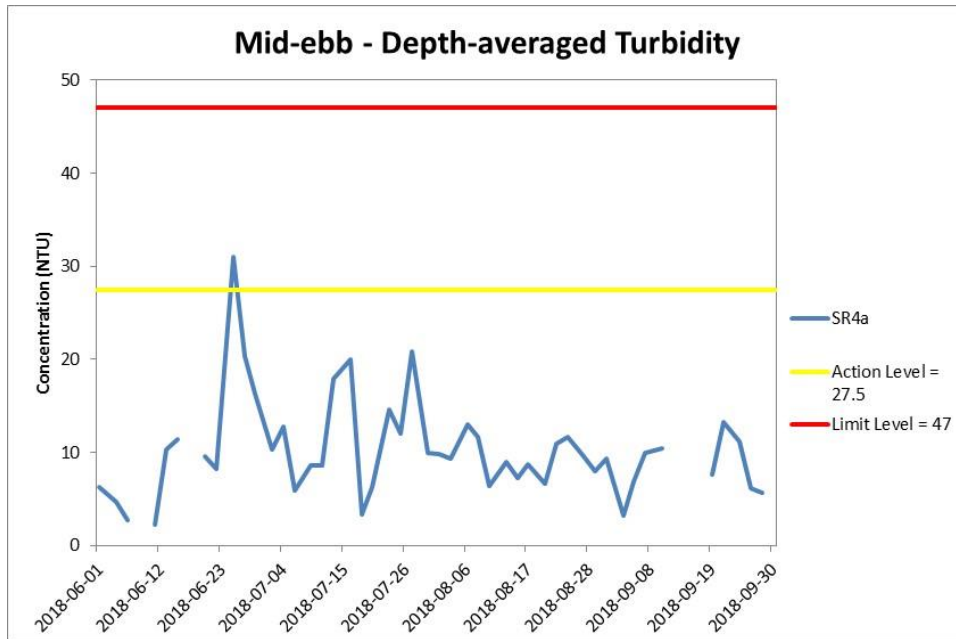
Figure J24 Impact Monitoring - Mean Level of depth-averaged Turbidity (NTU) during mid-ebb tide between 1 June and 30 September 2018 at SR4a.

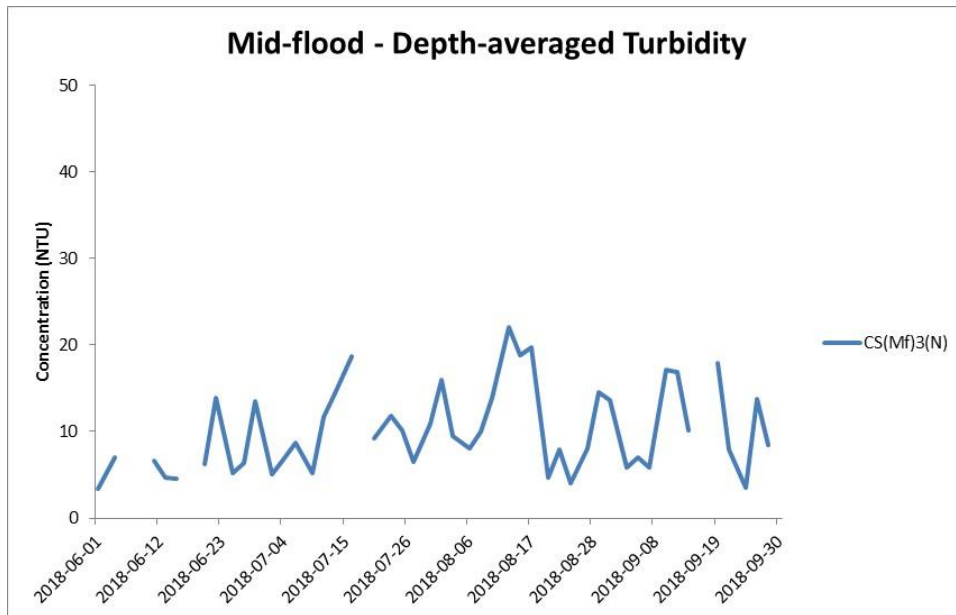
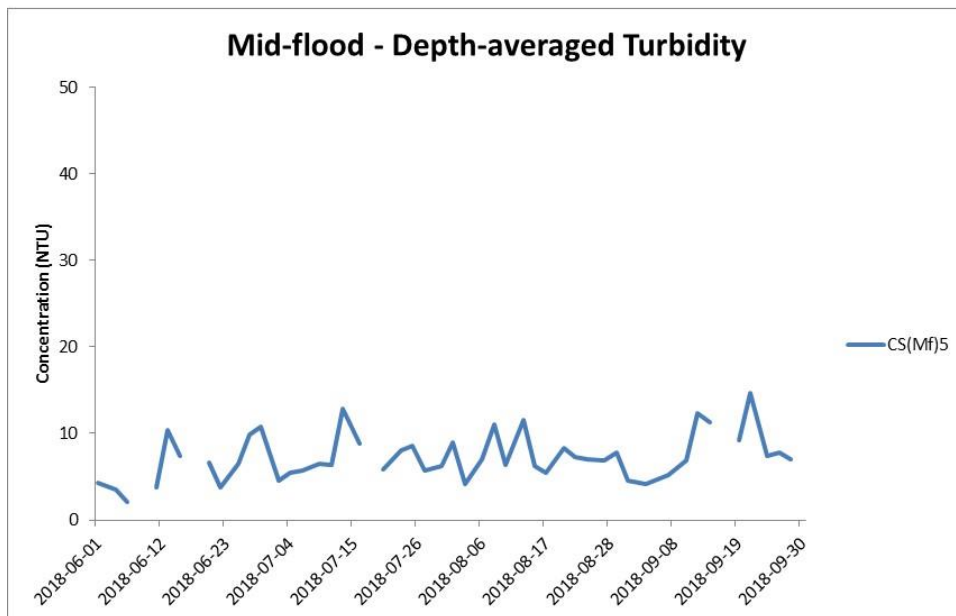
Figure J25 Impact Monitoring - Mean Level of depth-averaged Turbidity (NTU) during mid-flood tide between 1 June and 30 September 2018 at CS(Mf)3(N) and CS(MF)5.

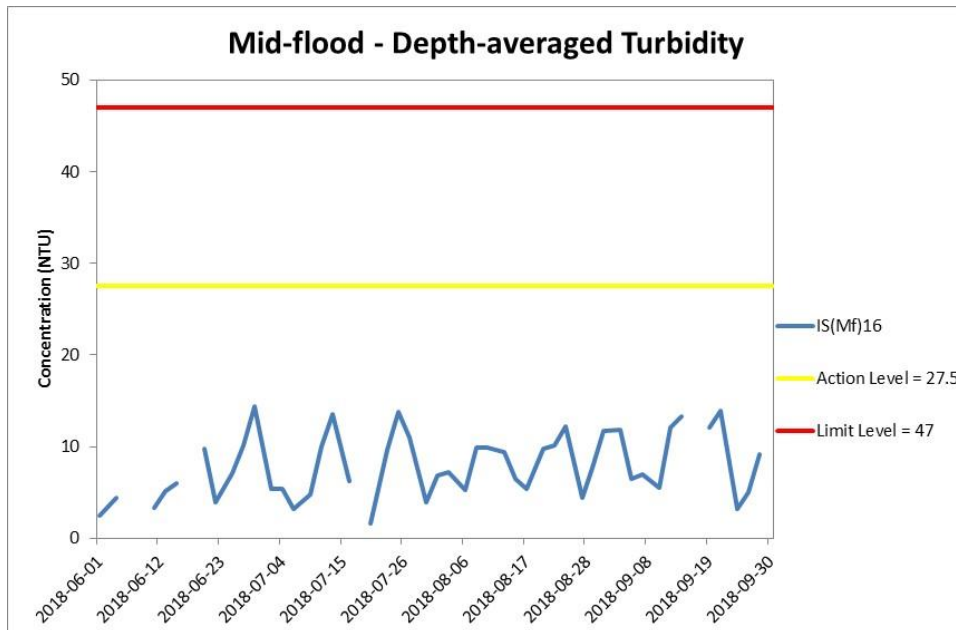
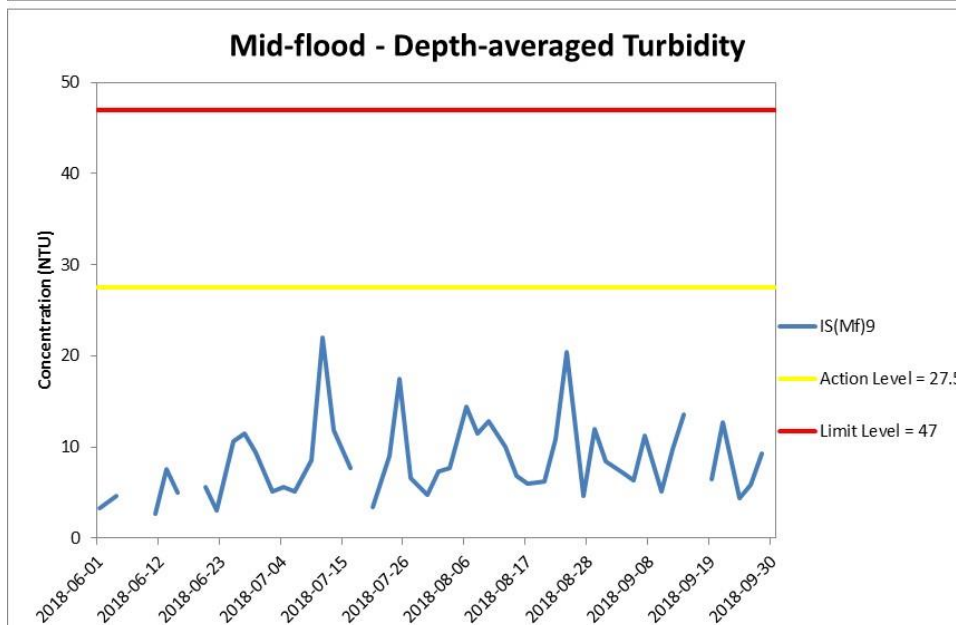
Figure J26 Impact Monitoring - Mean Level of depth-averaged Turbidity (NTU) during mid-flood tide between 1 June and 30 September 2018 at IS(Mf)16 and IS(Mf)9.

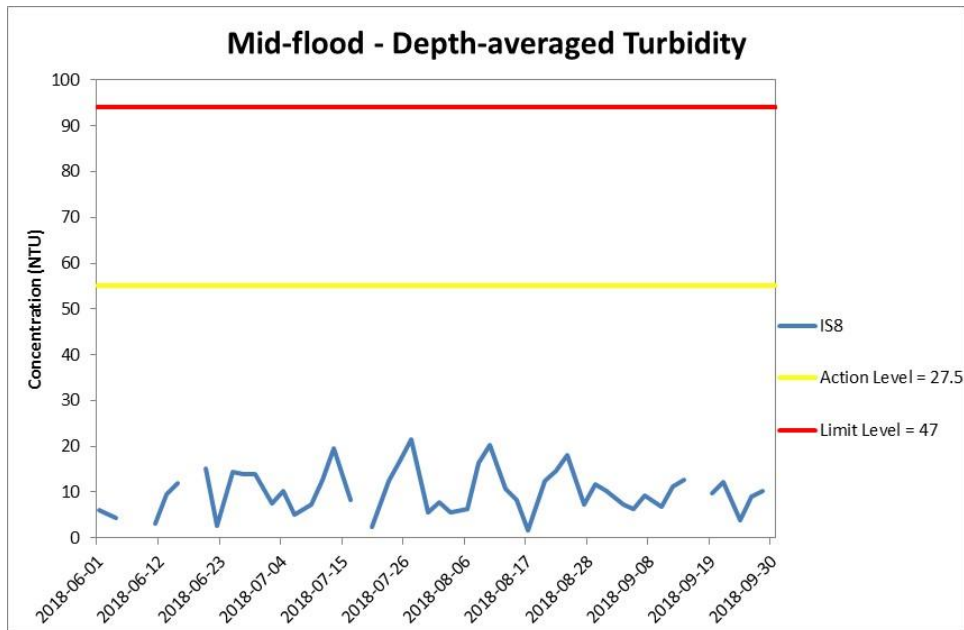
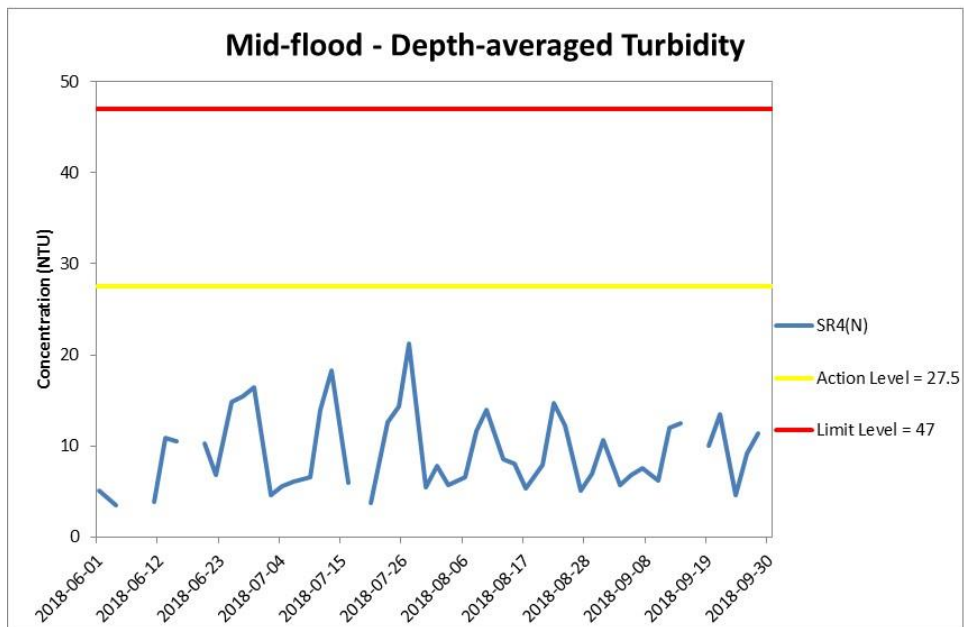
Figure J27 Impact Monitoring – Mean Level of depth-averaged Turbidity (NTU) during mid-flood tide between 1 June and 30 September 2018 at IS8 and SR4(N).

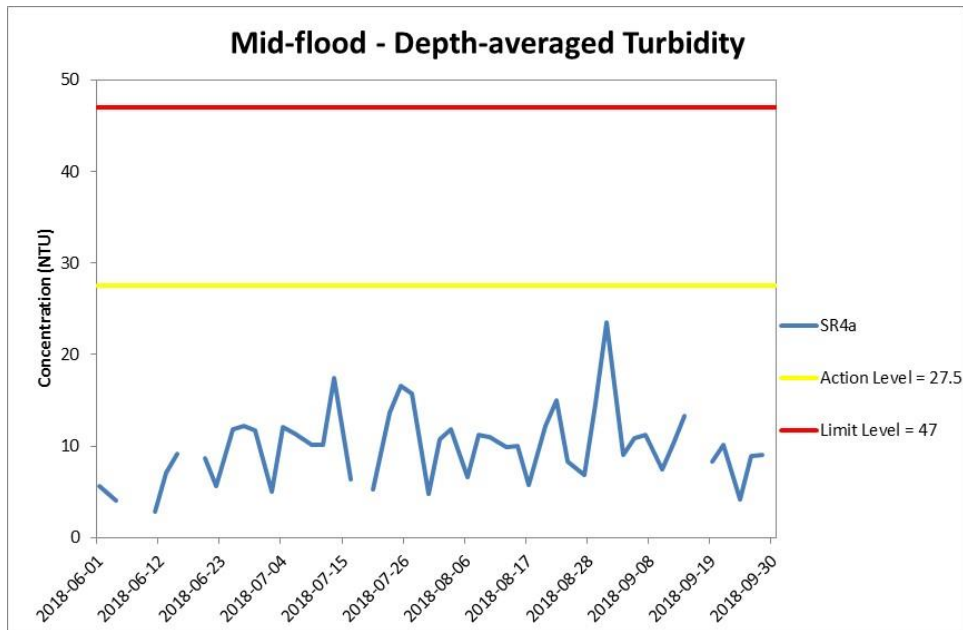
Figure J28 Impact Monitoring - Mean Level of depth-averaged Turbidity (NTU) during mid-flood tide between 1 June and 30 September 2018 at SR4a.

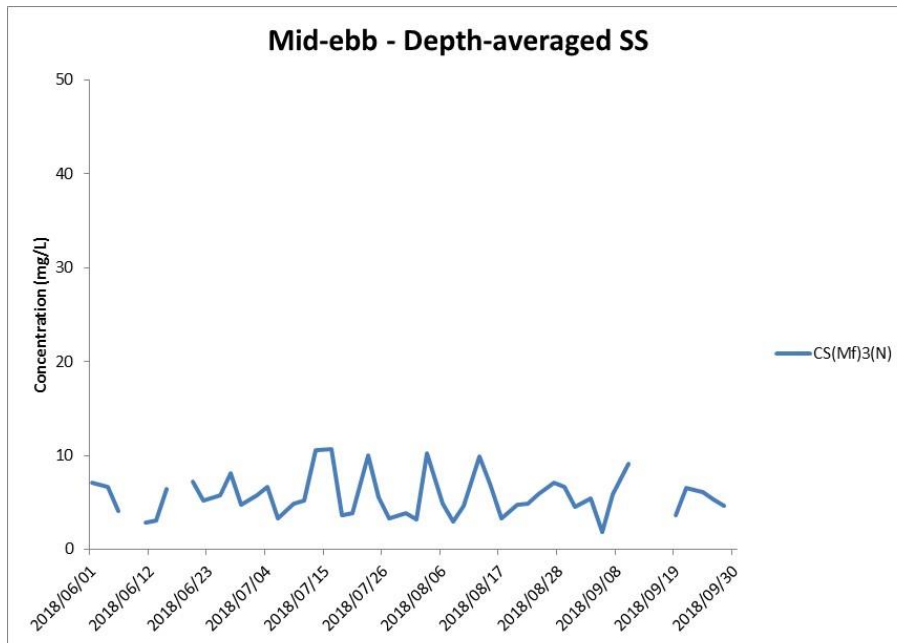
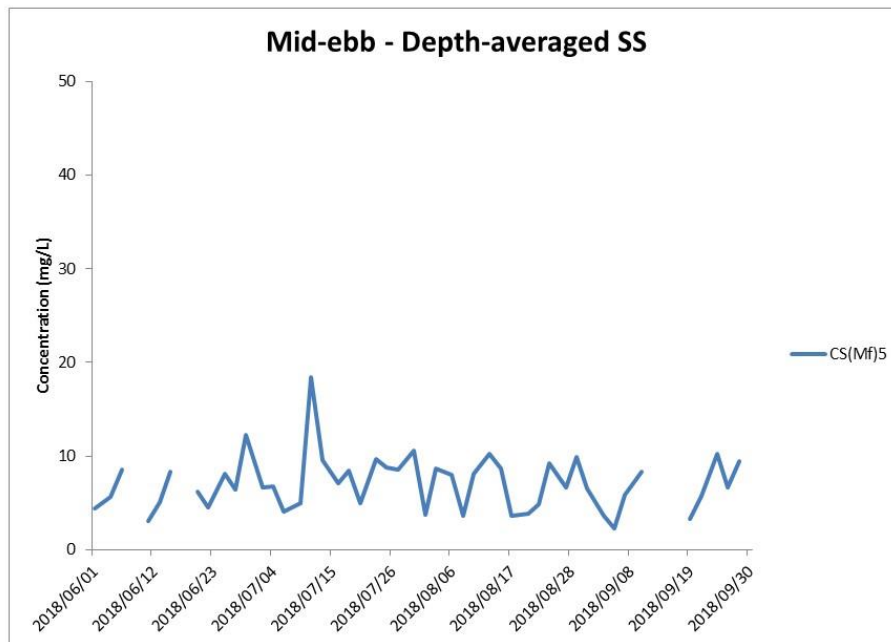
Figure J29 Impact Monitoring - Mean depth-averaged level of Suspended Solids (mg/L) during mid-ebb tide between 1 June and 30 September 2018 at CS(Mf)3(N) and CS(Mf)5.

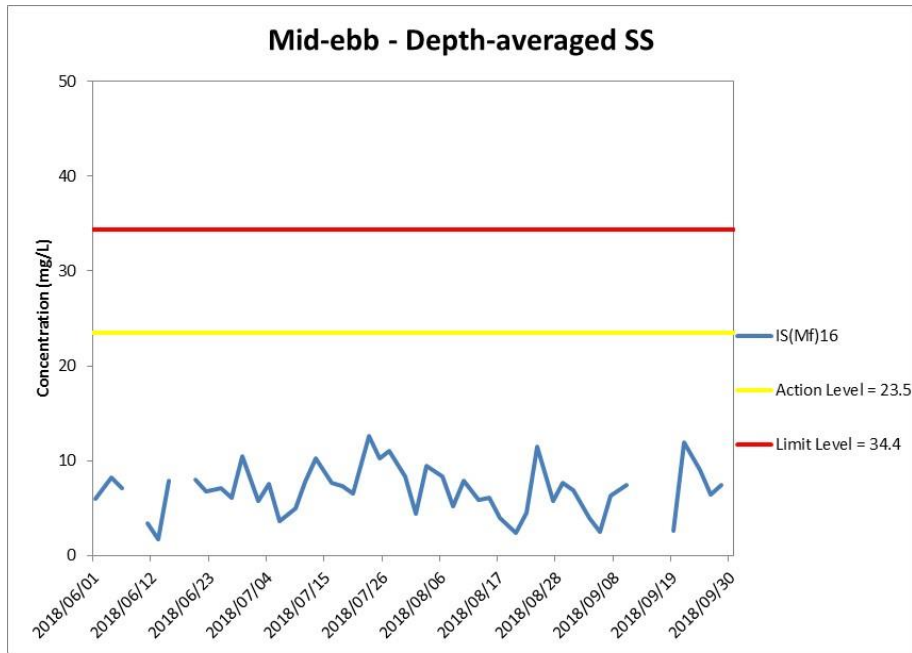
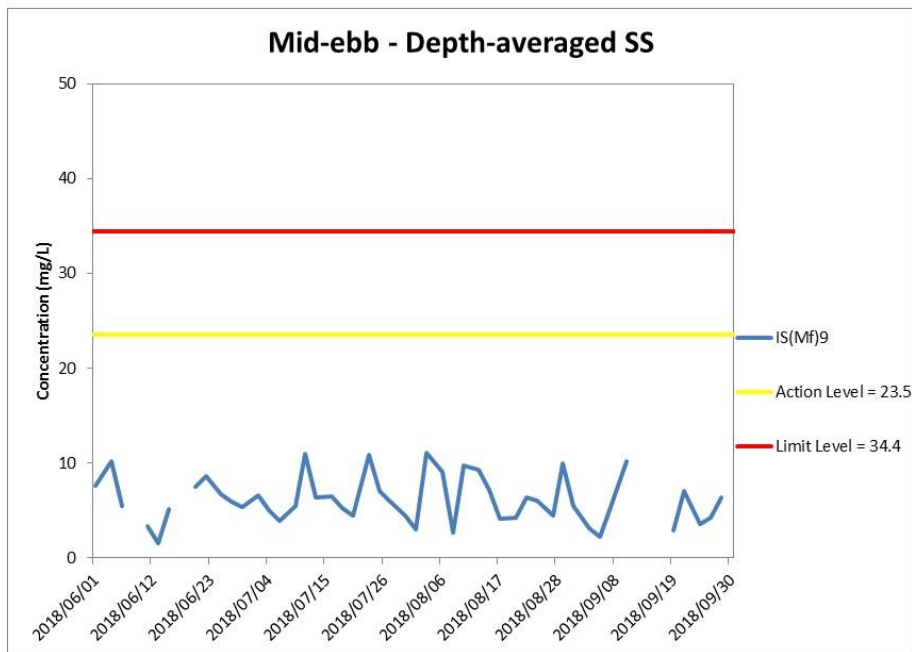
Figure J30 Impact Monitoring – Mean depth-averaged level of Suspended Solids (mg/L) during mid-ebb tide between 1 June and 30 September 2018 at IS(Mf)16 and IS(Mf)9.

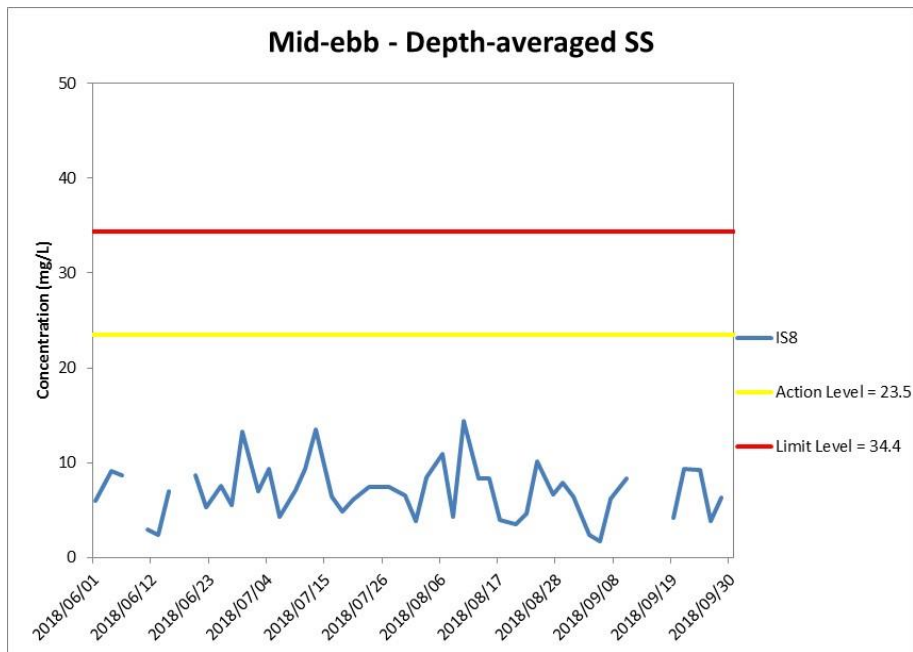
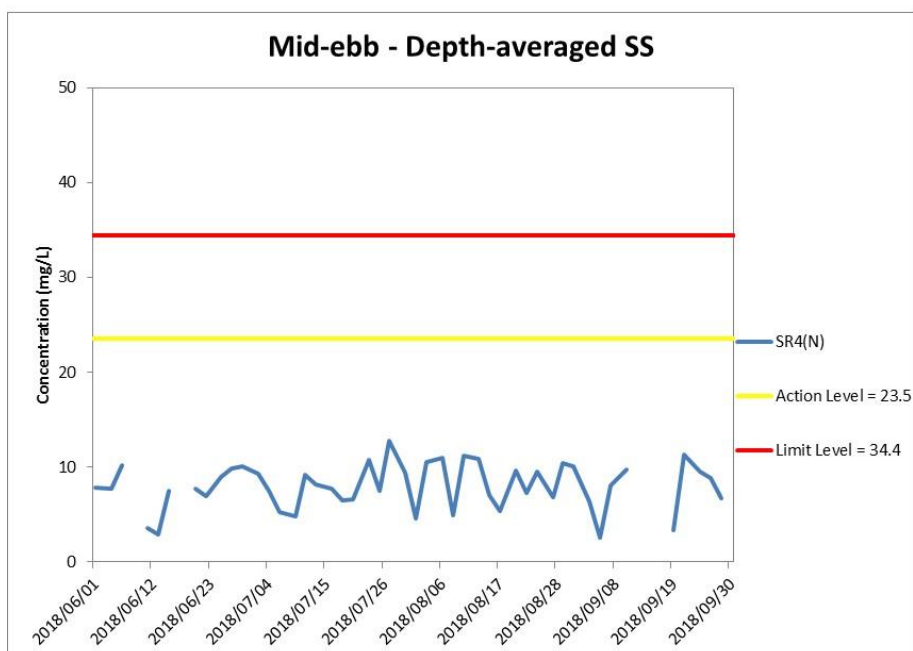
Figure J31 Impact Monitoring – Mean depth-averaged level of Suspended Solids (mg/L) during mid-ebb tide between 1 June and 30 September 2018 at IS8 and SR4(N).

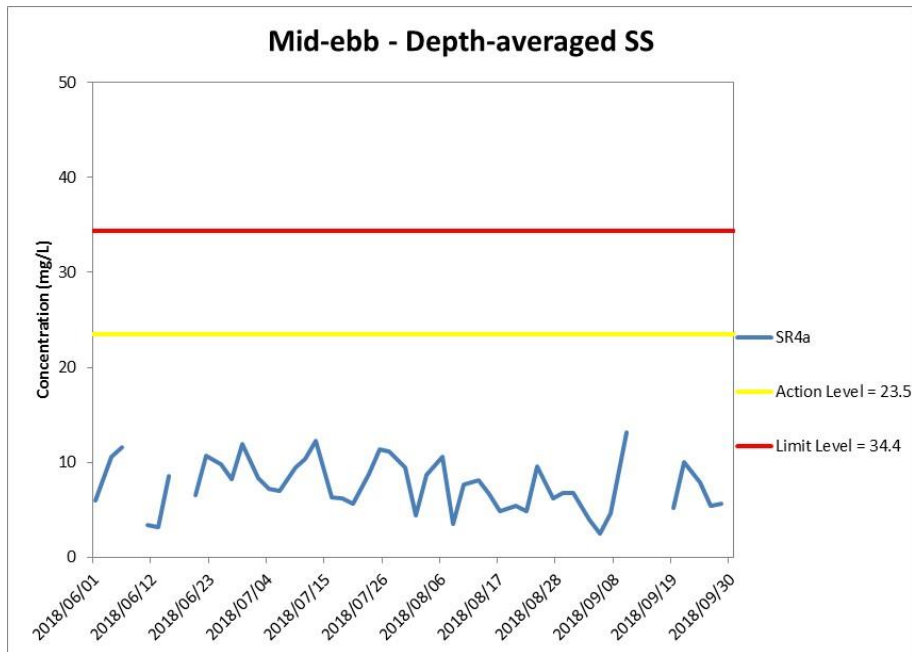
Figure J32 Impact Monitoring - Mean depth-averaged level of Suspended Solids (mg/L) during mid-ebb tide between 1 June and 30 September 2018 at SR4a.

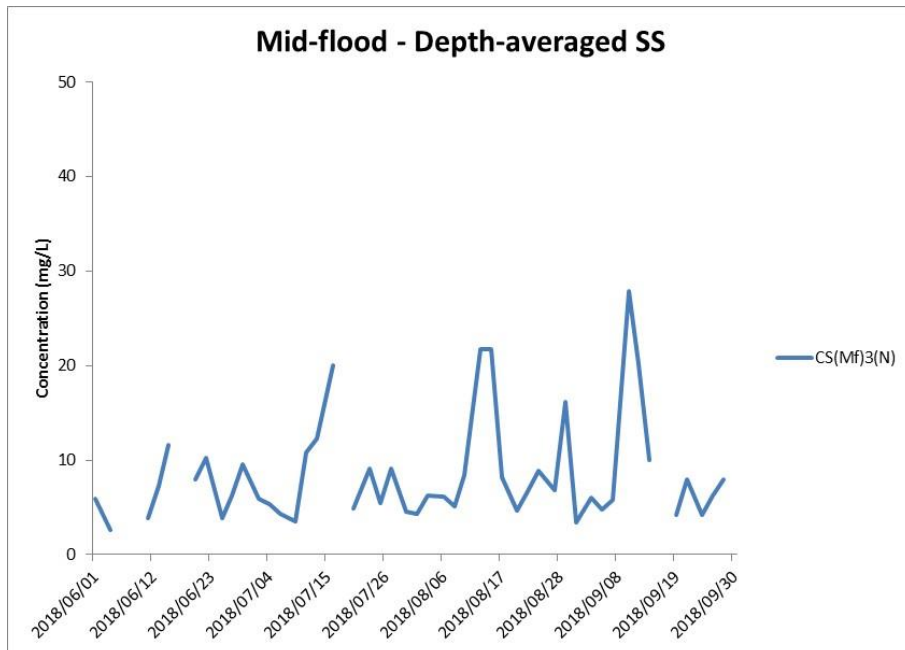
Figure J33 Impact Monitoring – Mean depth-averaged level of Suspended Solids (mg/L) during mid-flood tide between 1 June and 30 September 2018 at CS(Mf)3(N) and CS(Mf)5.

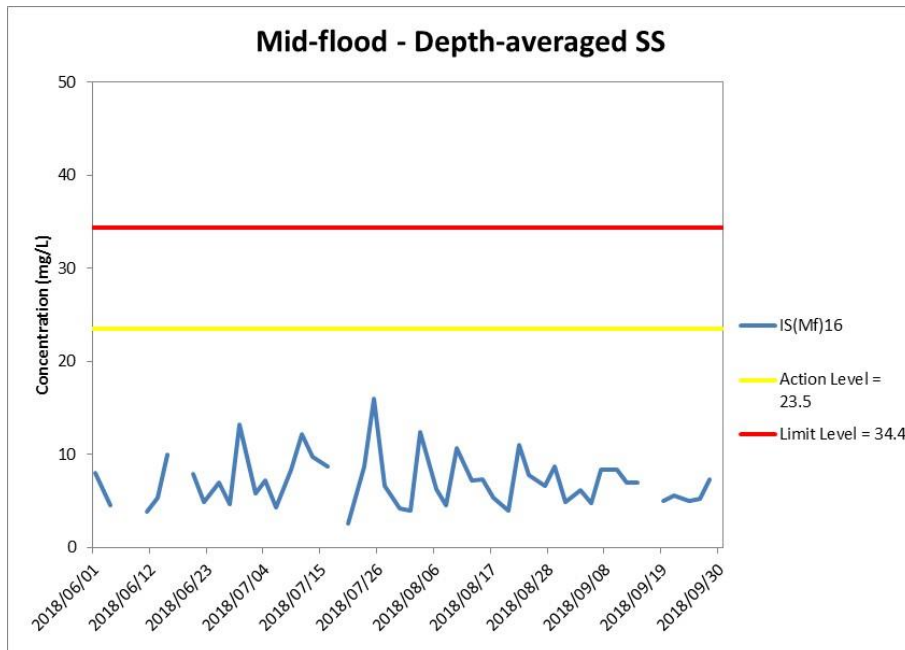
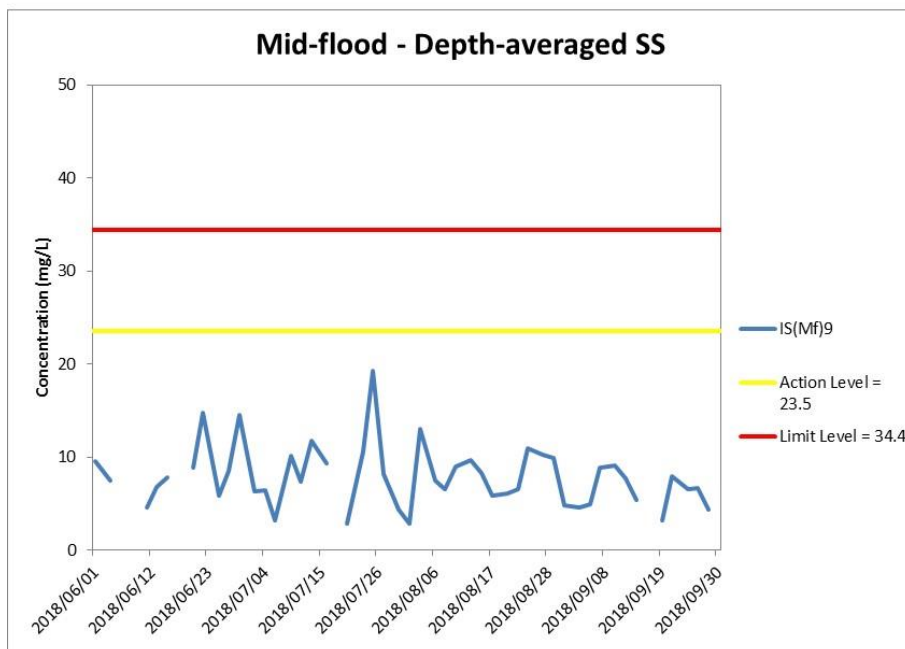
Figure J34 Impact Monitoring - Mean depth-averaged level of Suspended Solids (mg/L) during mid-flood tide between 1 June and 30 September 2018 at IS(Mf)16 and IS(Mf)9.

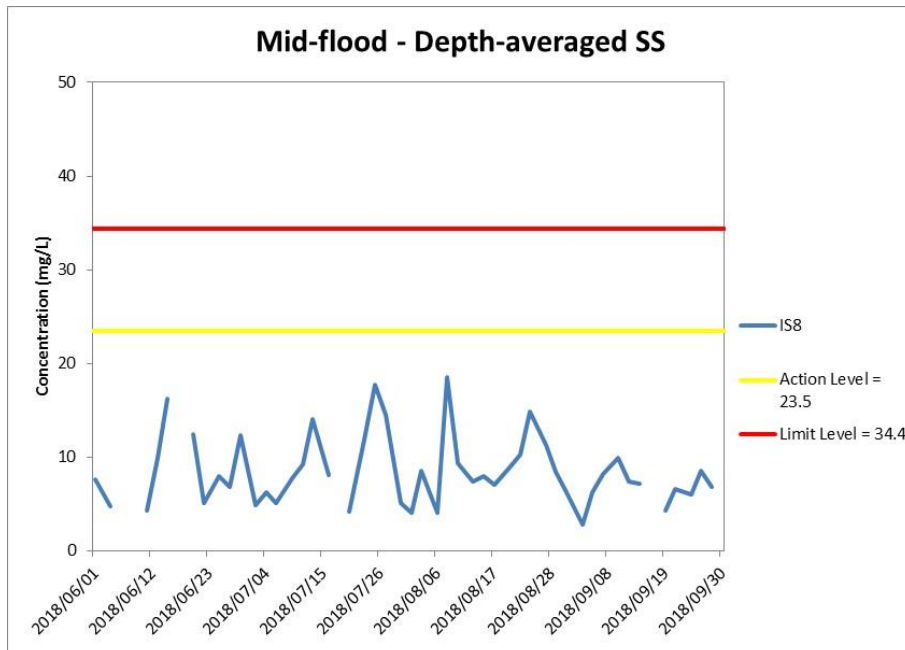
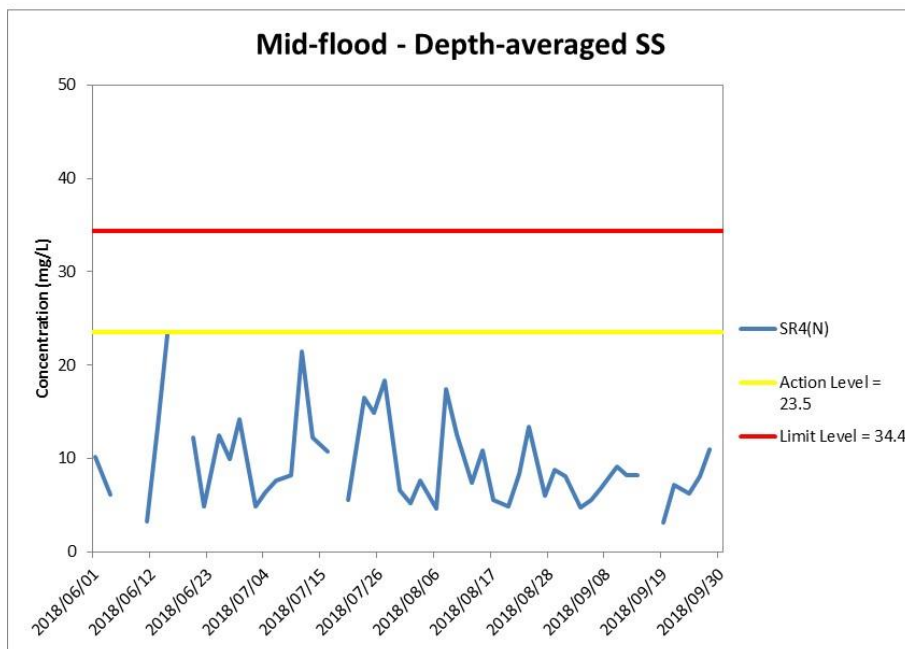
Figure J35 Impact Monitoring - Mean depth-averaged level of Suspended Solids (mg/L) during mid-flood tide between 1 June and 30 September 2018 at IS8 and SR4(N).

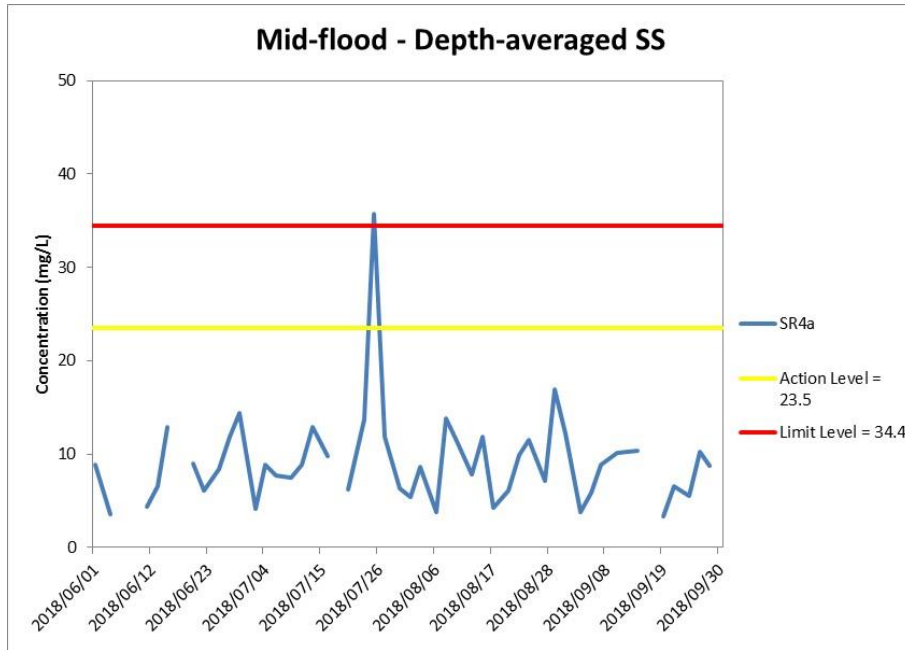
Figure J36 Impact Monitoring - Mean depth-averaged level of Suspended Solids (mg/L) during mid-flood tide between 1 June and 30 September 2018 at SR4a.
