**Contract No. HY/2012/07
Tuen Mun – Chek Lap Kok Link –
Southern Connection Viaduct Section**

Sixtieth Monthly EM&A Report

13 November 2018

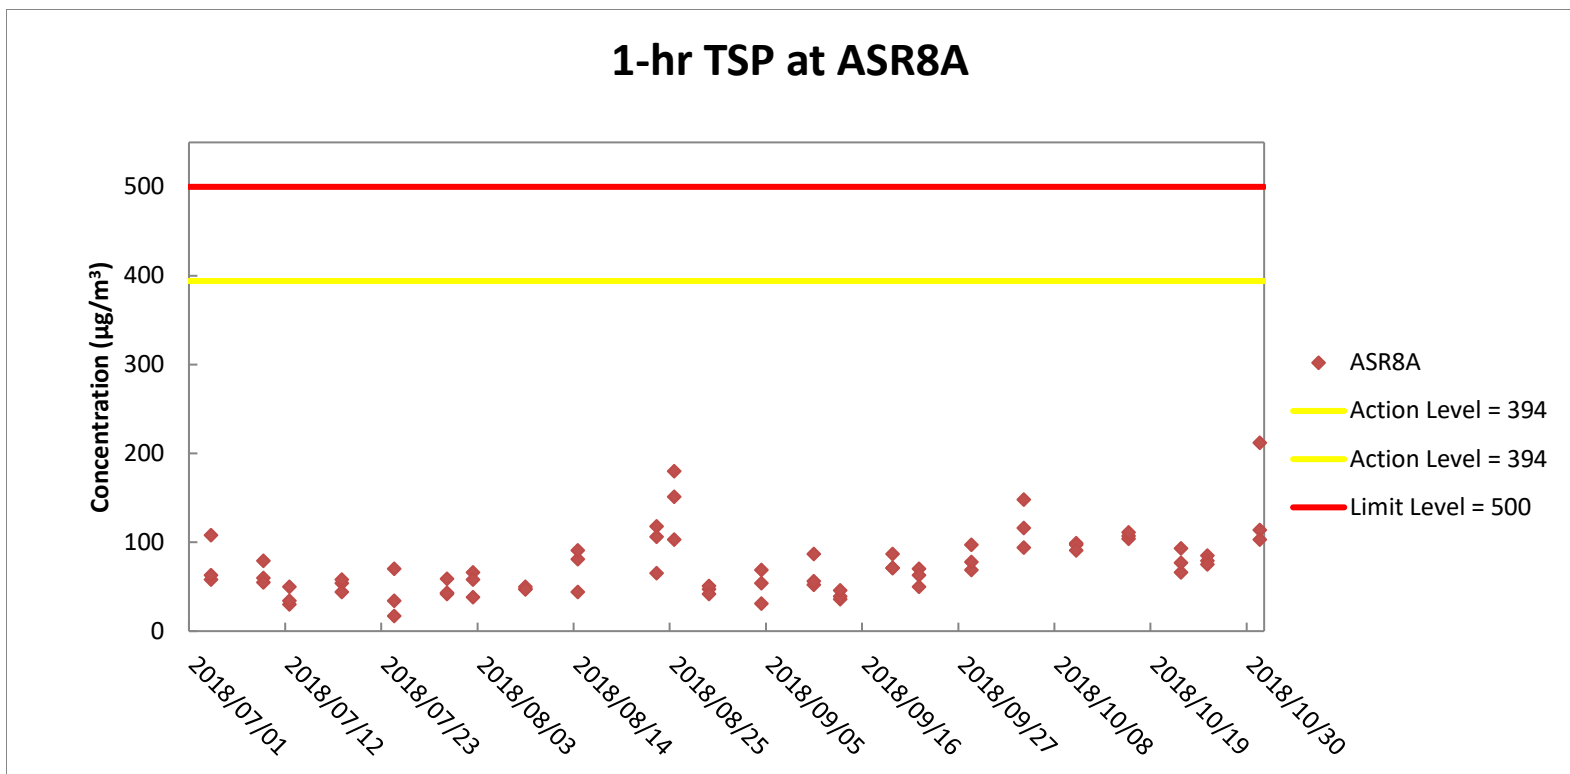
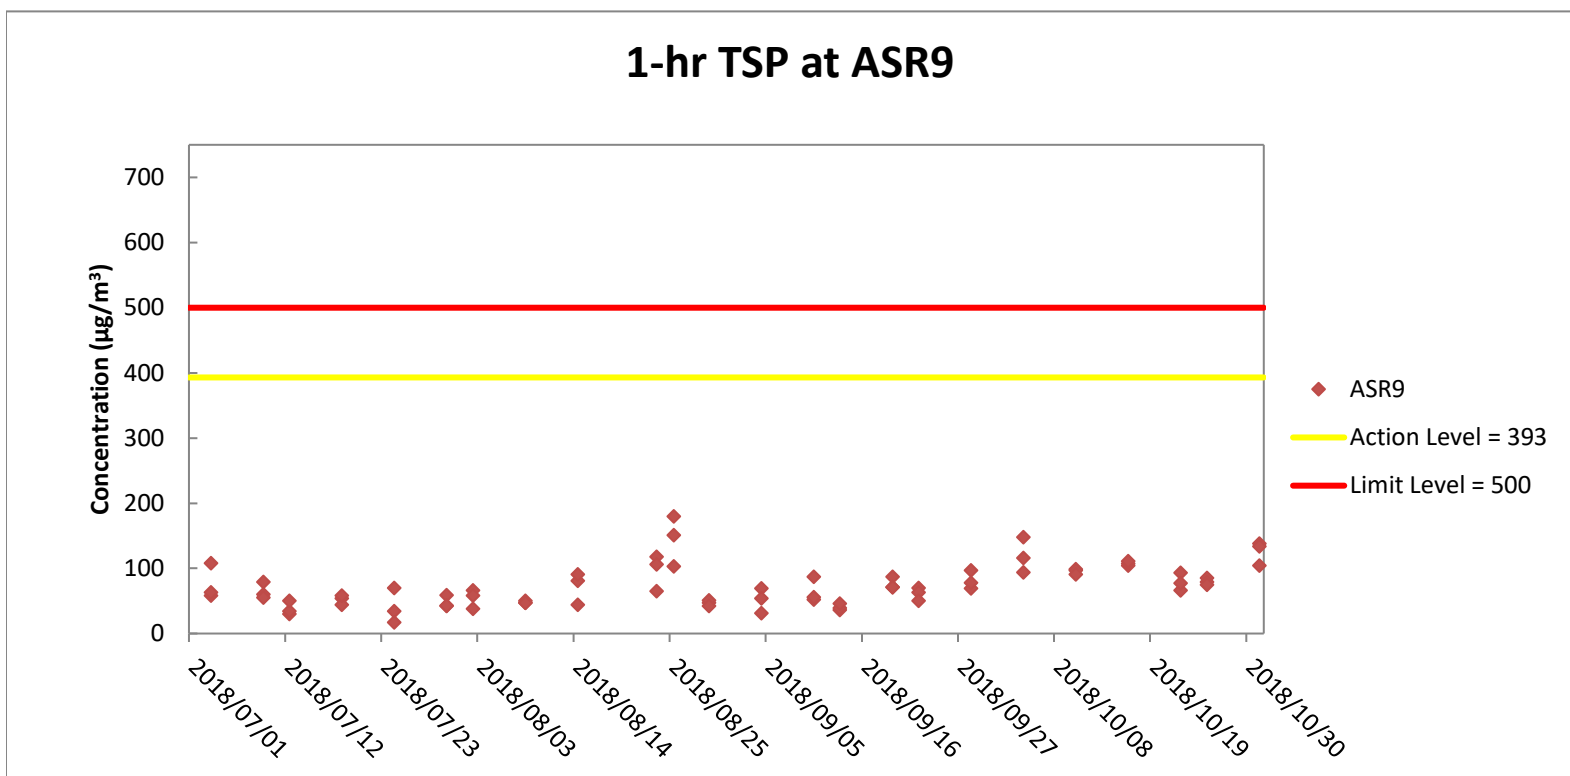
24-hour TSP Monitoring Results at Air Quality Monitoring Station ASR9

Project	Works	Date(yyyy-mm-dd)	Station	Time (hh:mm, 24hour)	Parameter	Results (ug/m3)	Action Level (ug/m3)	Limit Level (ug/m3)
TMCLKL	HY/2012/07	2018/10/04	ASR9	12:04	24-hr TSP	87	178	260
TMCLKL	HY/2012/07	2018/10/10	ASR9	11:56	24-hr TSP	73		
TMCLKL	HY/2012/07	2016/10/16	ASR9	11:43	24-hr TSP	73		
TMCLKL	HY/2012/07	2018/10/22	ASR9	11:59	24-hr TSP	72		
TMCLKL	HY/2012/07	2018/10/25	ASR9	11:48	24-hr TSP	64		
TMCLKL	HY/2012/07	2018/10/31	ASR9	11:46	24-hr TSP	100		
						Average	78	
						Min.	64	
						Max.	100

Weather condition within the reporting period varied between sunny to cloudy.

Major construction works undertaken within the reporting period include Pier construction; Re-alignment of Cheung Tung Road; Road works along North Lantau Highway; Asphalt paving; Sign gantries construction; Parapet installation; and Slope work of Viaducts A, B, C & D.

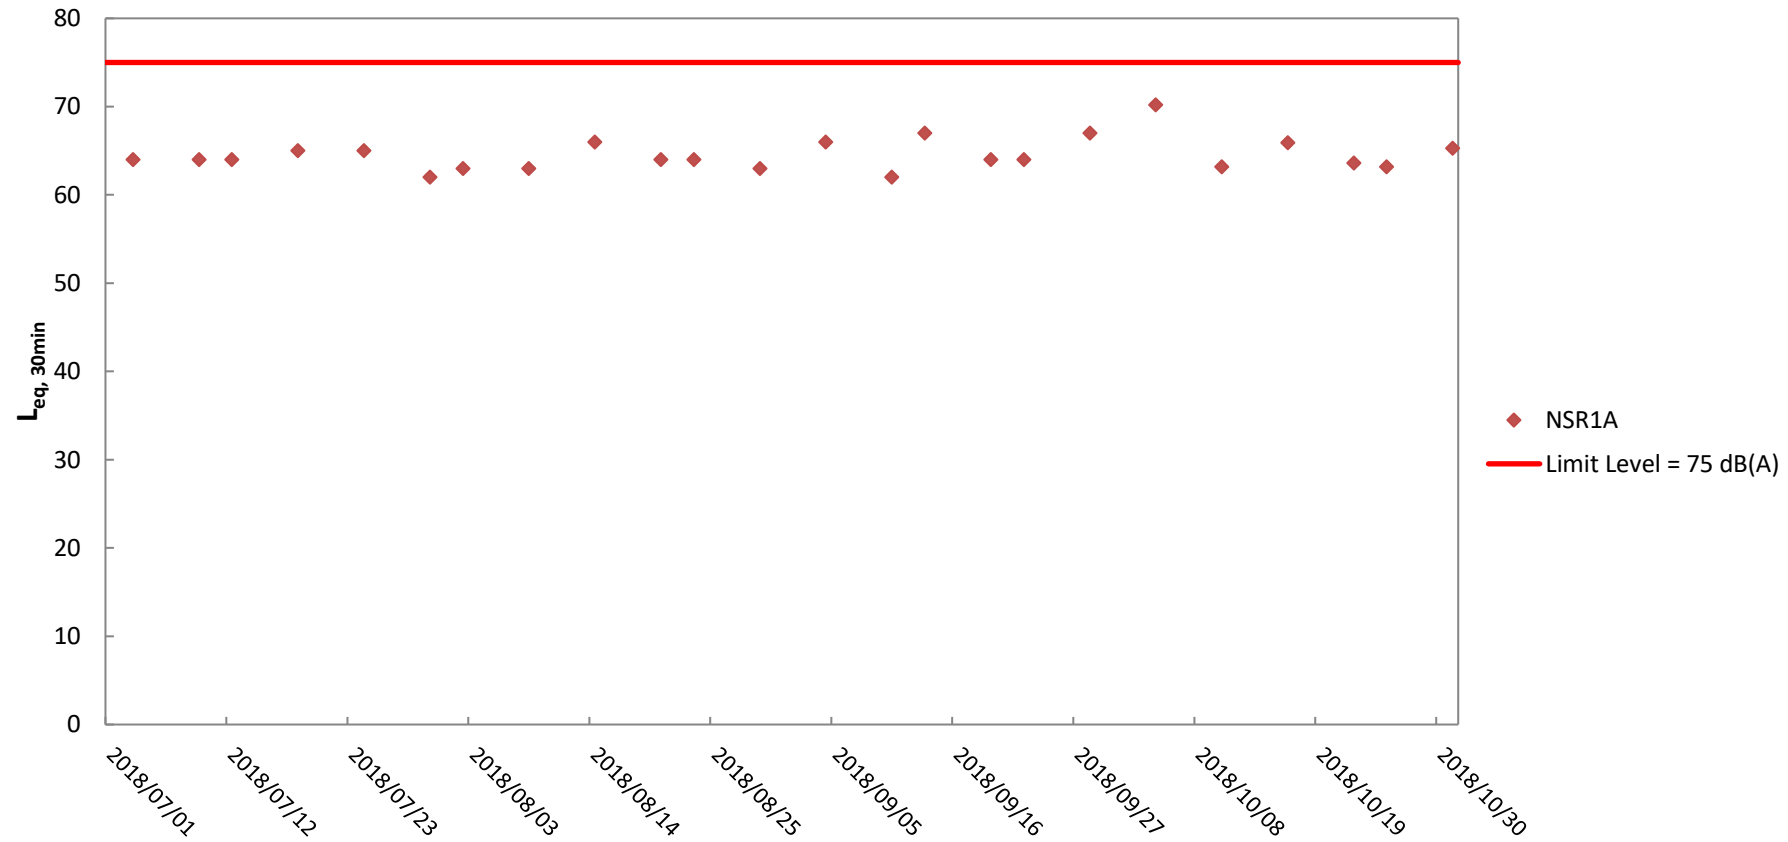
Noise Monitoring Results at NSR 1A ($L_{eq, 30min}$)

Weather condition within the reporting period varied between sunny to cloudy.

Major construction works undertaken within the reporting period include Pier construction; Re-alignment of Cheung Tung Road; Road works along North Lantau Highway; Asphalt paving; Sign gantries construction; Parapet installation; and Slope work of Viaducts A, B,C & D.

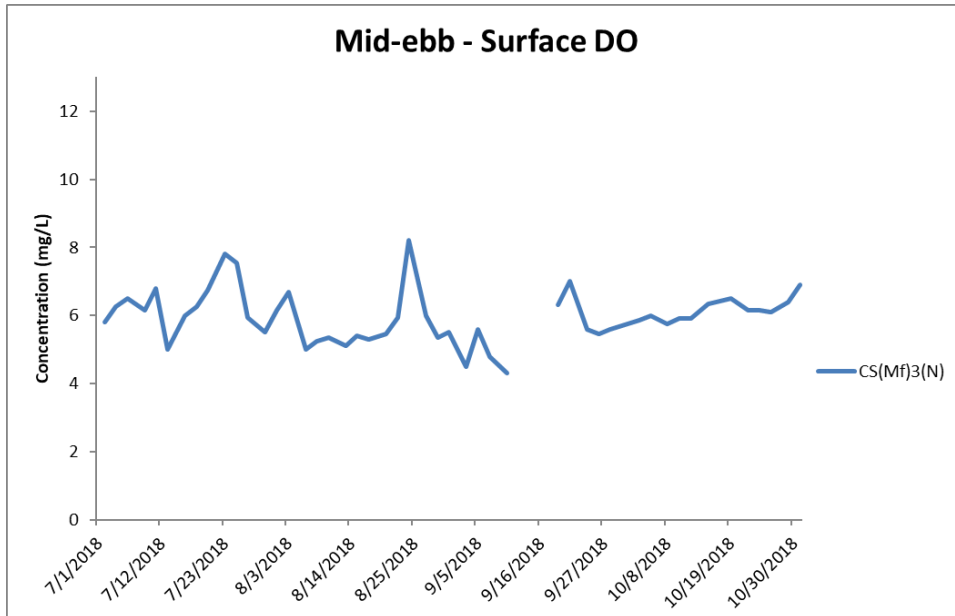
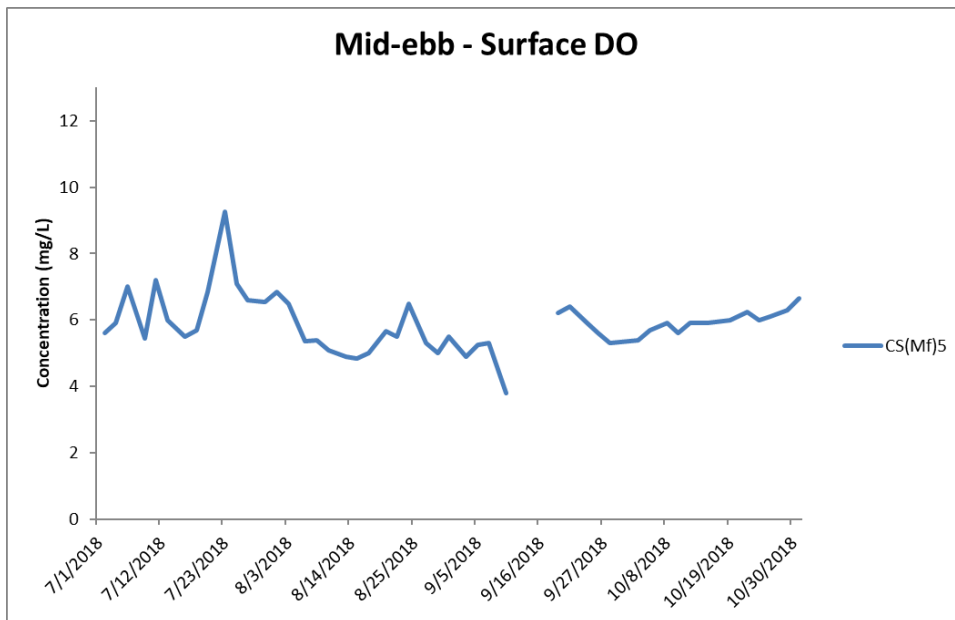
Figure J1 Impact Monitoring – Mean Level of Dissolved Oxygen (mg/L) in surface waters during mid-ebb tide between 1 July and 31 October 2018 at CS(Mf)3(N) and CS(Mf)5.

(Weather condition varied between sunny to rainy within the reporting period.)
 WQM on 1 and 17 October 2018 were cancelled due to suspension of marine works.
 In-situ monitoring is taken according to the requirement specified in the EM&A Manual, i.e. 3 water depth namely 1m below sea surface, mid-depth and 1m above sea bed. If the water depth is less than 3m, mid-depth sampling only. If water depth less than 6m, mid-depth may be omitted.
 Marine works within the reporting period include Uninstallation of marine piling platform.

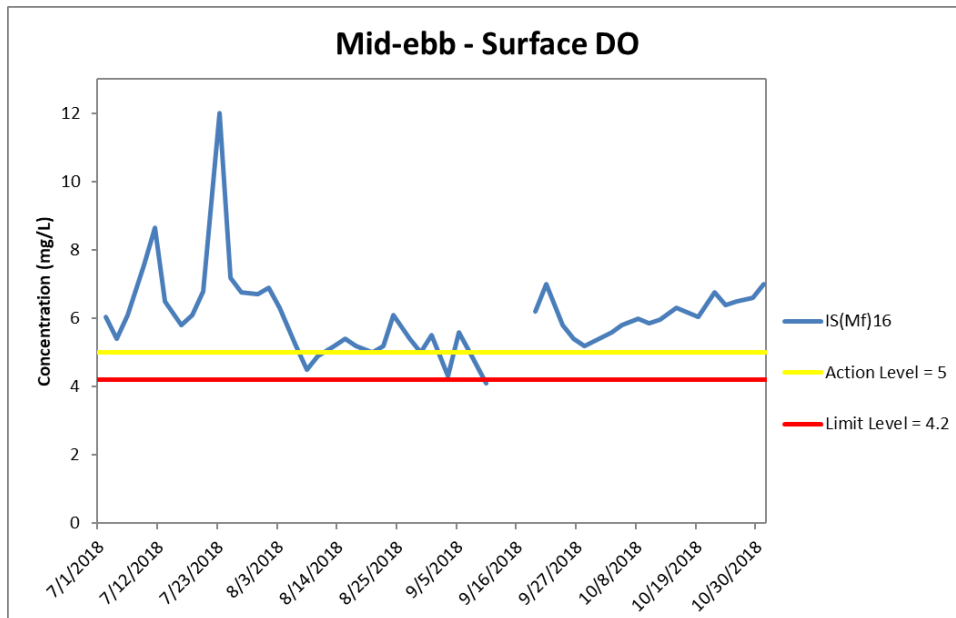
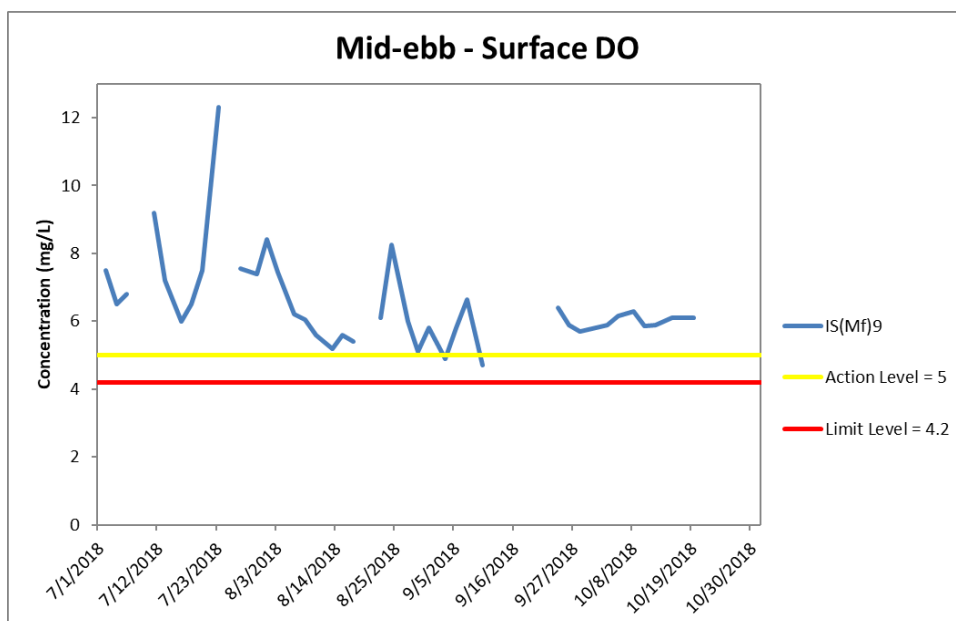
Figure J2 Impact Monitoring – Mean Level of Dissolved Oxygen (mg/L) in surface waters during mid-ebb tide between 1 July and 31 October 2018 at IS(Mf)16 and IS(Mf)9.

(Weather condition varied between sunny to rainy within the reporting period.)
 WQM on 1 and 17 October 2018 were cancelled due to suspension of marine works.

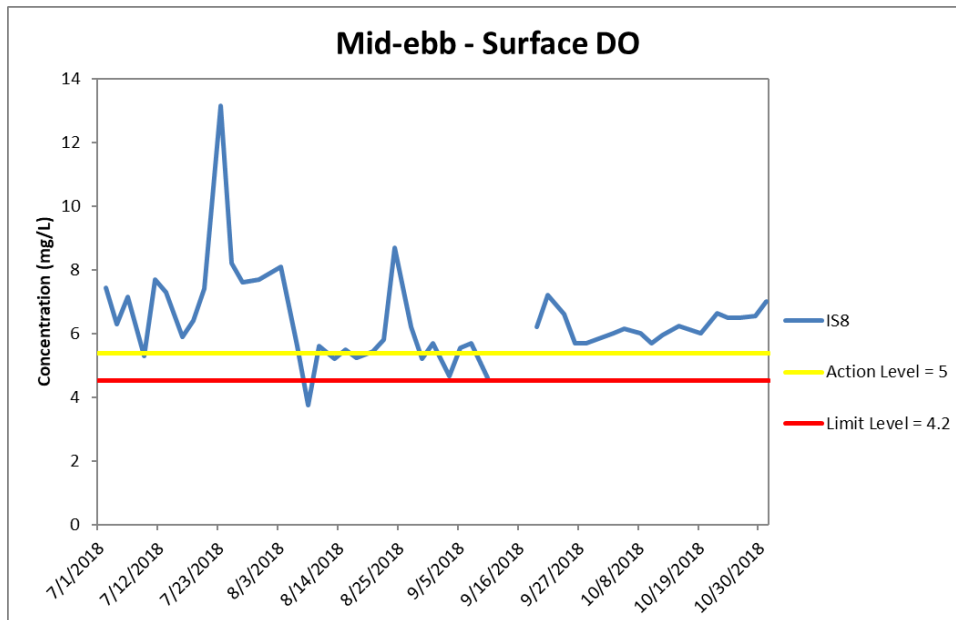
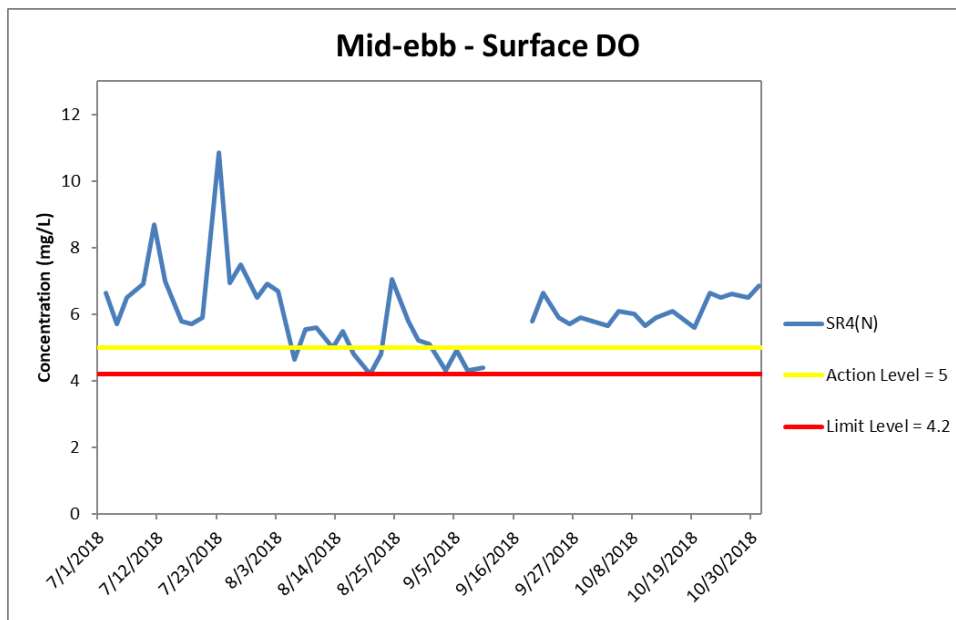
Figure J3 Impact Monitoring - Mean Level of Dissolved Oxygen (mg/L) in surface waters during mid-ebb tide between 1 July and 31 October 2018 at IS8 and SR4(N).

(Weather condition varied between sunny to rainy within the reporting period.)
 WQM on 1 and 17 October 2018 were cancelled due to suspension of marine works.
 In-situ monitoring is taken according to the requirement specified in the EM&A Manual, i.e. 3 water depth namely 1m below sea surface, mid-depth and 1m above sea bed. If the water depth is less than 3m, mid-depth sampling only. If water depth less than 6m, mid-depth may be omitted.
 Marine works within the reporting period include Uninstallation of marine piling platform.

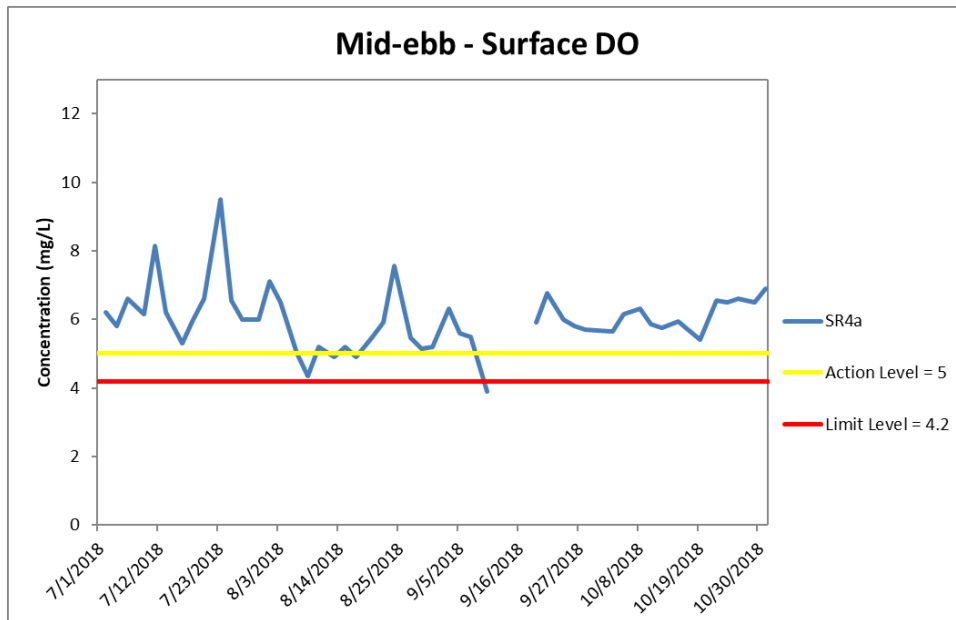
Figure J4 Impact Monitoring – Mean Level of Dissolved Oxygen (mg/L) in surface waters during mid-ebb tide between 1 July and 31 October 2018 at SR4a.

*(Weather condition varied between sunny to rainy within the reporting period.)
WQM on 1 and 17 October 2018 were cancelled due to suspension of marine works.*

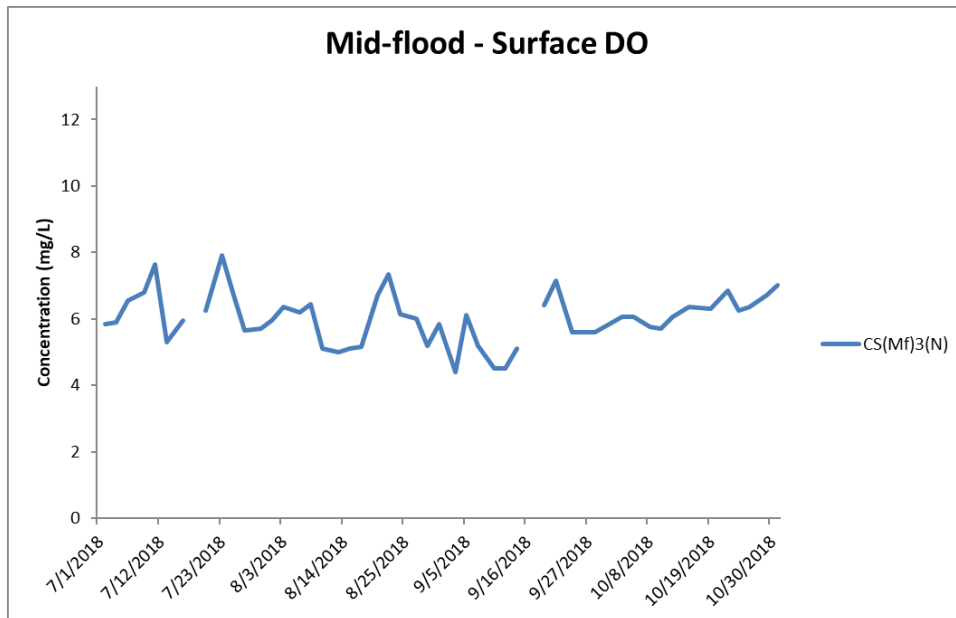
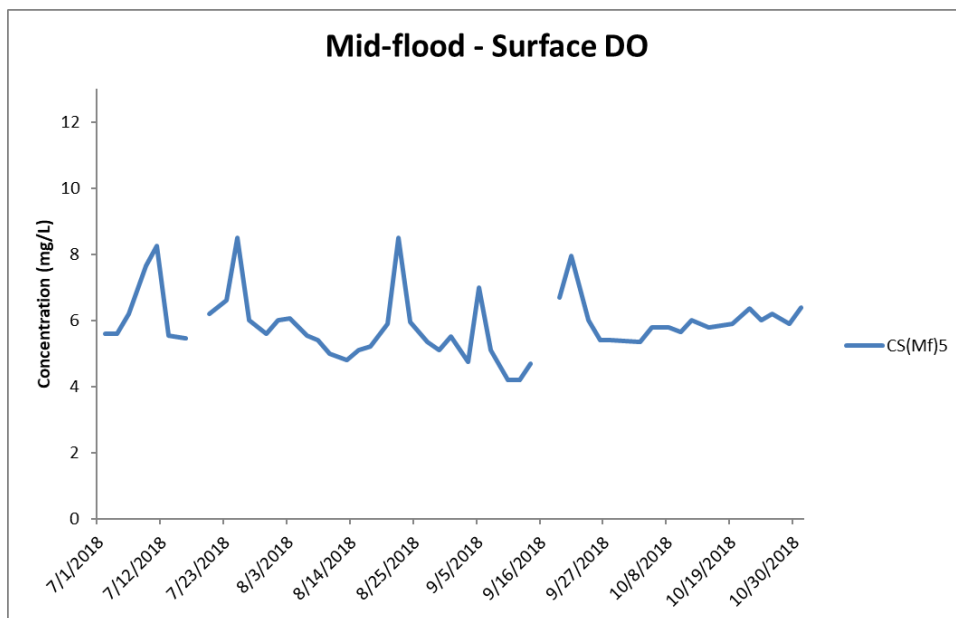
Figure J5 Impact Monitoring - Mean Level of Dissolved Oxygen (mg/L) in surface waters during mid-flood tide between 1 July and 31 October 2018 at CS(Mf)3(N) and CS(Mf)5.

*(Weather condition varied between sunny to rainy within the reporting period.)
WQM on 1 and 17 October 2018 were cancelled due to suspension of marine works.*

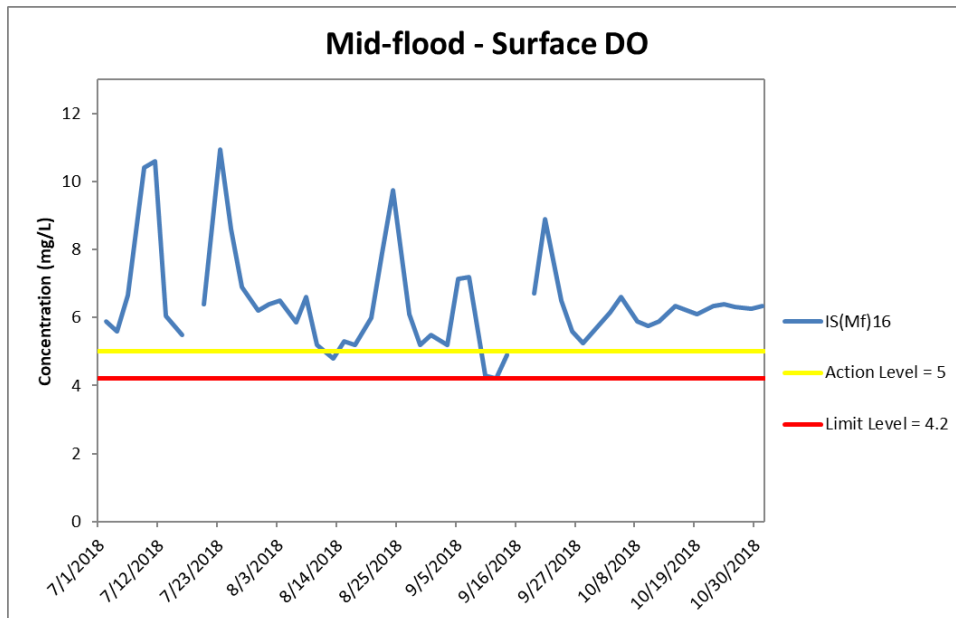
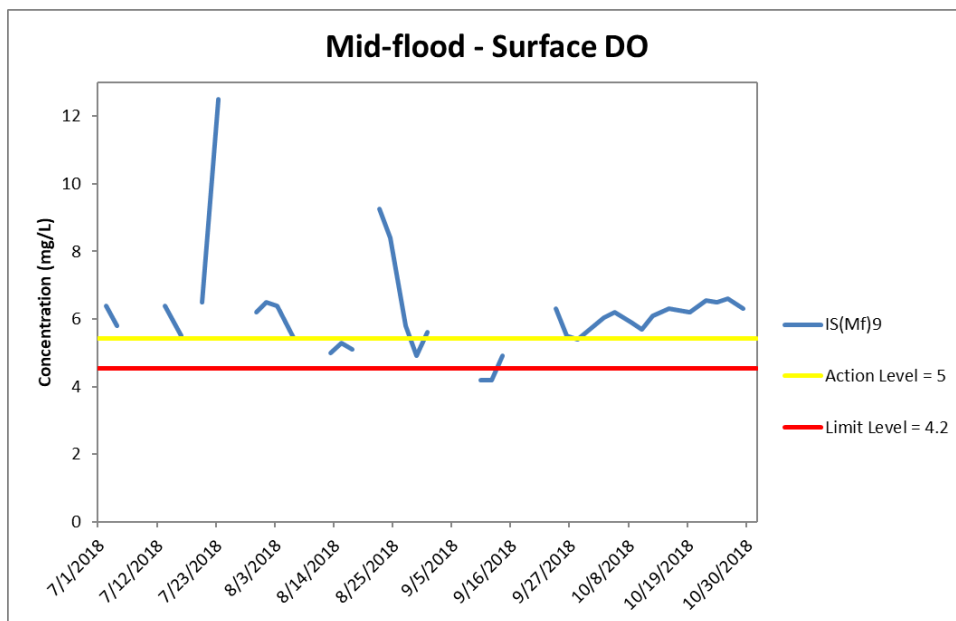
Figure J6 Impact Monitoring – Mean Level of Dissolved Oxygen (mg/L) in surface waters during mid-flood tide between 1 July and 31 October 2018 at IS(Mf)16 and IS(Mf)9.

*(Weather condition varied between sunny to rainy within the reporting period.)
WQM on 1 and 17 October 2018 were cancelled due to suspension of marine works.*

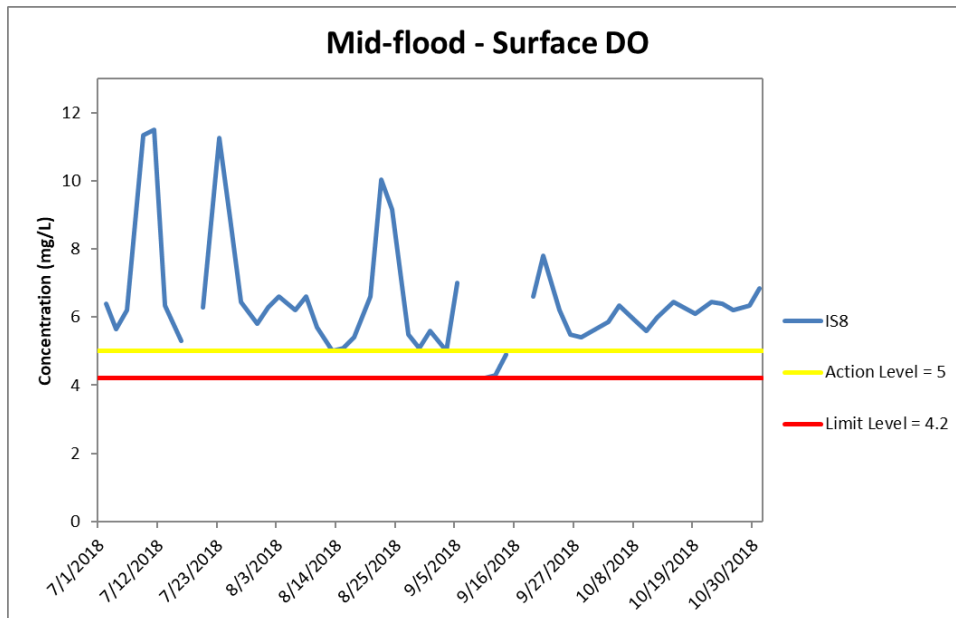
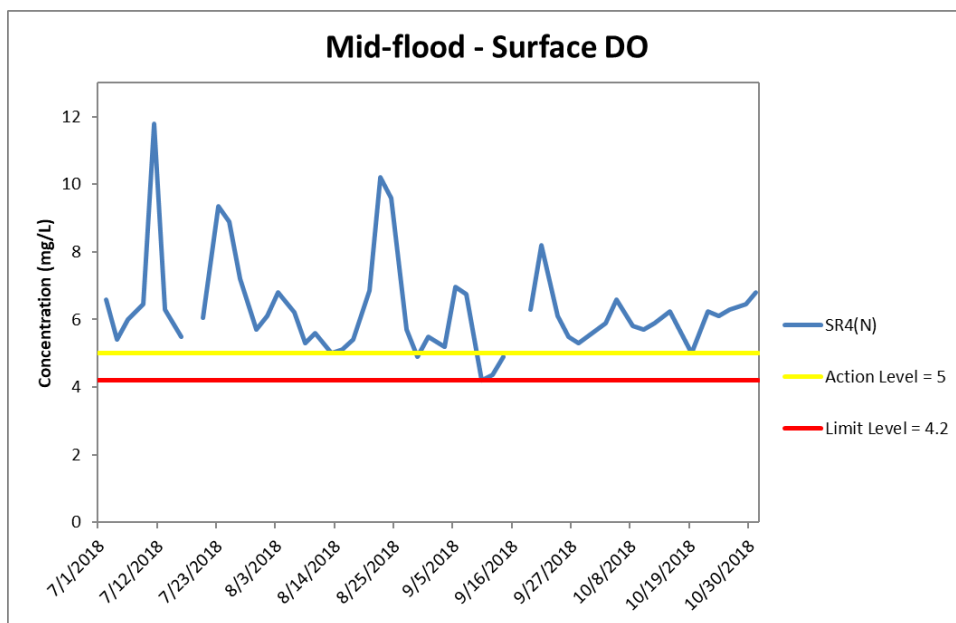
Figure J7 Impact Monitoring – Mean Level of Dissolved Oxygen (mg/L) in surface waters during mid-flood tide between 1 July and 31 October 2018 at IS8 and SR4(N).

(Weather condition varied between sunny to rainy within the reporting period.)
 WQM on 1 and 17 October 2018 were cancelled due to suspension of marine works.

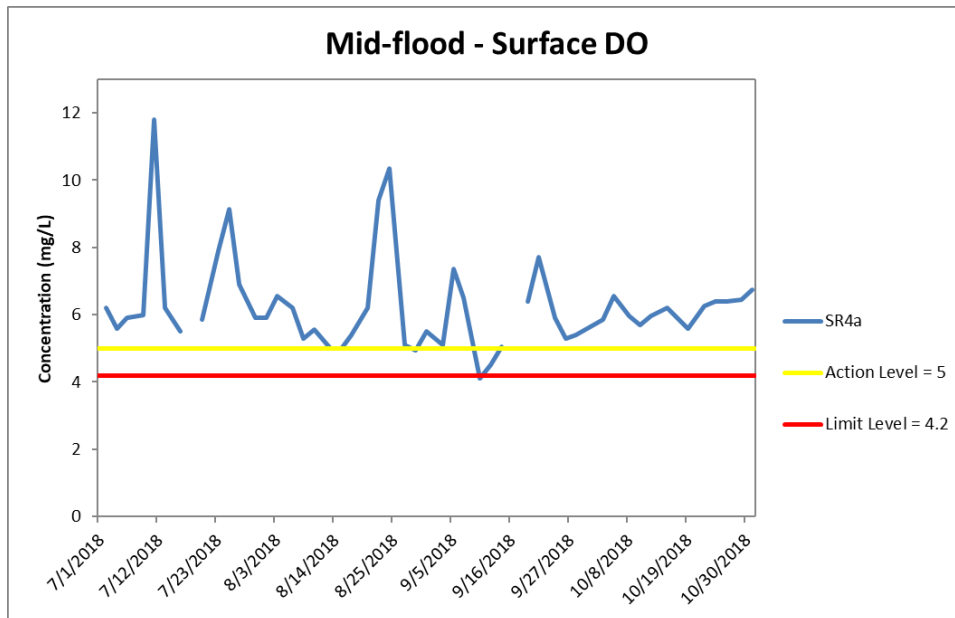
Figure J8 Impact Monitoring – Mean Level of Dissolved Oxygen (mg/L) in surface waters during mid-flood tide between 1 July and 31 October 2018 at SR4a.

*(Weather condition varied between sunny to rainy within the reporting period.)
WQM on 1 and 17 October 2018 were cancelled due to suspension of marine works.*

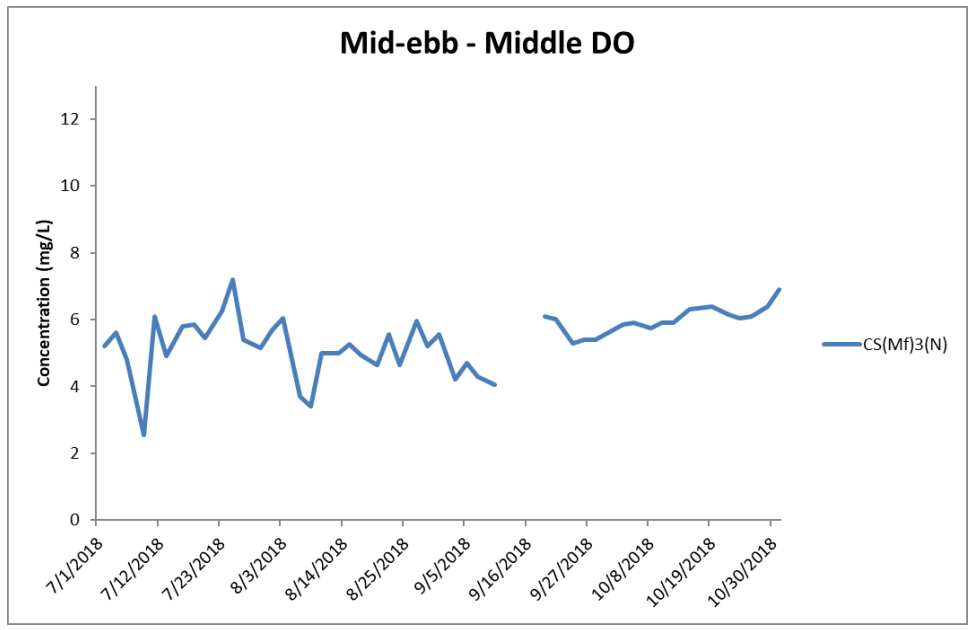
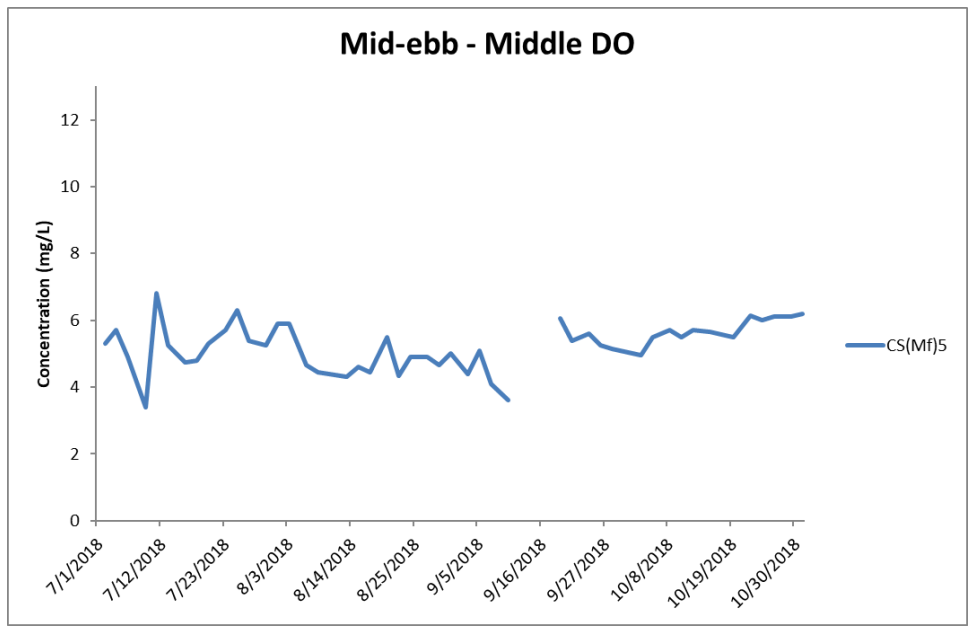
Figure J9 Impact Monitoring - Mean Level of Dissolved Oxygen (mg/L) in mid-depth waters during mid-ebb tide between 1 July and 31 October 2018 at CS(Mf)3(N) and CS(Mf)5.

(Weather condition varied between sunny to rainy within the reporting period.)
 WQM on 1 and 17 October 2018 were cancelled due to suspension of marine works.
 In-situ monitoring is taken according to the requirement specified in the EM&A Manual, i.e. 3 water depth namely 1m below sea surface, mid-depth and 1m above sea bed. If the water depth is less than 3m, mid-depth sampling only. If water depth less than 6m, mid-depth may be omitted.
 Marine works within the reporting period include Uninstallation of marine piling platform.

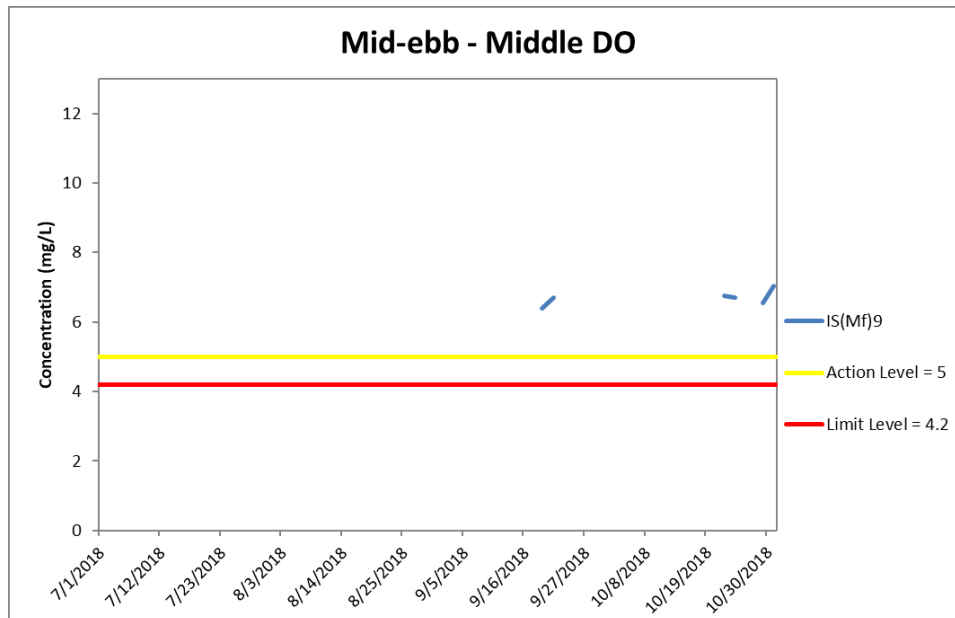
Figure J10 Impact Monitoring – Mean Level of Dissolved Oxygen (mg/L) in mid-depth waters during mid-ebb tide between 1 July and 31 October 2018 at IS(Mf)9.

(Weather condition varied between sunny to rainy within the reporting period.)
 WQM on 1 and 17 October 2018 were cancelled due to suspension of marine works.
 In-situ monitoring is taken according to the requirement specified in the EM&A Manual, i.e. 3 water depth namely 1m below sea surface, mid-depth and 1m above sea bed. If the water depth is less than 3m, mid-depth sampling only. If water depth less than 6m, mid-depth may be omitted.
 Marine works within the reporting period include Uninstallation of marine piling platform.

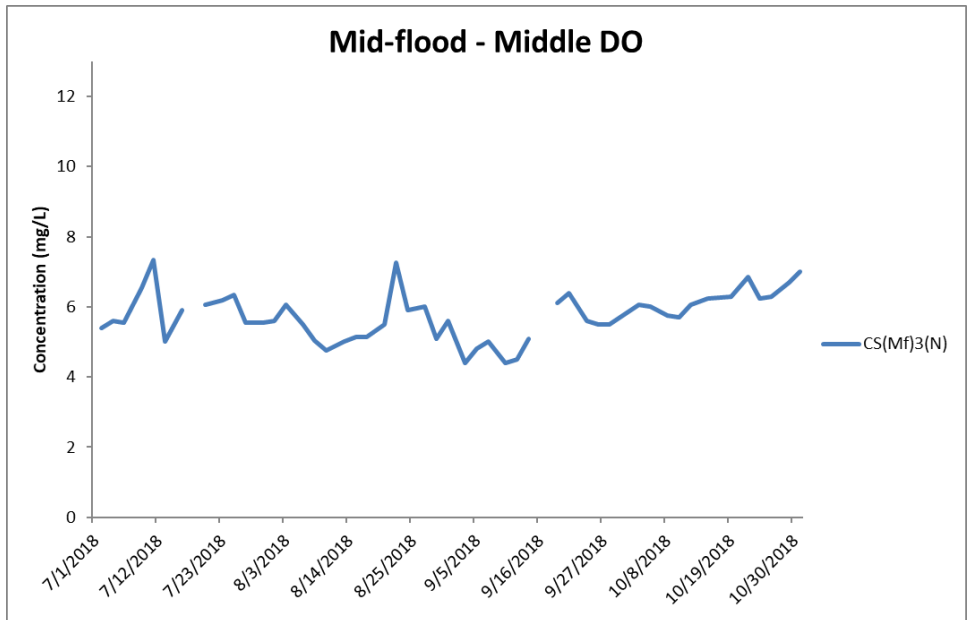
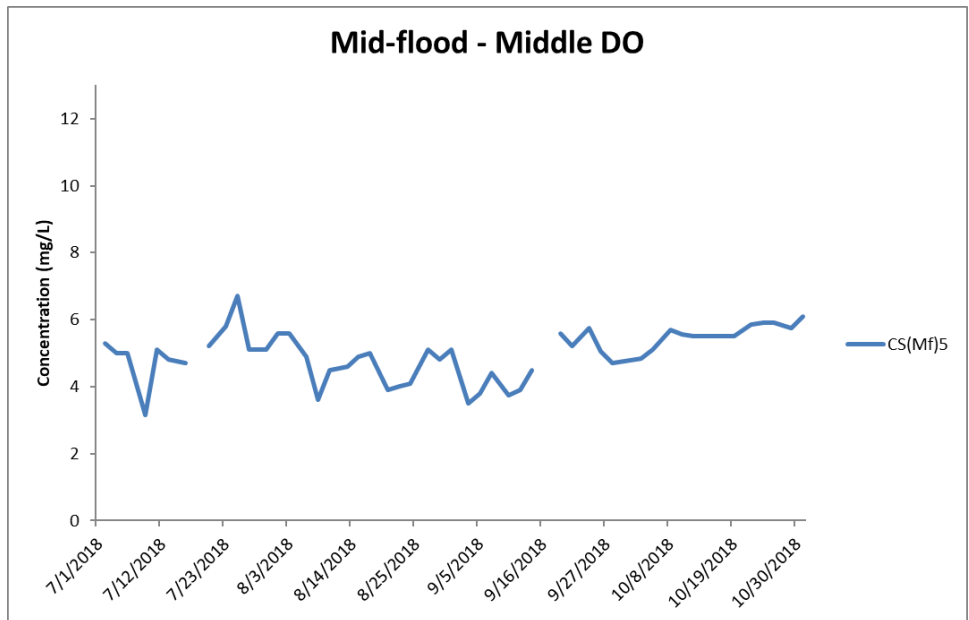
Figure J11 Impact Monitoring – Mean Level of Dissolved Oxygen (mg/L) in mid-depth waters during mid-flood tide between 1 July and 31 October 2018 at CS(Mf)3(N) and CS(Mf)5.

(Weather condition varied between sunny to rainy within the reporting period.)
 WQM on 1 and 17 October 2018 were cancelled due to suspension of marine works.
 In-situ monitoring is taken according to the requirement specified in the EM&A Manual, i.e. 3 water depth namely 1m below sea surface, mid-depth and 1m above sea bed. If the water depth is less than 3m, mid-depth sampling only. If water depth less than 6m, mid-depth may be omitted.
 Marine works within the reporting period include Uninstallation of marine piling platform.

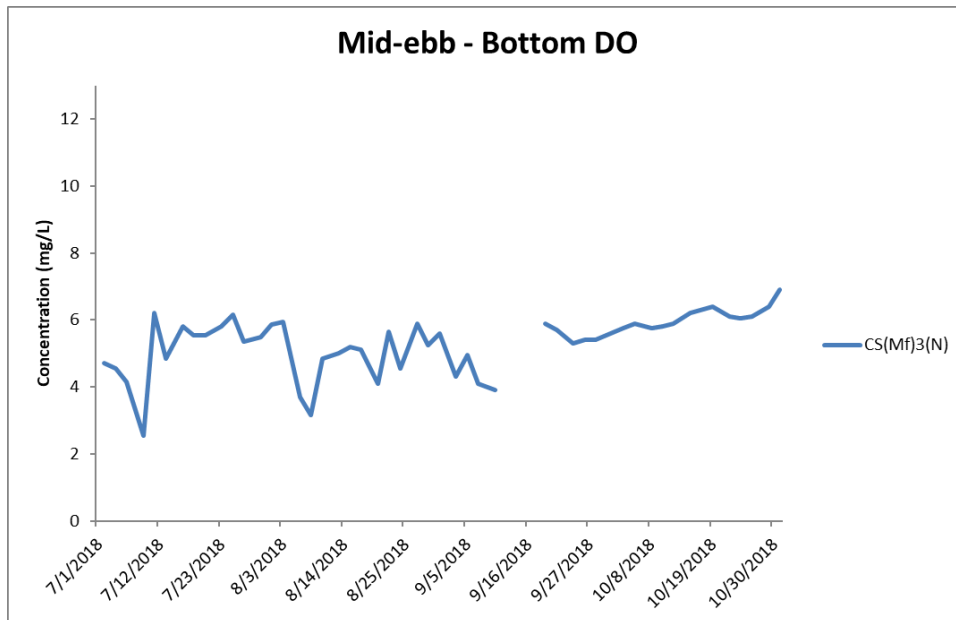
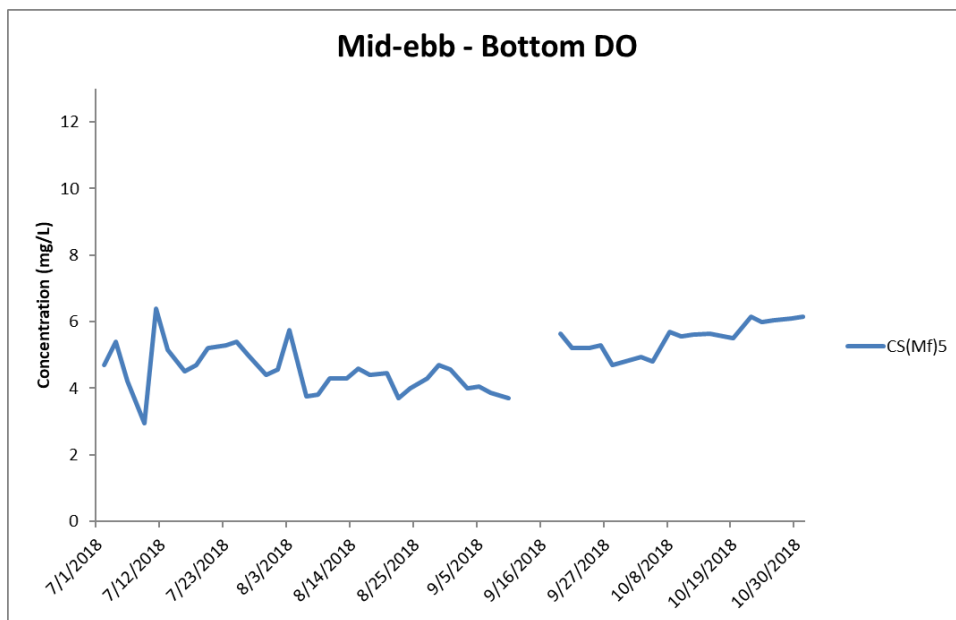
Figure J13 Impact Monitoring – Mean Level of Dissolved Oxygen (mg/L) in bottom waters during mid-ebb tide between 1 July and 31 October 2018 at CS(Mf)3(N) and CS(Mf)5.

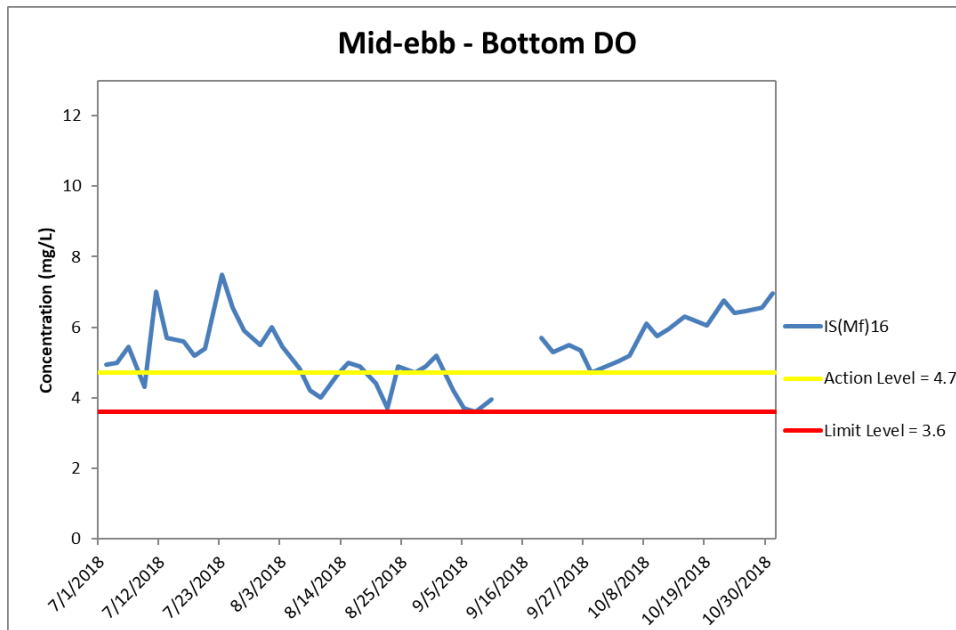
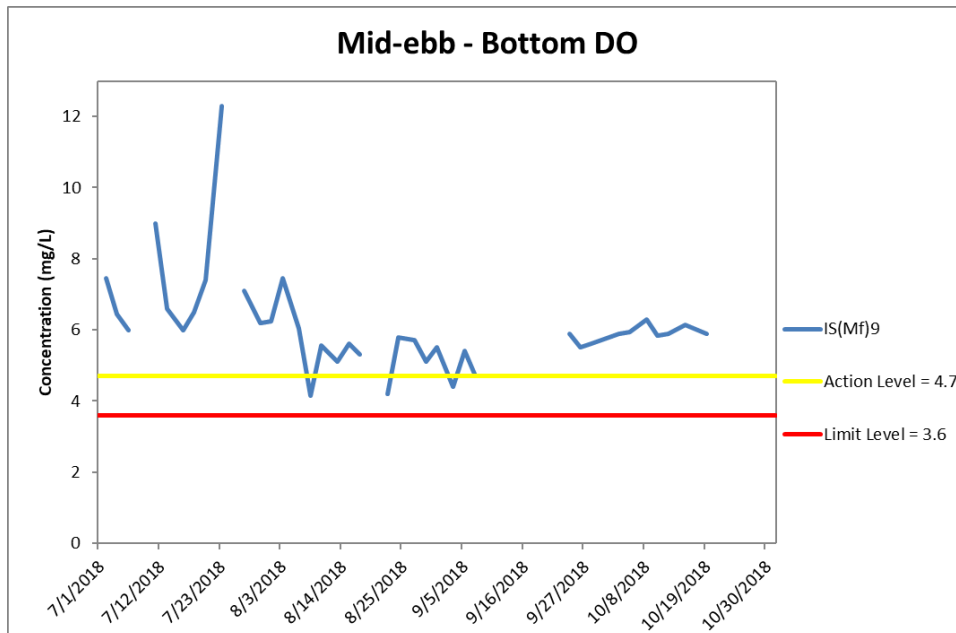
Figure J14 Impact Monitoring - Mean Level of Dissolved Oxygen (mg/L) in bottom waters during mid-ebb tide between 1 July and 31 October 2018 at IS(Mf)16 and IS(Mf)9.

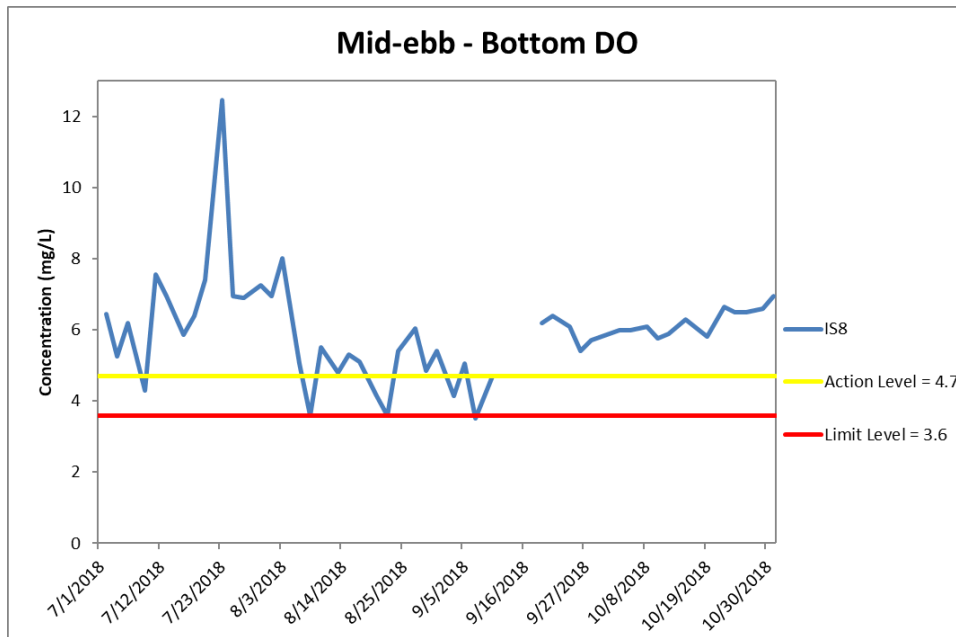
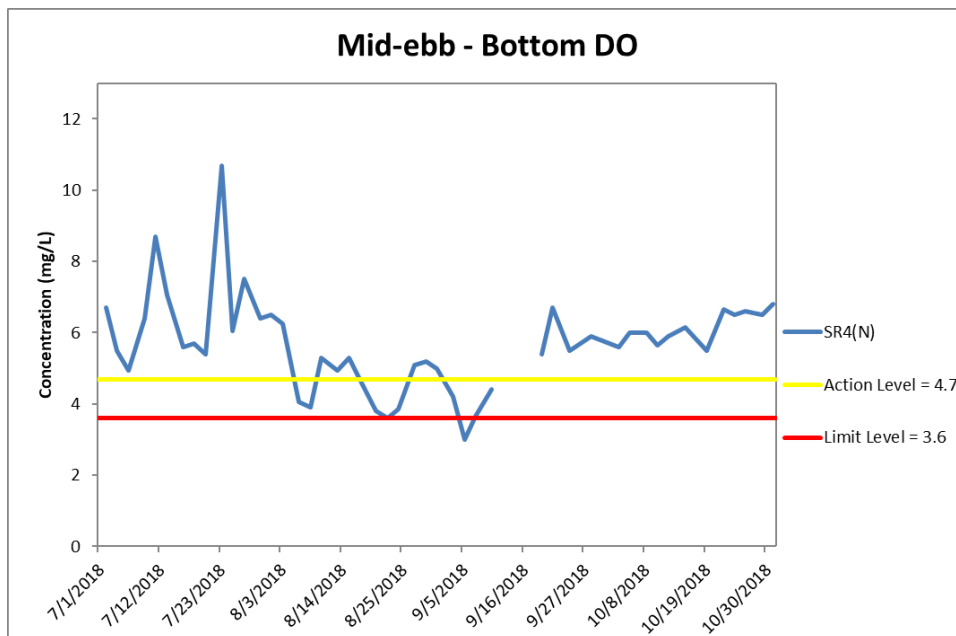
Figure J15 Impact Monitoring – Mean Level of Dissolved Oxygen (mg/L) in bottom waters during mid-ebb tide between 1 July and 31 October 2018 at IS8 and SR4(N).

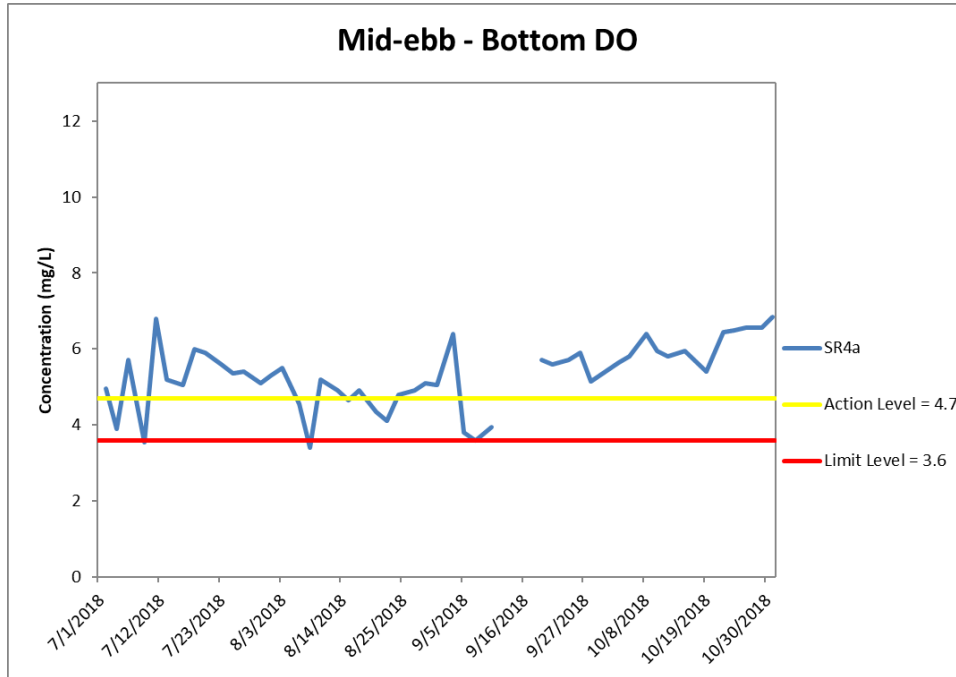
Figure J16 Impact Monitoring – Mean Level of Dissolved Oxygen (mg/L) in bottom waters during mid-ebb tide between 1 July and 31 October 2018 at SR4a.

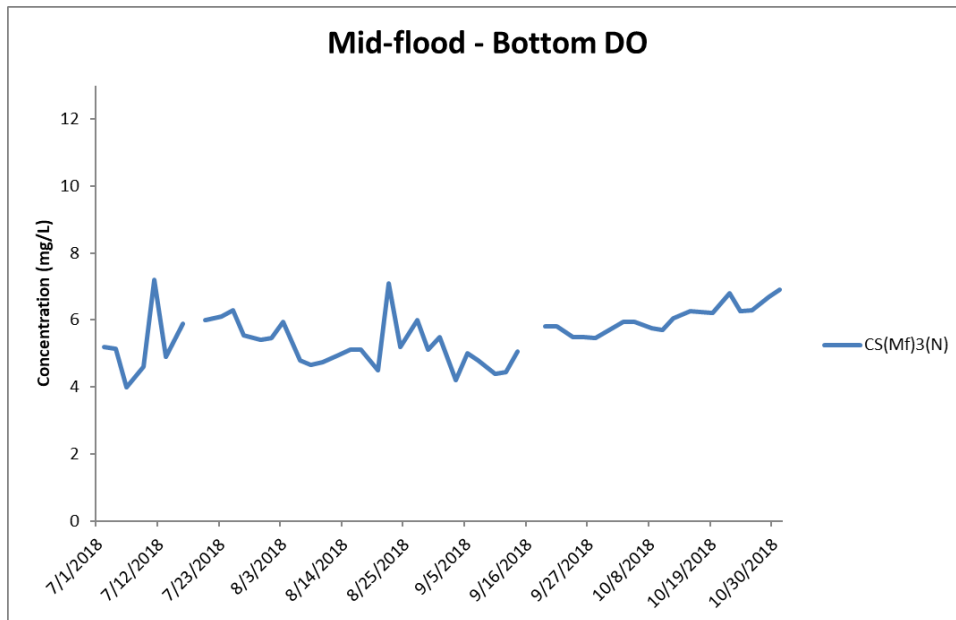
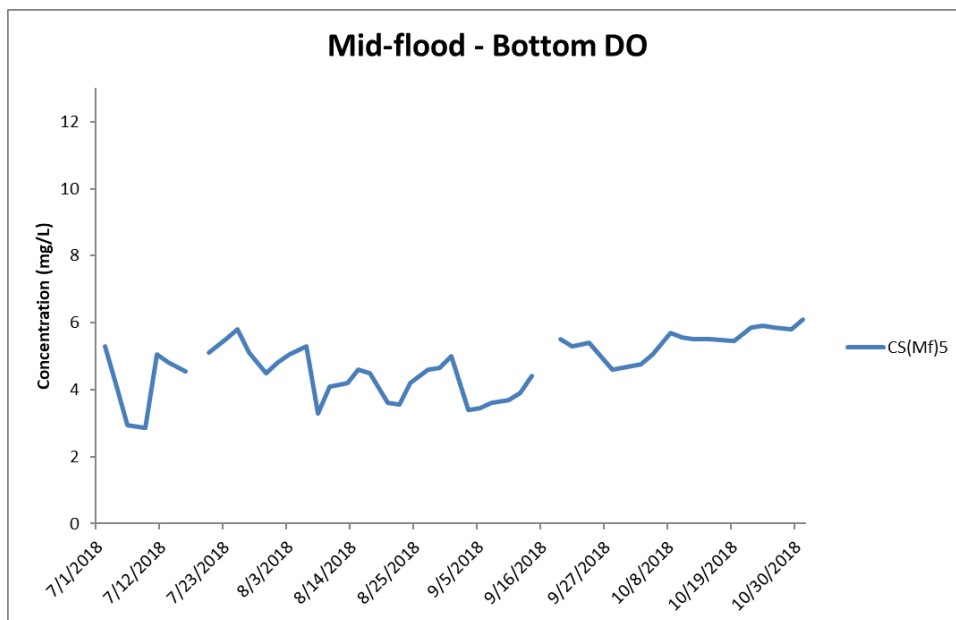
Figure J17 Impact Monitoring - Mean Level of Dissolved Oxygen (mg/L) in bottom waters during mid-flood tide between 1 July and 31 October 2018 at CS(Mf)3(N) and CS(Mf)5.
