**Contract No. HY/2012/07
Tuen Mun – Chek Lap Kok Link –
Southern Connection Viaduct Section**

Sixtieth Monthly EM&A Report

13 November 2018

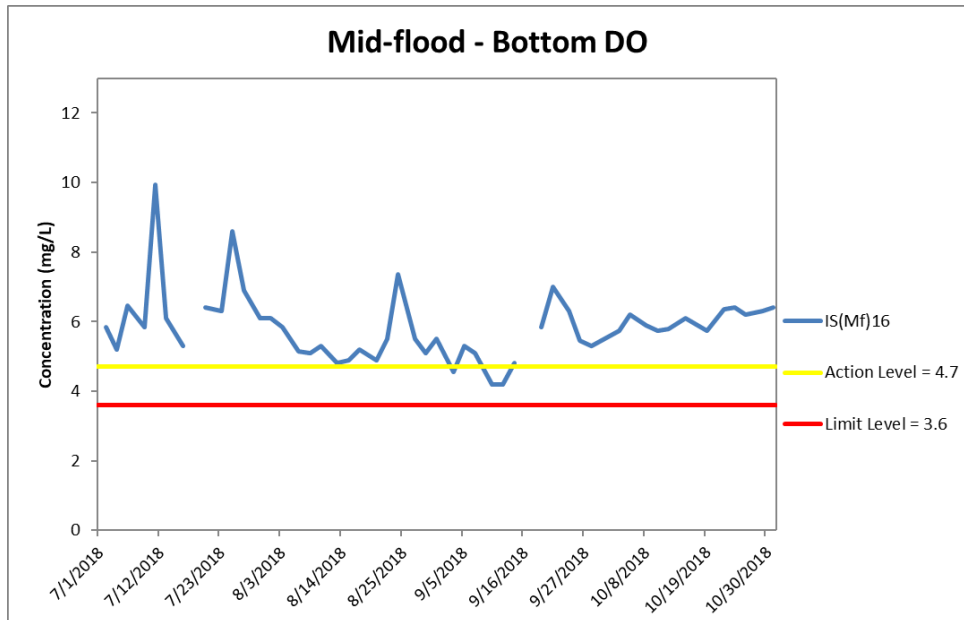
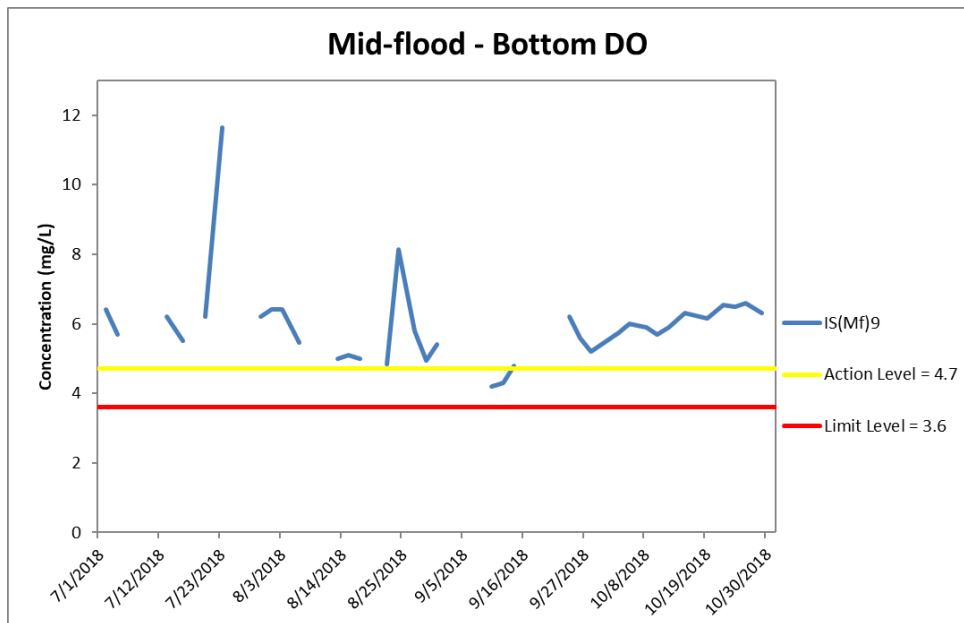
Figure J18 Impact Monitoring - Mean Level of Dissolved Oxygen (mg/L) in bottom waters during mid-flood tide between 1 July and 31 October 2018 at IS(Mf)16 and IS(Mf)9.

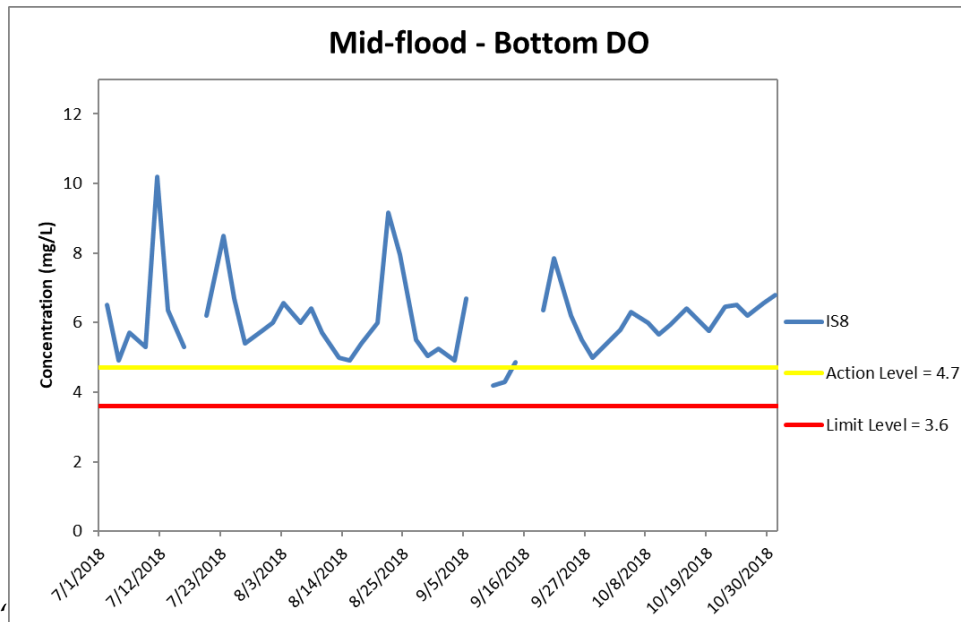
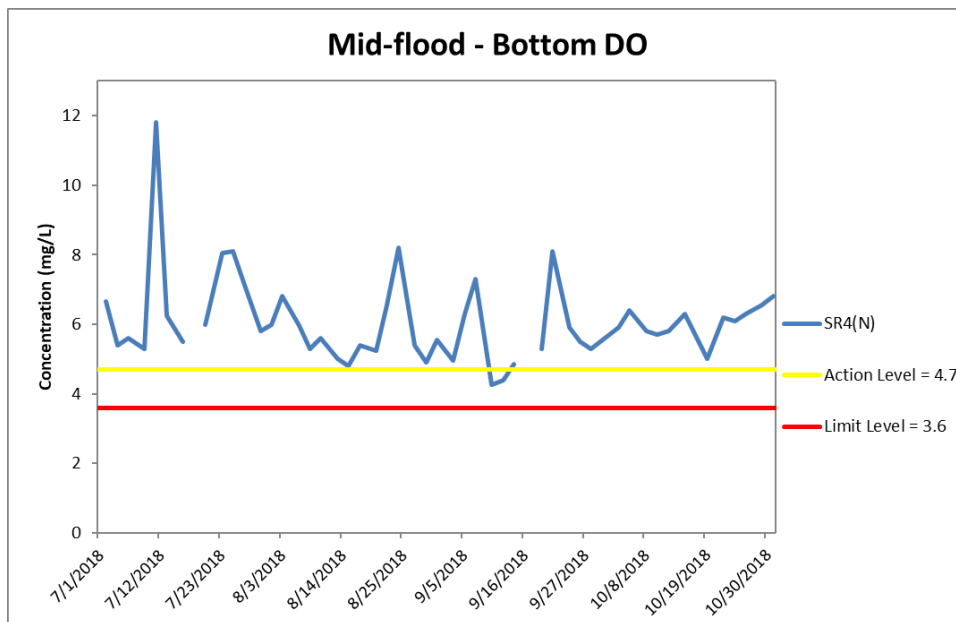
Figure J19 Impact Monitoring – Mean Level of Dissolved Oxygen (mg/L) in bottom waters during mid-flood tide between 1 July and 31 October 2018 at IS8 and SR4(N).

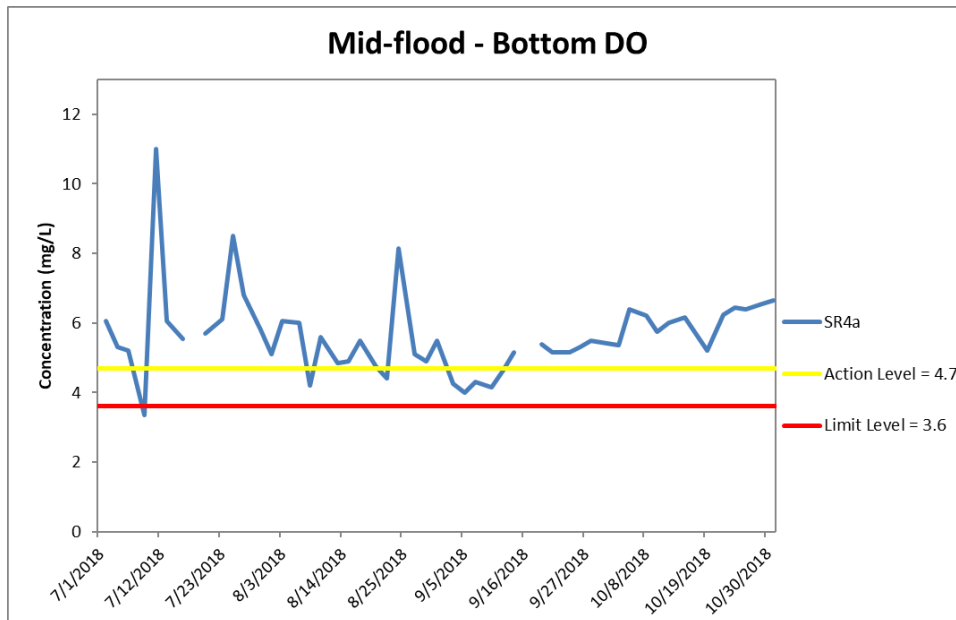
Figure J20 Impact Monitoring - Mean Level of Dissolved Oxygen (mg/L) in bottom waters during mid-flood tide between 1 July and 31 October 2018 at SR4a.

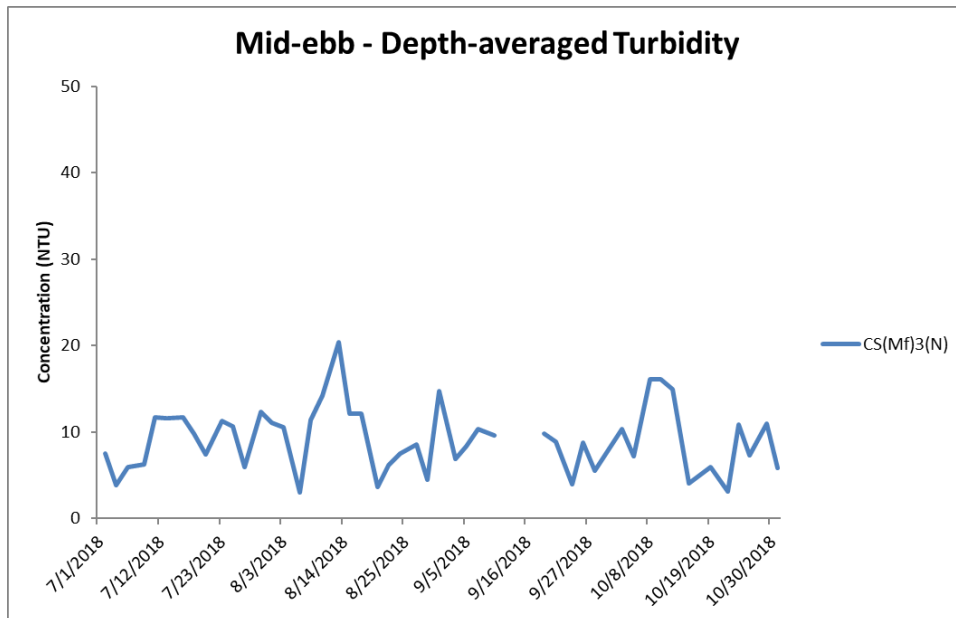
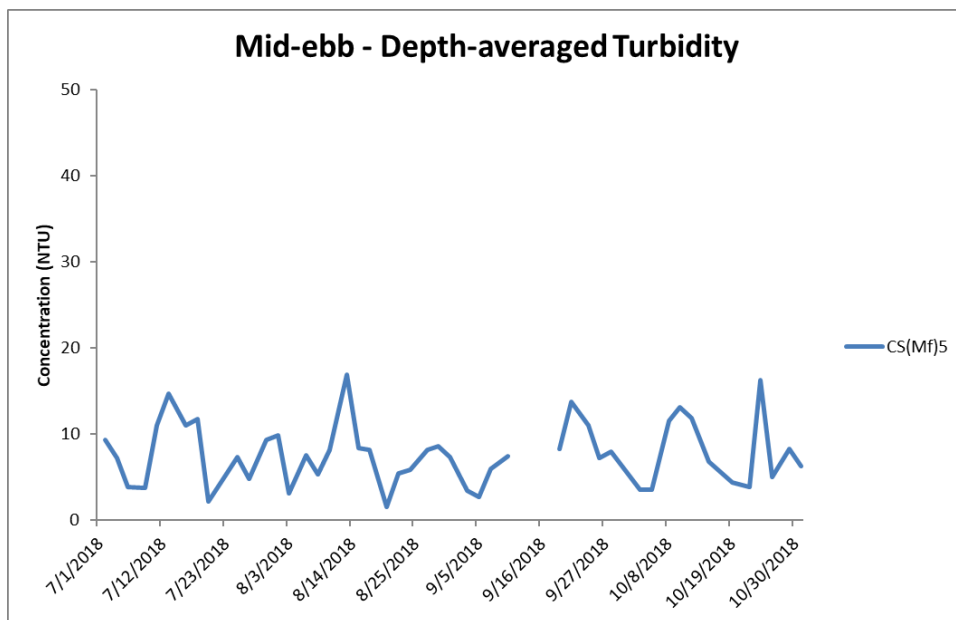
Figure J21 Impact Monitoring – Mean Level of depth-averaged Turbidity (NTU) during mid-ebb tide between 1 July and 31 October 2018 at CS(Mf)3(N) and CS(Mf)5.

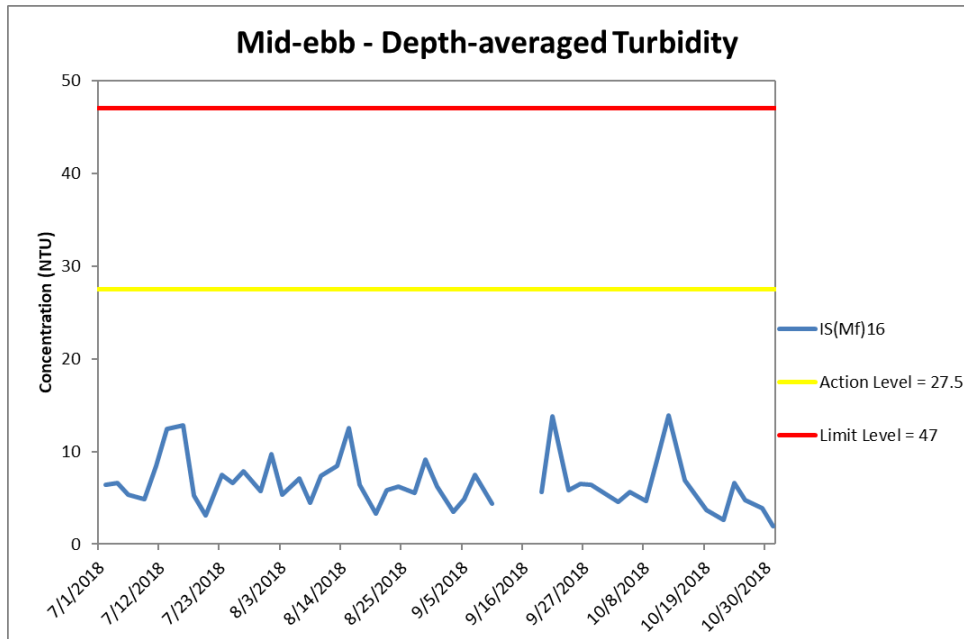
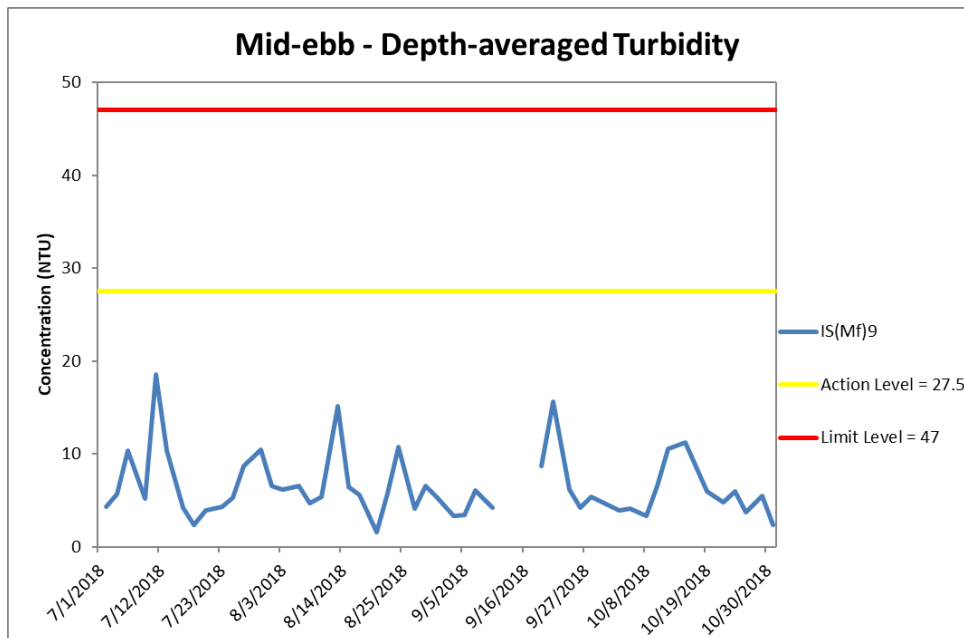
Figure J22 Impact Monitoring - Mean Level of depth-averaged Turbidity (NTU) during mid-ebb tide between 1 July and 31 October 2018 at IS(Mf)16 and IS(Mf)9.

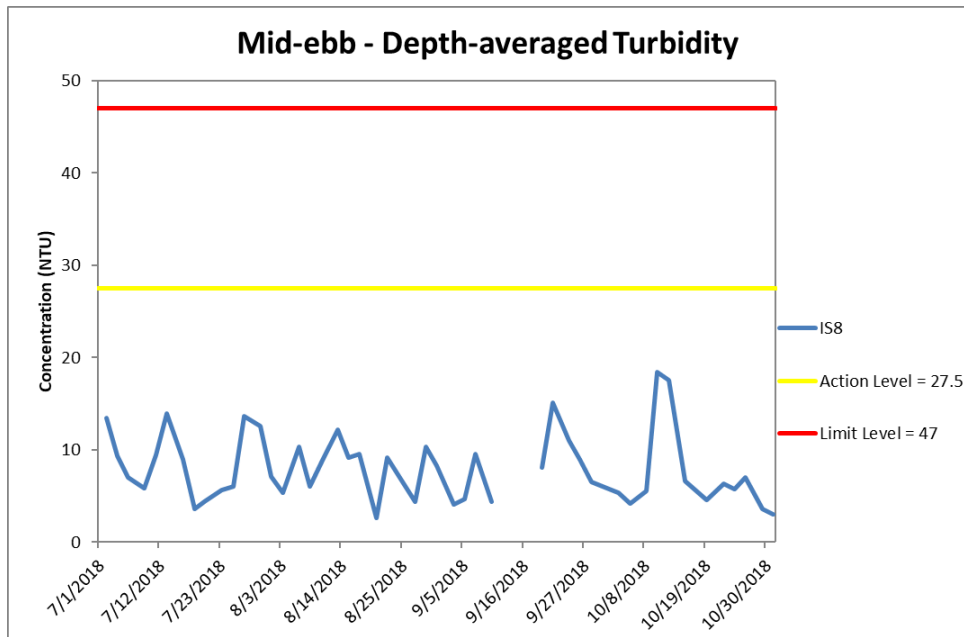
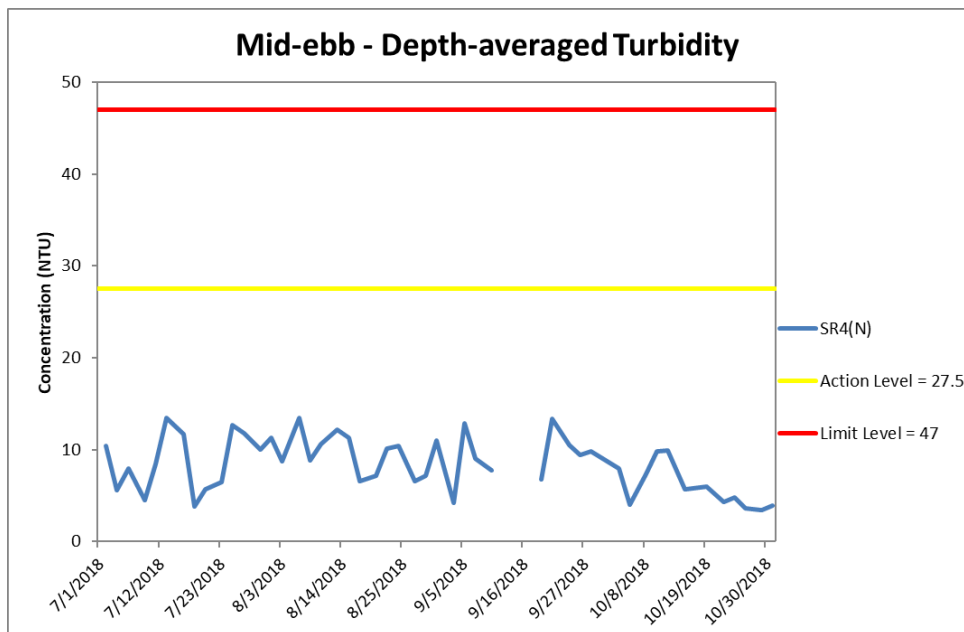
Figure J23 Impact Monitoring – Mean Level of depth-averaged Turbidity (NTU) during mid-ebb tide between 1 July and 31 October 2018 at IS8 and SR4(N).

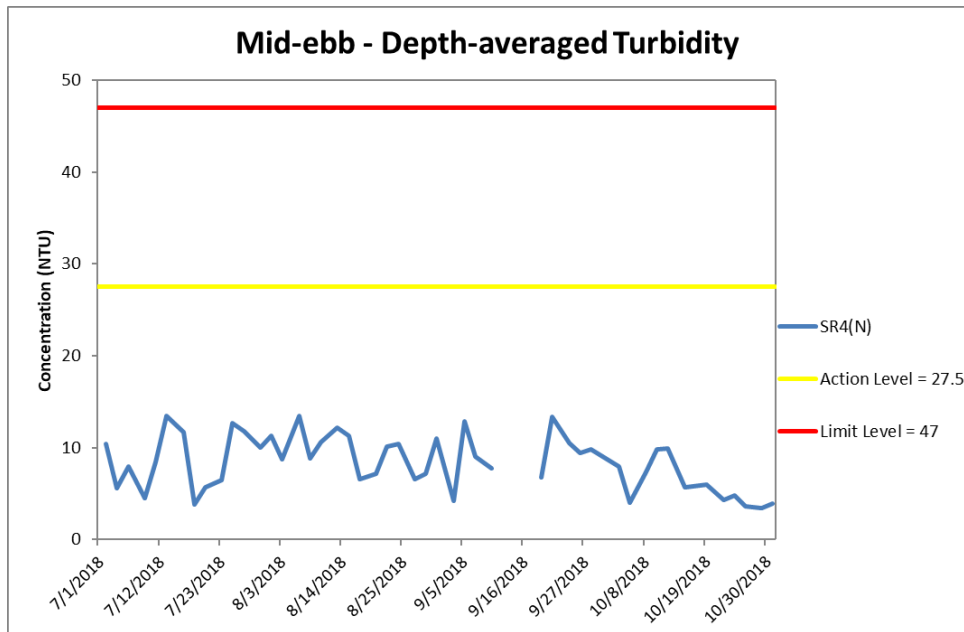
Figure J24 Impact Monitoring - Mean Level of depth-averaged Turbidity (NTU) during mid-ebb tide between 1 July and 31 October 2018 at SR4a.

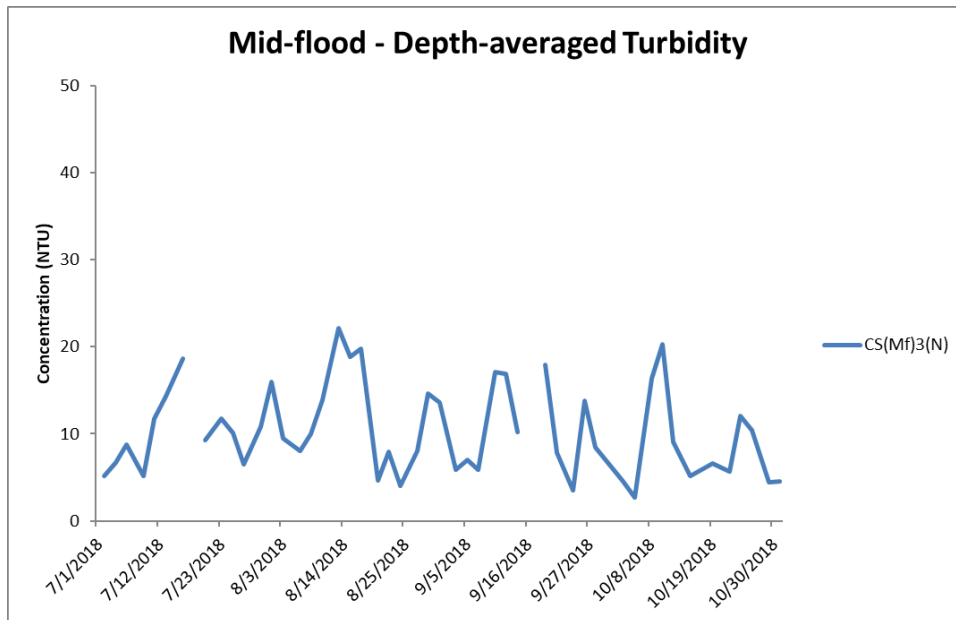
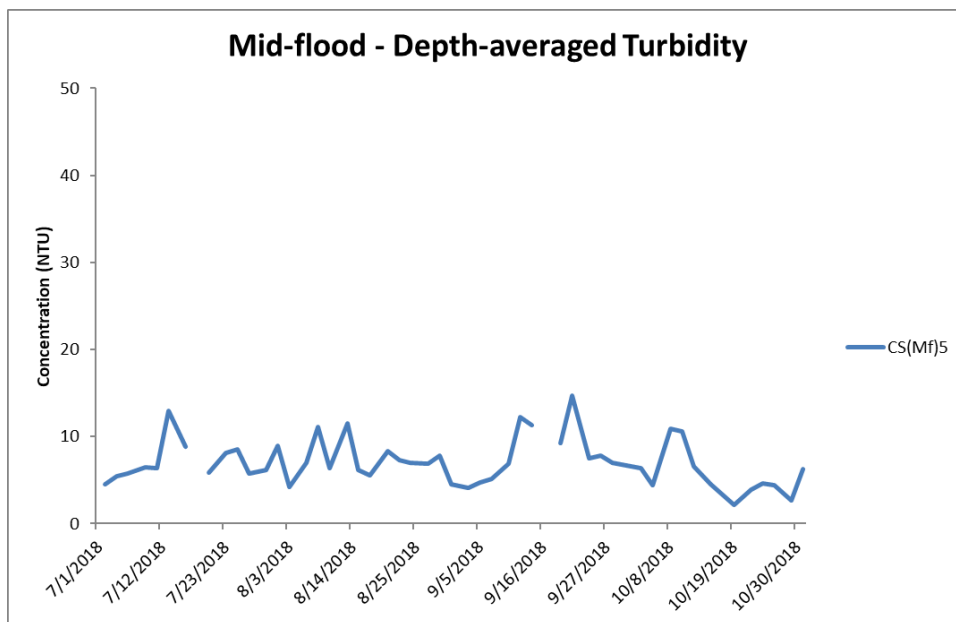
Figure J25 Impact Monitoring - Mean Level of depth-averaged Turbidity (NTU) during mid-flood tide between 1 July and 31 October 2018 at CS(Mf)3(N) and CS(MF)5.

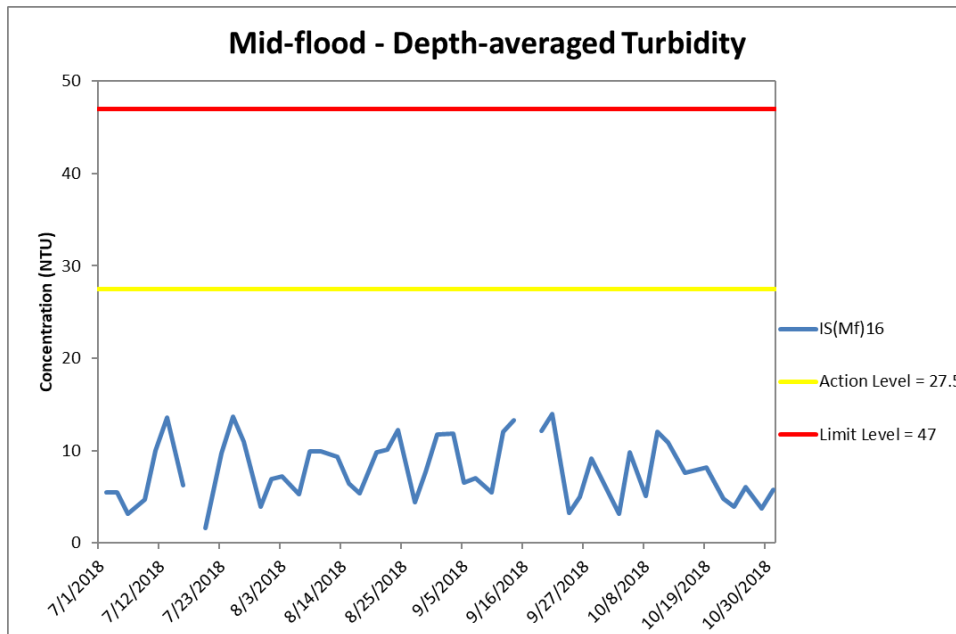
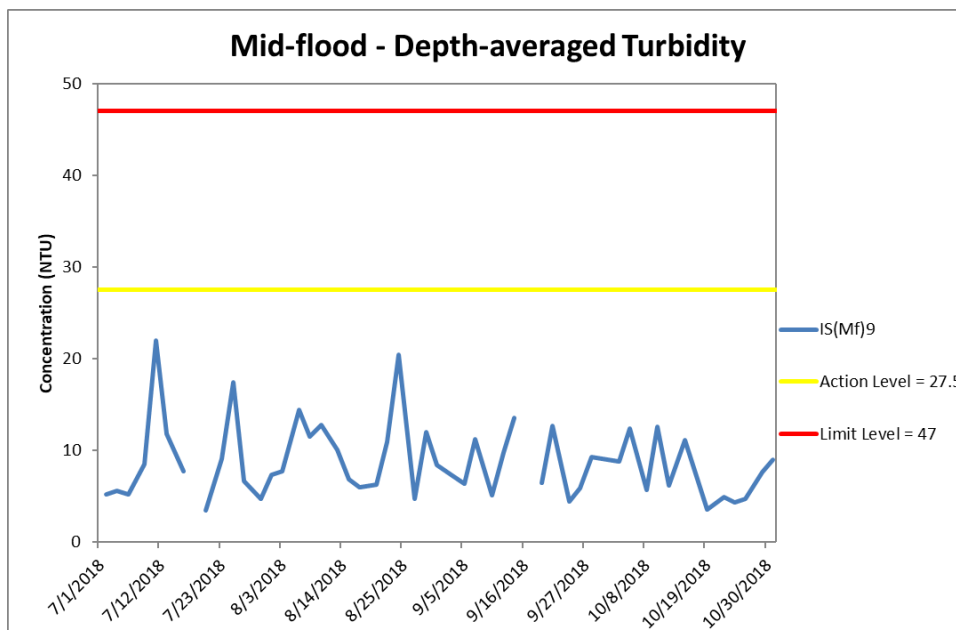
Figure J26 Impact Monitoring – Mean Level of depth-averaged Turbidity (NTU) during mid-flood tide between 1 July and 31 October 2018 at IS(Mf)16 and IS(Mf)9.

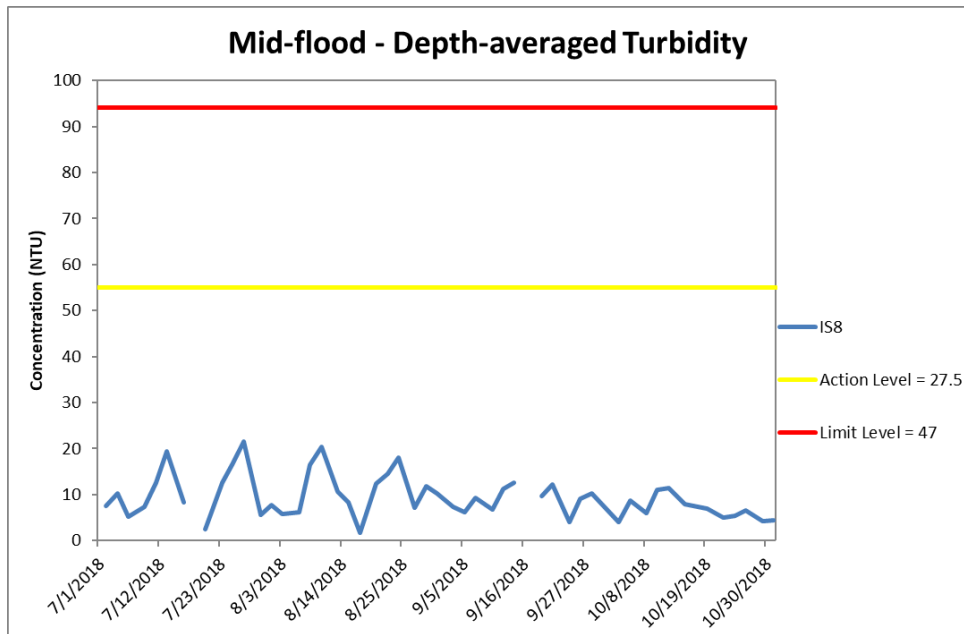
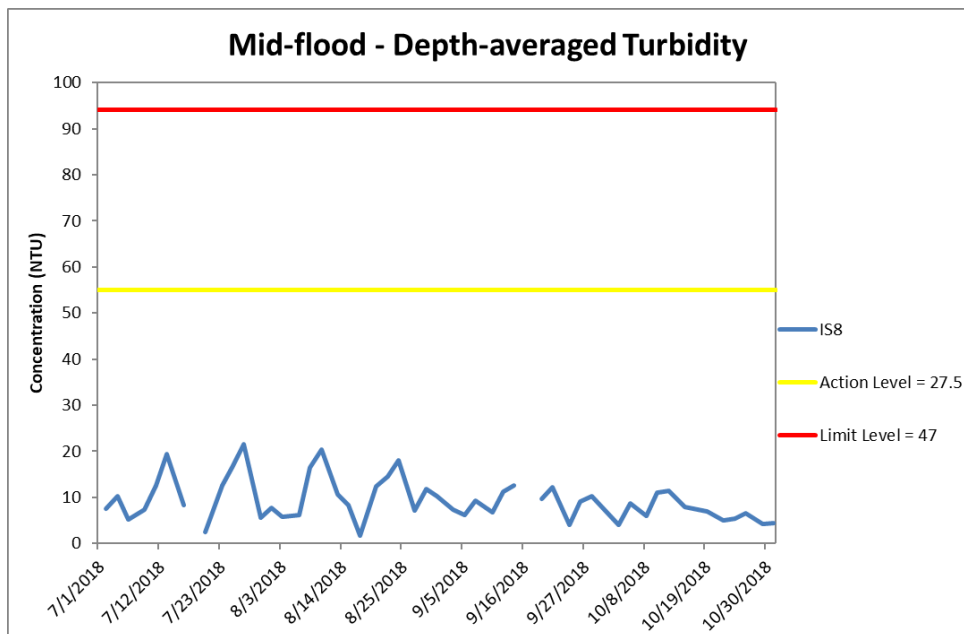
Figure J27 Impact Monitoring – Mean Level of depth-averaged Turbidity (NTU) during mid-flood tide between 1 July and 31 October 2018 at IS8 and SR4(N).

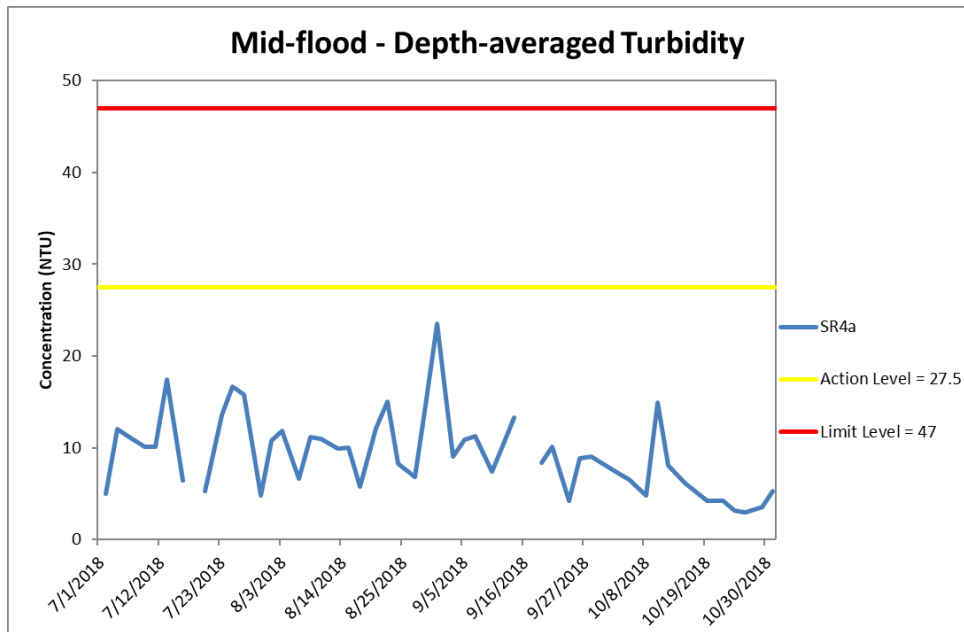
Figure J28 Impact Monitoring - Mean Level of depth-averaged Turbidity (NTU) during mid-flood tide between 1 July and 31 October 2018 at SR4a.

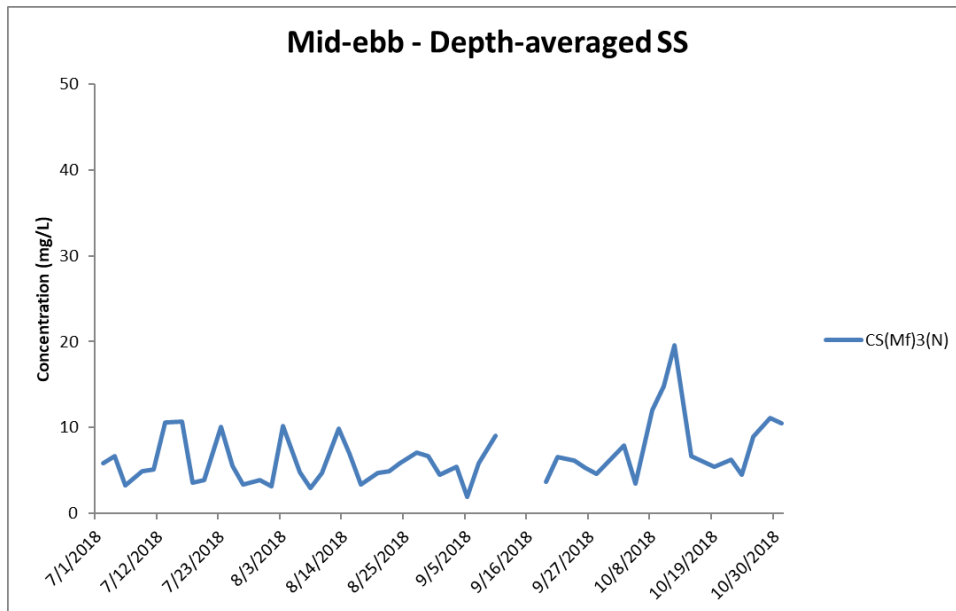
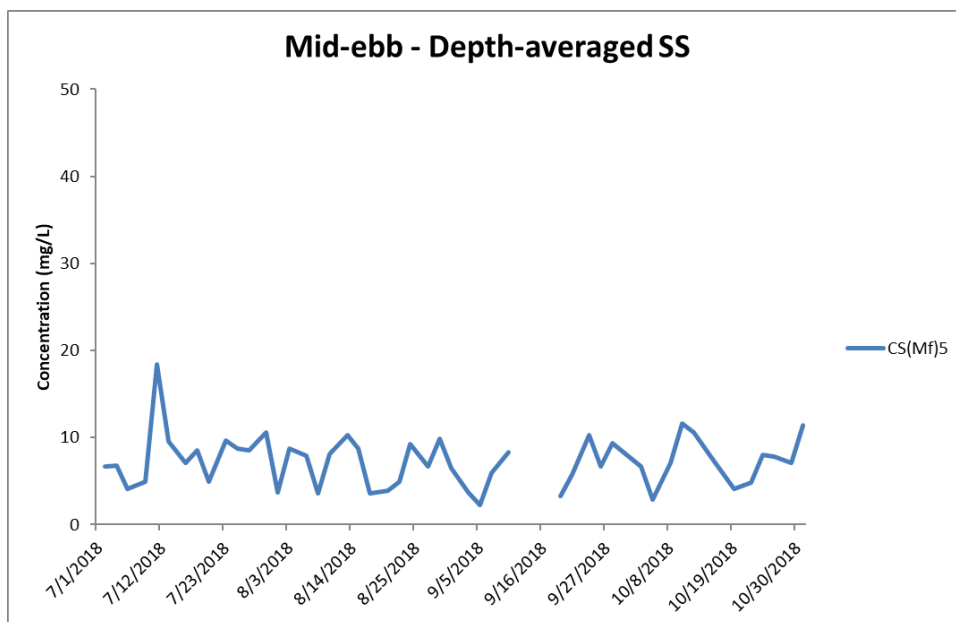
Figure J29 Impact Monitoring – Mean depth-averaged level of Suspended Solids (mg/L) during mid-ebb tide between 1 July and 31 October 2018 at CS(Mf)3(N) and CS(Mf)5.

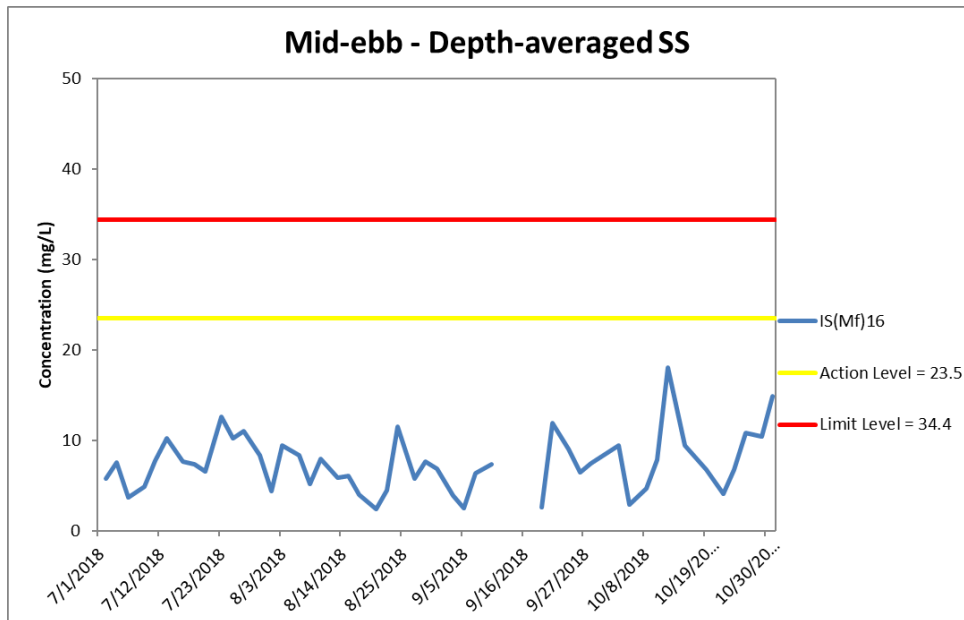
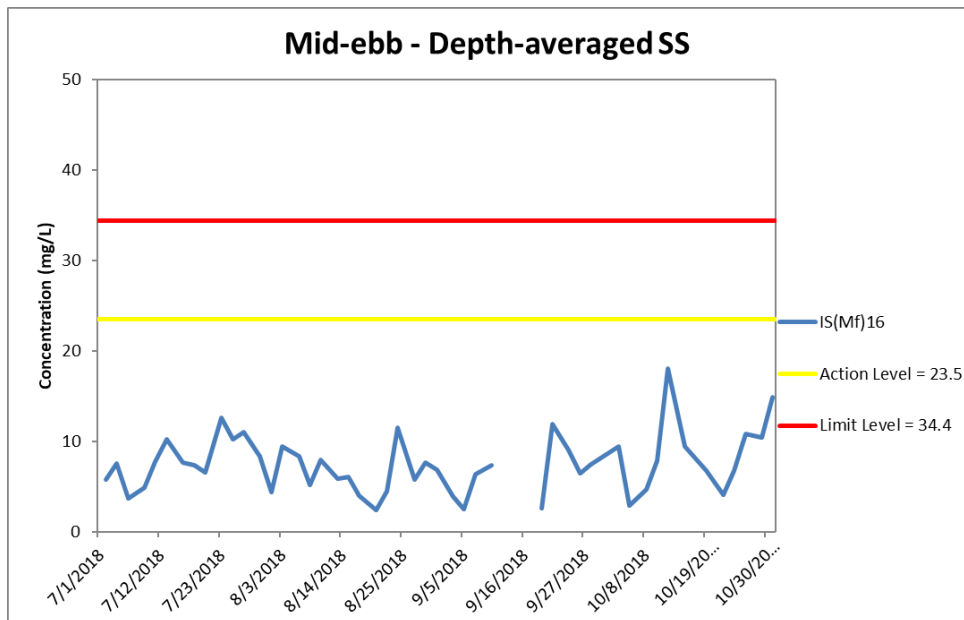
Figure J30 Impact Monitoring - Mean depth-averaged level of Suspended Solids (mg/L) during mid-ebb tide between 1 July and 31 October 2018 at IS(Mf)16 and IS(Mf)9.

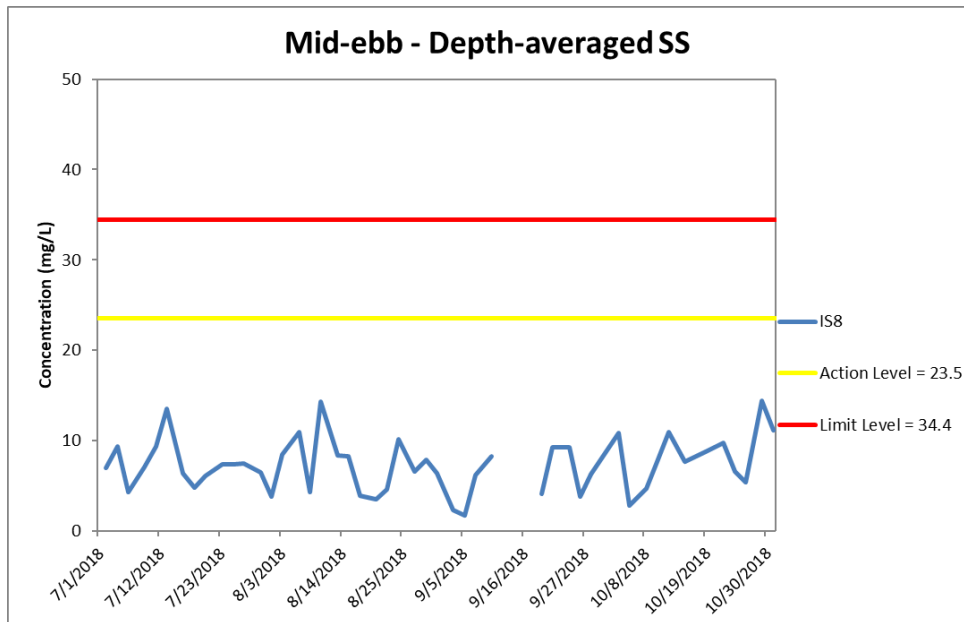
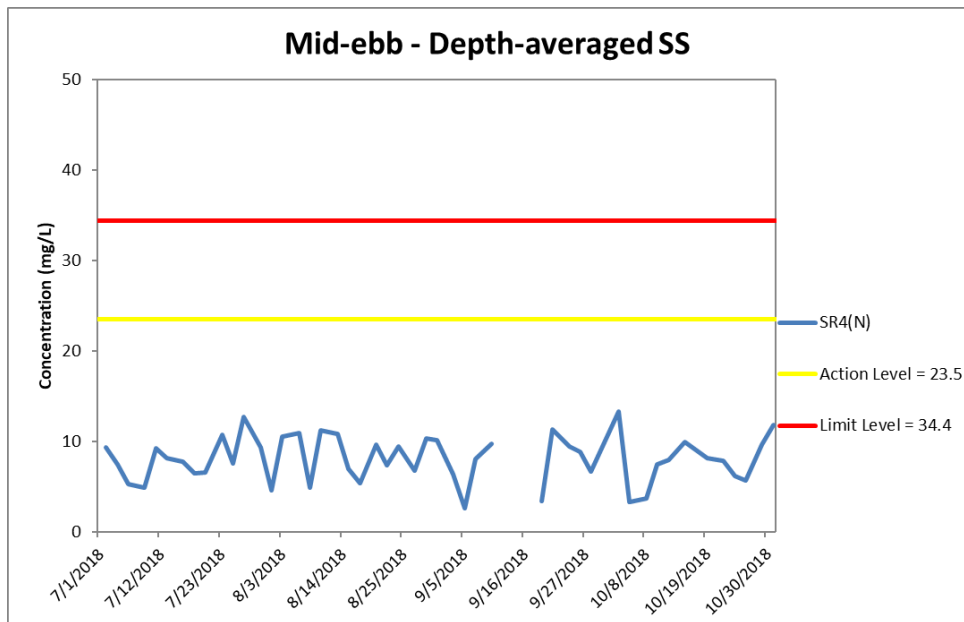
Figure J31 Impact Monitoring - Mean depth-averaged level of Suspended Solids (mg/L) during mid-ebb tide between 1 July and 31 October 2018 at IS8 and SR4(N).

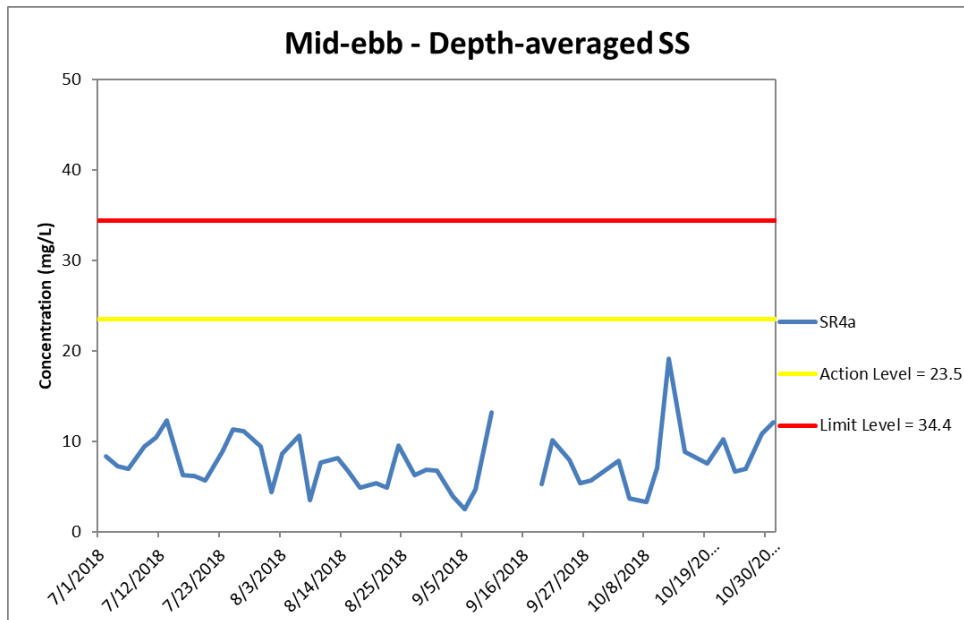
Figure J32 Impact Monitoring - Mean depth-averaged level of Suspended Solids (mg/L) during mid-ebb tide between 1 July and 31 October 2018 at SR4a.

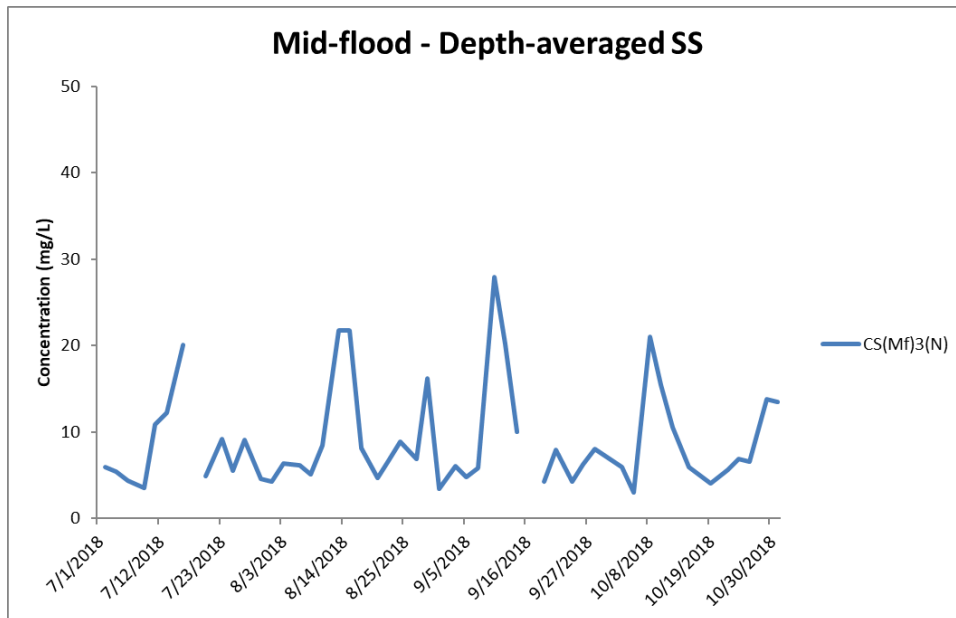
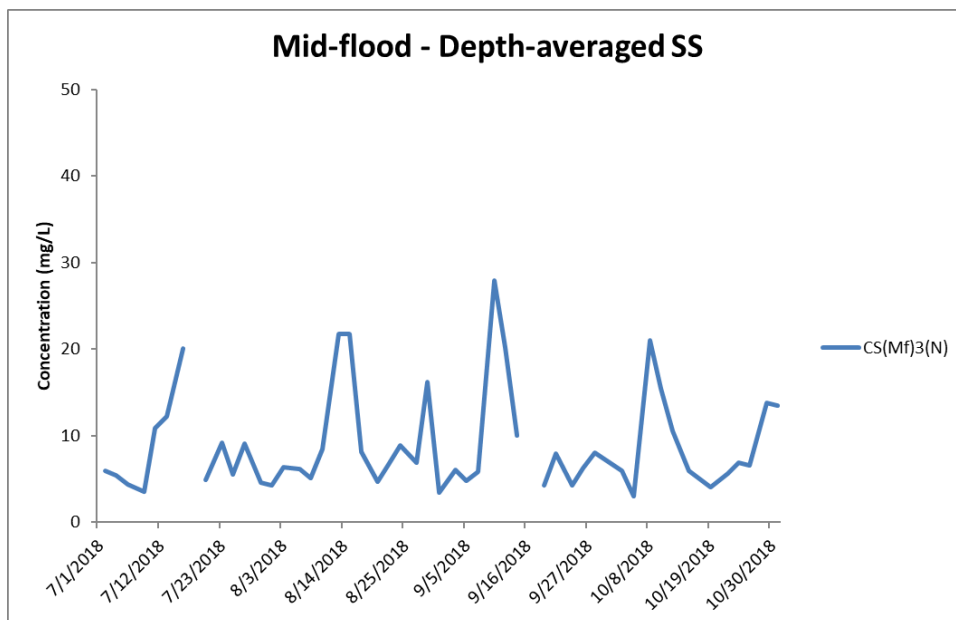
Figure J33 Impact Monitoring - Mean depth-averaged level of Suspended Solids (mg/L) during mid-flood tide between 1 July and 31 October 2018 at CS(Mf)3(N) and CS(Mf)5.

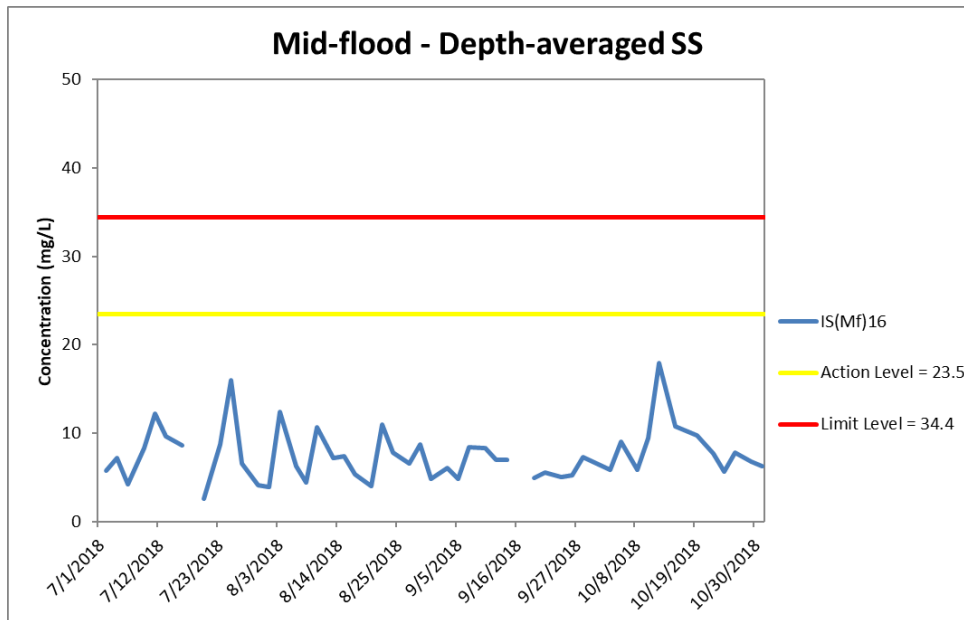
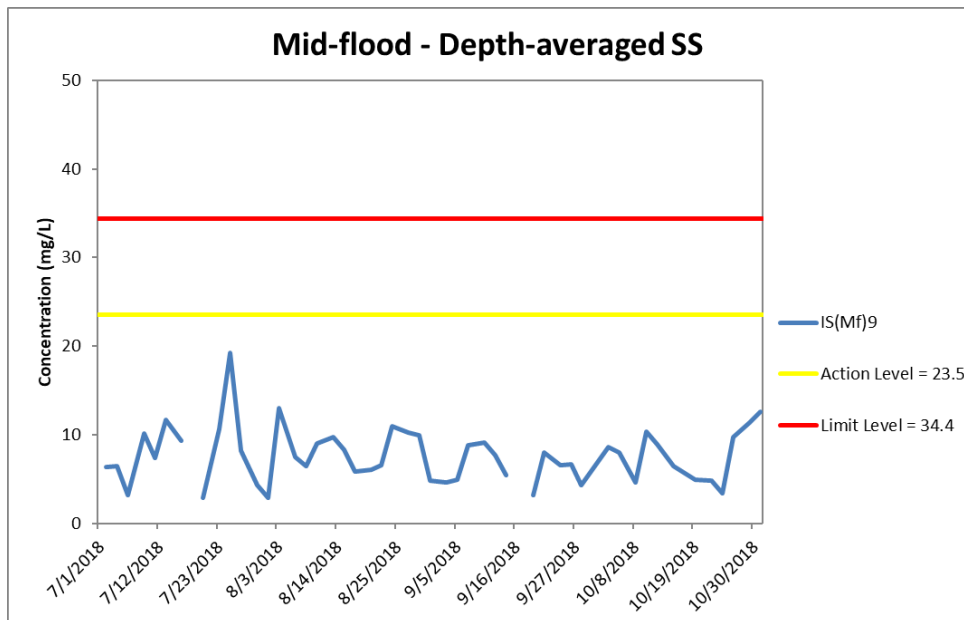
Figure J34 Impact Monitoring - Mean depth-averaged level of Suspended Solids (mg/L) during mid-flood tide between 1 July and 31 October 2018 at IS(Mf)16 and IS(Mf)9.

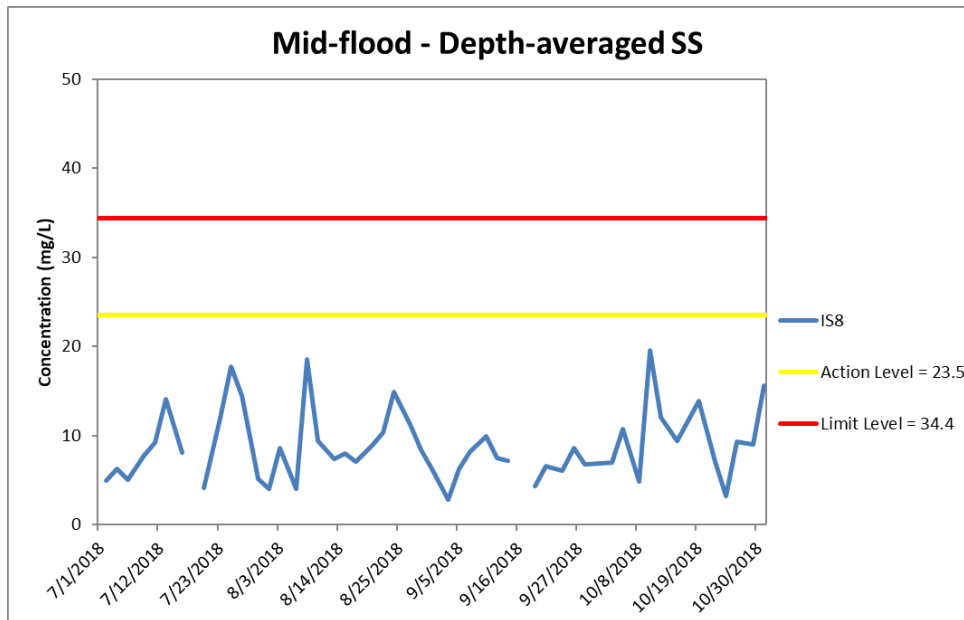
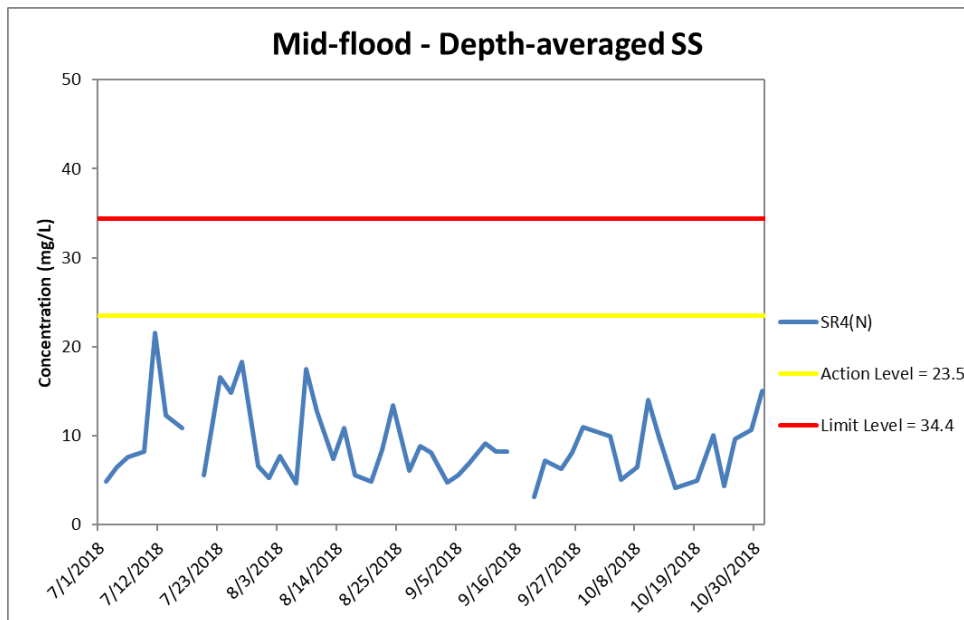
Figure J35 Impact Monitoring - Mean depth-averaged level of Suspended Solids (mg/L) during mid-flood tide between 1 July and 31 October 2018 at IS8 and SR4(N).

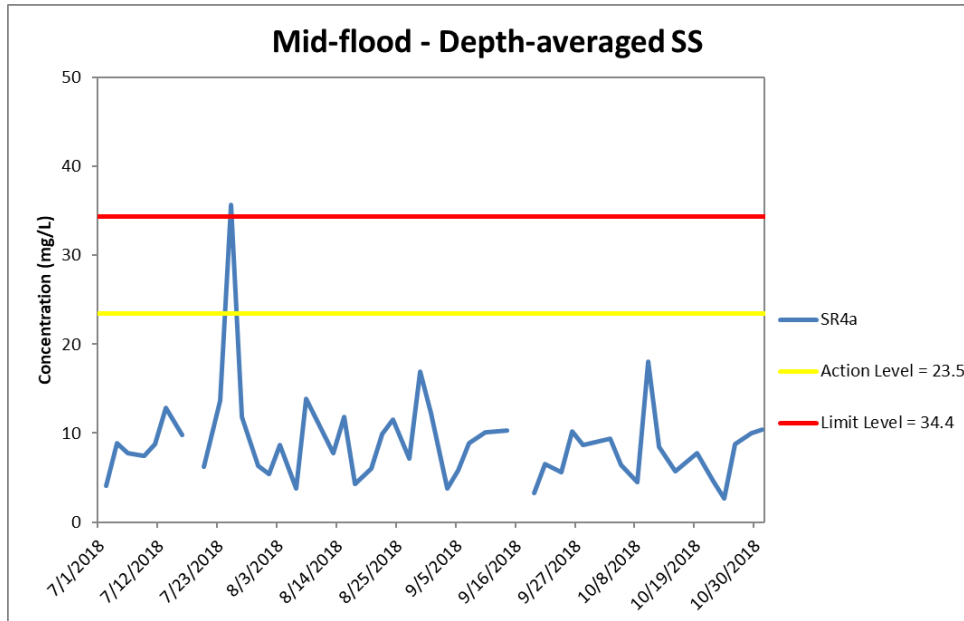
Figure J36 Impact Monitoring - Mean depth-averaged level of Suspended Solids (mg/L) during mid-flood tide between 1 July and 31 October 2018 at SR4a.
