**Contract No. HY/2012/07
Tuen Mun – Chek Lap Kok Link –
Southern Connection Viaduct Section**

Sixty-second Monthly EM&A Report

15 January 2019

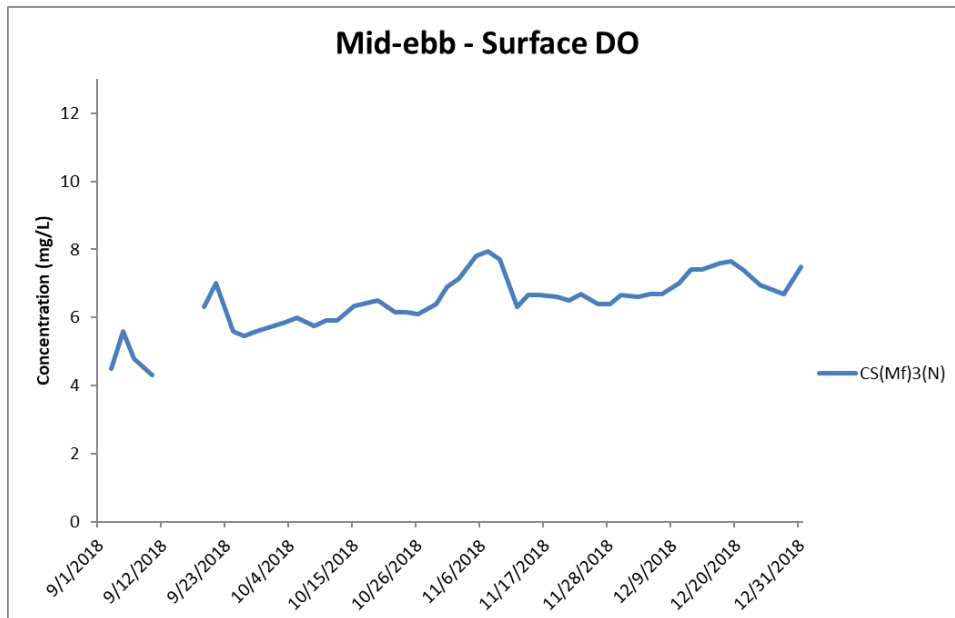
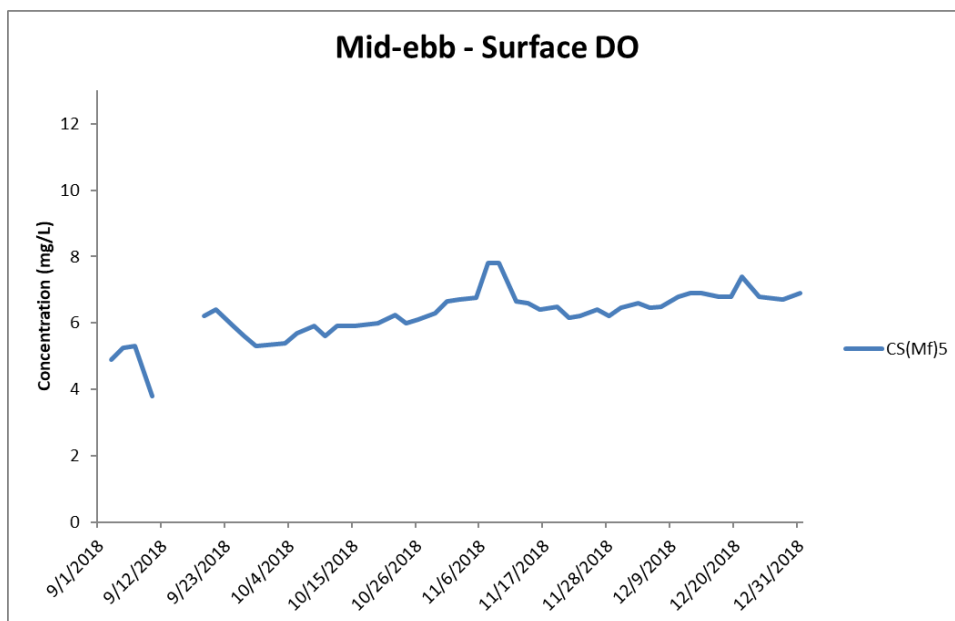
Figure J1 Impact Monitoring – Mean Level of Dissolved Oxygen (mg/L) in surface waters during mid-ebb tide between 1 September and 31 December 2018 at CS(Mf)3(N) and CS(Mf)5.

*(Weather condition varied between sunny to rainy within the reporting period.)
 WQM on 26 December 2018 was cancelled due to suspension of marine works.
 In-situ monitoring is taken according to the requirement specified in the EM&A Manual, i.e. 3 water depth namely 1m below sea surface, mid-depth and 1m above sea bed. If the water depth is less than 3m, mid-depth sampling only. If water depth less than 6m, mid-depth may be omitted.*

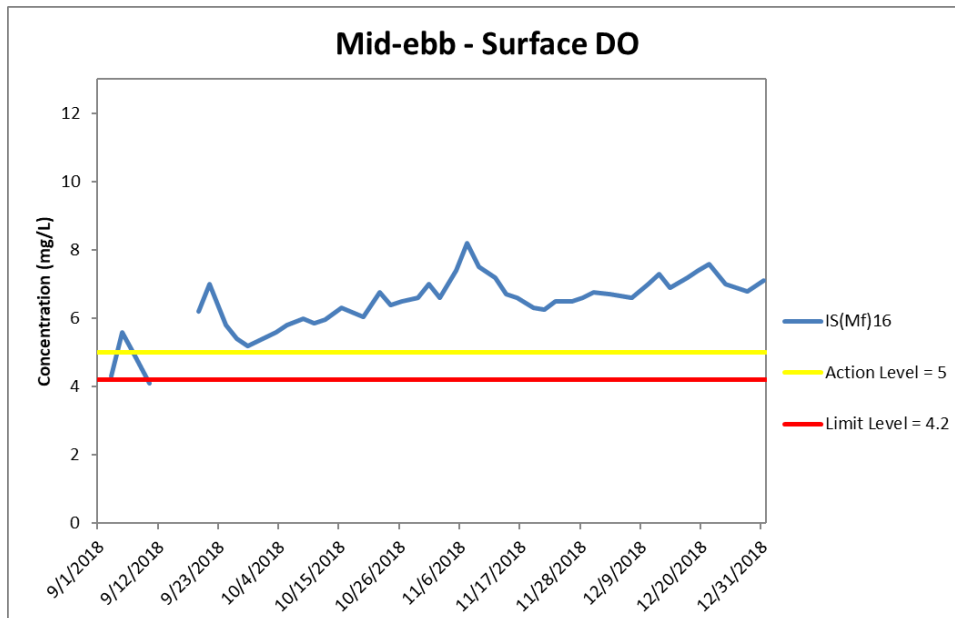
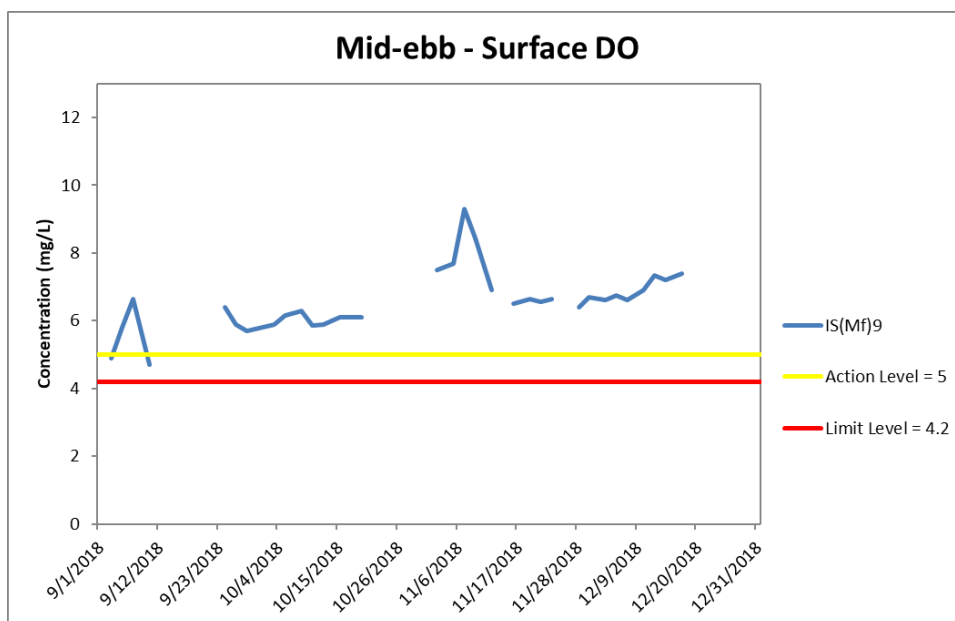
Figure J2 Impact Monitoring - Mean Level of Dissolved Oxygen (mg/L) in surface waters during mid-ebb tide between 1 September and 31 December 2018 at IS(Mf)16 and IS(Mf)9.

*(Weather condition varied between sunny to rainy within the reporting period.)
 WQM on 26 December 2018 was cancelled due to suspension of marine works.
 In-situ monitoring is taken according to the requirement specified in the EM&A Manual, i.e. 3 water depth namely 1m below sea surface, mid-depth and 1m above sea bed. If the water depth is less than 3m, mid-depth sampling only. If water depth less than 6m, mid-depth may be omitted.*

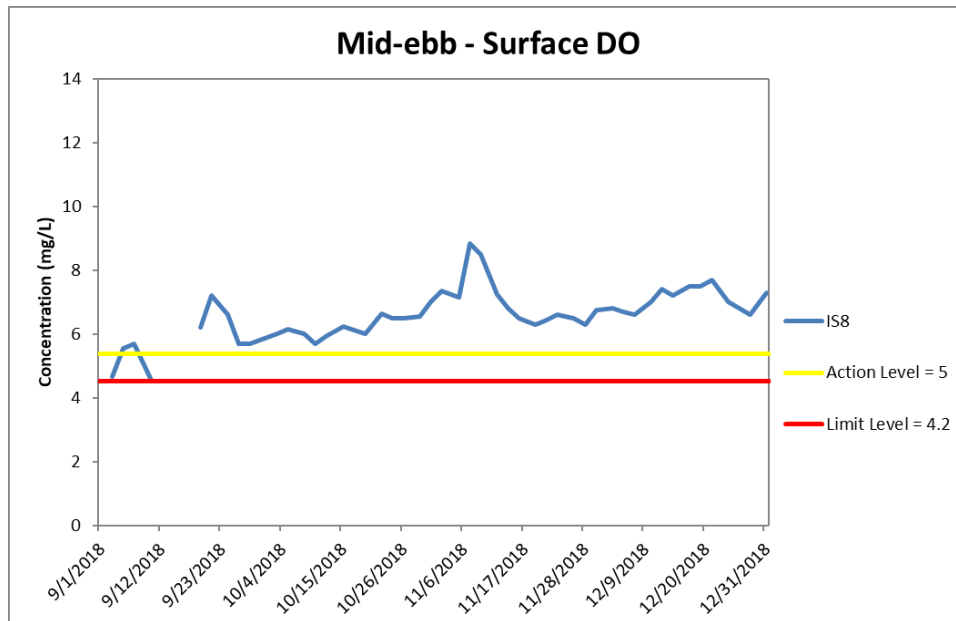
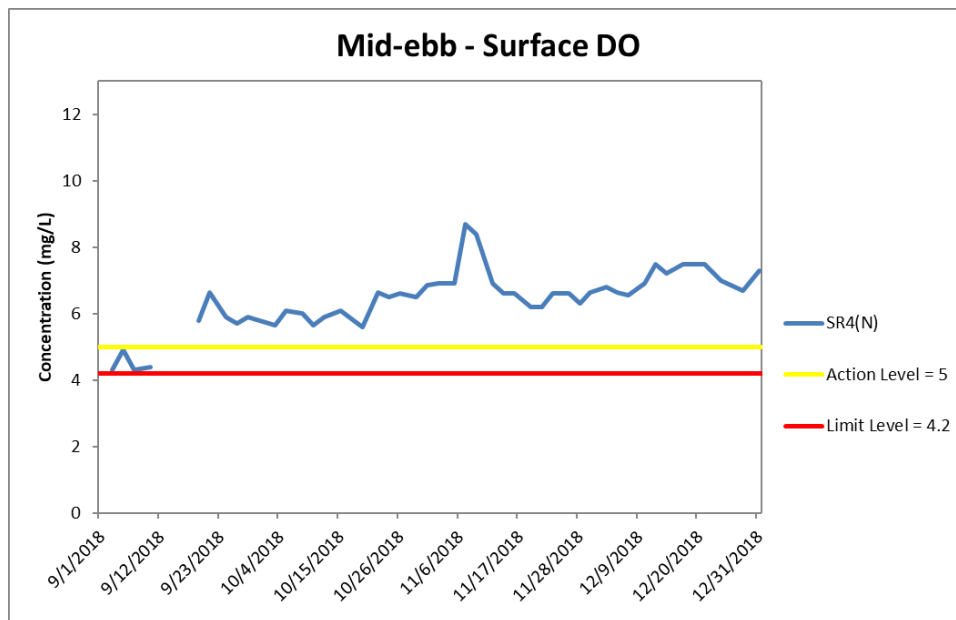
Figure J3 Impact Monitoring - Mean Level of Dissolved Oxygen (mg/L) in surface waters during mid-ebb tide between 1 September and 31 December 2018 at IS8 and SR4(N).

(Weather condition varied between sunny to rainy within the reporting period.)
 WQM on 26 December 2018 was cancelled due to suspension of marine works.
 In-situ monitoring is taken according to the requirement specified in the EM&A Manual, i.e. 3 water depth namely 1m below sea surface, mid-depth and 1m above sea bed. If the water depth is less than 3m, mid-depth sampling only. If water depth less than 6m, mid-depth may be omitted.

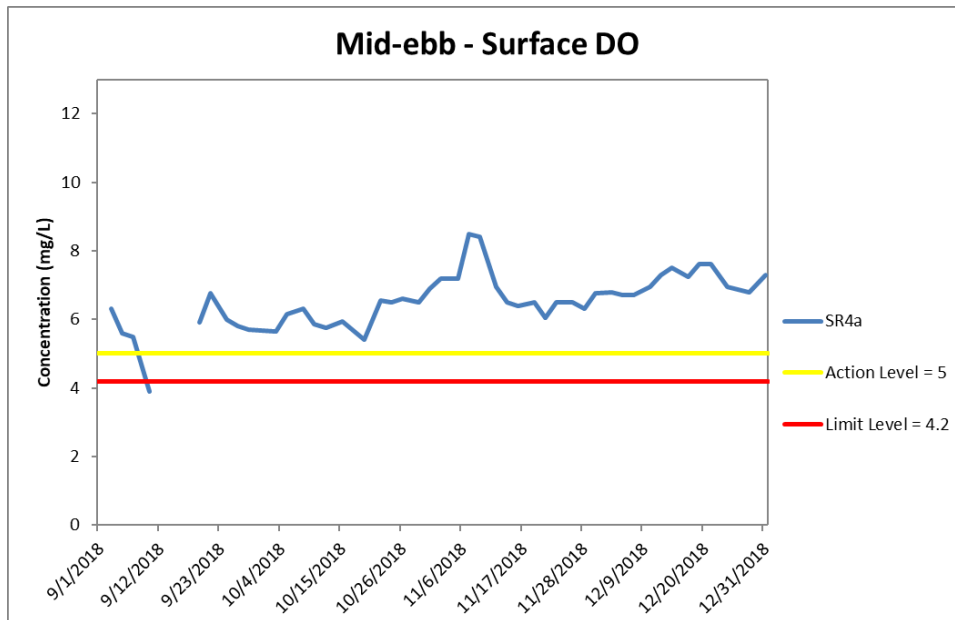
Figure J4 Impact Monitoring – Mean Level of Dissolved Oxygen (mg/L) in surface waters during mid-ebb tide between 1 September and 31 December 2018 at SR4a.

*(Weather condition varied between sunny to rainy within the reporting period.)
 WQM on 26 December 2018 was cancelled due to suspension of marine works.
 In-situ monitoring is taken according to the requirement specified in the EM&A Manual, i.e. 3 water depth namely 1m below sea surface, mid-depth and 1m above sea bed. If the water depth is less than 3m, mid-depth sampling only. If water depth less than 6m, mid-depth may be omitted.*

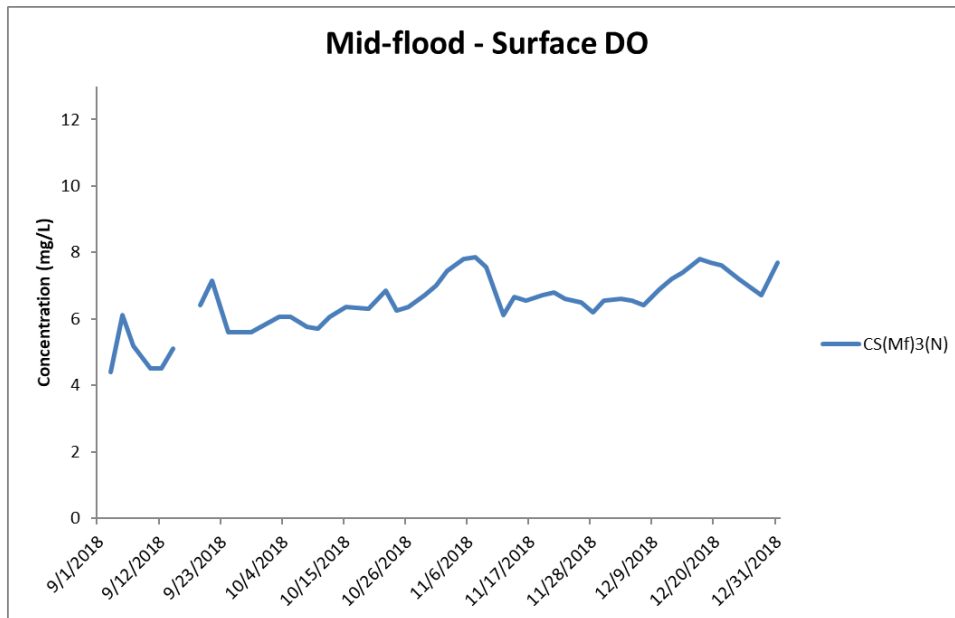
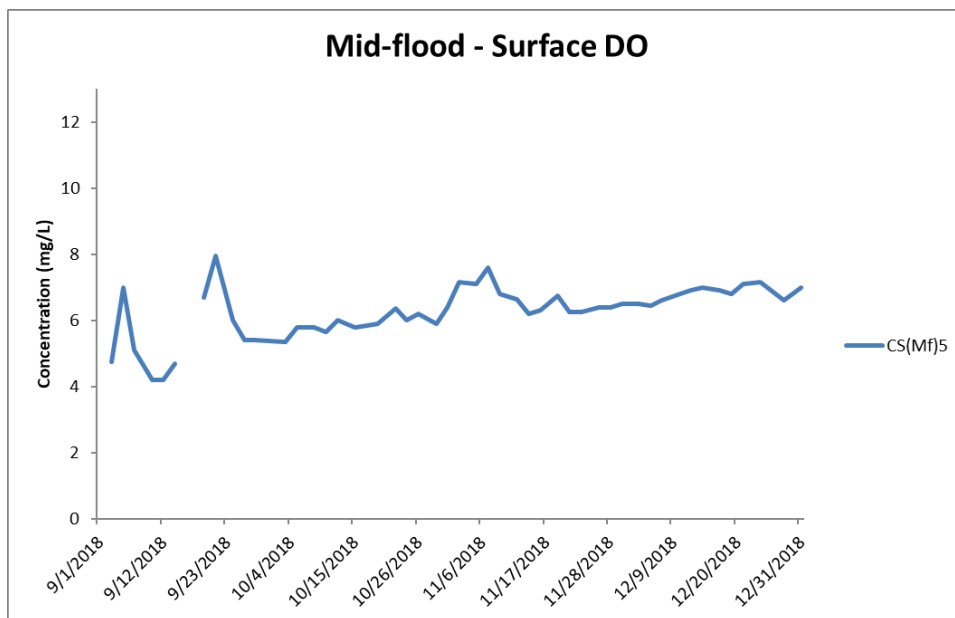
Figure J5 Impact Monitoring - Mean Level of Dissolved Oxygen (mg/L) in surface waters during mid-flood tide between 1 September and 31 December 2018 at CS(Mf)3(N) and CS(Mf)5.

*(Weather condition varied between sunny to rainy within the reporting period.)
 WQM on 26 December 2018 was cancelled due to suspension of marine works.
 In-situ monitoring is taken according to the requirement specified in the EM&A Manual, i.e. 3 water depth namely 1m below sea surface, mid-depth and 1m above sea bed. If the water depth is less than 3m, mid-depth sampling only. If water depth less than 6m, mid-depth may be omitted.*

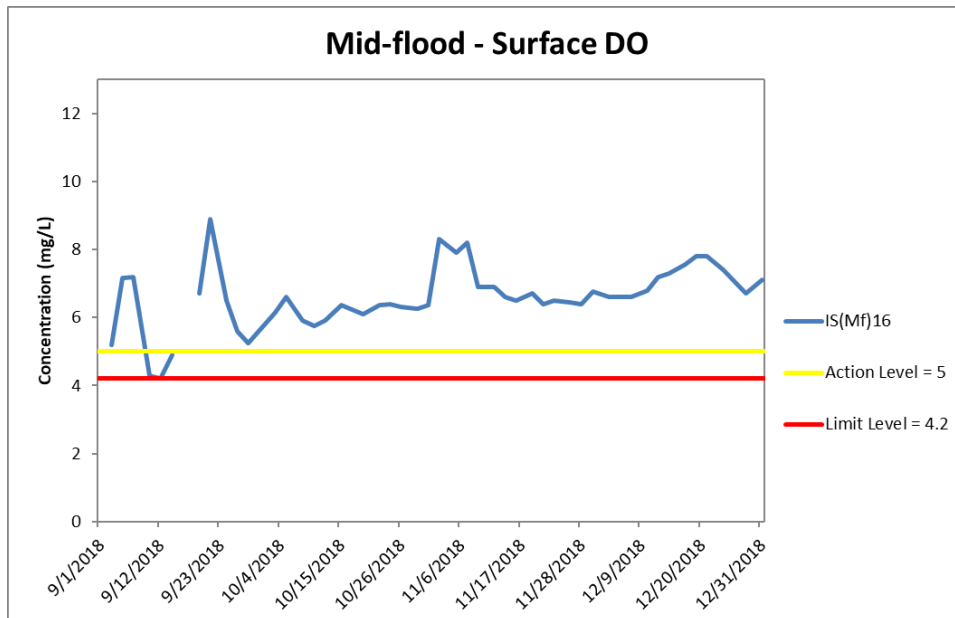
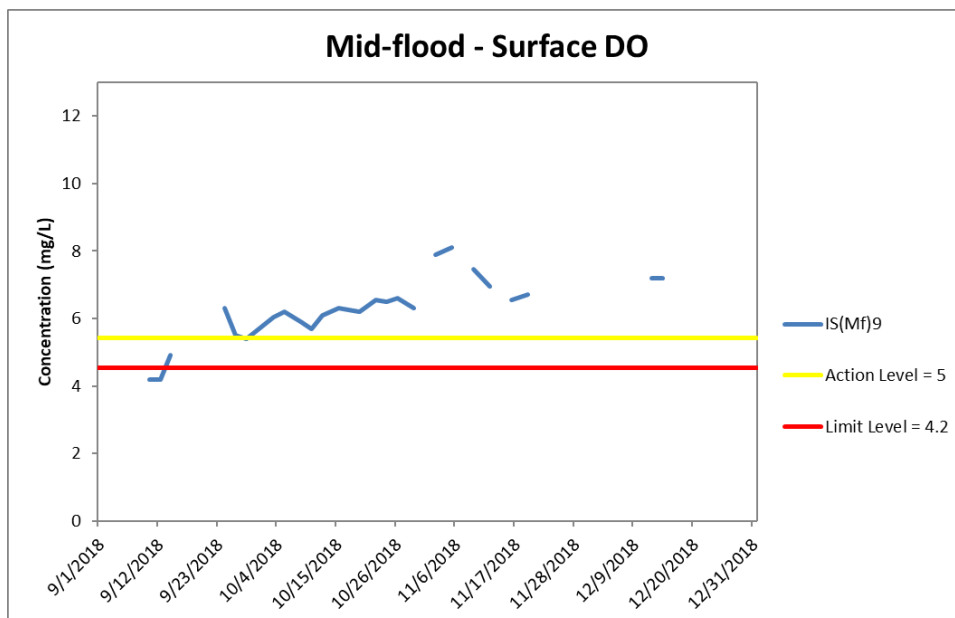
Figure J6 Impact Monitoring – Mean Level of Dissolved Oxygen (mg/L) in surface waters during mid-flood tide between 1 September and 31 December 2018 at IS(Mf)16 and IS(Mf)9.

(Weather condition varied between sunny to rainy within the reporting period.)
 WQM on 26 December 2018 was cancelled due to suspension of marine works.
 In-situ monitoring is taken according to the requirement specified in the EM&A Manual, i.e. 3 water depth namely 1m below sea surface, mid-depth and 1m above sea bed. If the water depth is less than 3m, mid-depth sampling only. If water depth less than 6m, mid-depth may be omitted.

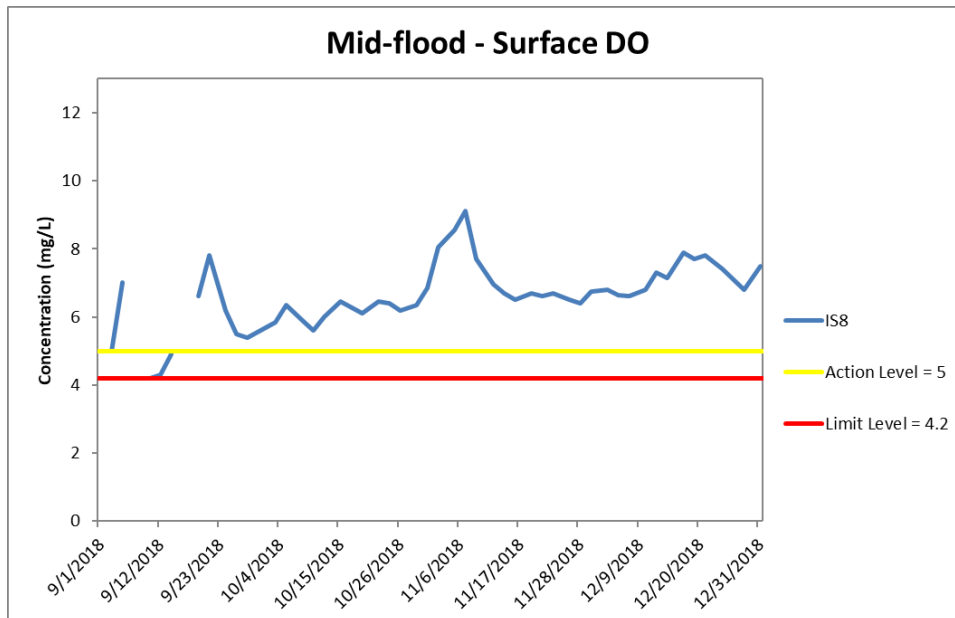
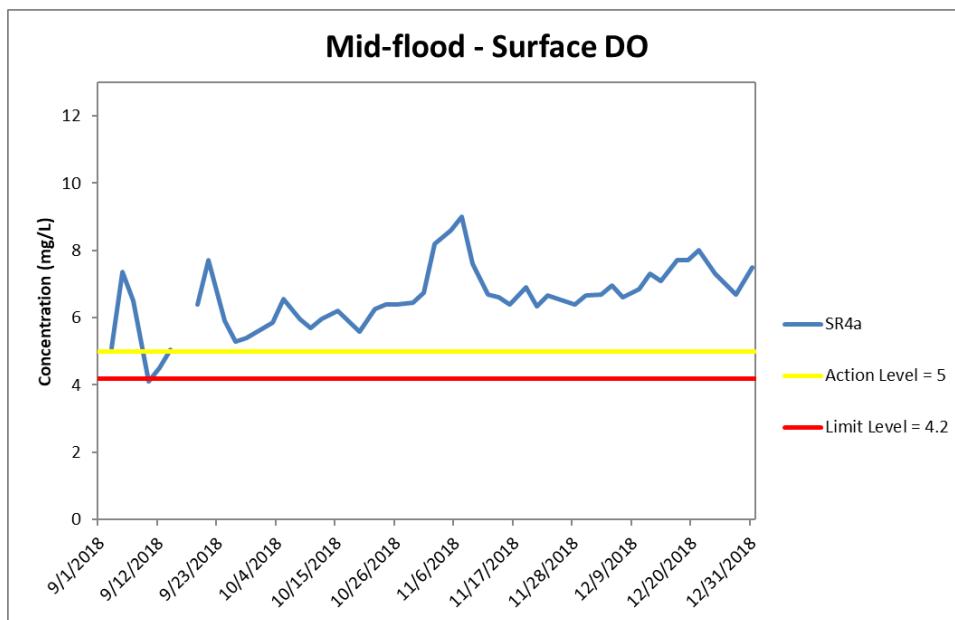
Figure J7 Impact Monitoring - Mean Level of Dissolved Oxygen (mg/L) in surface waters during mid-flood tide between 1 September and 31 December 2018 at IS8 and SR4(N).

*(Weather condition varied between sunny to rainy within the reporting period.)
 WQM on 26 December 2018 was cancelled due to suspension of marine works.
 In-situ monitoring is taken according to the requirement specified in the EM&A Manual, i.e. 3 water depth namely 1m below sea surface, mid-depth and 1m above sea bed. If the water depth is less than 3m, mid-depth sampling only. If water depth less than 6m, mid-depth may be omitted.*

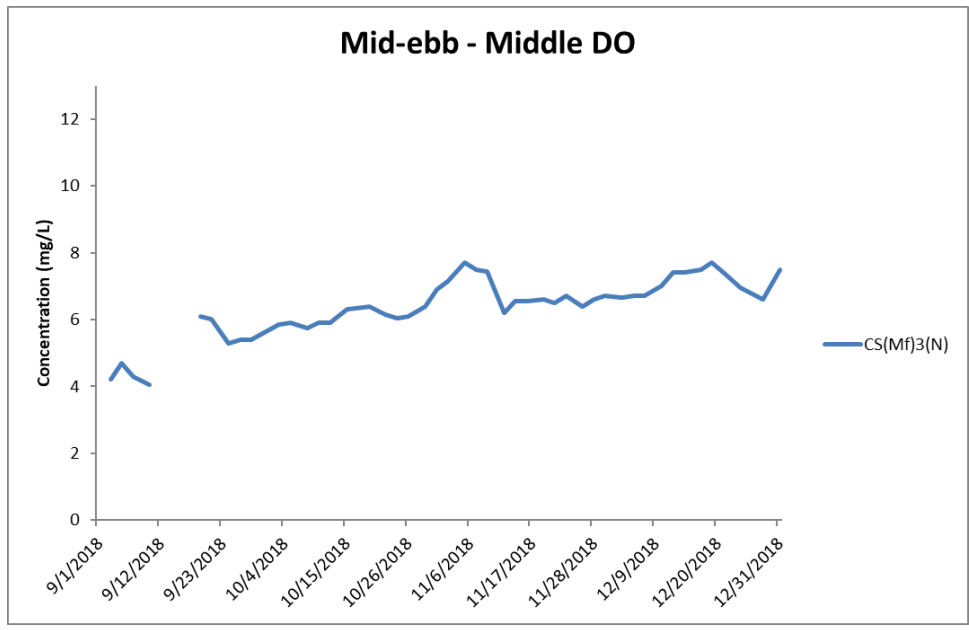
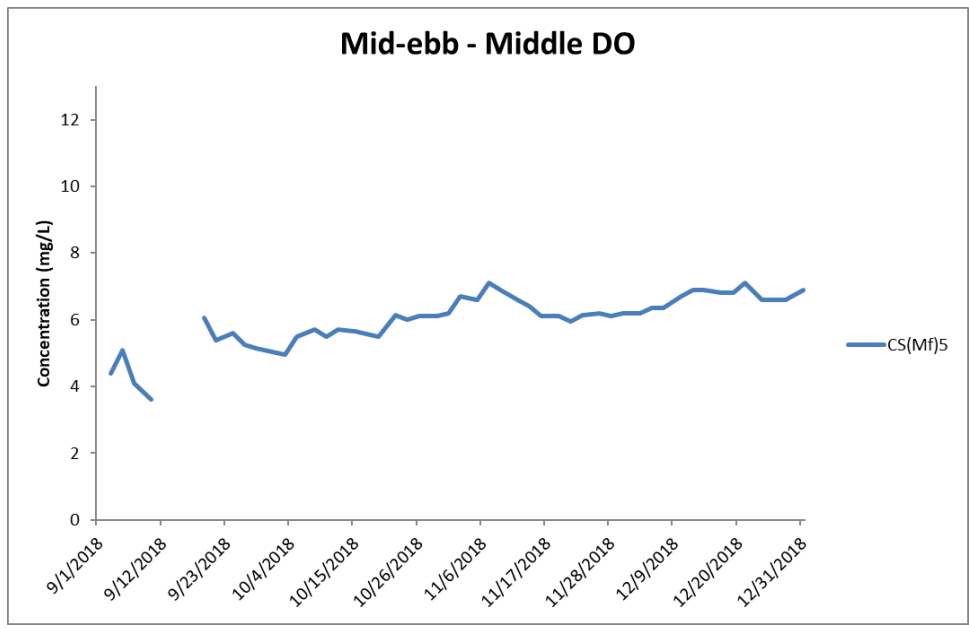
Figure J9 Impact Monitoring - Mean Level of Dissolved Oxygen (mg/L) in mid-depth waters during mid-ebb tide between 1 September and 31 December 2018 at CS(Mf)3(N) and CS(Mf)5.

*(Weather condition varied between sunny to rainy within the reporting period.)
 WQM on 26 December 2018 was cancelled due to suspension of marine works.
 In-situ monitoring is taken according to the requirement specified in the EM&A Manual, i.e. 3 water depth namely 1m below sea surface, mid-depth and 1m above sea bed. If the water depth is less than 3m, mid-depth sampling only. If water depth less than 6m, mid-depth may be omitted.*

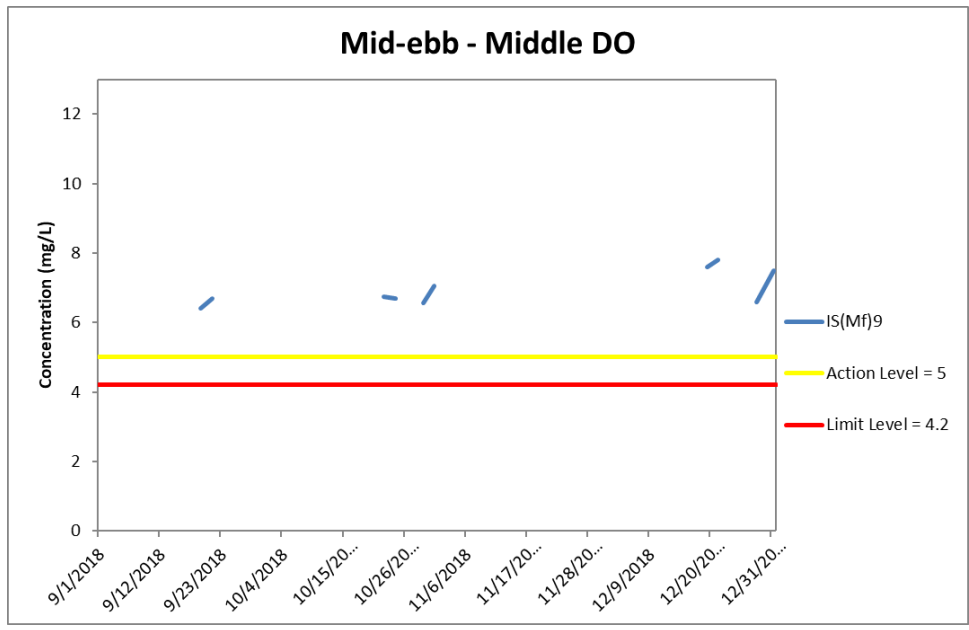
Figure J10 Impact Monitoring – Mean Level of Dissolved Oxygen (mg/L) in mid-depth waters during mid-ebb tide between 1 September and 31 December 2018 at IS(Mf)9.

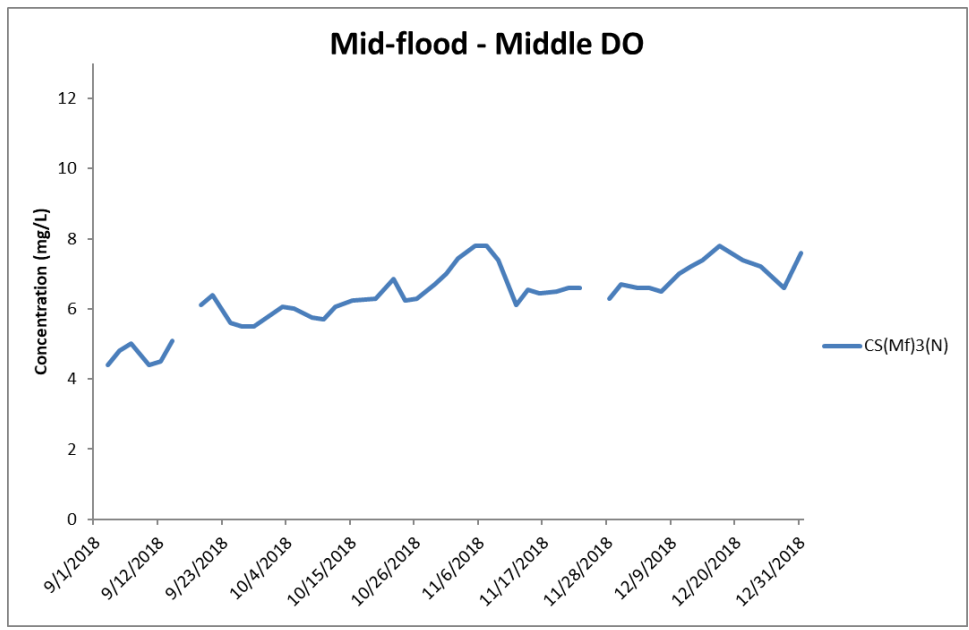
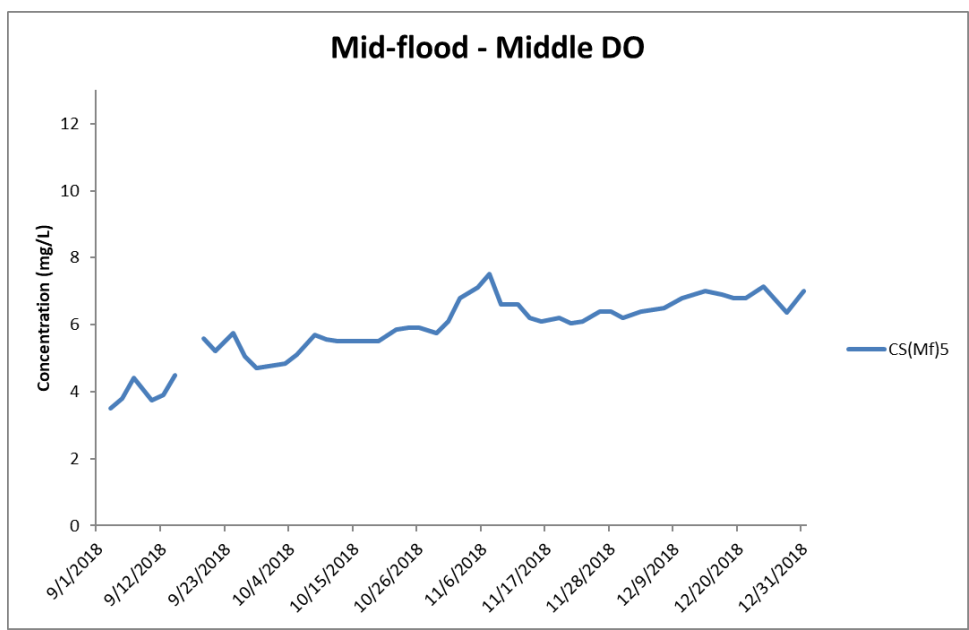
Figure J11 Impact Monitoring – Mean Level of Dissolved Oxygen (mg/L) in mid-depth waters during mid-flood tide between 1 September and 31 December 2018 at CS(Mf)3(N) and CS(Mf)5.

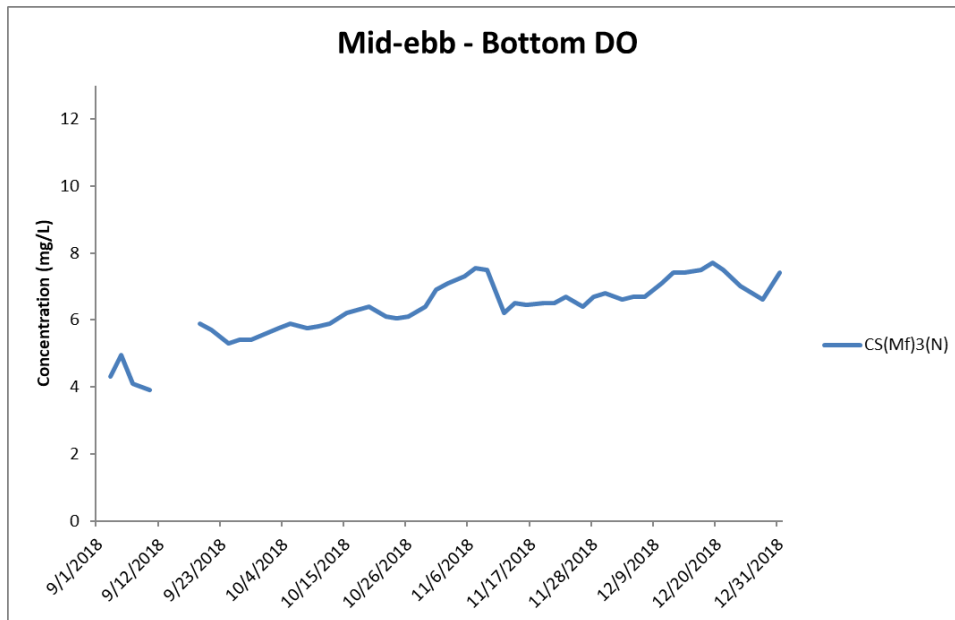
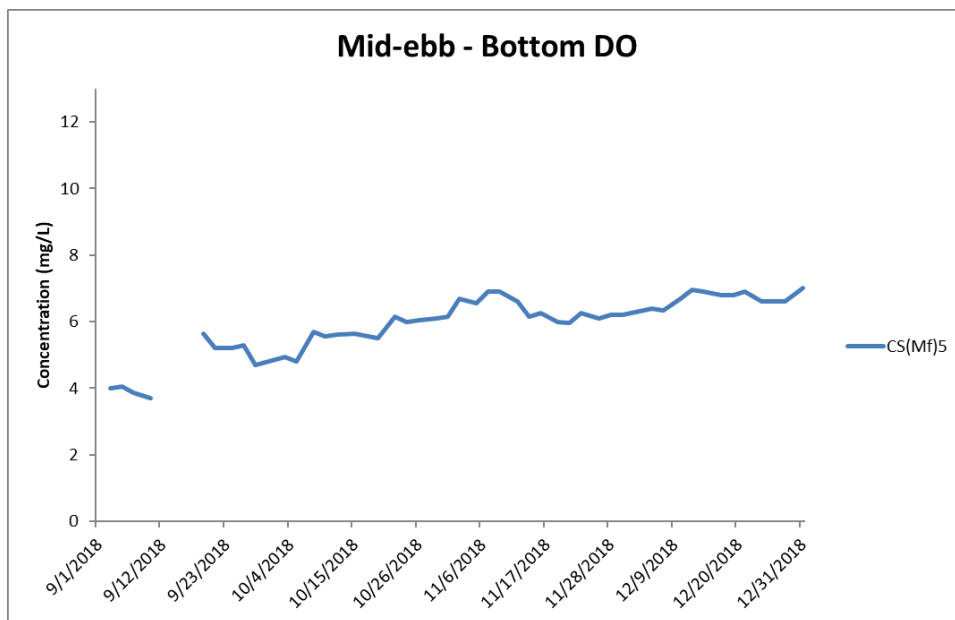
Figure J13 Impact Monitoring – Mean Level of Dissolved Oxygen (mg/L) in bottom waters during mid-ebb tide between 1 September and 31 December 2018 at CS(Mf)3(N) and CS(Mf)5.

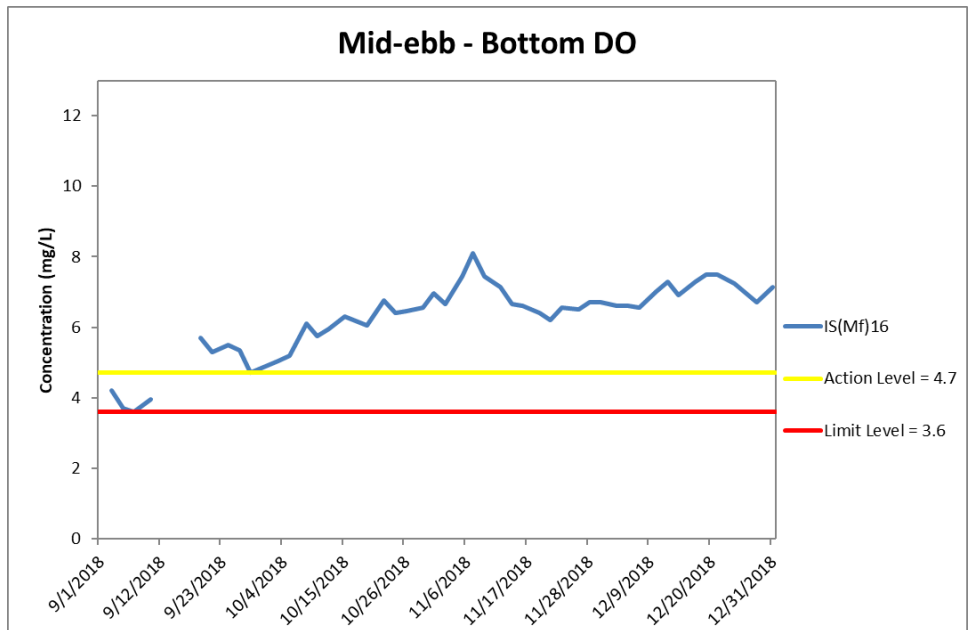
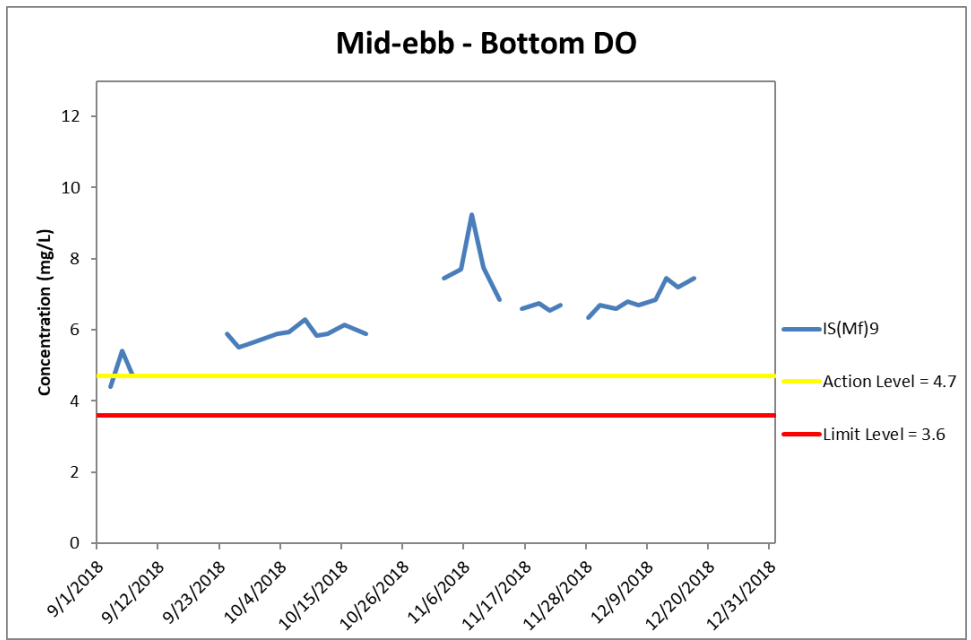
Figure J14 Impact Monitoring - Mean Level of Dissolved Oxygen (mg/L) in bottom waters during mid-ebb tide between 1 September and 31 December 2018 at IS(Mf)16 and IS(Mf)9.

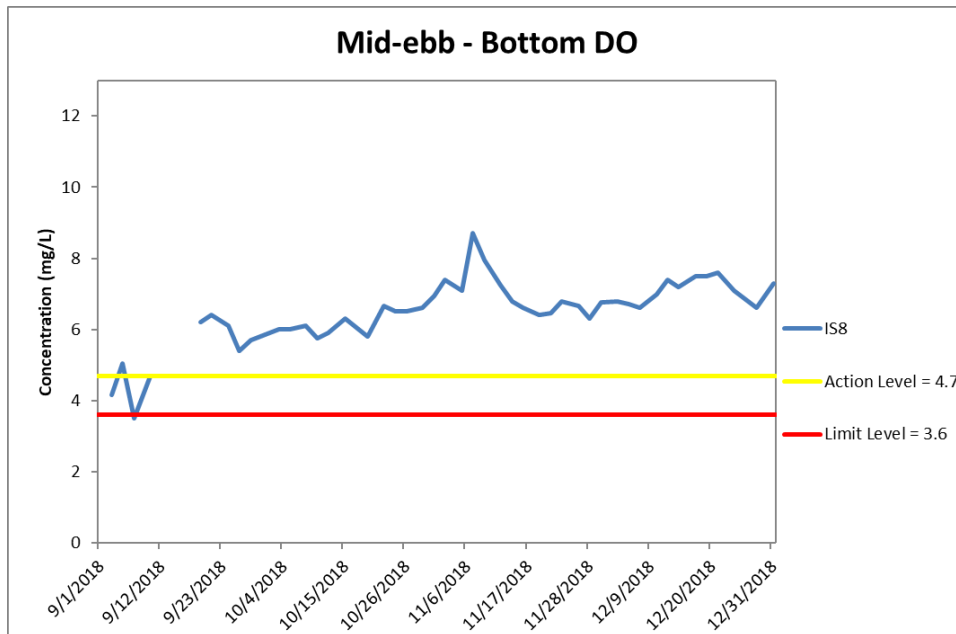
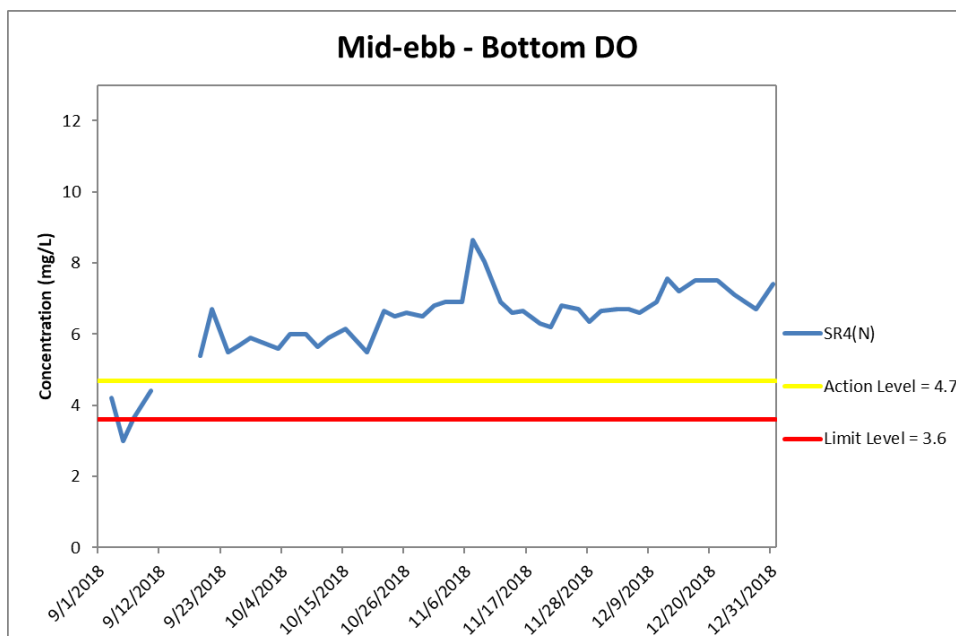
Figure J15 Impact Monitoring – Mean Level of Dissolved Oxygen (mg/L) in bottom waters during mid-ebb tide between 1 September and 31 December 2018 at IS8 and SR4(N).

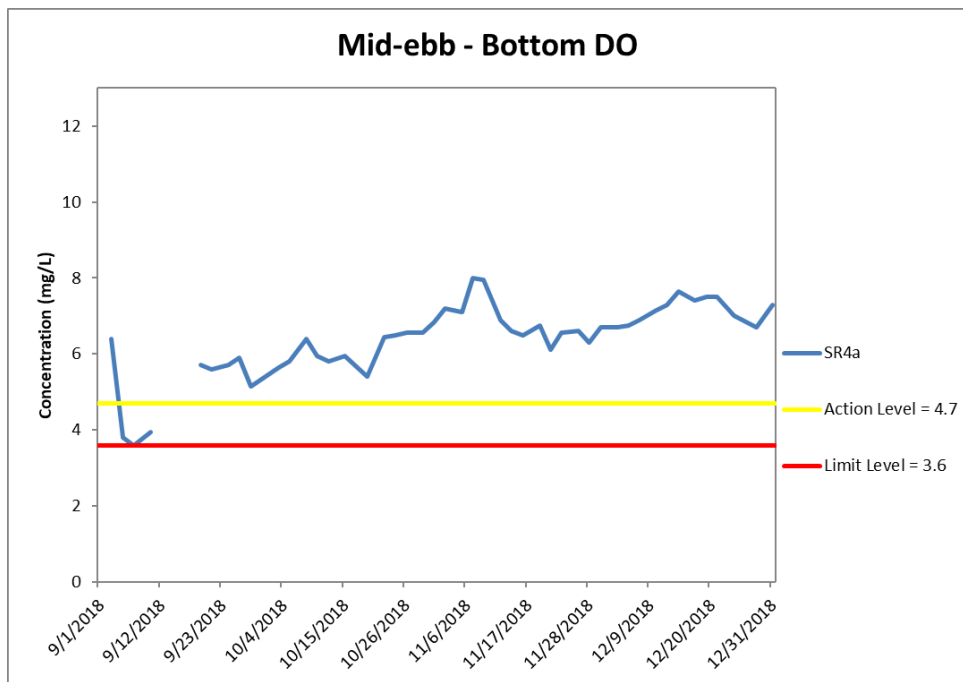
Figure J16 Impact Monitoring - Mean Level of Dissolved Oxygen (mg/L) in bottom waters during mid-ebb tide between 1 September and 31 December 2018 at SR4a.

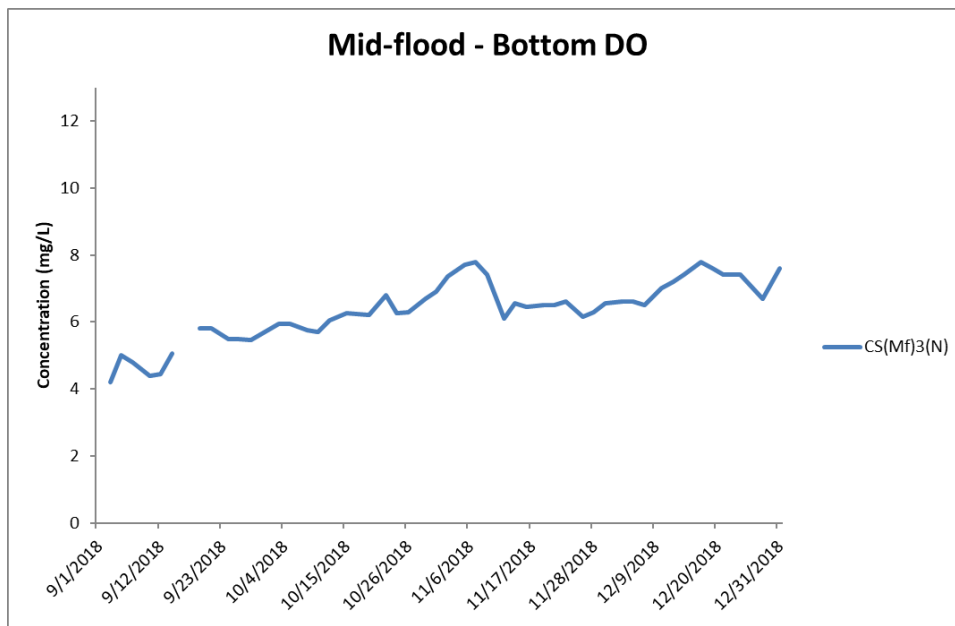
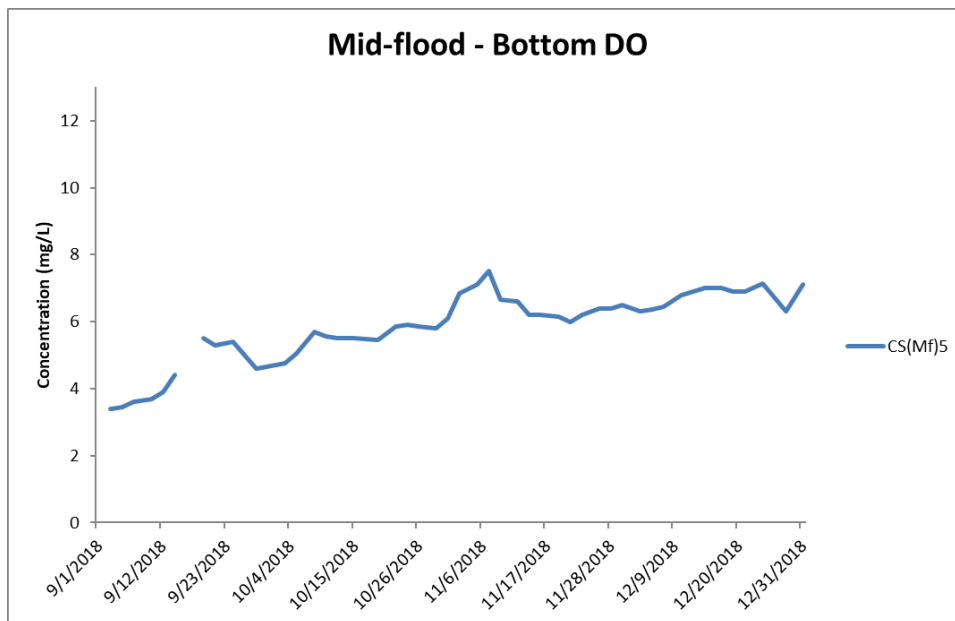
Figure J17 Impact Monitoring – Mean Level of Dissolved Oxygen (mg/L) in bottom waters during mid-flood tide between 1 September and 31 December 2018 at CS(Mf)3(N) and CS(Mf)5.

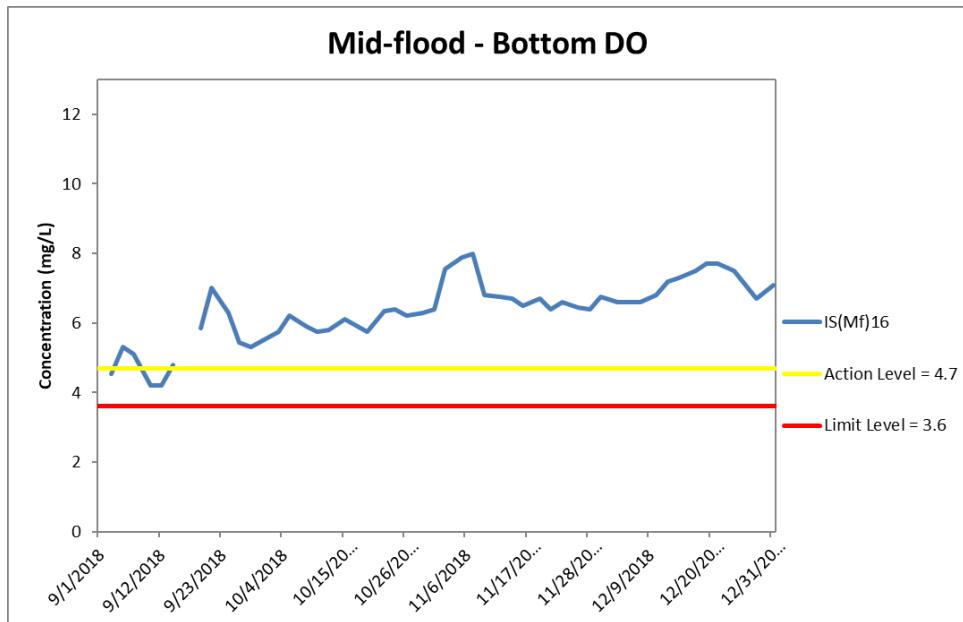
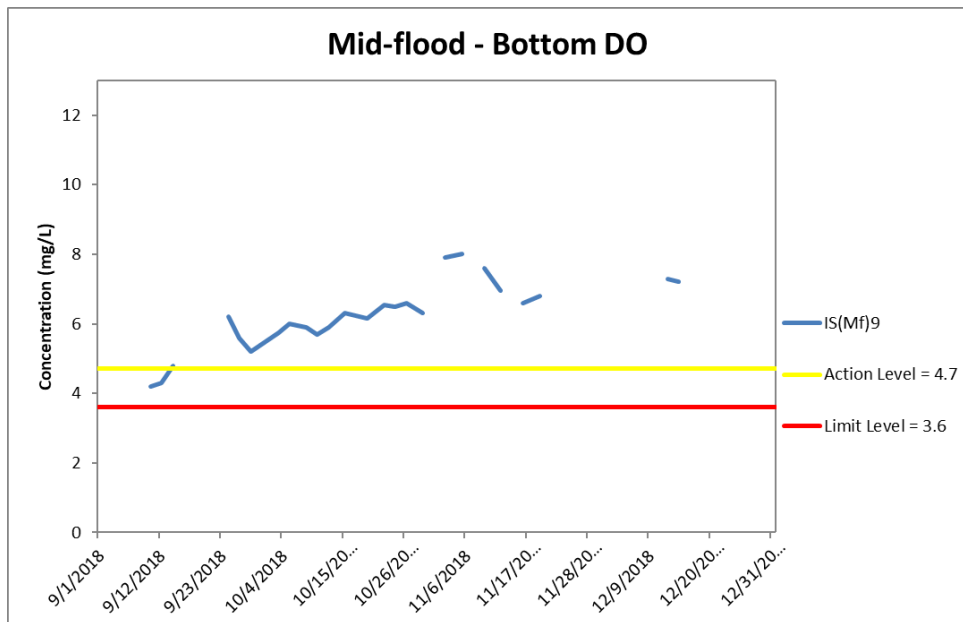
Figure J18 Impact Monitoring - Mean Level of Dissolved Oxygen (mg/L) in bottom waters during mid-flood tide between 1 September and 31 December 2018 at IS(Mf)16 and IS(Mf)9.

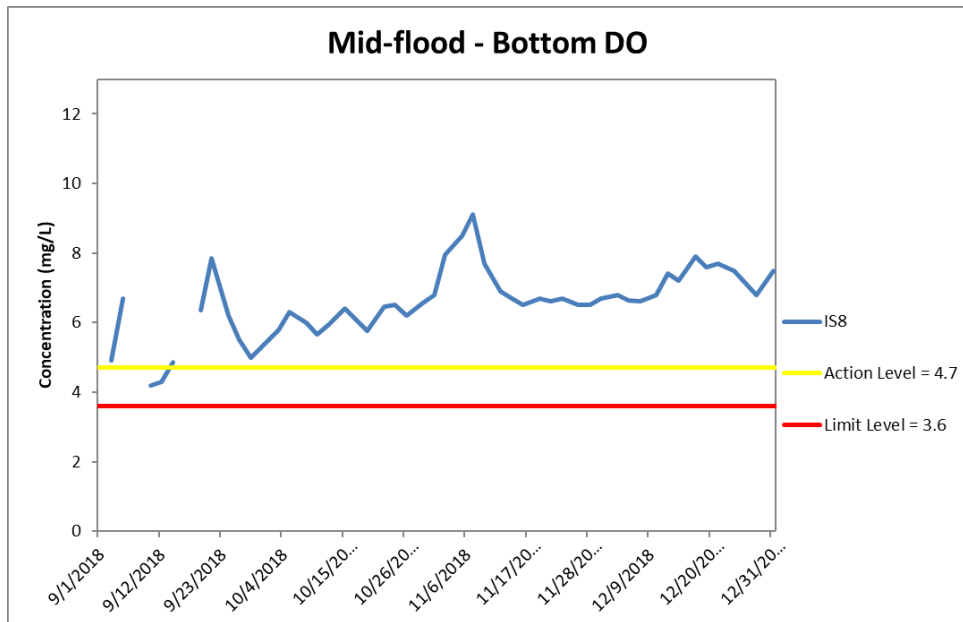
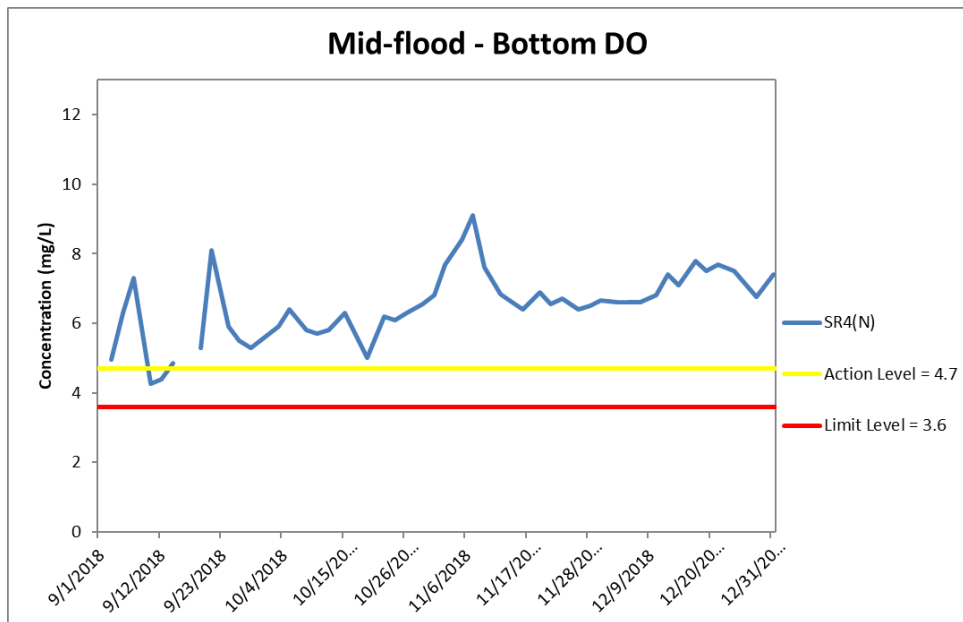
Figure J19 Impact Monitoring - Mean Level of Dissolved Oxygen (mg/L) in bottom waters during mid-flood tide between 1 September and 31 December 2018 at IS8 and SR4(N).

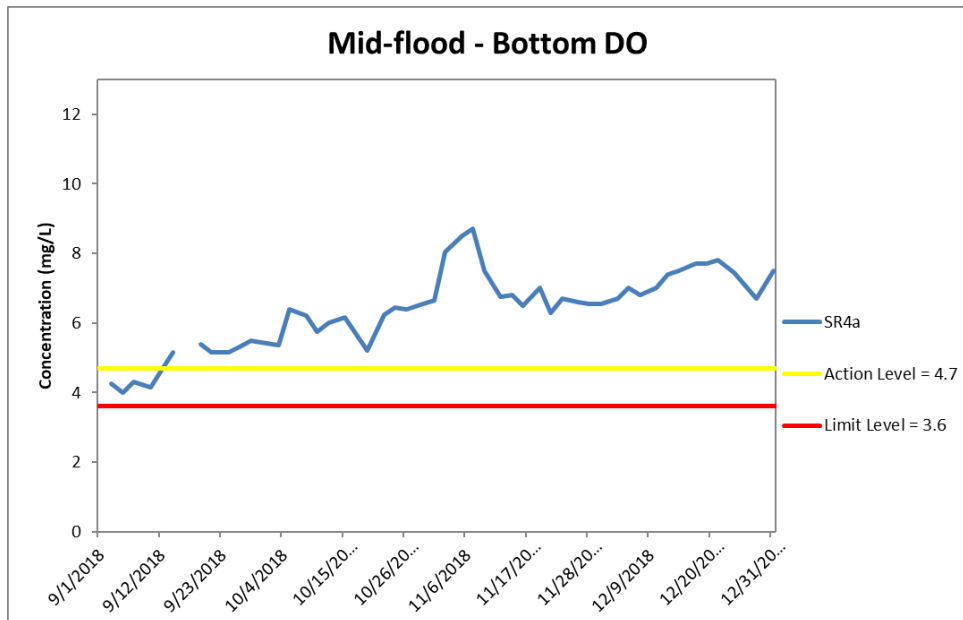
Figure J20 Impact Monitoring - Mean Level of Dissolved Oxygen (mg/L) in bottom waters during mid-flood tide between 1 September and 31 December 2018 at SR4a.

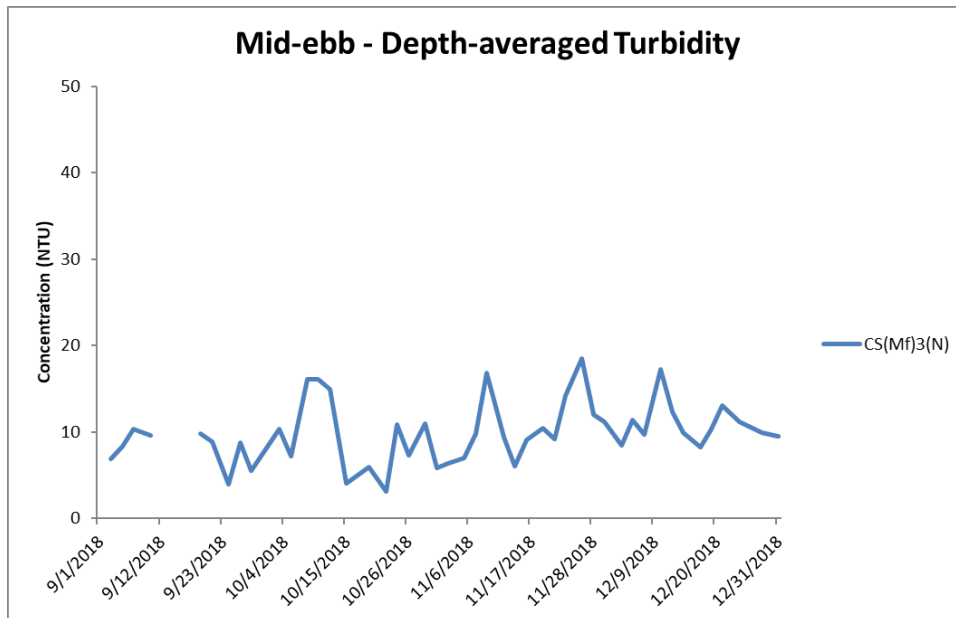
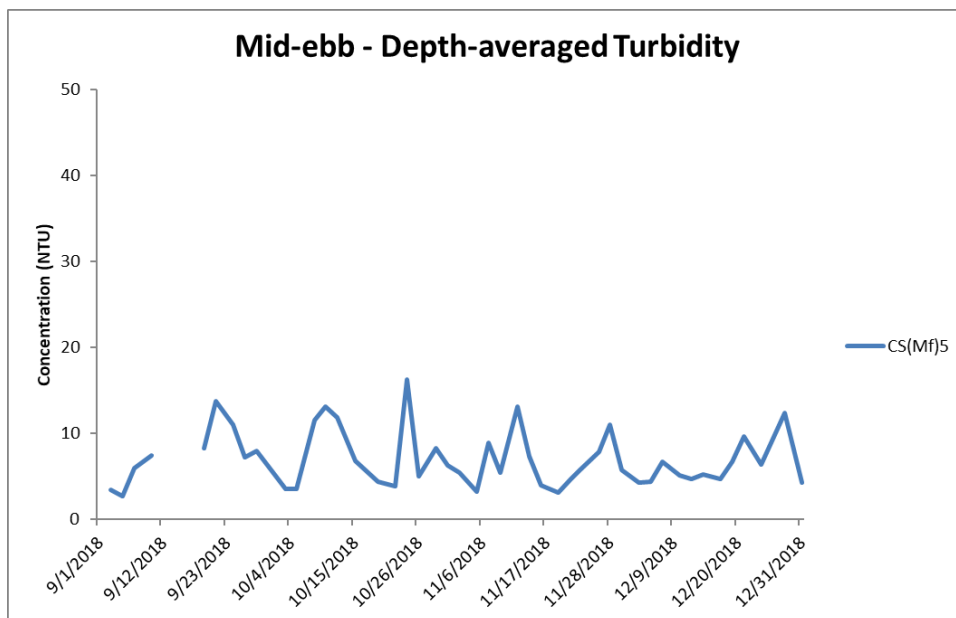
Figure J21 Impact Monitoring - Mean Level of depth-averaged Turbidity (NTU) during mid-ebb tide between 1 September and 31 December 2018 at CS(Mf)3(N) and CS(Mf)5.
