**Contract No. HY/2012/07
Tuen Mun – Chek Lap Kok Link –
Southern Connection Viaduct Section**

Sixty-second Monthly EM&A Report

15 January 2019

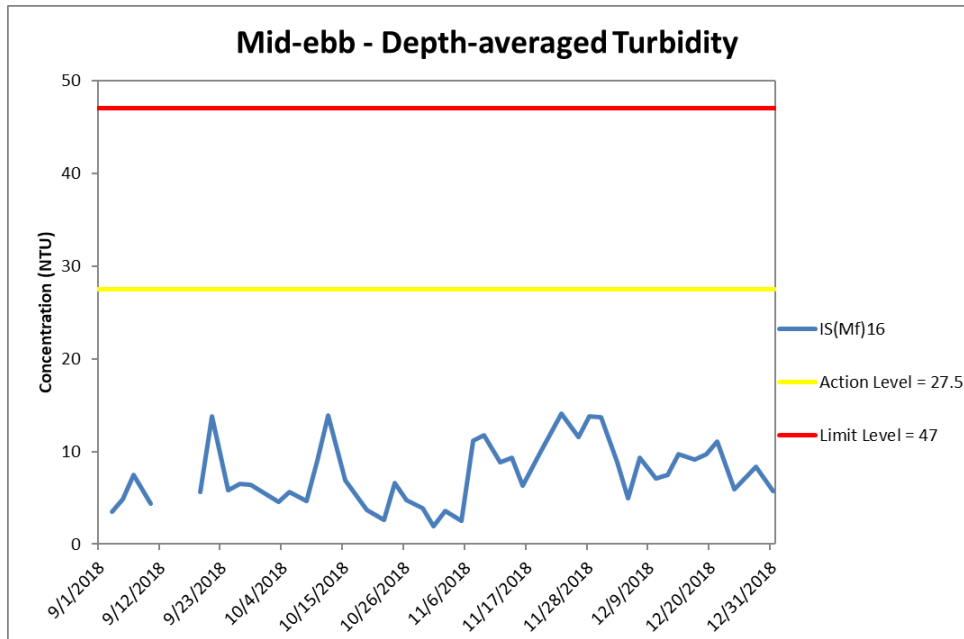
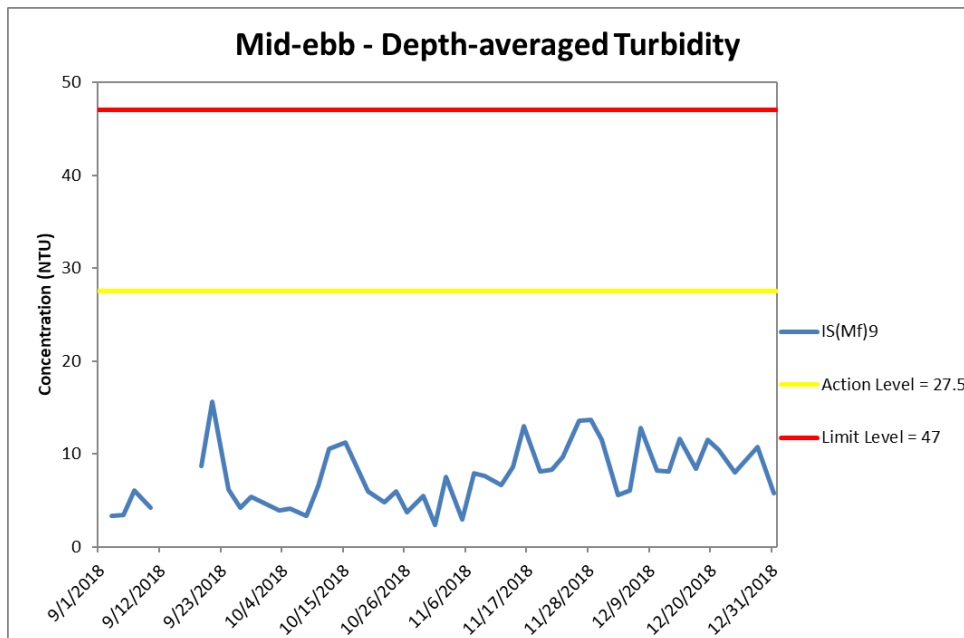
Figure J22 Impact Monitoring - Mean Level of depth-averaged Turbidity (NTU) during mid-ebb tide between 1 September and 31 December 2018 at IS(Mf)16 and IS(Mf)9.

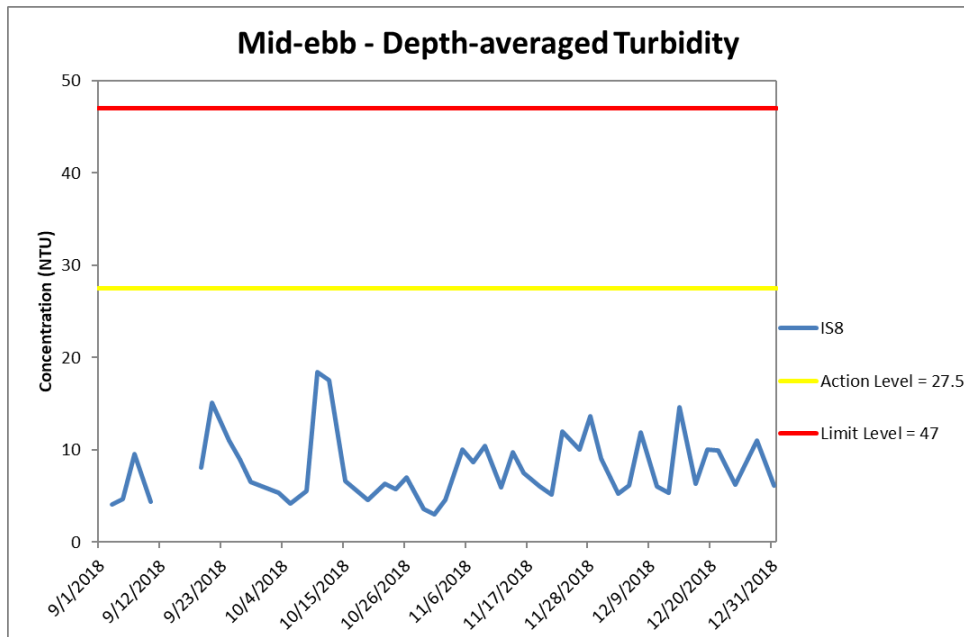
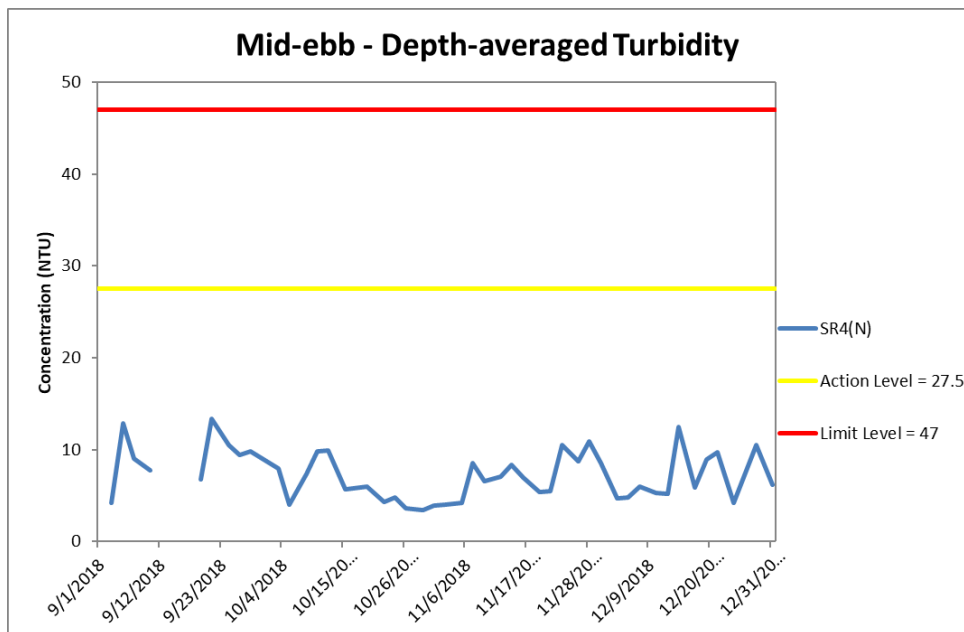
Figure J23 Impact Monitoring – Mean Level of depth-averaged Turbidity (NTU) during mid-ebb tide between 1 September and 31 December 2018 at IS8 and SR4(N).

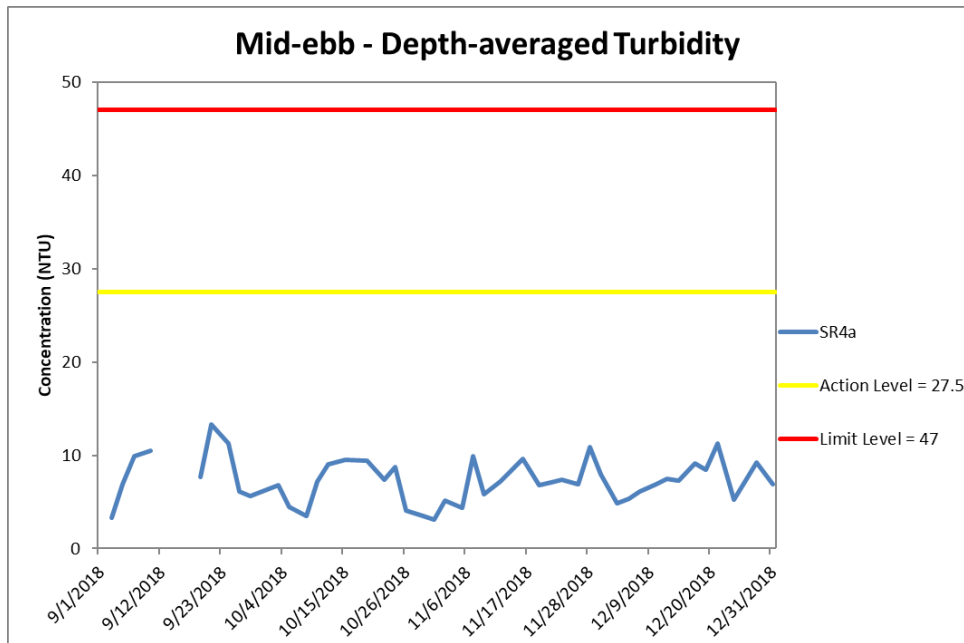
Figure J24 Impact Monitoring - Mean Level of depth-averaged Turbidity (NTU) during mid-ebb tide between 1 September and 31 December 2018 at SR4a.

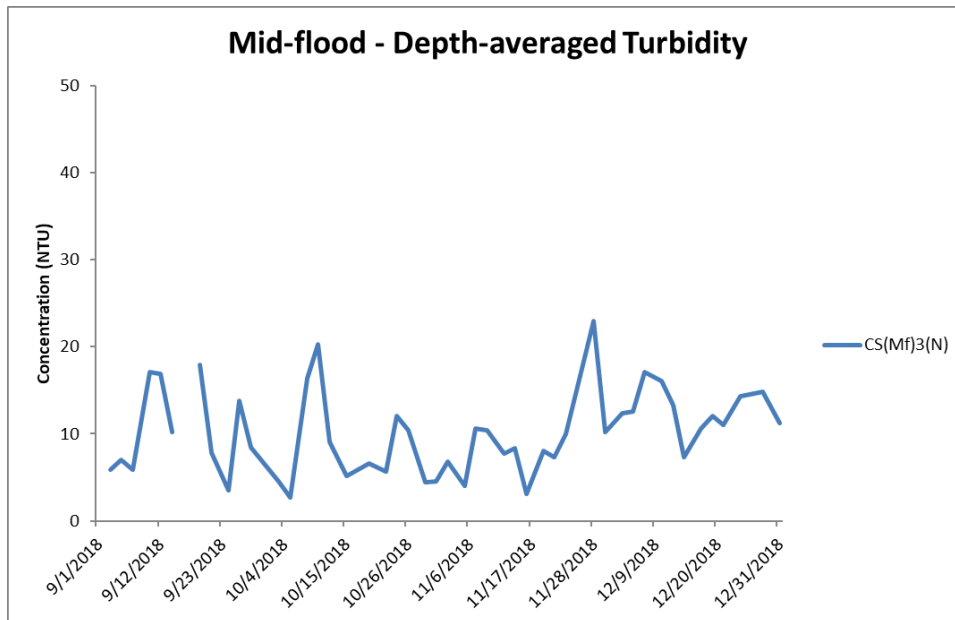
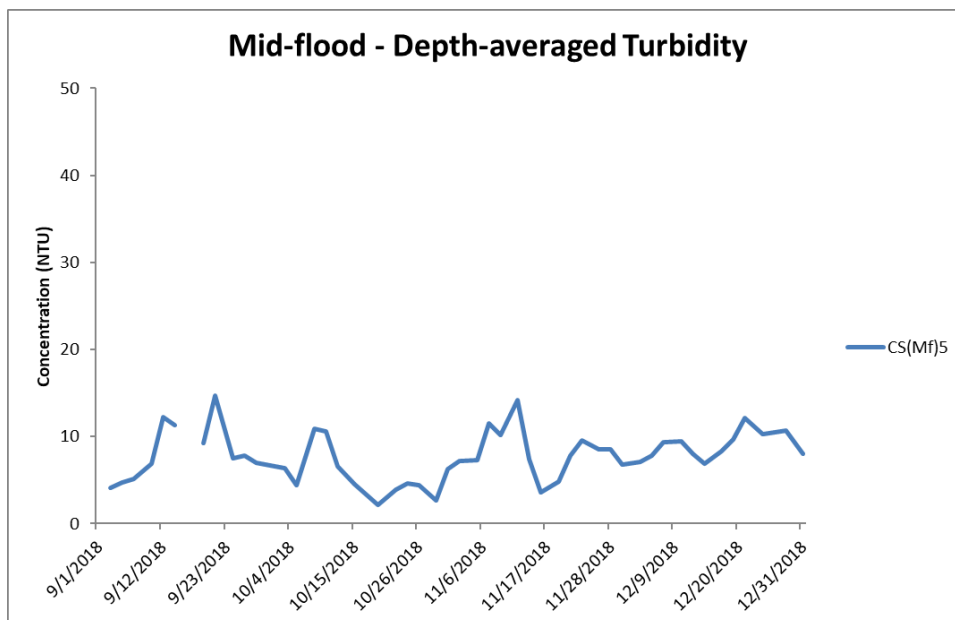
Figure J25 Impact Monitoring - Mean Level of depth-averaged Turbidity (NTU) during mid-flood tide between 1 September and 31 December 2018 at CS(Mf)3(N) and CS(MF)5.

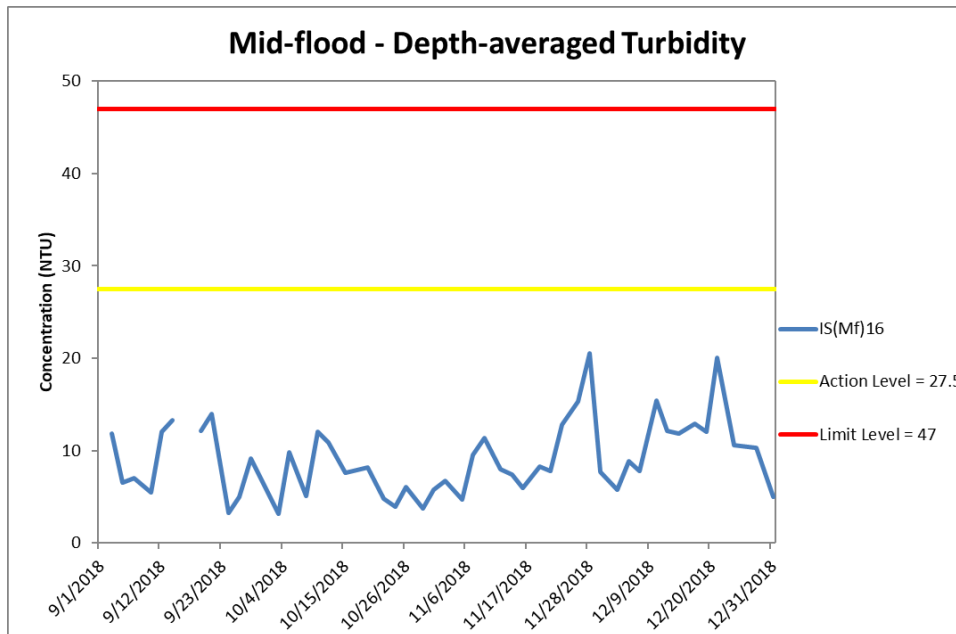
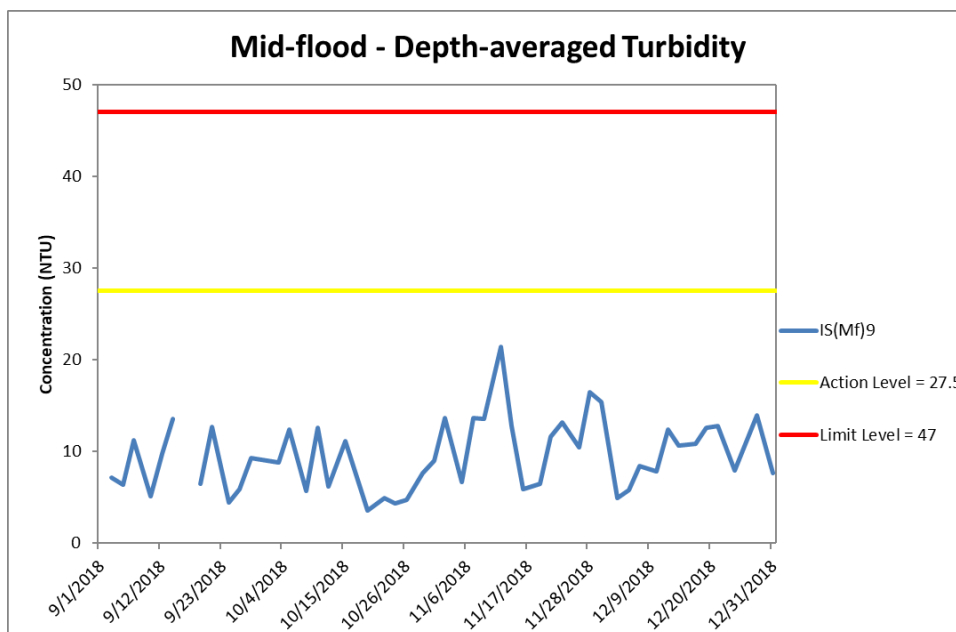
Figure J26 Impact Monitoring – Mean Level of depth-averaged Turbidity (NTU) during mid-flood tide between 1 September and 31 December 2018 at IS(Mf)16 and IS(Mf)9.

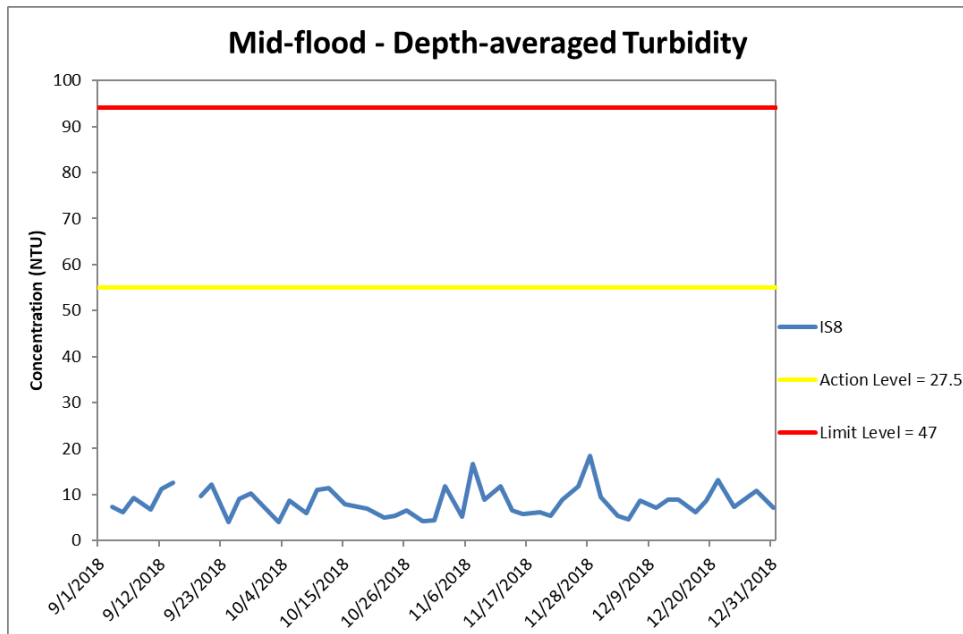
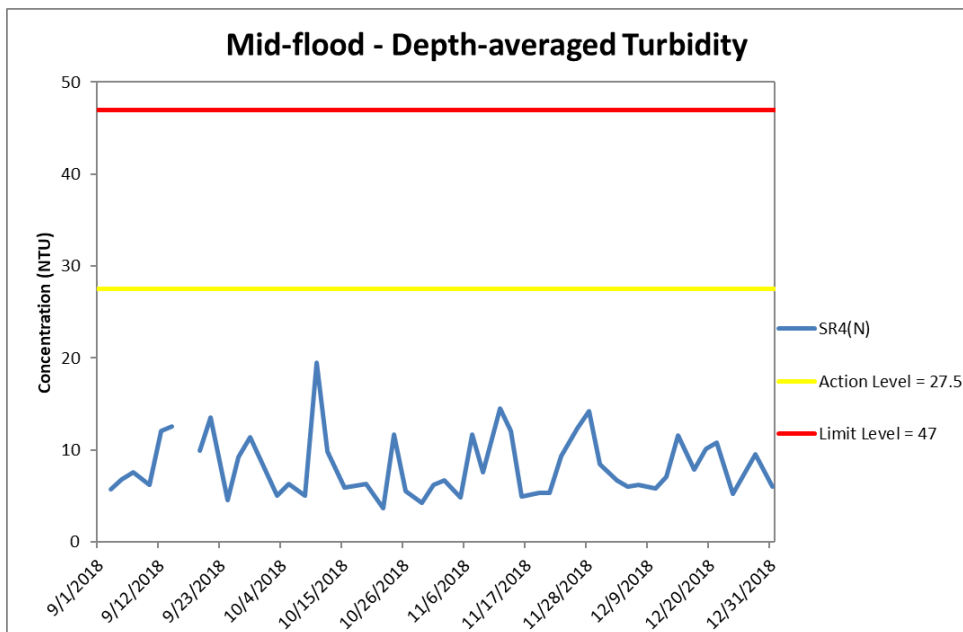
Figure J27 Impact Monitoring – Mean Level of depth-averaged Turbidity (NTU) during mid-flood tide between 1 September and 31 December 2018 at IS8 and SR4(N).

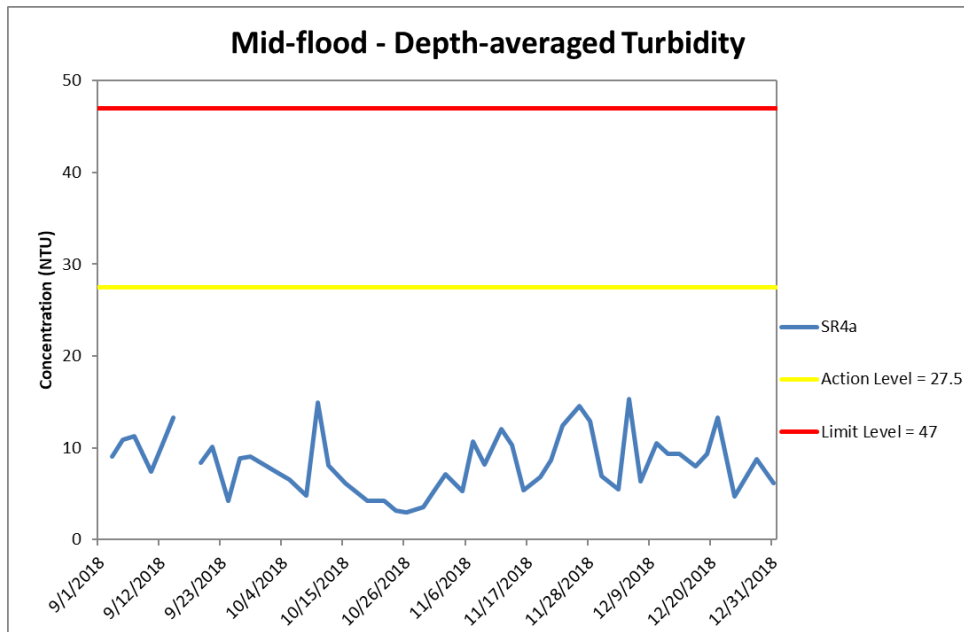
Figure J28 Impact Monitoring - Mean Level of depth-averaged Turbidity (NTU) during mid-flood tide between 1 September and 31 December 2018 at SR4a.

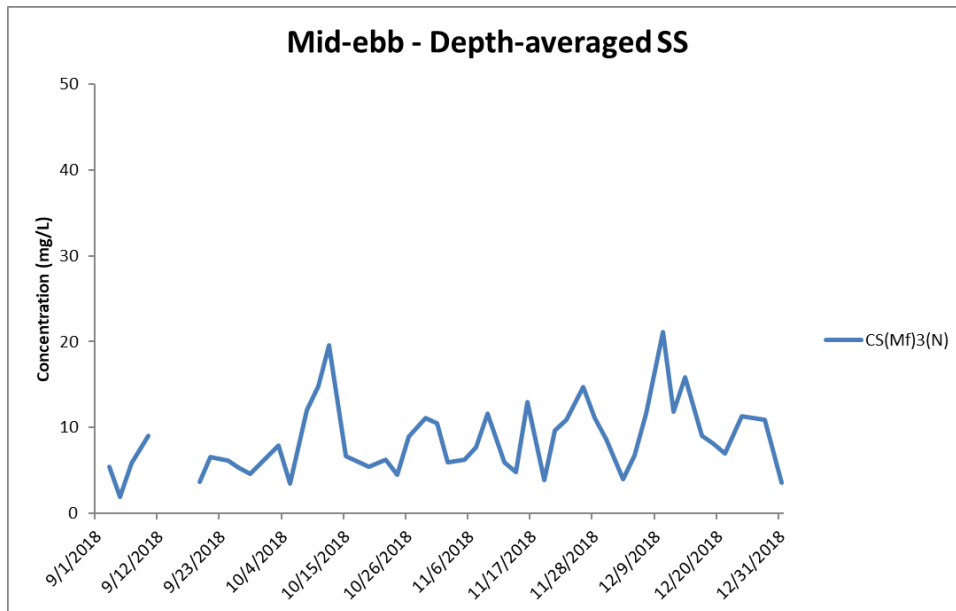
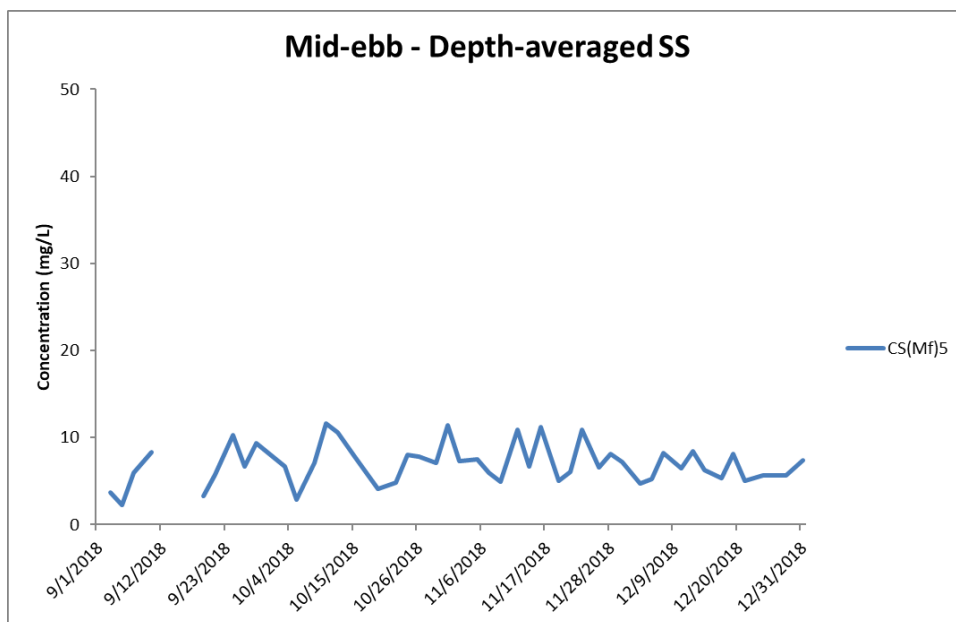
Figure J29 Impact Monitoring – Mean depth-averaged level of Suspended Solids (mg/L) during mid-ebb tide between 1 September and 31 December 2018 at CS(Mf)3(N) and CS(Mf)5.

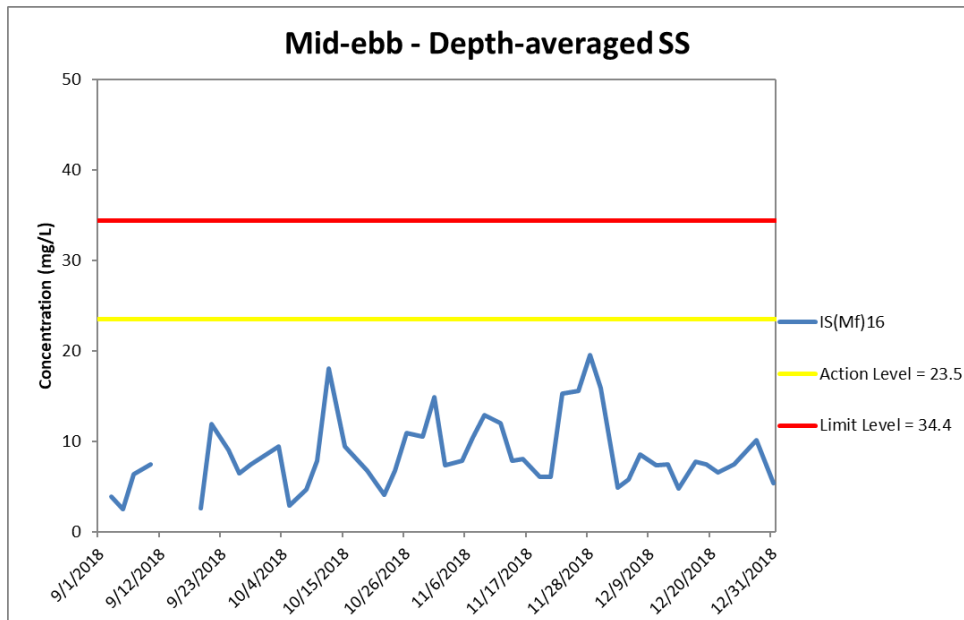
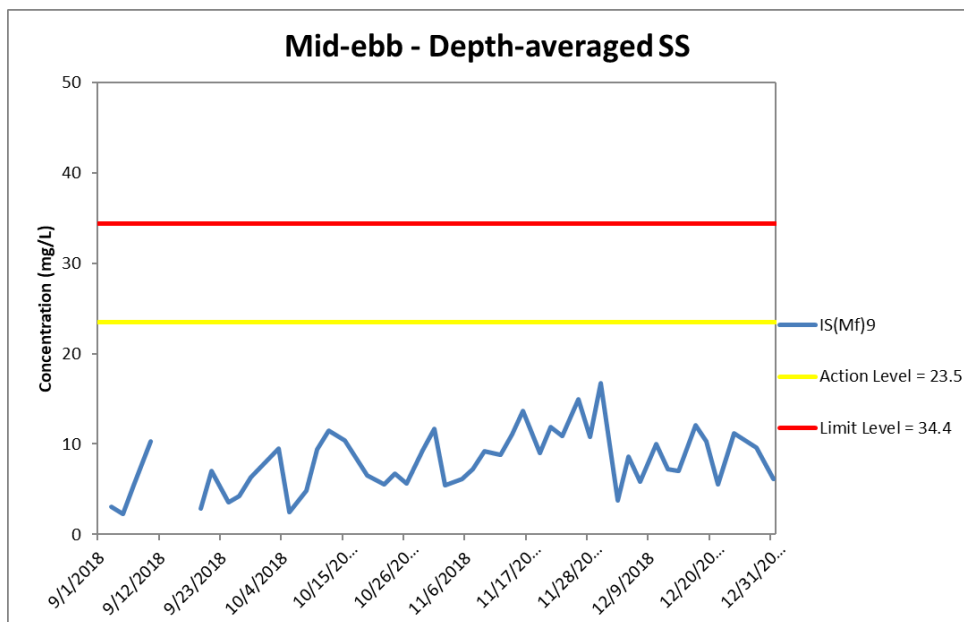
Figure J30 Impact Monitoring - Mean depth-averaged level of Suspended Solids (mg/L) during mid-ebb tide between 1 September and 31 December 2018 at IS(Mf)16 and IS(Mf)9.

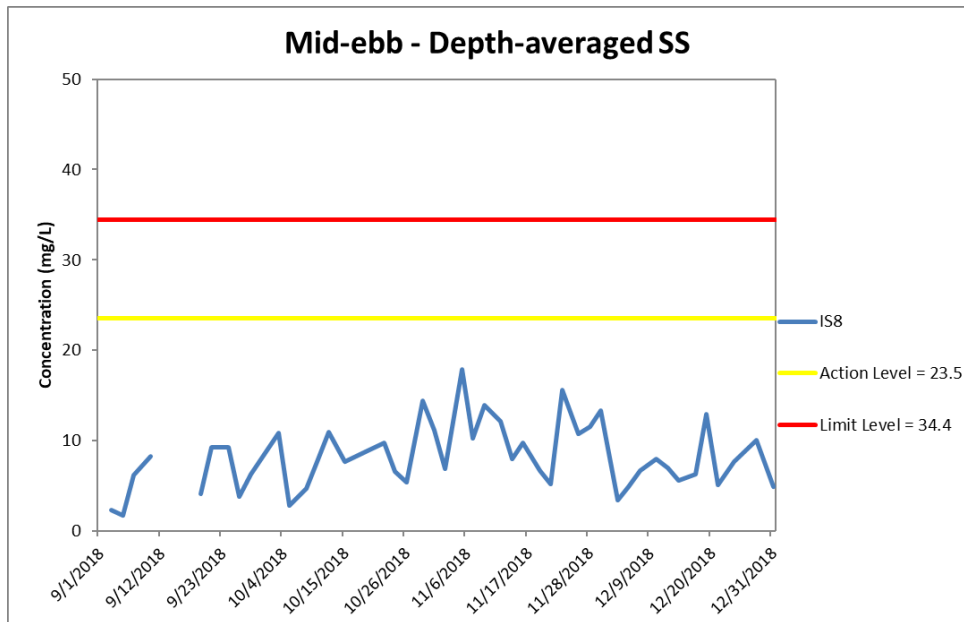
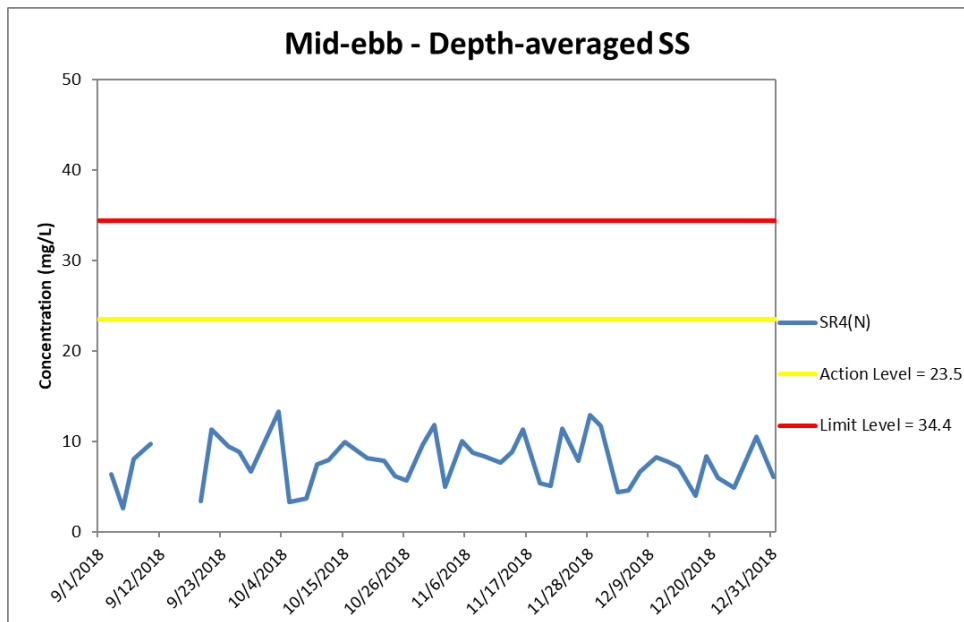
Figure J31 Impact Monitoring - Mean depth-averaged level of Suspended Solids (mg/L) during mid-ebb tide between 1 September and 31 December 2018 at IS8 and SR4(N).

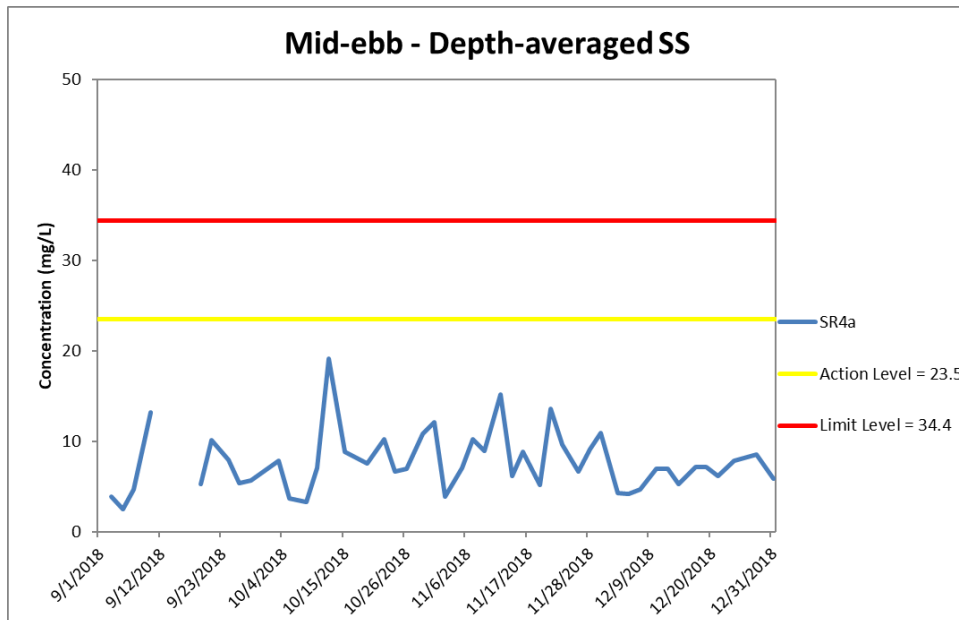
Figure J32 Impact Monitoring – Mean depth-averaged level of Suspended Solids (mg/L) during mid-ebb tide between 1 September and 31 December 2018 at SR4a.

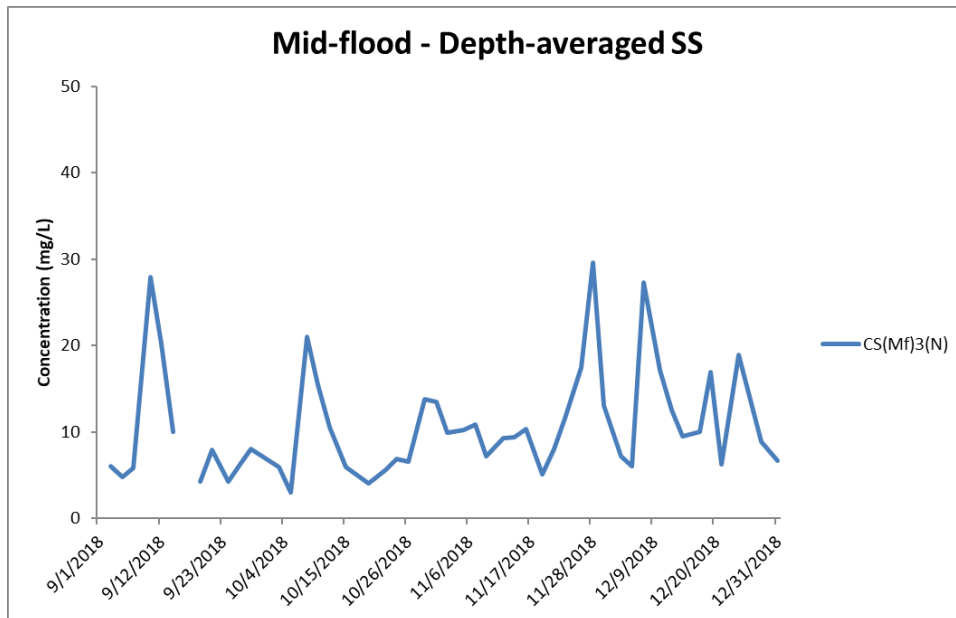
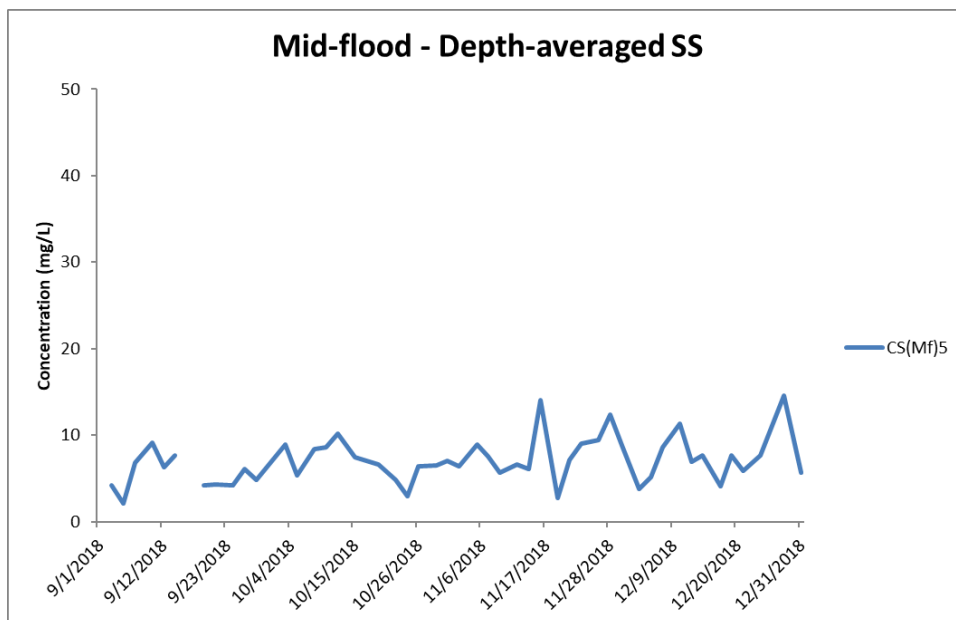
Figure J33 Impact Monitoring - Mean depth-averaged level of Suspended Solids (mg/L) during mid-flood tide between 1 September and 31 December 2018 at CS(Mf)3(N) and CS(Mf)5.

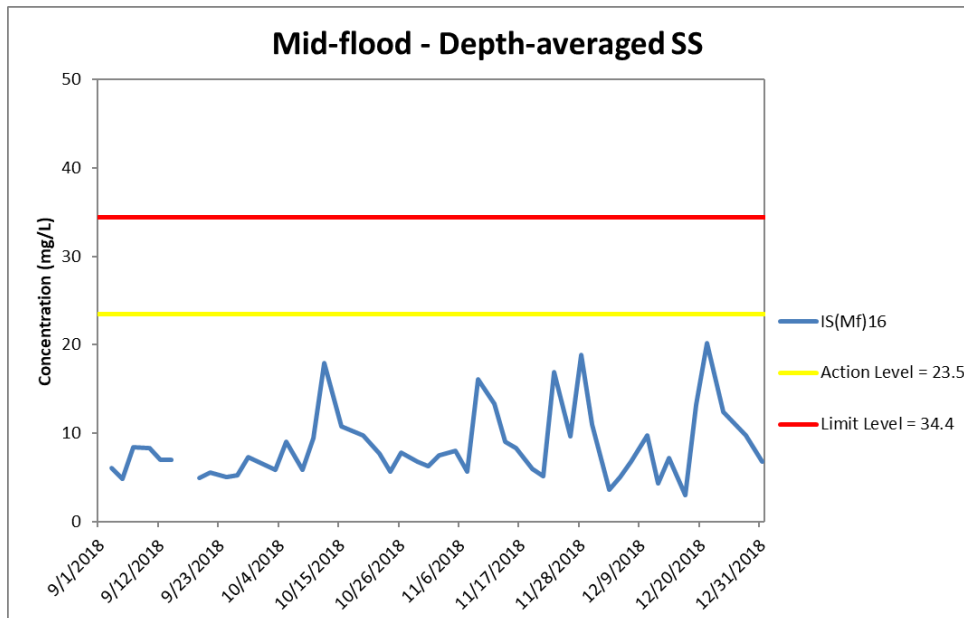
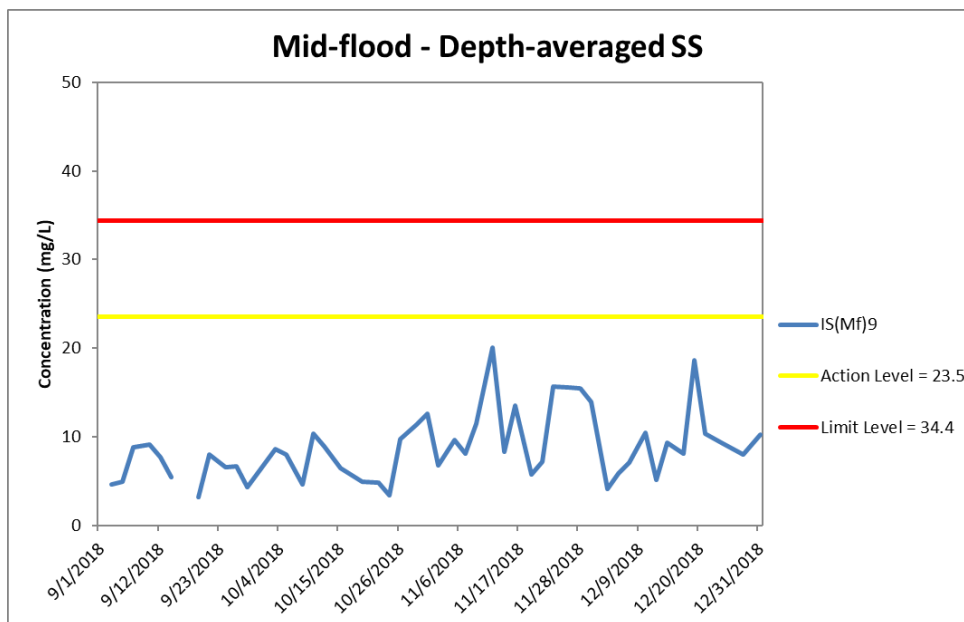
Figure J34 Impact Monitoring - Mean depth-averaged level of Suspended Solids (mg/L) during mid-flood tide between 1 September and 31 December 2018 at IS(Mf)16 and IS(Mf)9.

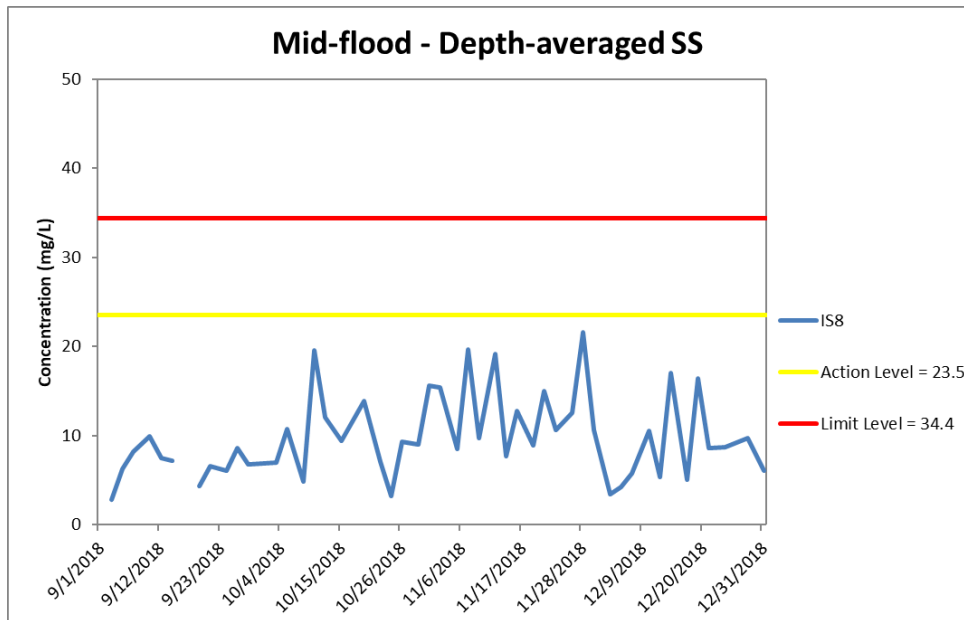
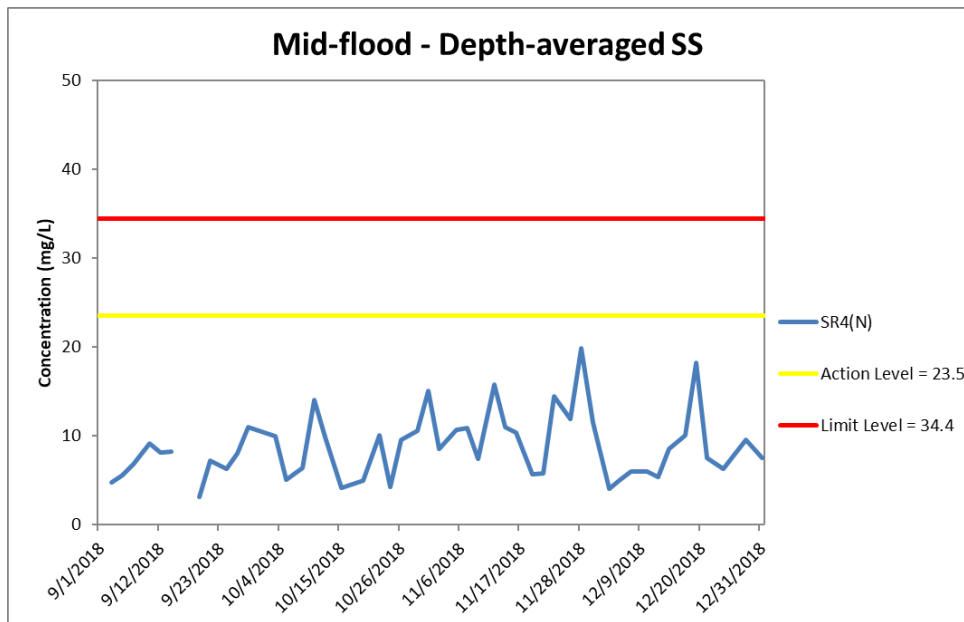
Figure J35 Impact Monitoring - Mean depth-averaged level of Suspended Solids (mg/L) during mid-flood tide between 1 September and 31 December 2018 at IS8 and SR4(N).

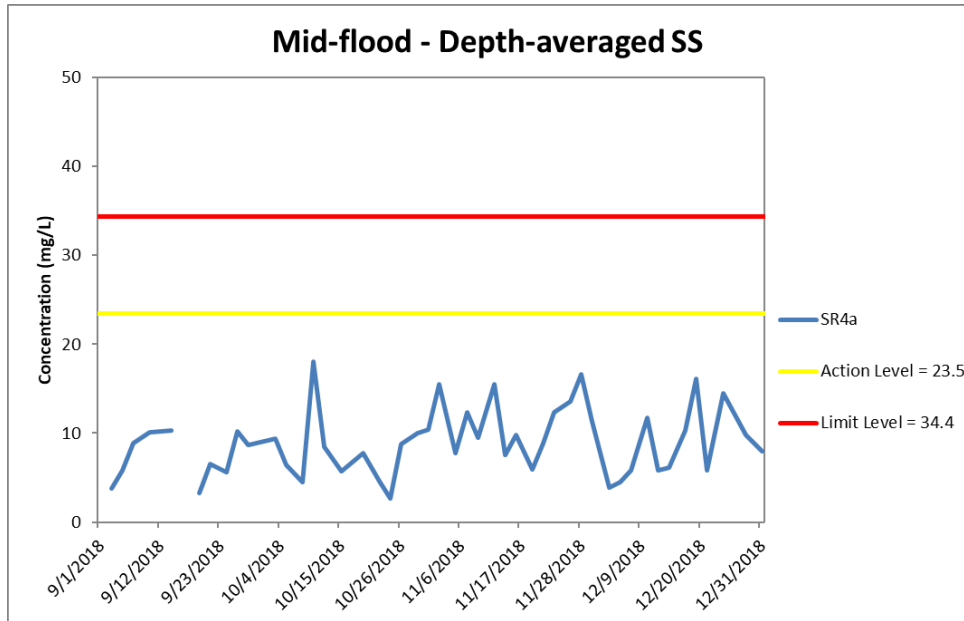
Figure J36 Impact Monitoring - Mean depth-averaged level of Suspended Solids (mg/L) during mid-flood tide between 1 September and 31 December 2018 at SR4a.
