**Contract No. HY/2012/07
Tuen Mun – Chek Lap Kok Link –
Southern Connection Viaduct Section**

Sixty-fourth Monthly EM&A Report

12 March 2019

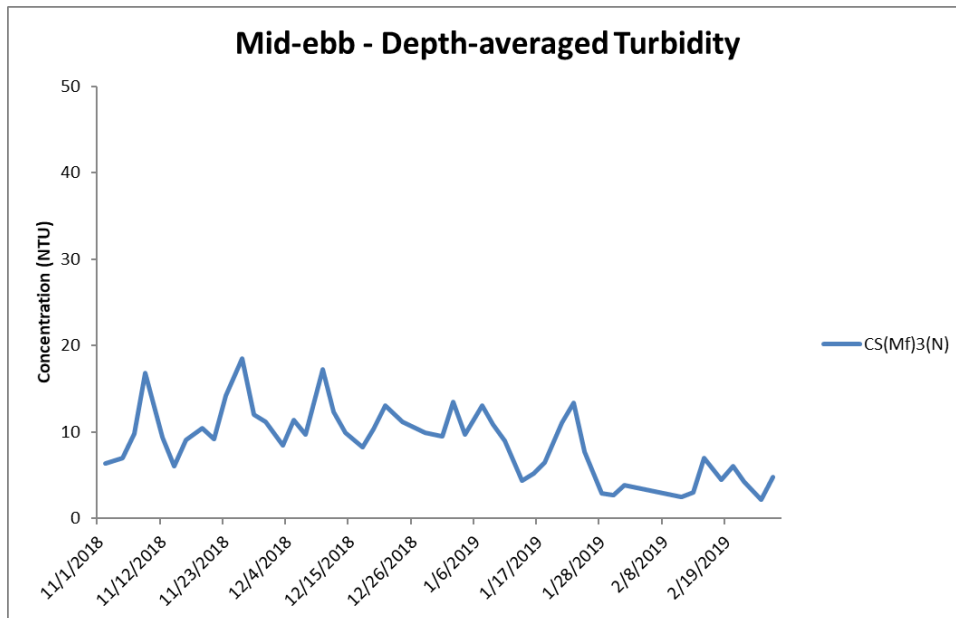
Figure J21 Impact Monitoring – Mean Level of depth-averaged Turbidity (NTU) during mid-ebb tide between 1 November 2018 and 28 February 2019 at CS(Mf)3(N) and CS(Mf)5.

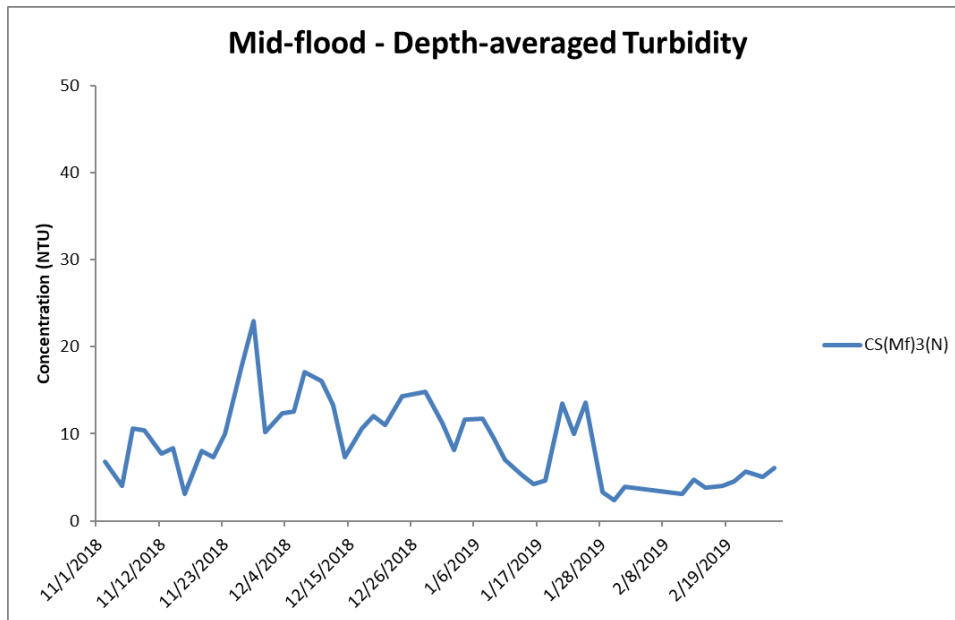
Figure J25 Impact Monitoring - Mean Level of depth-averaged Turbidity (NTU) during mid-flood tide between 1 November 2018 and 28 February 2019 at CS(Mf)3(N) and CS(MF)5.
