**Contract No. HY/2012/07  
Tuen Mun – Chek Lap Kok Link –  
Southern Connection Viaduct Section**

*Sixty-fifth Monthly EM&A Report*

12 April 2019

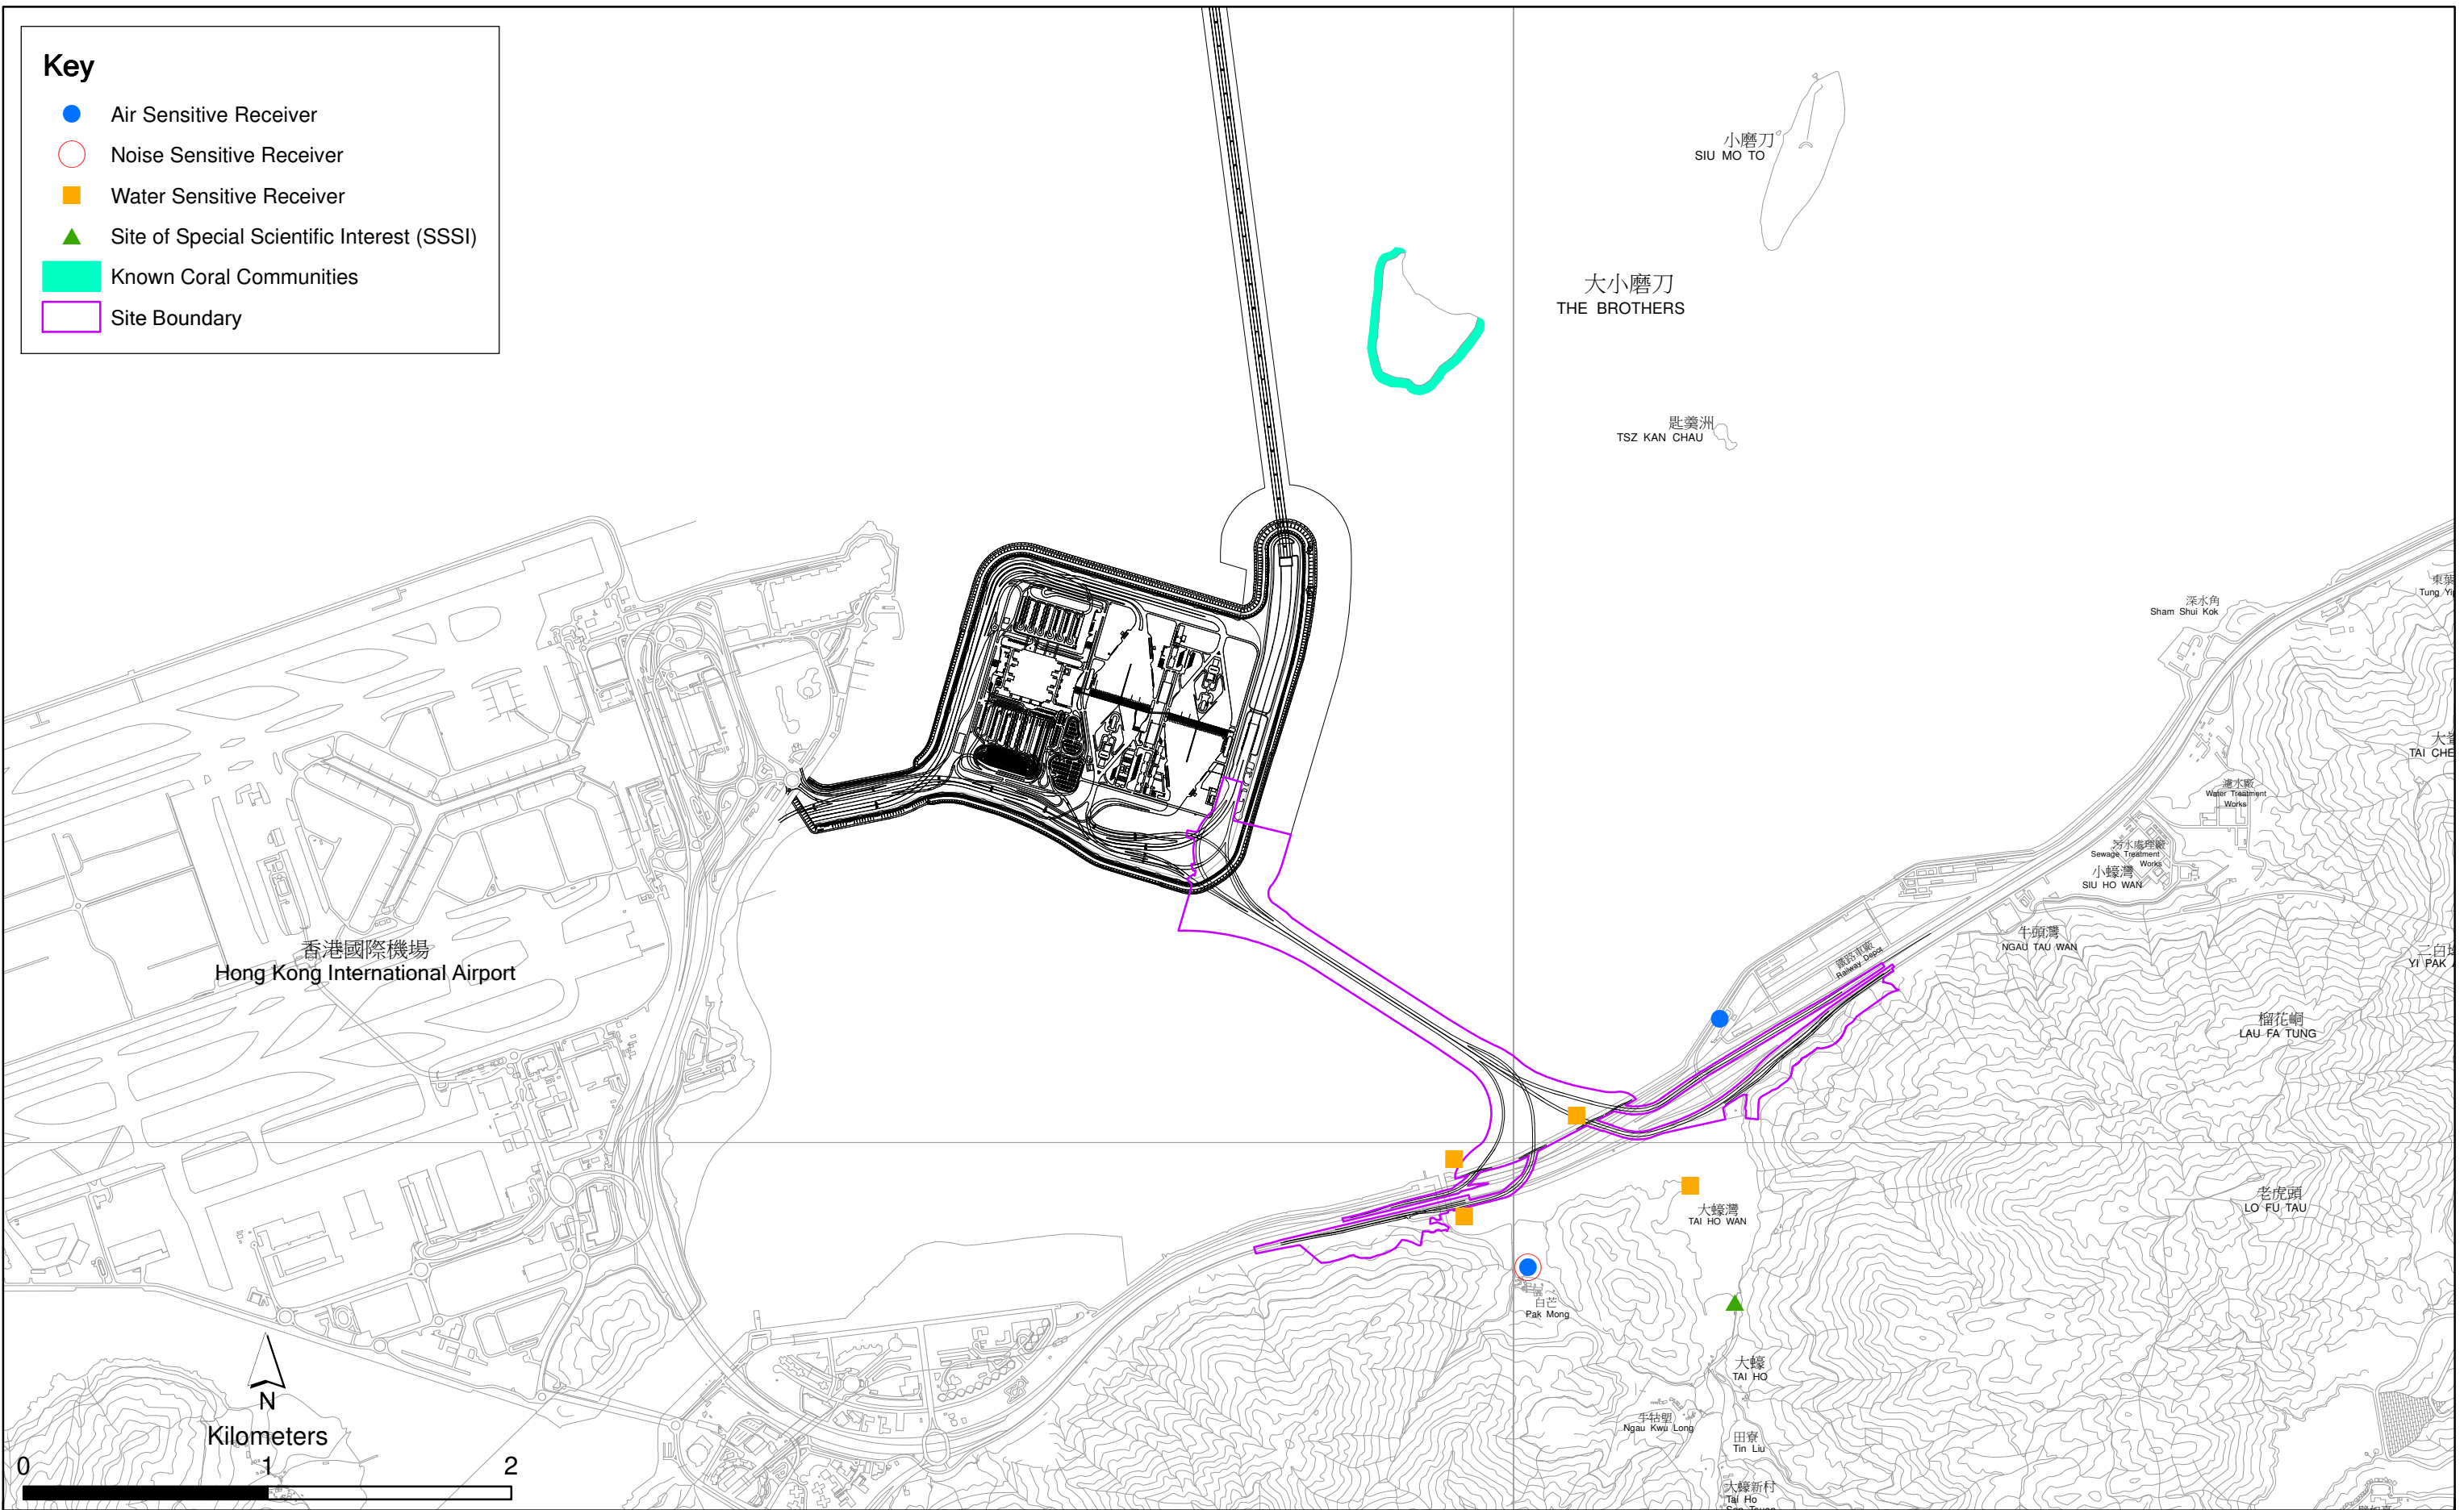
Figure 1.4

Environmental Sensitive Receivers in the Vicinity of Contract No. HY/2012/07  
Tuen Mun - Chek Lap Kok Link - Southern Connection Viaduct Section

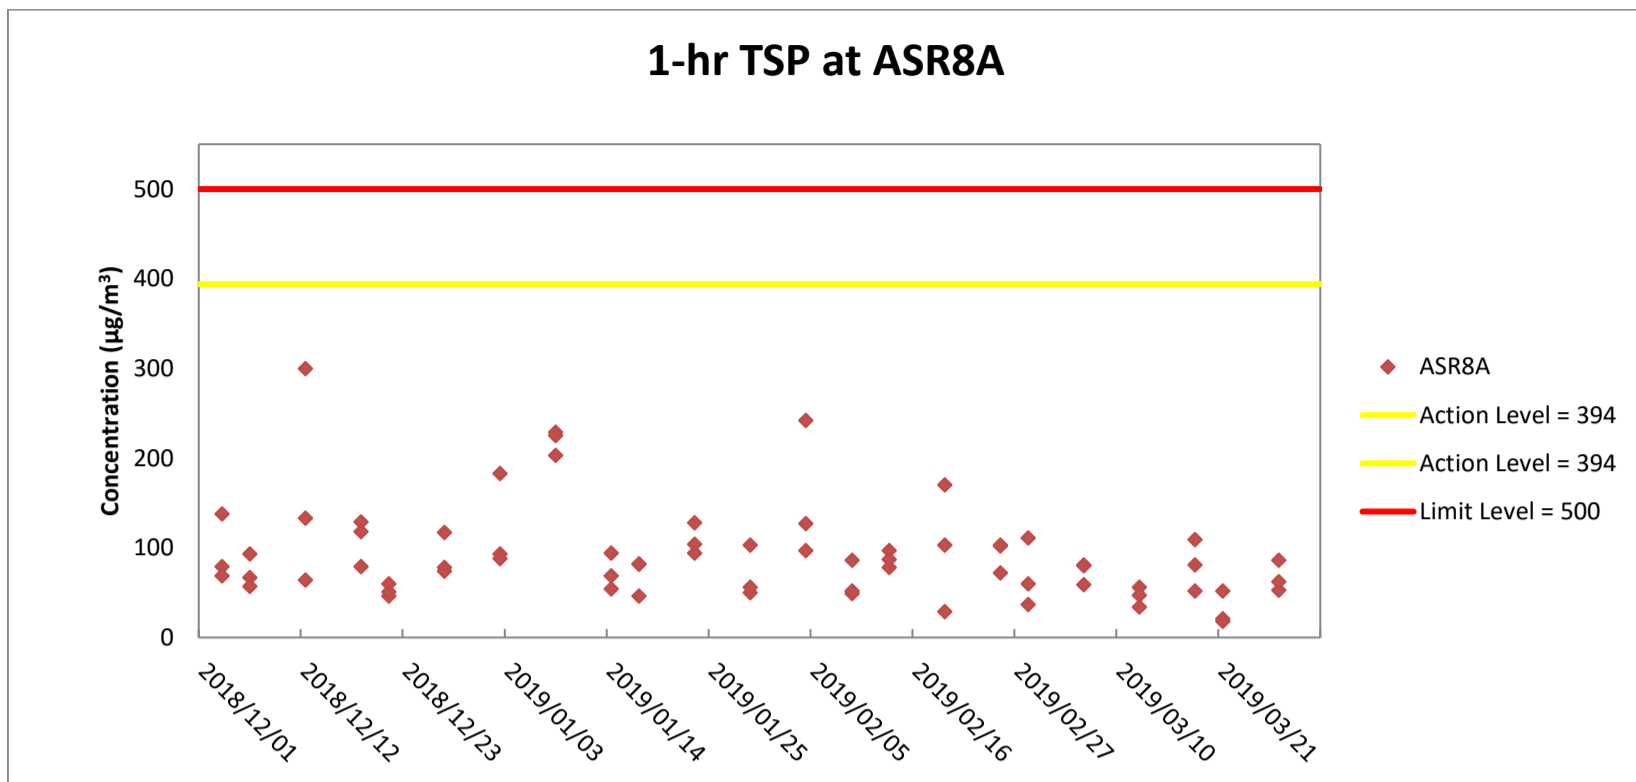
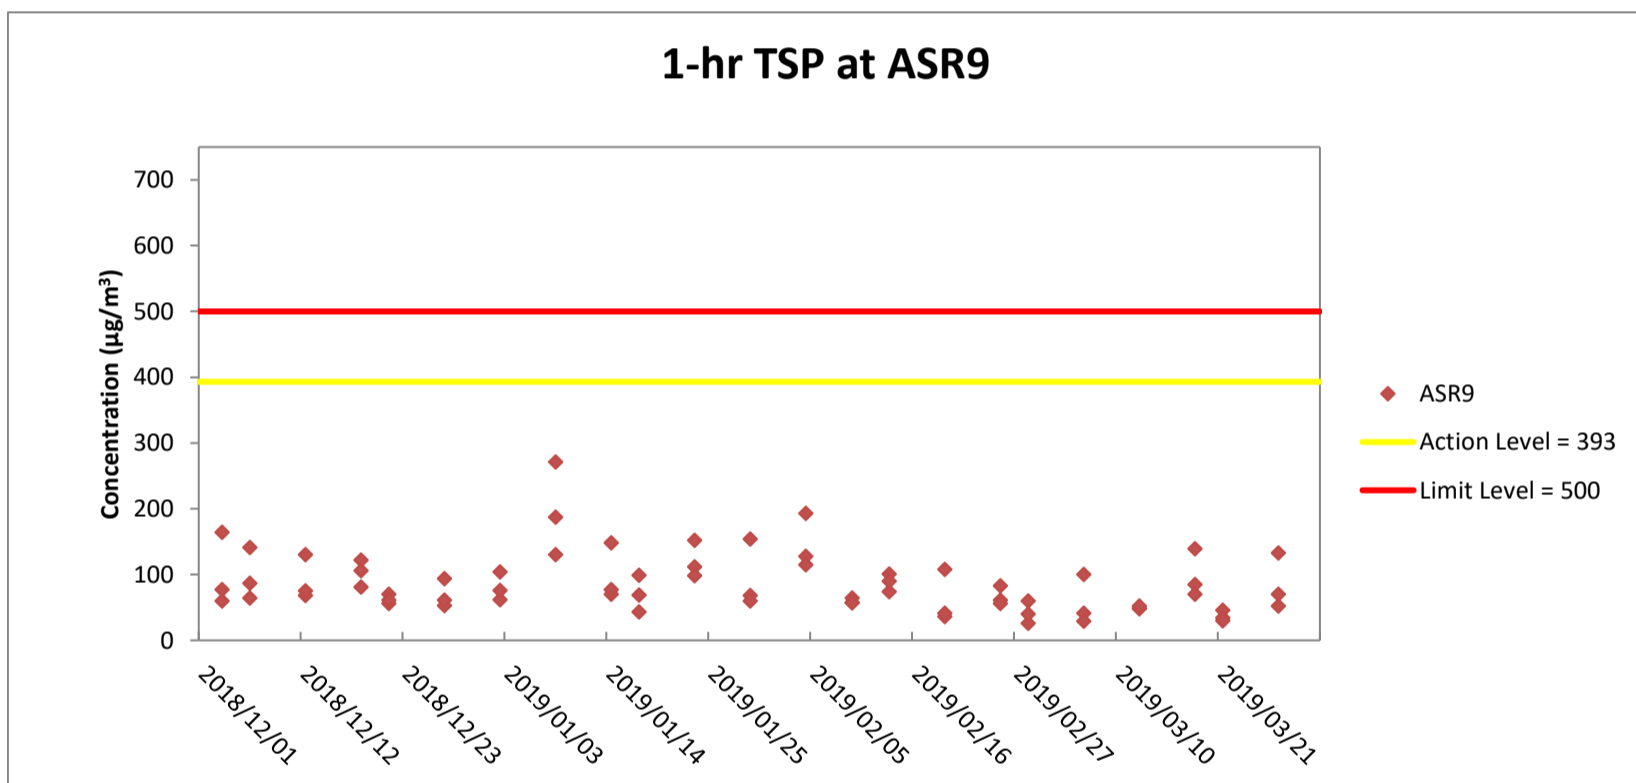
Weather condition within the reporting period varied between sunny to cloudy.

Major construction works undertaken within the reporting period include slope work at Viaduct A, landscaping works at NLH/CTR and HKBCF.

Marine works within the reporting period include reinstatement of seawall at seafront

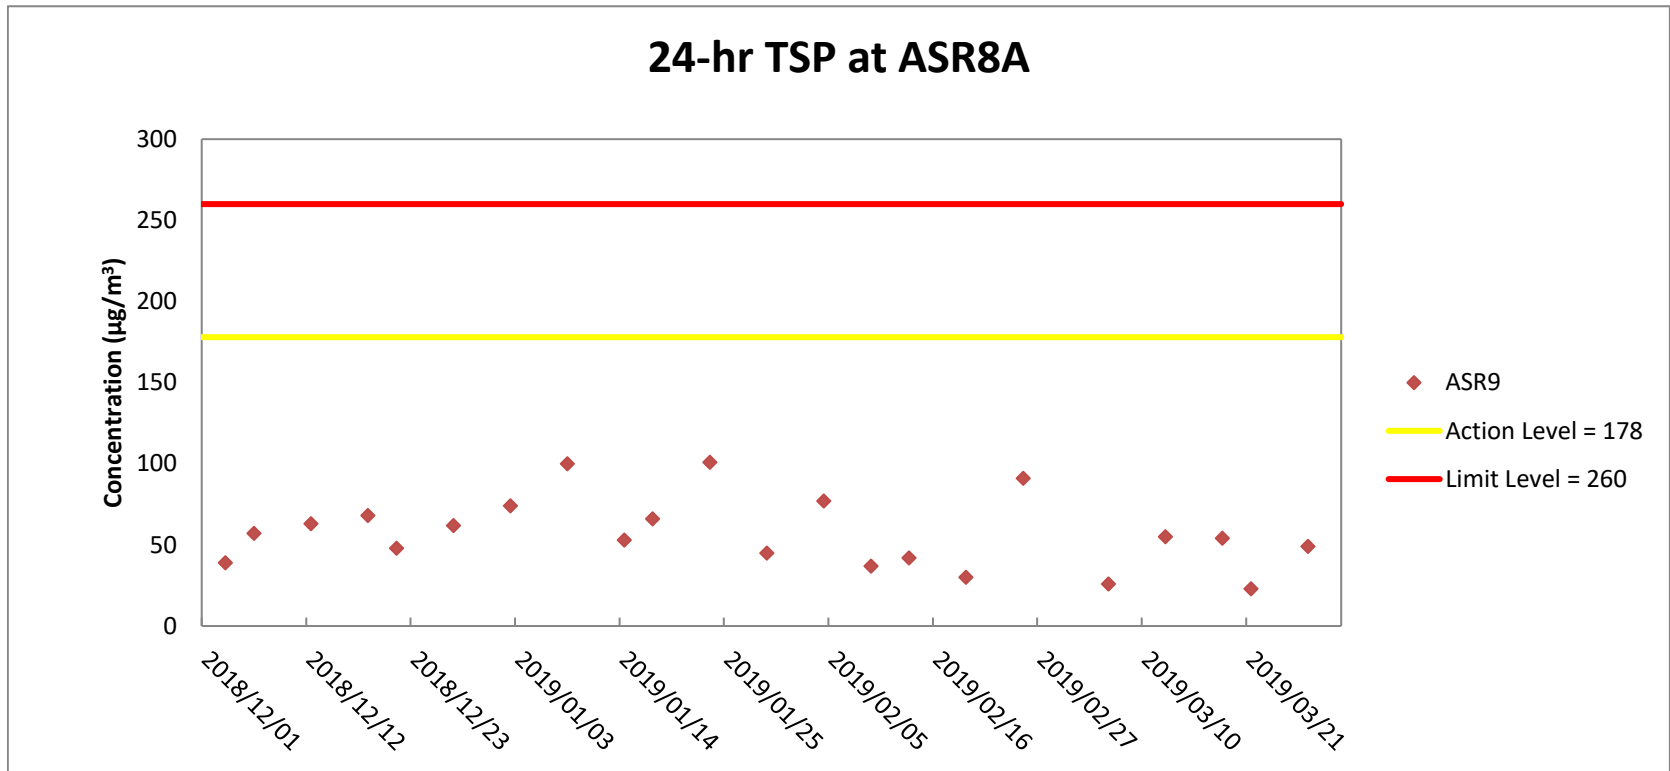
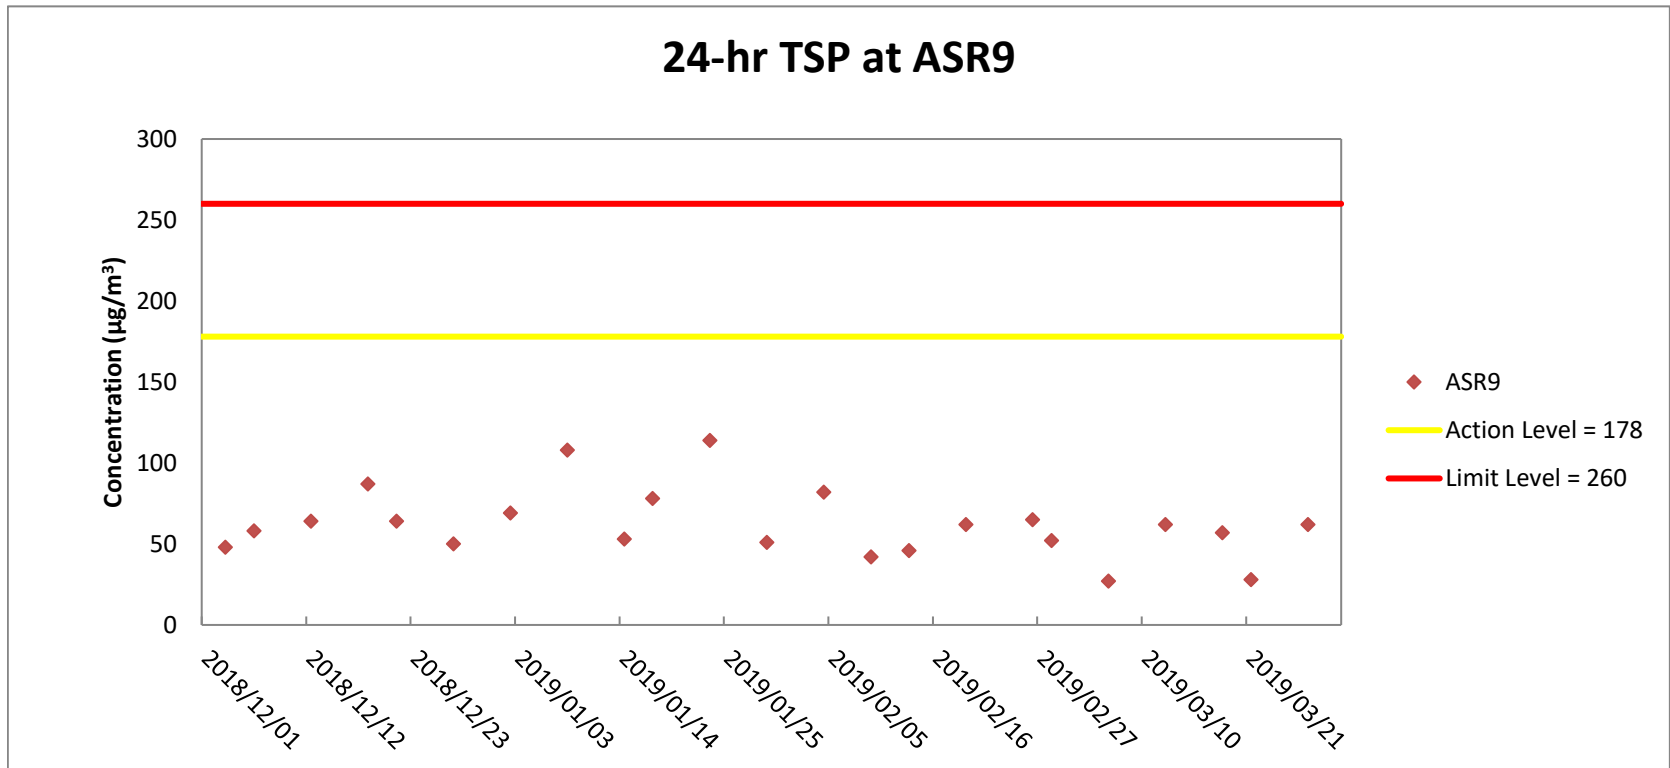
Weather condition within the reporting period varied between sunny to cloudy.

Major construction works undertaken within the reporting period include slope work at Viaduct A, landscaping works at NLH/CTR and HKBCF.

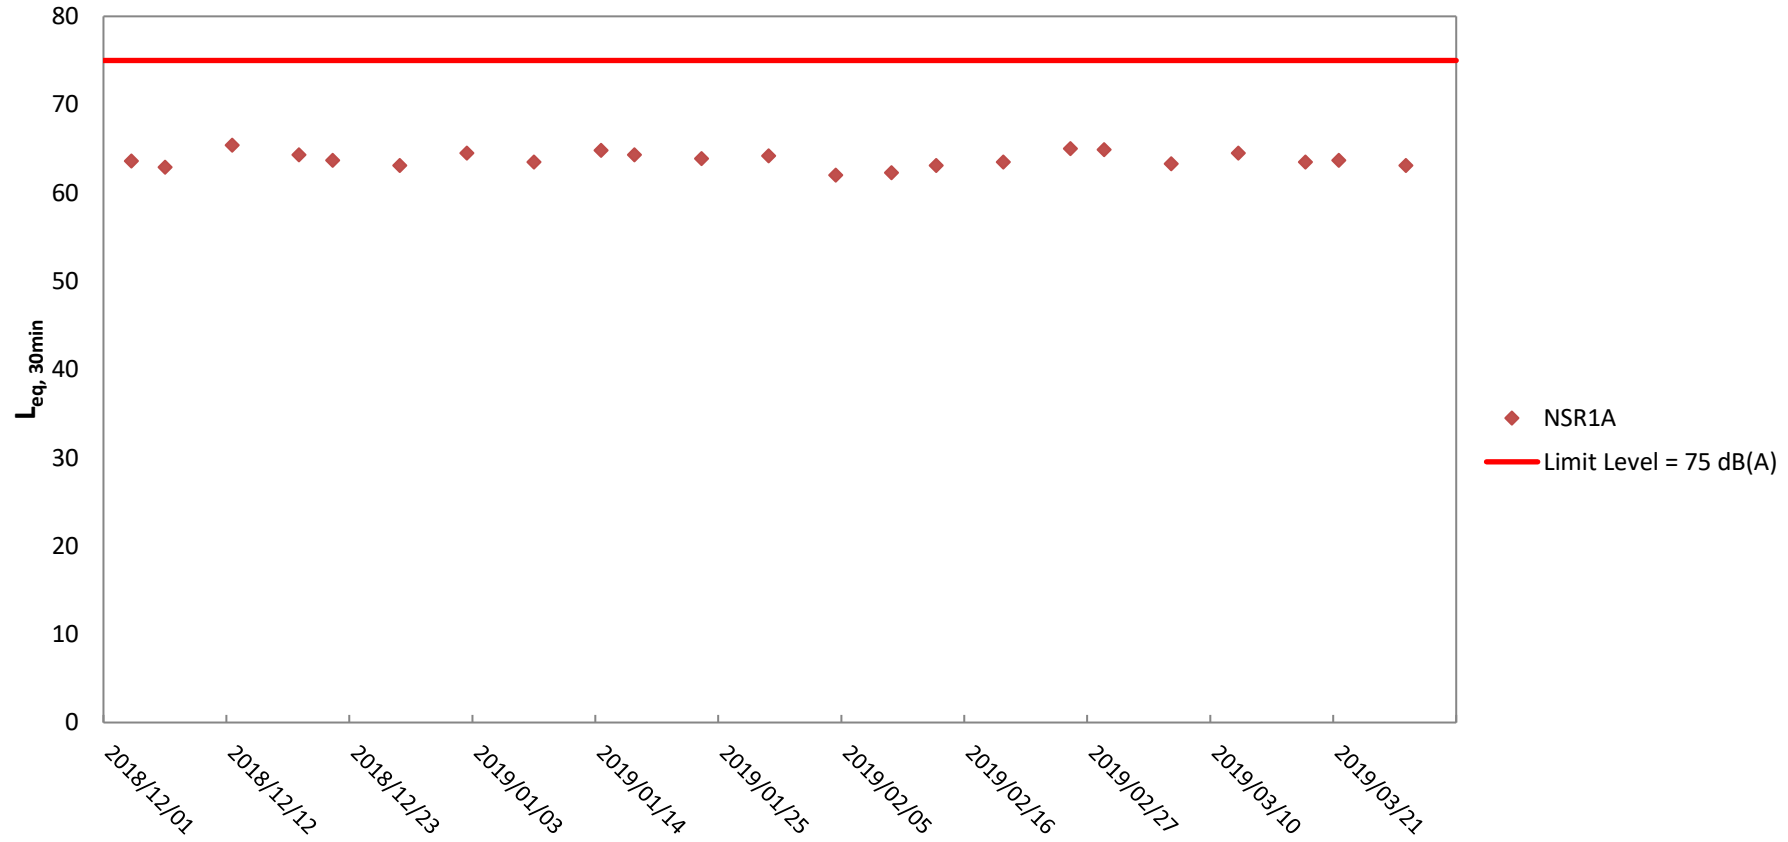
### Noise Monitoring Results at NSR 1A ( $L_{eq, 30min}$ )

Weather condition within the reporting period varied between sunny to cloudy.

Major construction works undertaken within the reporting period include slope work of viaduct A, landscaping works at NLH/CTR and HKBCF.

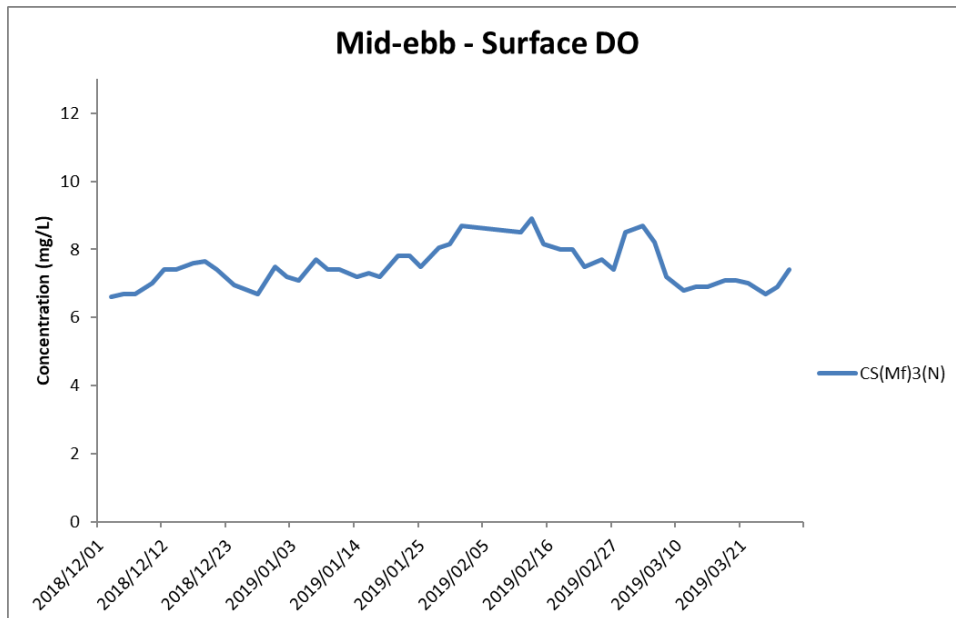
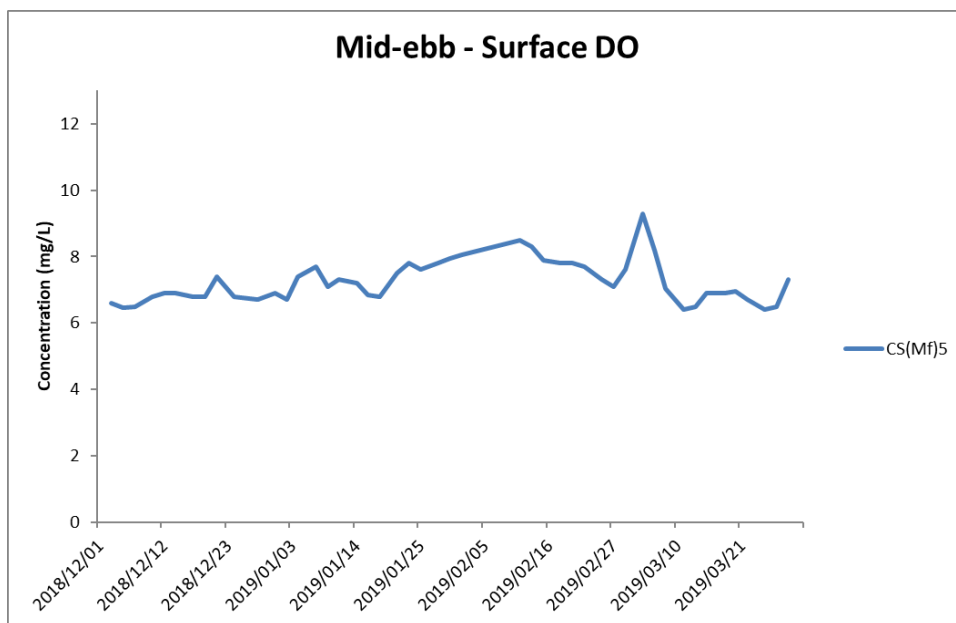
**Figure J1 Impact Monitoring – Mean Level of Dissolved Oxygen (mg/L) in surface waters during mid-ebb tide between 1 December 2018 and 31 March 2019 at CS(Mf)3(N) and CS(Mf)5.**

*(Weather condition varied between sunny to rainy within the reporting period.) In-situ monitoring is taken according to the requirement specified in the EM&A Manual, i.e. 3 water depth namely 1m below sea surface, mid-depth and 1m above sea bed. If the water depth is less than 3m, mid-depth sampling only. If water depth less than 6m, mid-depth may be omitted.*

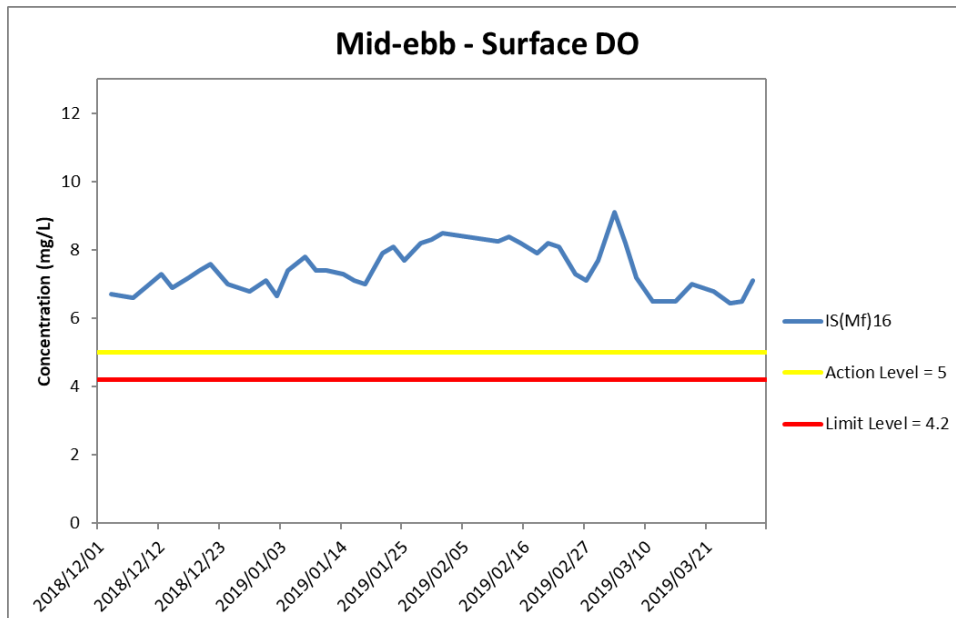
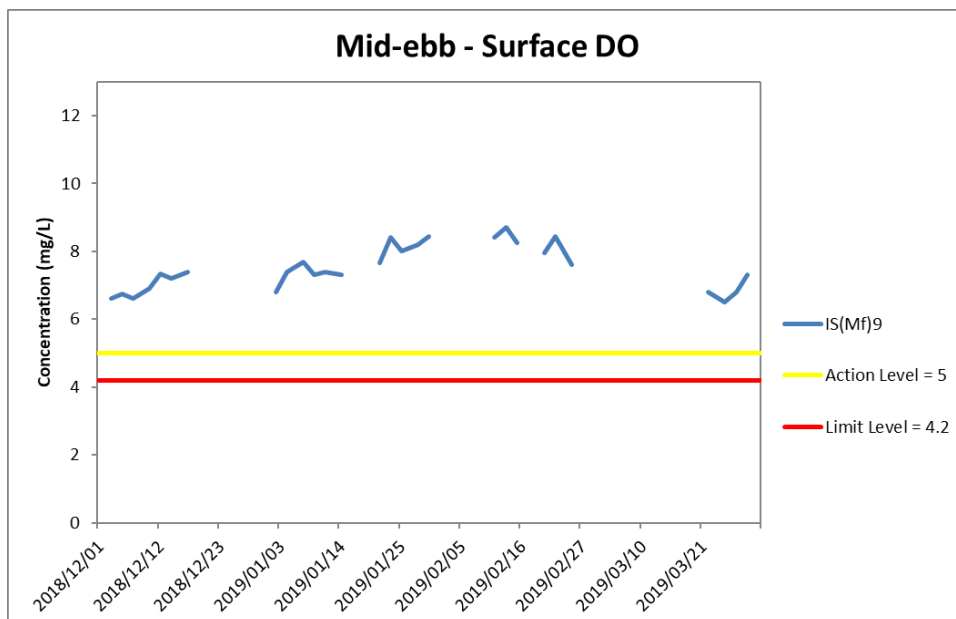
**Figure J2 Impact Monitoring - Mean Level of Dissolved Oxygen (mg/L) in surface waters during mid-ebb tide between 1 December 2018 and 31 March 2019 at IS(Mf)16 and IS(Mf)9.**

*(Weather condition varied between sunny to rainy within the reporting period.)  
In-situ monitoring is taken according to the requirement specified in the EM&A Manual, i.e. 3 water depth namely 1m below sea surface, mid-depth and 1m above sea bed. If the water depth is less than 3m, mid-depth sampling only. If water depth less than 6m, mid-depth may be omitted.*

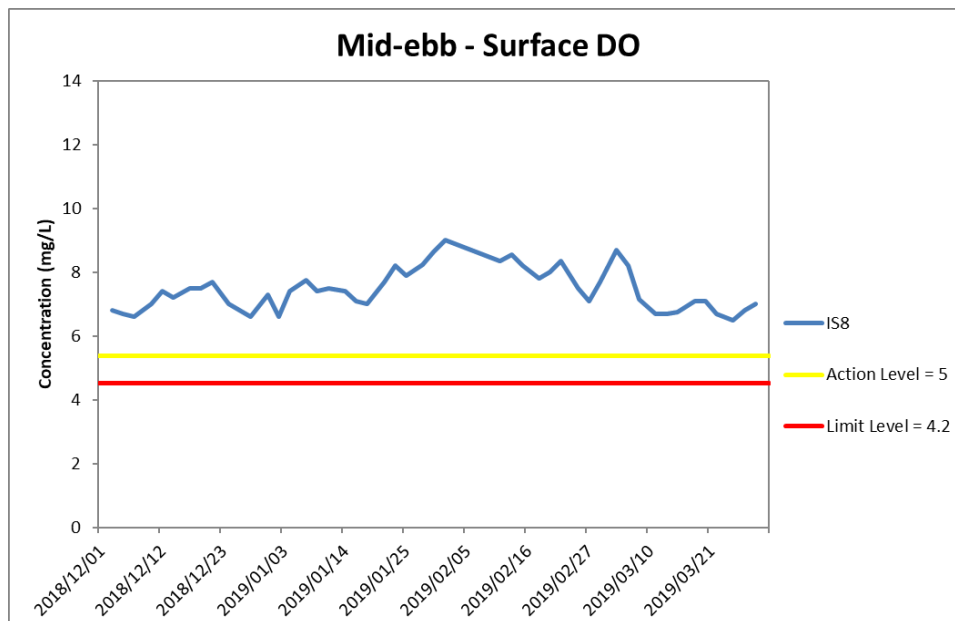
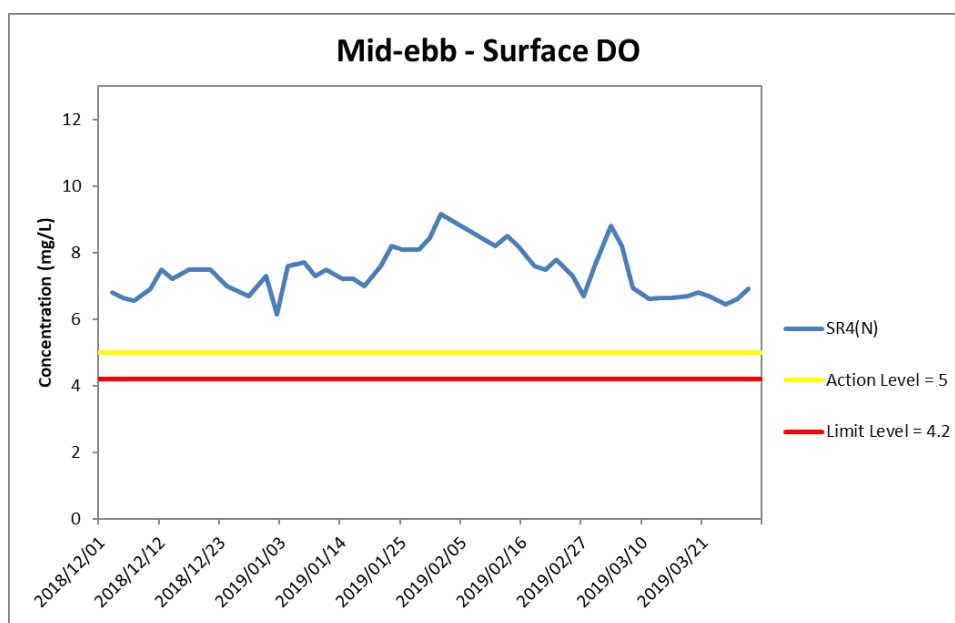
**Figure J3 Impact Monitoring - Mean Level of Dissolved Oxygen (mg/L) in surface waters during mid-ebb tide between 1 December 2018 and 31 March 2019 at IS8 and SR4(N).**

*(Weather condition varied between sunny to rainy within the reporting period.) In-situ monitoring is taken according to the requirement specified in the EM&A Manual, i.e. 3 water depth namely 1m below sea surface, mid-depth and 1m above sea bed. If the water depth is less than 3m, mid-depth sampling only. If water depth less than 6m, mid-depth may be omitted.*

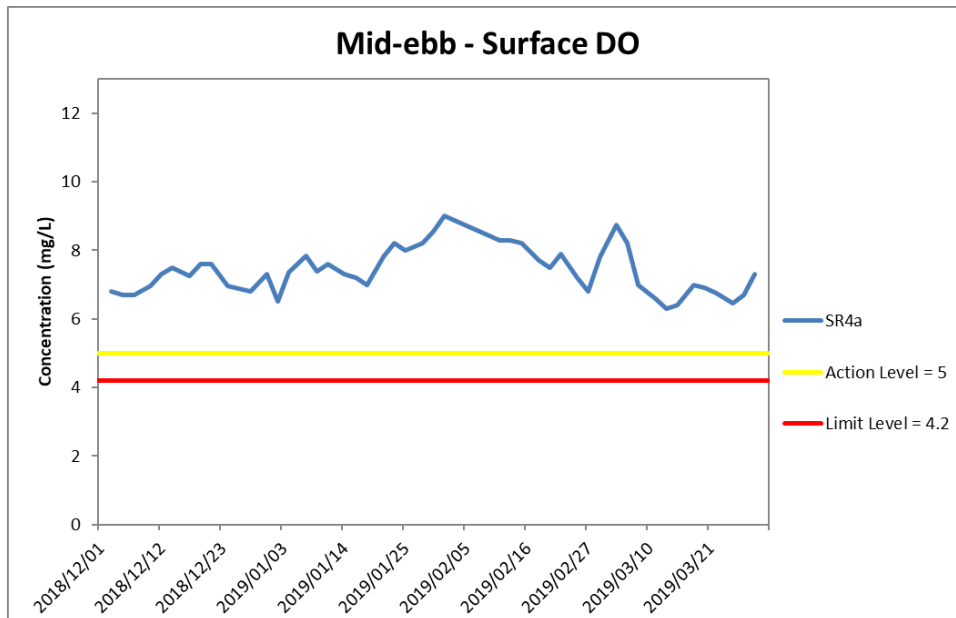
**Figure J4 Impact Monitoring – Mean Level of Dissolved Oxygen (mg/L) in surface waters during mid-ebb tide between 1 December 2018 and 31 March 2019 at SR4a.**

*(Weather condition varied between sunny to rainy within the reporting period.)  
In-situ monitoring is taken according to the requirement specified in the EM&A Manual, i.e. 3 water depth namely 1m below sea surface, mid-depth and 1m above sea bed. If the water depth is less than 3m, mid-depth sampling only. If water depth less than 6m, mid-depth may be omitted.*

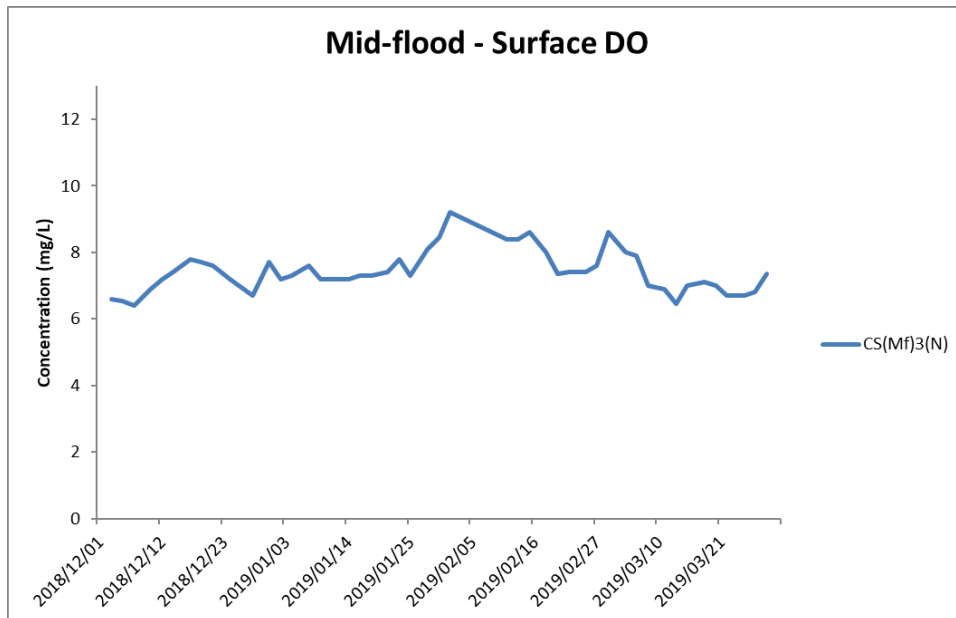
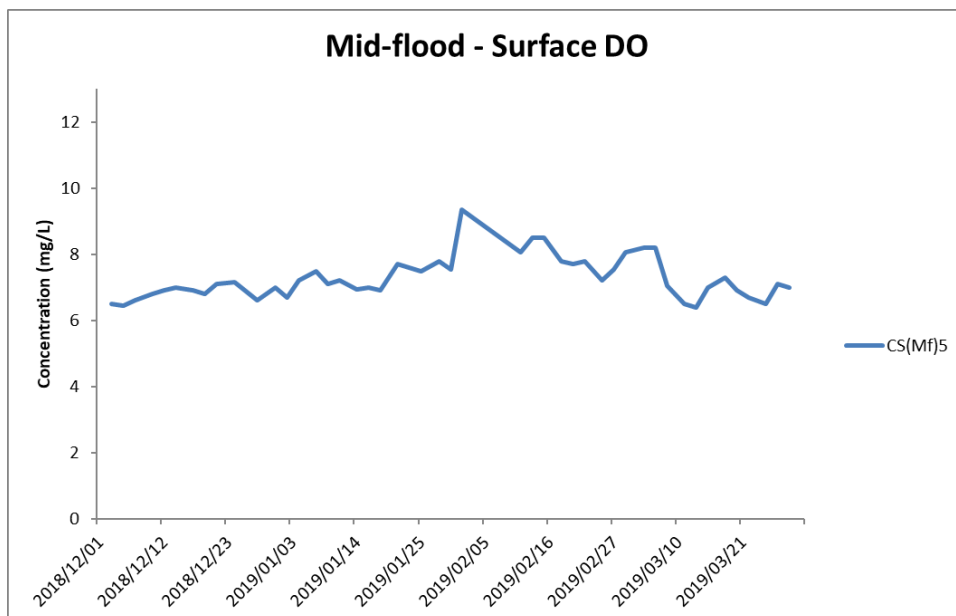
**Figure J5 Impact Monitoring - Mean Level of Dissolved Oxygen (mg/L) in surface waters during mid-flood tide between 1 December 2018 and 31 March 2019 at CS(Mf)3(N) and CS(Mf)5.**

*(Weather condition varied between sunny to rainy within the reporting period.)  
 In-situ monitoring is taken according to the requirement specified in the EM&A Manual, i.e. 3 water depth namely 1m below sea surface, mid-depth and 1m above sea bed. If the water depth is less than 3m, mid-depth sampling only. If water depth less than 6m, mid-depth may be omitted.*

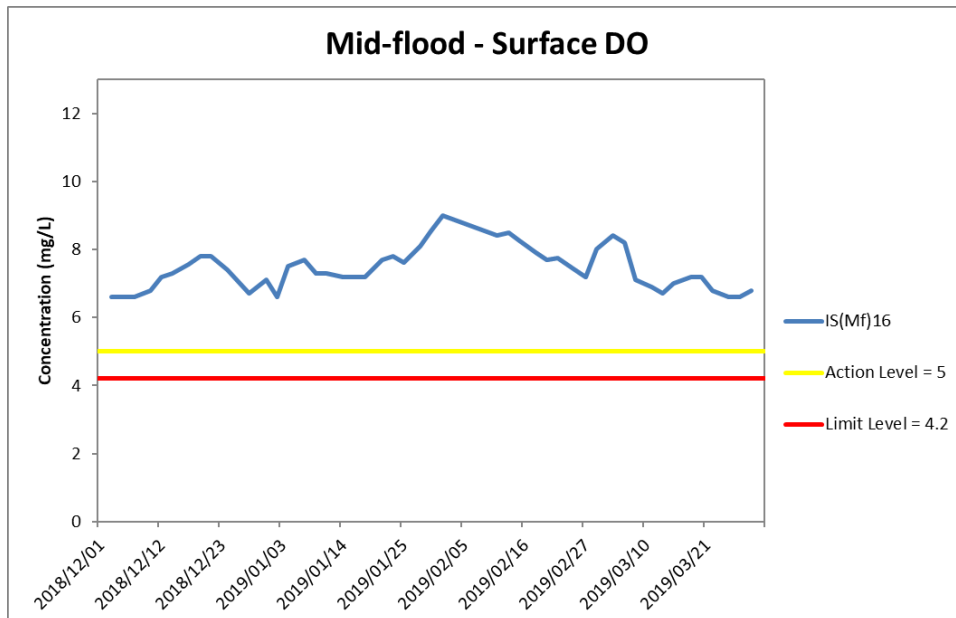
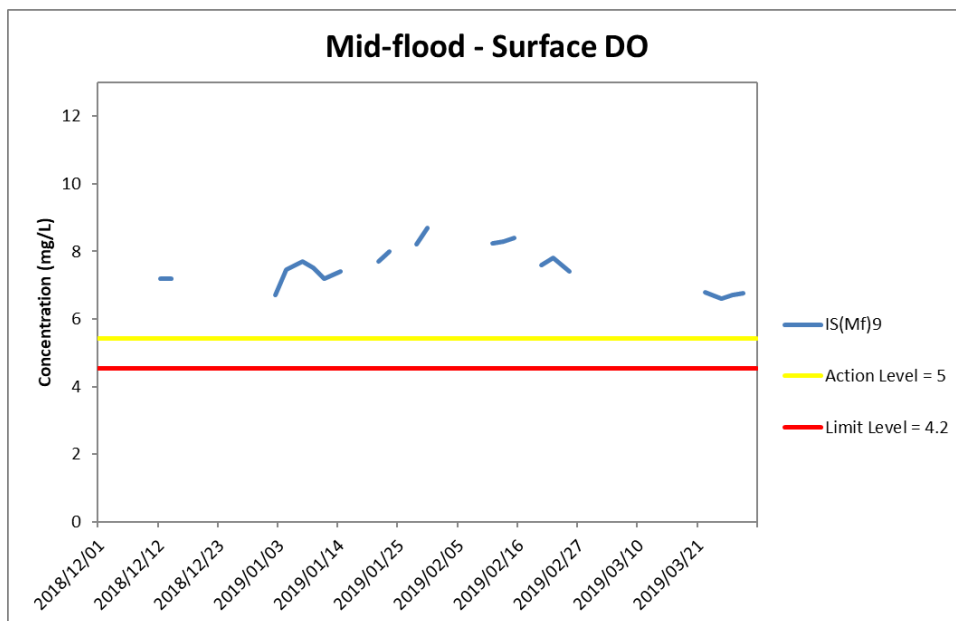
**Figure J6 Impact Monitoring - Mean Level of Dissolved Oxygen (mg/L) in surface waters during mid-flood tide between 1 December 2018 and 31 March 2019 at IS(Mf)16 and IS(Mf)9.**

*(Weather condition varied between sunny to rainy within the reporting period.)  
In-situ monitoring is taken according to the requirement specified in the EM&A Manual, i.e. 3 water depth namely 1m below sea surface, mid-depth and 1m above sea bed. If the water depth is less than 3m, mid-depth sampling only. If water depth less than 6m, mid-depth may be omitted.*

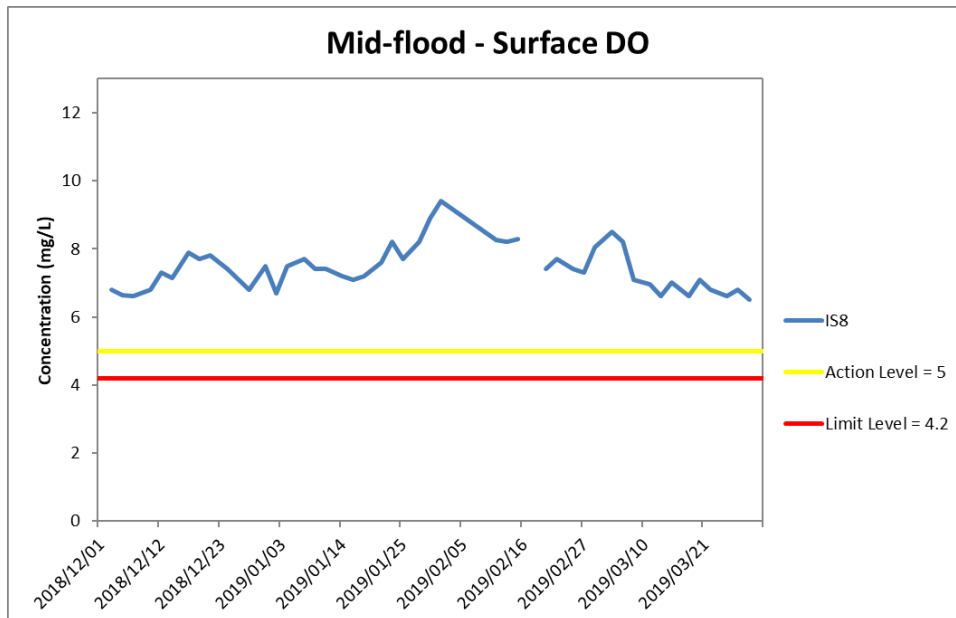
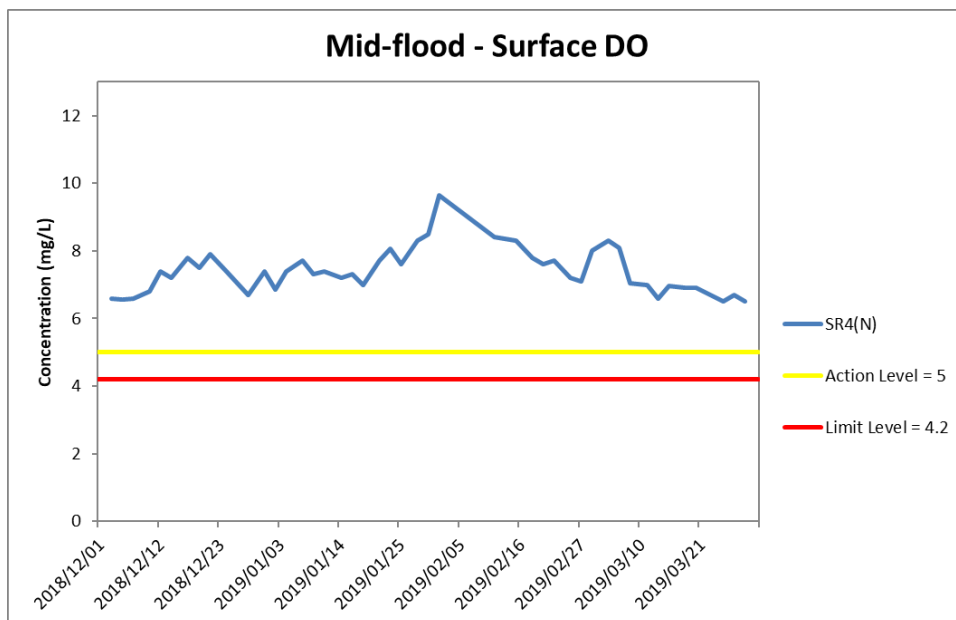
**Figure J7 Impact Monitoring - Mean Level of Dissolved Oxygen (mg/L) in surface waters during mid-flood tide between 1 December 2018 and 31 March 2019 at IS8 and SR4(N).**

*(Weather condition varied between sunny to rainy within the reporting period.) In-situ monitoring is taken according to the requirement specified in the EM&A Manual, i.e. 3 water depth namely 1m below sea surface, mid-depth and 1m above sea bed. If the water depth is less than 3m, mid-depth sampling only. If water depth less than 6m, mid-depth may be omitted.*

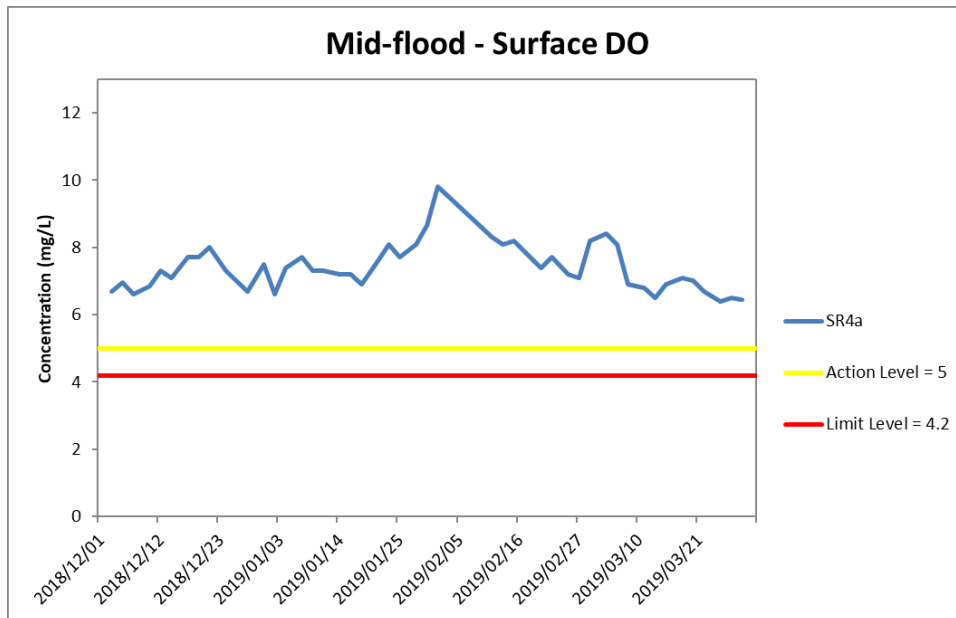
**Figure J8 Impact Monitoring – Mean Level of Dissolved Oxygen (mg/L) in surface waters during mid-flood tide between 1 December 2018 and 31 March 2019 at SR4a.**

*(Weather condition varied between sunny to rainy within the reporting period.)  
In-situ monitoring is taken according to the requirement specified in the EM&A Manual, i.e. 3 water depth namely 1m below sea surface, mid-depth and 1m above sea bed. If the water depth is less than 3m, mid-depth sampling only. If water depth less than 6m, mid-depth may be omitted.*

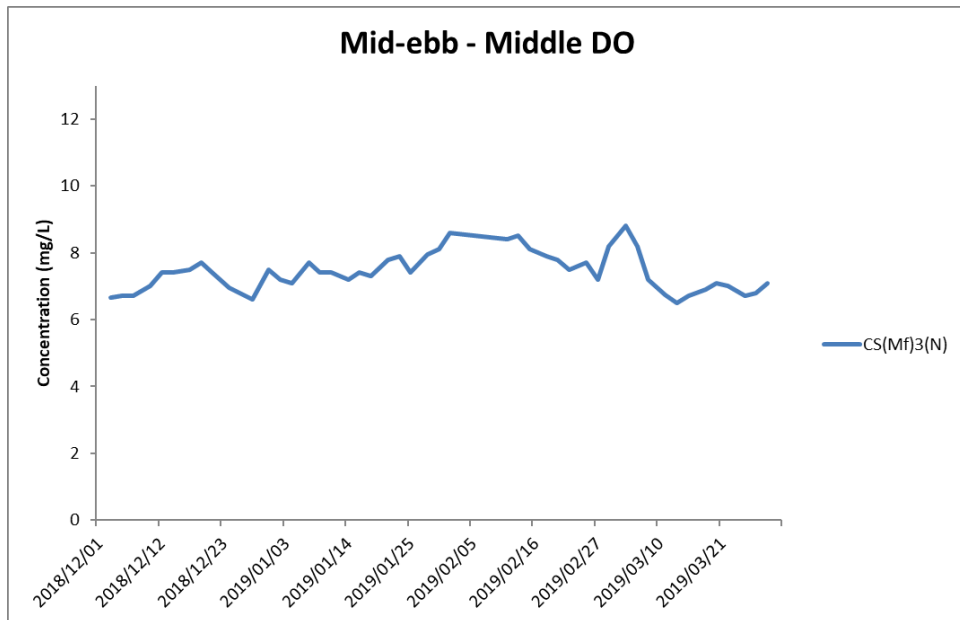
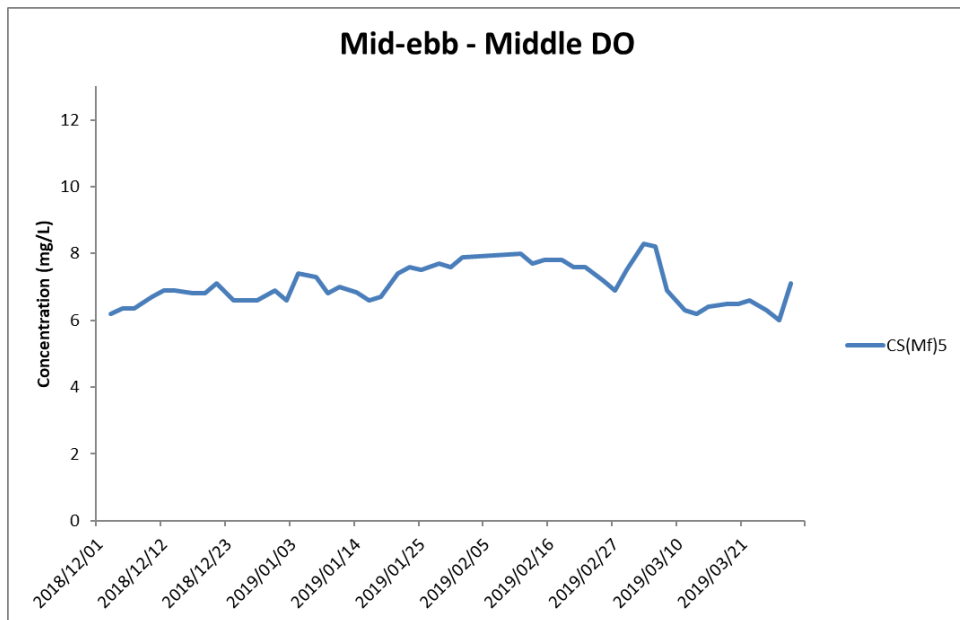
**Figure J9 Impact Monitoring - Mean Level of Dissolved Oxygen (mg/L) in mid-depth waters during mid-ebb tide between 1 December 2018 and 31 March 2019 at CS(Mf)3(N) and CS(Mf)5.**

*(Weather condition varied between sunny to rainy within the reporting period.) In-situ monitoring is taken according to the requirement specified in the EM&A Manual, i.e. 3 water depth namely 1m below sea surface, mid-depth and 1m above sea bed. If the water depth is less than 3m, mid-depth sampling only. If water depth less than 6m, mid-depth may be omitted.*

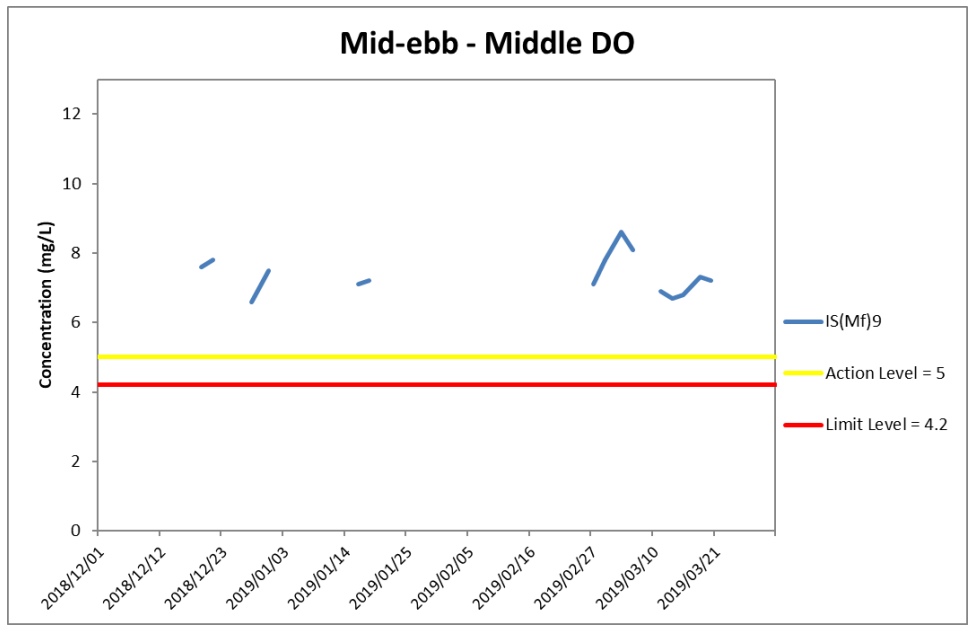
**Figure J10 Impact Monitoring – Mean Level of Dissolved Oxygen (mg/L) in mid-depth waters during mid-ebb tide between 1 December 2018 and 31 March 2019 at IS(Mf)9.**
