**Contract No. HY/2012/07  
Tuen Mun – Chek Lap Kok Link –  
Southern Connection Viaduct Section**

*Sixty-fifth Monthly EM&A Report*

12 April 2019

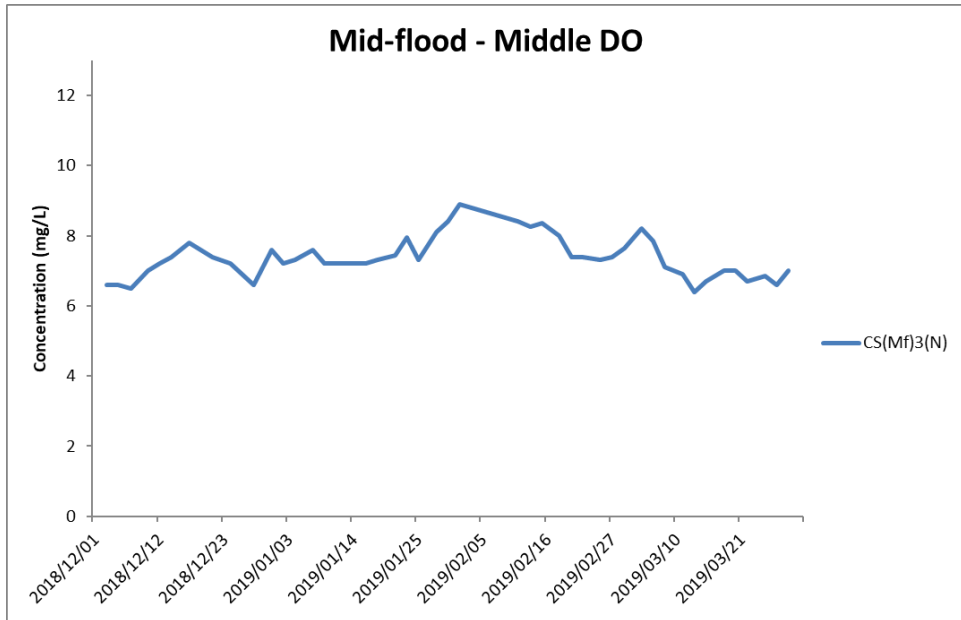
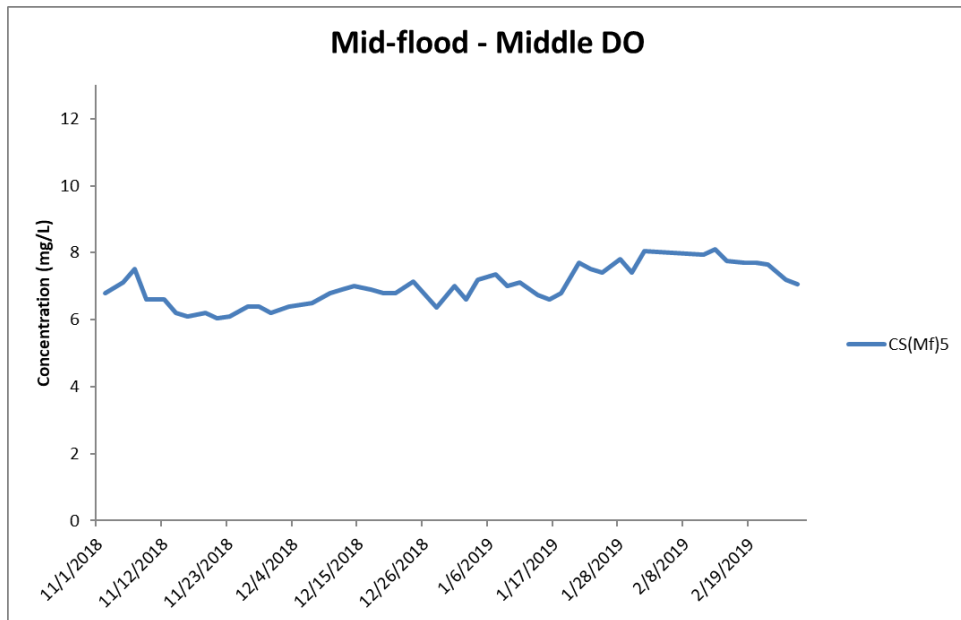
**Figure J11 Impact Monitoring – Mean Level of Dissolved Oxygen (mg/L) in mid-depth waters during mid-flood tide between 1 December 2018 and 31 March 2019 at CS(Mf)3(N) and CS(Mf)5.**

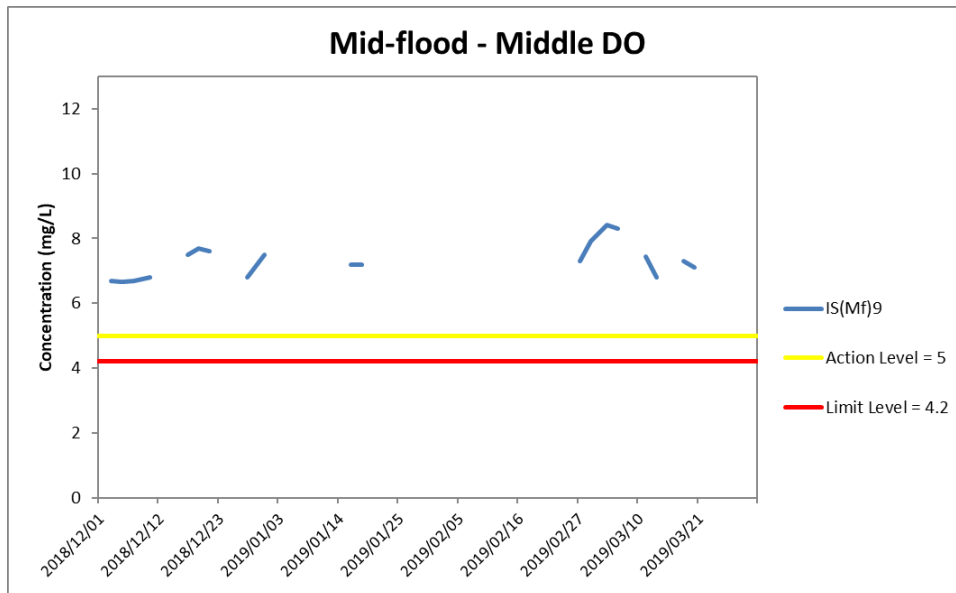
**Figure J12 Impact Monitoring - Mean Level of Dissolved Oxygen (mg/L) in mid-depth waters during mid-flood tide between 1 December 2018 and 31 March 2019 at IS(Mf)9.**

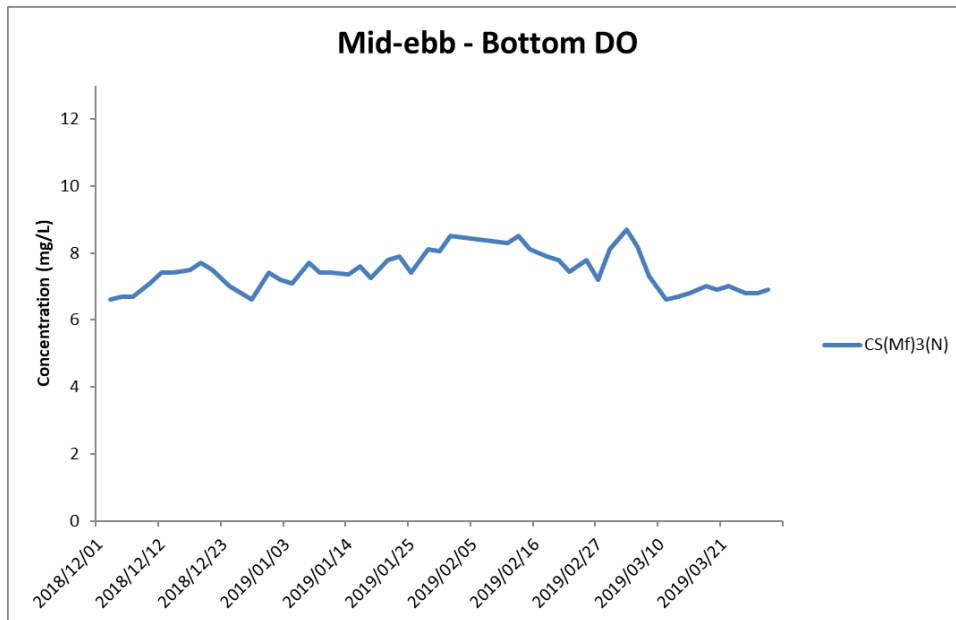
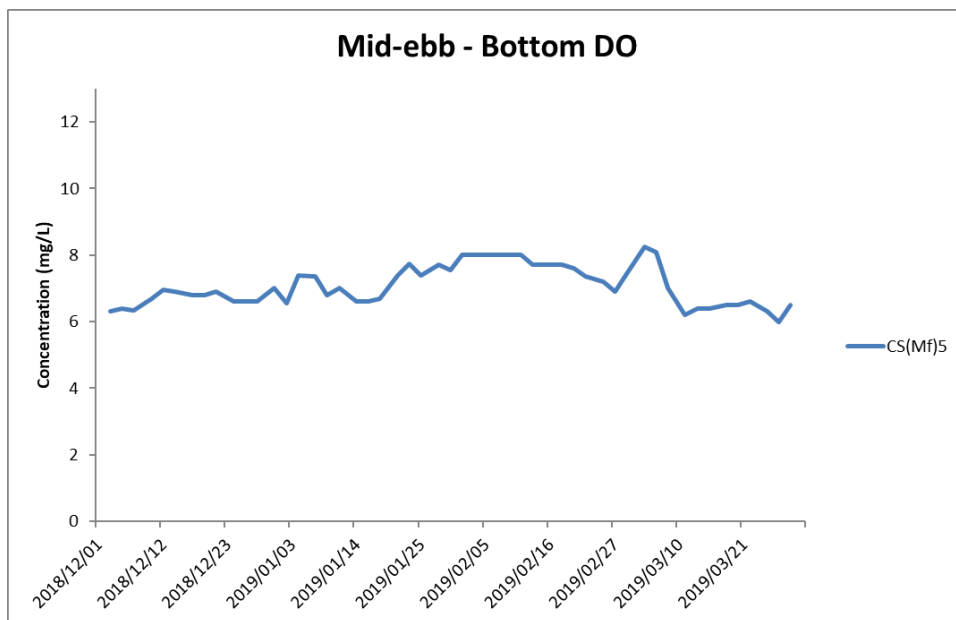
**Figure J13 Impact Monitoring – Mean Level of Dissolved Oxygen (mg/L) in bottom waters during mid-ebb tide between 1 December 2018 and 31 March 2019 at CS(Mf)3(N) and CS(Mf)5.**

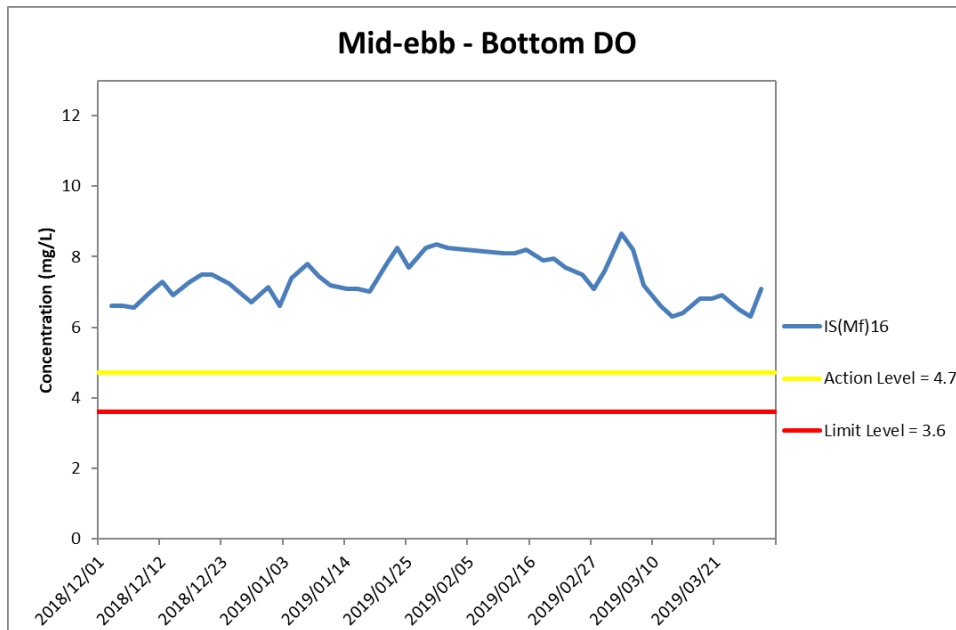
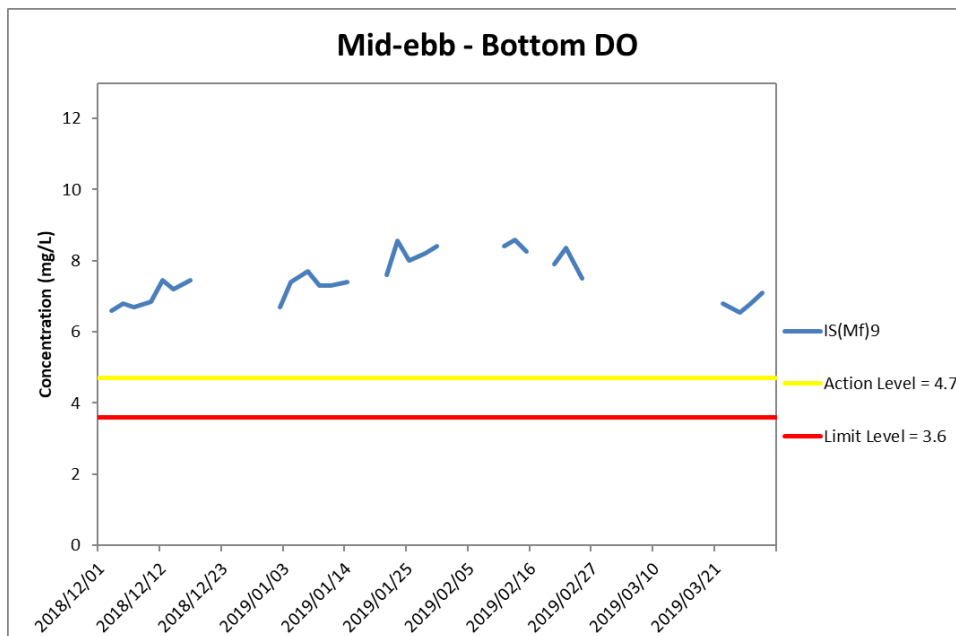
**Figure J14 Impact Monitoring - Mean Level of Dissolved Oxygen (mg/L) in bottom waters during mid-ebb tide between 1 December 2018 and 31 March 2019 at IS(Mf)16 and IS(Mf)9.**

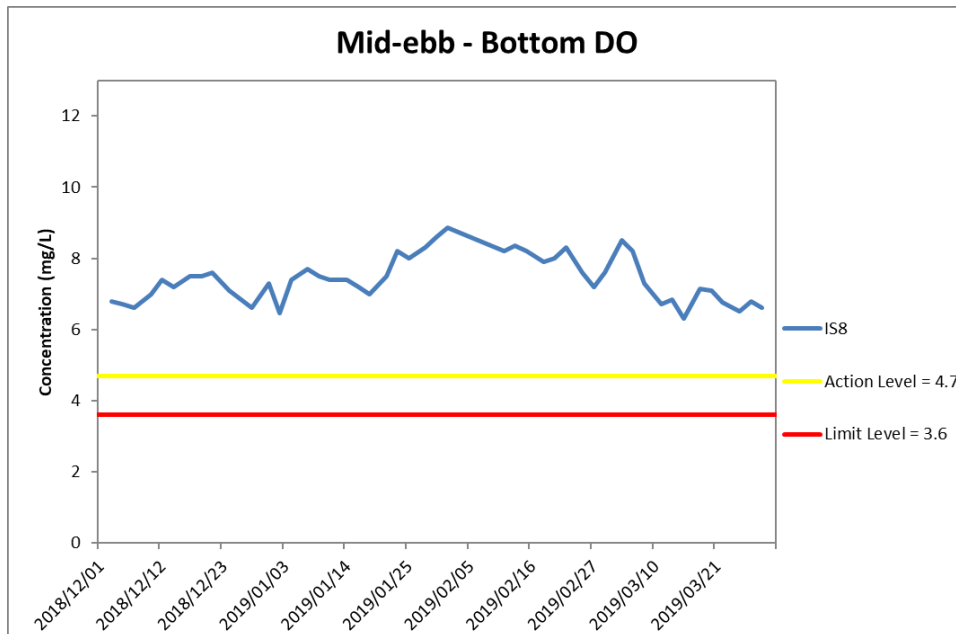
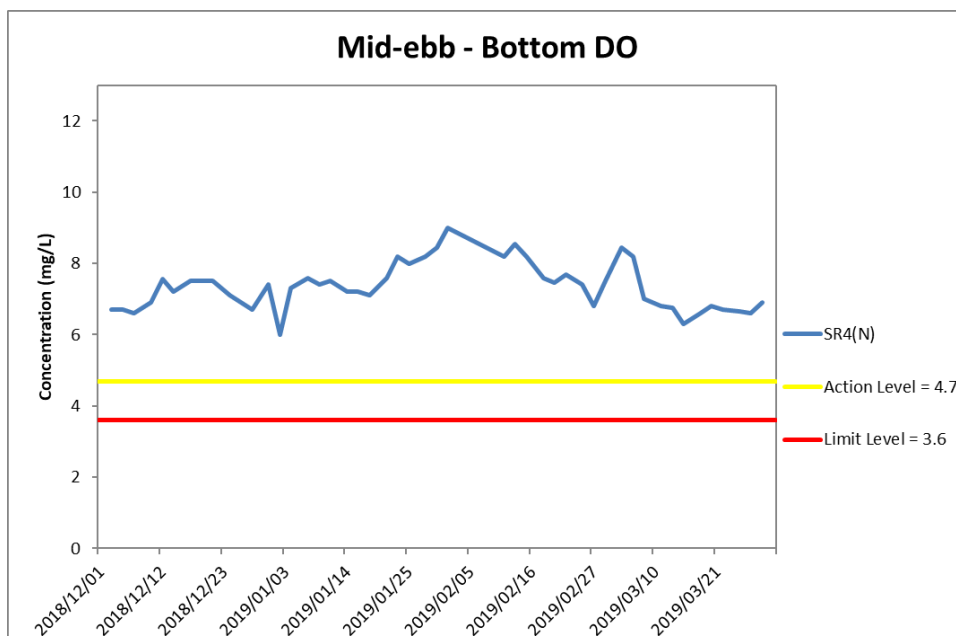
**Figure J15 Impact Monitoring – Mean Level of Dissolved Oxygen (mg/L) in bottom waters during mid-ebb tide between 1 December 2018 and 31 March 2019 at IS8 and SR4(N).**

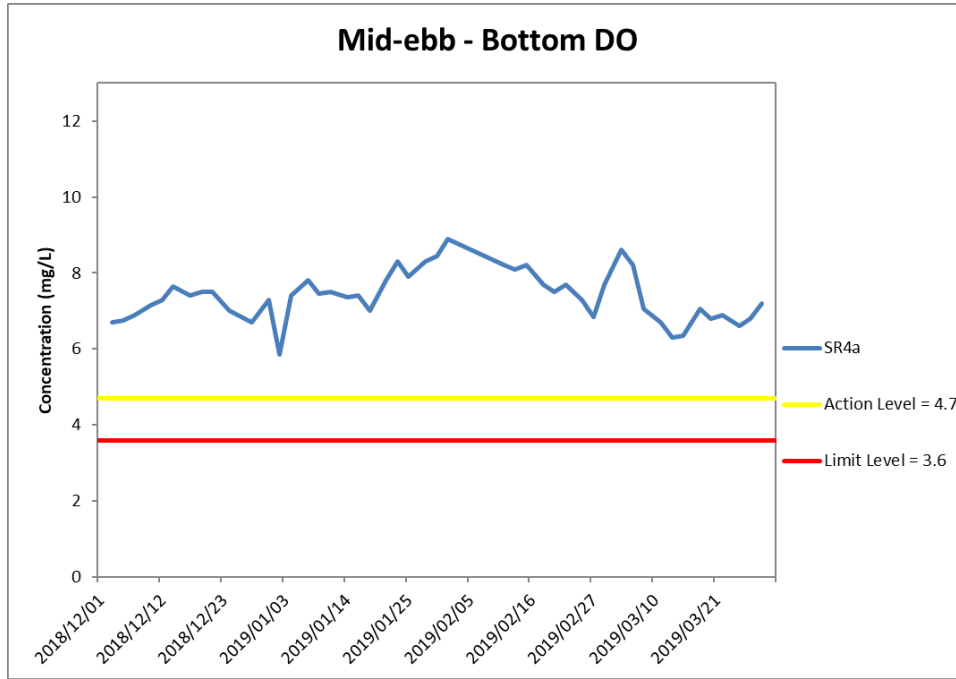
**Figure J16 Impact Monitoring - Mean Level of Dissolved Oxygen (mg/L) in bottom waters during mid-ebb tide between 1 December 2018 and 31 March 2019 at SR4a.**

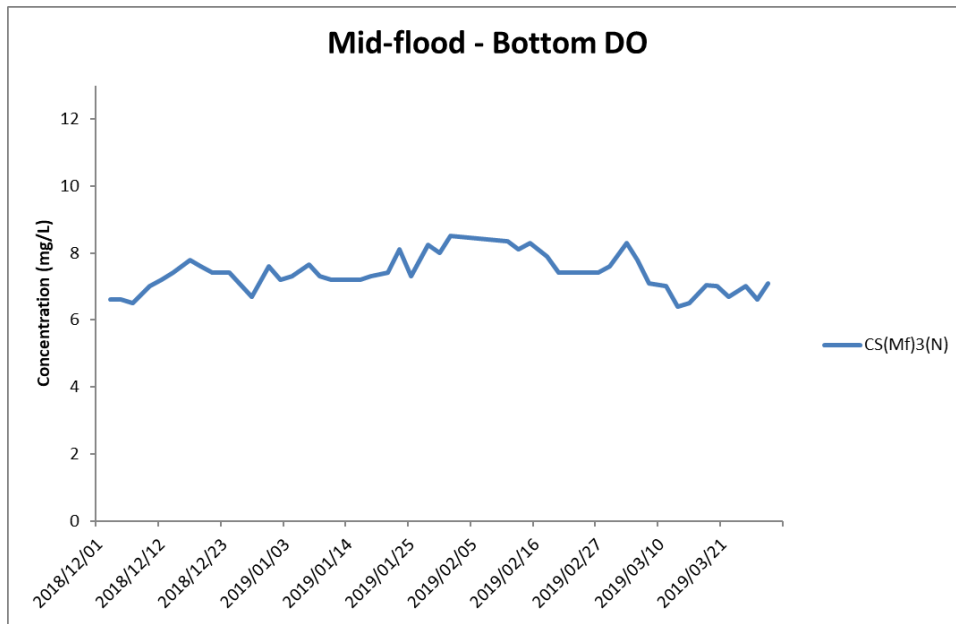
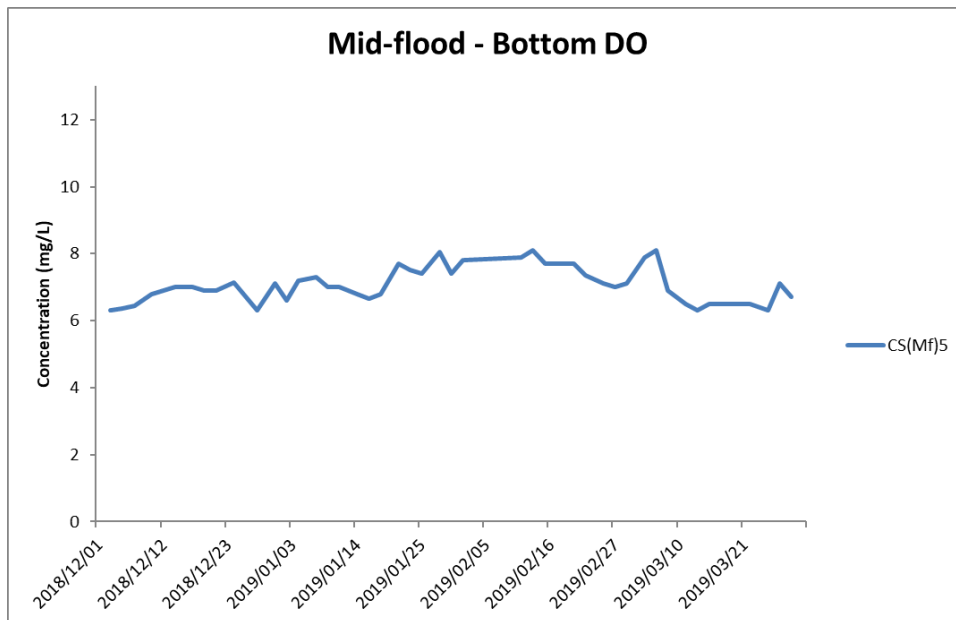
**Figure J17 Impact Monitoring - Mean Level of Dissolved Oxygen (mg/L) in bottom waters during mid-flood tide between 1 December 2018 and 31 March 2019 at CS(Mf)3(N) and CS(Mf)5.**

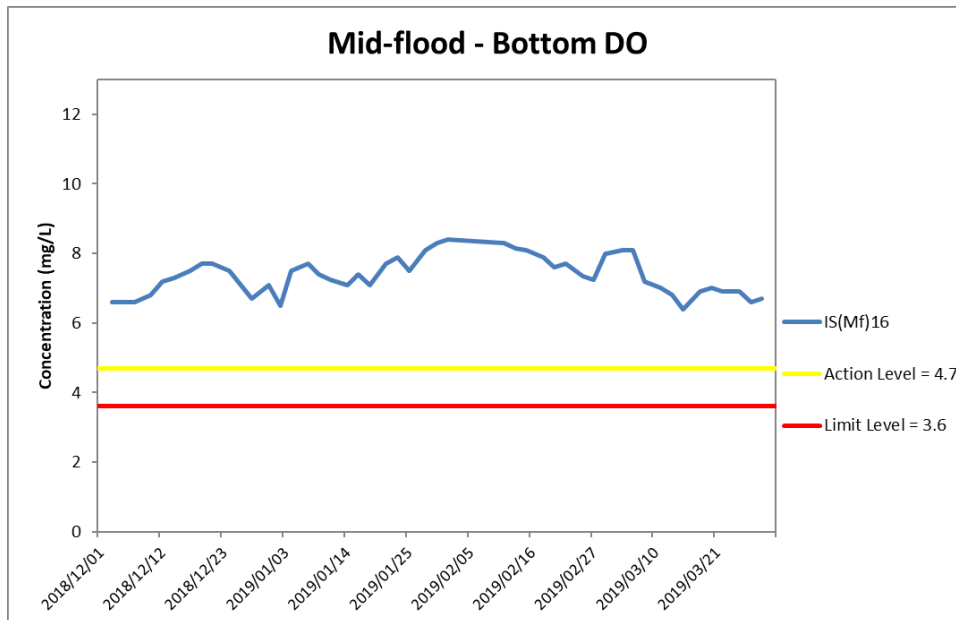
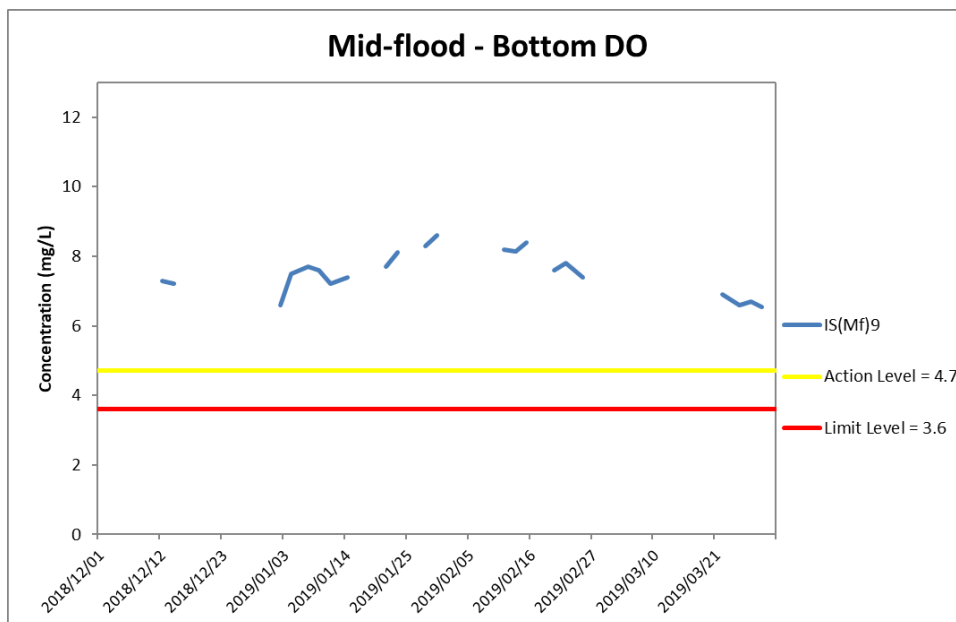
**Figure J18 Impact Monitoring - Mean Level of Dissolved Oxygen (mg/L) in bottom waters during mid-flood tide between 1 December 2018 and 31 March 2019 at IS(Mf)16 and IS(Mf)9.**

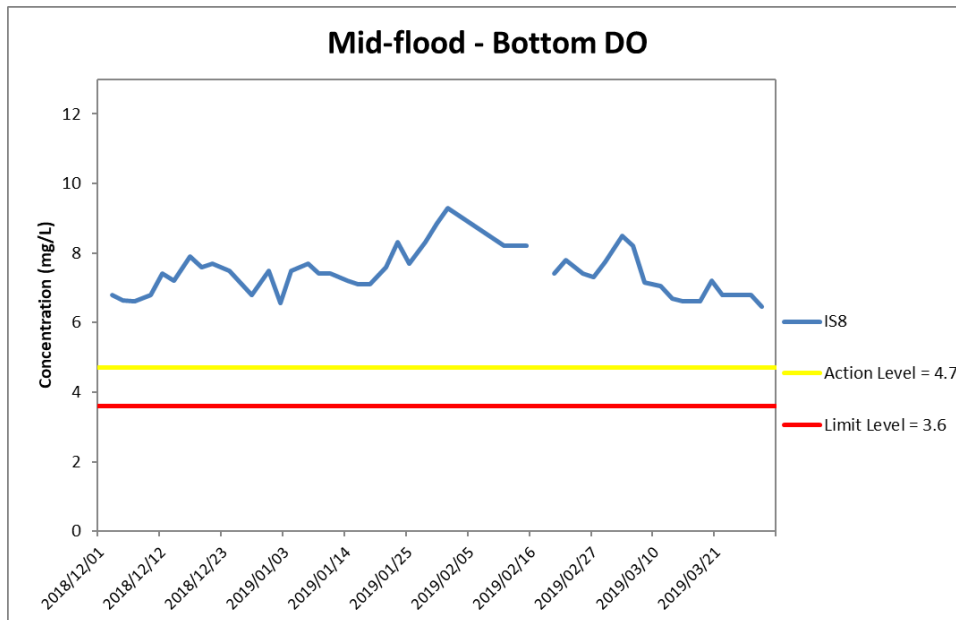
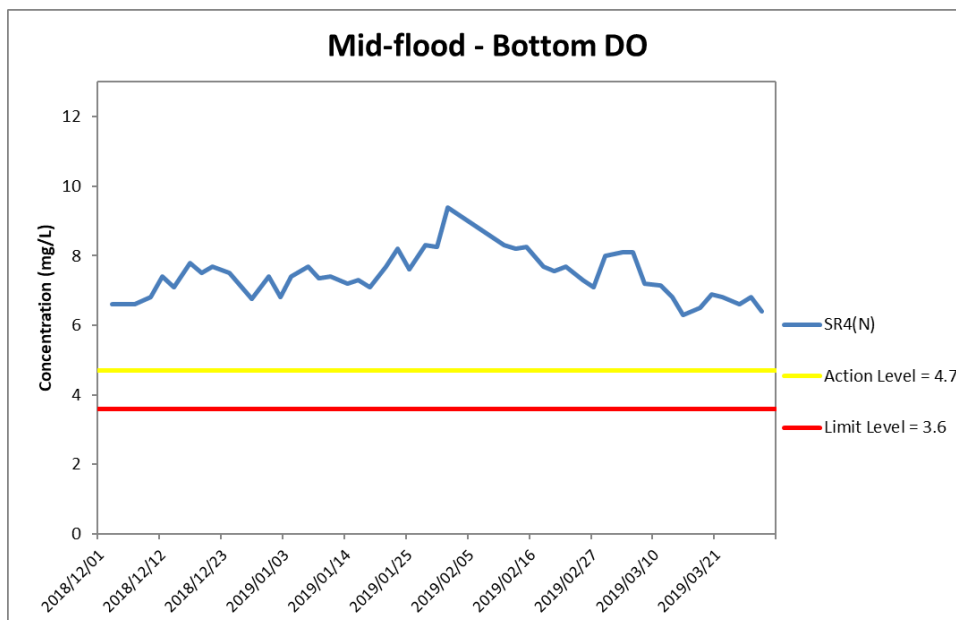
**Figure J19 Impact Monitoring - Mean Level of Dissolved Oxygen (mg/L) in bottom waters during mid-flood tide between 1 December 2018 and 31 March 2019 at IS8 and SR4(N).**

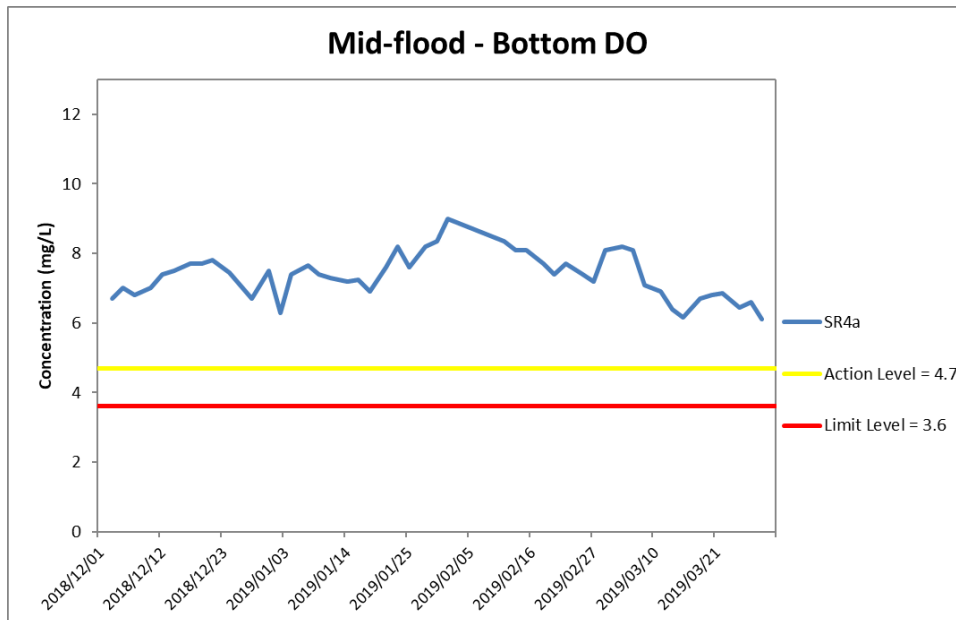
**Figure J20 Impact Monitoring - Mean Level of Dissolved Oxygen (mg/L) in bottom waters during mid-flood tide between 1 December 2018 and 31 March 2019 at SR4a.**

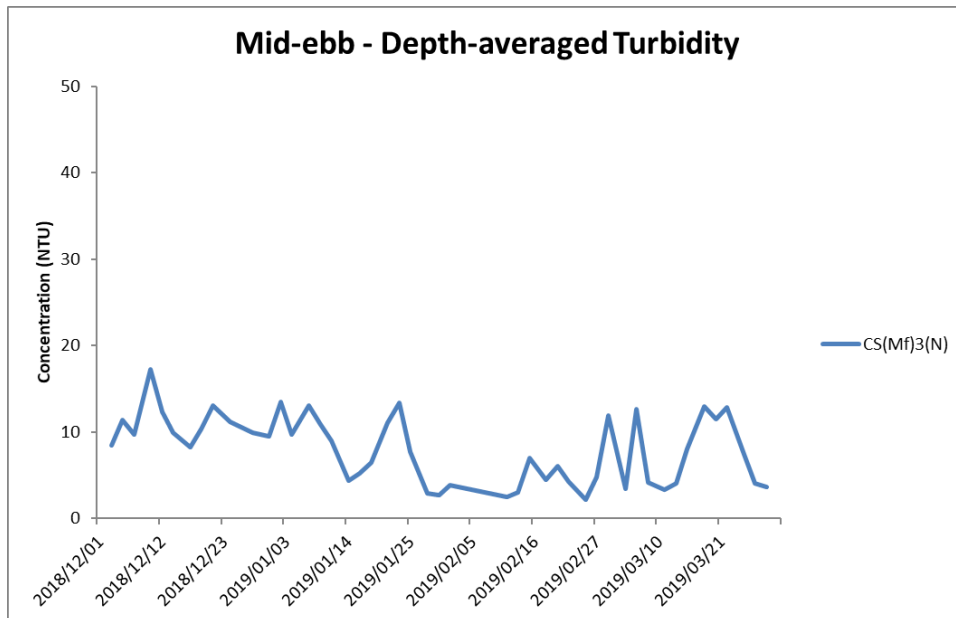
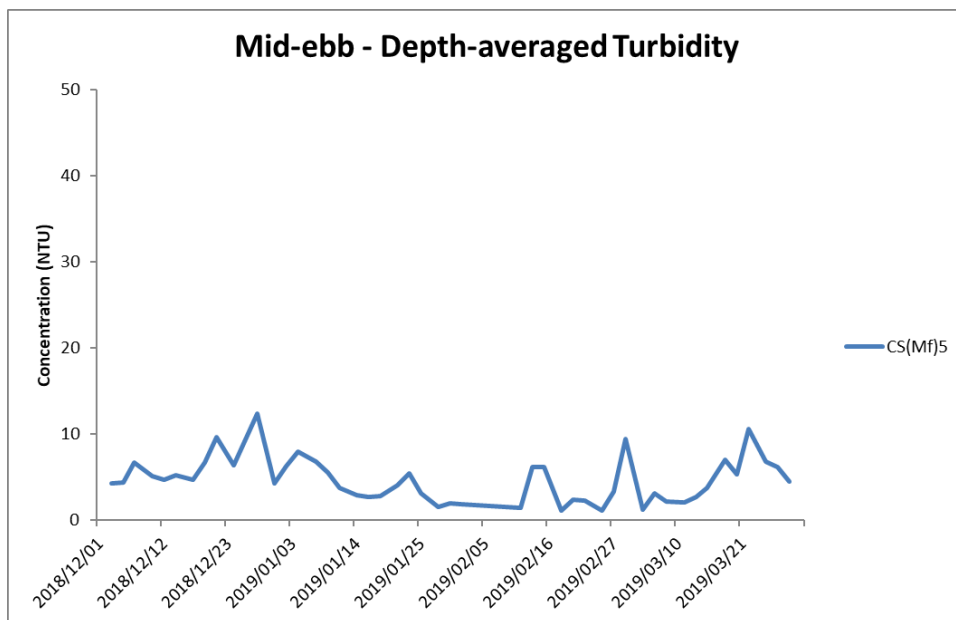
**Figure J21 Impact Monitoring – Mean Level of depth-averaged Turbidity (NTU) during mid-ebb tide between 1 December 2018 and 31 March 2019 at CS(Mf)3(N) and CS(Mf)5.**

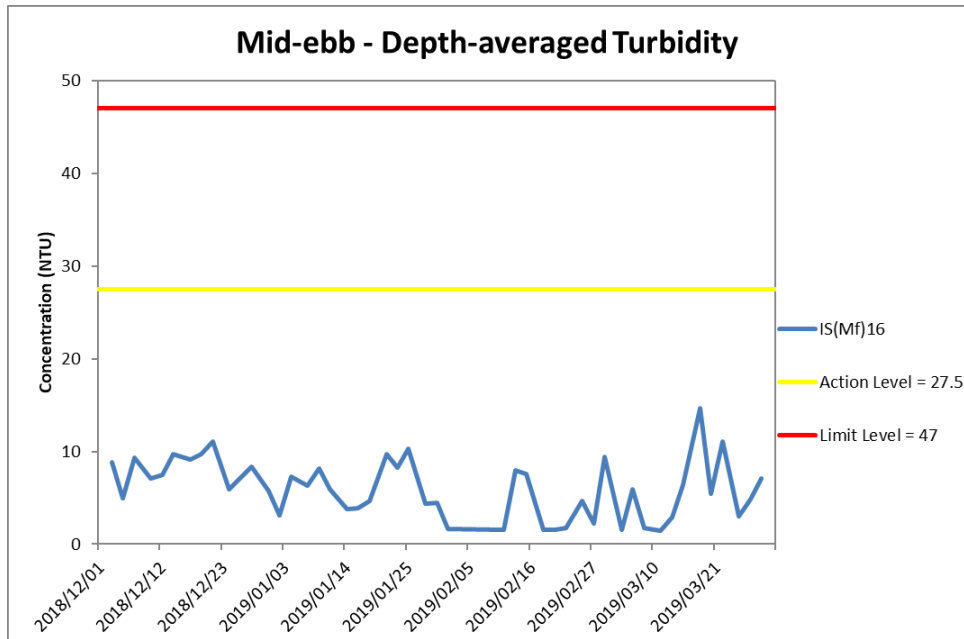
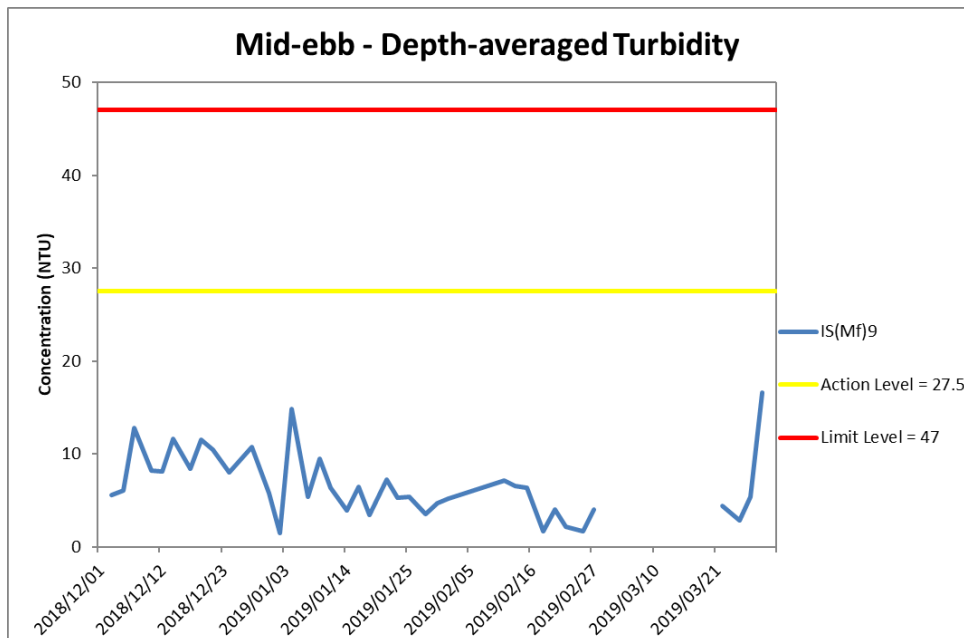
**Figure J22 Impact Monitoring - Mean Level of depth-averaged Turbidity (NTU) during mid-ebb tide between 1 December 2018 and 31 March 2019 at IS(Mf)16 and IS(Mf)9.**

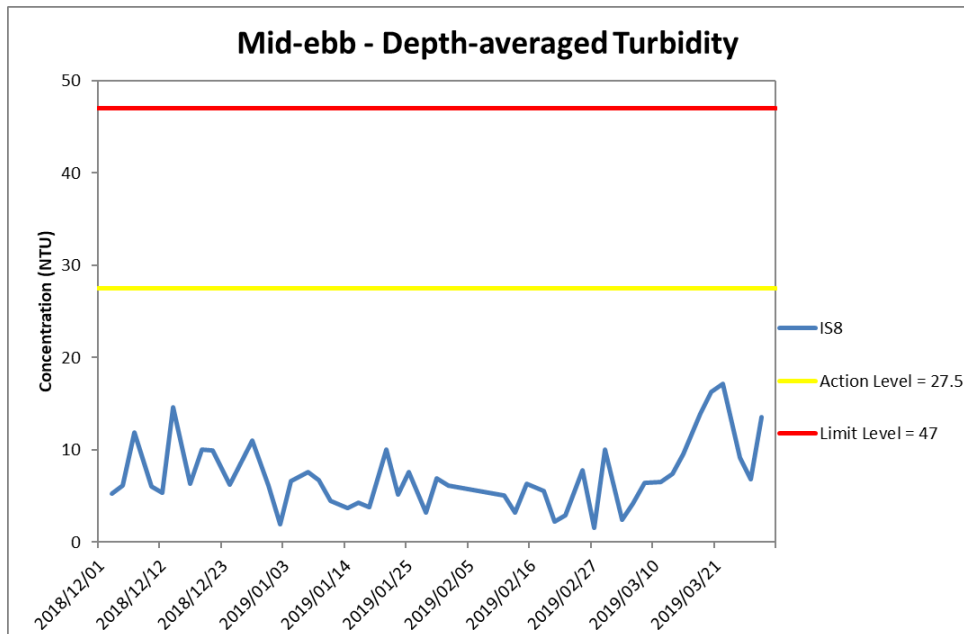
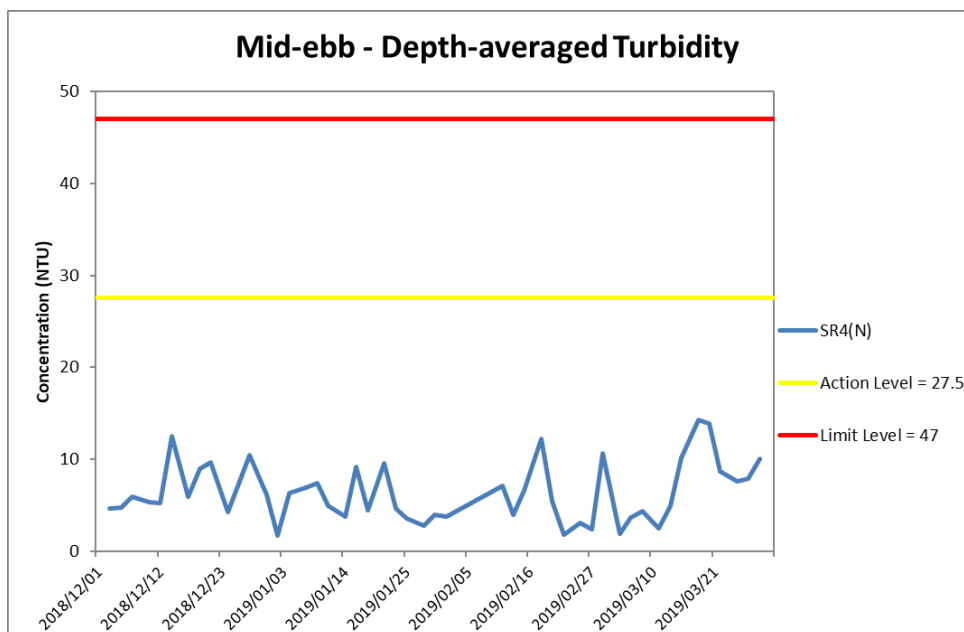
**Figure J23 Impact Monitoring - Mean Level of depth-averaged Turbidity (NTU) during mid-ebb tide between 1 December 2018 and 31 March 2019 at IS8 and SR4(N).**

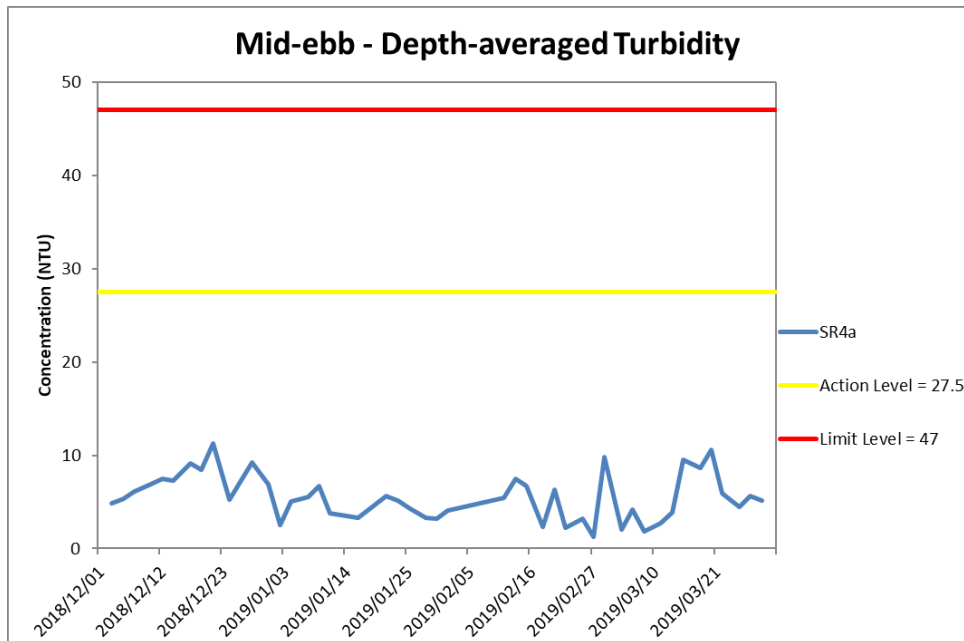
**Figure J24 Impact Monitoring - Mean Level of depth-averaged Turbidity (NTU) during mid-ebb tide between 1 December 2018 and 31 March 2019 at SR4a.**

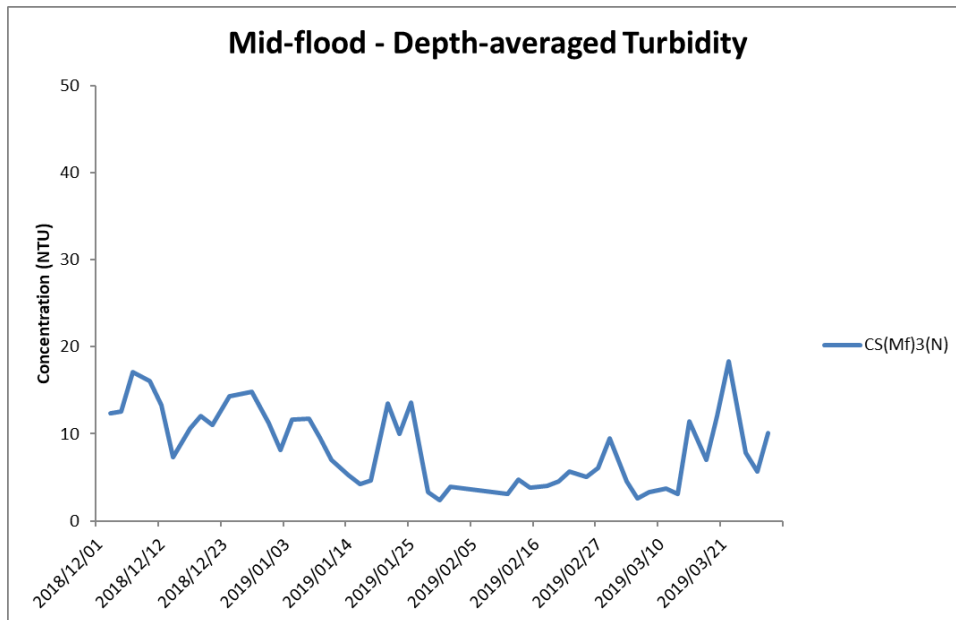
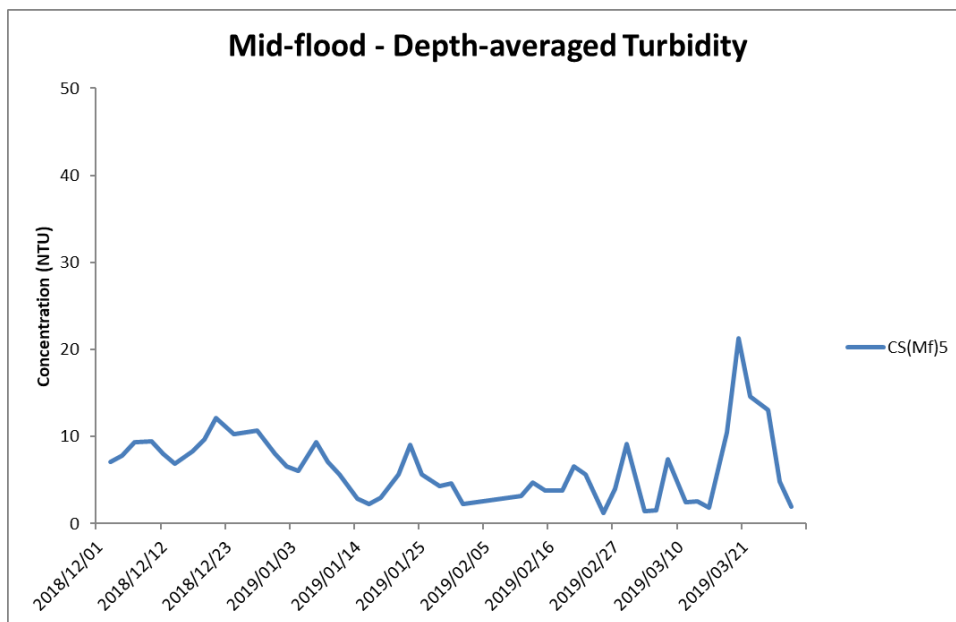
**Figure J25 Impact Monitoring - Mean Level of depth-averaged Turbidity (NTU) during mid-flood tide between 1 December 2018 and 31 March 2019 at CS(Mf)3(N) and CS(MF)5.**

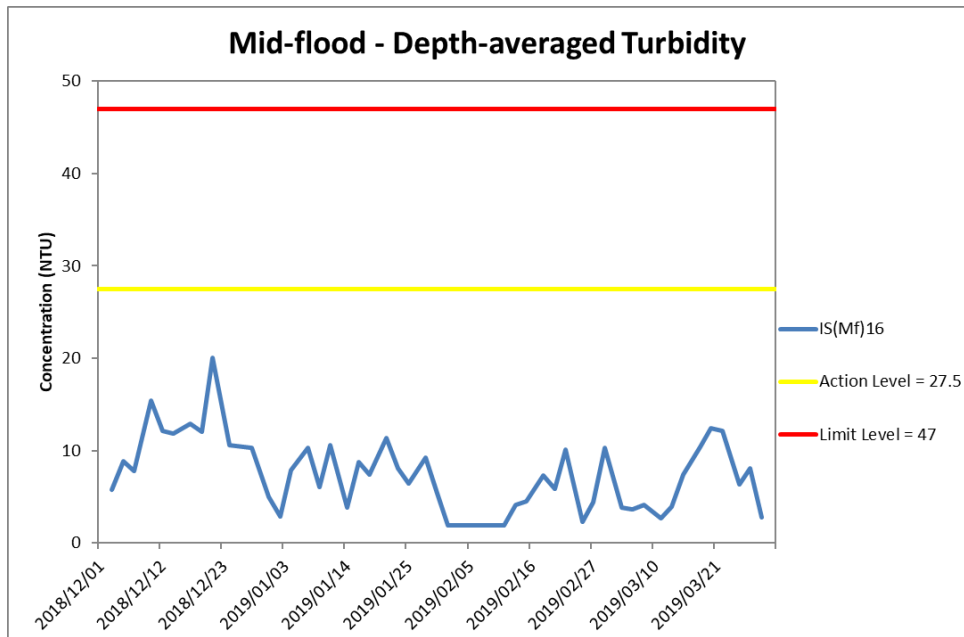
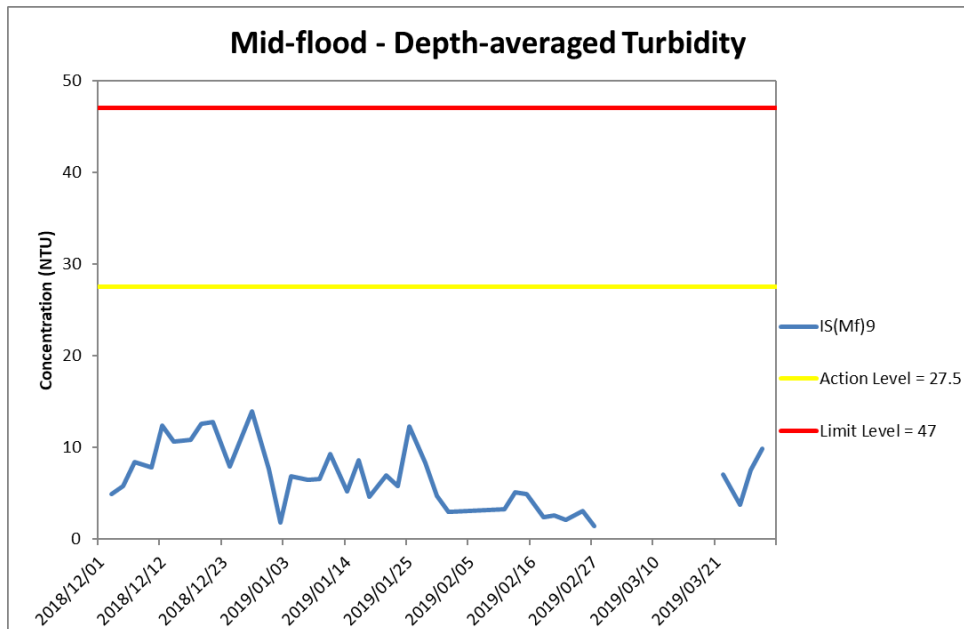
**Figure J26 Impact Monitoring – Mean Level of depth-averaged Turbidity (NTU) during mid-flood tide between 1 December 2018 and 31 March 2019 at IS(Mf)16 and IS(Mf)9.**

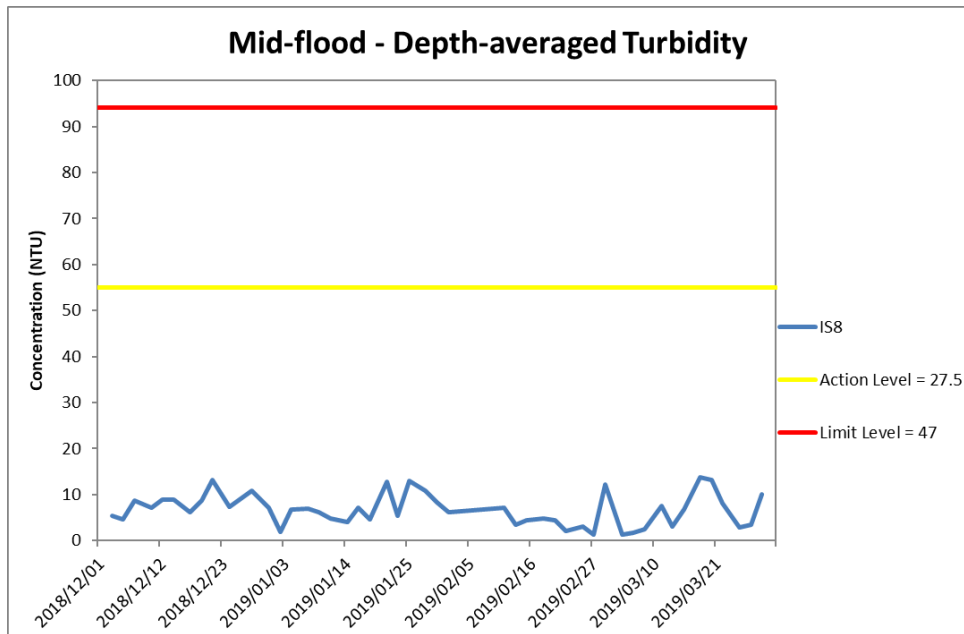
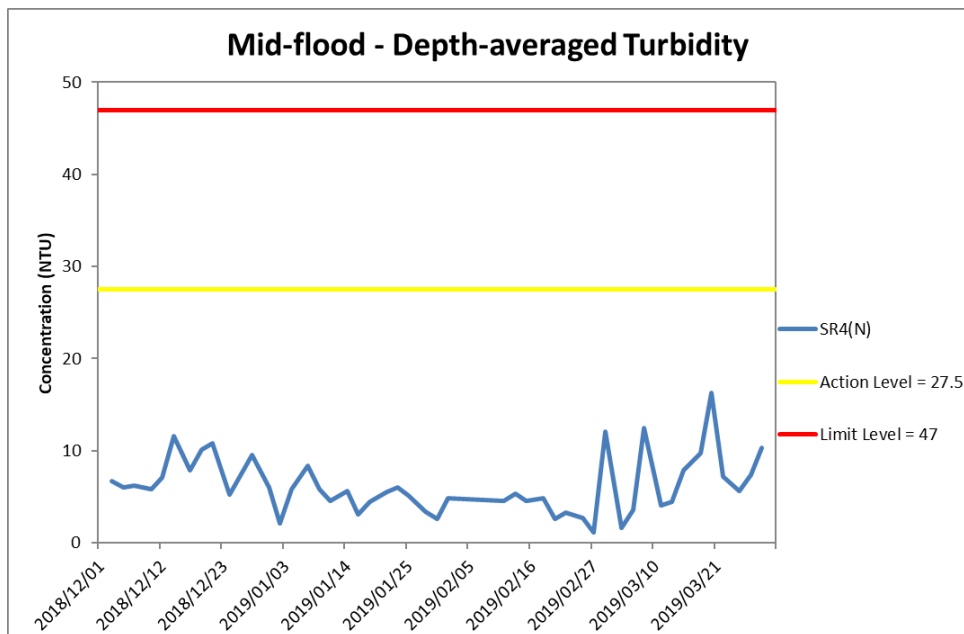
**Figure J27 Impact Monitoring – Mean Level of depth-averaged Turbidity (NTU) during mid-flood tide between 1 December 2018 and 31 March 2019 at IS8 and SR4(N).**

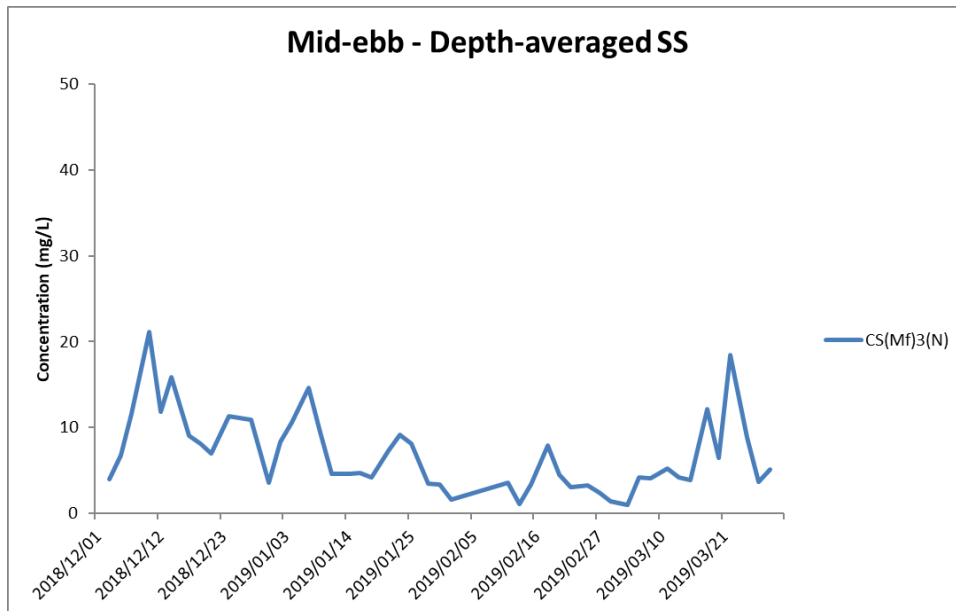
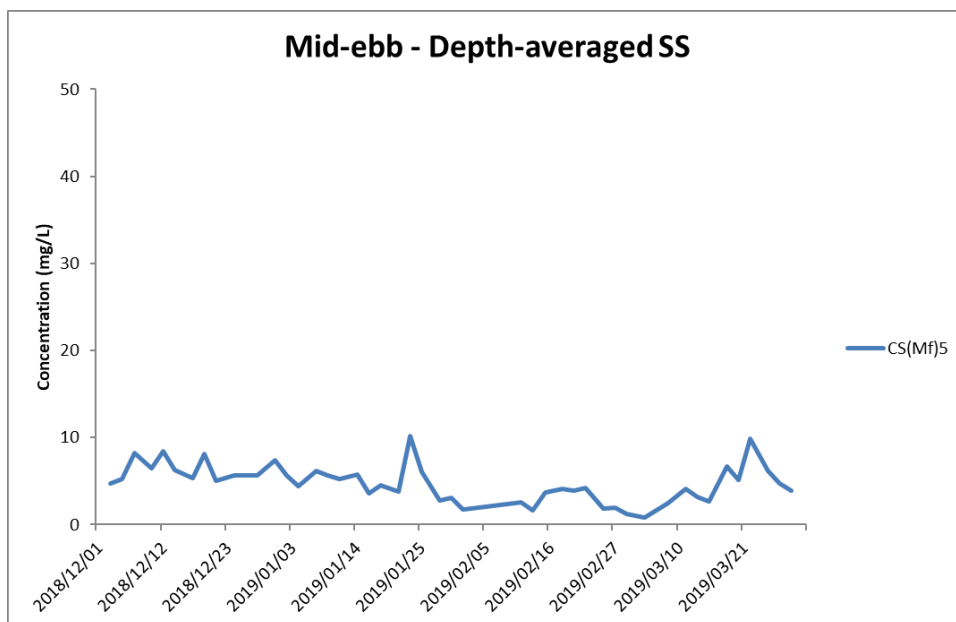
**Figure J29 Impact Monitoring – Mean depth-averaged level of Suspended Solids (mg/L) during mid-ebb tide between 1 December 2018 and 31 March 2019 at CS(Mf)3(N) and CS(Mf)5.**

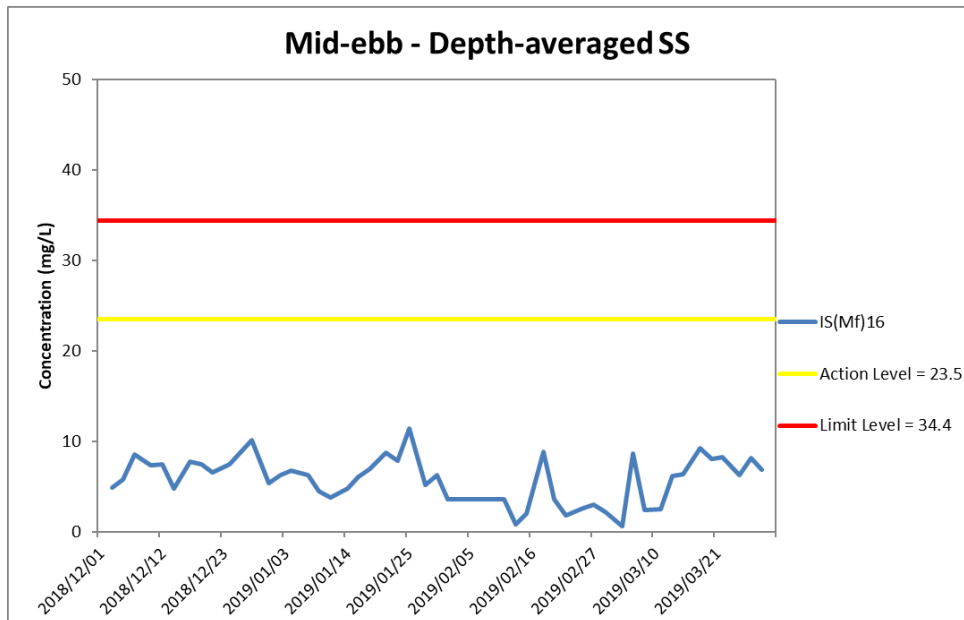
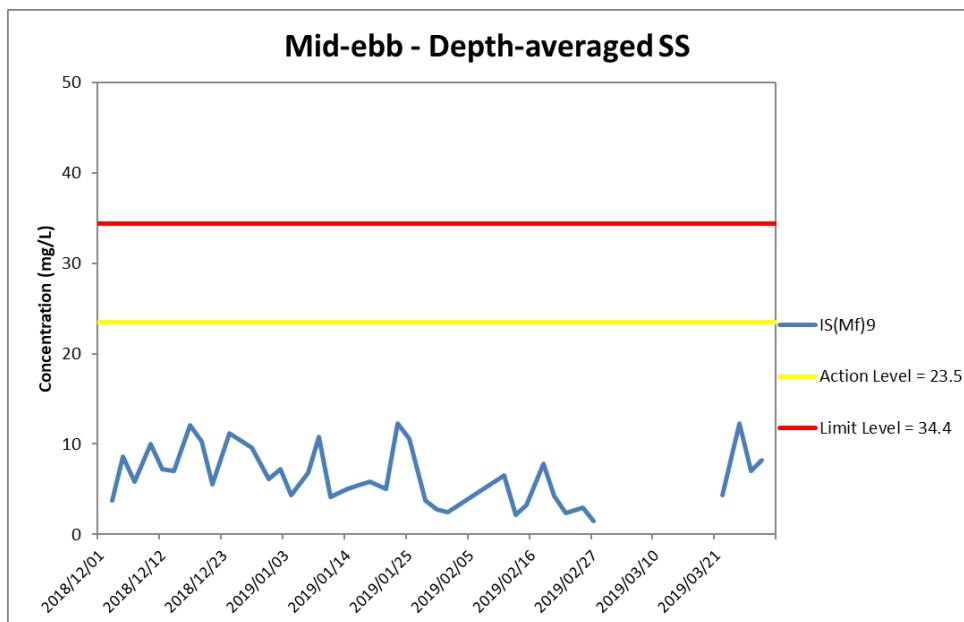
**Figure J30 Impact Monitoring - Mean depth-averaged level of Suspended Solids (mg/L) during mid-ebb tide between 1 December 2018 and 31 March 2019 at IS(Mf)16 and IS(Mf)9.**

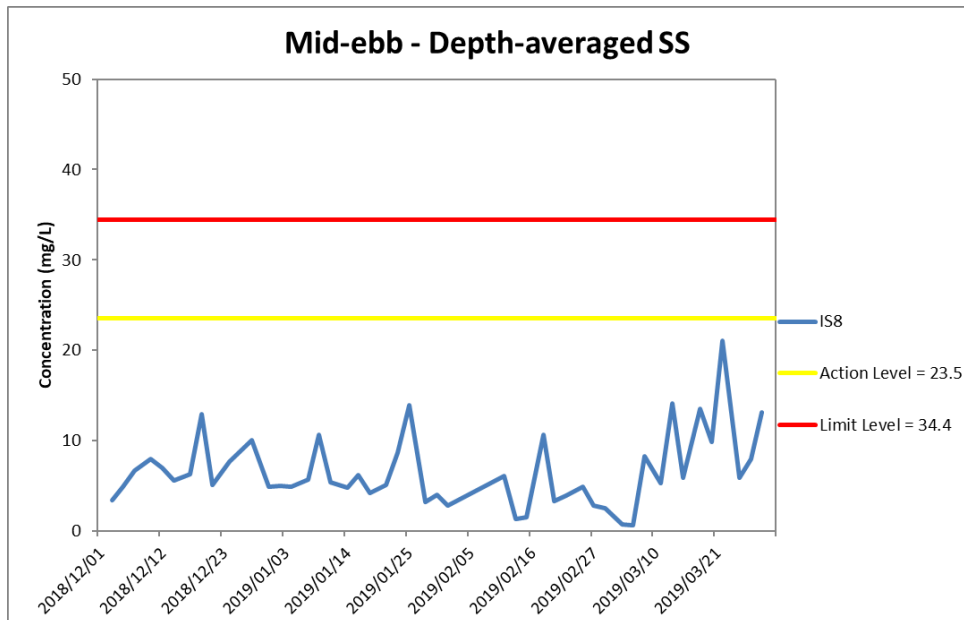
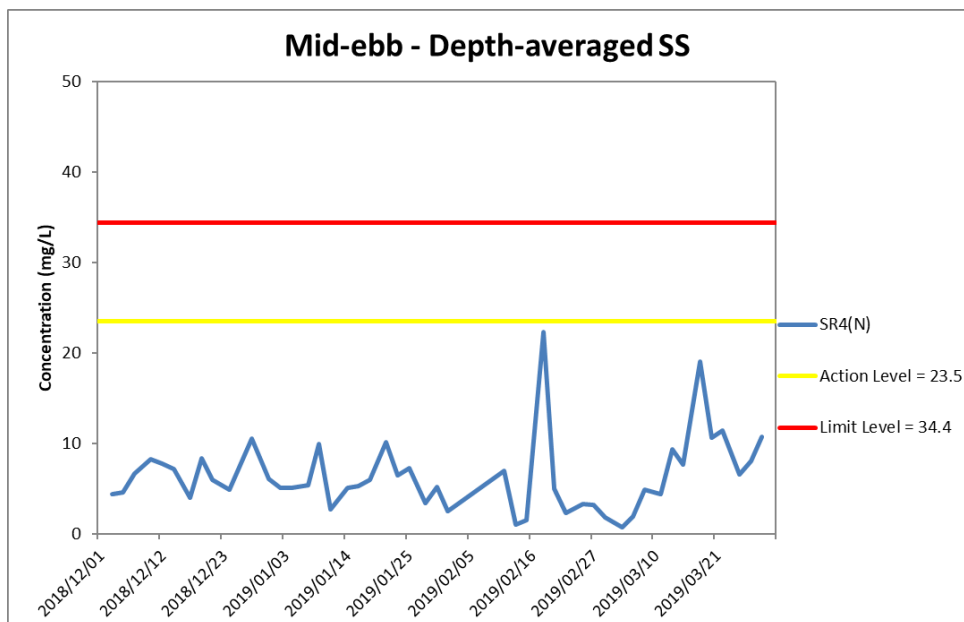
**Figure J31 Impact Monitoring - Mean depth-averaged level of Suspended Solids (mg/L) during mid-ebb tide between 1 December 2018 and 31 March 2019 at IS8 and SR4(N).**
