**Contract No. HY/2012/07  
Tuen Mun – Chek Lap Kok Link –  
Southern Connection Viaduct Section**

*Sixty-fifth Monthly EM&A Report*

12 April 2019

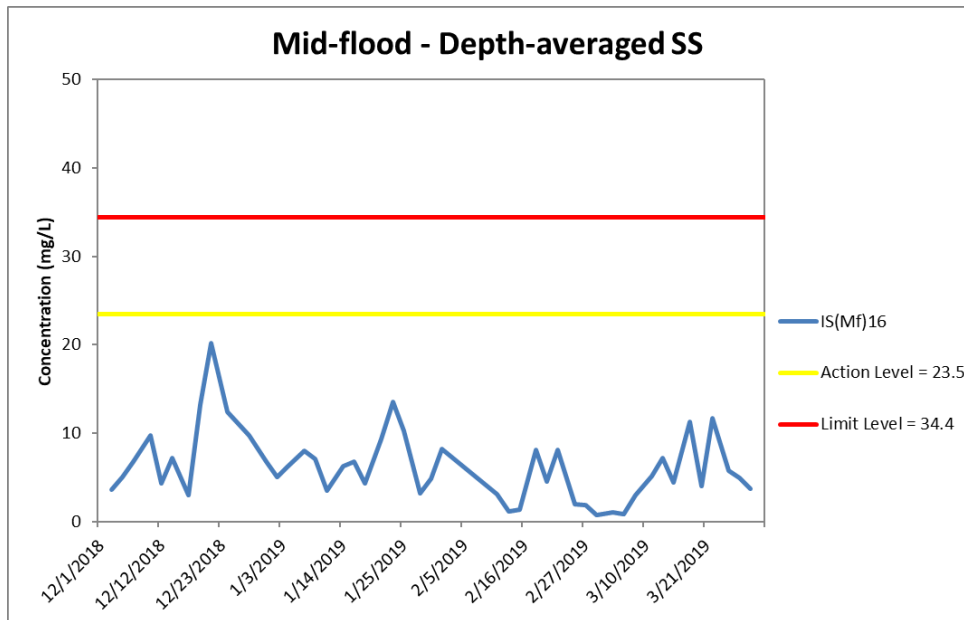
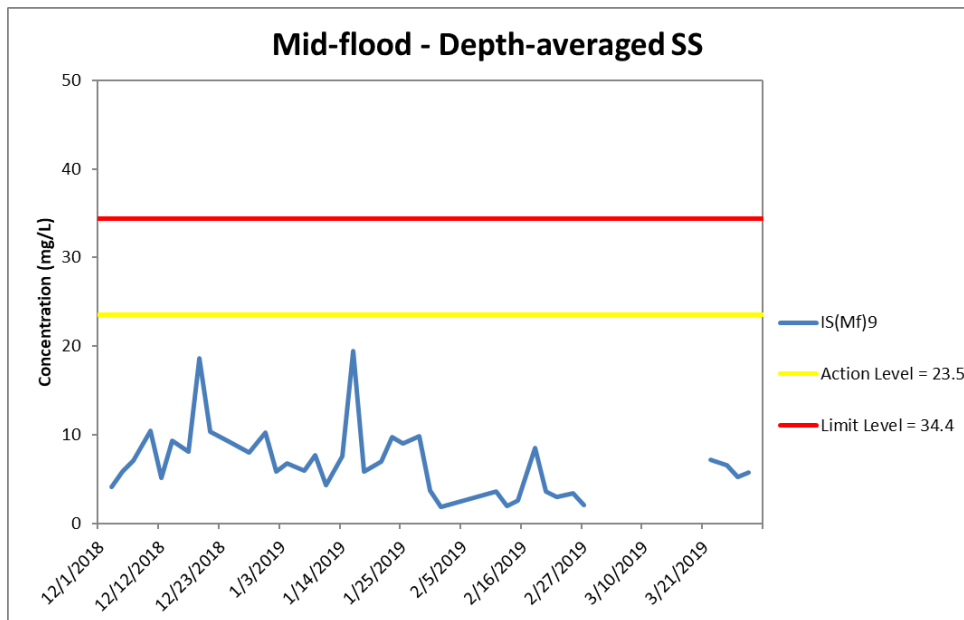
**Figure J34 Impact Monitoring - Mean depth-averaged level of Suspended Solids (mg/L) during mid-flood tide between 1 December 2018 and 31 March 2019 at IS(Mf)16 and IS(Mf)9.**

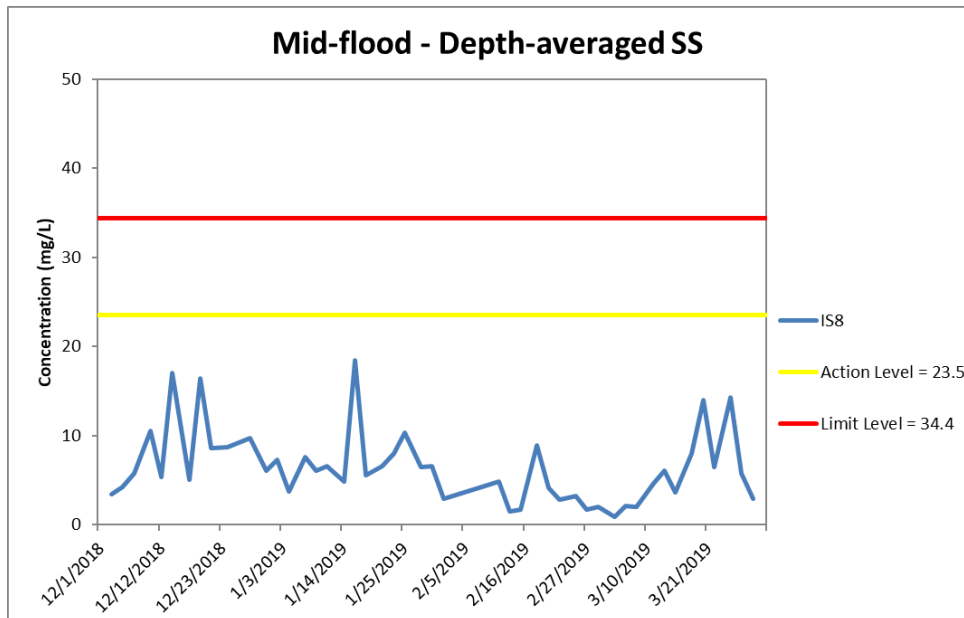
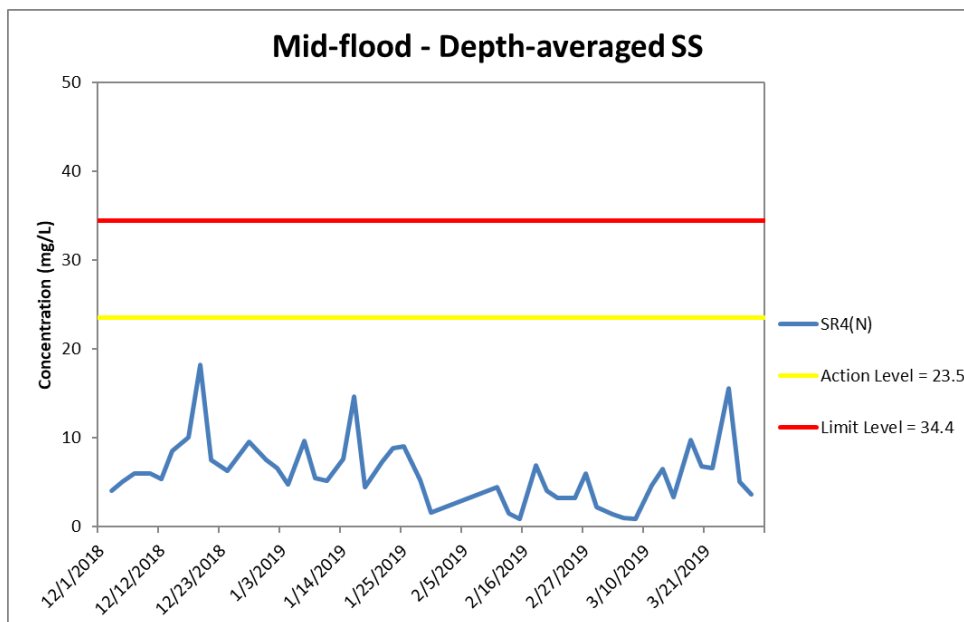
**Figure J35 Impact Monitoring - Mean depth-averaged level of Suspended Solids (mg/L) during mid-flood tide between 1 December 2018 and 31 March 2019 at IS8 and SR4(N).**

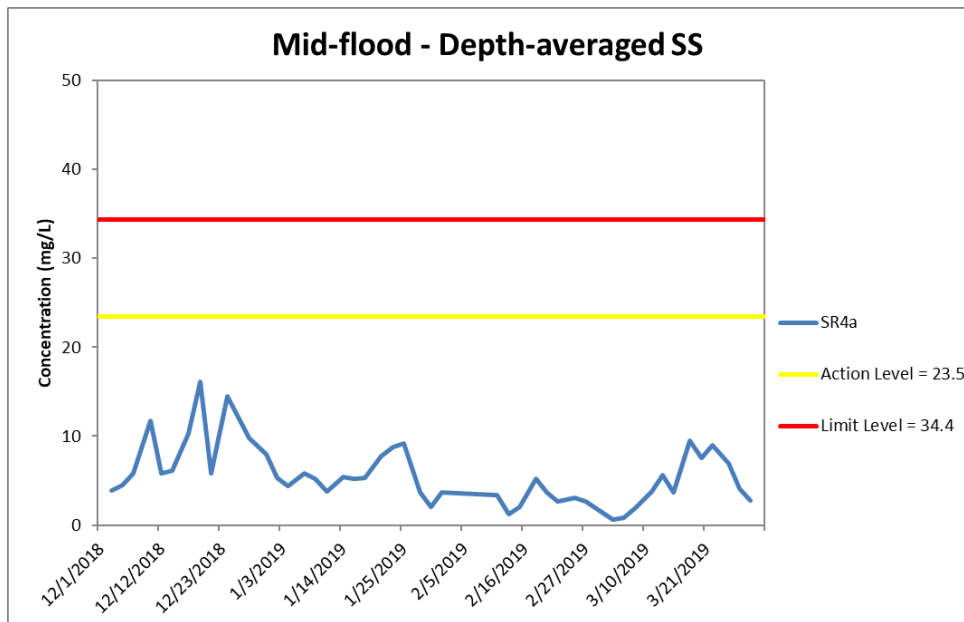
**Figure J36 Impact Monitoring - Mean depth-averaged level of Suspended Solids (mg/L) during mid-flood tide between 1 December 2018 and 31 March 2019 at SR4a.**
