**Contract No. HY/2012/07
Tuen Mun – Chek Lap Kok Link –
Southern Connection Viaduct Section**

Sixty-Sixth Monthly EM&A Report

15 May 2019

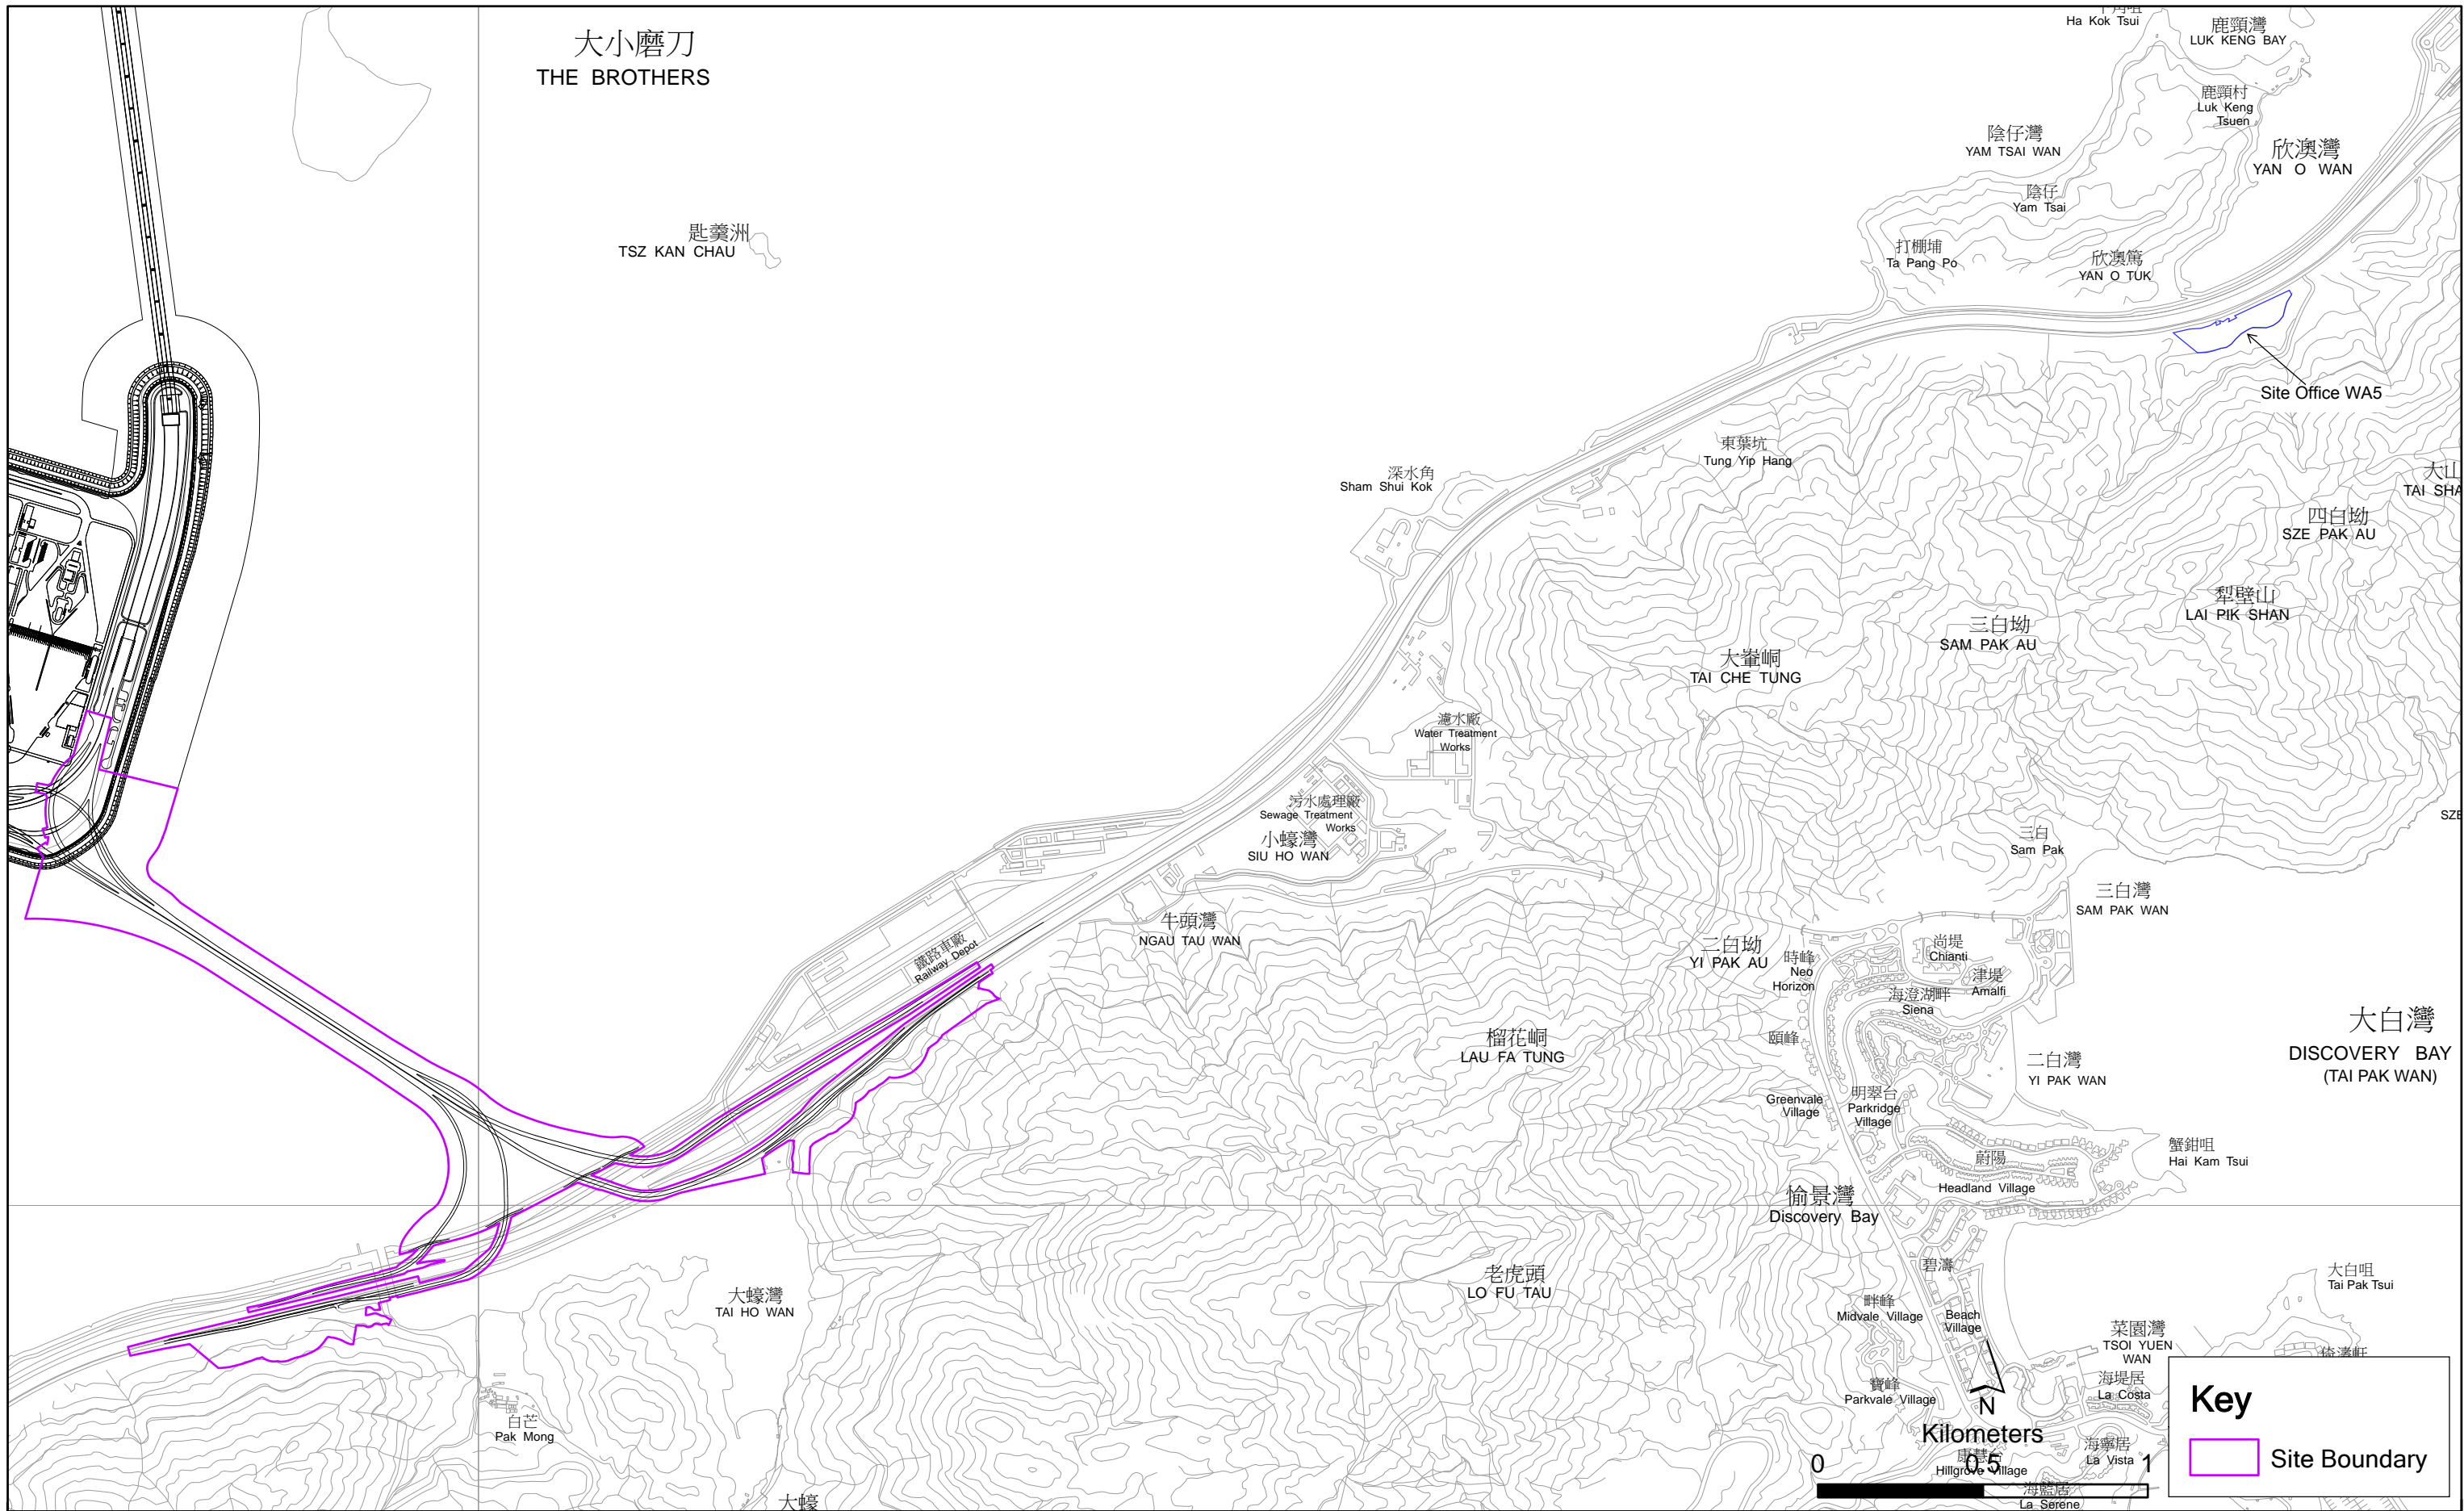
Figure 1.1

General Layout Plan of the Project
