**Contract No. HY/2012/07  
Tuen Mun – Chek Lap Kok Link –  
Southern Connection Viaduct Section**

*Sixty-Seventh Monthly EM&A Report*

14 June 2019

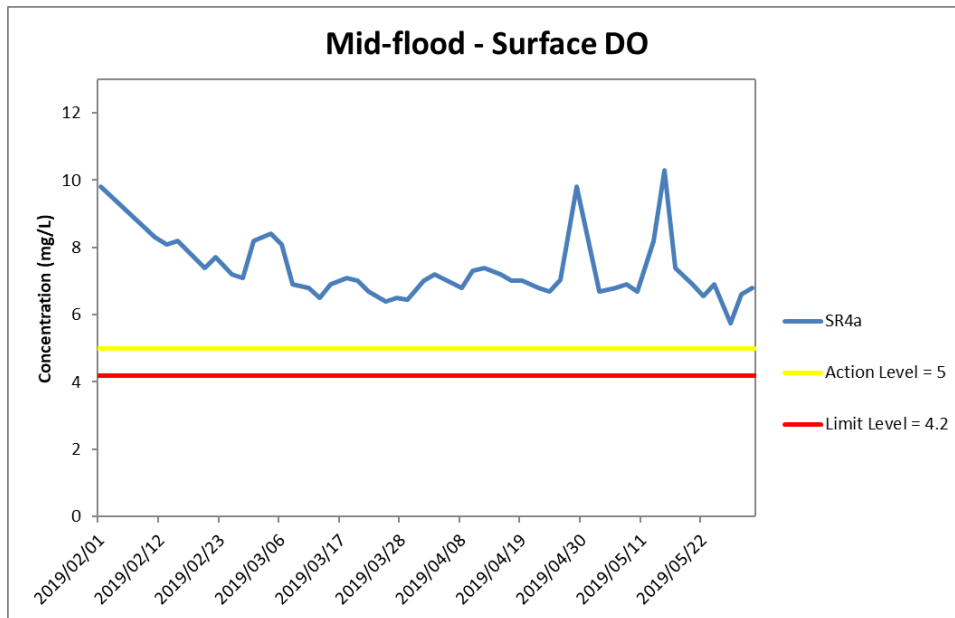
**Figure J8 Impact Monitoring - Mean Level of Dissolved Oxygen (mg/L) in surface waters during mid-flood tide between 1 February and 31 May 2019 at SR4a.**

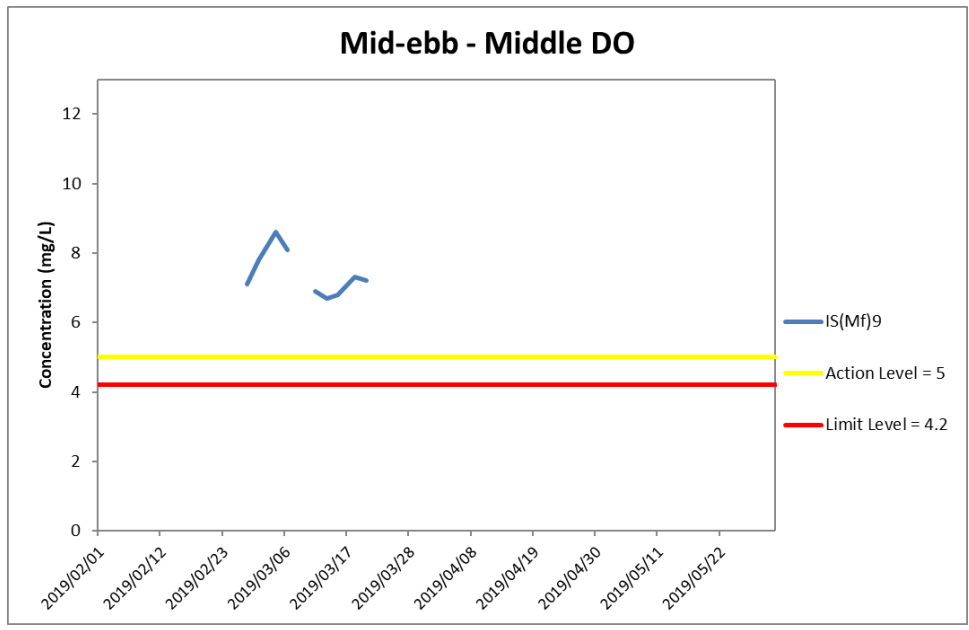
**Figure J10 Impact Monitoring – Mean Level of Dissolved Oxygen (mg/L) in mid-depth waters during mid-ebb tide between 1 February and 31 May 2019 at IS(Mf)9.**

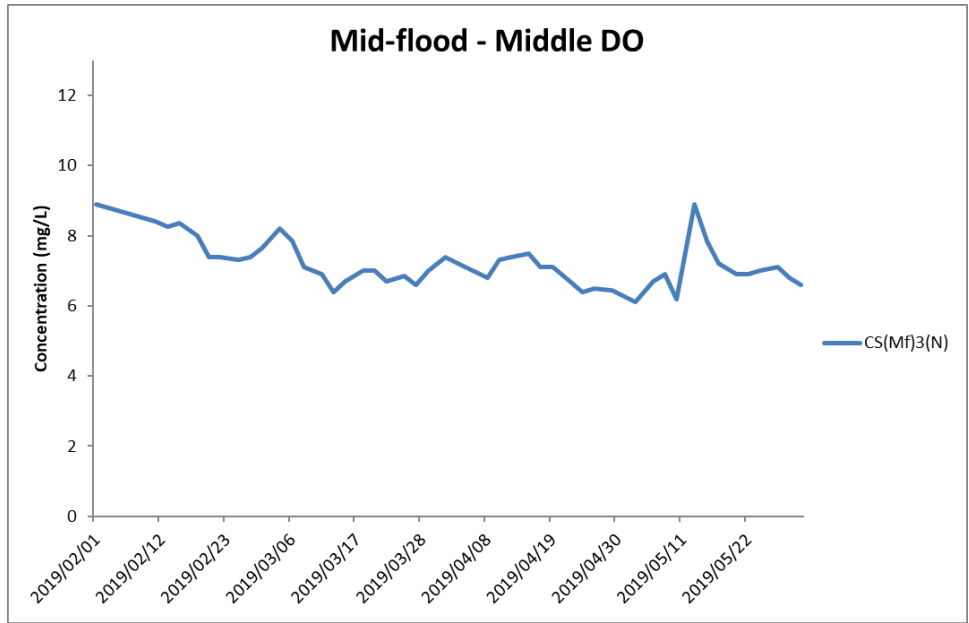
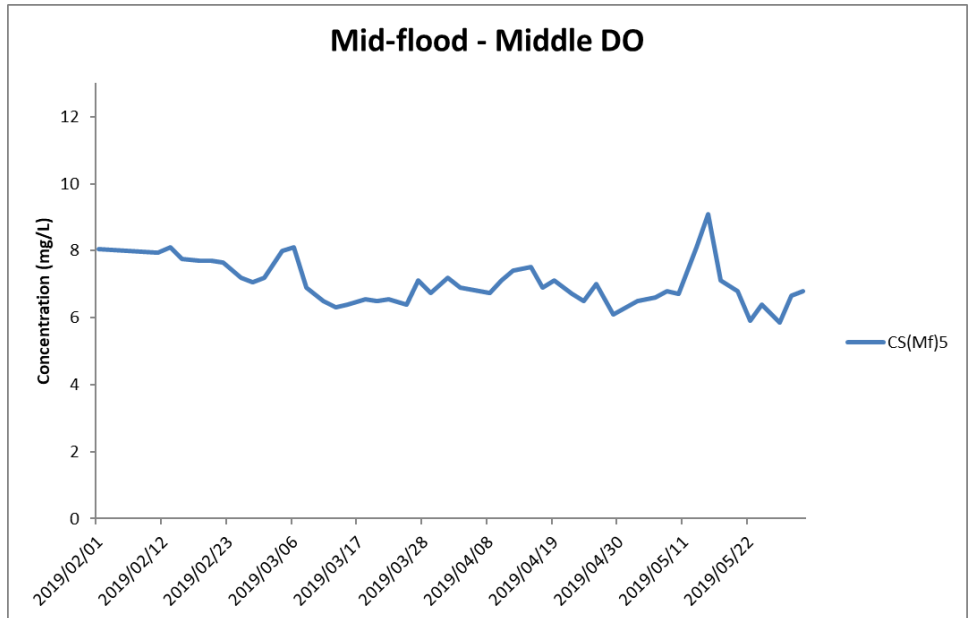
**Figure J11 Impact Monitoring – Mean Level of Dissolved Oxygen (mg/L) in mid-depth waters during mid-flood tide between 1 February and 31 May 2019 at CS(Mf)3(N) and CS(Mf)5.**

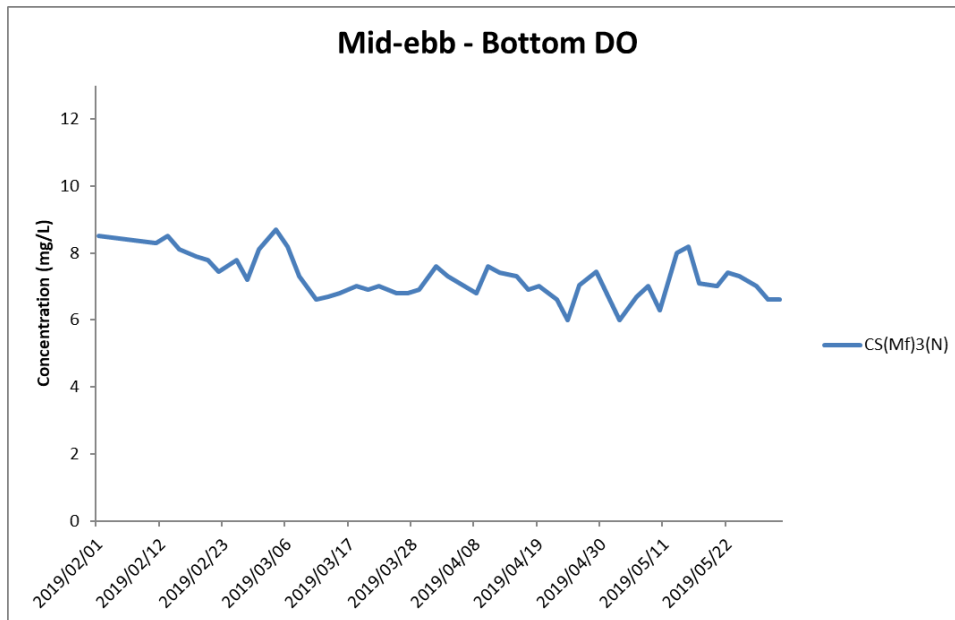
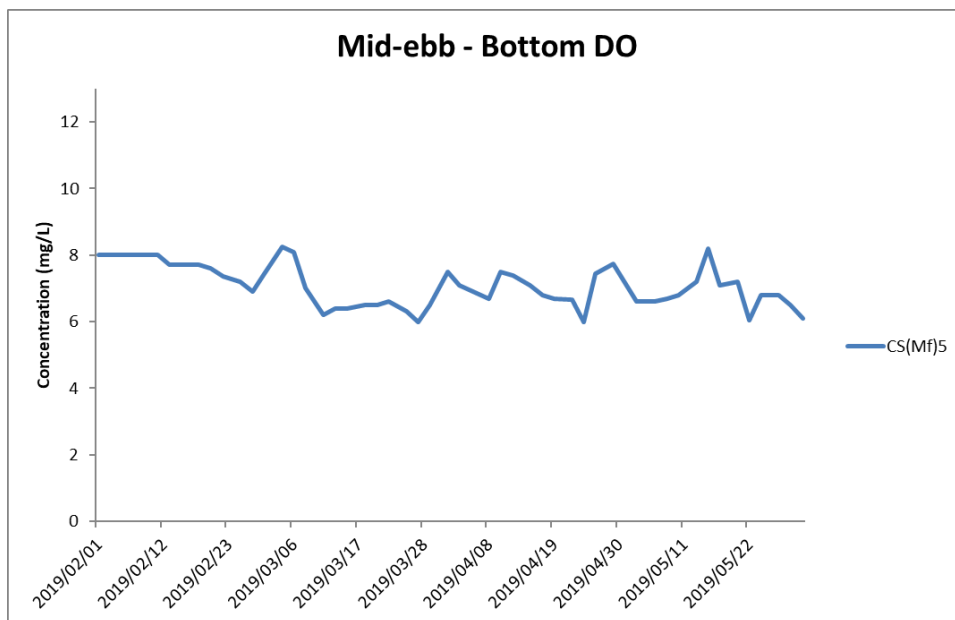
**Figure J13 Impact Monitoring – Mean Level of Dissolved Oxygen (mg/L) in bottom waters during mid-ebb tide between 1 February and 31 May 2019 at CS(Mf)3(N) and CS(Mf)5.**

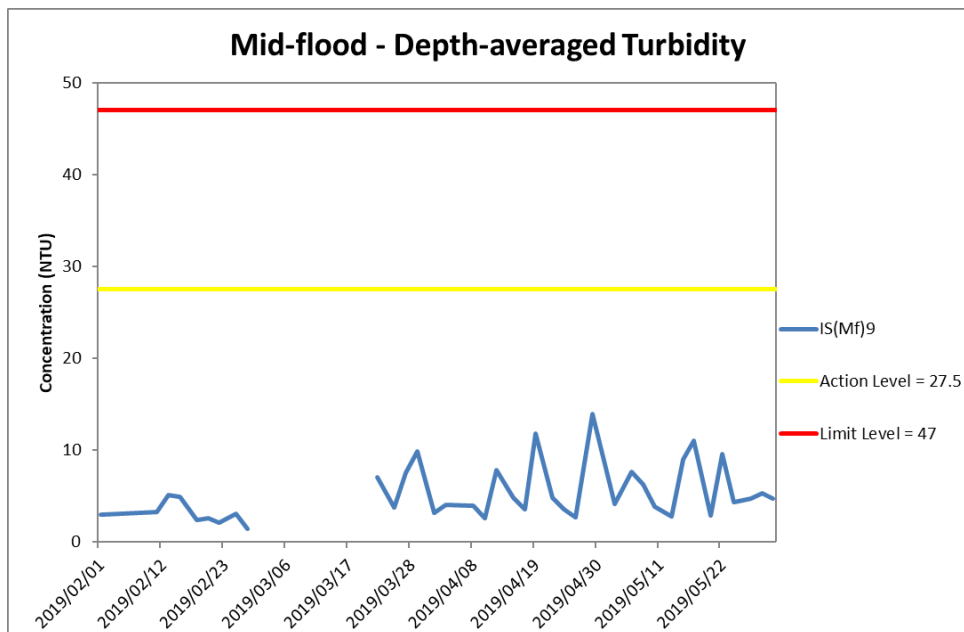
**Figure J26 Impact Monitoring – Mean Level of depth-averaged Turbidity (NTU) during mid-flood tide between 1 February and 31 May 2019 at IS(Mf)16 and IS(Mf)9.**

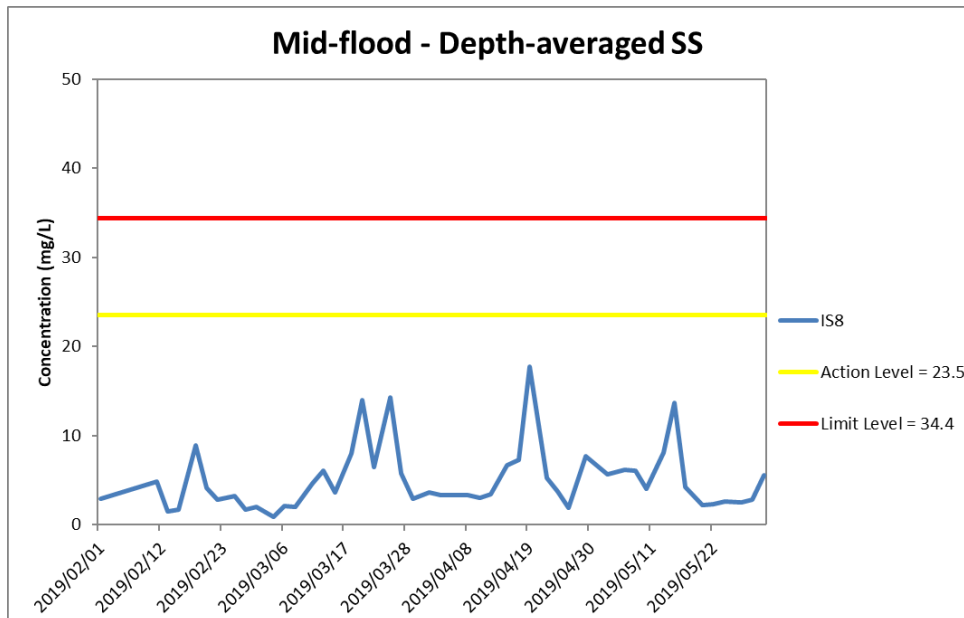
**Figure J35 Impact Monitoring - Mean depth-averaged level of Suspended Solids (mg/L) during mid-flood tide between 1 February and 31 May 2019 at IS8 and SR4(N).**
