**Agreement No. CE 67/2015 (HY)
Cycle Tracks from Tuen Mun
to Sheung Shui – Remaining Works
Design and Construction**

**Monthly EM&A Report
(Version 1.0)**

January 2017

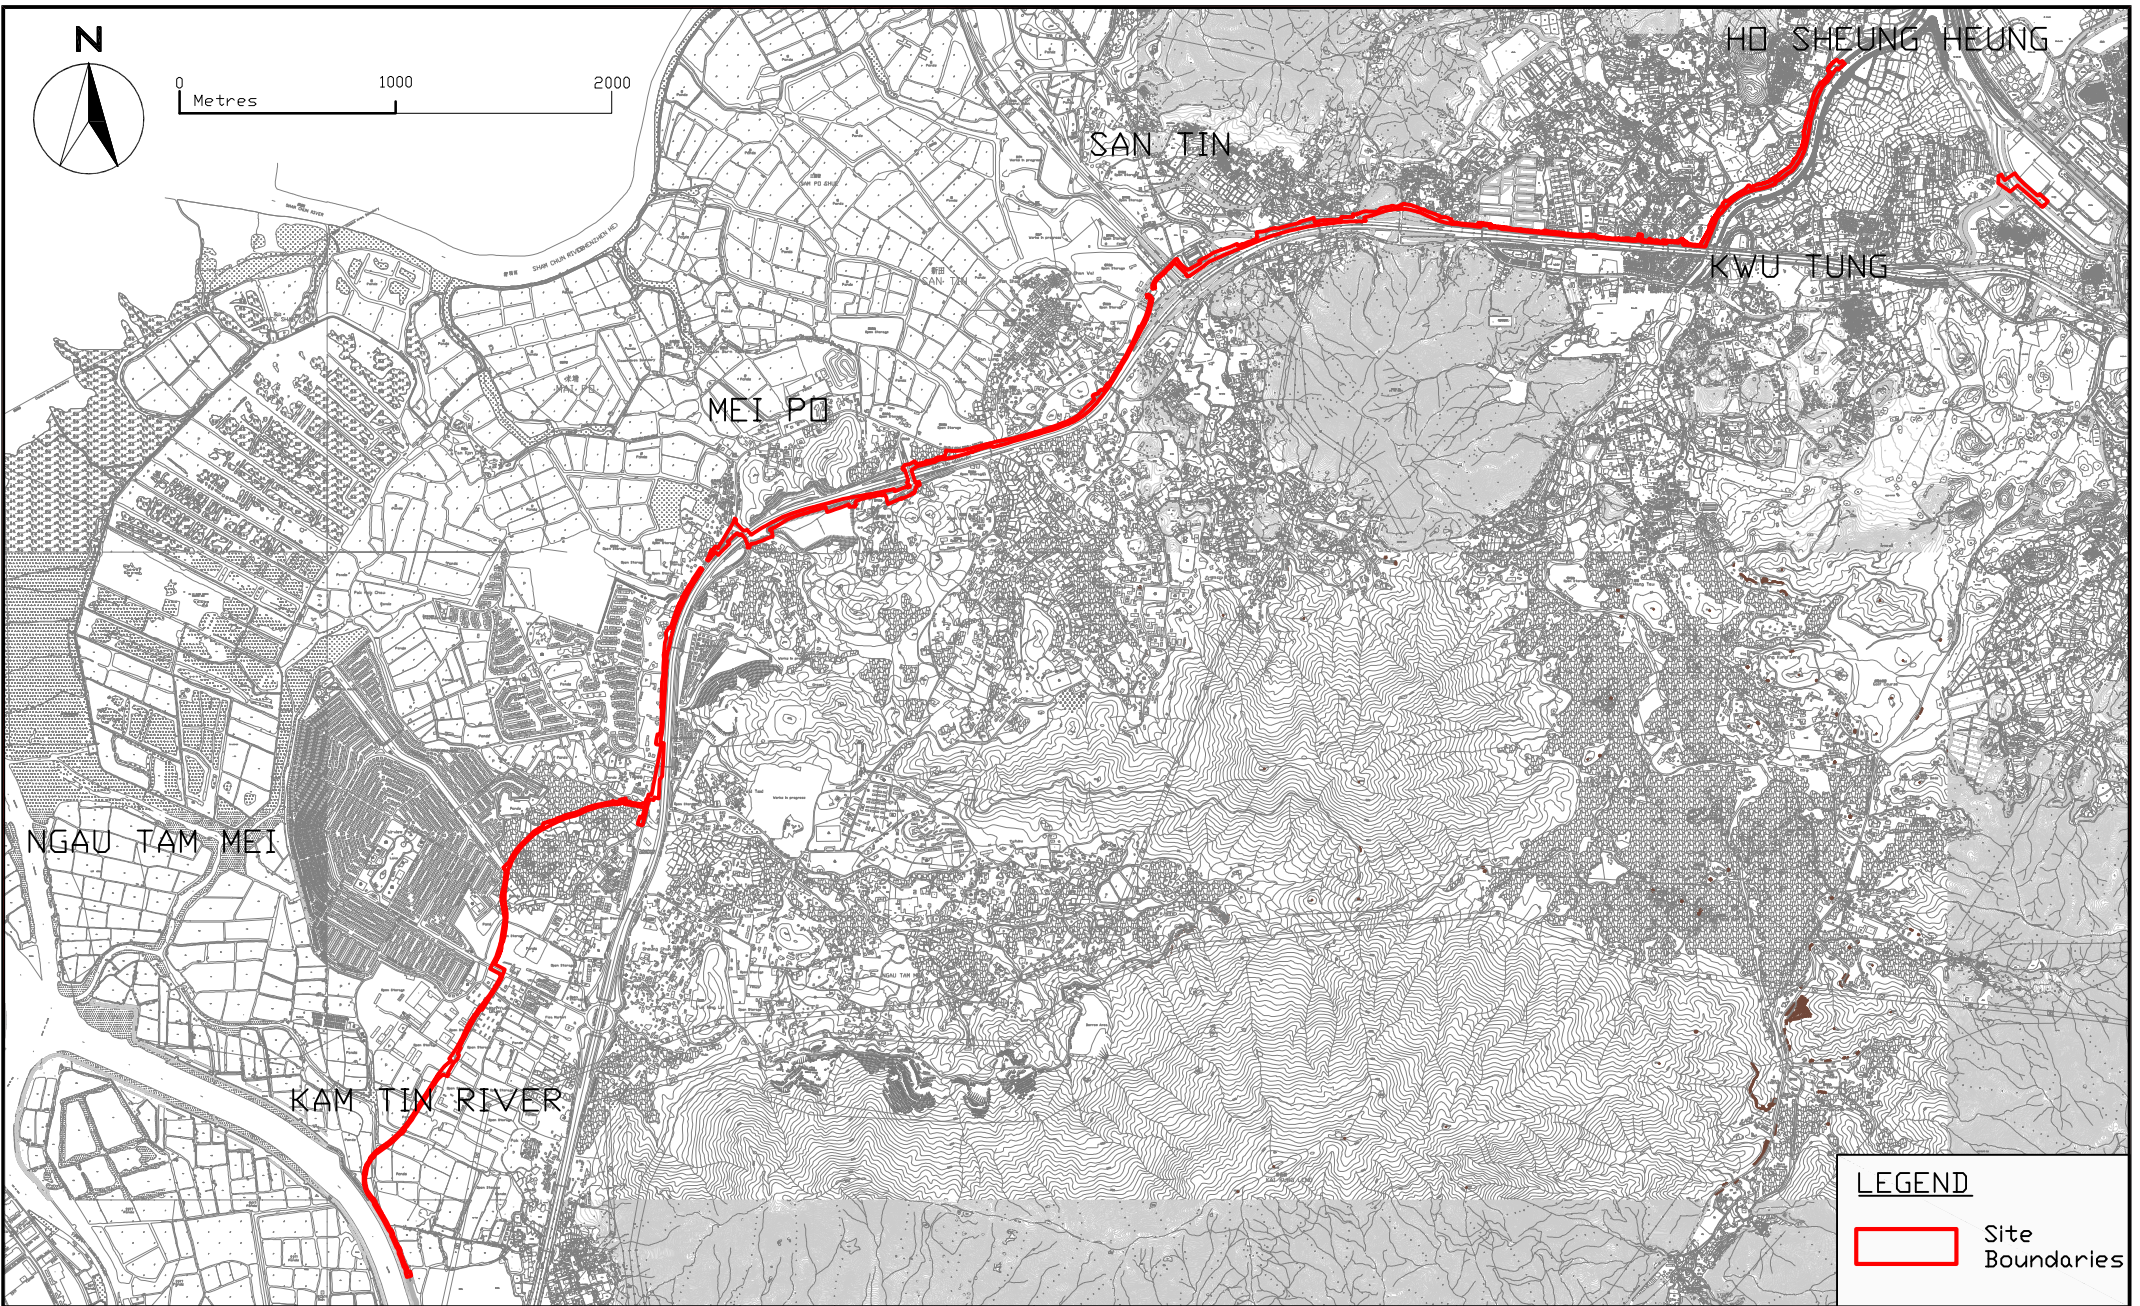
SCALE	A4 1:35m	DATE	Aug 2016
CHECK	JL	DRAWN	VW
JOB No.	MA16036	FIGURE NO.	1a
		REV	-

SITE LAYOUT PLAN

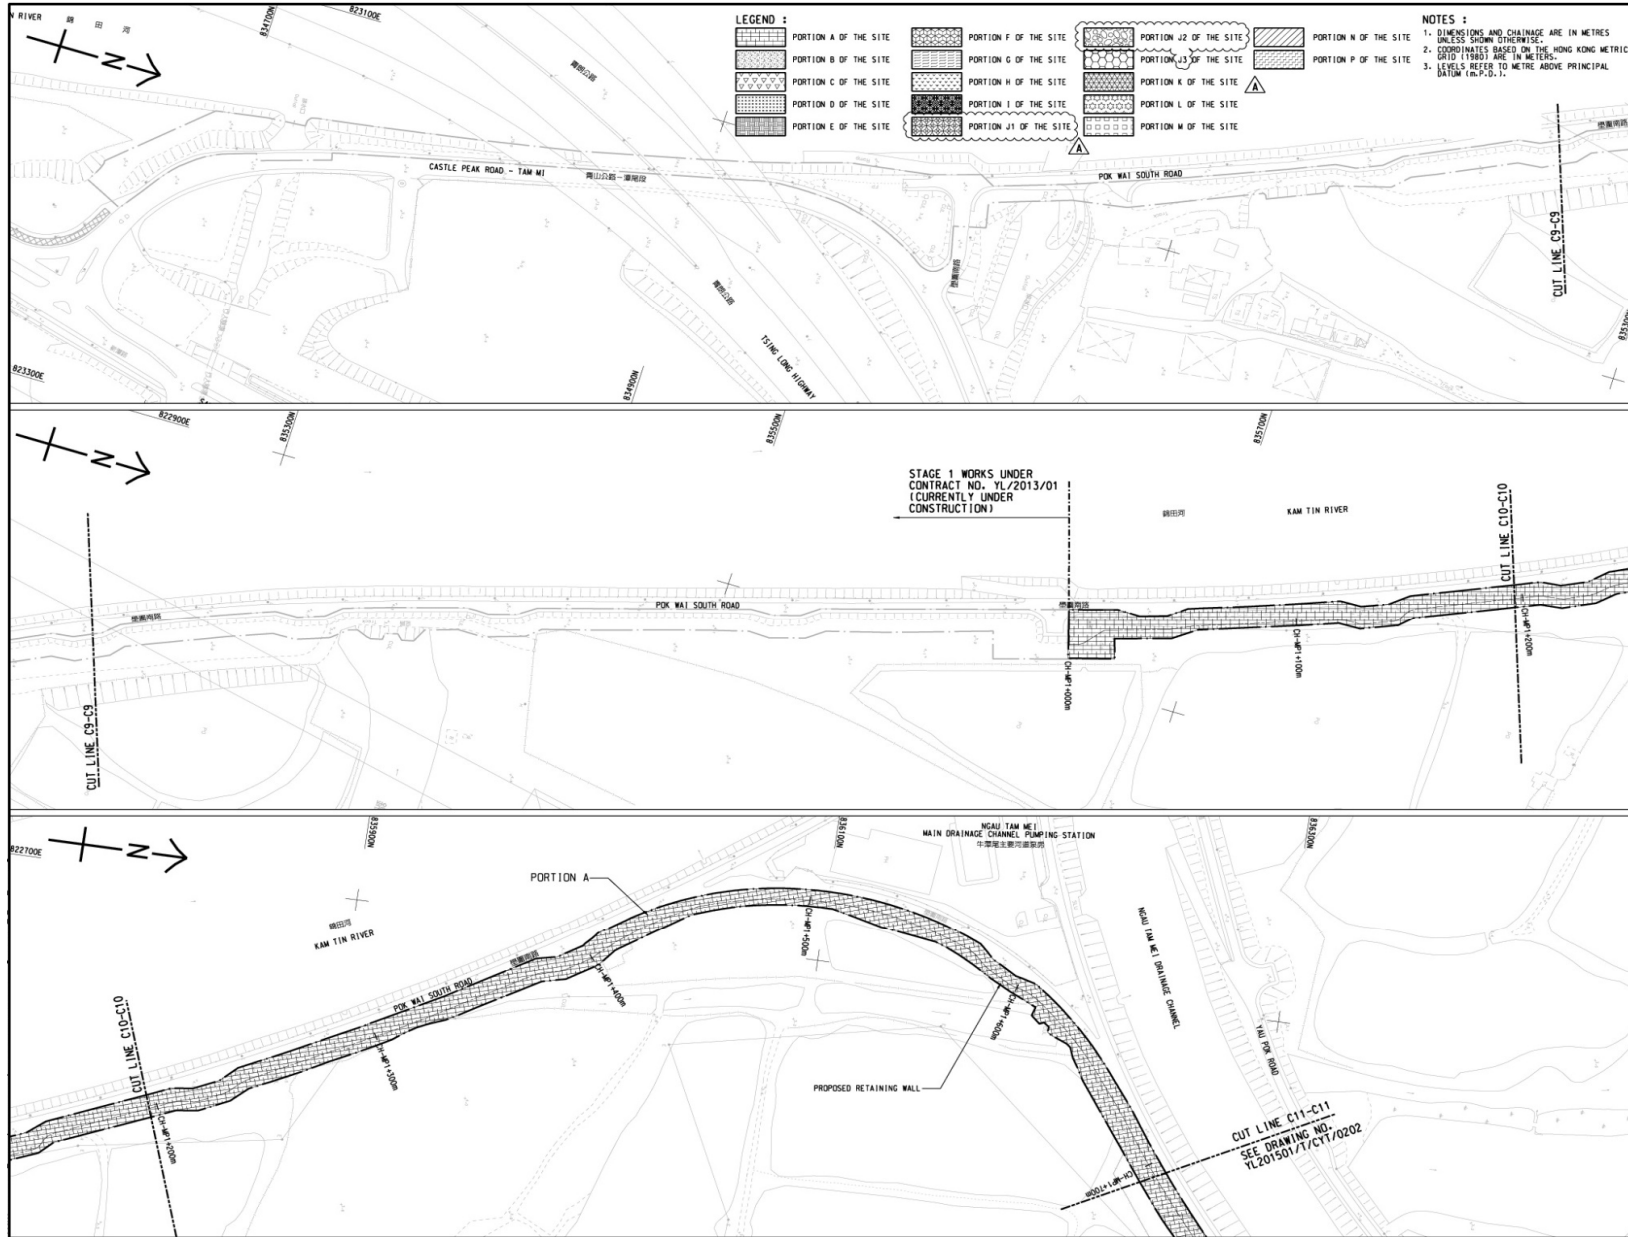
Scale	N.T.S	Project No.	MA16036
Date	Dec-16	Figure	1b

Title Agreement No. CE 67/2015(HY)
 Cycle Tracks from Tuen Mun to Sheung Shui - Remaining Works
 Design and Construction
 Site Layout Plan

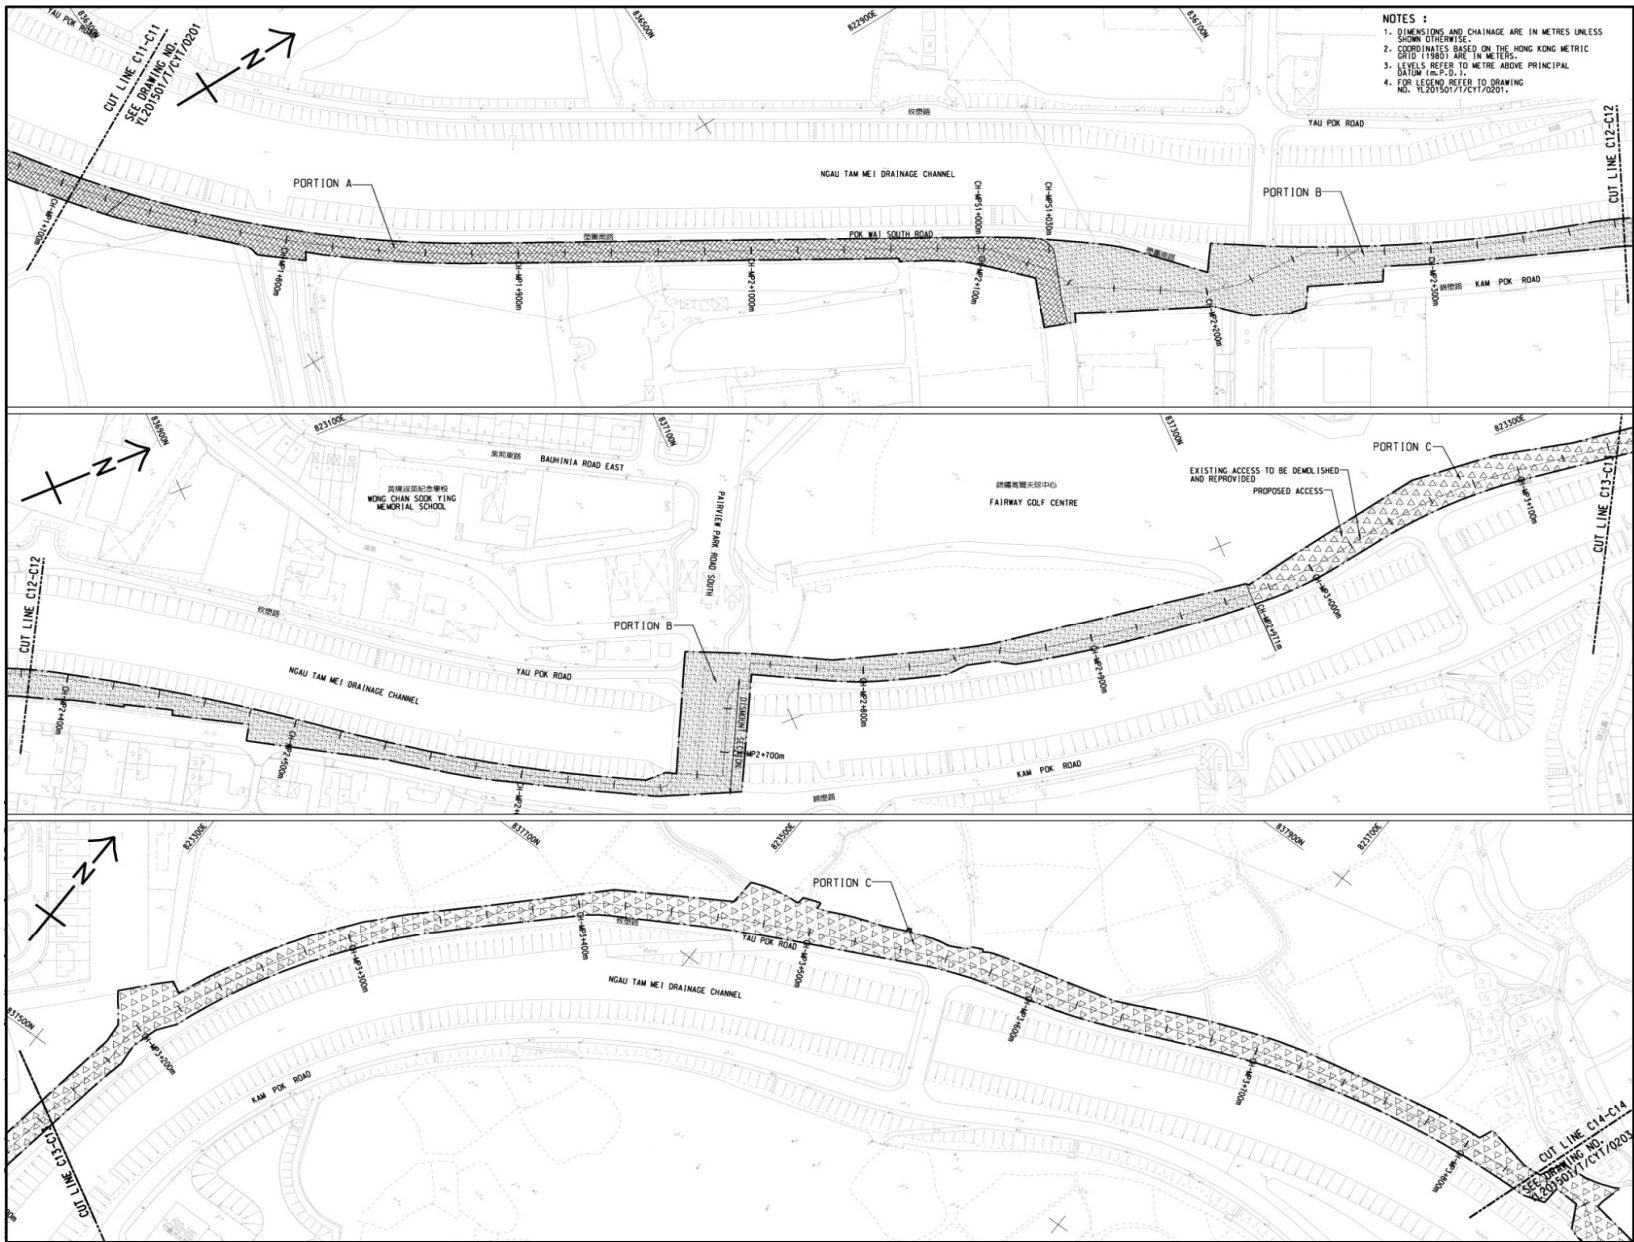
Scale	N.T.S	Project No.	MA16036
Date	Dec-16	Figure	1c

Title Agreement No. CE 67/2015(HY)
 Cycle Tracks from Tuen Mun to Sheung Shui - Remaining Works
 Design and Construction
 Site Layout Plan

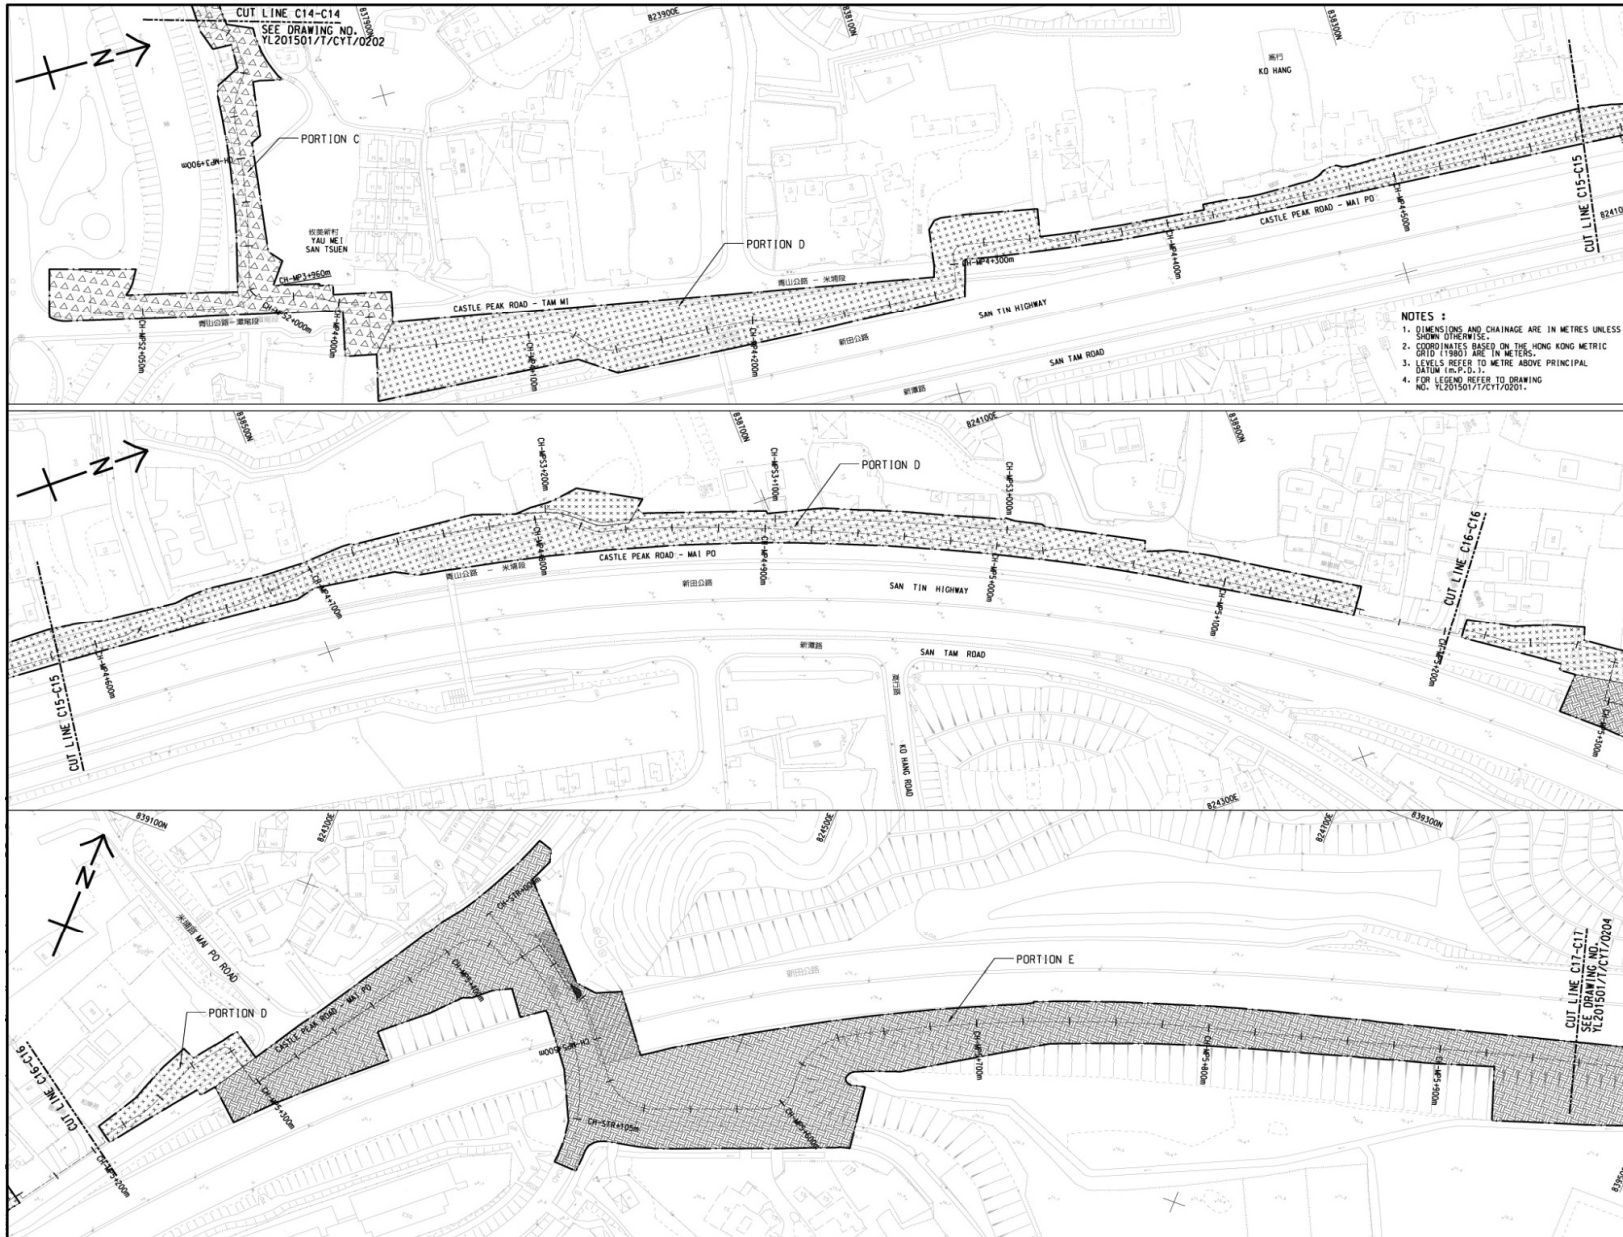
Scale	N.T.S	Project No.	MA16036
Date	Dec-16	Figure	1d

Title Agreement No. CE 67/2015(HY)
 Cycle Tracks from Tuen Mun to Sheung Shui - Remaining Works
 Design and Construction
 Site Layout Plan

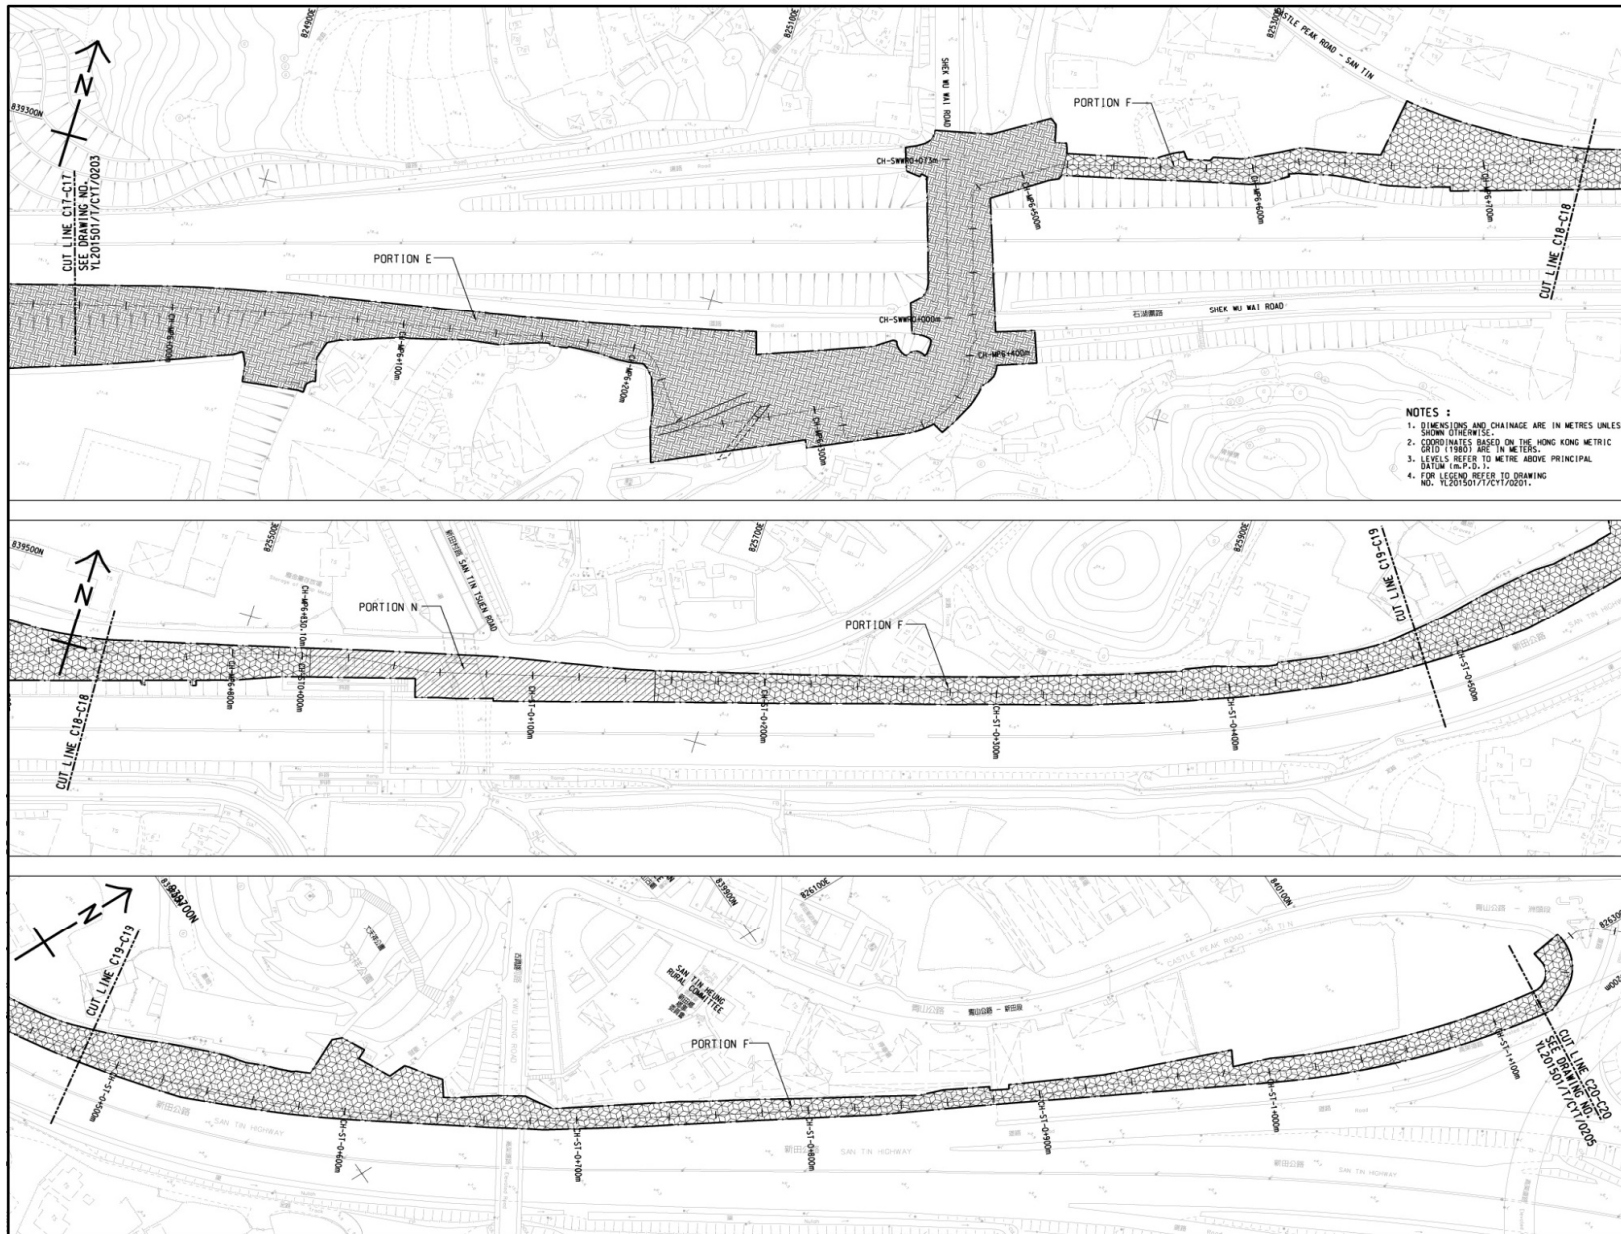
Scale	N.T.S	Project No.	MA16036
Date	Dec-16	Figure	1e

Title Agreement No. CE 67/2015(HY)
 Cycle Tracks from Tuen Mun to Sheung Shui - Remaining Works
 Design and Construction
 Site Layout Plan

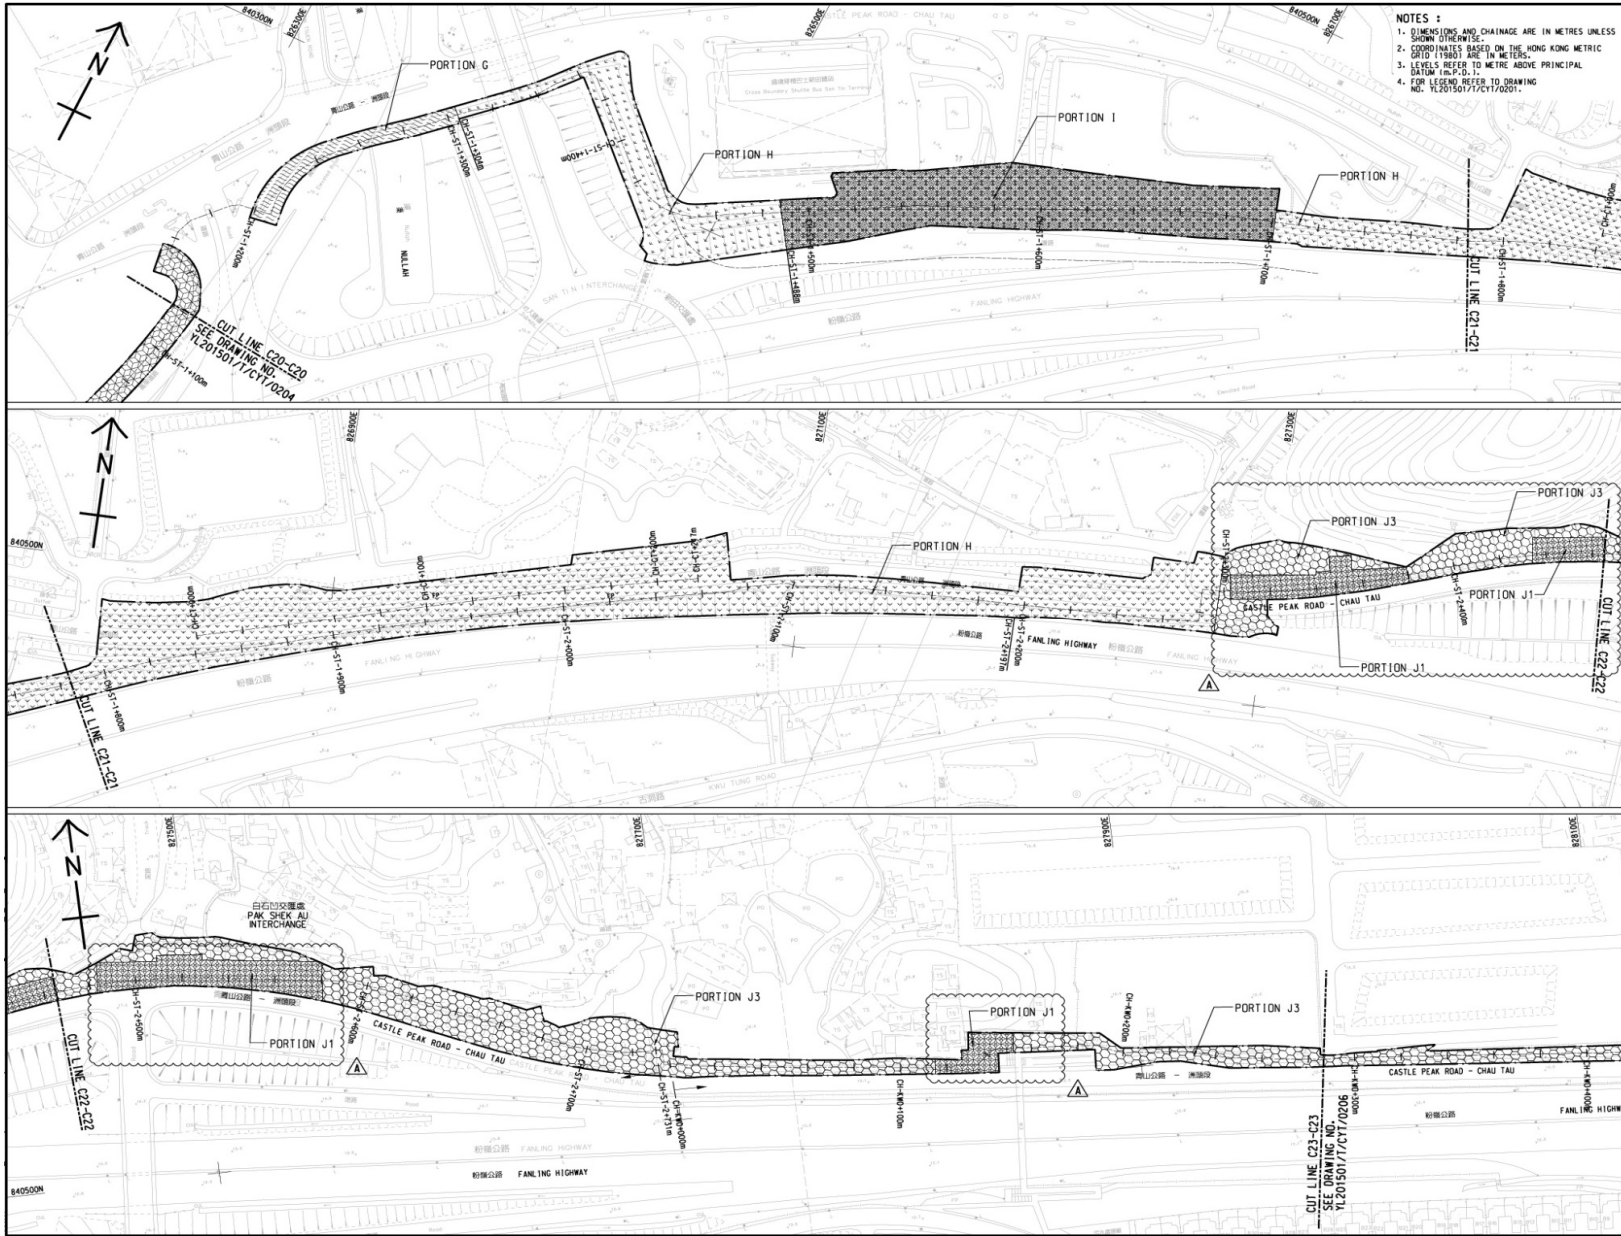
Scale	N.T.S	Project No.	MA16036
Date	Dec-16	Figure	1f

Title Agreement No. CE 67/2015(HY)
 Cycle Tracks from Tuen Mun to Sheung Shui - Remaining Works
 Design and Construction
 Site Layout Plan

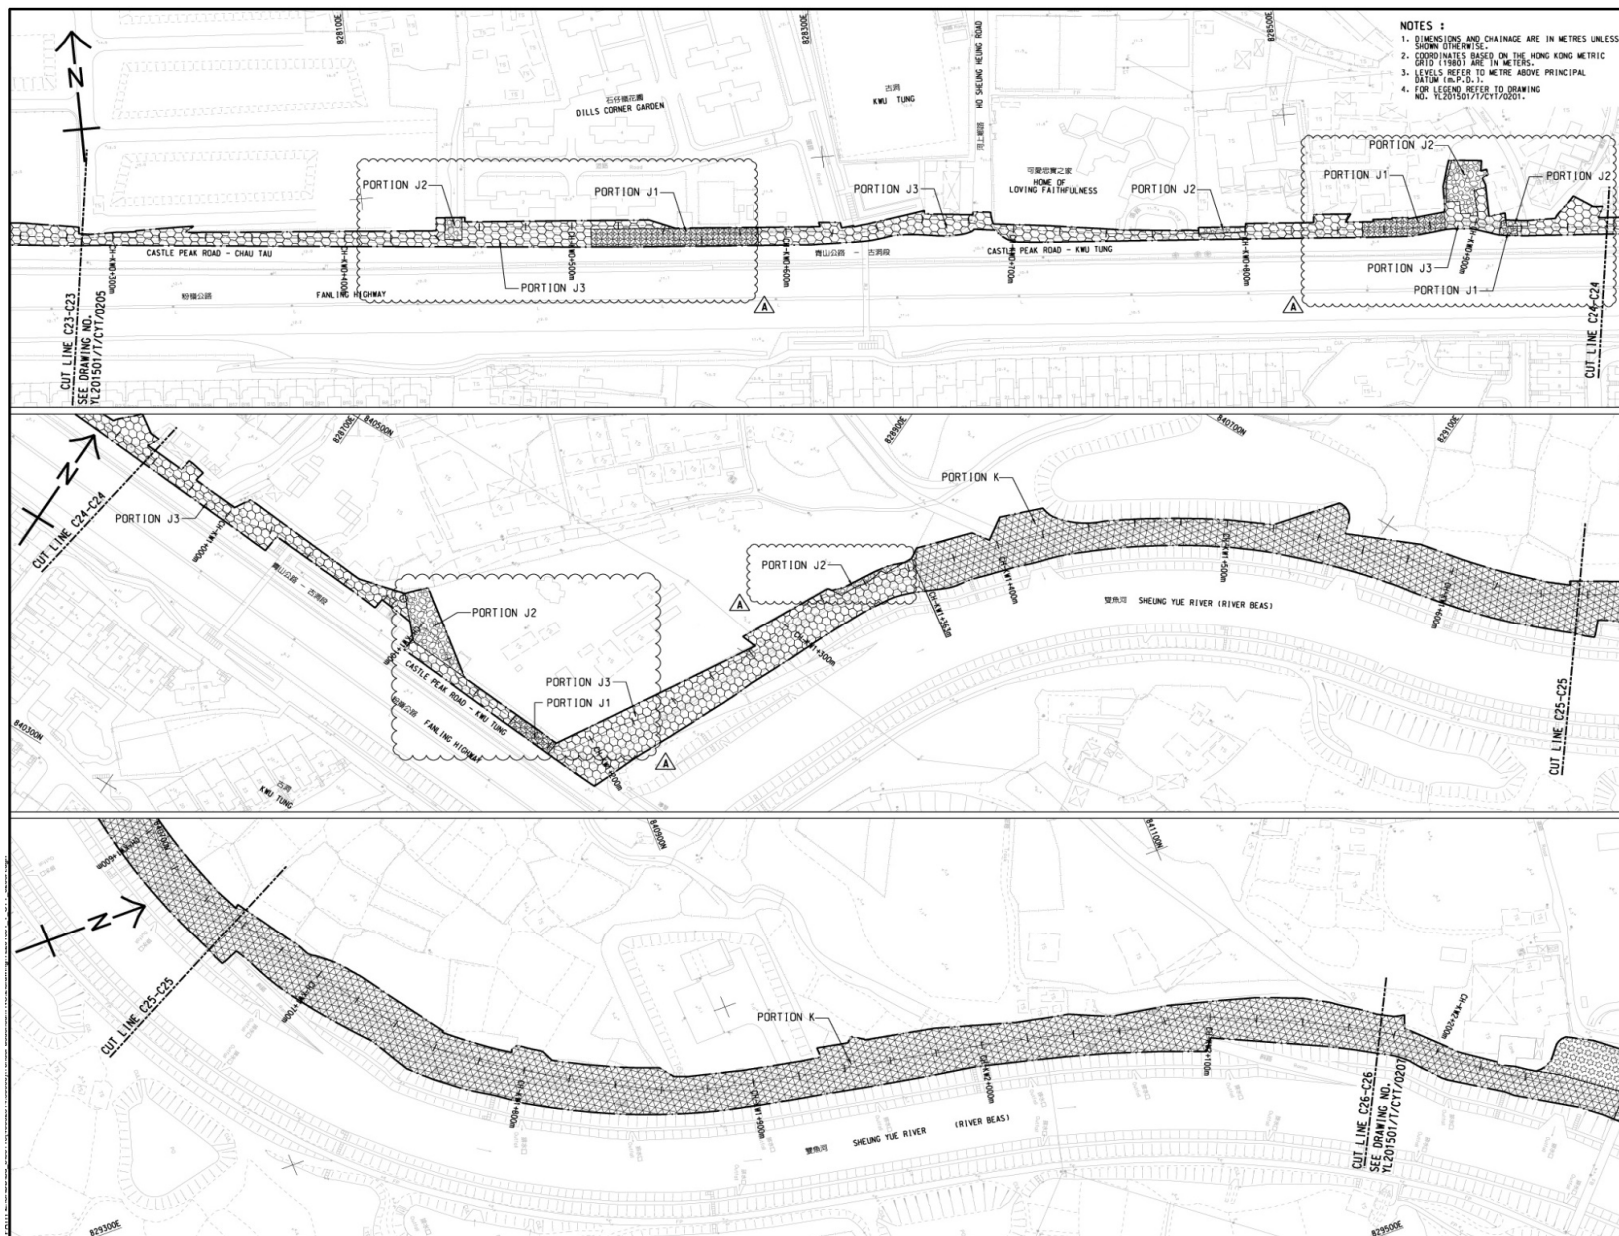
Scale	N.T.S	Project No.	MA16036
Date	Dec-16	Figure	1g

Title Agreement No. CE 67/2015(HY)
 Cycle Tracks from Tuen Mun to Sheung Shui - Remaining Works
 Design and Construction
 Site Layout Plan

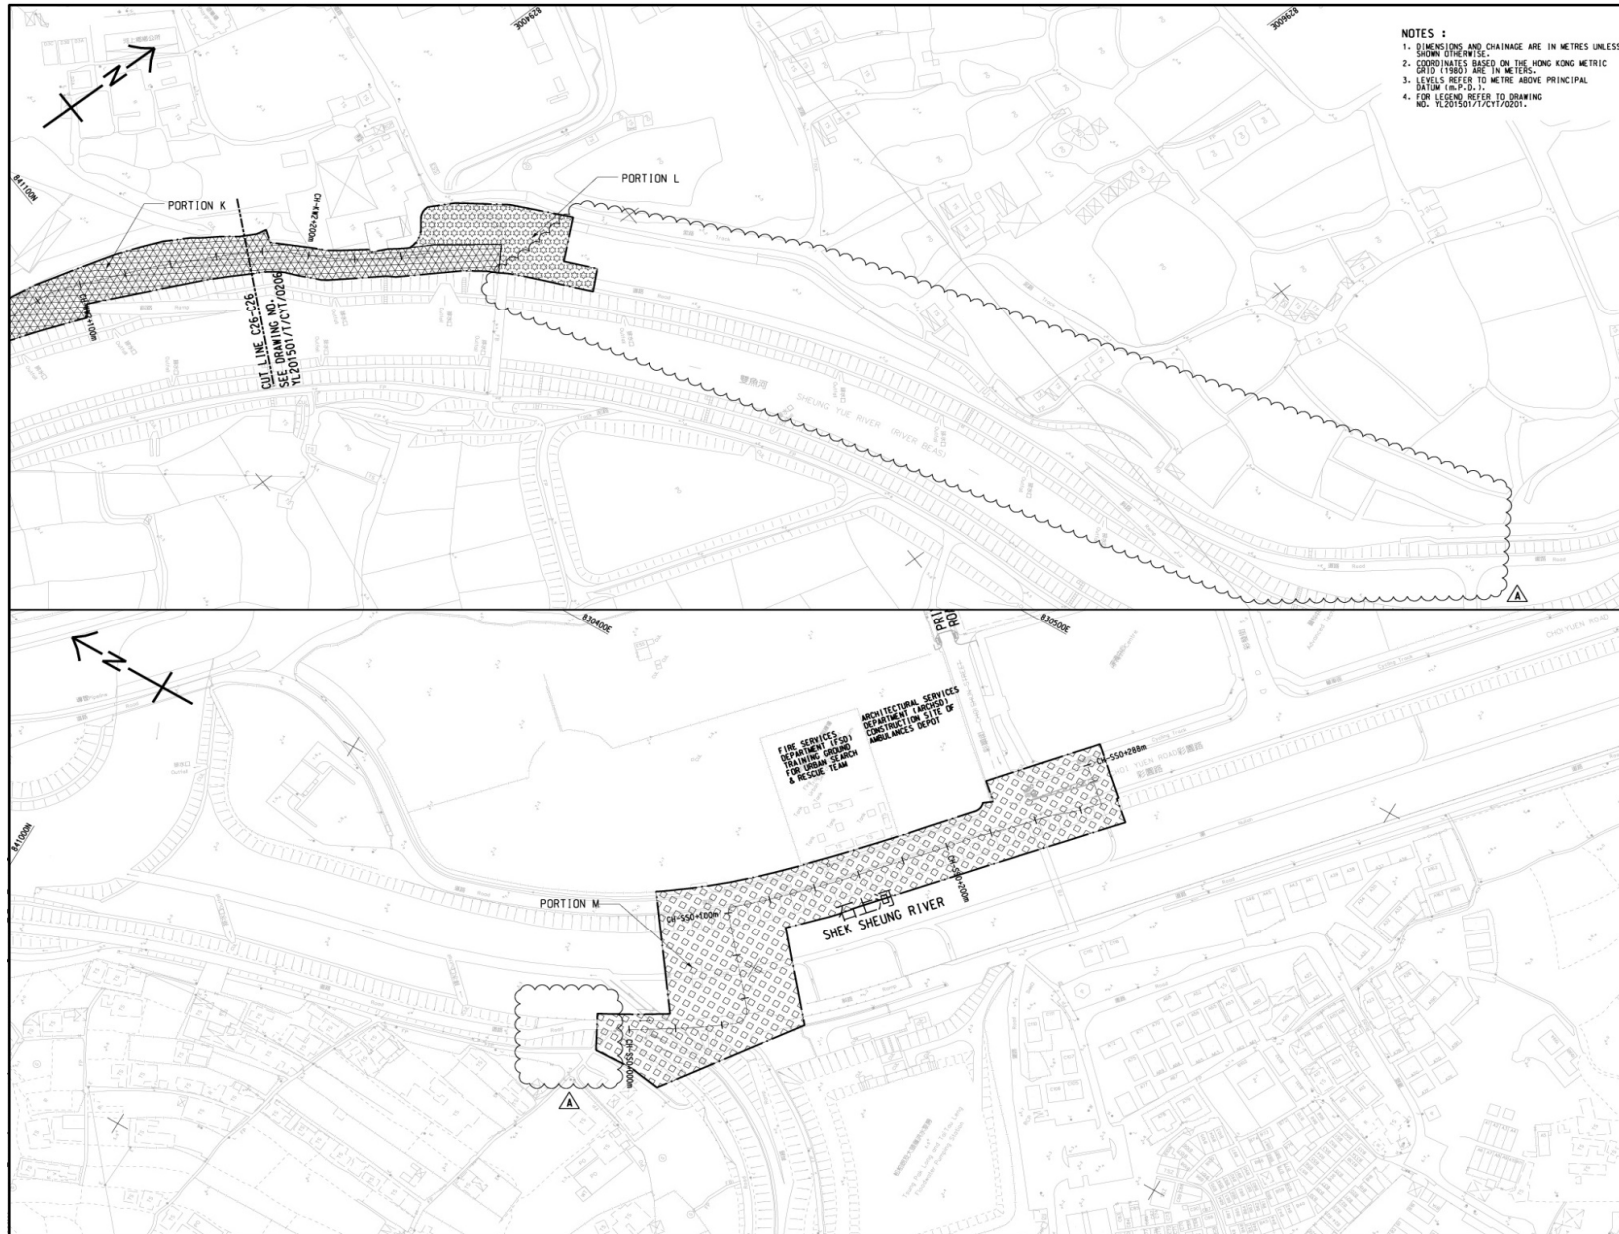
Scale	N.T.S	Project No.	MA16036
Date	Dec-16	Figure	1h

Agreement No. CE 67/2015(HY)
 Cycle Tracks from Tuen Mun to Sheung Shui - Remaining Works
 Design and Construction
 Site Layout Plan

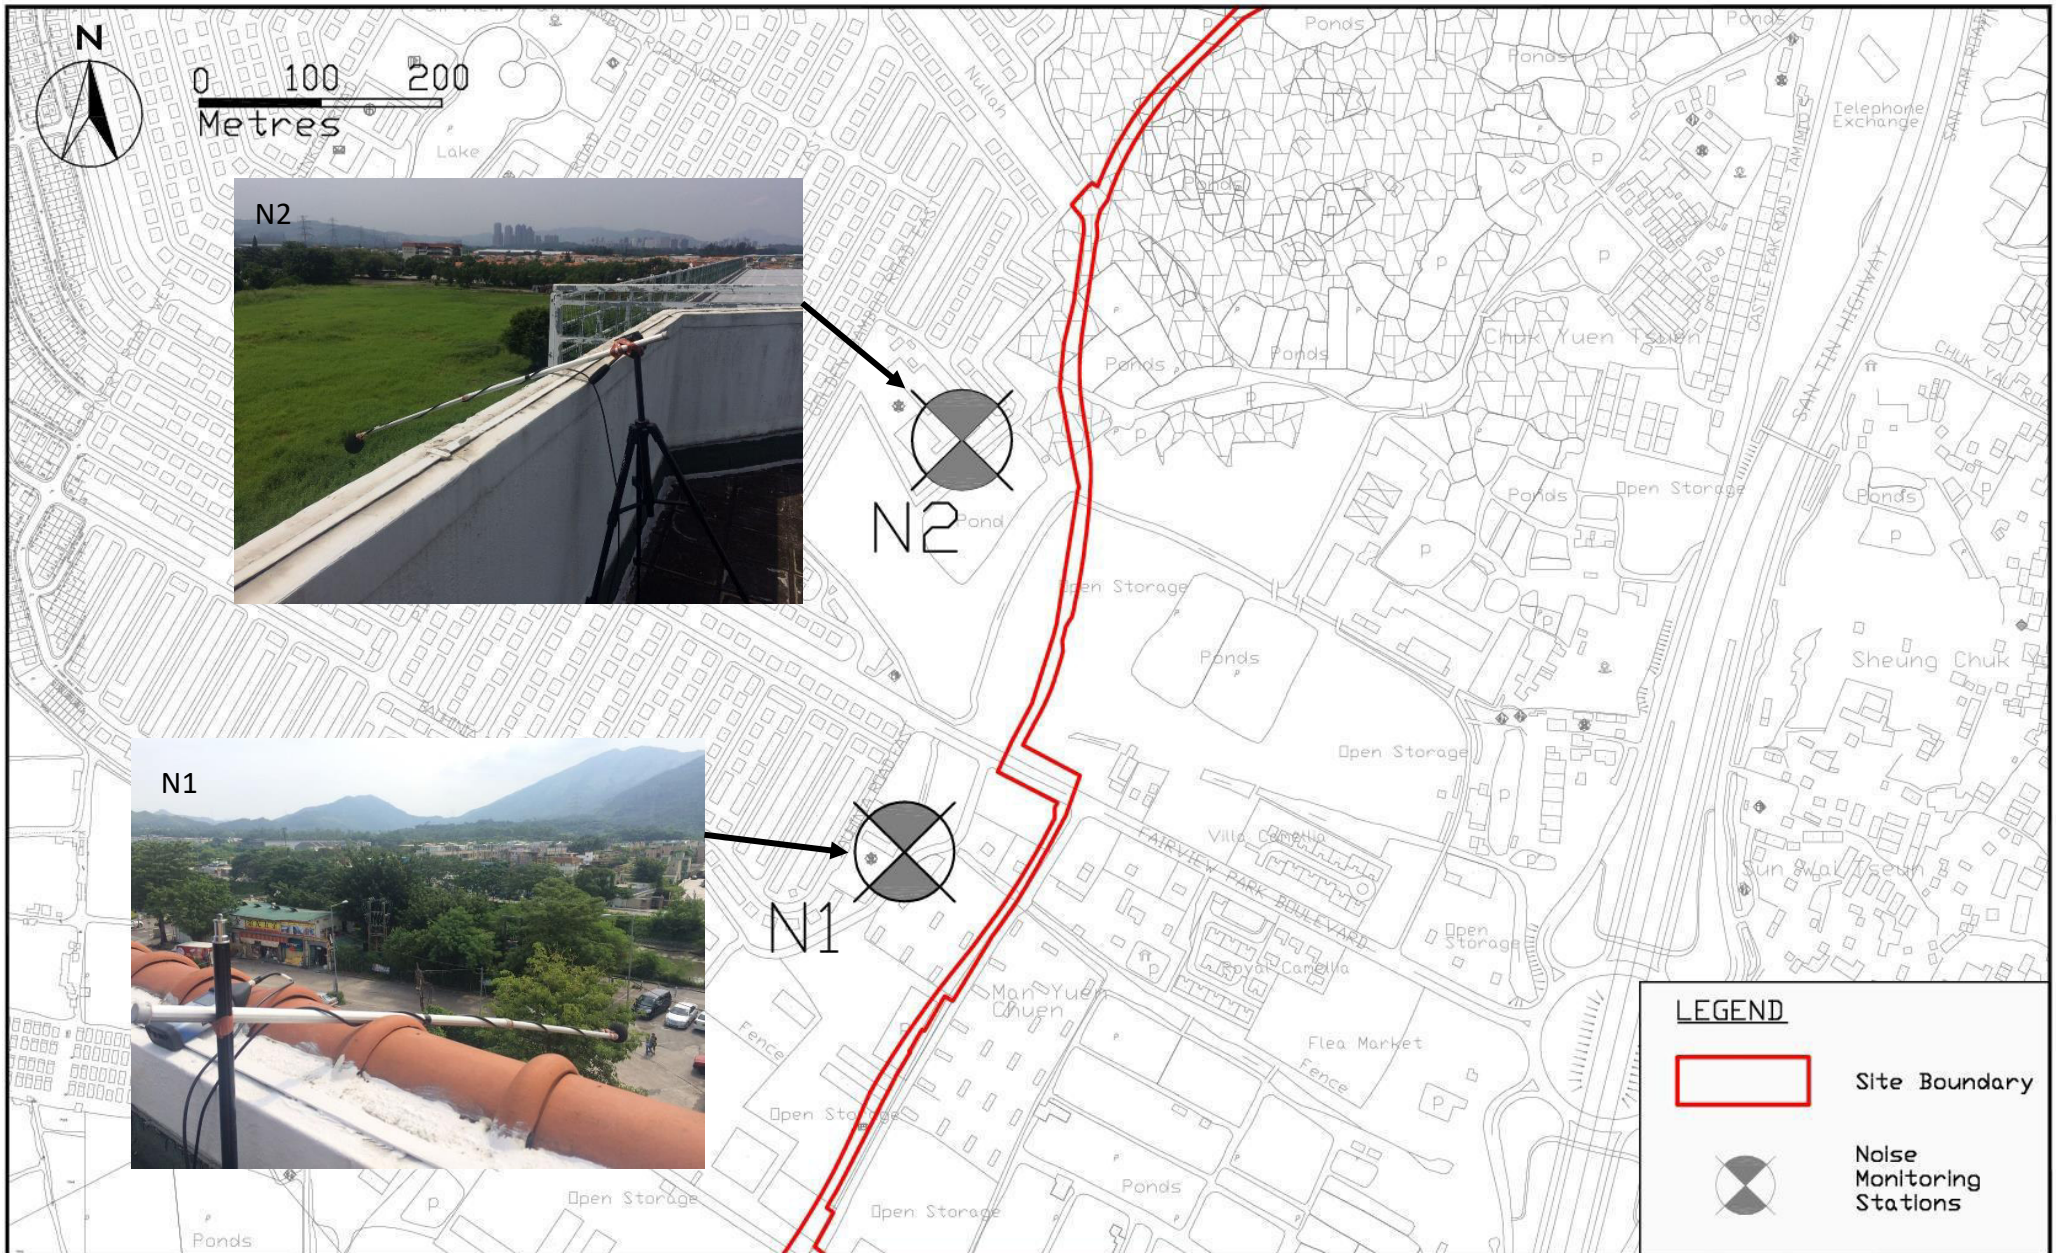
SCALE	A4 1:6m	DATE	Aug 2016	
CHECK	JL	DRAWN	VW	
JOB No.	MA16036	FIGURE NO.	2a	REV
				-

Locations of the Noise Monitoring Stations (N1, N2)

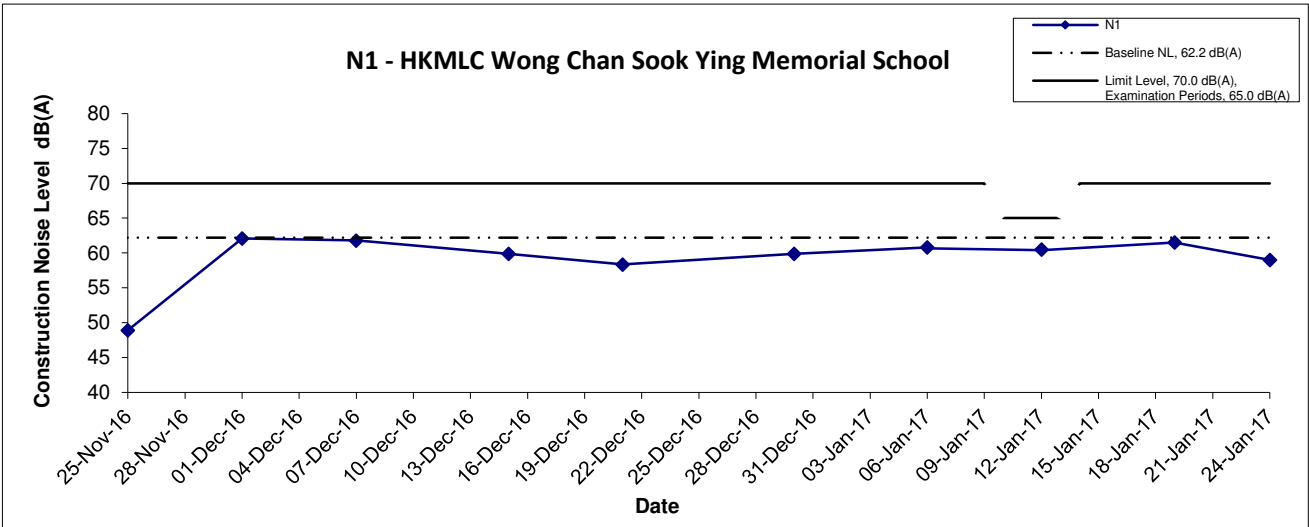
Title Agreement No. CE 67/2015 (HY) Cycle Tracks from Tuen Mun to Sheung Shui - Remaining Works - Design and Construction Graphical Presentation of Construction Noise Monitoring Results	Scale	Project No.	CINOTECH
	N.T.S	MA16036	
	Date	Appendix	
	Jan 17	E

Location N7 - Village House in Shek Wui Wai							
Date	Time	Weather	Unit: dB (A) (30-min)				
			Measured Noise Level			Baseline Level	Construction Noise Level
			L _{eq}	L ₁₀	L ₉₀	L _{eq}	L _{eq}
6-Jan-17	11:00	Sunny	67.9	68.7	62.4	70.7	67.9 Measured ≤ Baseline
12-Jan-17	15:00	Cloudy	74.2	76.2	66.0		71.6
19-Jan-17	13:45	Cloudy	74.8	76.3	69.0		72.7
24-Jan-17	10:55	Cloudy	71.0	73.1	68.9		59.2
