Contract No. YL/2015/01 Cycle Tracks from Tuen Mun to Sheung Shui – Remaining Works Submission of Monthly Environmental Monitoring and Audit (EM&A) Report (February 2021)

Agreement No. CE 67/2015 (HY)
Cycle Tracks from Tuen Mun
to Sheung Shui – Remaining Works
Design and Construction

Monthly EM&A Report (Version 1.0)

February 2021

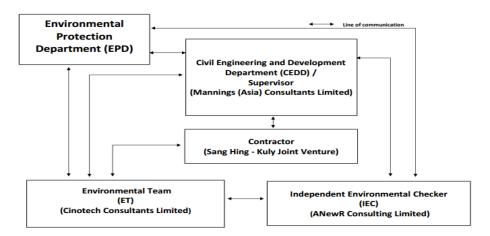
Figure 3 Organization Structure (Environmental Aspects)

1.7 The Organizational Structure for Environmental Management is shown in **Figure 3**.
