Contract No. YL/2015/01
Cycle Tracks from Tuen Mun to Sheung Shui – Remaining Works
Submission of Monthly Environmental Monitoring and Audit (EM&A) Report (March 2021)

Agreement No. CE 67/2015 (HY) Cycle Tracks from Tuen Mun to Sheung Shui – Remaining Works Design and Construction

Monthly EM&A Report (Version 1.0)

March 2021

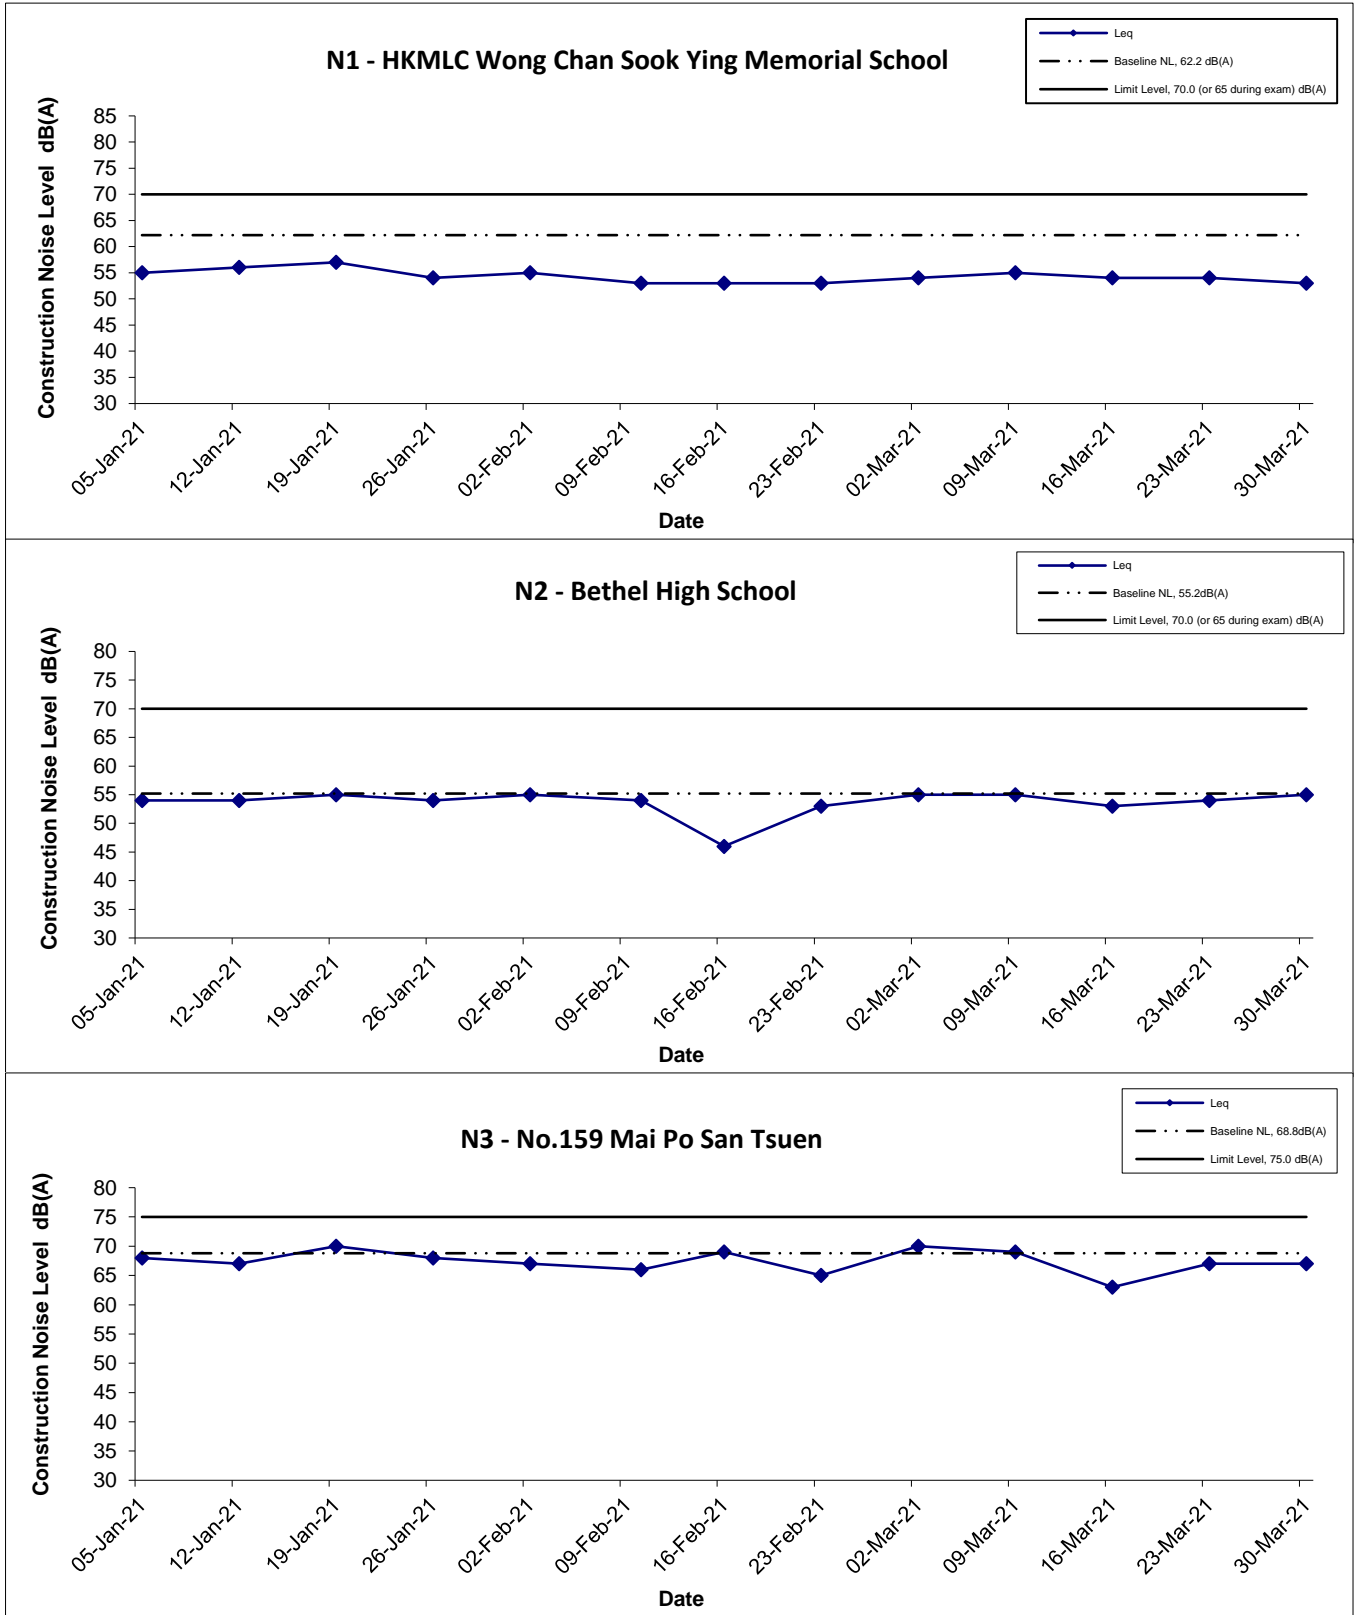
Title	Agreement No. CE 67/2015 (HY)	Scale	Project	CINOTECH
	Cycle Tracks from Tuen Mun to Sheung Shui - Remaining Works - Design and Construction	N.T.S	No. MA16036	
	Graphical Presentation of Construction Noise Monitoring Results	Date Mar 21	Appendix E

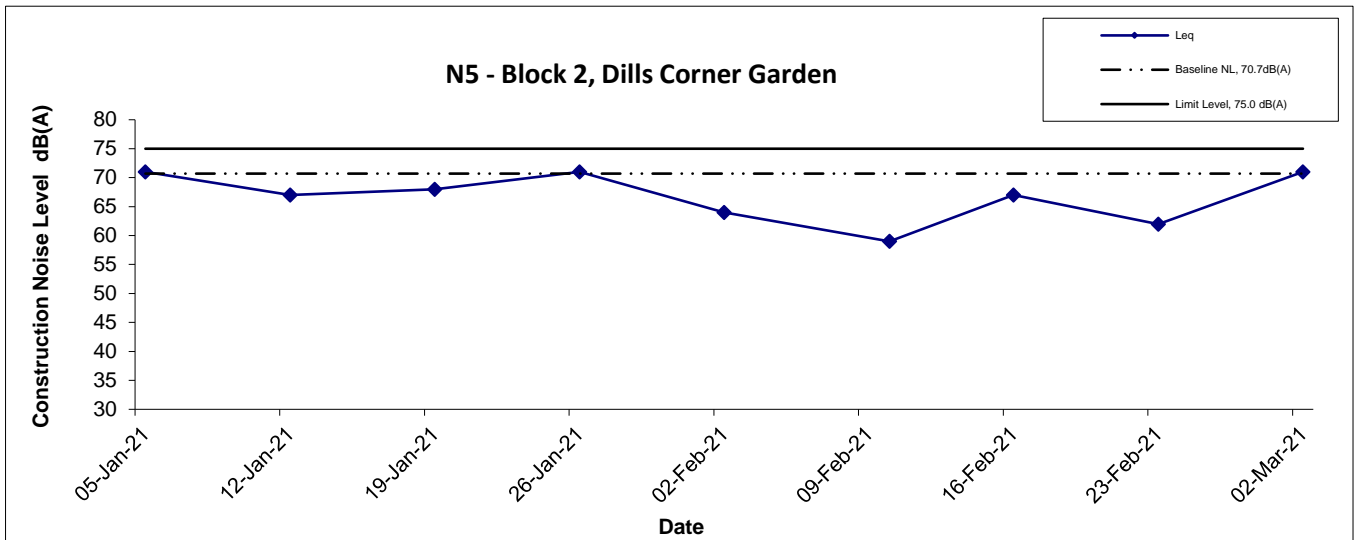
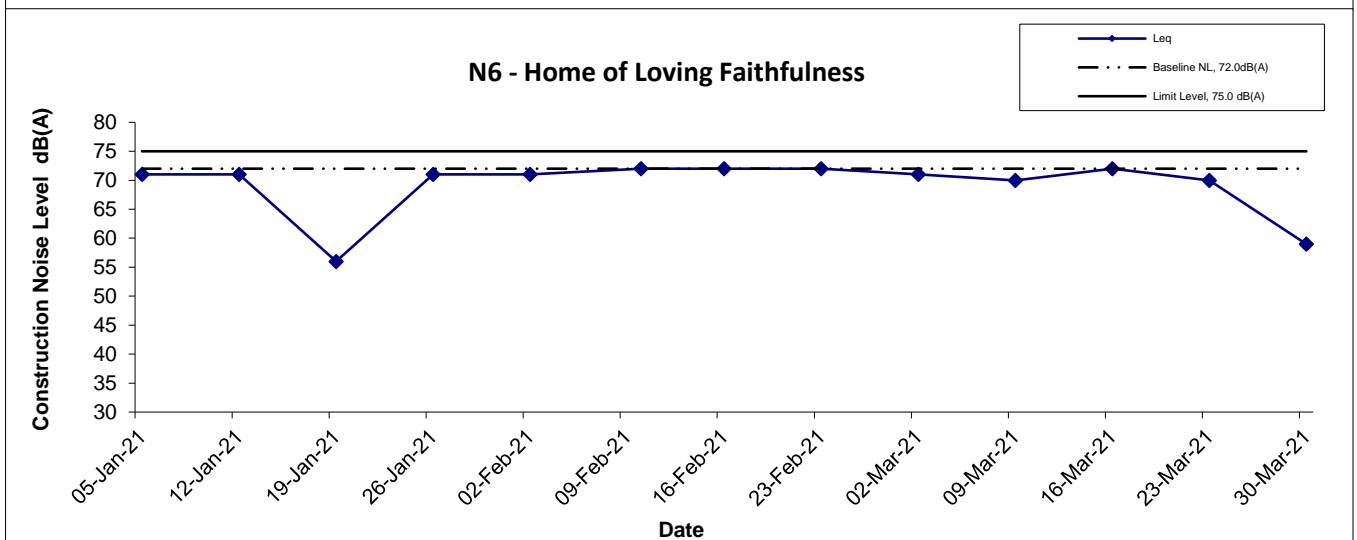
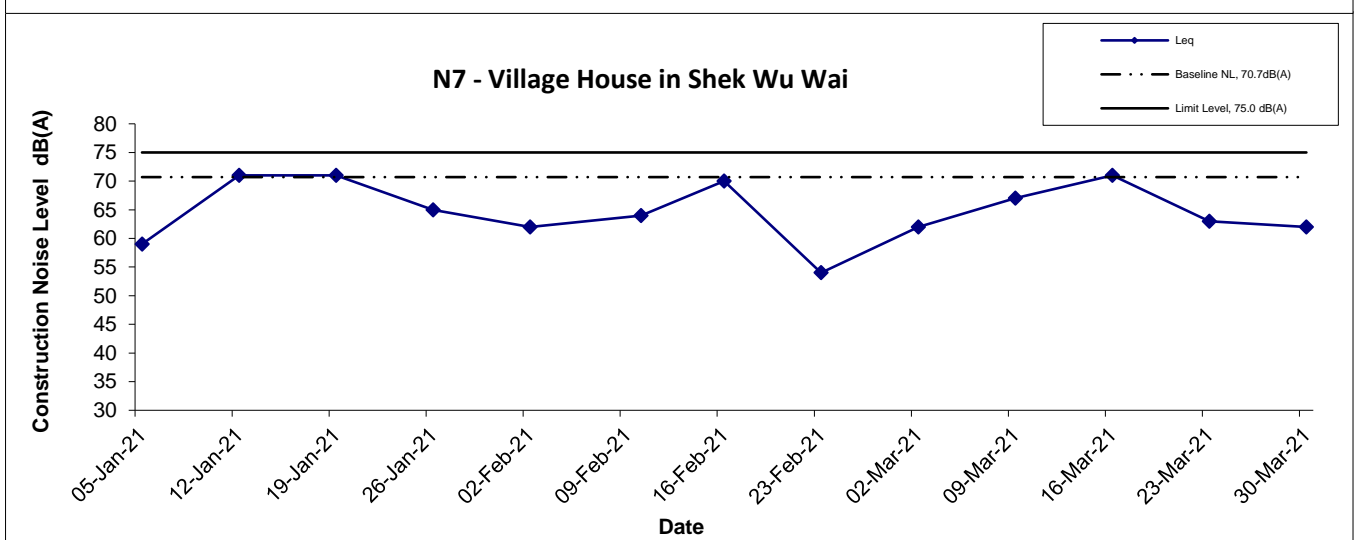
Title Agreement No. CE 67/2015 (HY) Cycle Tracks from Tuen Mun to Sheung Shui - Remaining Works - Design and Construction Graphical Presentation of Construction Noise Monitoring Results	Scale N.T.S	Project No. MA16036
