## Hong Kong – Zhuhai – Macao Bridge Hong Kong Boundary Crossing Facilities – Reclamation Works

Monthly EM&A Report for January 2018

**Contract No. HY/2010/02 – HZMB HKBCF – Reclamation Works  
Monthly Environmental Monitoring & Audit Report for January 2018**

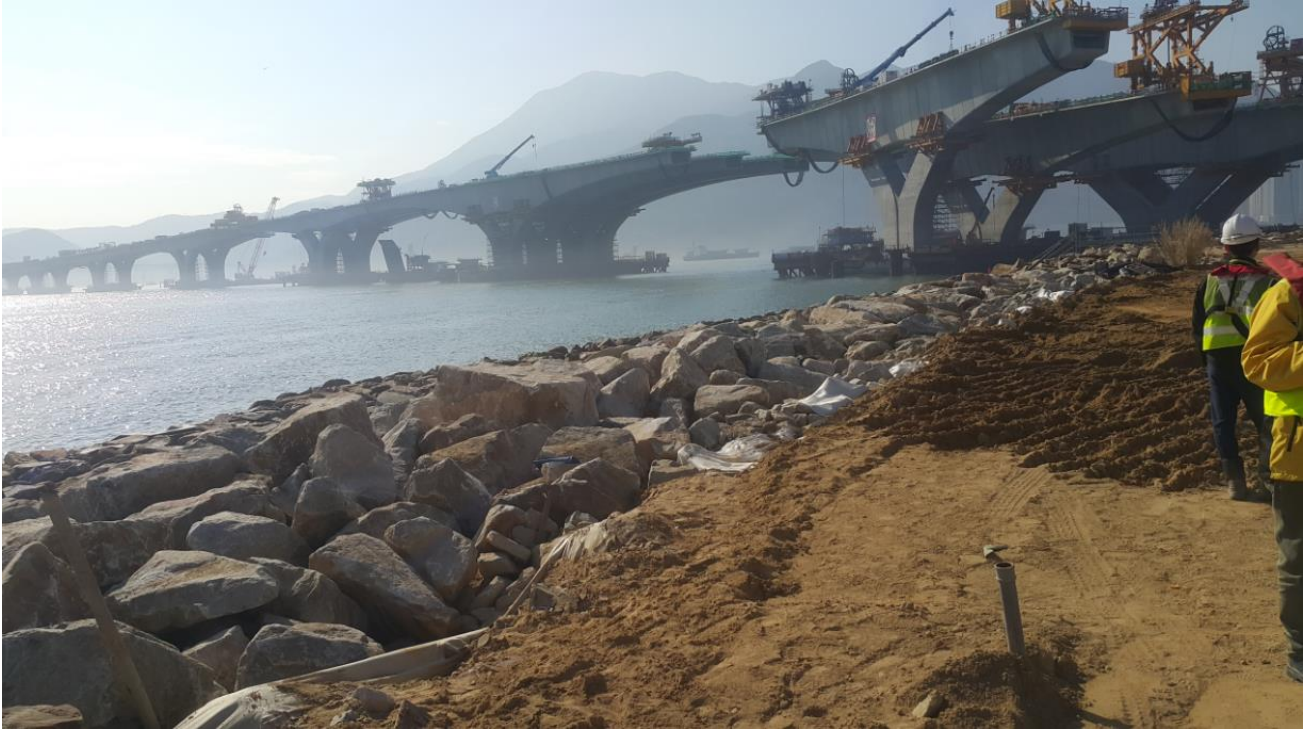
**Photo record taken on 18 January 2018 showed no fugitive dust was generated at outfall area.**

<b>Actions taken / to be taken</b>	<p>The Contractor was recommended to continue implementing existing dust mitigation measures.</p> <p>Dust suppression should be provided to dusty materials for all works which might generate fugitive dust.</p>		
<b>Remarks</b>	--
