**Central Kowloon Route**

**Yau Ma Tei West**

**November 2022**

Monthly EM&A Report No. 46

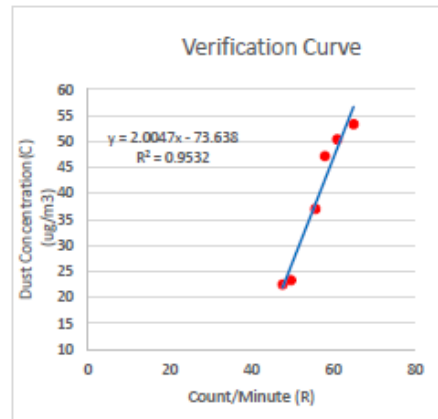
K-Factor to be inputted in LD-5R (corrected 1 decimal point): 0.7

By Linear Regression of y on x:  
 slope, mh= 2.0047  
 intercept, ch= -73.6384  
 \*Correlation Coefficient, R= 0.9763  
 Verification Test Result: Strong Correlation, Results were accepted.  
 \* If the Correlation Coefficient, R is <0.5. Checking and Re-verification are required.

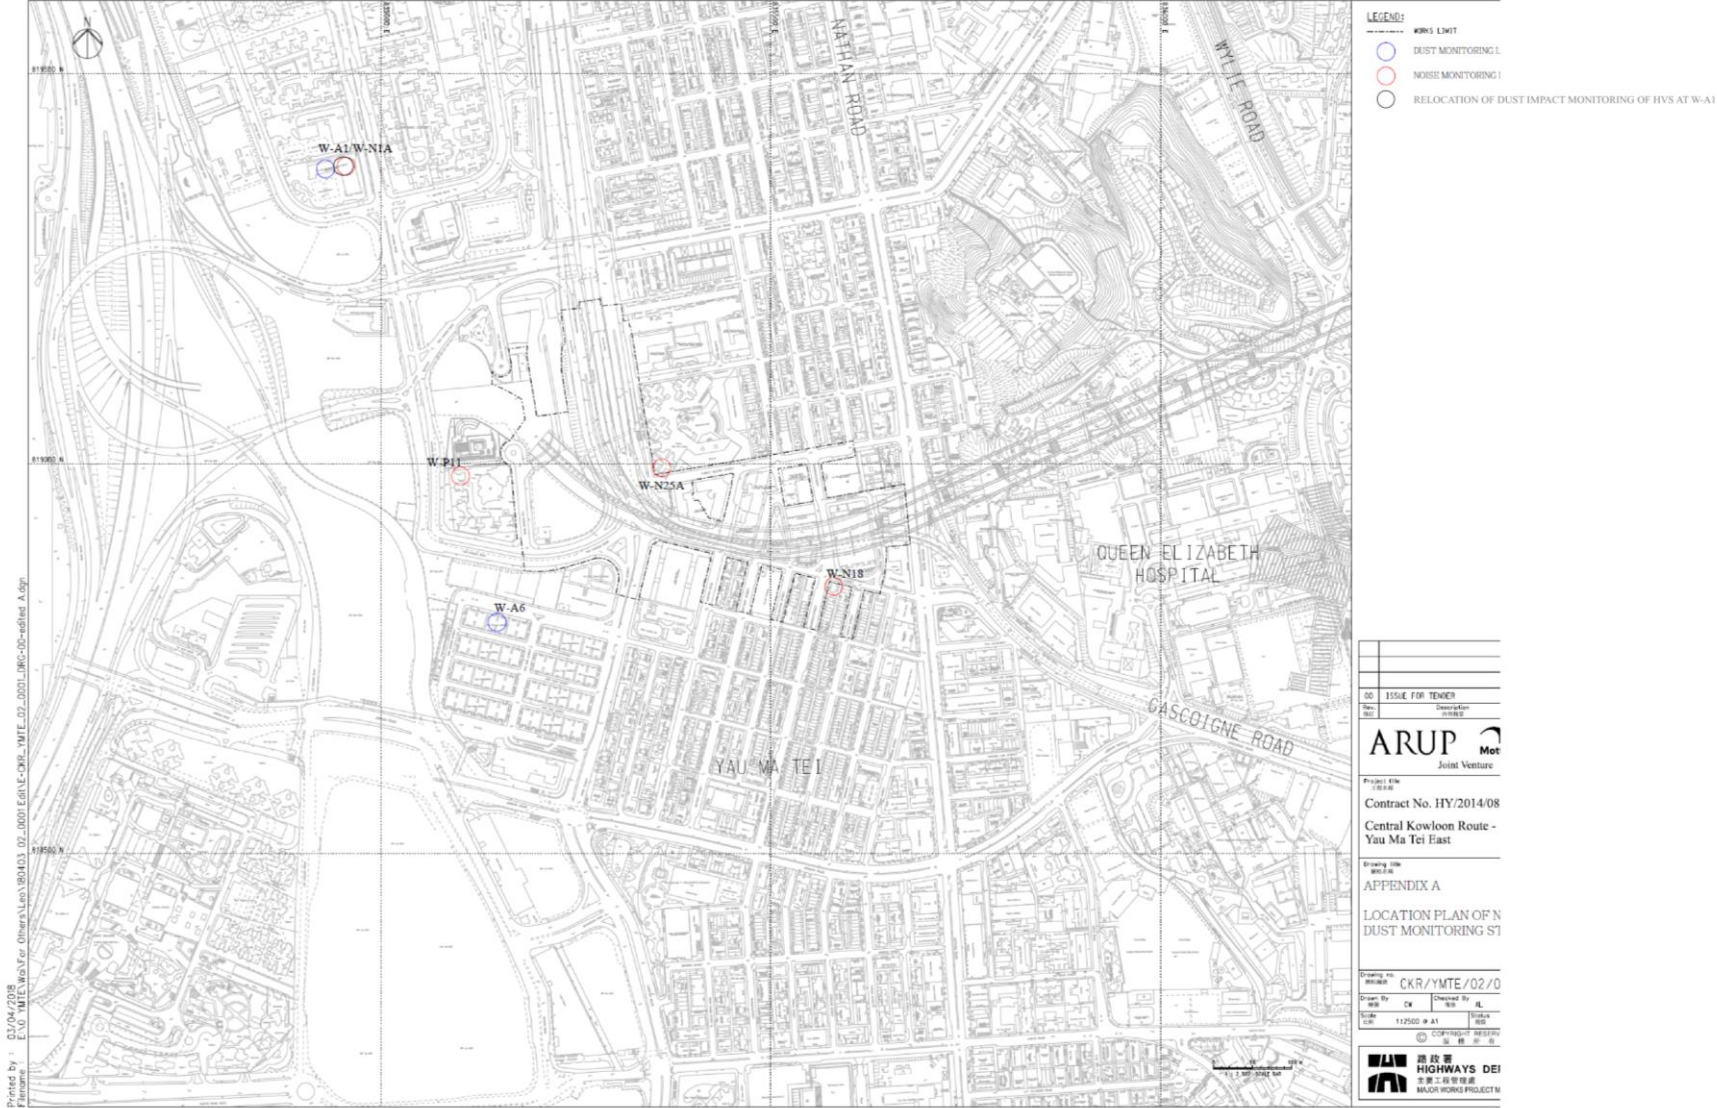
## Location Plan of Noise and Air Quality Monitoring Station

- 3.4.1. During the site visit, both of the original proposed dust monitoring locations were rejected due to the condition at The Coronation was not favourable for monitoring and the access was declined by the management office of Hong Kong Community College (HKCC) of PolyU. Two alternative air monitoring stations Yau Ma Tei Catholic Primary School (Hoi Wang Road) and Man Cheong Building had been proposed by ET and approved by IEC. 2 designated air monitoring locations were identified and agreed with IEC and EPD. Details of air monitoring stations are described in Table 3.3. The location plan of air quality monitoring stations is shown in Appendix K.
