Central Kowloon Route

Yau Ma Tei West

Contract No. HY/2014/20

December 2022

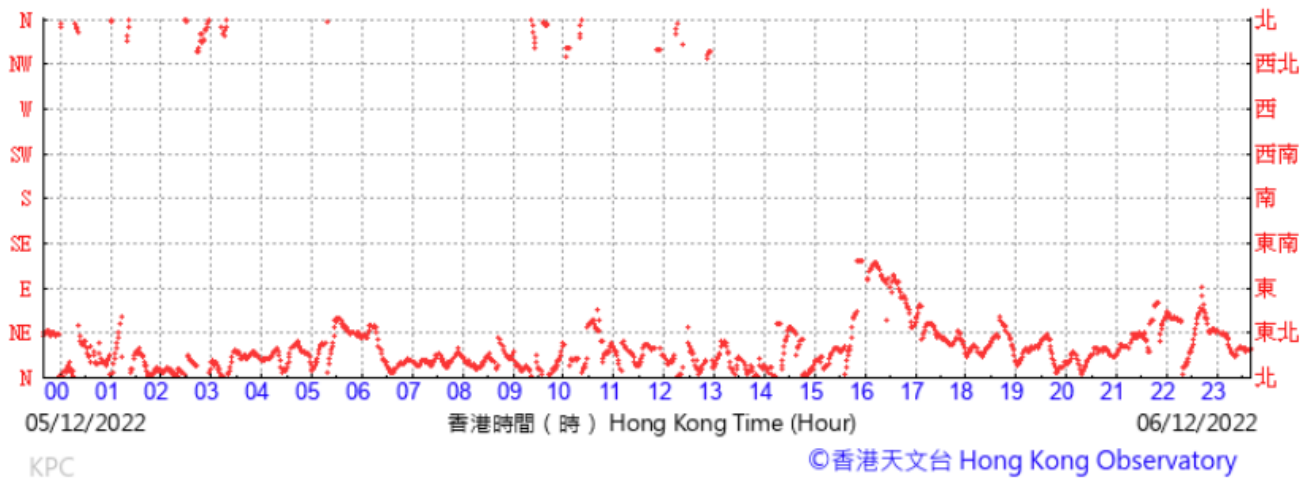
Wind direction data for 6, 7, 12, 13, 17, 18, 23, 24, 29 and 30 December 2022

(於香港時間06/12/2022 23 時 40 分更新) (Updated at 23:40H on 06/12/2022)

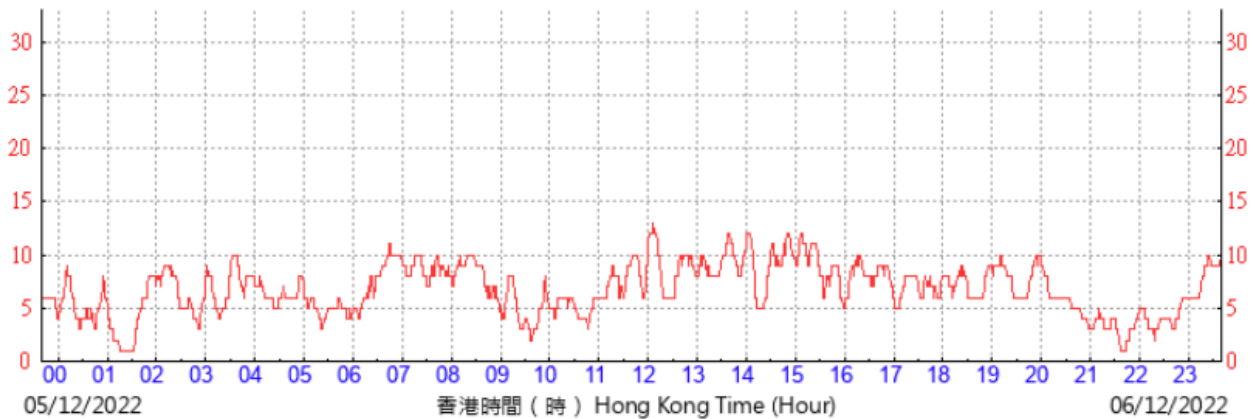
Wind speed data for 6, 7, 12, 13, 17, 18, 23, 24, 29 and 30 December 2022

(公里/小時) (於香港時間06/12/2022 23 時 40 分更新) (Updated at 23:40H on 06/12/2022) (km/h)
