**Central Kowloon Route**

**Yau Ma Tei West**

## Environmental Permit No. EP-457/2013/D

Monthly EM&A Report No. 48

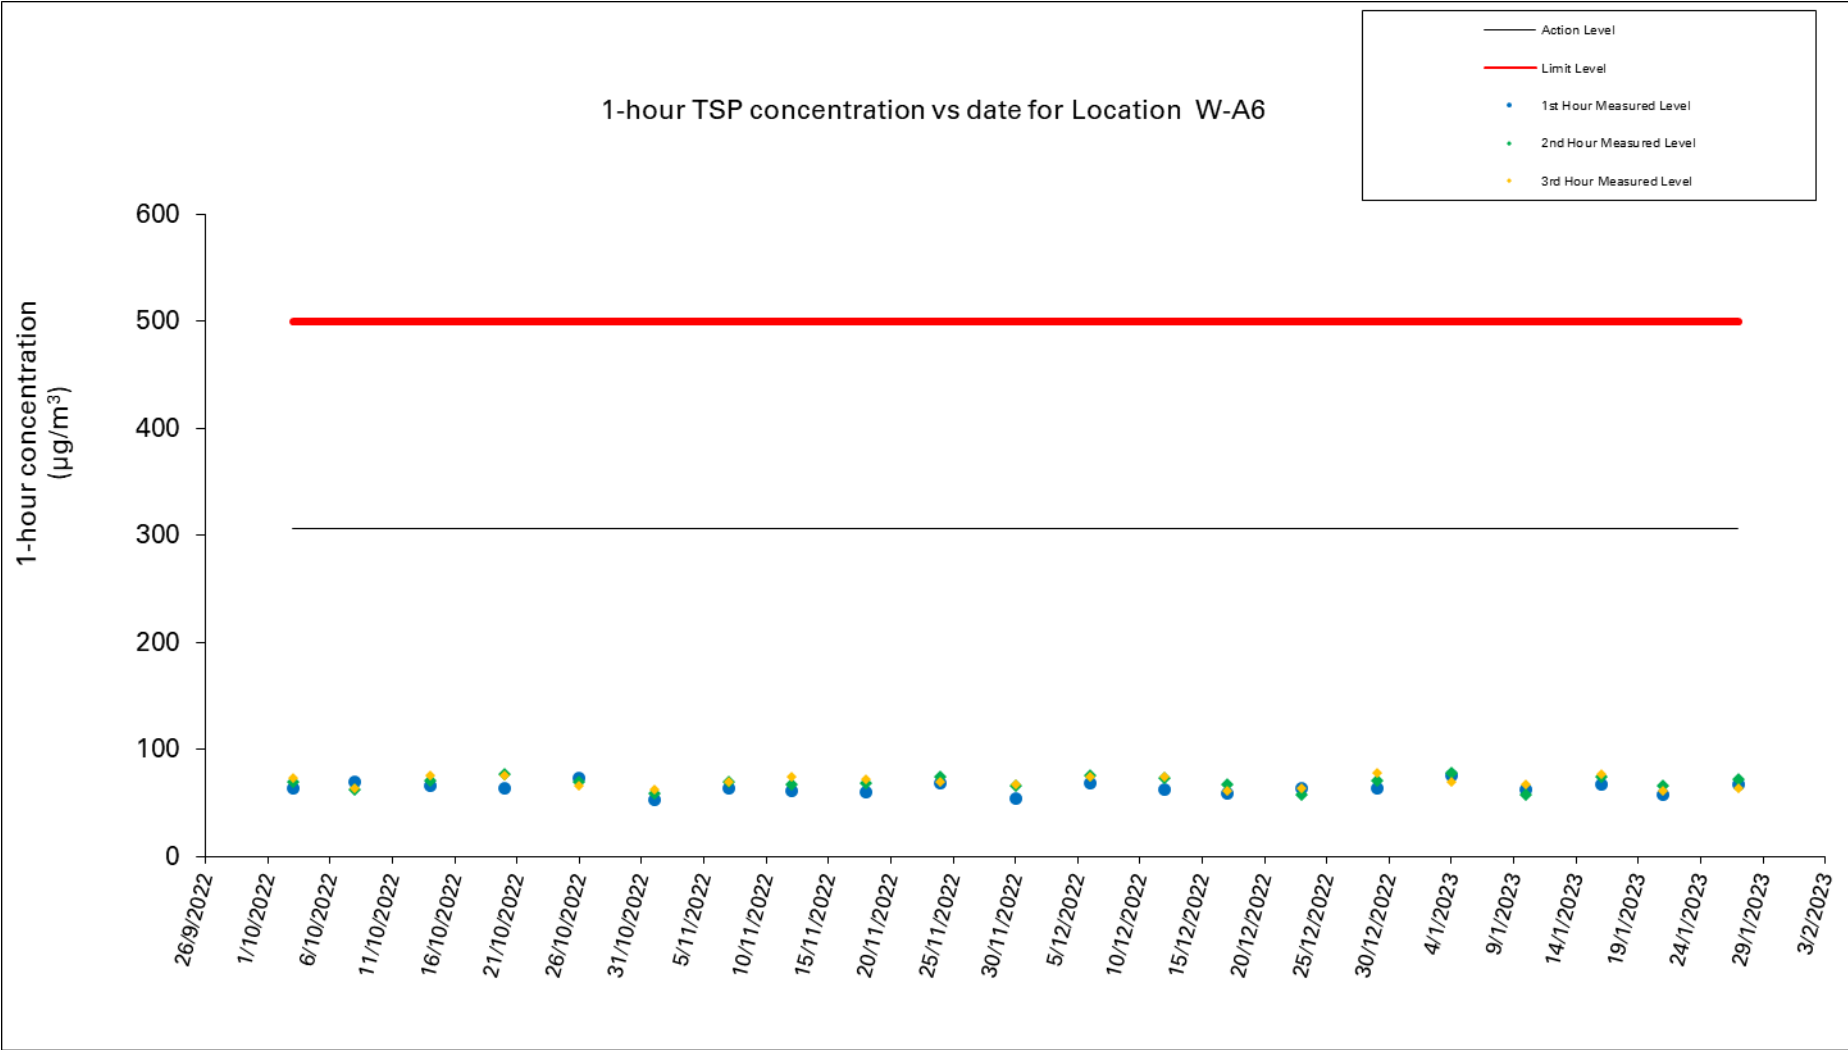
Figure 2: Graphical Illustration of Measured 1-hour TSP ( $\mu\text{g}/\text{m}^3$ ) Levels at W-A6

Location: Man Cheong Building (W-A6)  
Monitoring date: 4, 10, 16, 21 and 27 January 2023  
Parameter : TSP 1-hour  
Other Factors Nearby traffic
