Central Kowloon Route

Yau Ma Tei West

Contract No. HY/2014/20

Monthly EM&A Report No. 54

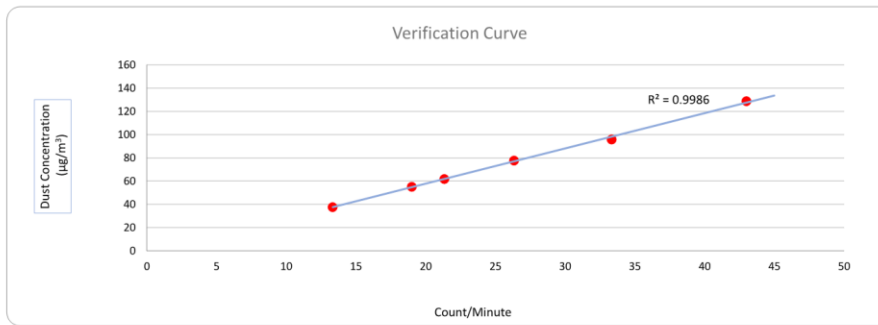
Linear Regression of y on x

Slope, K factor:	3.0313	Intercept:	-2.8495	*Correlation Coefficient, R:	0.9993
Verification Test Result: Strong Correlation, Results were accepted.			* If the Correlation Coefficient, R is <0.5. Checking and Re-verification are required.

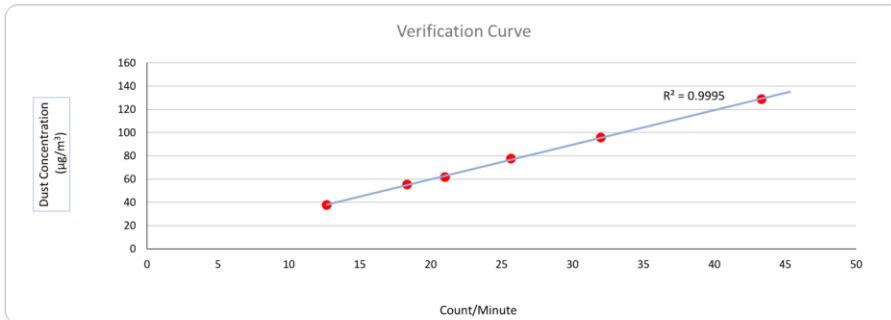
Linear Regression of y on x

Slope, K factor:	2.9749	Intercept:	0.2715	*Correlation Coefficient, R:	0.9998
Verification Test Result: <u>Strong Correlation, Results were accepted.</u>			* If the Correlation Coefficient, R is <0.5. Checking and Re-verification are required.

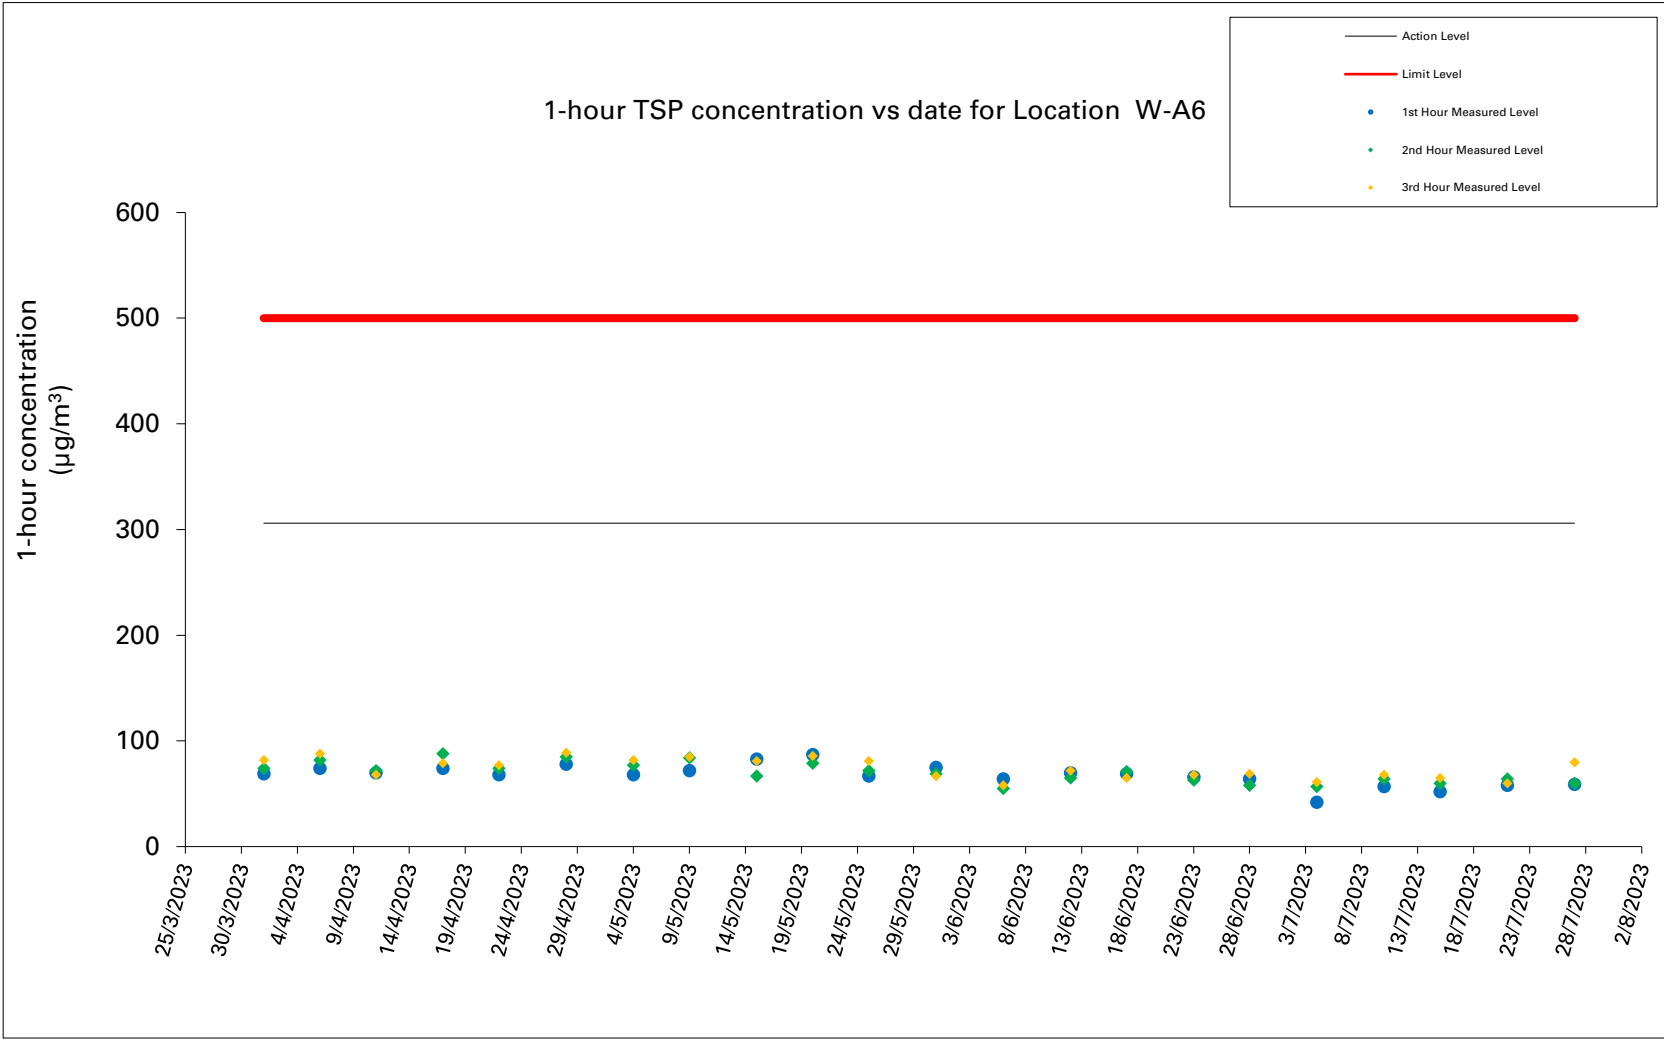
Figure 2: Graphical Illustration of Measured 1-hour TSP ($\mu\text{g}/\text{m}^3$) Levels at W-A6

Location: Man Cheong Building (W-A6)
Monitoring date: 4, 10, 15, 21 and 27 July 2023
Parameter : TSP 1-hour
Other Factors Nearby traffic

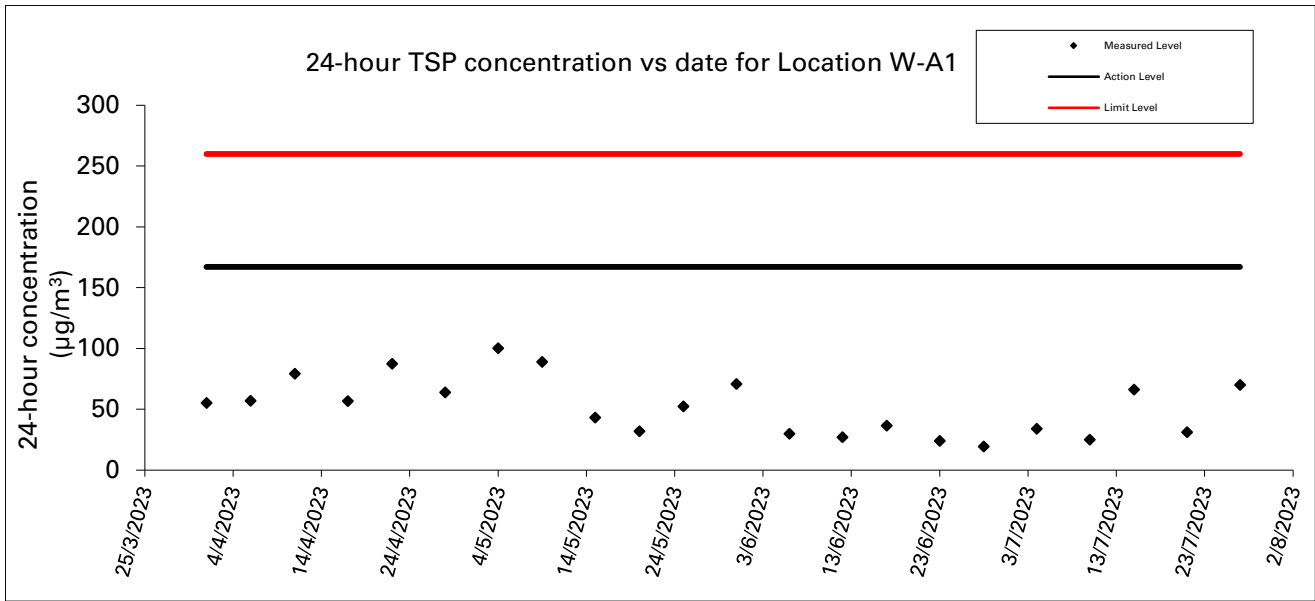
Figure 3: Graphical Illustration of Measured 24-hour TSP ($\mu\text{g}/\text{m}^3$) Levels at W-A1

Location: Yau Ma Tei Catholic Primary School (Hoi Wang Road) (W-A1)
 Monitoring date: 4, 10, 15, 21 and 27 July 2023
 Parameter : TSP 24-hour
 Other Factors Nearby traffic

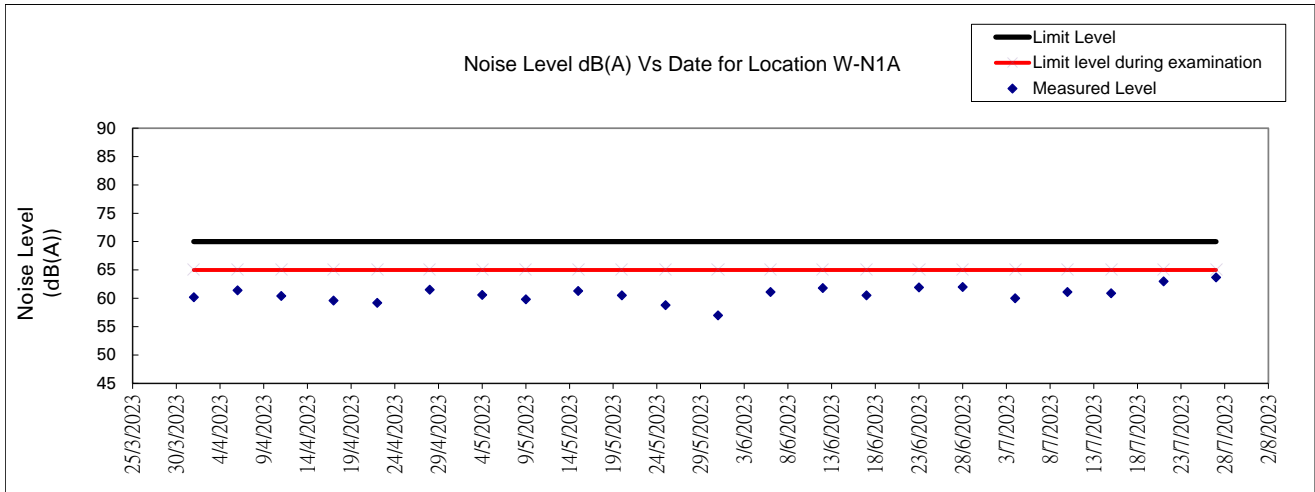
Figure 1: Graphical Illustration of Measured Noise Levels at W-N1A

Date	Weather	Start Time - End Time	L_{eq}	L_{10}	L_{90}	Wind speed (m/s)
04/07/2023	Sunny	11:29 - 11:59	65.1	66.4	63.2	3.1
10/07/2023	Sunny	10:40 - 11:10	66.0	70.4	65.5	3.9
15/07/2023	Fine	11:29 - 11:59	65.5	66.9	64.4	1.1
21/07/2023	Sunny	10:24 - 10:54	66.6	71.0	65.3	2.2
27/07/2023	Sunny	10:26 - 10:56	64.8	69.5	59.8	2.2
