AGREEMENT NO. CE 45/2008 (CE)
LIANTANG/HEUNG YUEN WAI
BOUNDARY CONTROL POINT AND ASSOCIATED
WORKS

19th QUARTERLY ENVIRONMENTAL MONITORING & 0 AUDIT SUMMARY REPORT – (February to April 2018)

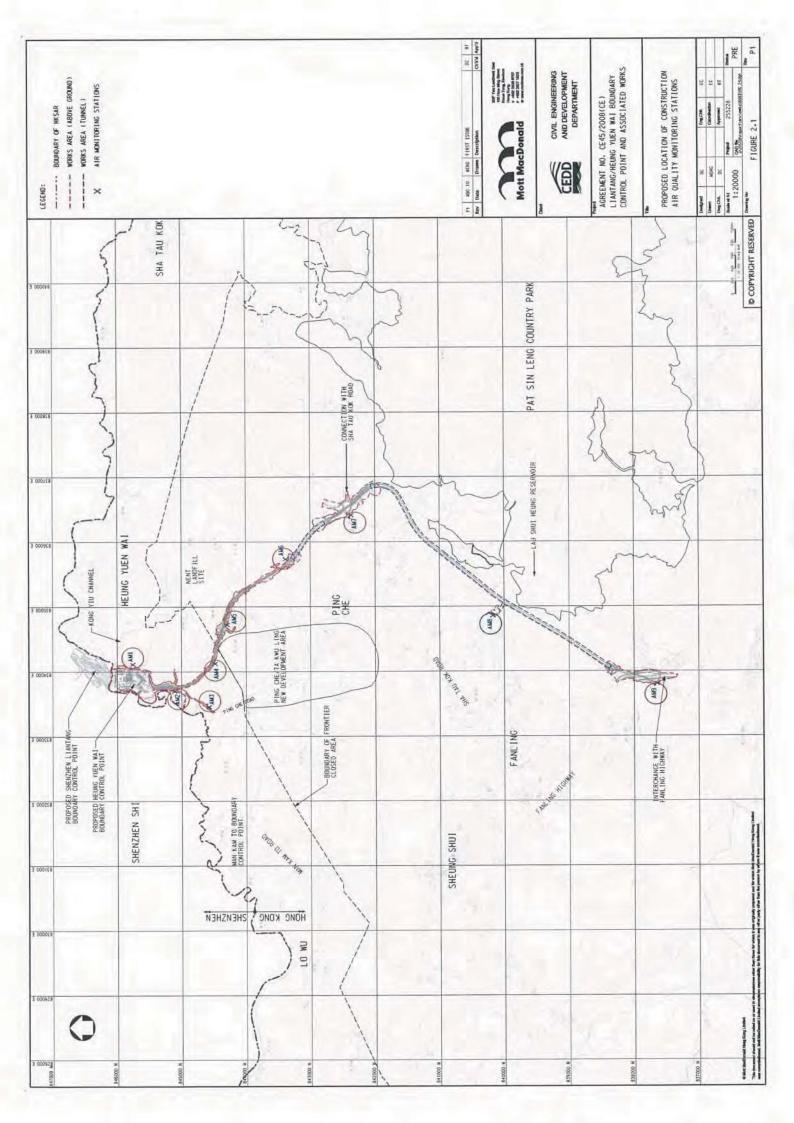
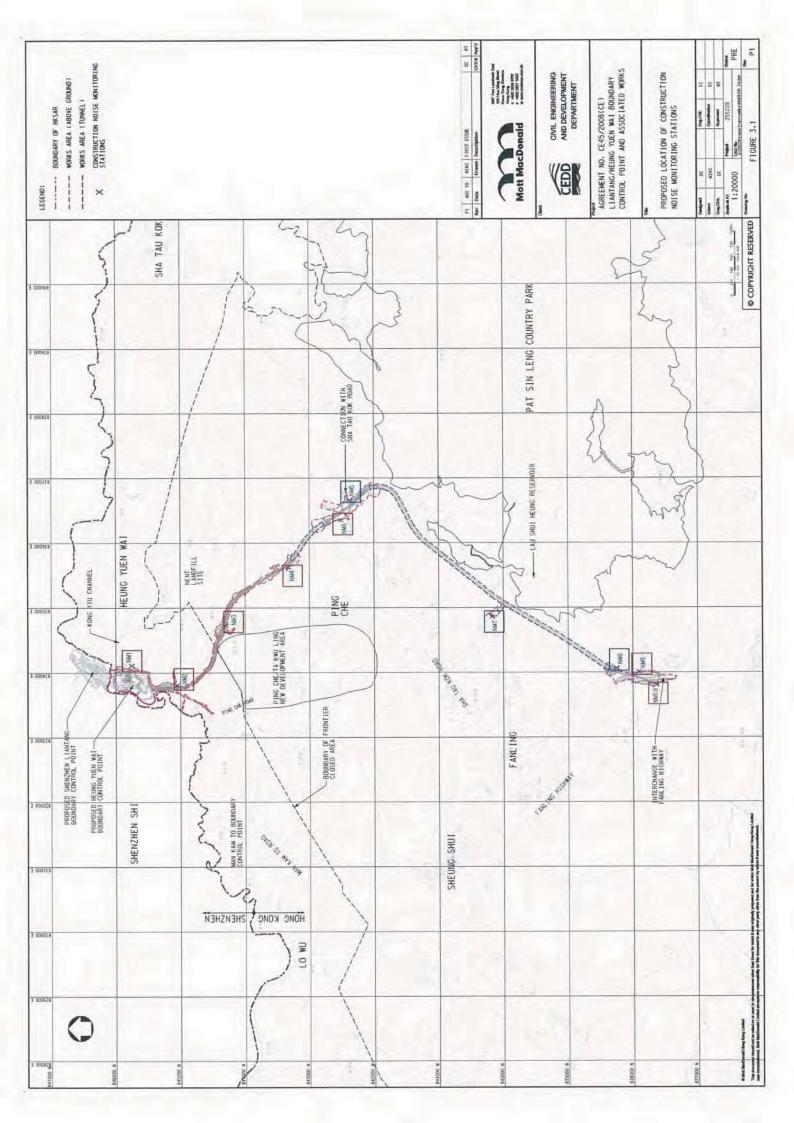
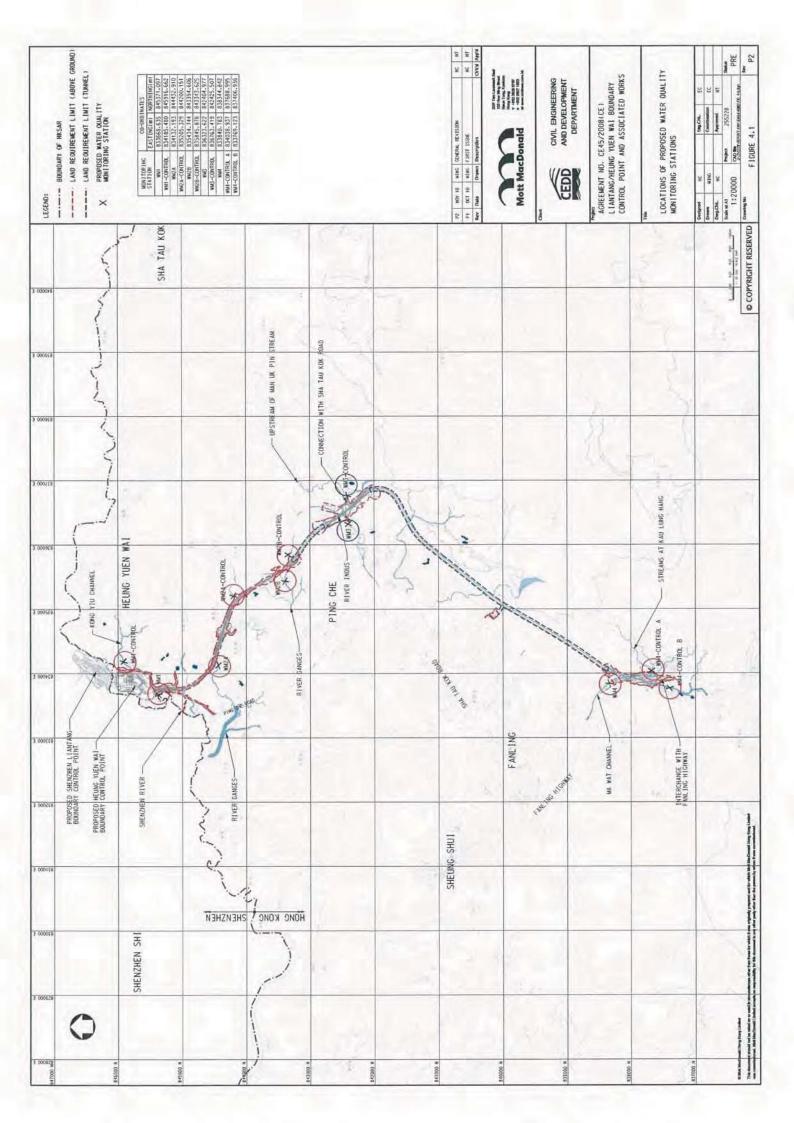
Designated Monitoring Locations as Recommended in the Approved EM&A Manual

3.3.1 The designated monitoring locations as recommended in the *EM&A Manual* are shown in *Appendix C*. As the access to some of the designated monitoring locations was questionable due to safety reason or denied by the landlords, alternative locations therefore have had proposed. The latest alternative monitoring locations has been updated in the revised EM&A Programme (Rev.7) which approved by EPD on 7 April 2017. Besides, Location AM1b was temporary suspended (24-hour TSP monitoring) since 27 April 2018 as the rented land was demolished and returned to the landlord. Alterative location to replaced AM1b is being seeking by ET for IEC and EPD approval. *Table 3-2*, *Table 3-3* and *Table 3-4* are respectively listed the air quality, construction noise and water quality monitoring locations for the Project and a map showing these monitoring stations is presented in *Appendix D*.
