JOB No.: TCS00694/13

**AGREEMENT NO. CE 45/2008 (CE)
LIANTANG/HEUNG YUEN WAI
BOUNDARY CONTROL POINT AND ASSOCIATED WORKS**

**ECOLOGICAL MONITORING REPORT FOR THE
WOODLAND COMPENSATION AREA
(DECEMBER 2020 TO FEBRUARY 2021)**

**PREPARED FOR
CIVIL ENGINEERING AND DEVELOPMENT
DEPARTMENT (CEDD)**

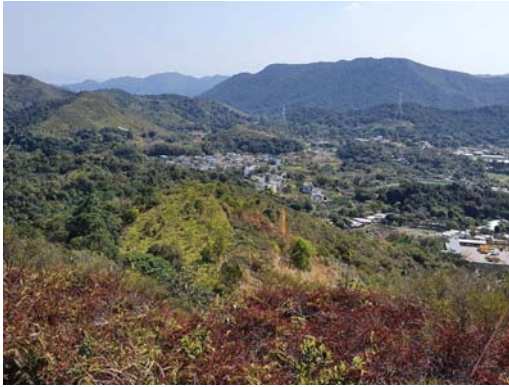
1. Eastern Ridgeline

- Signs of anthropogenic disturbance within the WCA were noted along the transect route on the hillslope and ridgeline of Cheung Shan, and snapped branches of woody plants, or damaged *Acacia mangium* trees, were frequently noted. On the other hand, vigorous growth of ground cover (especially the fern *Dicranopteris pedata*) has also noticed during the transect inspection, where planted woody seedlings would found shaded under the fond of the fern or leaves of other herbaceous plants.

- The tree species planted for the enhancement planting phase were only occasionally encountered* as single individual or in cluster along the transect on the hillslope, and found to be more abundant along the eastern ridgeline or near the bottom of the slope; and they are mostly appeared in fair condition with the tree *Schefflera heptaphylla*, *Reevesia thyrsoidea*, the shrubs *Melicope pteleifolia*, *Psychotria asiatica* and *Ilex asprella* appeared to be well established and generally in good condition.

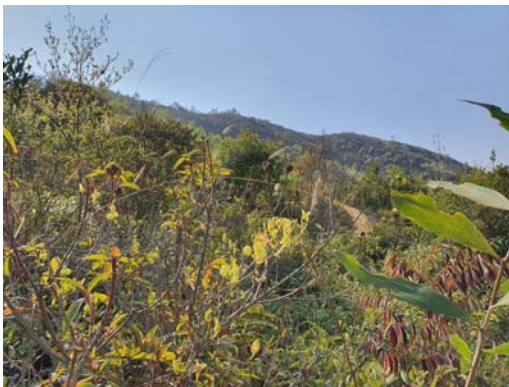
3. Hillslope of Cheung Shan

- The overall health condition of those species planted for the initial planting phase was generally fair, and the native species *Schima superba*, *Melastoma sanguineum*, *Rhodomyrtus tomentosa* and *Gordonia axillaris*, as well as the exotic *Acacia mangium*, were found in good condition. Re-sprouting of the deciduous *Phyllanthus emblica* has also be noted.

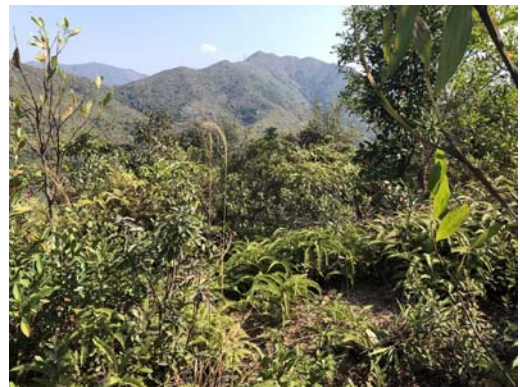
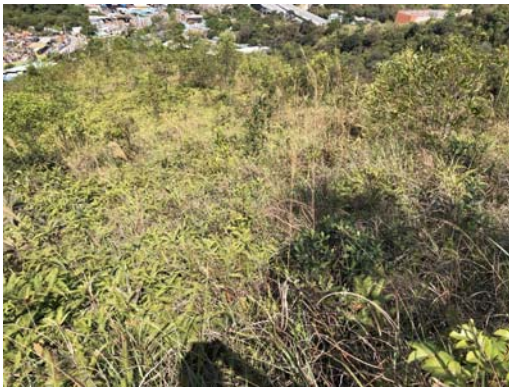
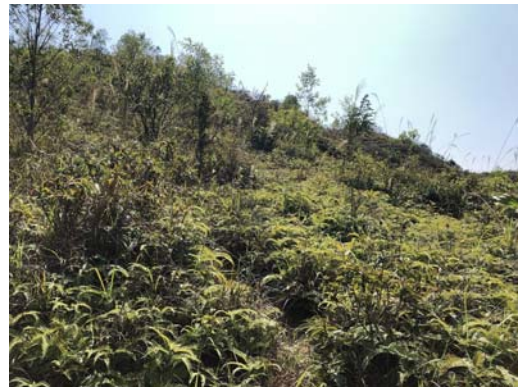
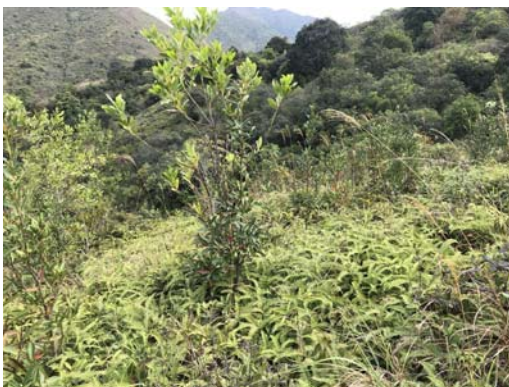
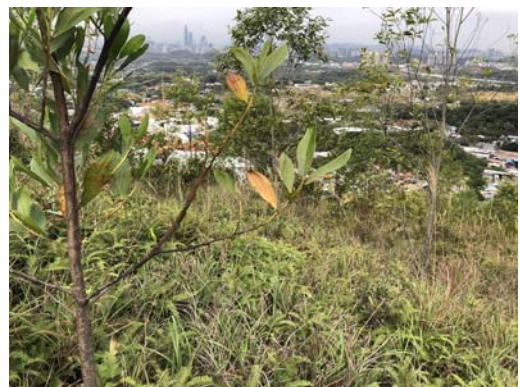
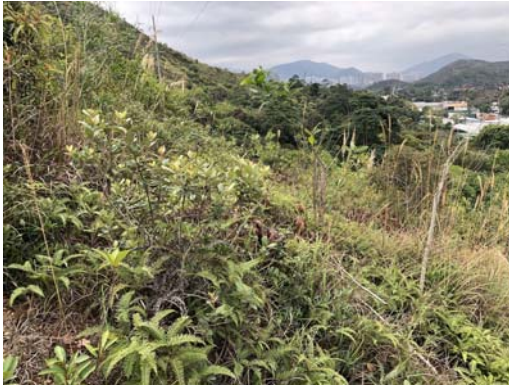
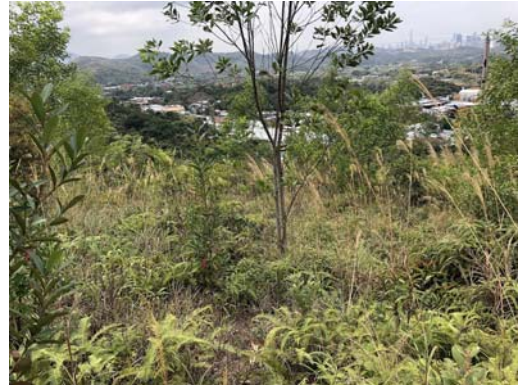
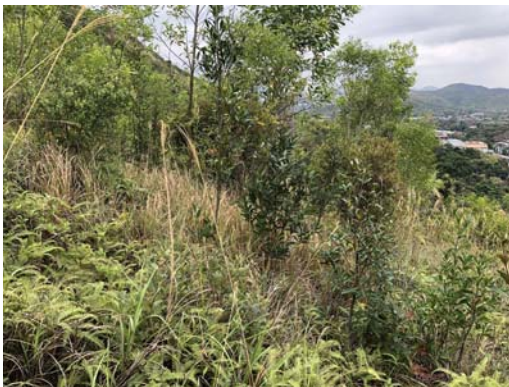
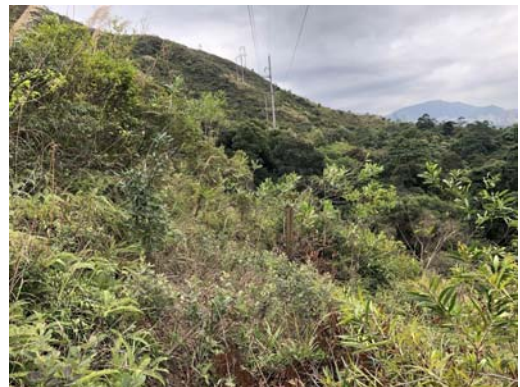
3.2.1 The nine 20m x 20m sampling quadrats have been placed within the planted area of the WCA, and at area where the majority of the seedlings were planted and considered suitable for long term monitoring; in which 2 of them were located on the ridgeline and the rest are located on the north-facing slope of Cheung Shan (see **Appendix C**). The quadrat monitoring was conducted on **22nd and 23rd February 2021**, and the weather was dry and sunny on both days. **Appendix D** illustrates the condition of the quadrats during the time of monitoring.

- Health condition: Generally speaking, the health condition of the seedlings planted for the initial or enhancement phase within the quadrats was found either in fair or good condition.

- As a whole, except 6 species recorded with > 80% survival rate (, i.e., *Castanopsis fissa*, *Litsea glutinosa*, *Mallotus paniculatus*, *Schima superba*, *Rhaphiolepis indica* and *Rhodomyrtus tomentosa*), as well as the *Melastoma sanguineum* recorded with a survival rate of 71.8%, the remaining 23 species all recorded with a survival rate below 70% during the monitoring period.

- The overall decrease in survival rate of the planted species during the monitoring period may due to the excessive desiccation stress resulted from the exceptional warm and sunnier weather in Hong Kong in Dec '20 to Feb '21, as well as the much drier and limited rainfall in Dec '20 and Jan '21. Nonetheless, it has already speculated that the poor survival rate of those species planted for enhancement planting may due to the poor vigor of the planted seedlings or poor recovery of the seedlings from the transplanting shock, especially under the unusual drier weather in Hong Kong since the seedlings was planted in Sep '19 as well as during the growing season in 2020.

- Regardless whether the poor survival rate of those species recorded with survival rate <70% is related to usual drier weather condition, or the seedlings were out-competed by other self-established or planted woody plants, the updated replanting arrangements as detailed in Table 6 and 7 below are recommended, in which *Schima superba* has been recommended to substitute *Sapium discolor*. The necessity for the replanting of the *Gordonia axillaris*, which is one of the species well-established under the planting program, will be further reviewed from future monitoring. On the other hand, action for both *Acacia sp.* would not be unnecessary as they were planned for thinning in the planting program.

- The Contractor would be responsible for implementing action of replanting and other remedial measures agreed by AFCD. All of the replanting works should make reference and conform to the Section 5 “Planting Management” of the approved Woodland Compensation Plan (WCP), in particular it should be undertaken within the planting season and in suitable planting area based on their habitat/micro-habitat requirements, and should not be shaded from adjacent plants to avoid competition for light and other resources.

- Finally, with respect to the timing of this reporting and the replanting program, it is recommended to carry out the replanting work at the onset of growing season, i.e., March 2021 as such to safeguard and increase the chance of recovery of the planted seedlings from the transplanting shock, and hence the survival rate of the planted seedlings.
