**AGREEMENT NO. CE 45/2008 (CE)
LIANTANG/HEUNG YUEN WAI
BOUNDARY CONTROL POINT AND ASSOCIATED WORKS**

**MONITORING REPORT FOR WETLAND
COMPENSATION AREA (No.1) – OCTOBER 2020**

**PREPARED FOR
CIVIL ENGINEERING AND DEVELOPMENT DEPARTMENT**

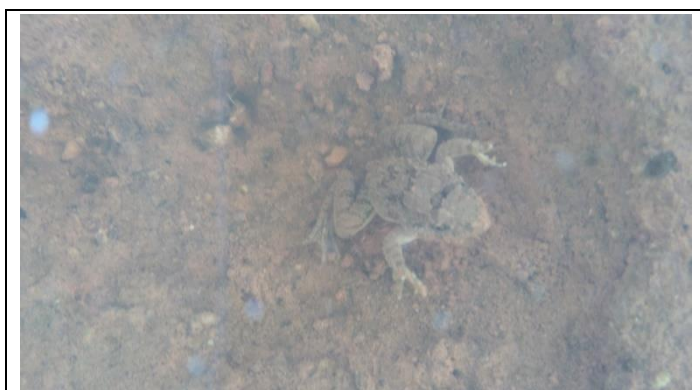
3.1.6 In the Reporting Month during day time survey, the monitoring did not record any amphibian larvae within the WCA, but a single Paddy Frog 澤蛙 *Fejervarya limnocharis* was found in Pond D (*Photo 1*).

Photo 1: Recorded Amphibian Paddy Frog 澤蛙 *Fejervarya limnocharis* in Pond D.

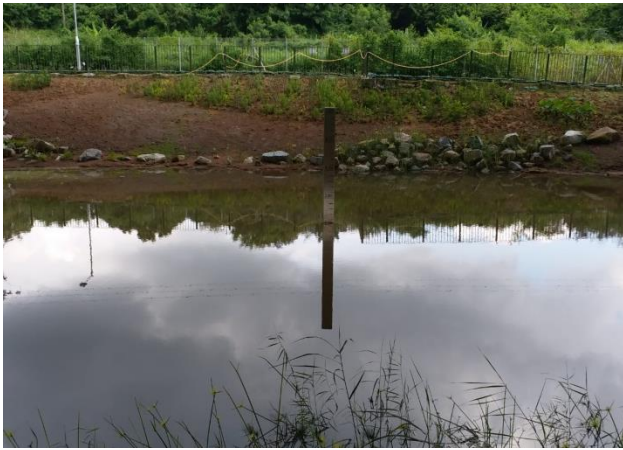
Ponds A

3.3.1 Site inspection for the establishment of WCA was conducted by ET on 7th, 14th, 21st and 29th **October 2020**. The conditions of WCA were general in order and no sign of flooding/ storm damage observed. Photographic records for the WCA are shown in *Appendix C*.
