**AGREEMENT NO. CE 45/2008 (CE)  
LIANTANG/HEUNG YUEN WAI  
BOUNDARY CONTROL POINT AND ASSOCIATED WORKS**

**MONITORING REPORT FOR WETLAND  
COMPENSATION AREA (No.2) –NOVEMBER 2020**

**PREPARED FOR  
CIVIL ENGINEERING AND DEVELOPMENT DEPARTMENT**

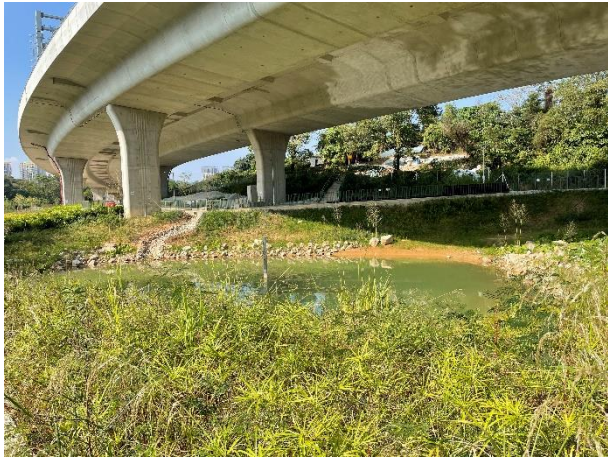
Ponds A

3.3.1 Site inspection for the establishment of WCA was conducted by ET on 4<sup>th</sup>, 11<sup>th</sup>, 19<sup>th</sup> and 26<sup>th</sup> **November 2020**. The conditions of WCA were general in order and no sign of flooding/ storm damage observed. Photographic records for the WCA are shown in *Appendix C*.
